# Mega Washing & Dyeing Ltd

BK Bari, Taltoli, Hotapara, Mirzapur, Gazipur

06<sup>th</sup> March, 2017

# Observations

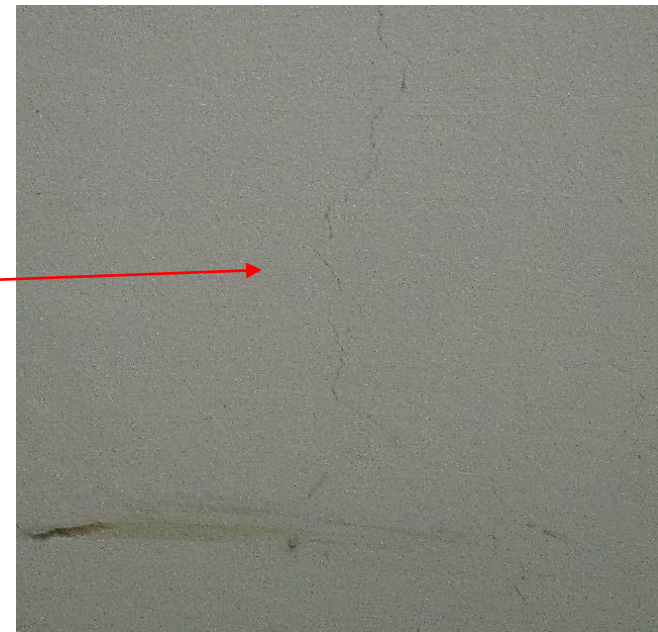
Cracking to soffit of 1<sup>st</sup> floor slab

Hairline cracking was observed on the soffit of 1<sup>st</sup> floor slab in several location. Building Engineer to investigate extend of crack and suggest remedial actions as required.

| Item No. | Observation | Recommended Action Plan | Recommended Timeline |
|---|---|---|---|
| 1 | Production Building<br>Hairline cracking on 1st floor slab soffit | Building Engineer to monitor cracks at slab soffit. | 6-weeks |
| 2 | Production Building<br>Hairline cracking on 1st floor slab soffit | Building Engineer to investigate the extend of crack, if cracks are only in the plaster. | 6-weeks |
| 3 | Production Building<br>Hairline cracking on 1st floor slab soffit | Building Engineer to advise remedial actions(if required). | 6-months |

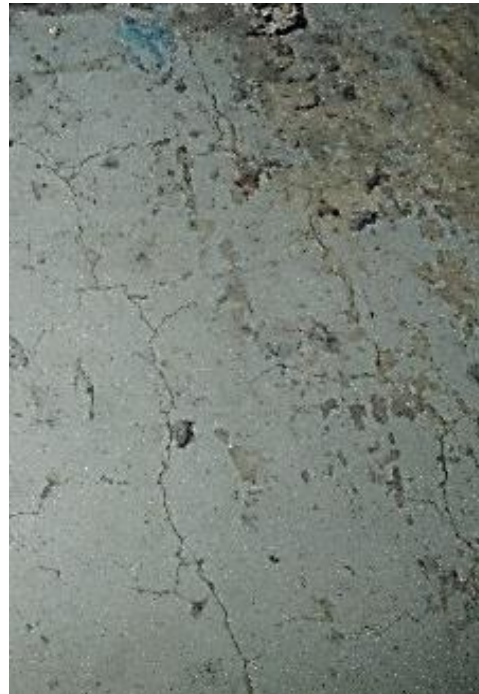
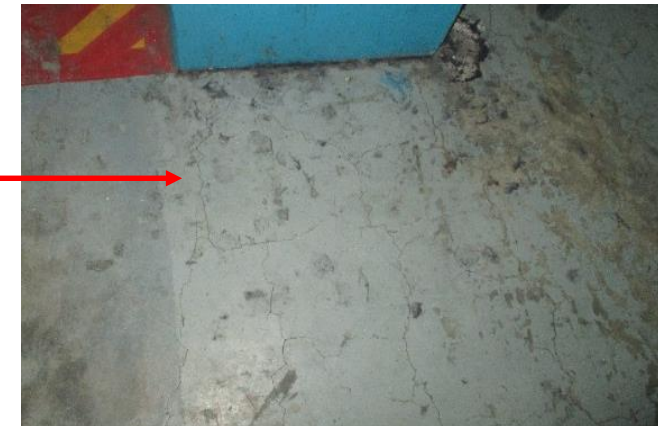
Cracking to soffit of 1<sup>st</sup> floor slab

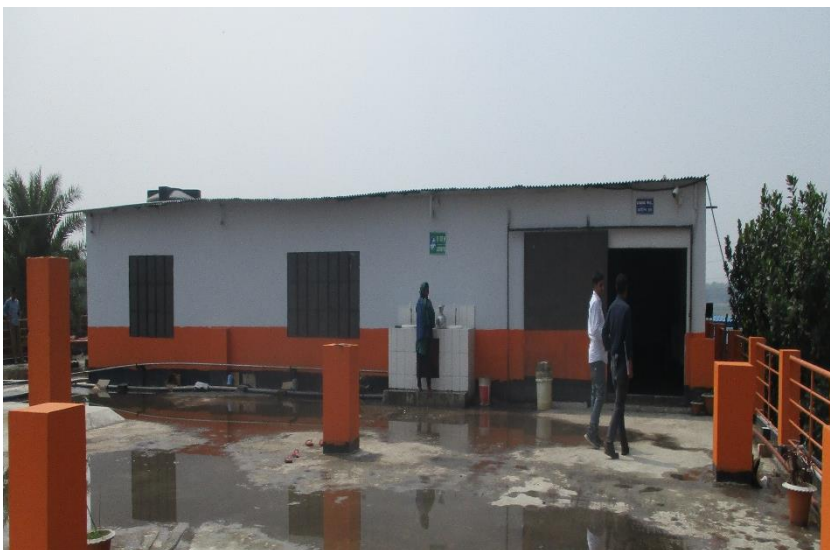
Apparently non-engineered steel shed

There is no structural drawings and documents of steel shed. Additionally connections were appeared to be inadequate. Which made the stability of the shed questionable. Factory engineer to check the adequacy of connections as well as the structural member against vertical and wind load.

| Item No. | Observation | Recommended Action Plan | Recommended Timeline |
|---|---|---|---|
| 4 | Production Building:<br>Apparently inadequate connections of steel shed on roof | Building engineer to check the adequacy of connections for roof top shed. | 6-weeks |
| 5 | Production Building:<br>Apparently inadequate connections of steel shed on roof | Building engineer to confirm satisfactory structural performance of the shed under lateral loading. | 6-weeks |
| 6 | Production Building:<br>Apparently inadequate connections of steel shed on roof | Remedial works to be carried out if required. | 6-months |

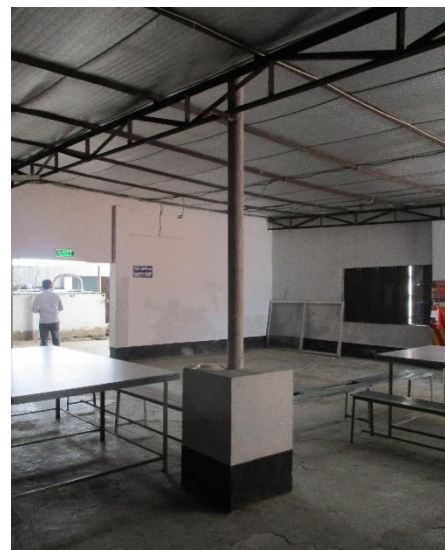
Truss to pipe connections

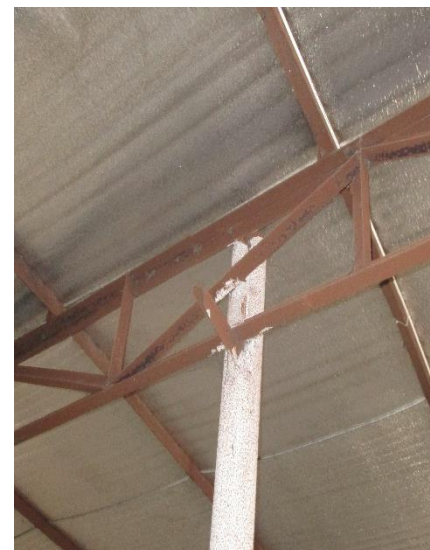
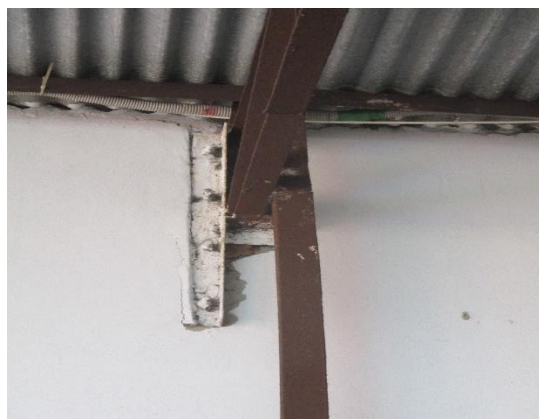
Connection with wall

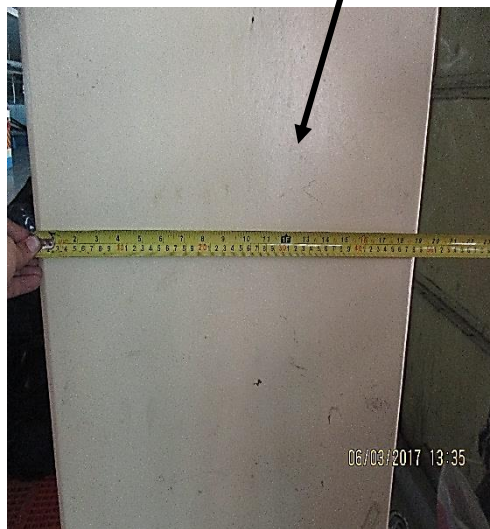
C2 type column

Dimensions of all columns were found 480mmX480mm with render on 1<sup>st</sup> floor where column schedule indicates that the dimensions of C1 type column should be 500mm x 500mm and C2 type should be 450mmx 450mm

| Item No. | Observation | Recommended Action Plan | Recommended Timeline |
|---|---|---|---|
| 7 | Production Building:<br>Discrepancy between as built drawing and site observation | Building engineer to survey the whole shed and produce as-built documentation reflecting the as constructed condition. | 6-weeks |
| 8 | Production Building:<br>Discrepancy between as built drawing and site observation | Prepare calculations showing the structural adequacy of the column taking into account the imposed loading. | 6-weeks |
| 9 | Production Building:<br>Discrepancy between as built drawing and site observation | Remedial works to be carried out if required. | 6-months |

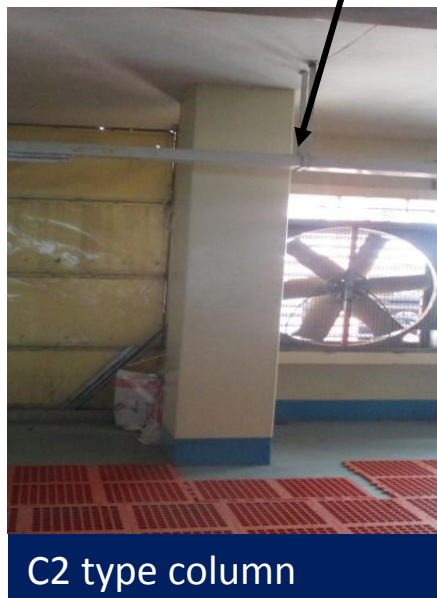
From the column schedule of as-built structural drawing C2 type column has 4no's rebar at each side. But from ferro scanning Image it was confirmed that there is 3 no's of rebar in each side of this type of column.

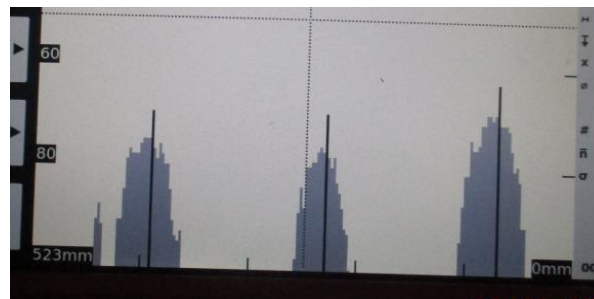
3 nos. bar was found on each side with ferro scanning.

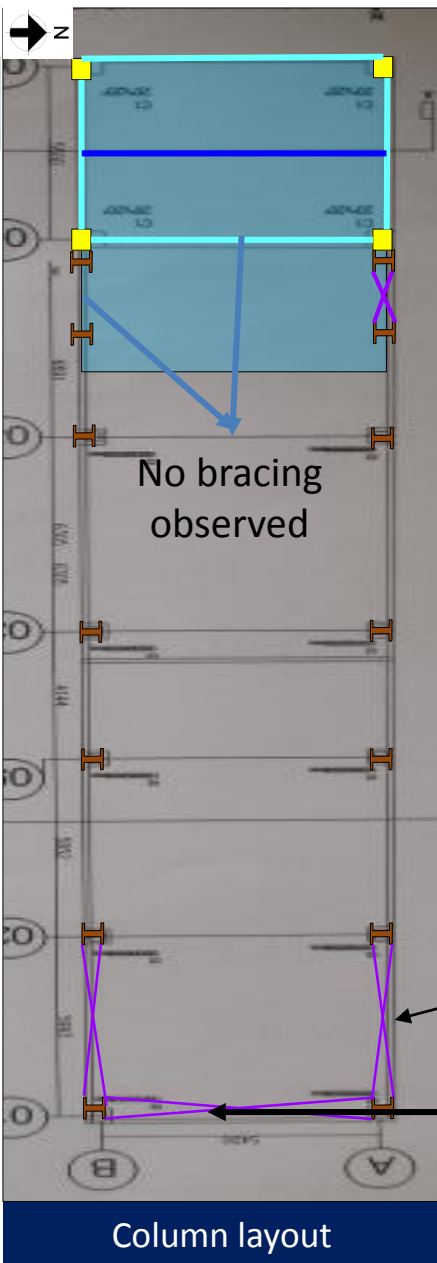
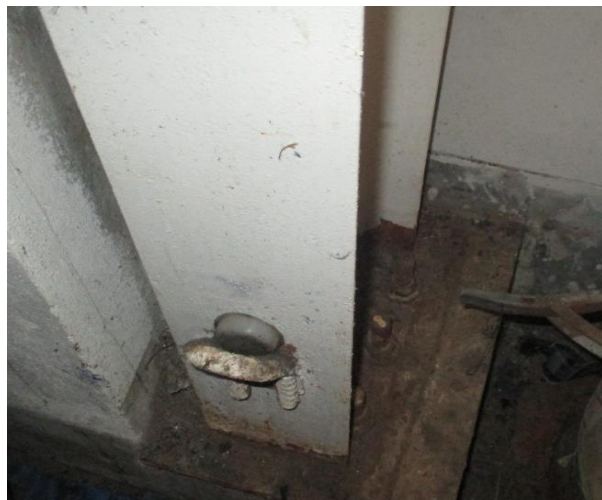
Corroded steel column at support.

Vertical bracings were found untied and loosely connected with columns. Bracings were missing at west side of the structure. Corrosion were observed at support of the columns. Factory engineer to review the design for lateral stability and suggest proper remedial action regarding corrosion and stability.

| Item No. | Observation | Recommended Action Plan | Recommended Timeline |
|---|---|---|---|
| 11 | Utility Shed:<br>Untied bracings and Corrosion in Structural steel section | Building Engineer to check the extend of corrosion in the structural member and suggest appropriate remedial actions where required. | 6-weeks |
| 12 | Utility Shed:<br>Untied bracings and Corrosion in Structural steel section | Remedial works to be carried out. | 6-months |

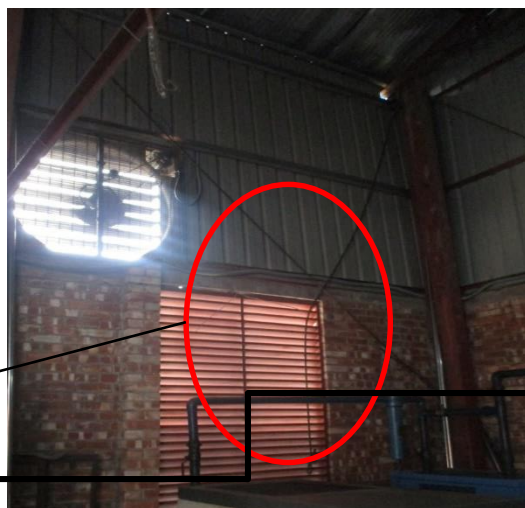
Untied vertical bracings at North side

| Item No. | Observation | Recommended Action Plan | Recommended Timeline |
|---|---|---|---|
| 10 | Utility Shed:<br>Untied bracings and Corrosion in Structural steel section | Building Engineer to check the bracing system and stability of the structure against lateral load. | 6-weeks |

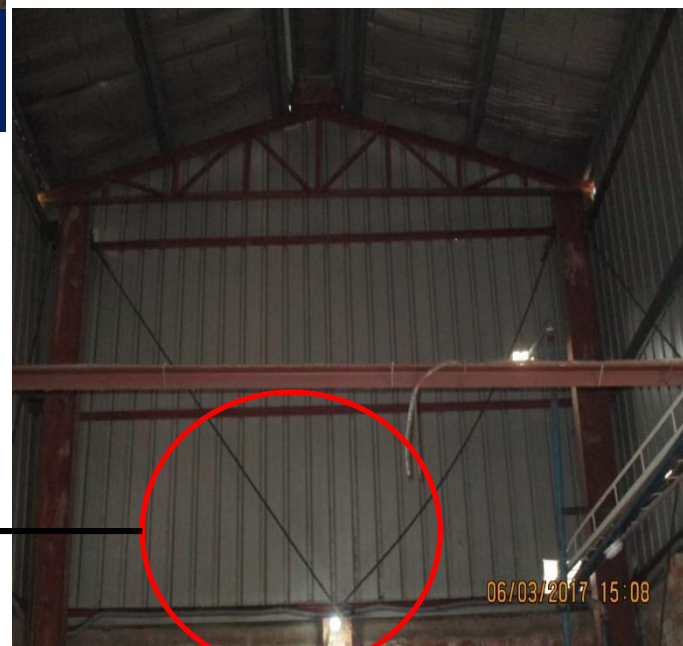
Untied and loose vertical bracing at east side.

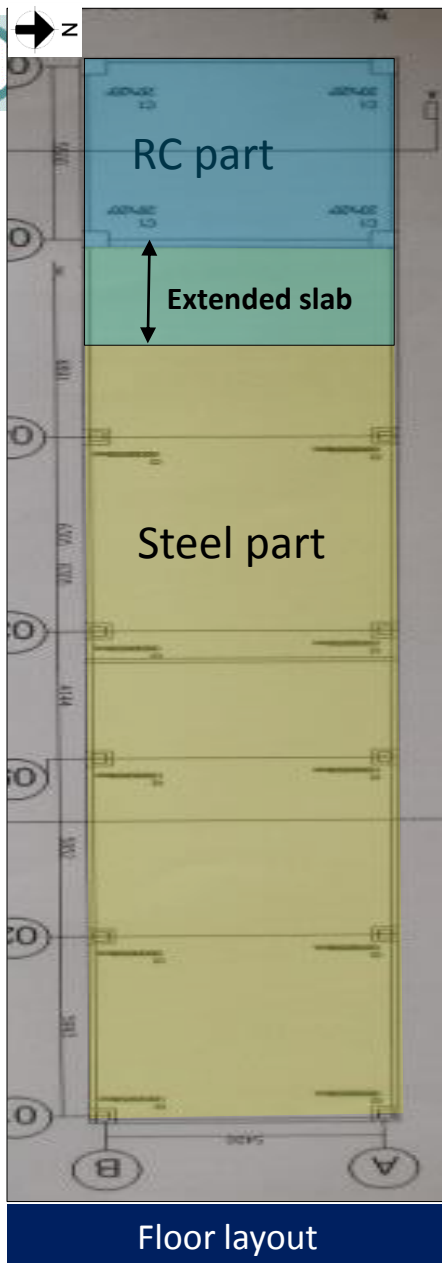
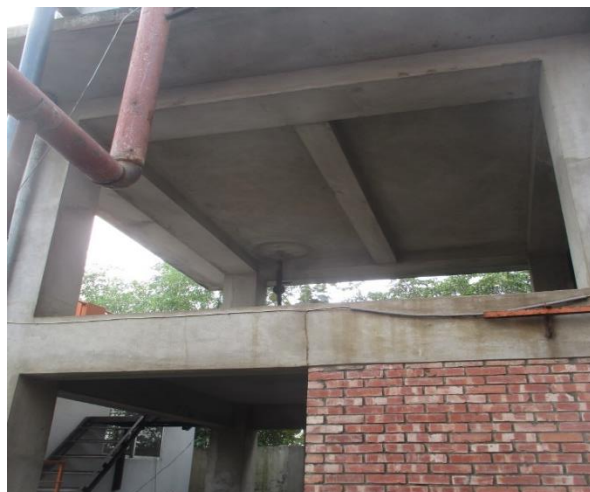
A two storied RC part of utility shed.

Two storied RC part including 4.7m extension of slab was not included in drawings. Additionally bracings and connection details for steel part of utility shed were not available.

Factory engineer need to produce a set of as-built drawings considering actual condition.

| Item No. | Observation | Recommended Action Plan | Recommended Timeline |
|---|---|---|---|
| 13 | Utility Shed:<br>Missing information's in provided drawings | Building engineer to survey the whole shed and produce as-built documentation reflecting the as constructed condition. | 6-weeks |

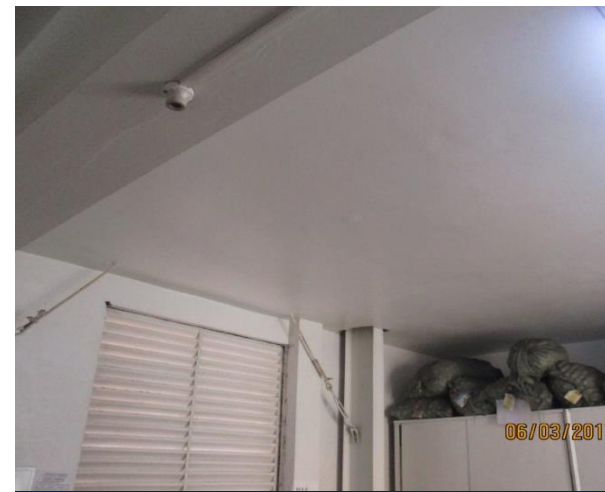
4.7m extension of RC slab supported on load bearing wall at east side.

| Item No. | Observation | Recommended Action Plan | Recommended Timeline |
|---|---|---|---|
| 14 | Utility Shed:<br>Missing information's in provided drawings | Prepare calculations showing the structural adequacy of the extended slab taking into account the imposed loading. | 6-weeks |

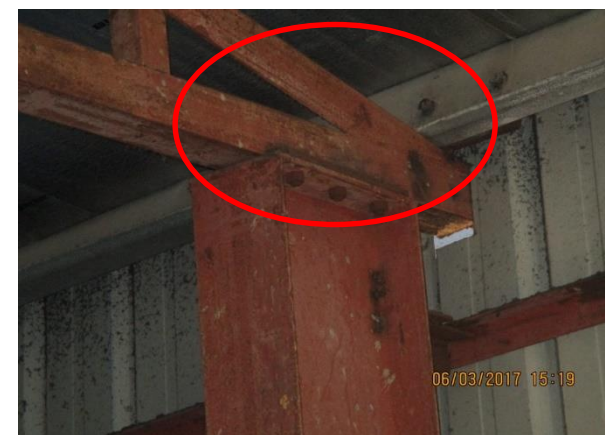
Bolted connection between steel truss and column.

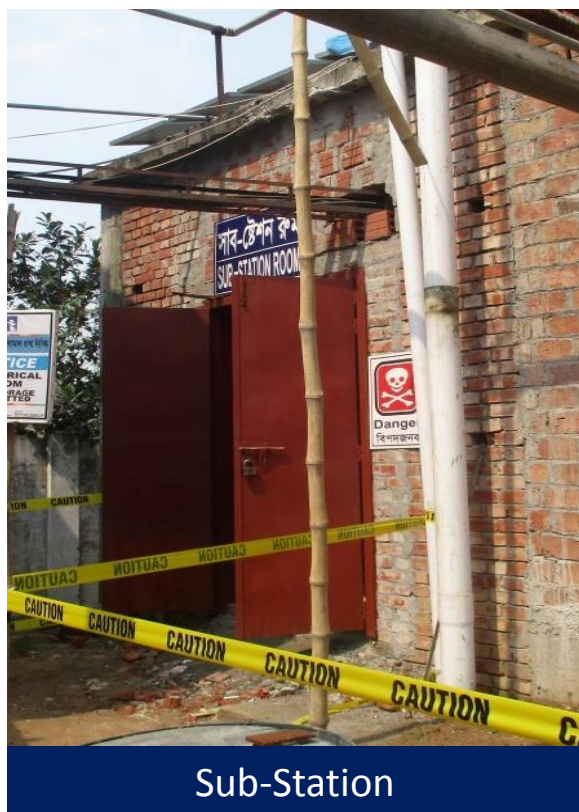
Sub-Station

No drawings & documents or information's were available on site. Factory engineer is required to prepare a full set of as-built drawing.

| Item No. | Observation | Recommended Action Plan | Recommended Timeline |
|---|---|---|---|
| 16 | Sub-station, Doctor & Childcare Building:<br>Missing drawings and documents | Building engineer to survey the whole structure and produce as-built documentation reflecting the as constructed condition. | 6-weeks |
