# Lintas Bangladesh Co. Ltd

Adamjee EPZ, Siddhirganj  
(23.677561, 90.525548)  
27<sup>th</sup> April, 2017

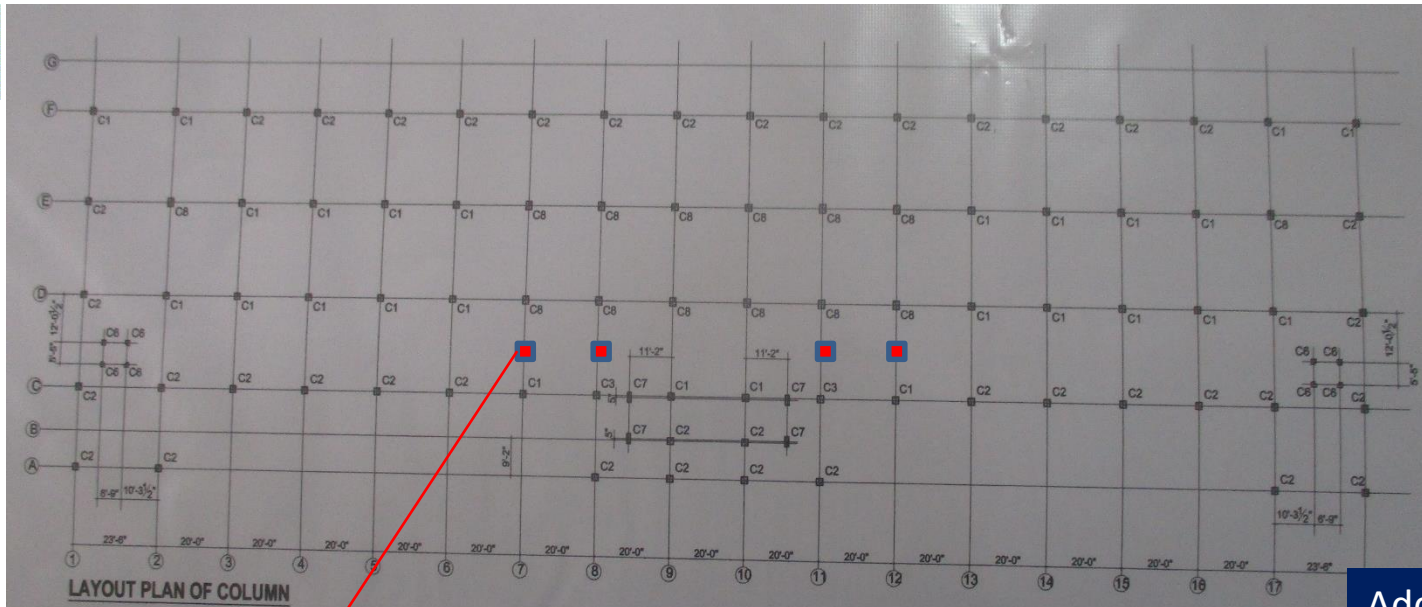
Column layout plan.

**Foundation system of additional columns are required to verify**

■ Additional Column of 300X300 mm.

Additional columns have observed in highlighted area. No foundation system is shown on drawings for those additional columns. So the load path and foundation system of the columns are required to investigate by factory engineer.

| Item No. | Observation | Recommended Action Plan | Recommended Timeline |
|---|---|---|---|
| 1 | Foundation system of additional columns are required to verify | Building Engineer is required to investigate the foundation system of the additional columns. Also load path of the additional columns are required to verify. | 6-weeks |
| 2 | Foundation system of additional columns are required to verify | Update the drawings considering additional columns. | 6-weeks |

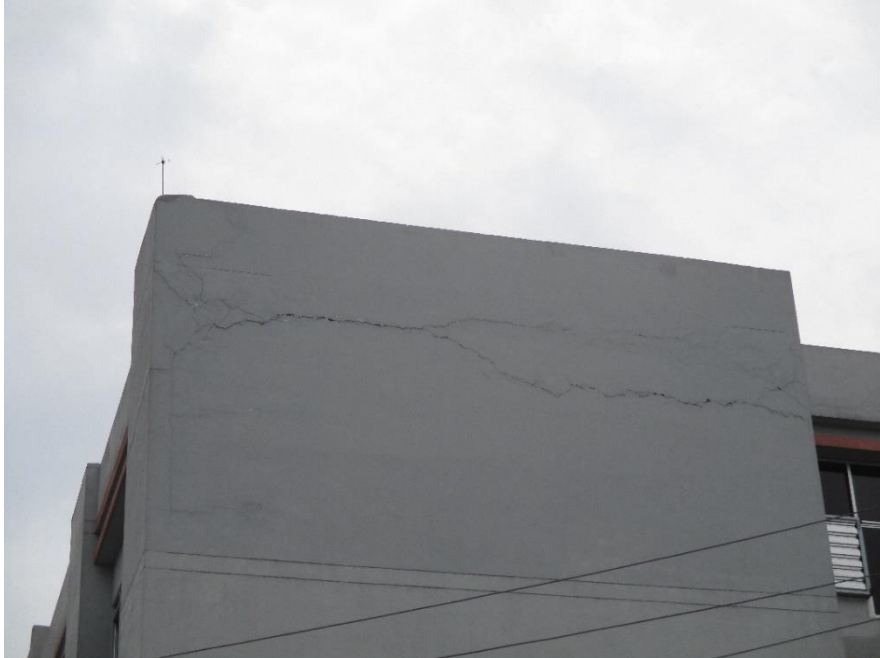
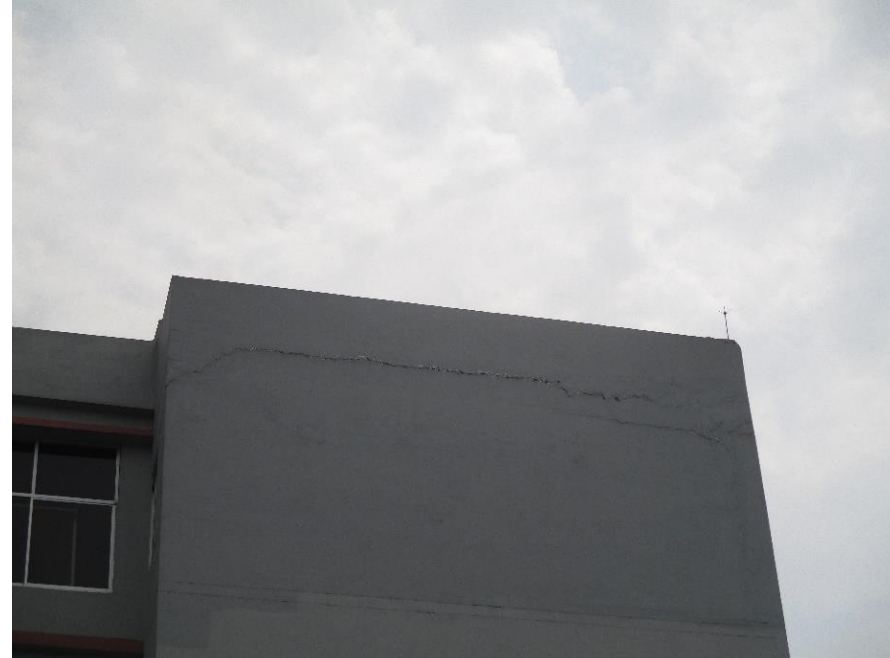
**Cracks on façade walls.**

Cracks were observed on façade walls. Building engineer to investigate the reason of cracks.

| Item No. | Observation | Recommended Action Plan | Recommended Timeline |
|---|---|---|---|
| 3 | Cracks on façade walls | Building engineer is required to investigate the reason of cracks on façade walls. | 6-weeks |
| 4 | Cracks on façade walls | Carry out suitable repair works as per investigation report. | 6-months |

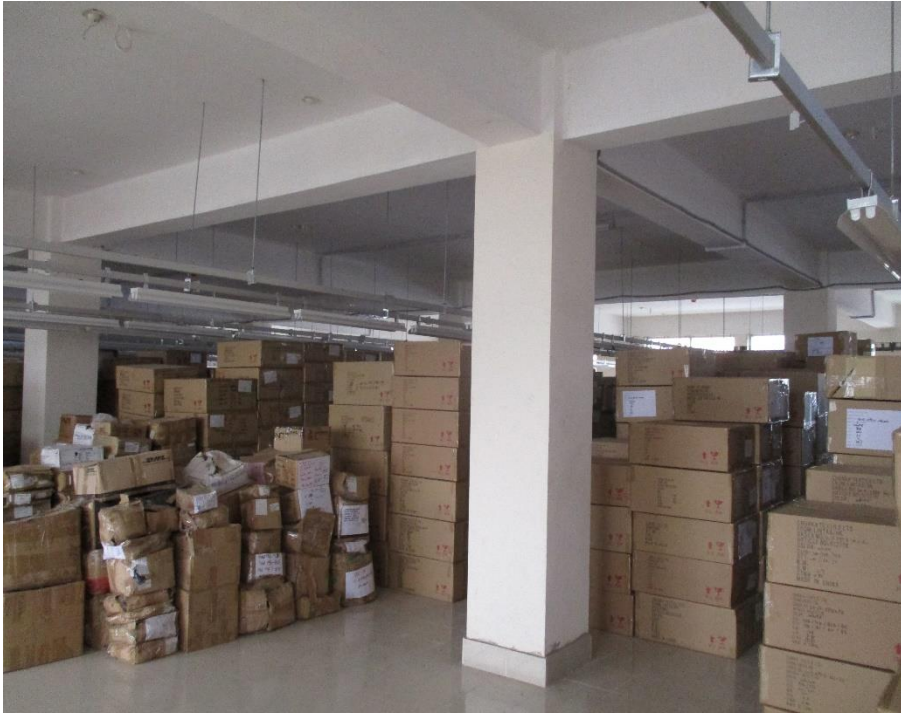
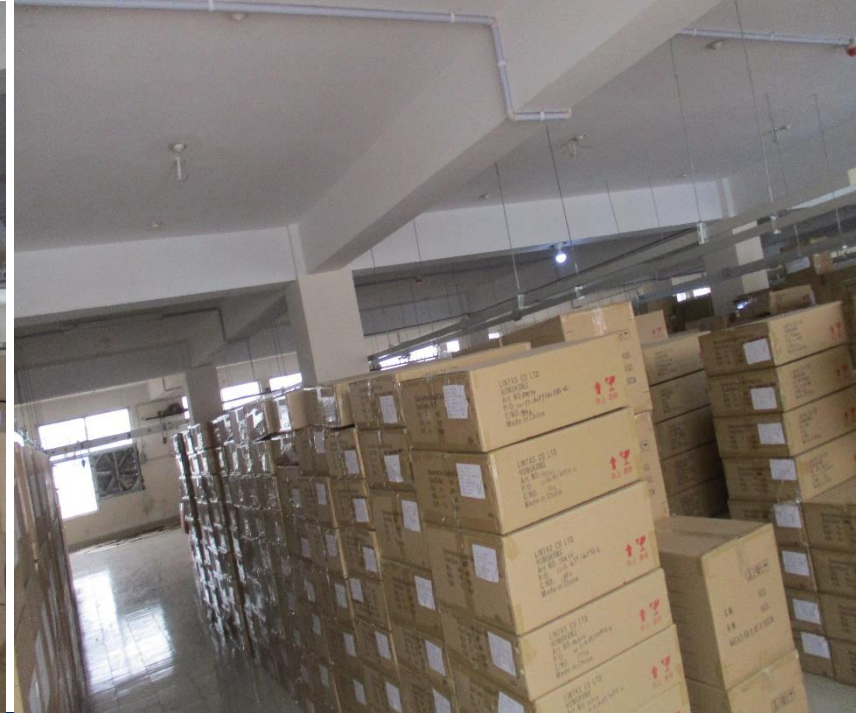
**Implement floor load management program.**

No load management programs were observed. Factory is required to implement load management program as per its floor loading capacity and follow the load plans for all floors of the building and make sure that the workers understand the loading requirements.

| Item No. | Observation | Recommended Action Plan | Recommended Timeline |
|---|---|---|---|
| 5 | Implement floor load management program | Factory is required to implement load management program as per its floor loading capacity. | 6-weeks |
| 6 | Implement floor load management program | Follow the load plans for all floors of the buildings and make sure that the workers understand the loading requirements. | 6-months |

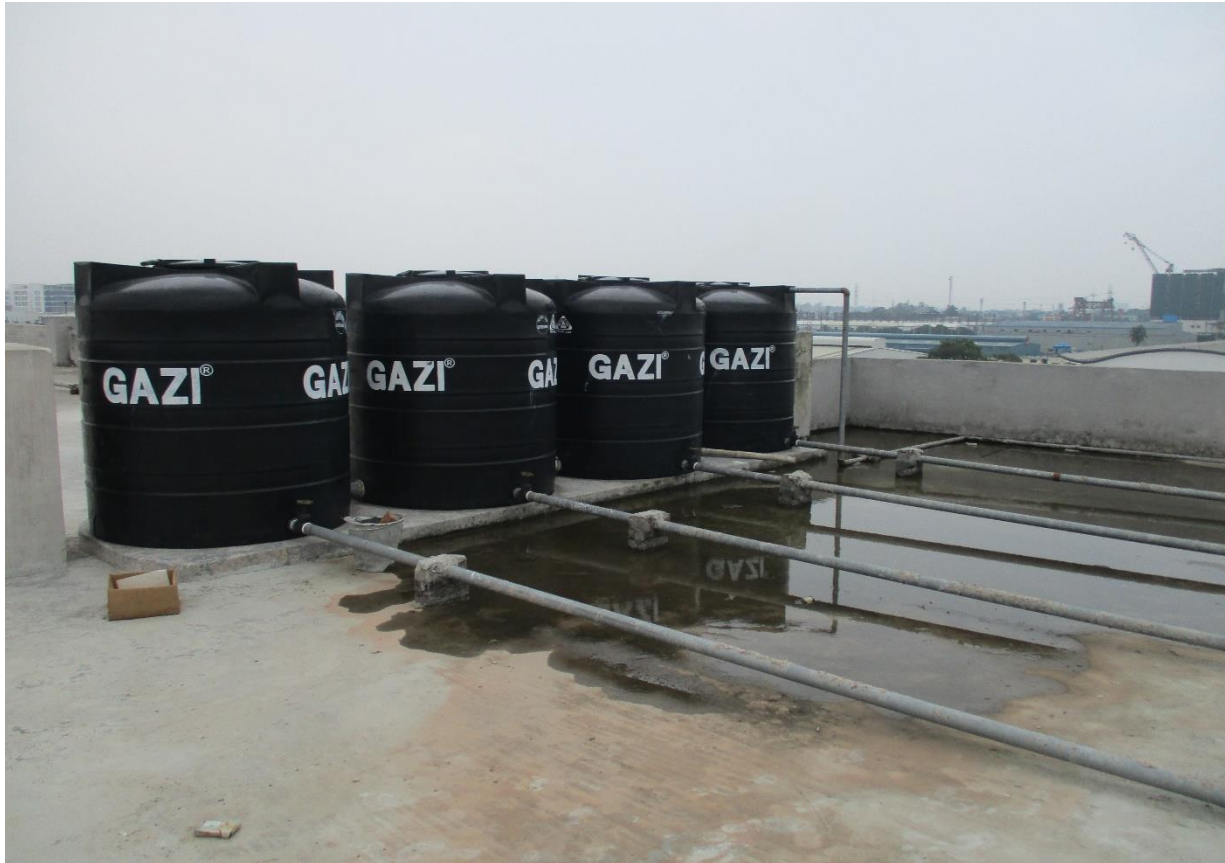
# Water ponding at roof

Water ponding was observed at roof. No water proofing layer and proper drainage system was observed on roof.

Water ponding on main factory building roof

| Item No. | Observation | Recommended Action Plan | Recommended Timeline |
|---|---|---|---|
| 7 | Water ponding at roof | Roof slab drainage system should be investigated and improved | 6-months |

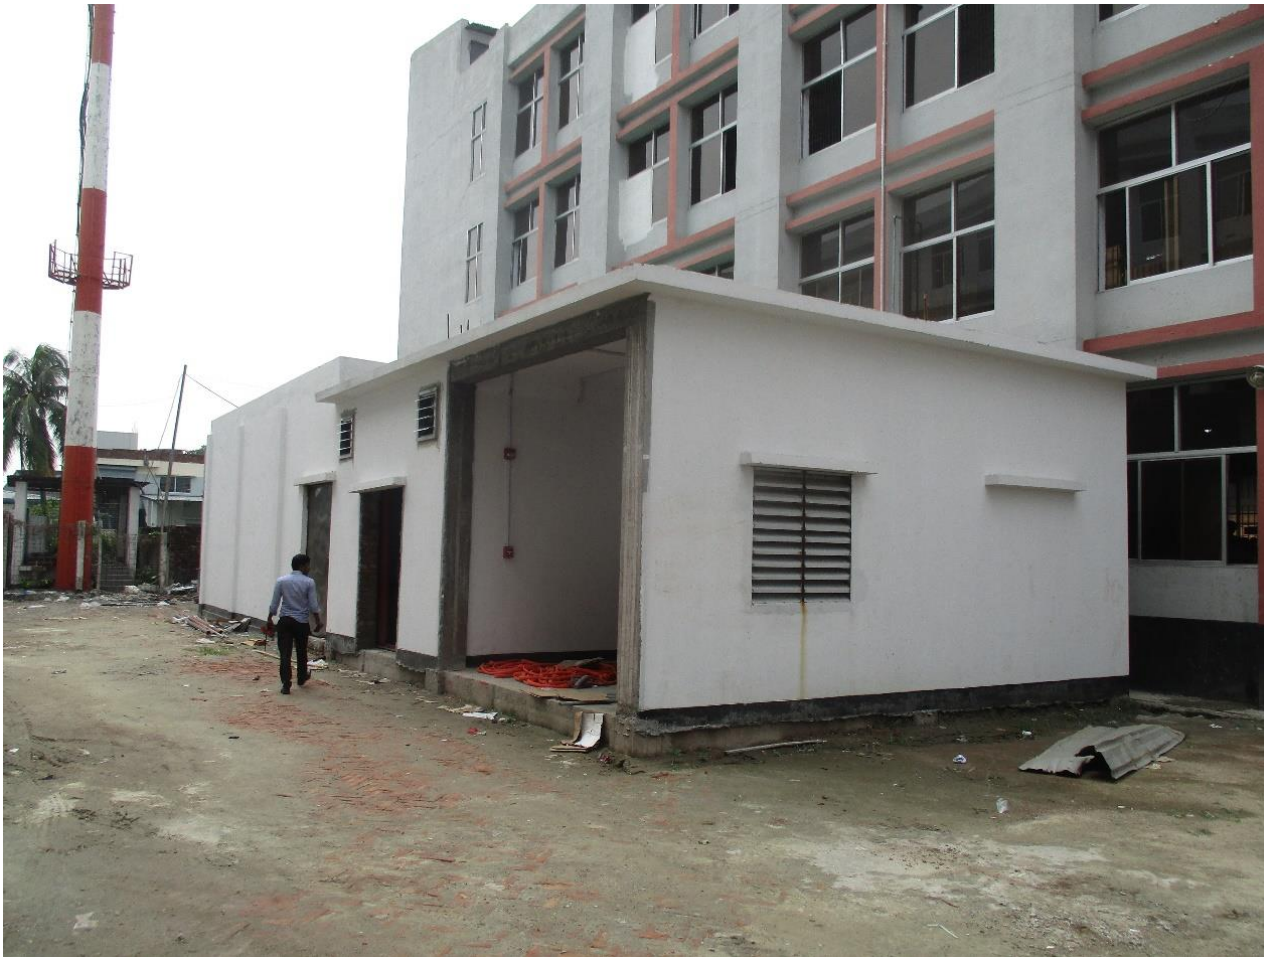
**No as built drawings were available for the  
single storey structures**

No as built drawings were available on site for utility building and wastage shed for review. Building engineer is required to produce as built drawings for the structures.

| Item No. | Observation | Recommended Action Plan | Recommended Timeline |
|---|---|---|---|
| 8 | No as built drawings were available for the single storey structures | Produce as built drawings for single storey structures | 6-weeks |
