# Dekko Knitwear Ltd

Plot # I/5, I/7, I/9, I/11 and I/13, Road # 6, Section-7, Mirpur, Dhaka  
(23.819708, 90.364331)  
16<sup>th</sup> May, 2017

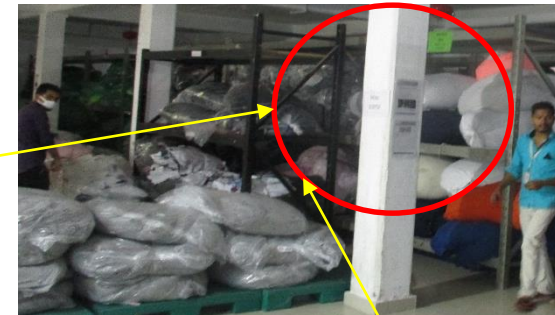
Floor load plan

Live load plan of 3kpa(63psf)  
not maintain properly

No load management programs were visible except post of load plan. Factory is required to implement load management program as per its floor loading capacity and Follow the load plans for all floors of the buildings and make sure that the workers understand the loading requirements.

| Item No. | Observation | Recommended Action Plan | Recommended Timeline |
|---|---|---|---|
| 1 | Implement floor loading management program | Factory is required to implement load management program as per its floor loading capacity. | 6-weeks |
| 2 | Implement floor loading management program | Follow the load plans for all floors of the buildings and make sure that the workers understand the loading requirements. | 6-months |

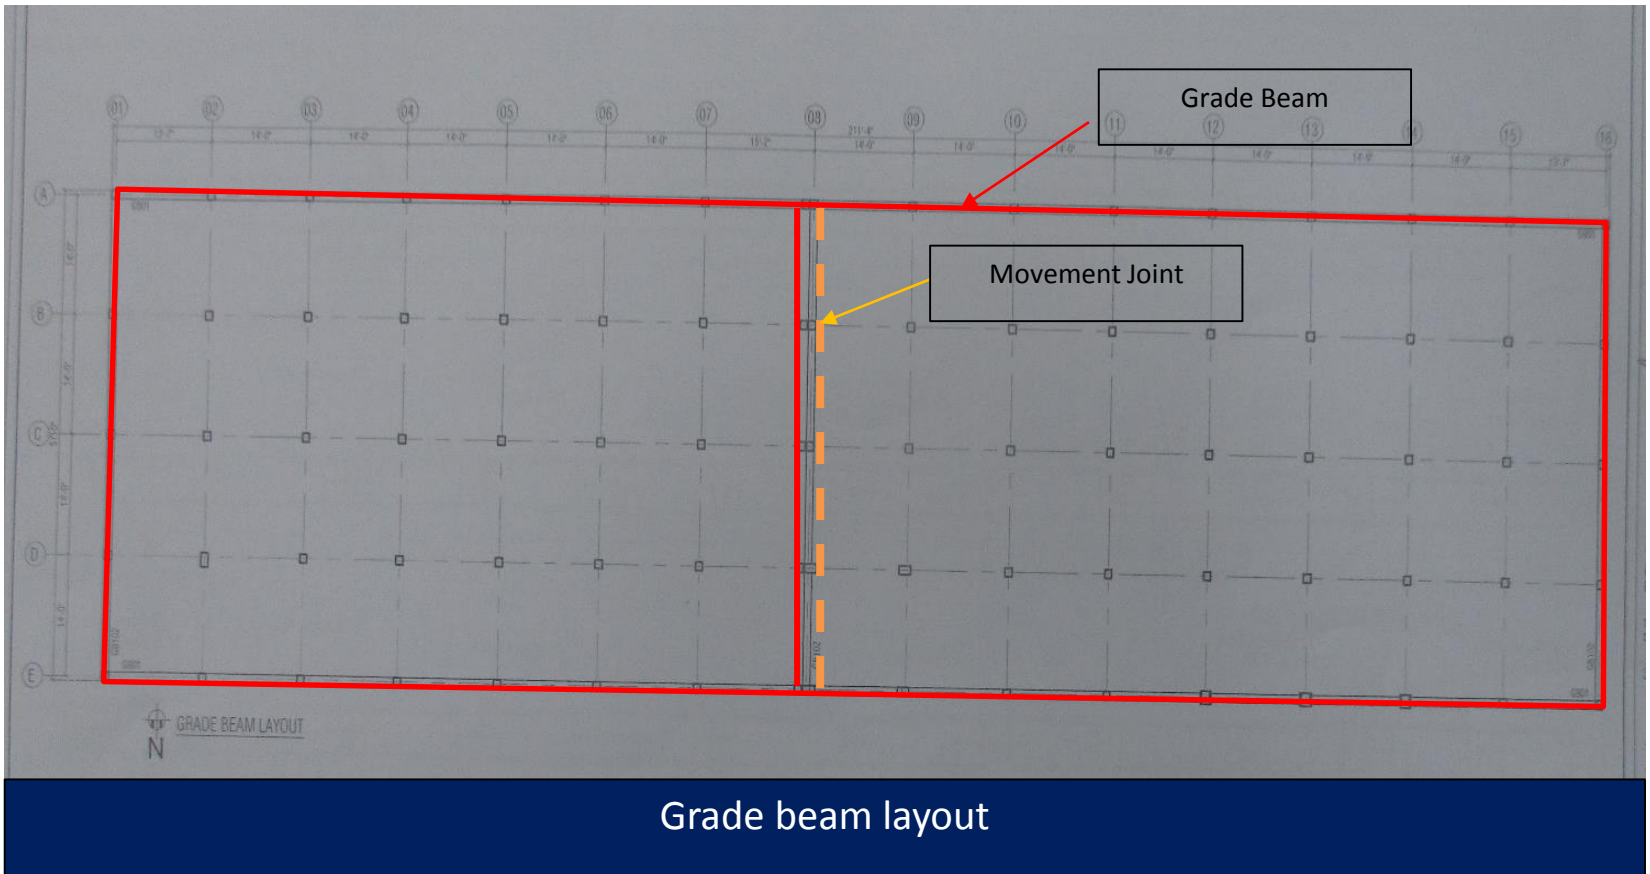
There is no grade beams for internal grids, grade beam exists only in periphery as per provided drawings. Apparently slenderness effect may act on the internal columns. Building engineer is required check the slenderness effect of those columns.

| Item No. | Observation | Recommended Action Plan | Recommended Timeline |
|---|---|---|---|
| 3 | Check the slenderness effect of internal columns | Building engineer is to check the slenderness effect of internal columns by further reviewing the existing DEA report with Accord. | 6-weeks |
| 4 | Check the slenderness effect of internal columns | Carryout necessary remedial works where necessary. | 6-months |
