# Epyllion Style Ltd.(Extension Project)

Nayapara, Vhawal Mirzapur, Gazipur Sadar, Gazipur-1703.

23<sup>rd</sup> April 2017

# Observation

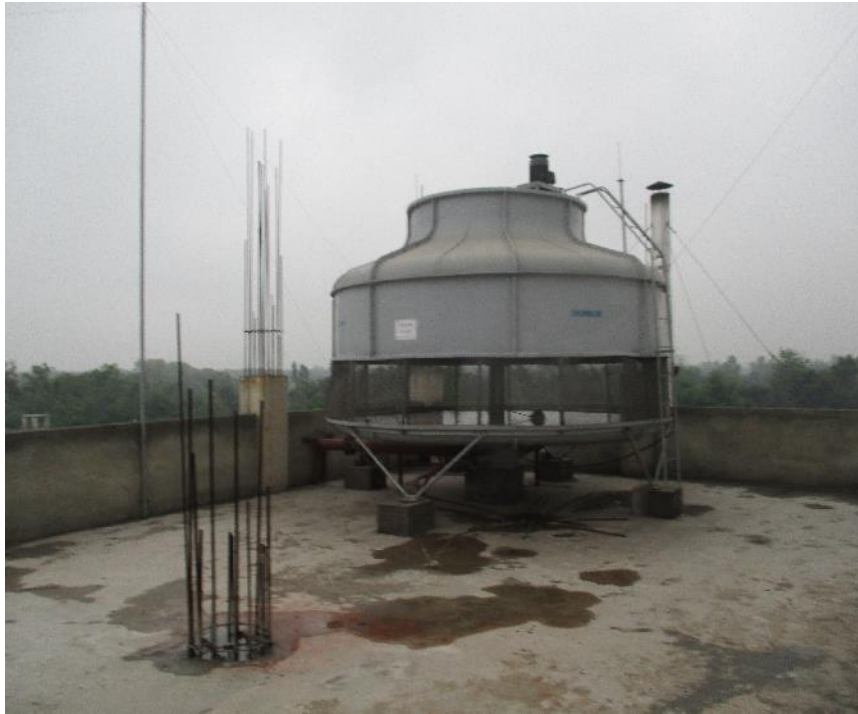
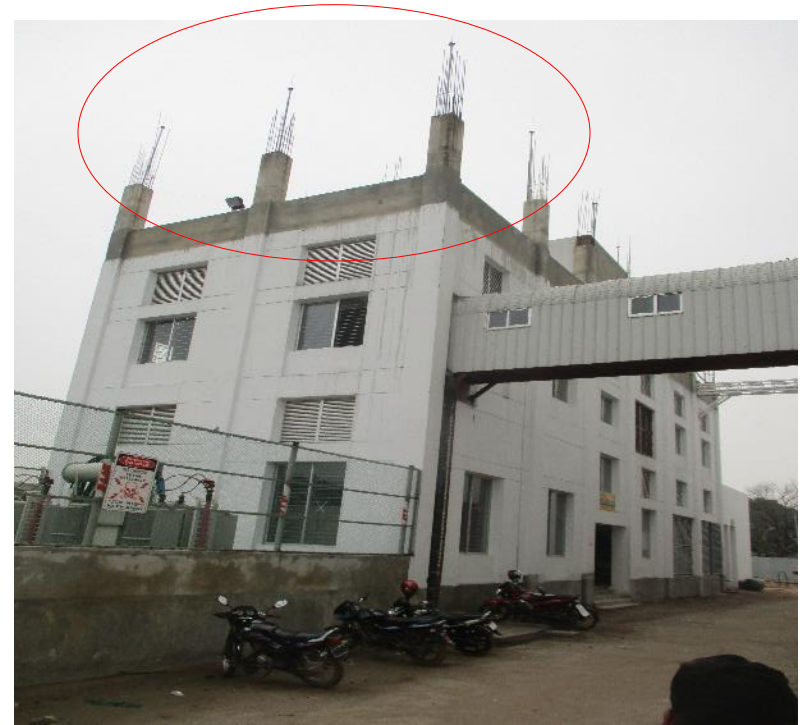
# Exposed Rebar observed on roof

Exposed Rebar observed on roof of Substation Building which is susceptible to corrosion.

- Item 1: Exposed Rebar observed on roof
- Item 2: Water Clogging observed on roof

| Item No. | Observation | Recommended Action Plan | Recommended Timeline |
|---|---|---|---|
| 1 | Exposed Rebar observed on roof | Building Engineer to suggest a proper remedial measures to protect exposed re-bars from corrosion and carry out remedial works. | 6-weeks |

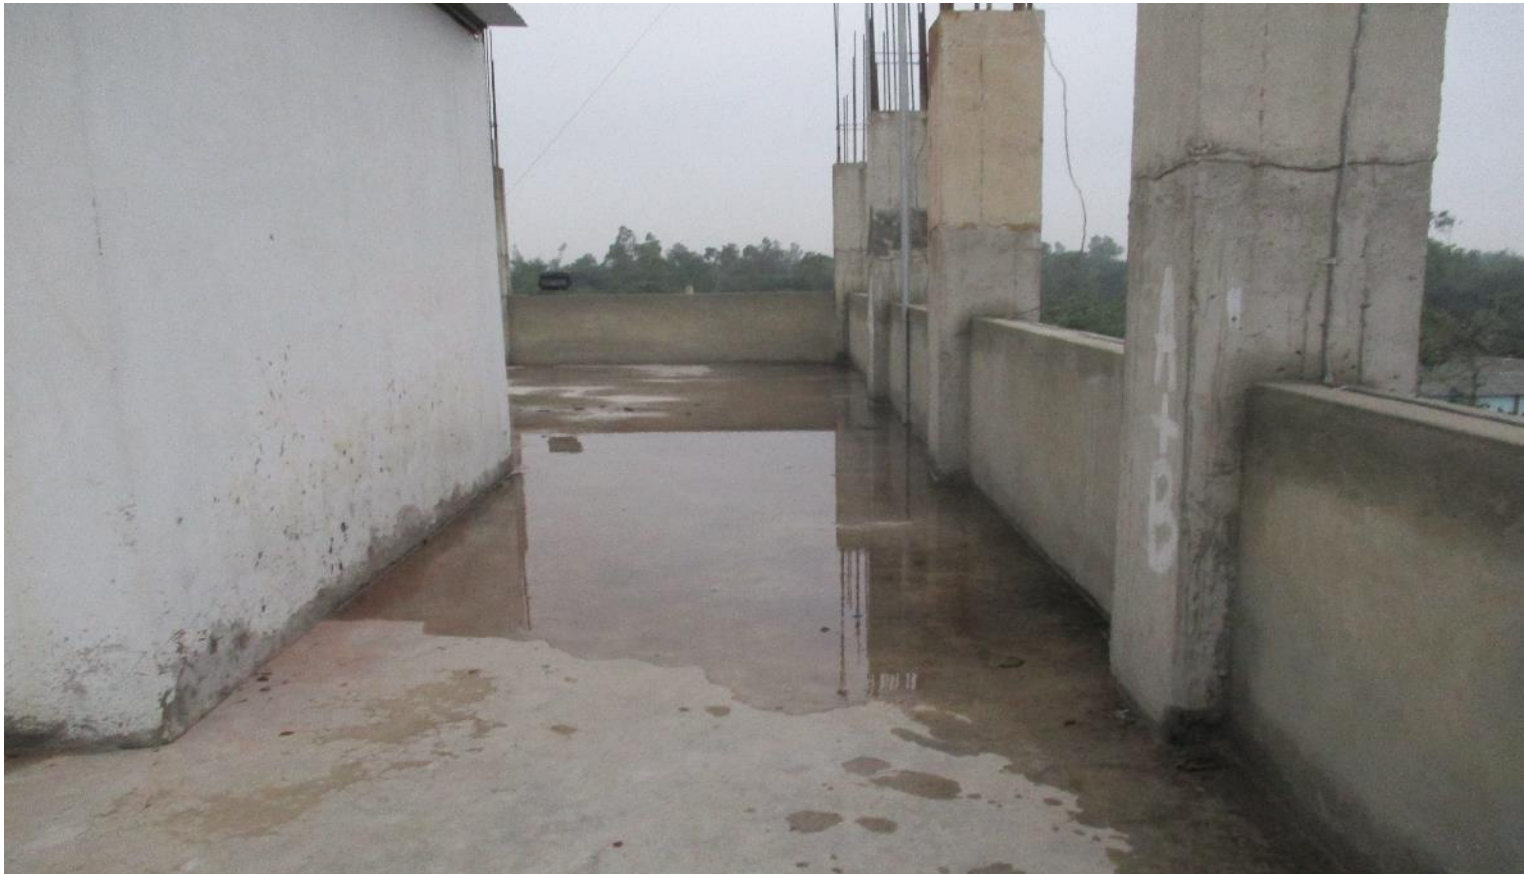
# Water Clogging observed on roof

Water Clogging was observed on roof of Substation Building. Factory is required to implement proper drainage system to avoid water ingress and deterioration of structural elements.

| Item No. | Observation | Recommended Action Plan | Recommended Timeline |
|---|---|---|---|
| 2 | Water Clogging observed on roof | Provide proper drainage system to avoid water clogging. | 6-weeks |
