FIRE SAFETY INSPECTION REPORT

BANDO DESIGN LTD.

**PURBO NARSHINGAPUR, EARPUR UNION PANSHAD
ROAD, ASHULIA, DHAKA, BANGLADESH**

March 29, 2014

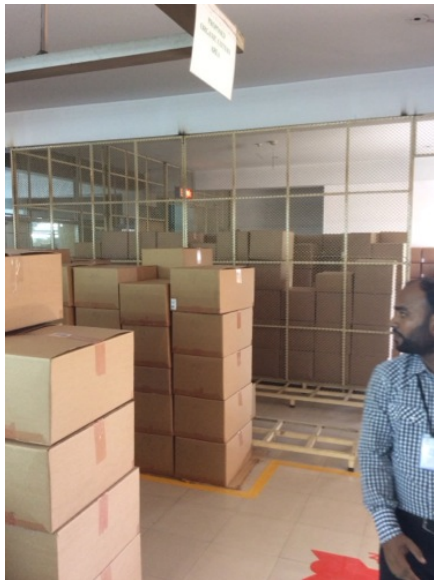
No.	Category	Finding	Recommendation	Remediation Timeframe
F-1	Fire Rated Construction	Storage rooms on floors G, 1, 2, and 4 and process areas on multiple floors used for combustible storage are not separated by fire-rated construction.	<p>Provide dedicated storage rooms separated by minimum 1-hr fire-rated construction.</p> <p>Where separate storage rooms are not feasible, provide defined storage areas and limit the storage arrangement as follows:</p> <ul style="list-style-type: none"> - Maximum height of 2.4m and maximum area of 23m² - If sprinkler protected: maximum height of 3.66m and maximum area of 93m² <p>Separate areas of unenclosed combustible storage by a minimum clear distance of 3m.</p>	Within 3 months

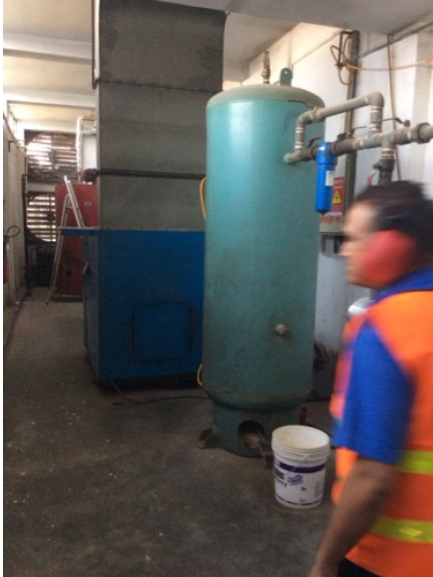
F-2	Fire Rated Construction	The boiler is not separated from egress path by fire-rated construction.	Separate the boiler by a minimum 2-hr fire-rated construction. Seal and/or protected all openings to maintain the required fire separations	Within 3 months
-----	-------------------------	--	---	-----------------

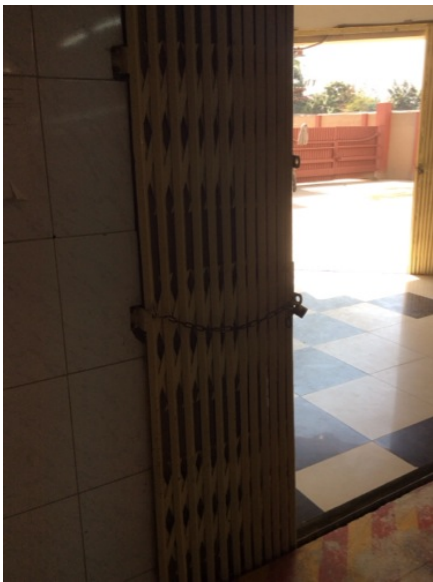
F-3	Fire Rated Construction	The East exit stairs are not separated from the transformer room.	Provide minimum 1.5-hr fire rated doors and seal all unprotected openings to separate the exit stairs from work areas and other building spaces on all floor levels. Ensure that the fire doors are self-closing and positive latching and that they are provided with fire exit (panic) hardware where serving production floors.	Within 3 months
			If fire doors are required to be held open for functional reasons, provide automatic-closing devices tied to the fire alarm system.

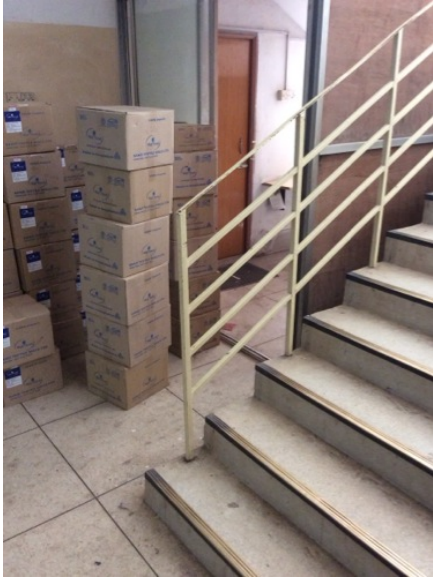
F-4	Egress	Storage was located in both an stair at the ground floor.	Remove all storage from exit stairs and egress paths.	Immediate
-----	--------	---	---	-----------

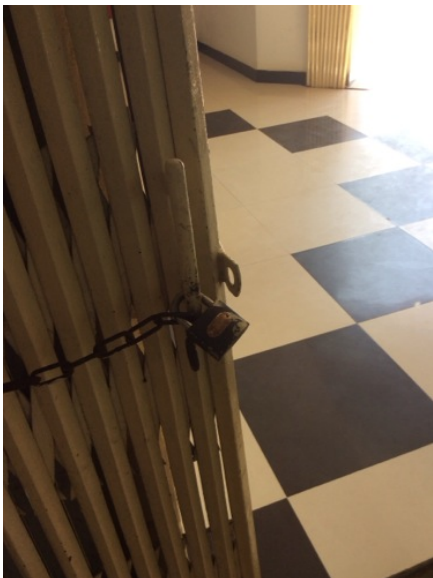
F-5 Egress

Egress doors and gates with locking features are provided throughout both stairs

Remove locking features from all egress doors and gates.

If locks are required for security reasons, utilize special door locking features complying with NFPA 101.

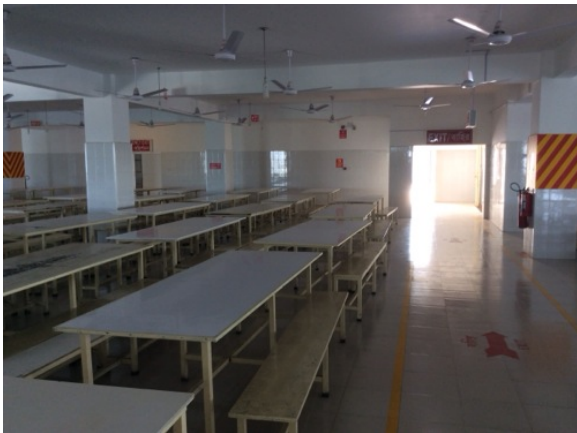
F-6	Egress	<p>Exit capacity is not adequate for the occupant load on floors 2 or 4 and from the dining room on floor 5. Floor 2 has 849 occupants and Floor 4 has 705 occupants. The stair capacity is 653. The dining room on floor 5 has a reported capacity of 550 occupants, and only two exit doors from the room.</p>	<p>Reduce the number of occupants to no more than the exit capacity immediately.</p> <p>In the future, if the greater occupant load is desired, add additional exits.</p>	Immediate
-----	--------	--	---	-----------

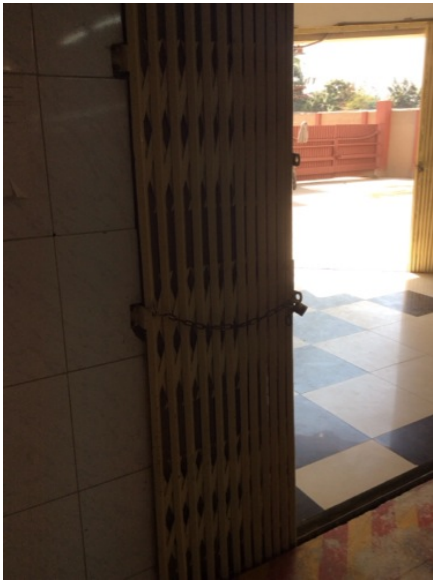
F-7	Egress	<p>Collapsible gates and sliding doors are provided throughout factory and interior partitions.</p>	<p>Replace all gates and sliding doors along the means of egress with side-hinged, swinging egress doors.</p> <p>If locks are required for security reasons, utilize special door locking features complying with NFPA 101.</p>	Within 1 month
-----	--------	---	---	----------------

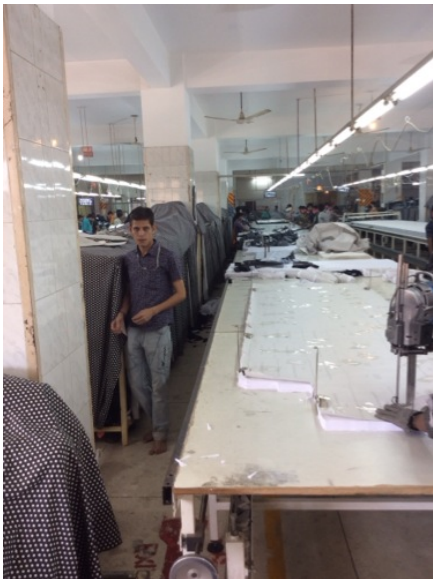
F-8	Egress	The width of egress aisles adjacent to the cutting tables on the ground floor 3 is less than 36-in.	Provide minimum aisle widths of 36-in.	Within 3 months
-----	--------	---	--	-----------------

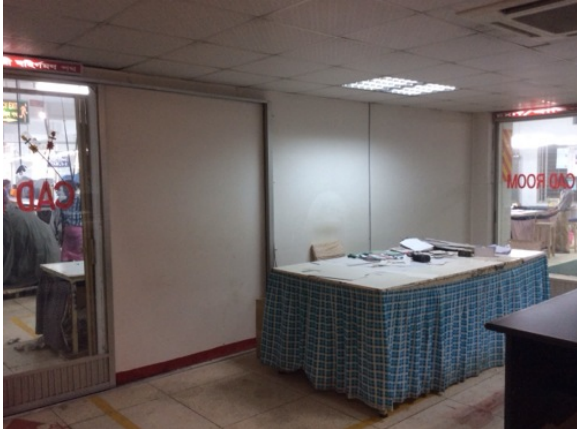
F-10	Egress	The exits are not remotely located from each other such that a single fire event could compromise both exits in the dining area and the laboratory.	- Provide additional exit(s). and/or - Provide sprinkler protection in accordance with NFPA 13.	Within 3 months
------	--------	---	---	-----------------

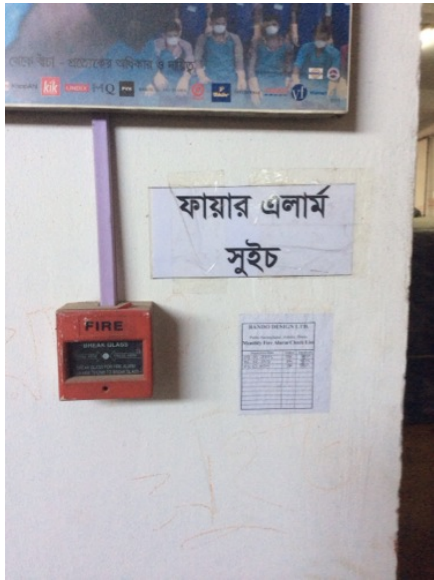
F-11	Fire Protection	The fire alarm system is antiquated, not a listed system, and does not provide alarm and notification features consistent with acceptable standards.	Replace the fire alarm system with a new, listed addressable fire alarm system in accordance with NFPA 72.	Design within 4 months, install within 9 months
------	-----------------	--	--	---

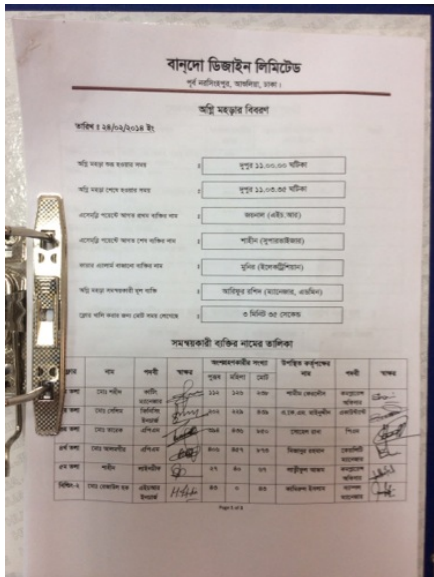
F-12	Fire Protection	Inspection, testing, and maintenance of the fire alarm system is not in accordance with NFPA 72.	Inspect, test and maintain the fire alarm system, and keep written records on-site, in accordance with NFPA 72.	Within 3 months
------	-----------------	--	---	-----------------

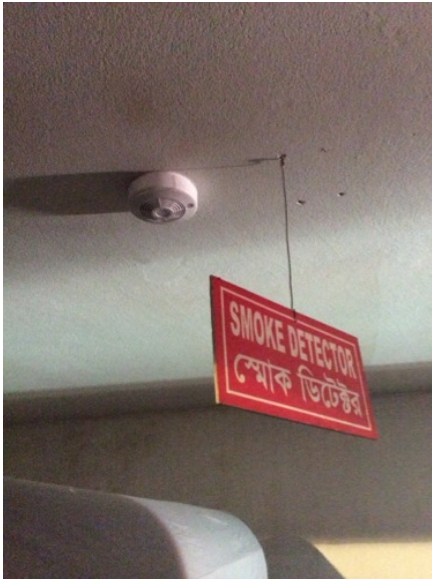
F-13	Fire Protection	The building is equipped with single-station smoke alarms. Smoke alarm activation sounds only a local alarm and does not provide automatic fire alarm notification of occupants.	Remove single-station smoke alarms. Provide automatic smoke detection throughout the building, tied into the fire alarm system, in accordance with NFPA 72.	Within 6 months
------	-----------------	--	---	-----------------

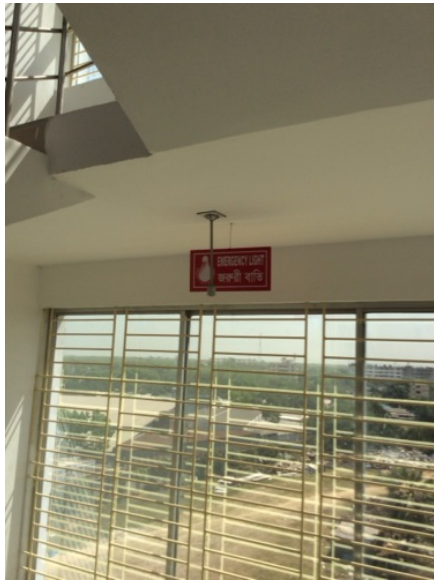
F-14	Egress Lighting	Emergency lighting is not fully installed in areas of construction on floors 4 and 5.	Regularly test the emergency lighting system on each floor and replace/repair lights as needed.	Within 1 month
------	-----------------	---	---	----------------

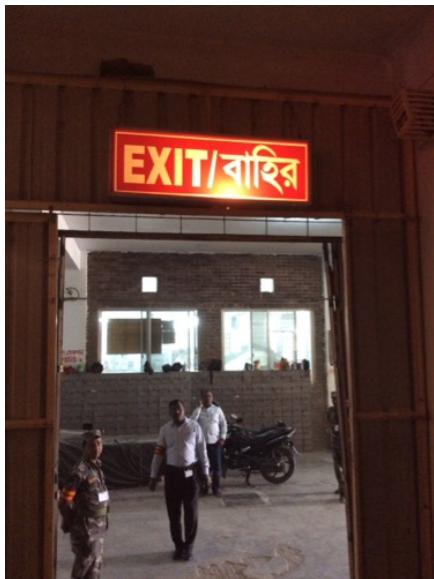
F-15	Egress Lighting	Exit signs not installed on floors 4 and 5	Provide exit signs above all exits to the exterior and all doors to the exit stairs.	Within 3 months
------	-----------------	--	--	-----------------
