# **FIRE SAFETY INSPECTION REPORT**

**MEDITEX INDUSTRIES LIMITED.**

**PLOT 912, KASHIMPUR ROAD, KONABARI, GAZIPUR**

April 7, 2014

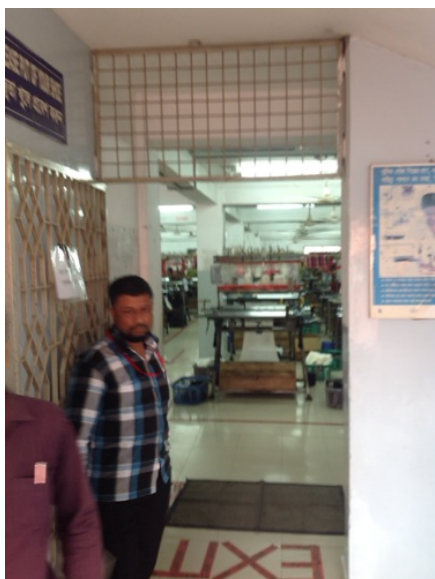
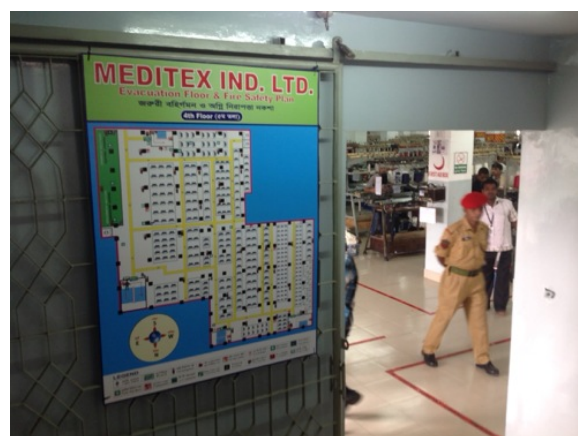
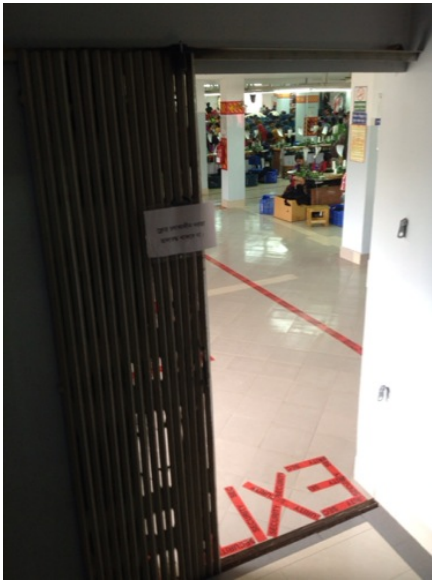
| No. | Category | Finding | Recommendation | Remediation Timeframe |
|---|---|---|---|---|
| F-1 | Fire Rated Construction | The exit stairs are not separated from work areas, other spaces on each floor by fire-rated construction. | <p>Provide minimum 1.5-hr fire rated doors and seal all unprotected openings to separate the exit stairs from work areas and other building spaces on all floor levels. Ensure that the fire doors are self-closing and positive latching and that they are provided with fire exit (panic) hardware where serving production floors.</p> <p>If fire doors are required to be held open for functional reasons, provide automatic-closing devices tied to the fire alarm system.</p> | Within 3 months |

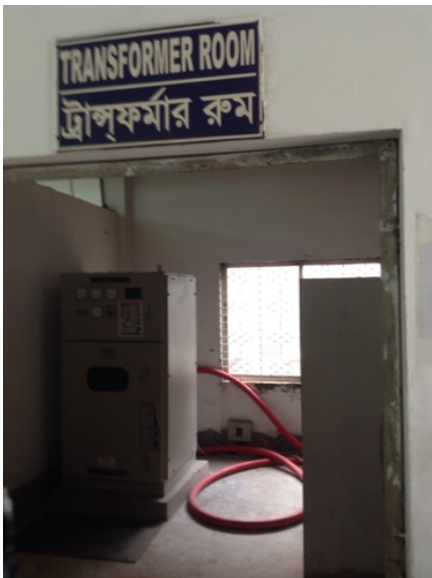
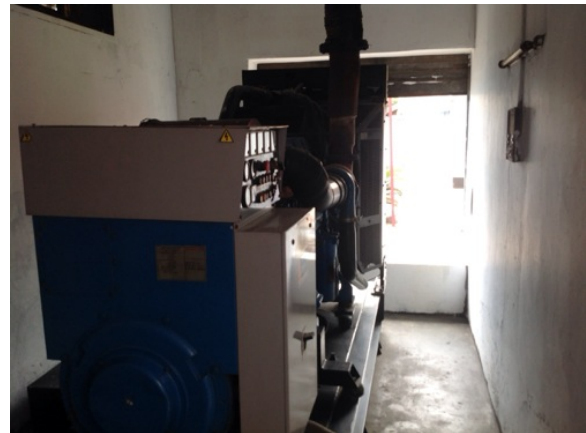
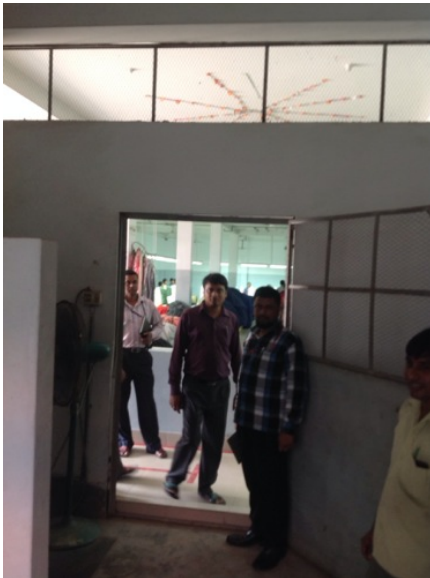
| F-2 | Fire Rated Construction | The boiler / generator / transformer room is not separated by fire-rated construction (openings, non-rated doors, penetrations). | Separate the boiler / generator / transformer room by a minimum 2-hr fire-rated construction. Seal and/or protected all openings to maintain the required fire separations | Within 3 months |

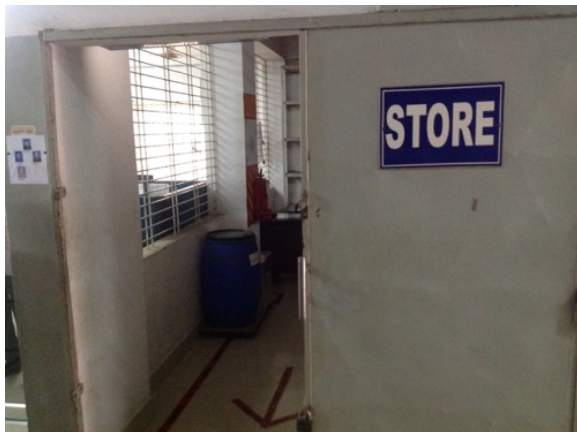
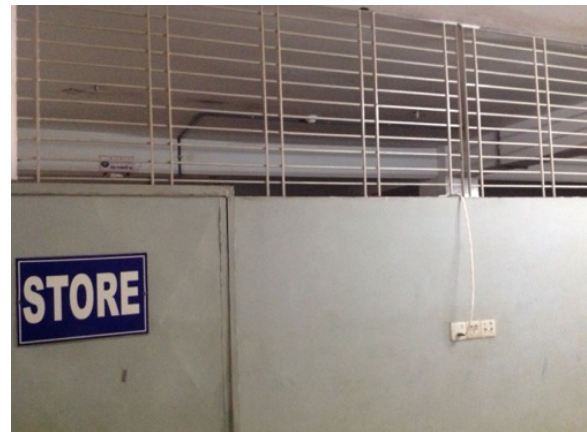
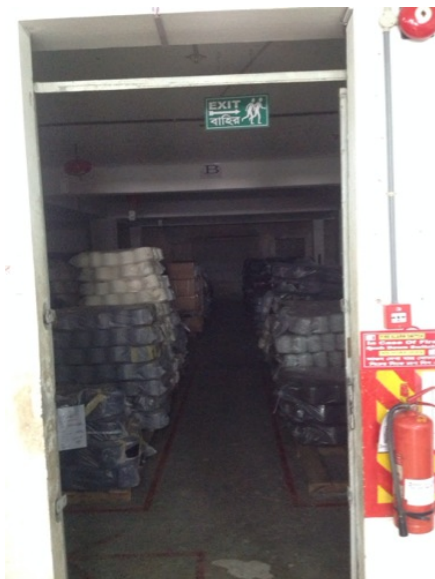
| F-3 | Fire Rated Construction | Areas used for storage are not separated by fire-rated construction on ground floor. | <p>Provide dedicated storage rooms separated by minimum 1-hr fire-rated construction.</p> <p>Where separate storage rooms are not feasible, provide defined storage areas and limit the storage arrangement as follows:</p> <ul style="list-style-type: none"><li>- Maximum height of 2.4m and maximum area of 23m<sup>2</sup></li><li>- If sprinkler protected: maximum height of 3.66m and maximum area of 93m<sup>2</sup></li></ul> <p>Separate areas of unenclosed combustible storage by a minimum clear distance of 3m.</p> | Within 3 months |

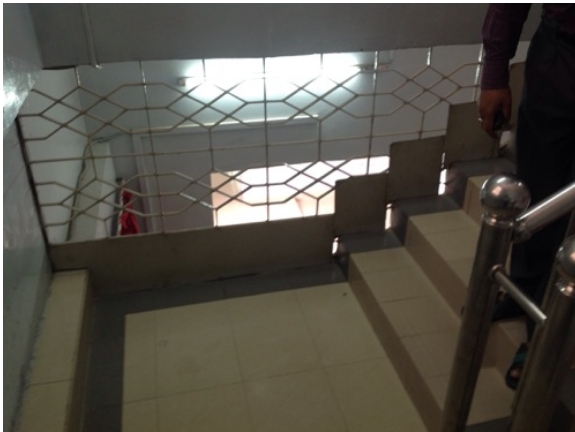
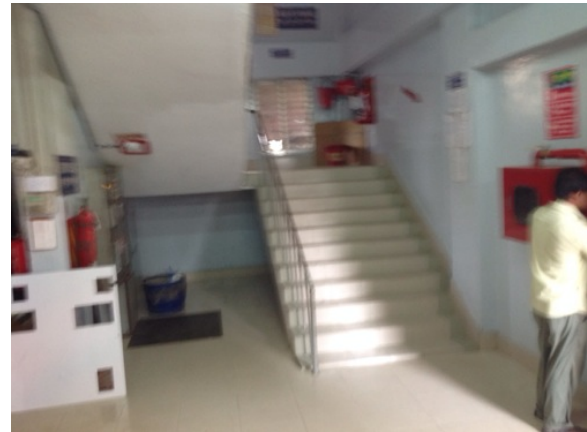
| F-4 | Fire Rated Construction | The exit stairs are not separated from work areas, other spaces on each floor by fire-rated construction north west exit. | <p>Provide minimum 1.5-hr fire rated doors and seal all unprotected openings to separate the exit stairs from work areas and other building spaces on all floor levels. Ensure that the fire doors are self-closing and positive latching and that they are provided with fire exit (panic) hardware where serving production floors.</p> <p>If fire doors are required to be held open for functional reasons, provide automatic-closing devices tied to the fire alarm system.</p> | Within 3 months |

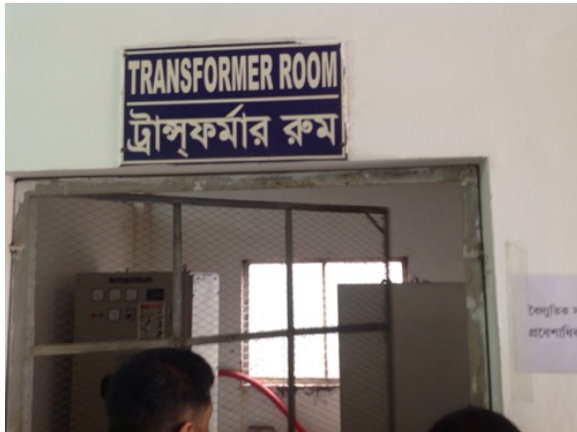
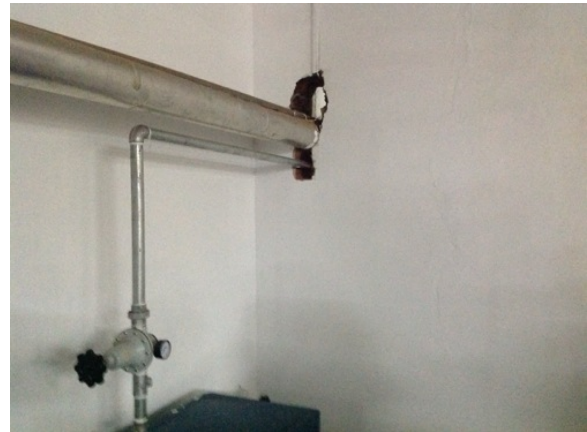
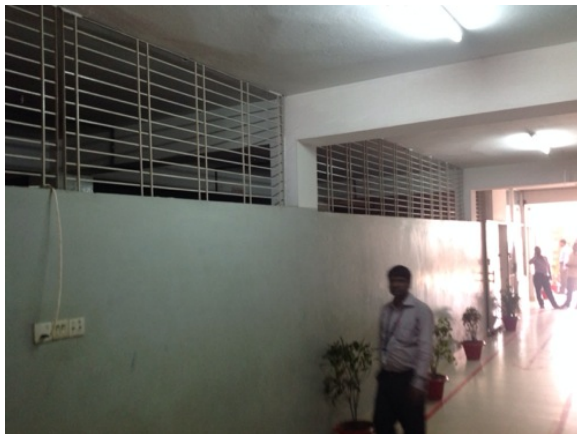
| F-5 | Fire Rated Construction | Not constructed of proper fire rated materials. Several penetrations and other deficiencies compromise integrity of the room which could lead to increased fire spread. | <p>Provide minimum 1hr fire rated room and seal all unprotected openings to separate from work areas and other building spaces on all floor levels. Ensure that the fire doors are self-closing and fire rated for use.</p> | Within 6 months |

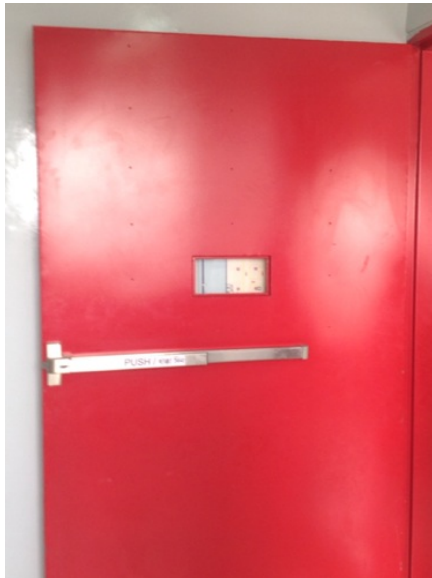
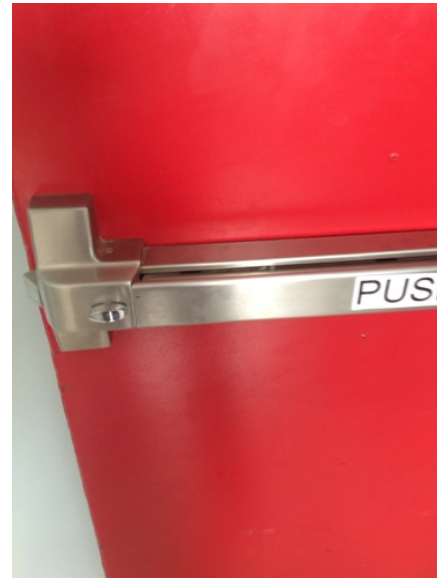
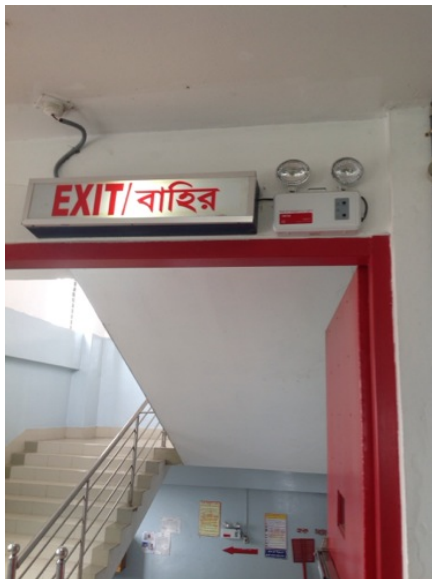
| F-6 | Fire Rated Construction | Fire doors in use on south exit do not have proper documentation for proof of rating. | Have manufacture provide the documentation need or replace doors with the correct UL/FM/CE or other acceptable devices. | Within 6 months |

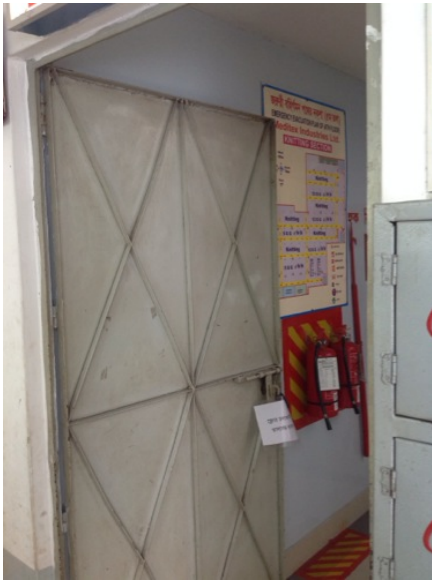
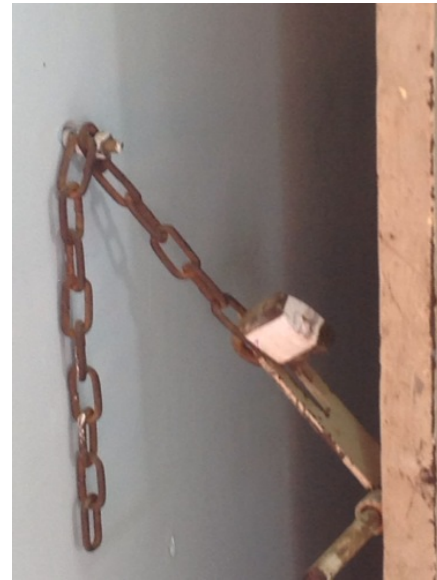
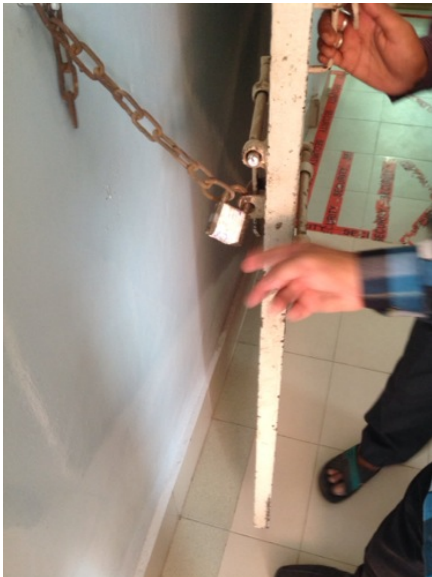
| F-7 | Egress | Egress doors / gates with locking features are provided at [building exits, exit stairs, along egress routes, exit discharge. | Remove locking features from all egress doors / gates.<br><br>If locks are required for security reasons, utilize special door locking features complying with NFPA 101. | Immediate |

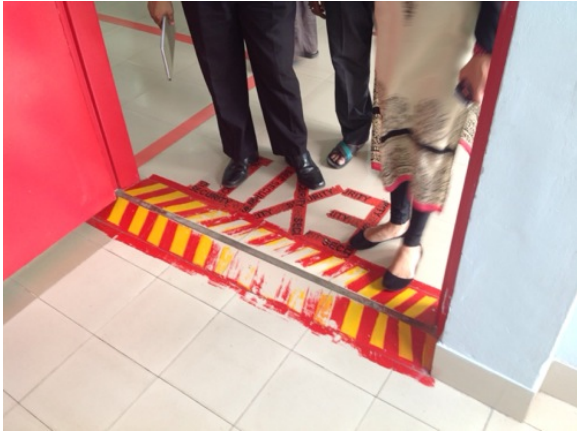
| F-8 | Egress | Objects in exit access path are a tripping hazard. | Remove | Immediate |

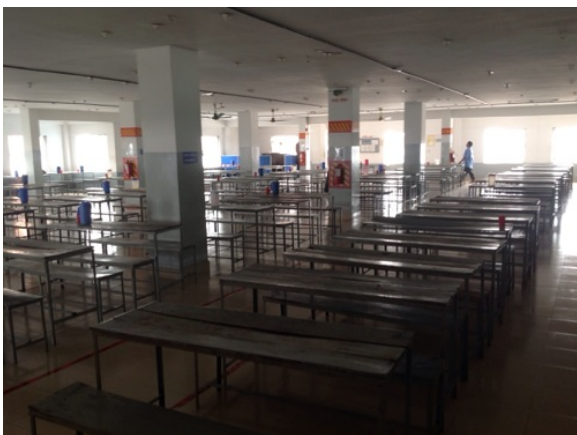
| F-9 | Egress | Exit capacity is not adequate for the occupant load. The fifth floor has a work area and dining facility. If both are used and at maximum capacity the occupant load exceeds the exit capacity by 142 people. | Reduce the capacity of the dining area by 150. | Immediate |

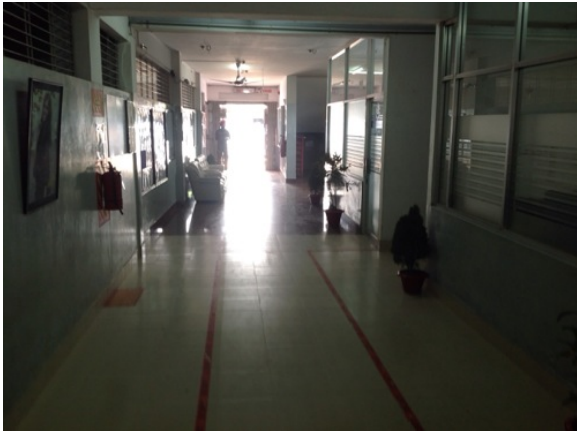
| F-10 | Egress | Storage was located in the egress path. The main exit ground floor is being used as a reception area and has desk, chairs and other related items in the exit route. | Keep egress paths and stairs clear of storage. | Immediate |

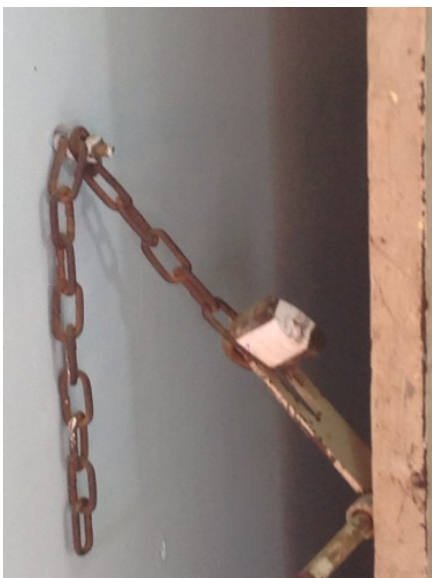
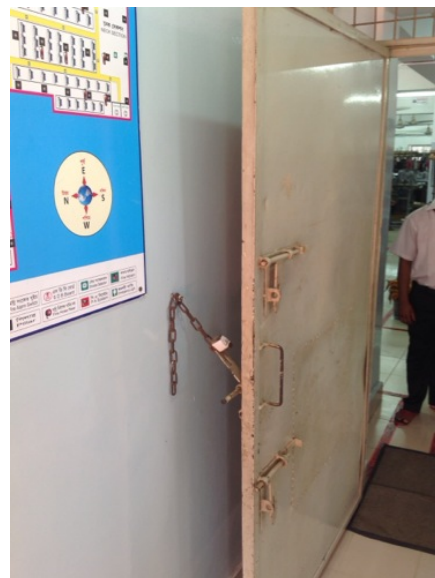
| F-11 | Egress | Exit stairwell doors are being locked in the open positions. | Remove locks . | Immediate |

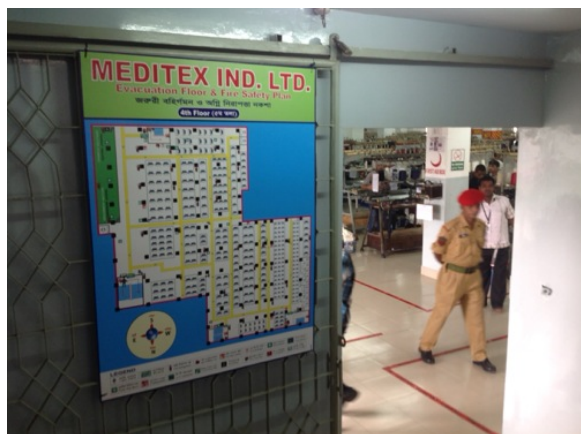
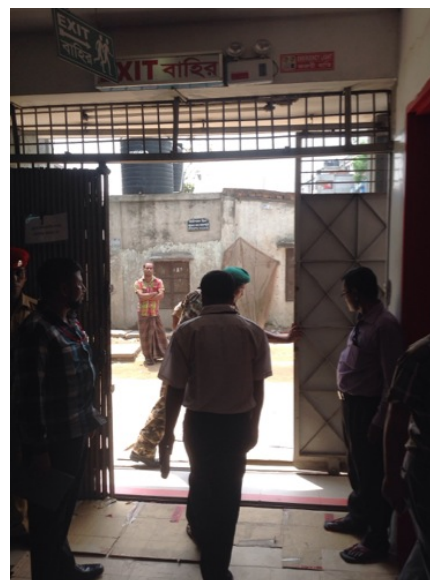
| F-12 | Egress | Collapsible gates / sliding doors are provided at building exits, exit stairs, along egress routes, exit discharges throughout the factory. | <p>Replace all gates / sliding doors along the means of egress with side-hinged, swinging egress doors.</p> <p>If locks are required for security reasons, utilize special door locking features complying with NFPA 101.</p> | Within 1 month |

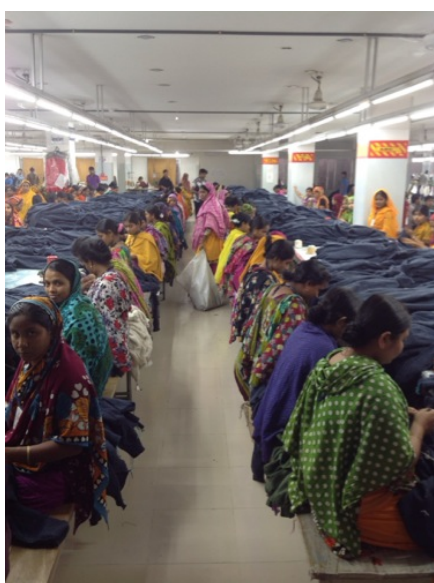
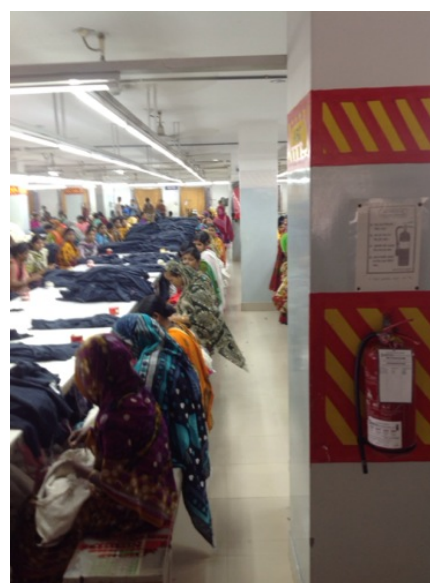
| F-13 | Egress | Not enough exit aisle access for workers in knitting areas. | Separate the machines and add more exit aisle access for workers. | Within 3 months |

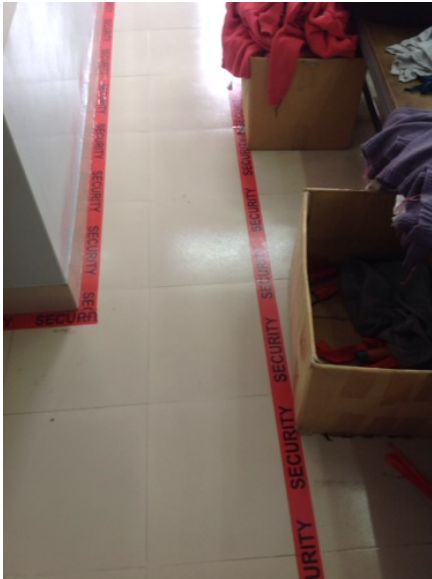
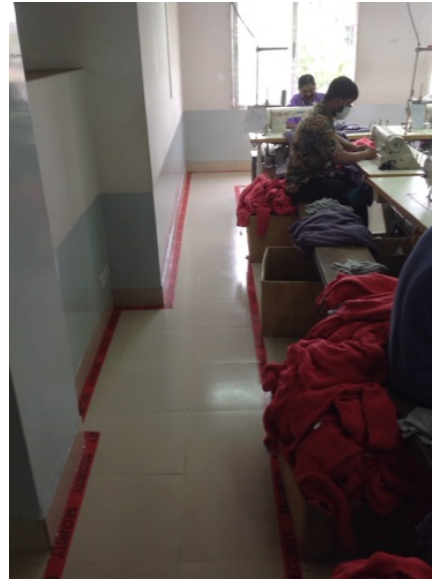
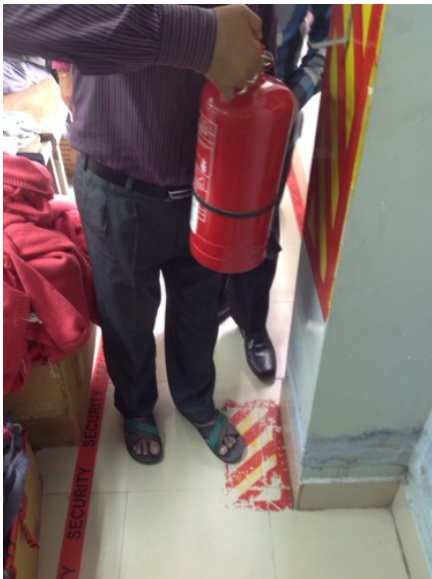
| F-14 | Egress | Several egress paths along the outer walls of the facility on several floors were inadequate, less than 36 inches | Increase exit opening to a minimum of 36 inches. | Within 3 months |

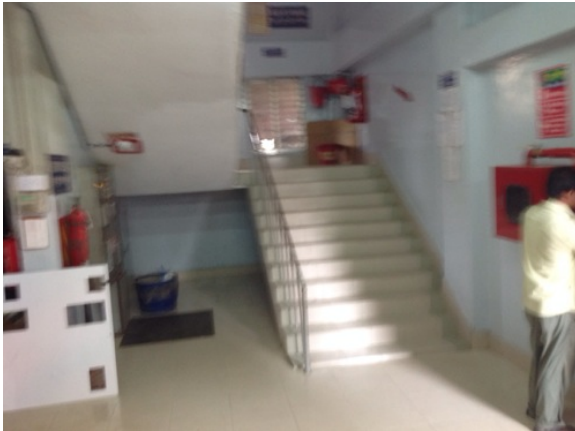
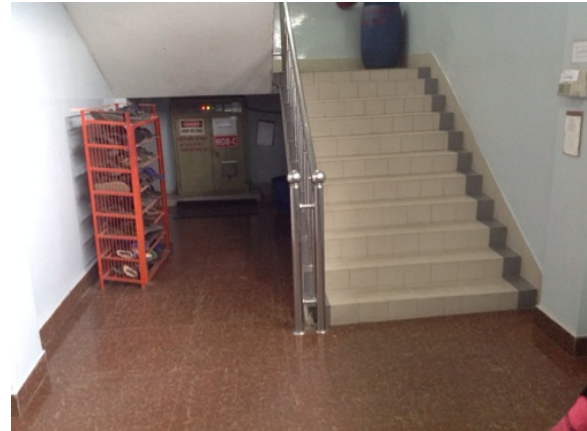
| F-15 | Egress | Exit stairs discharge inside the building. The south exit discharges onto the Ground floor working area, | Provide 2-hr fire-rated exit passageway leading directly outside. | Within 6 months |

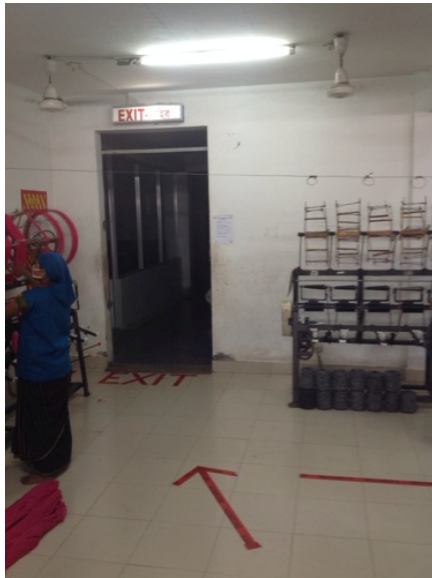
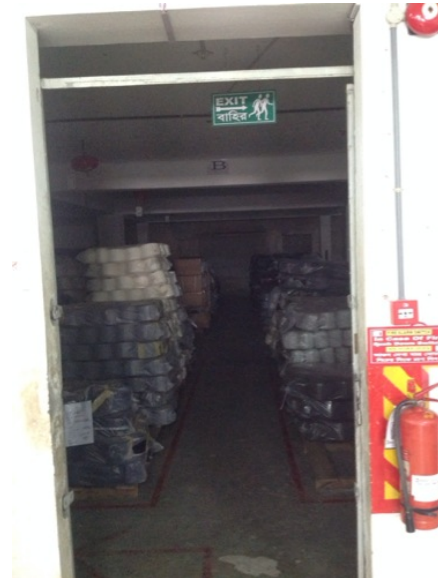
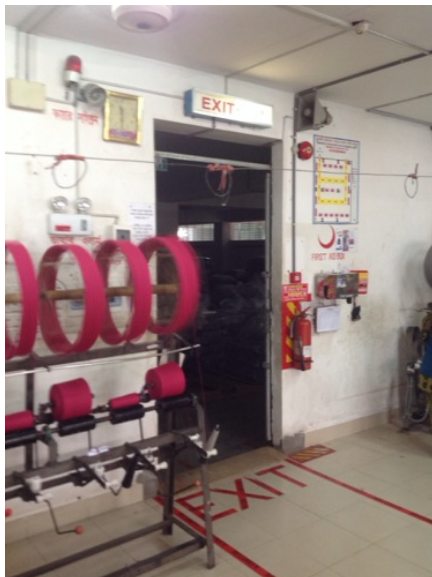
| F-16 | Egress | Ground floor Mending section has to exit though the storage room to gain access to a means of exit access. | Open a direct exit to the outside from the back wall in this section or provide a corridor that the requirements of an exit enclosure through the storage area to the north exit access path. | Within 6 months |

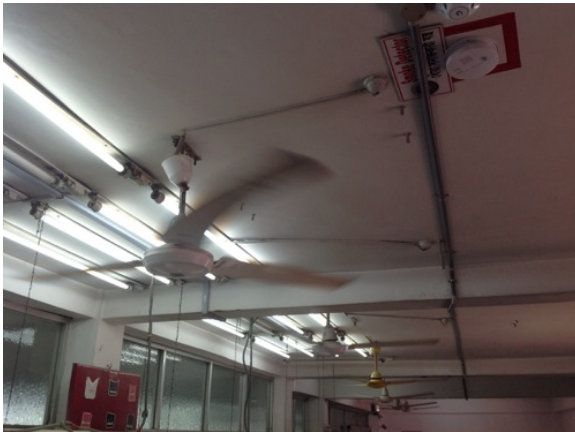
| F-17 | Fire Protection | The number of ceiling fans in use would seriously delay the detection of a fire and activation of the fire alarm system do to the volume of heat and smoke being displaced during their use. | Replace the fans with a HVAC system that would have less effect on system activation and is tied to the fire alarm system and shuts down when the system is activated. | Within 12 Months |

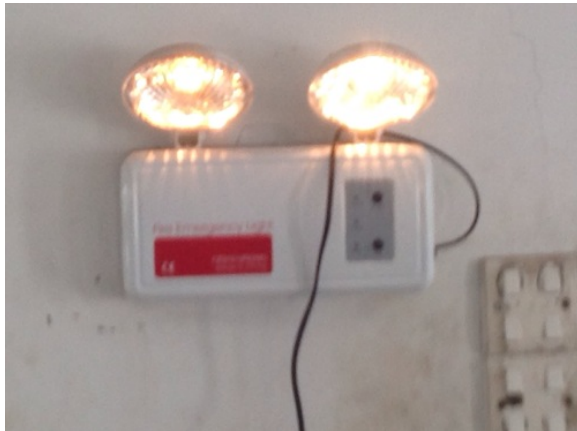
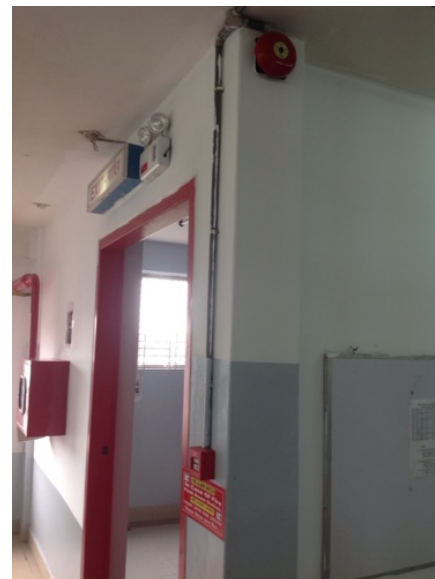
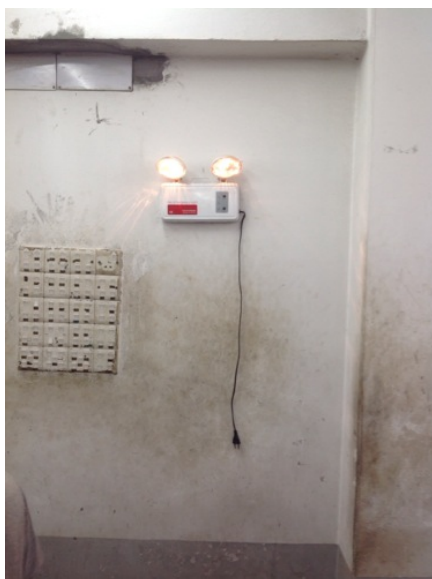
| F-19 | Egress Lighting | Based on the number and location of emergency lights observed, adequate illumination levels are not anticipated along egress routes on ground or first floor. | Test the emergency lighting system on each floor and provide additional emergency fixtures to provide adequate illumination along the means of egress. Provide a minimum illumination of 10 lux at the floor level within exit stairs and exit discharge paths and minimum 2.5 lux along exit access aisles. | Within 3 months |

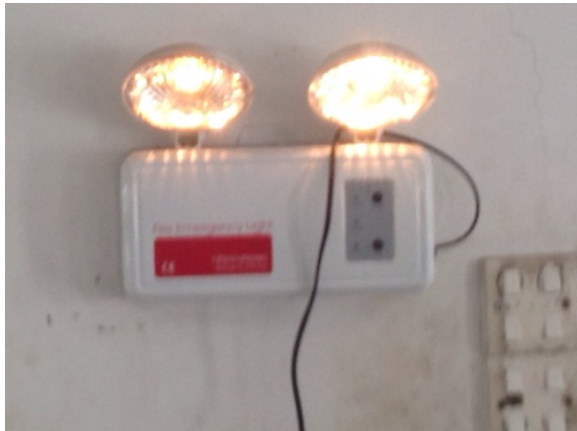
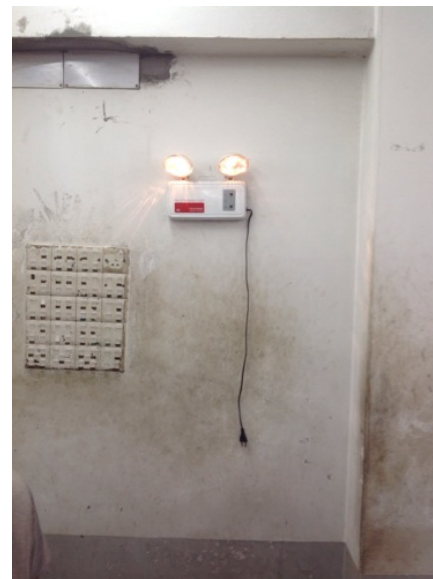
| F-20 | Egress Lighting | Based on the number and location of emergency lights observed, adequate illumination levels are not anticipated along egress routes. This was observed on all floors. | Test the emergency lighting system on each floor and provide additional emergency fixtures to provide adequate illumination along the means of egress. Provide a minimum illumination of 10 lux at the floor level within exit stairs and exit discharge paths and minimum 2.5 lux along exit access aisles. | Within 3 months |
