Comptex Bangladesh Ltd

Robintex (BD) Ltd

Vulta, Rupganj, Narayangonj, Bangladesh
(+23.772621N, 90.560453E)
17 May 2014

Observations

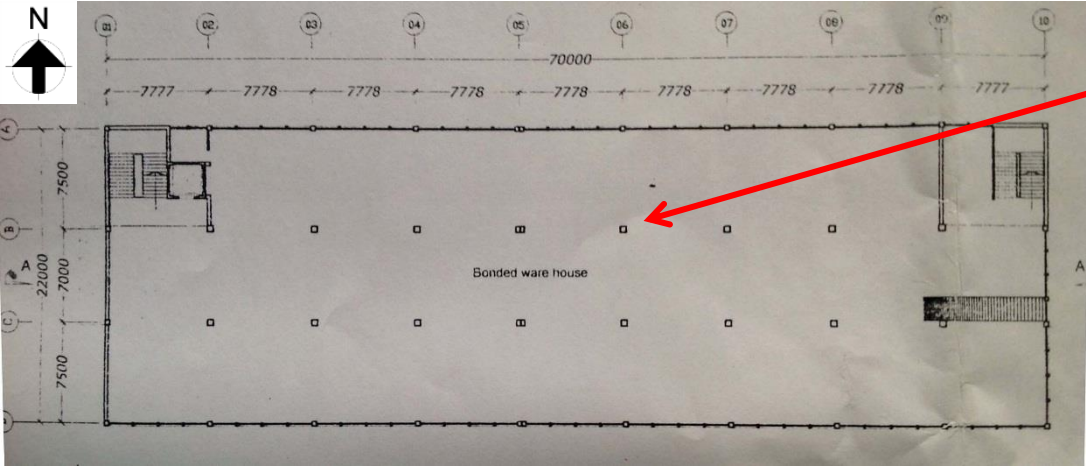
Typical column layout

**Columns appear to be stressed to a
high level and require immediate
review**

Outline calculations indicate that columns are stressed to a high level and require immediate review.

Design check to be carried out on all columns

Building Engineer to perform detailed calculations including a Detail Engineering Assessment (see attached scope) and concrete tests to prove adequacy of column sizes, and (if required):

- Reduce loads by vacating floors
- Reinforce columns

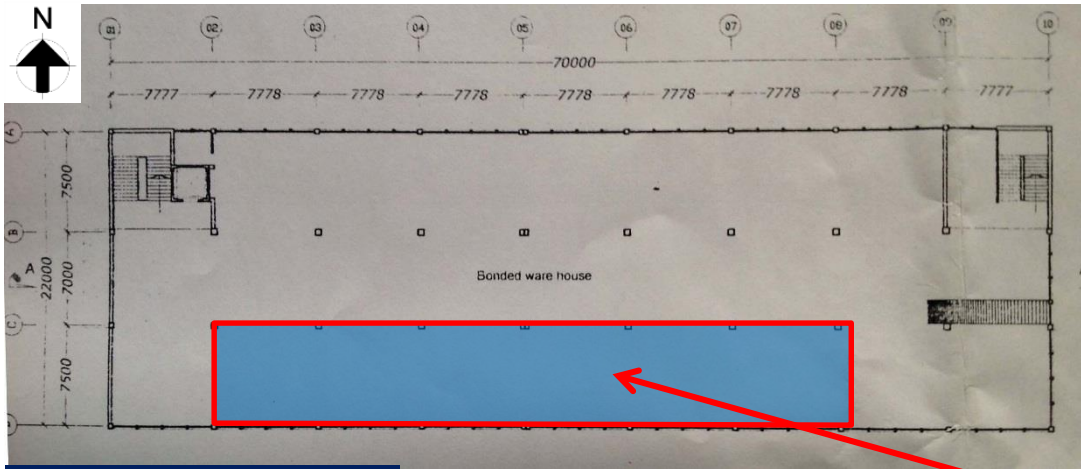
Ground Floor Plan

Cracking on soffit of ground floor slab

Cracking on ground floor slab soffit (particularly adjacent to building joint) was observed – including beam cracks. Building Engineer to review.

Item No.	Observation	Recommended Action Plan	Recommended Timeline
7	Comptex New Factory – Building 3 Cracking on soffit of ground floor slab	Sections of plaster finish to slab soffit to be removed to investigate if cracks penetrate the building structure.	Immediate - Now
8	Comptex New Factory – Building 3 Cracking on soffit of ground floor slab	Building Engineer to obtain loading from equipment on ground floor and verify the adequacy of the floor slab structure.	6-weeks
9	Comptex New Factory – Building 3 Cracking on soffit of ground floor slab	If required, relocate equipment and carry out remedial works to repair cracks on slab soffit.	6-weeks
10	Comptex New Factory – Building 3 Cracking on soffit of 3rd floor slab	Sections of plaster finish to soffit of 3rd floor slab to be removed to investigate if cracks penetrate the building structure.	6-weeks
11	Comptex New Factory – Building 3 Cracking on soffit of 3rd floor slab	Building Engineer to carry out design check on slab to confirm that these cracks are non-structural.	6-months

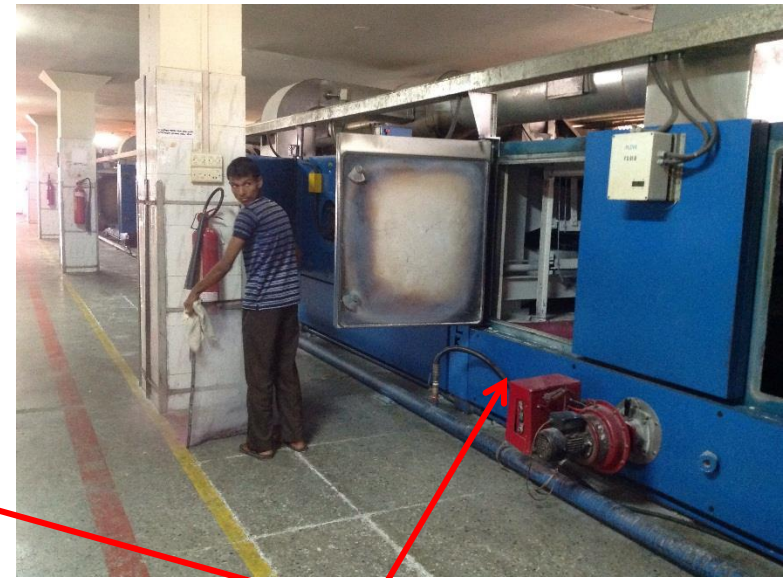
Stantar machines on ground floor – floor vibration noted

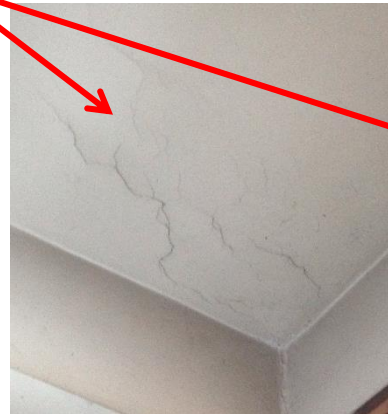
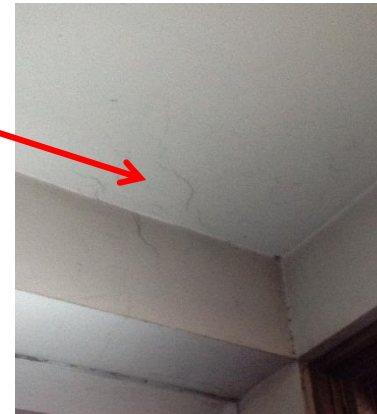
Cracking on soffit of ground floor slab

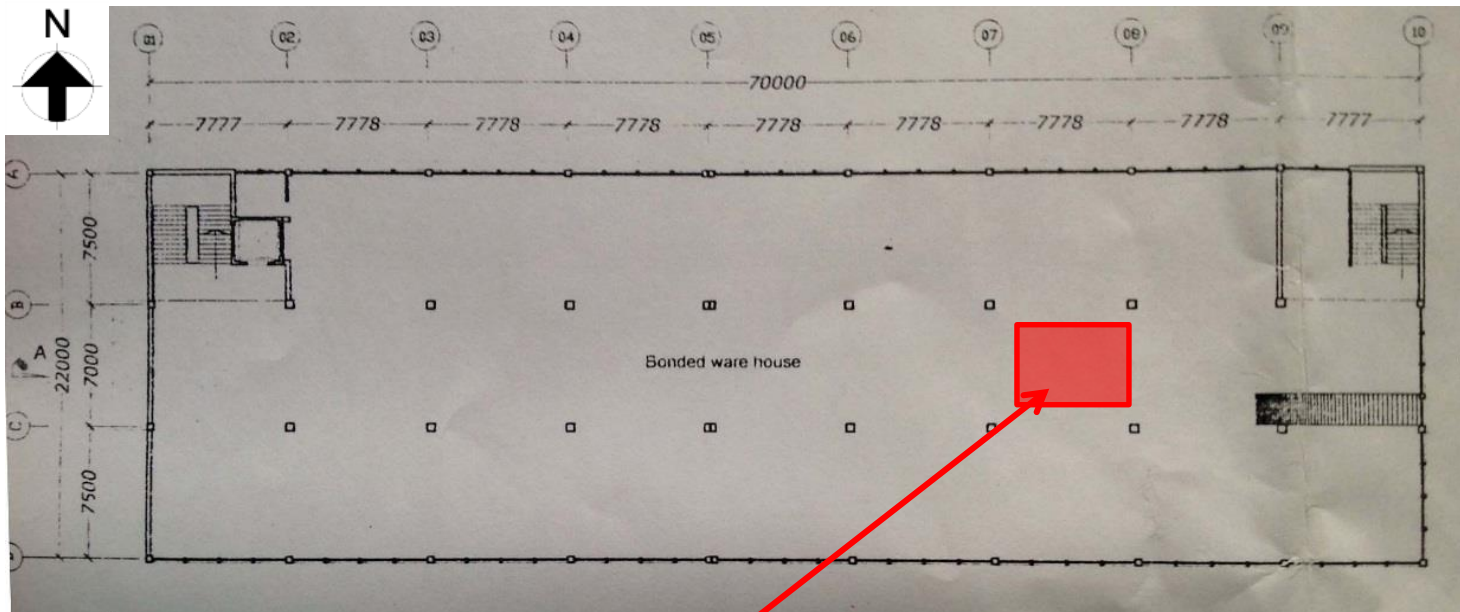
3rd Floor Soffit

Cracking on soffit of 3rd floor slab

Evidence of slab cracks noted – Building Engineer to review if cracks penetrate to building structure

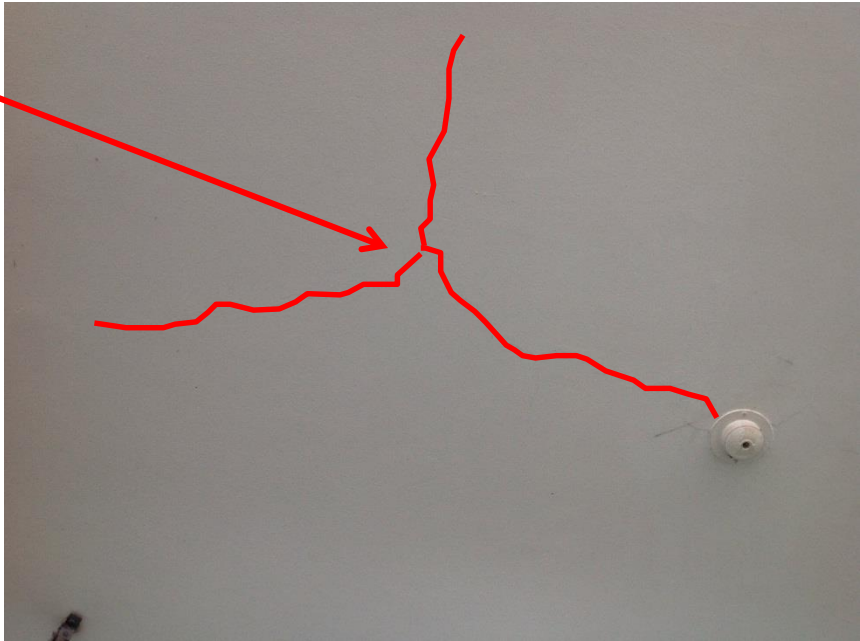
Crack on slab soffit

Cracking on 3rd floor soffit

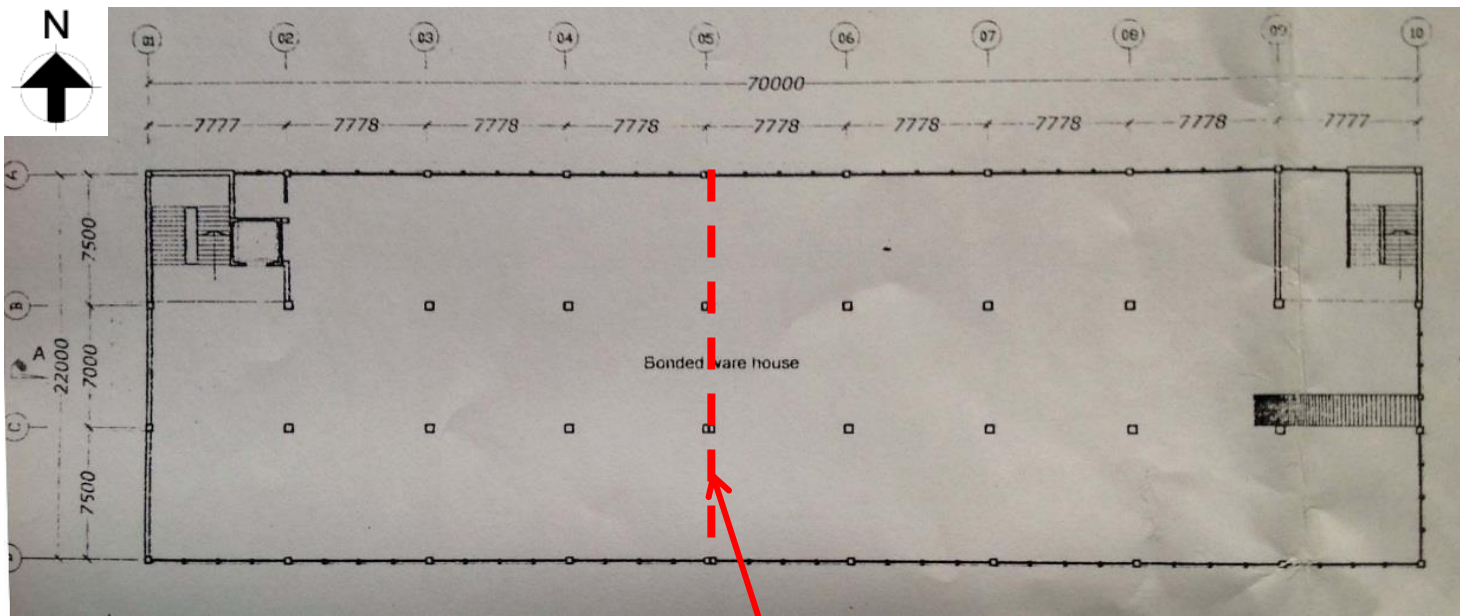
Building Joint

Cracked plasterwork at building movement joint

Some loose plasterwork at the building joint, particularly on the 2nd floor soffit, to be made good to avoid possibility of falling plaster at a future date.

12	Comptex New Factory – Building 3 Cracked plasterwork at building movement joint	Building Engineer to inspect internal line of building movement joint and prepare a schedule of areas where making good works are required to ensure that there is no risk of falling plasterwork.	6-months
13	Comptex New Factory – Building 3 Cracked plasterwork at building movement joint	Carry out making good works per Building Engineers schedule.	6-months

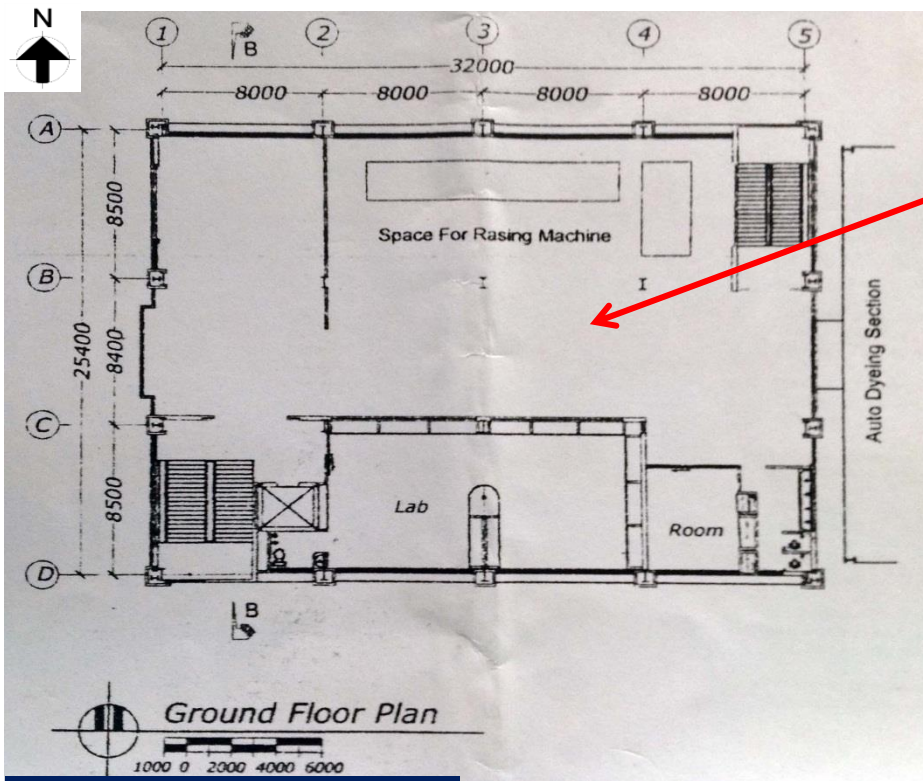
Typical column layout

**Columns, within the basement,
appear to be stressed in excess of
normal design limits**

Cursory calculations indicate that column working stress, within the basement concrete columns, is in excess of normal design limits

Design check to be carried out on all concrete columns within the basement

Building Engineer is to perform detailed calculations and concrete tests to prove column size and (if required):

- Reduce loads by vacating floors
- Reinforce columns

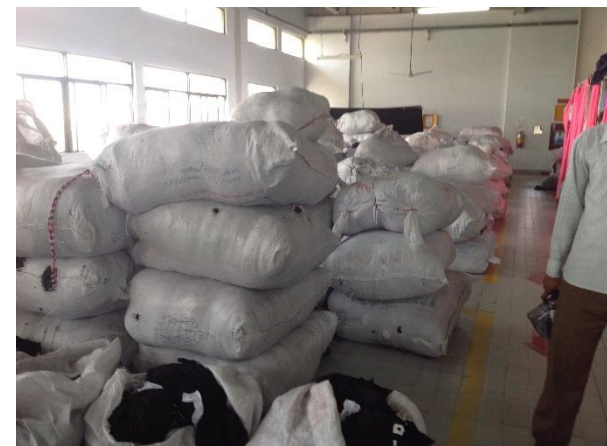
Storage load on 1st floor

Building Engineer to prepare controlled loading plans, based on floor slab and column capacity, for all floors which will designate allowable storage density and where storage may be placed.

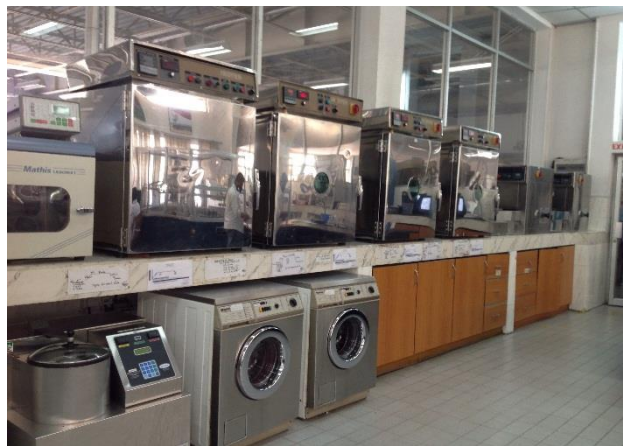
Loading on Ground floor

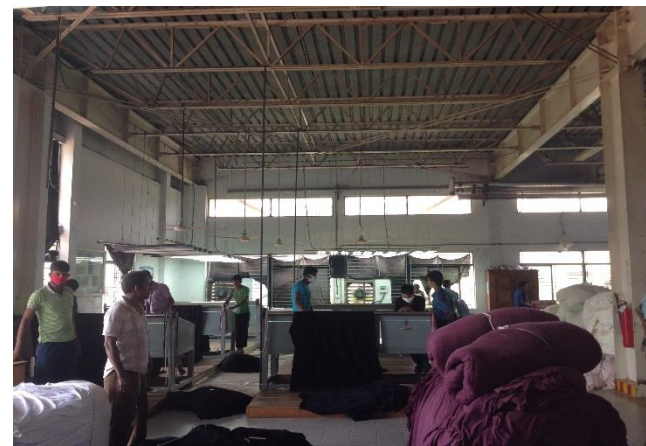
Storage load on Ground floor

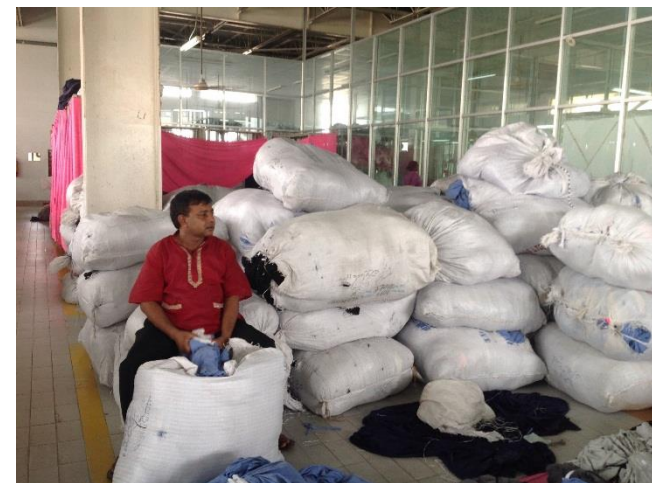
Storage load on 1st floor

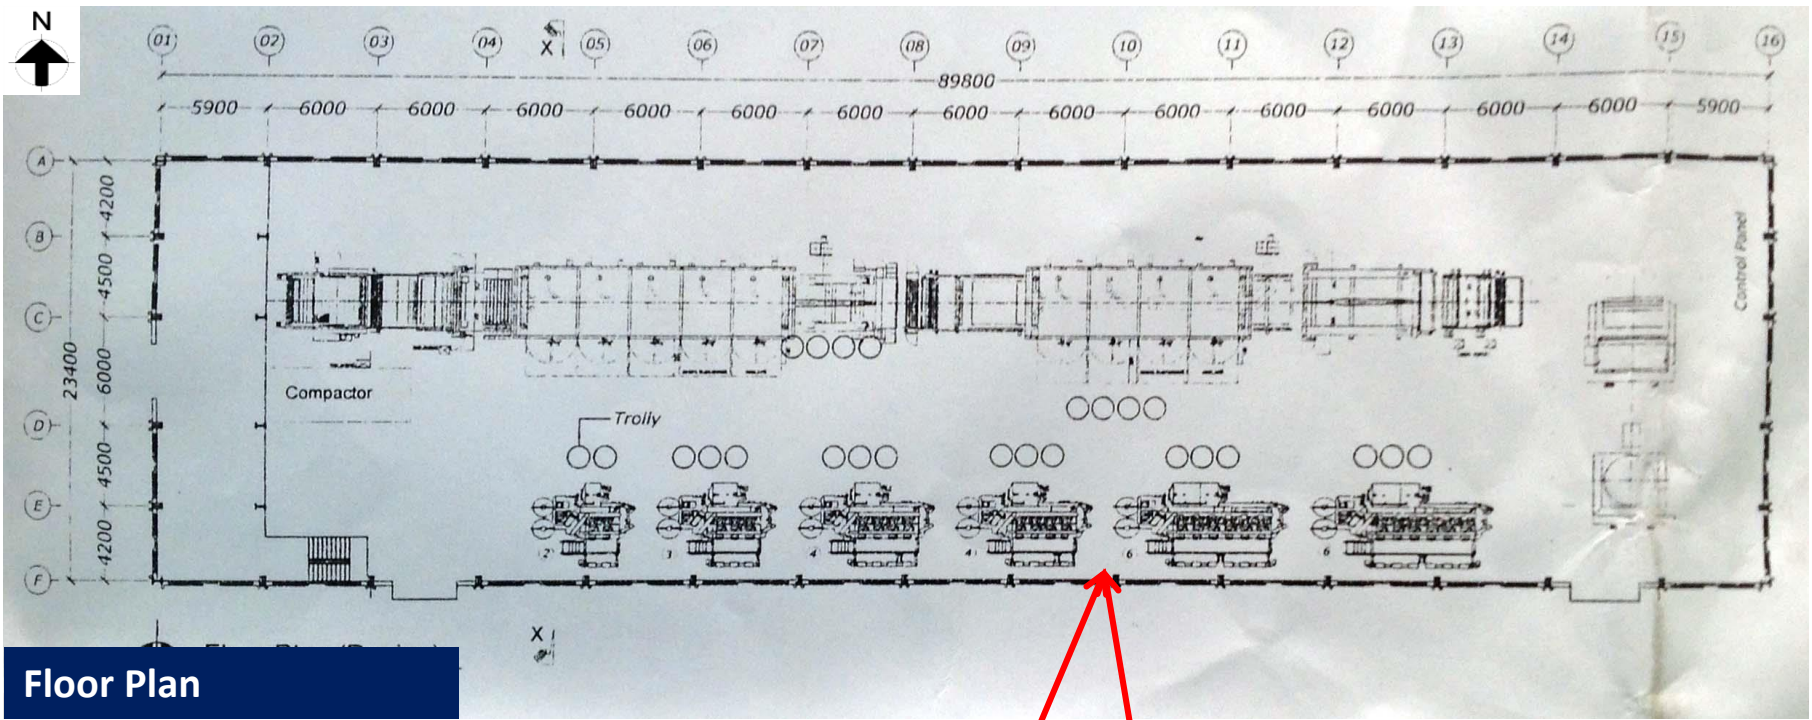
Floor Plan

Damaged bracing and corrosion of structural steel sections

Item No.	Observation	Recommended Action Plan	Recommended Timeline
20	Comptex Textiles Dyeing Unit – Building 2 Damaged bracing and corrosion of structural steel sections	Building Engineer to survey building bracing for completeness and to identify areas of corrosion on the steel frame.	6-weeks
21	Comptex Textiles Dyeing Unit – Building 2 Damaged bracing and corrosion of structural steel sections	Building Engineer to issue a schedule of remedial works for bracing reinstatement and corrosion protection.	6-weeks
22	Comptex Textiles Dyeing Unit – Building 2 Damaged bracing and corrosion of structural steel sections	Remedial works to be carried out.	6-months
23	Comptex Textiles Dyeing Unit – Building 2 Missing flange restraints to roof steel rafters	The design of the steel roof should be checked by the Building Engineer - specifically the provision of compression flange restraints should be reviewed as they are not all provided in matching locations on each rafter as would be expected.	6-months

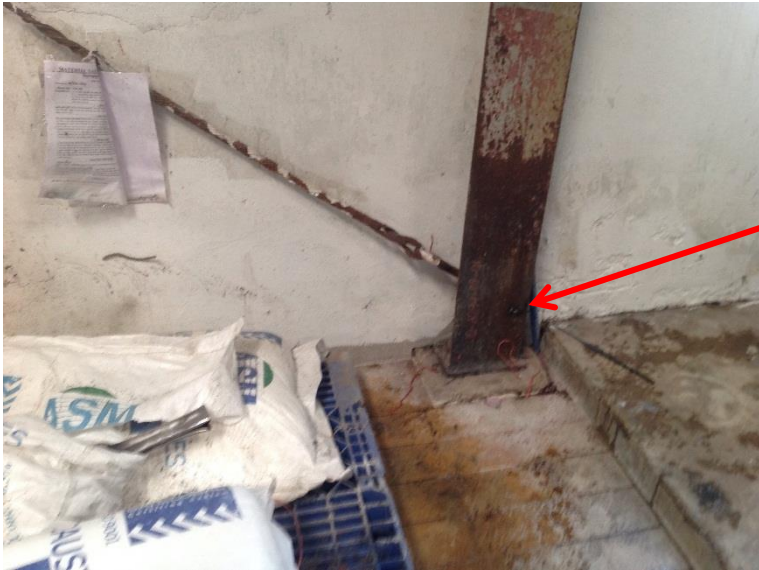
Corrosion of steel section

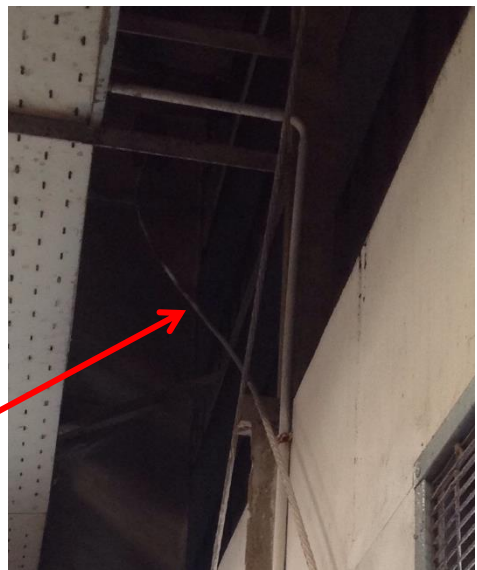
Damaged bracing to be reinstated

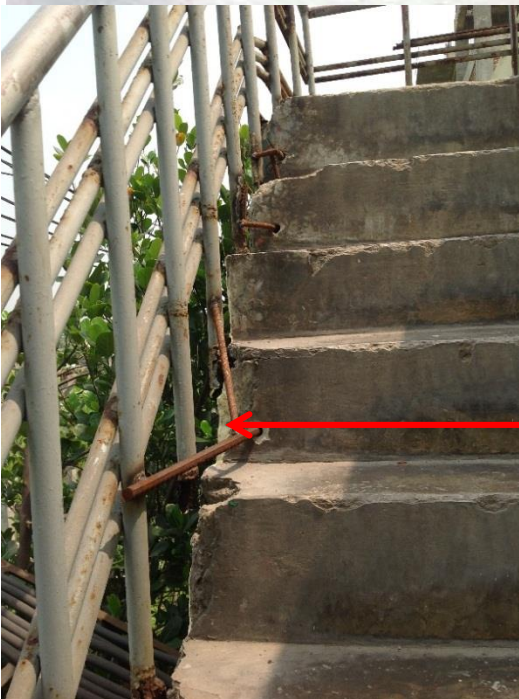
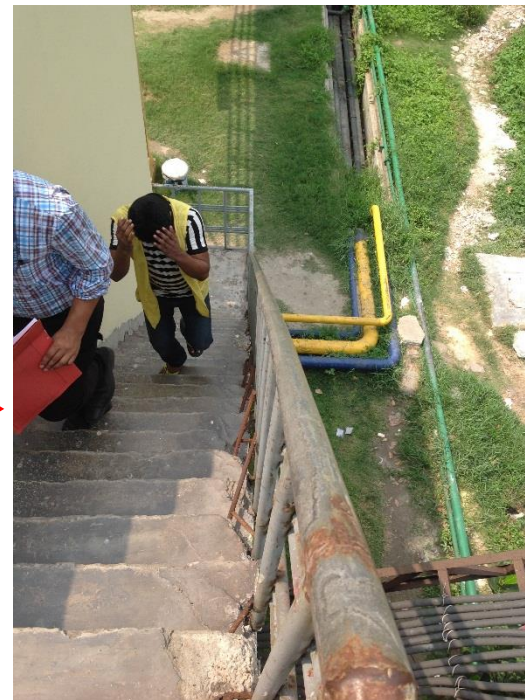
Defective Handrail to stairs

Defective handrail to a steep stairs, danger to people using it. Handrail and fixing to concrete to be reviewed by Building Engineer.

Item No.	Observation	Recommended Action Plan	Recommended Timeline
25	Comptex Utility Building – Building 4 Defective Handrail to stairs	Building Engineer to inspect stairs handrail and issue schedule of works required.	6-weeks
26	Comptex Utility Building – Building 4 Defective Handrail to stairs	Remedial works to be carried out.	6-weeks
27	Comptex Utility Building – Building 4 Basement columns do not correspond with structural drawings	Building Engineer to survey as constructed building – in particular columns within the basement. Updated drawings to be prepared showing the as constructed layout.	6-weeks
28	Comptex Utility Building – Building 4 Basement columns do not correspond with structural drawings	Prepare calculations showing the structural adequacy of the building columns and equipment support columns taking into account the factory design imposed loading and the as built structure.	6-months

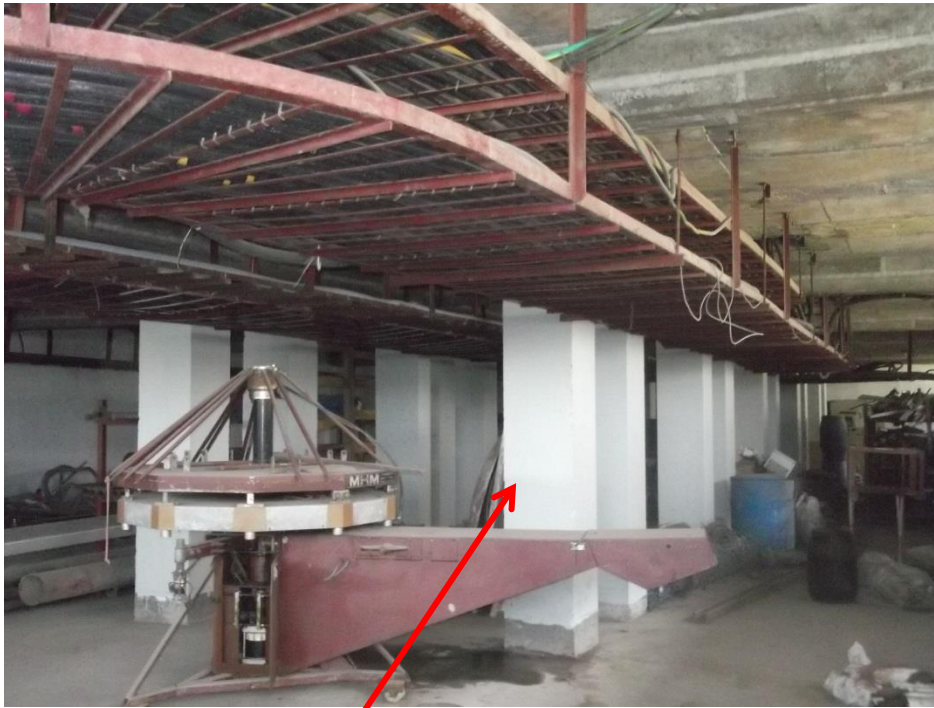
**Basement columns do not correspond
with structural drawings**

View of specific equipment support columns within the basement of the Utility Building

Building Engineer to update basement column layout and prepare design verification calculations for equipment support columns.

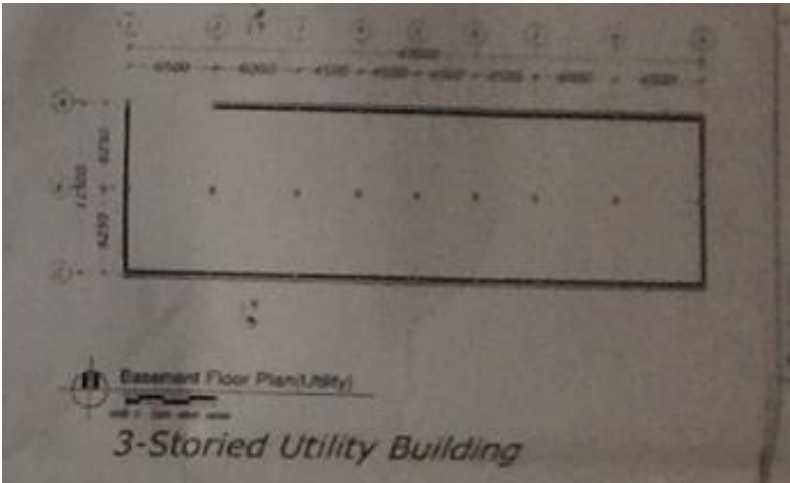
Utility Building Basement – original structural layout does not show equipment support columns

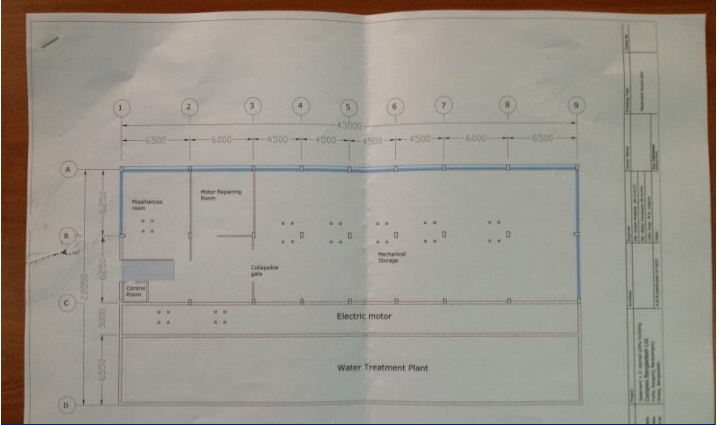
Utility Building Basement – updated Architectural layout showing equipment support columns.

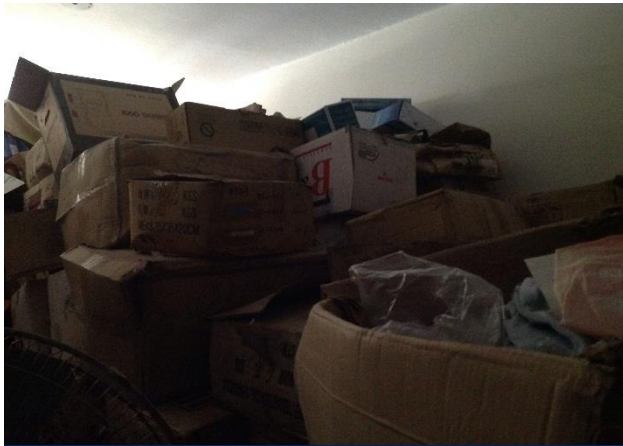
Storage load on 2nd floor

Building Engineer to prepare controlled loading plans, based on floor slab and column capacity, for all floors which will designate allowable storage density and where storage may be placed.

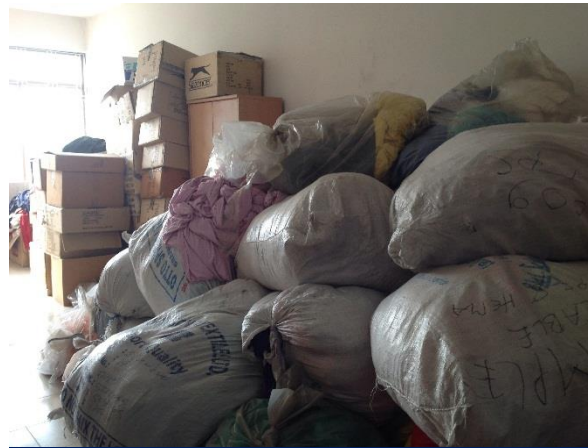
Storage load on 2nd floor

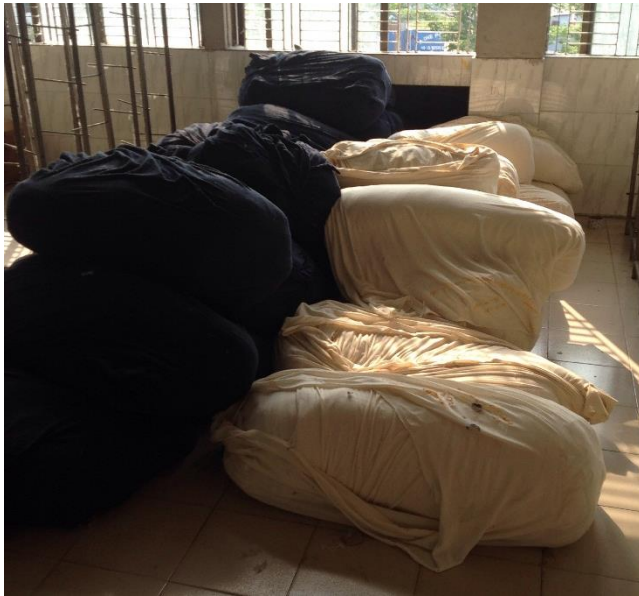
Storage load on 1st floor

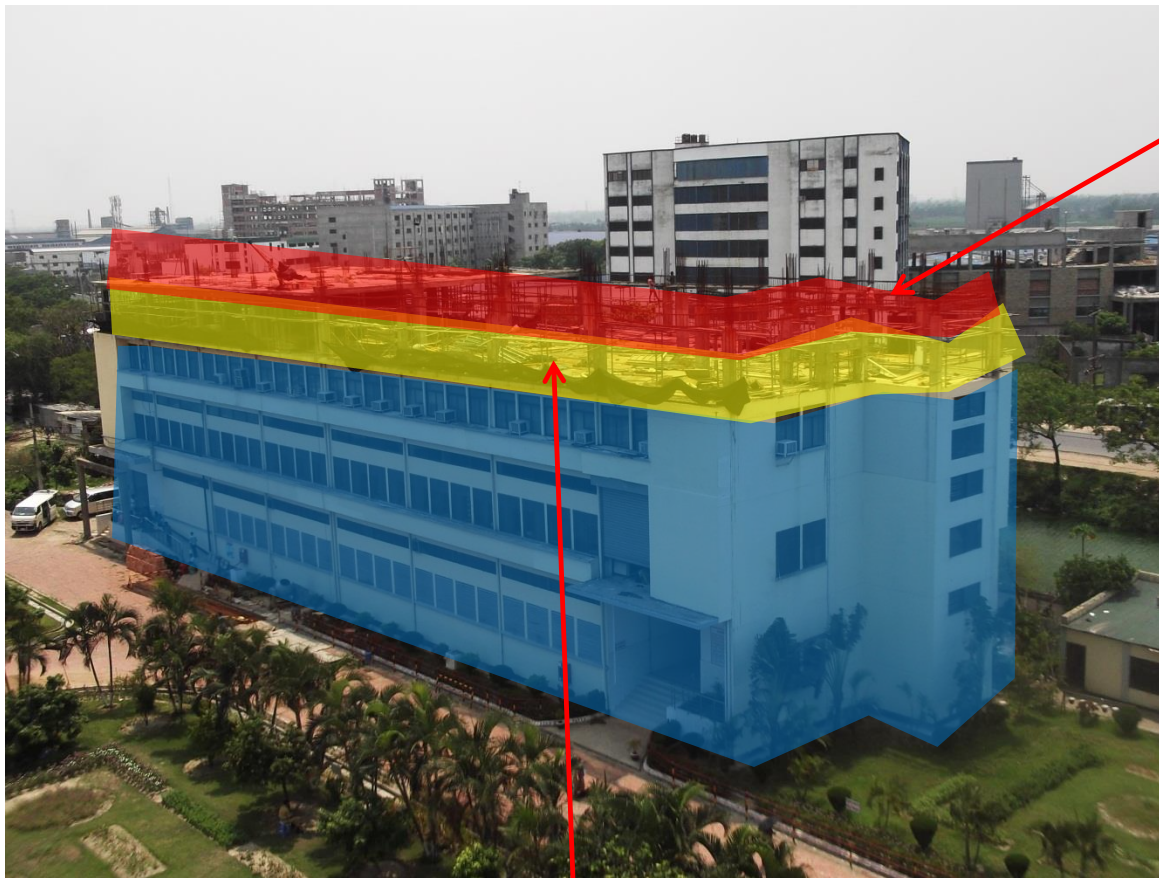
Permit for a total of 5 storeys

Existing structure – 3 storeys
4th storey currently being constructed

Any proposed additions to the existing building structure, including addition of a 5th storey, should be reviewed by the Building Engineer

Permit allows a total of 5 storeys. Building Engineer to review structural design and concrete strength within existing columns prior to commencing construction of any further building extension above the 4 storeys currently being constructed.
