# TM Textiles & Garments Ltd.

Kashor, Hobibari, Bhaluka, Mymensing  
(24.298229 N, 90.366558E)

25 May 2014

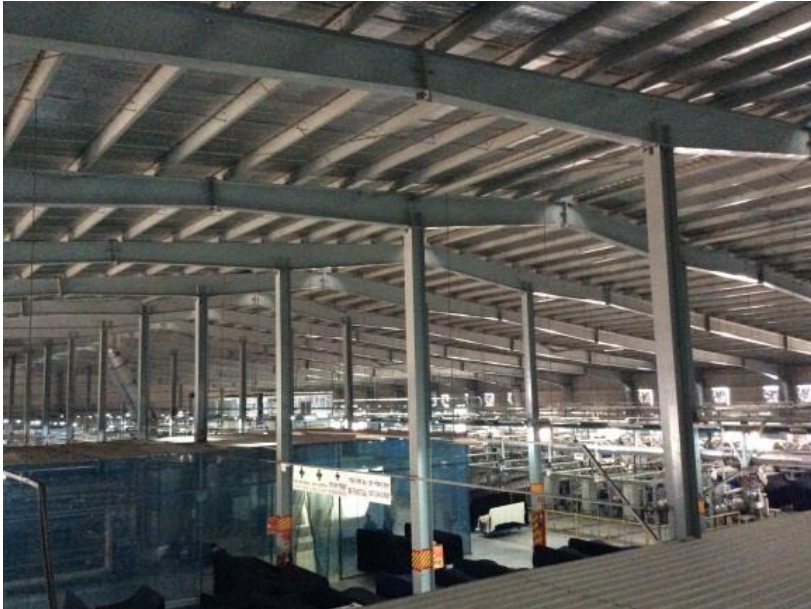
There was no fire protection on steel structures across the entire site .

Typical Roof structure type observed in garment building, knitting building and dyeing building

Item No.	Observation	Recommended Action Plan	Recommended Timeline
1	There was no fireproofing of steelwork	Building Engineer to assess the requirement for providing fire protection to the steelwork particularly in relation to the mezzanine structures and the 2 storey buildings	6-weeks
2	There was no fireproofing of steelwork	Fire protection works to the steelwork as deemed required by the Building Engineer are to be implemented on site. The Building Engineer is to inspect these works during the implementation stage and on completion to confirm that the works comply with the requirements.	6-months
3	Lateral Stability of the portal frame structures	The Building Engineer is to assess the lateral stability of the portal frames in all buildings in the direction perpendicular to the portal frames. This assessment should confirm or otherwise that the steel rope bracing and circular hollow sections provide sufficient resistance to lateral loading in this direction.	6-months

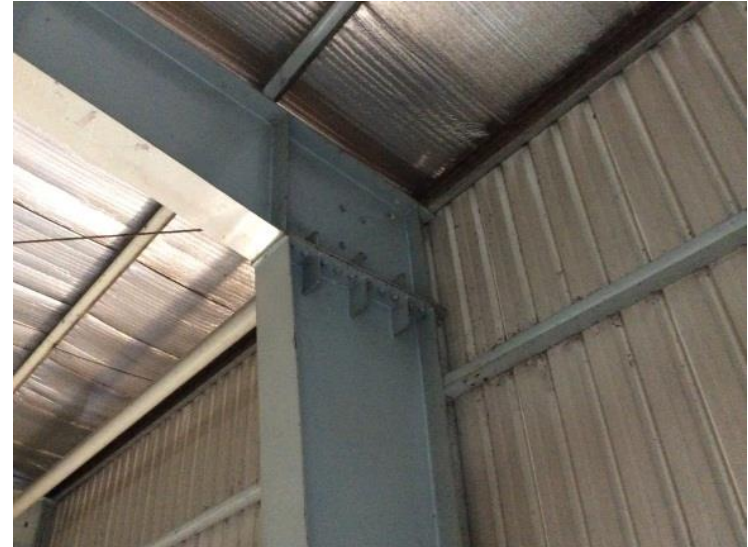
Typical portal frame steel connection

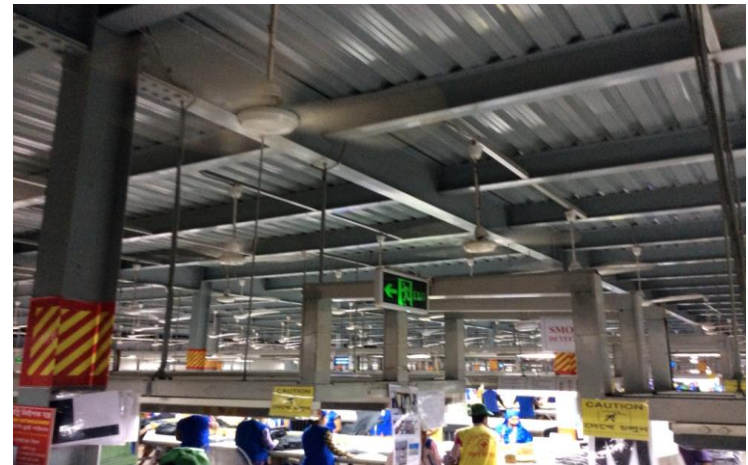
Typical Elevated Floor Structure

No fireproofing to steelwork

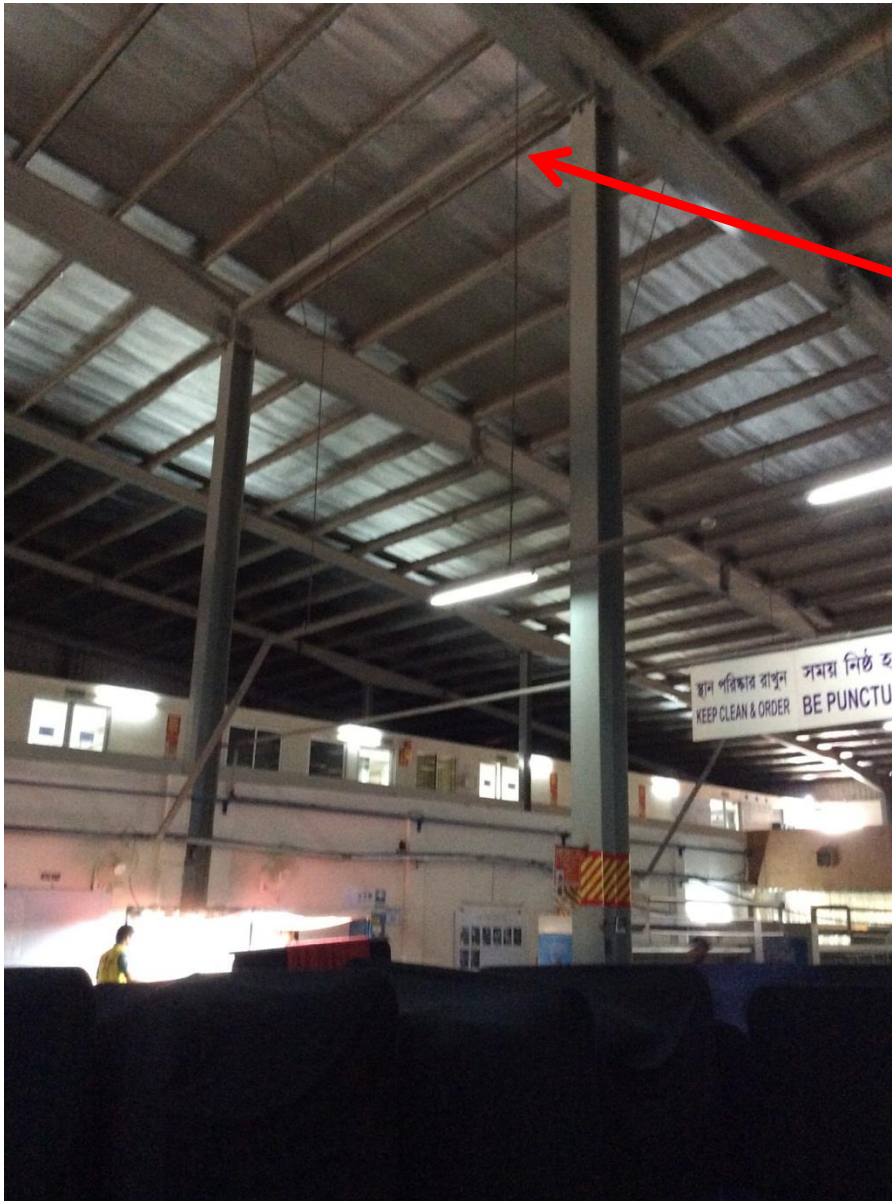
Relatively small circular hollow section used as a component in the portal frame stability system

4	Lateral Stability of the portal frame structures	The Building Engineer is to monitor the implementation of any measures deemed necessary on site following the assessment noted above.	6-months
5	Construction works on-going	It was noted on site that construction works are on-going in relation to a new Warehouse, a new scissor lift in the Knitting Building and a new section of mezzanine in the Knitting Building. The Building Engineer is to carry out a structural assessment of these works to confirm their structural adequacy and where relevant to confirm that the existing building has sufficient structural capacity to cater for these changes and additional loading.	6-weeks
6	Construction works on-going	The Building Engineer is to monitor the implementation of any measures deemed necessary on site following the assessment noted above.	6-months

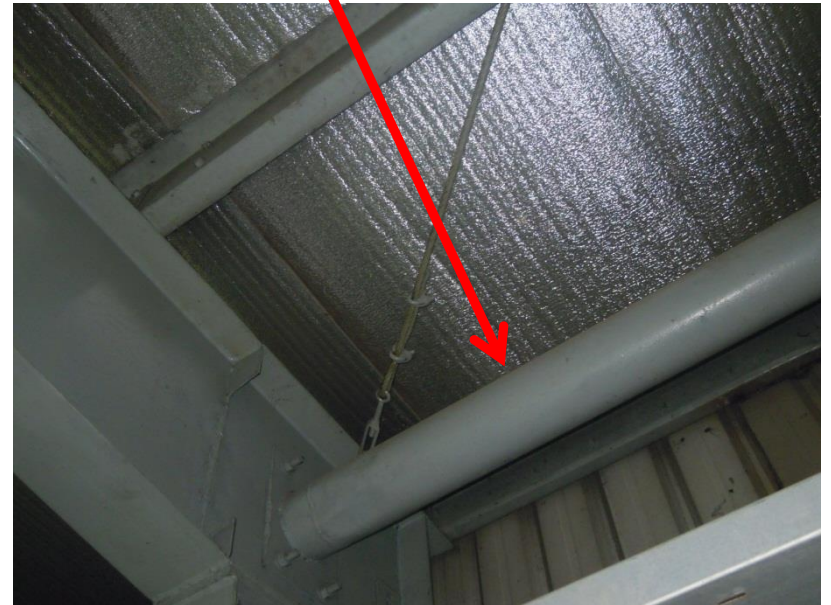
Lateral stability of the portal frame structures

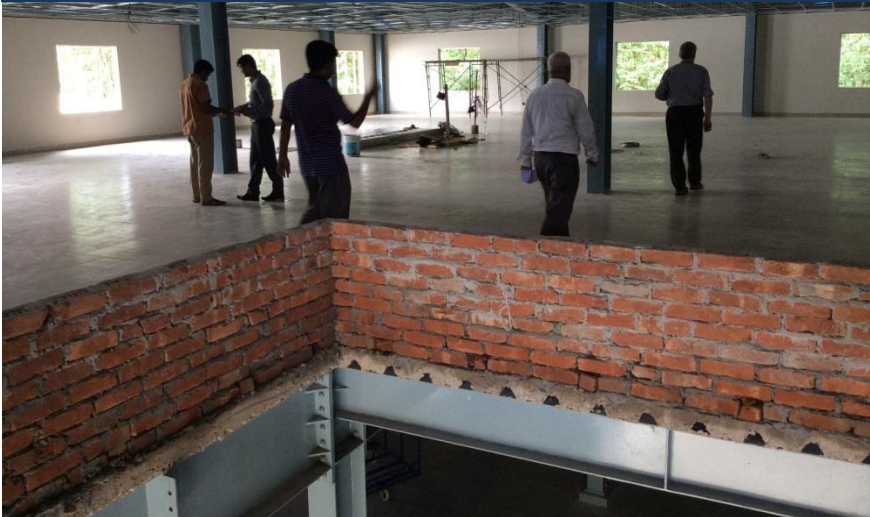
Some construction work was on-going, and not shown in building permits

Lift pit in new warehouse building

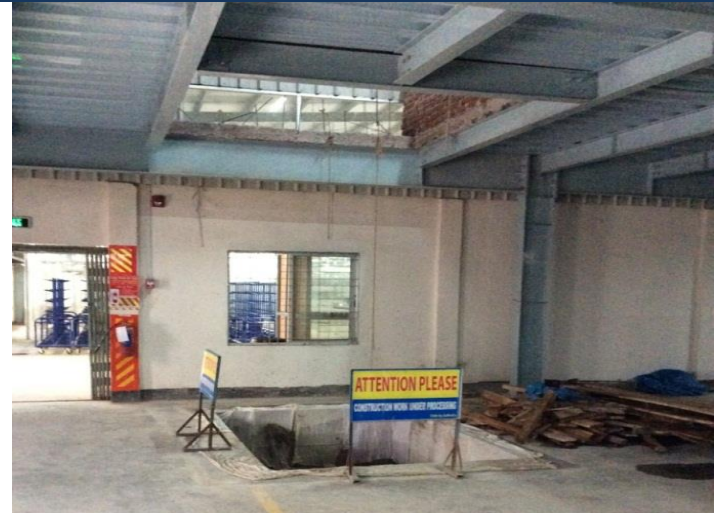
New lift pit in knitting building

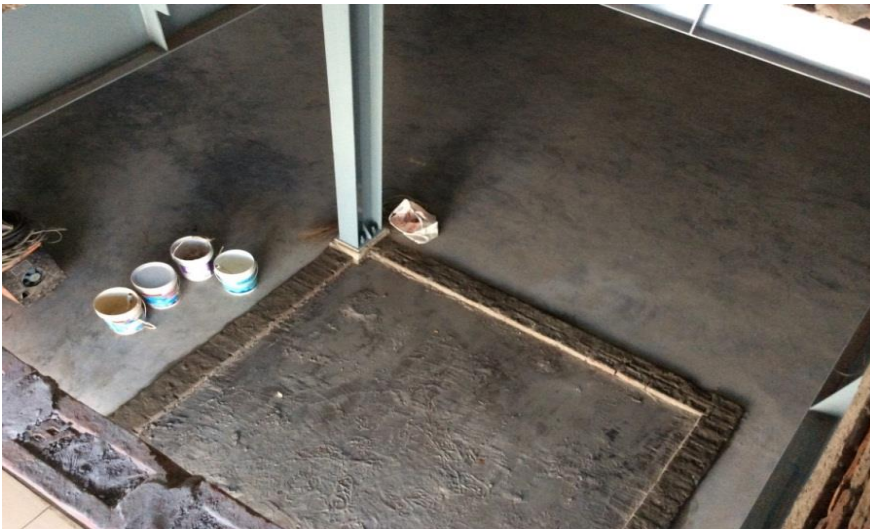
Construction works ongoing

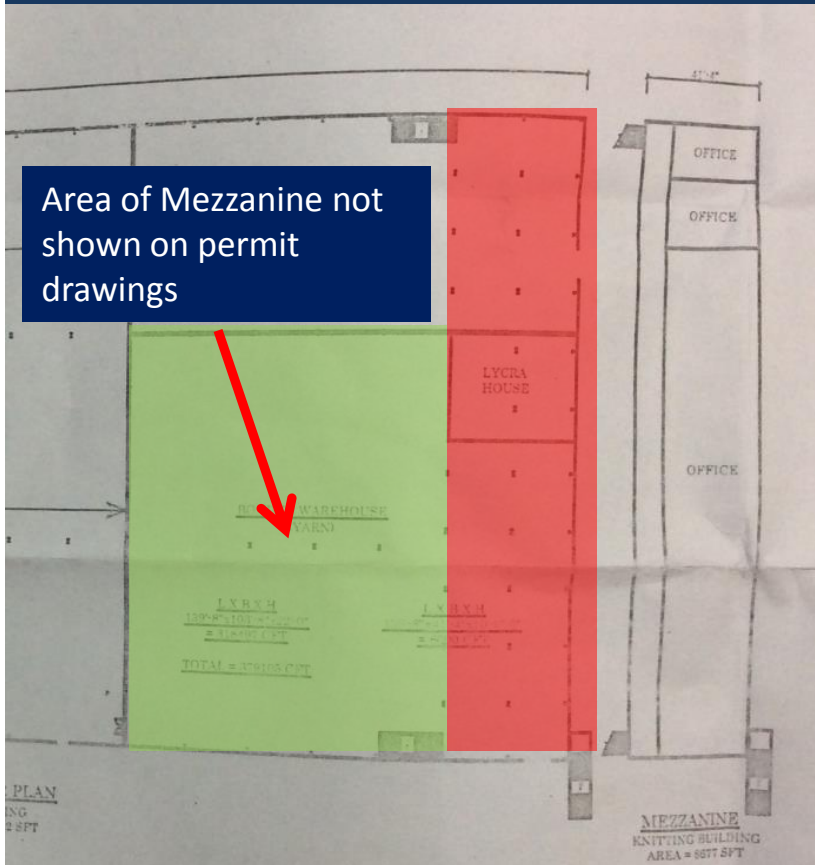
The majority of the mezzanine level in the knitting building was used for storage area, with the remaining area either used as walkways or unused on the day of inspection

Area of mezzanine level in knitting building

Item No.	Observation	Recommended Action Plan	Recommended Timeline
7	Storage Loading on the new mezzanine in the Knitting Building	The capacity of the mezzanine structure is to be assessed by the Building Engineer to confirm that the mezzanine structure is designed to carry the loading from the storage noted.	6-months
8	Storage Loading on the new mezzanine in the Knitting Building	Produce and actively manage a loading plan for all elevated floor plates for all buildings within the factory complex giving consideration to floor capacity and column capacity.	6-months
9	Water Tank loading on the roof of Medical and Day Care Building	The capacity of the roof structure is to be assessed by the Building Engineer to confirm that the roof structure is designed to carry the loading from the water tanks noted.	6-months
10	Water Tank loading on the roof of Medical and Day Care Building	Produce and actively manage a loading plan for all elevated floor plates for all buildings within the factory complex giving consideration to floor capacity and column capacity.	6-months

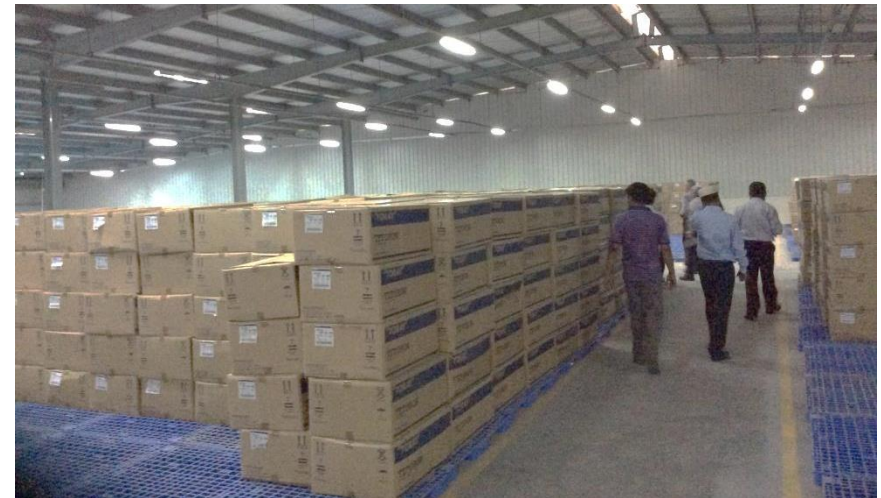
Storage in additional mezzanine area (not shown in permit drawings)

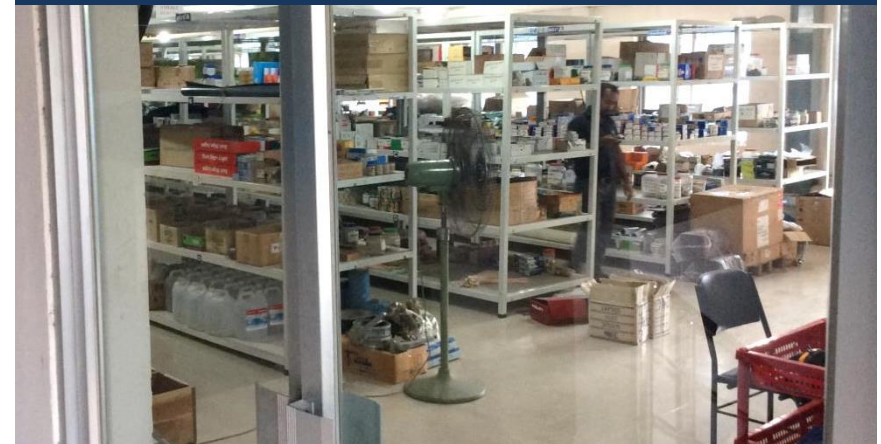
Storage in area specified as office in permit drawings

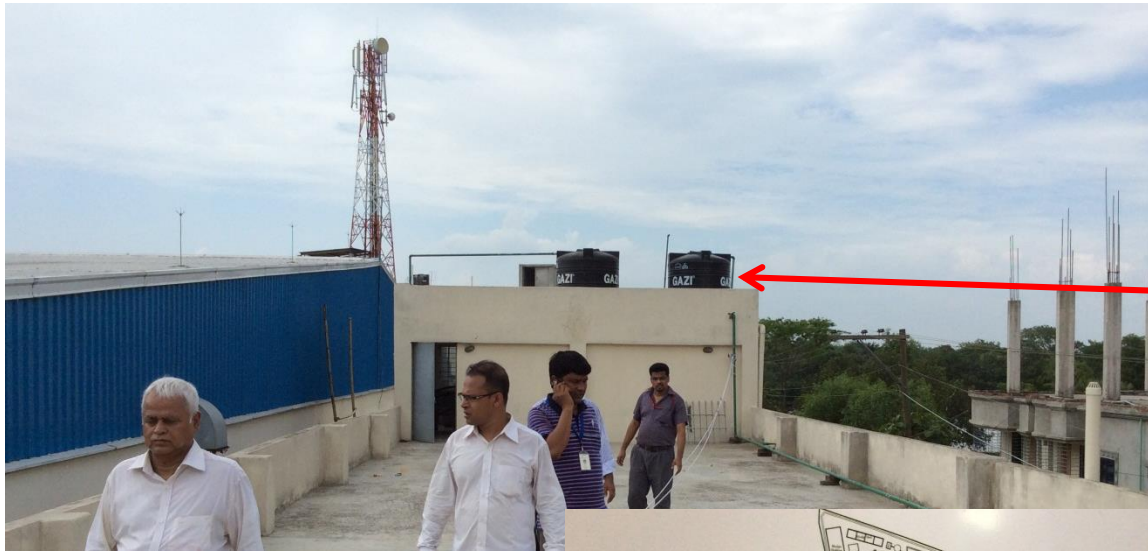
Water tanks positioned above the stair core on Medical Centre Building

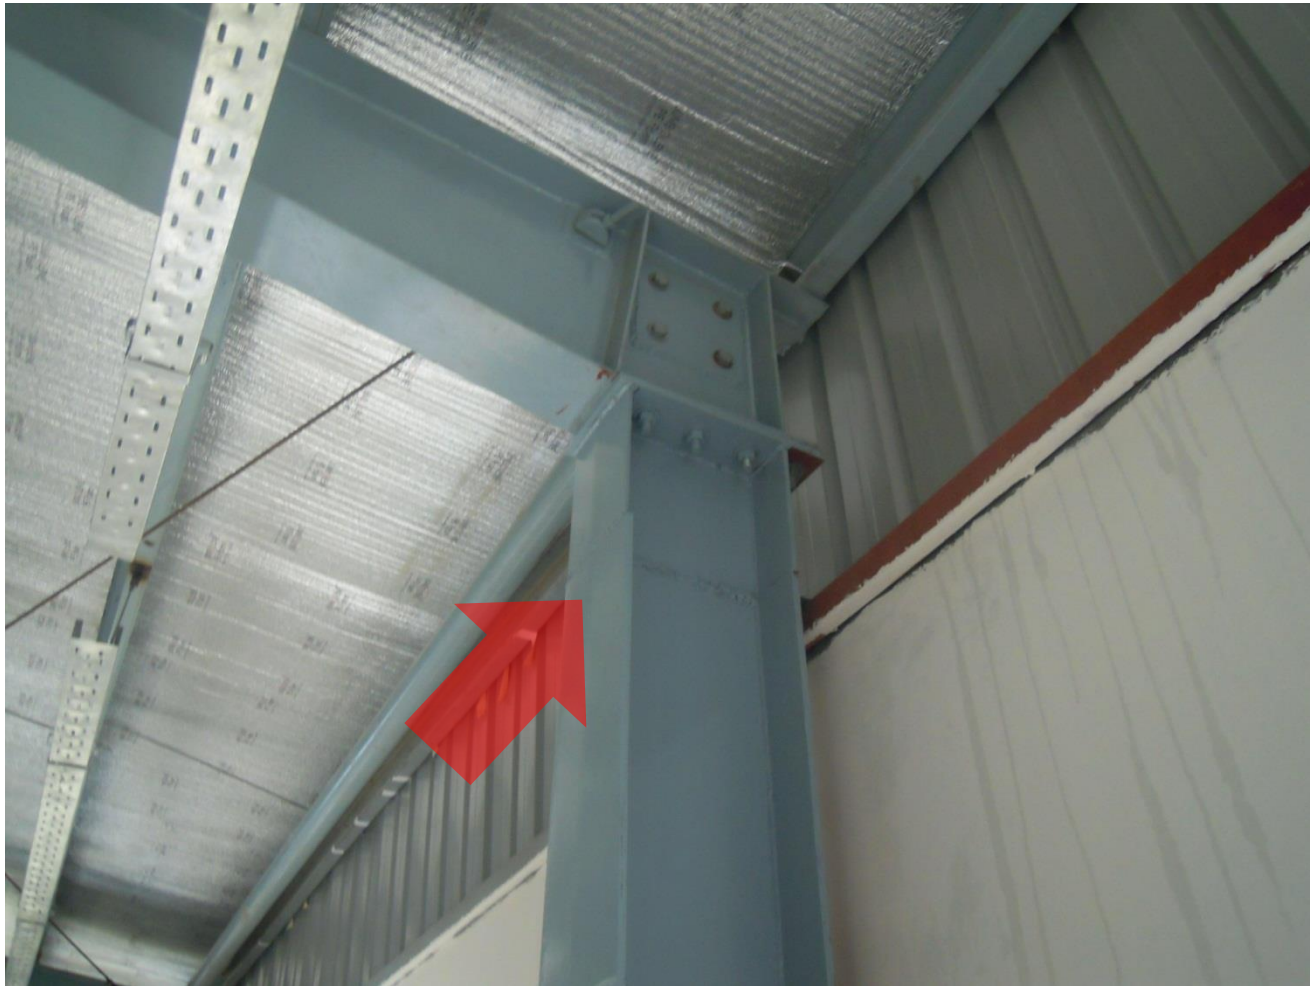
Change in column size was observed towards top of column in the new warehouse building

Change in column section size in the new warehouse

Item No.	Observation	Recommended Action Plan	Recommended Timeline
11	Change in column section size in the new Warehouse	The capacity of the reduced column section is to be assessed by the Building Engineer to confirm that it is structurally adequate.	6-months
12	Change in column section size in the new Warehouse	The Building Engineer is to monitor the implementation of any measures deemed necessary on site following the assessment noted above.	6-months
13	Possible future extension works noted to Knitting Building	If any additions to the building structure are proposed, the Building Engineer shall provide calculations showing the structural adequacy of all columns taking into account any additions to the existing structure, the loading and as built structure, including in-situ concrete strength testing.	6-months
14	Inconsistencies between the permit/ structural drawings and the as-built structures	Building Engineer to check, collect information and produce accurate and fully complete as-built documentation.	6-months

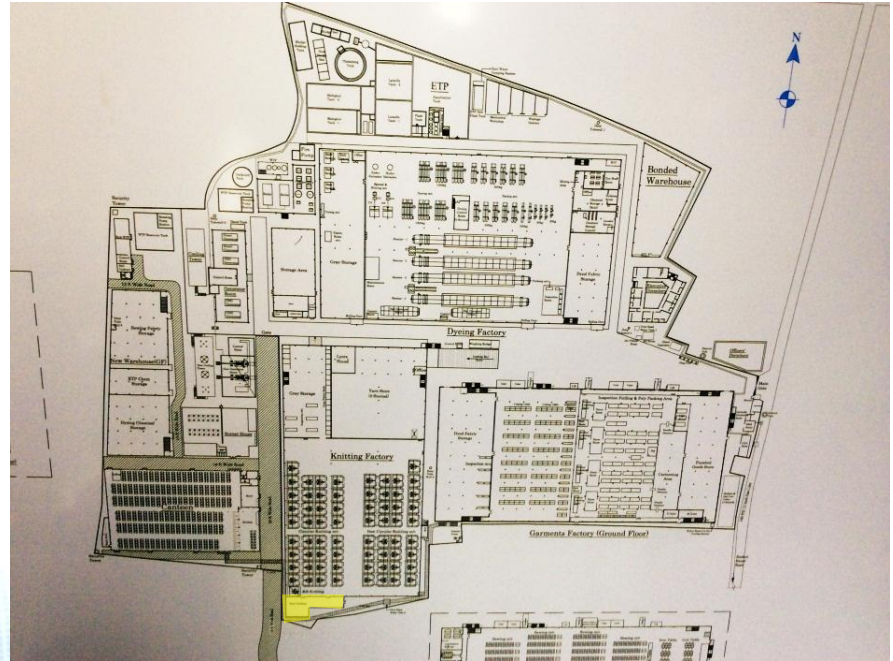
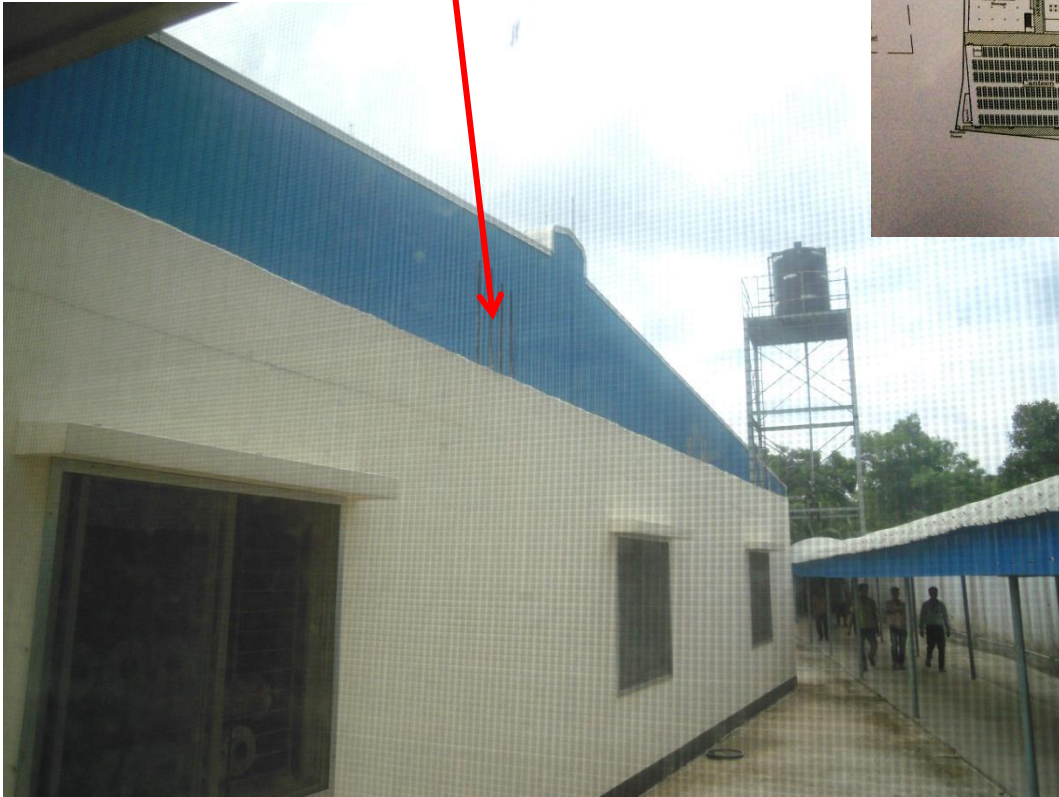
Reinforcement was observed to be extending from the outside walls of the reinforced concrete extension of the knitting building.

Possible future extension works noted

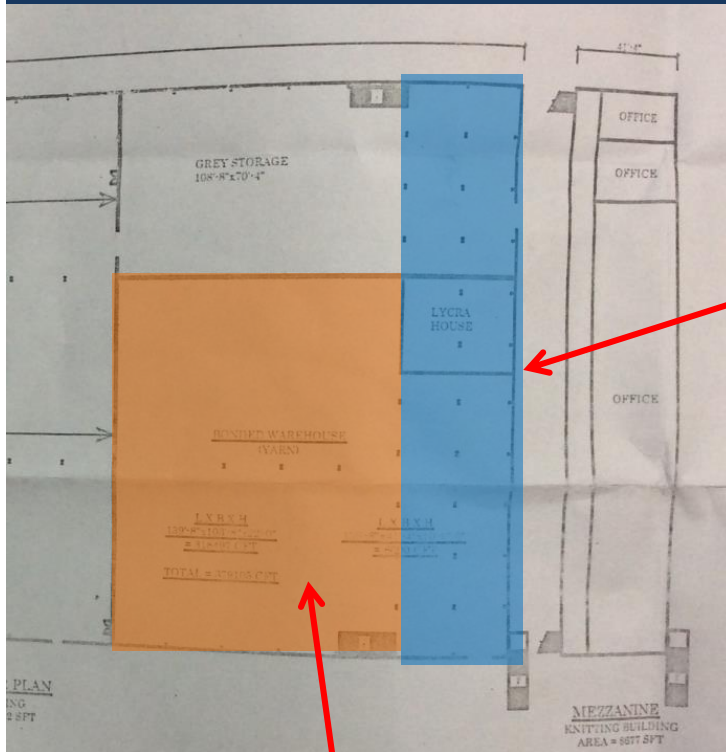
The mezzanine area within the knitting building was significantly larger than the permit drawings suggested. Steelwork had been provided beneath the extension to support this, although this was also excluded from the structural drawings.

Extent of mezzanine according to building permit

Additional mezzanine area observed

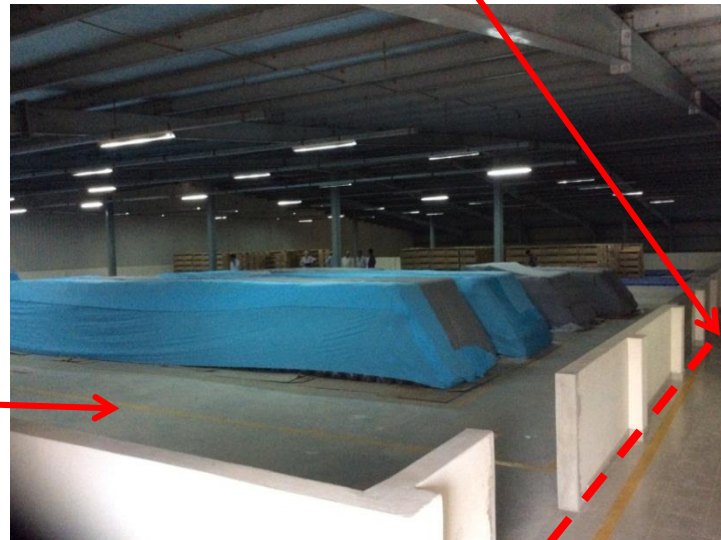
Inconsistencies between permit drawings and as-built structures

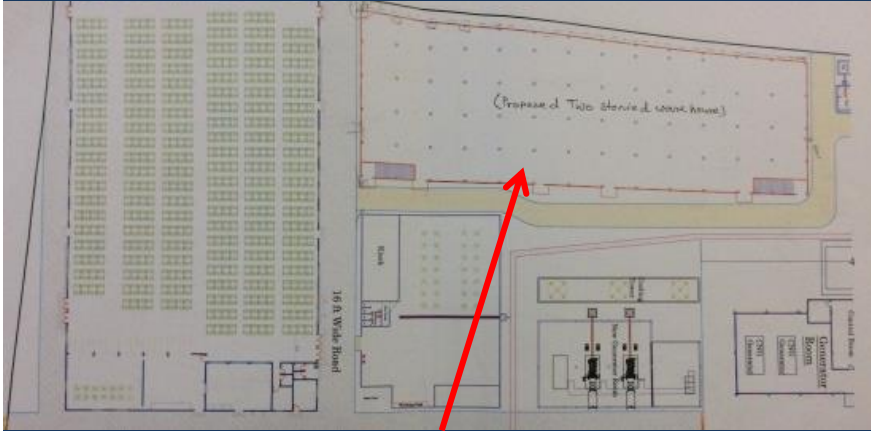
No permit had been obtained for the new warehouse building by the day of inspection

New warehouse as proposed in plan

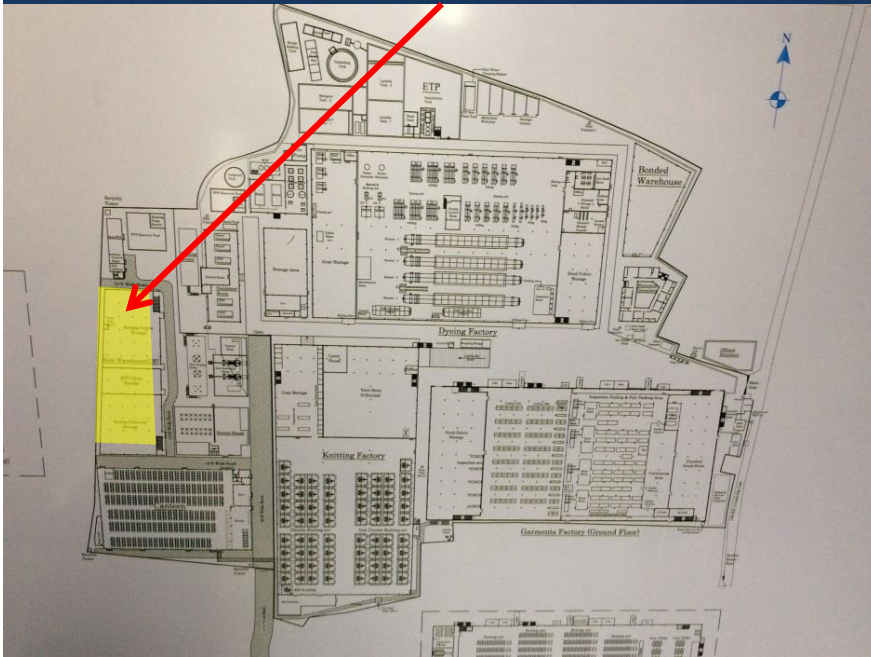
Inconsistencies between permit drawings and as-built structures
