# New Age Garments Ltd New Age Apparels Ltd Kei Lock Garments Ltd

Nishchintopur, Asulia, Savar, Dhaka  
(23.924895, 90.308234)  
9<sup>th</sup> April 2014

# Executive Summary (continued)

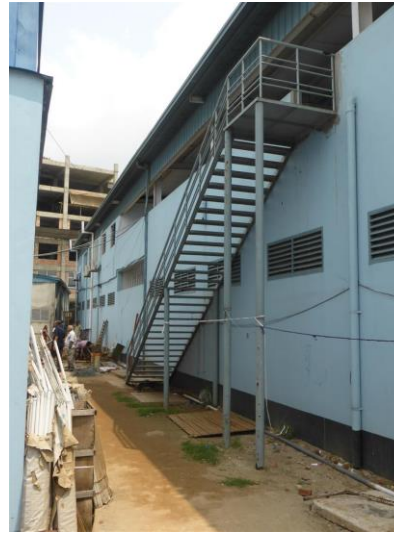
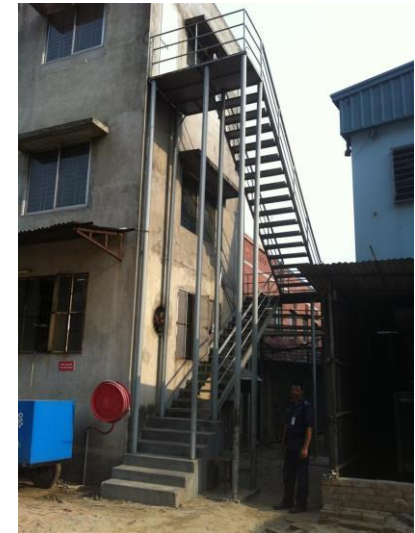
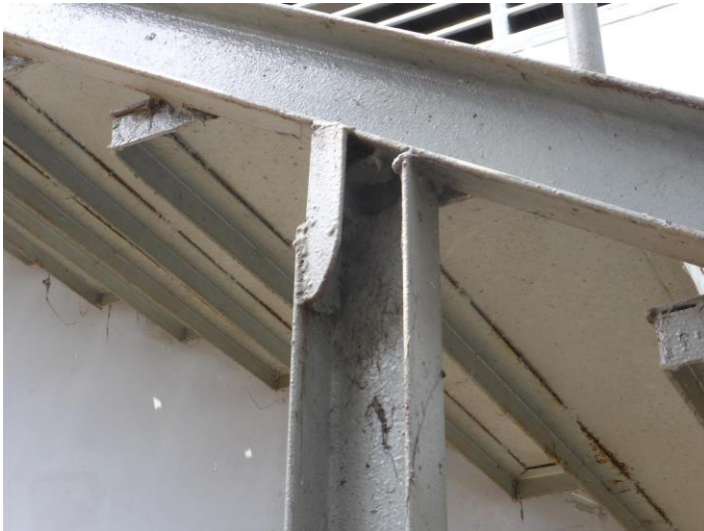
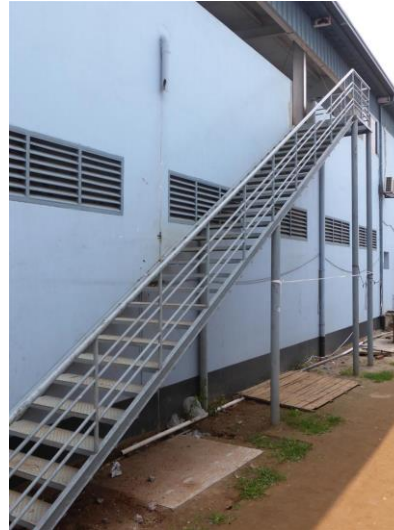
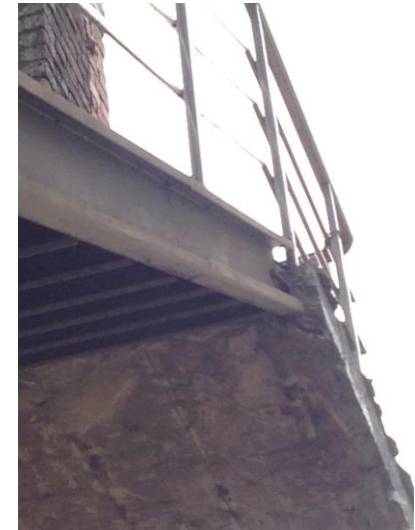
# **Undocumented and non-engineered External Steel Stairs (Buildings 2 & 3)**

- External steel stairs do not appear to be engineered.
- Fixed to structure by tack welds to rebar.
- Slenderness of posts and structural capacity of sections appear to be insufficient for spans under full loading.

- Immediately prop all external steel escape stairs at steel stringer and at tack welded connections to concrete landings.
- Building engineer to supervise propping.

- Building Engineer to review **escape stairs** structural elements and all connection details for full access loads on stairs.
- Building engineer to design appropriate strengthening works as required.
- Factory manager to manage and co-ordinate any strengthening works with fire escape strategy for all areas.

- Complete strengthening works and appropriate as-built drawings.

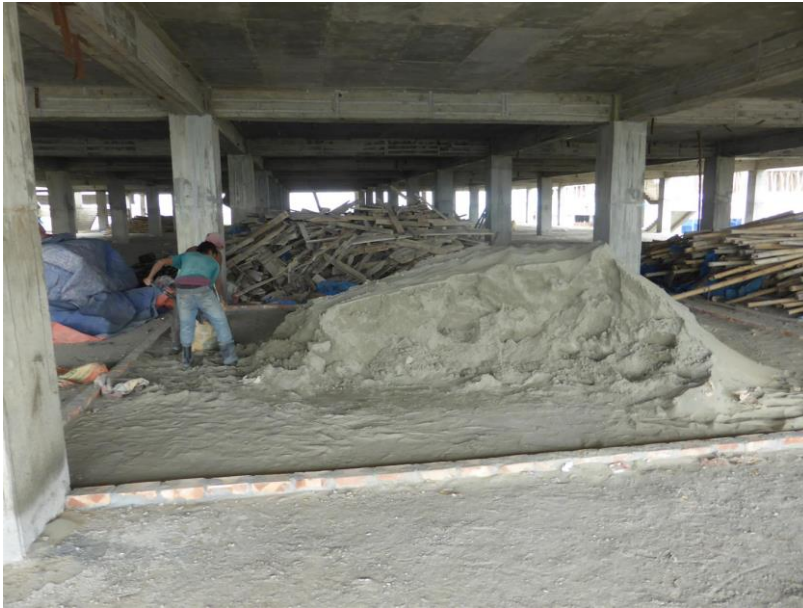
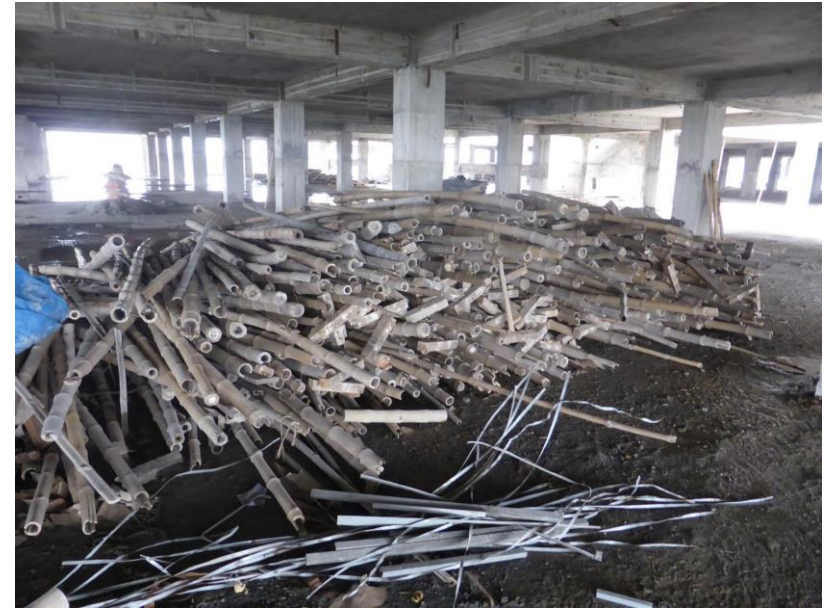
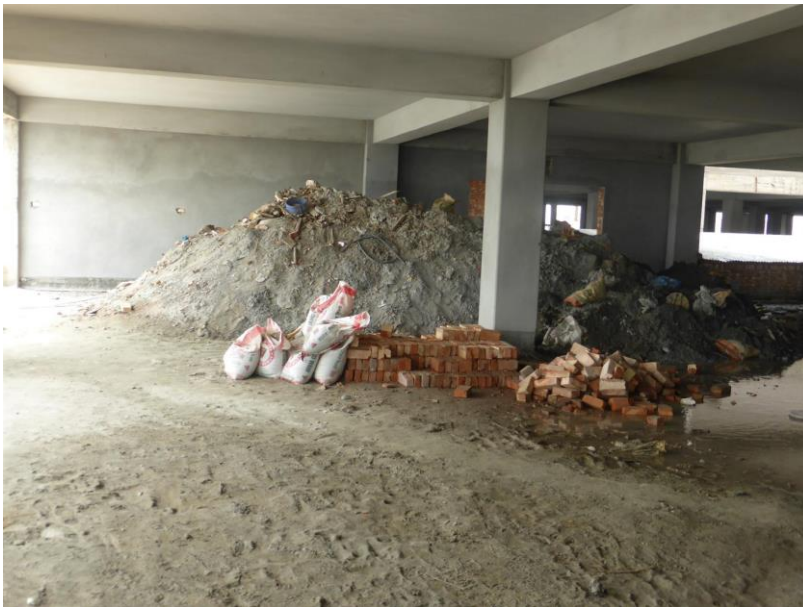
# Load management (All buildings)

**Instances of high construction loads (particularly rubble and sand piled up to approx. 2m) on a number of upper levels in Building 1.**

- Building Engineer to review all construction loading and advise safe load limits
- Maintain current use of the floors within Buildings 2 & 3 and do not change use or increase occupation or loading prior to completion of safe loading plans by the building engineer.

- Building Engineer to create controlled loading plans for all floors, which account for existing solid partition loads, extra finishes, heavy fixed items etc. and are based on the structural capacity of supporting slabs, beams and columns.
- Factory management to display plans and educate all relevant factory management on implementation.

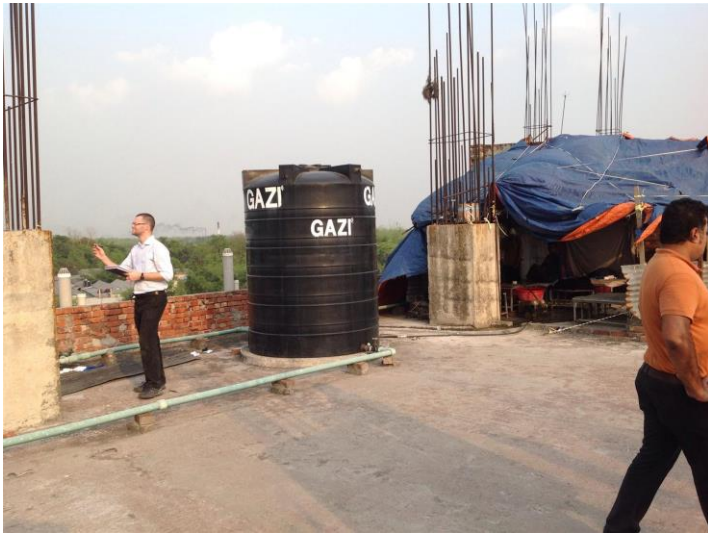
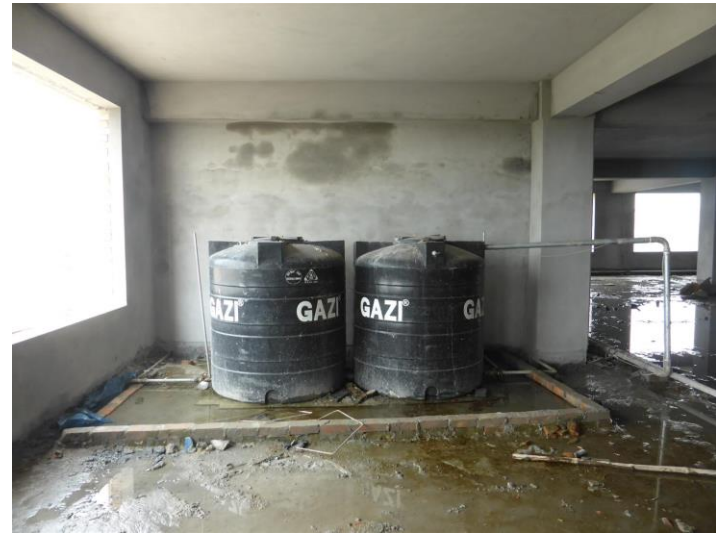
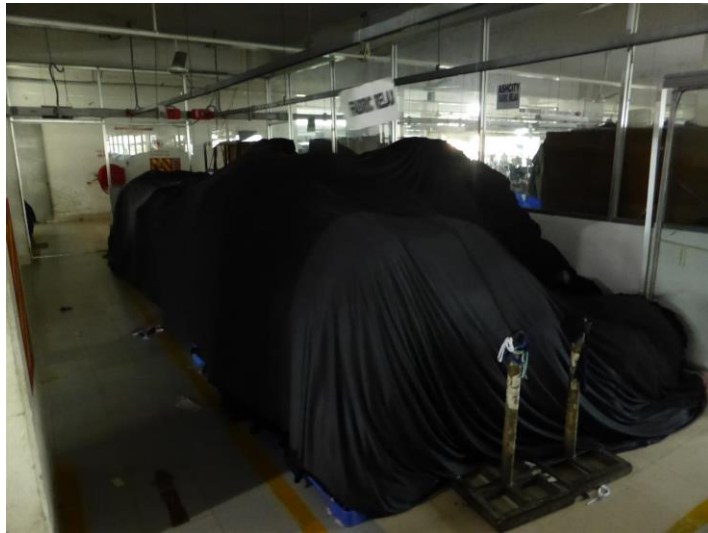
**Localised areas of high load observed in buildings 1, 2 and 3 relating to toilet core build-ups, water tanks, material storage, solid partitions.**

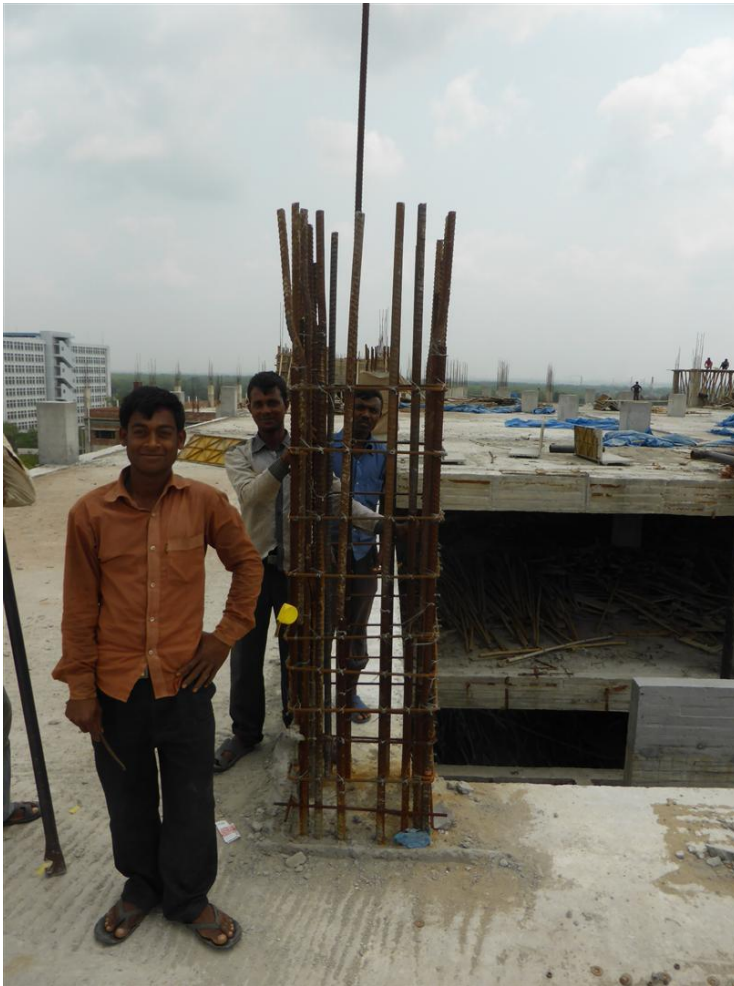
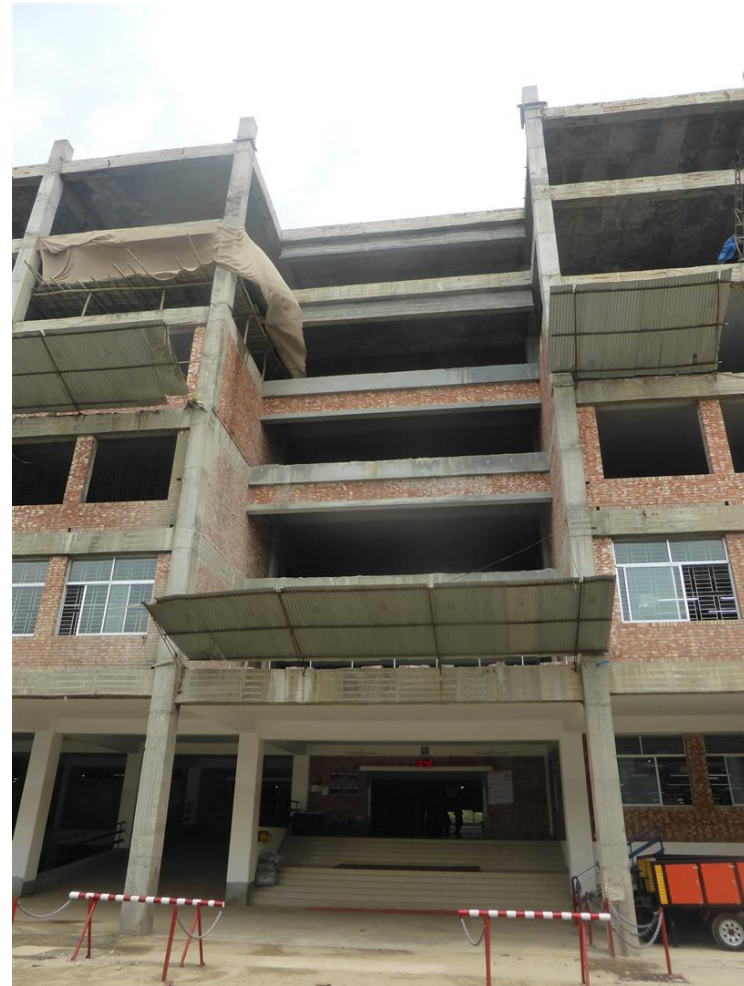
# **Construction Health and Safety (Construction and Factory Workers)**

- No edge protection for workers building levels above. Risk of workers or objects falling to levels below.
- Risk to workers accessing lower levels from falling objects from above (partial protection in place as shown).

- Review edge protection to prevent workers falling / items falling on factory workers.

- Factory Management to consider edge protection measures during on-going construction works.
- Ensure all access/ egress routes from factory are protected from falling items from above.

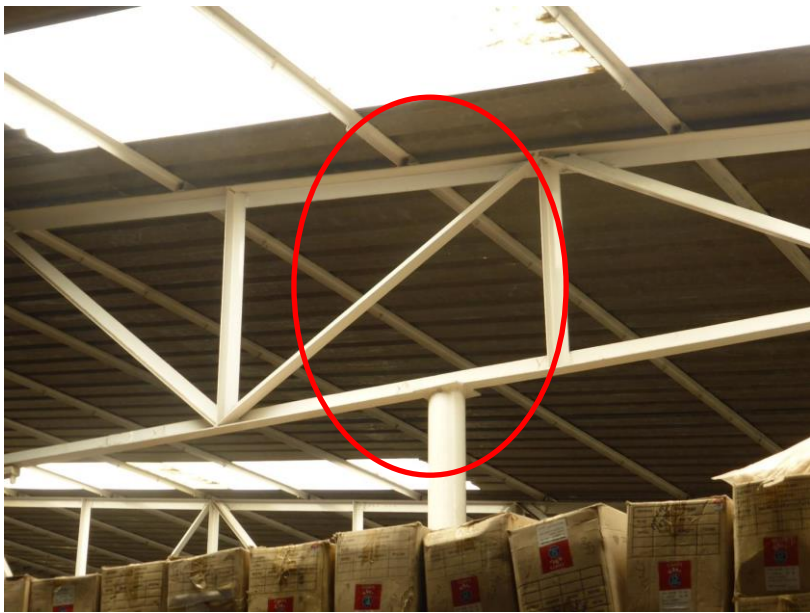
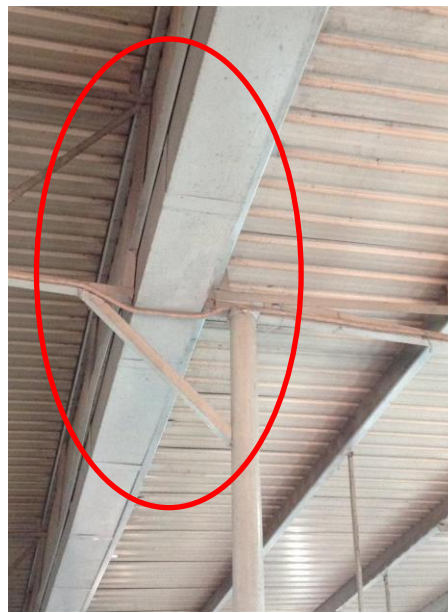
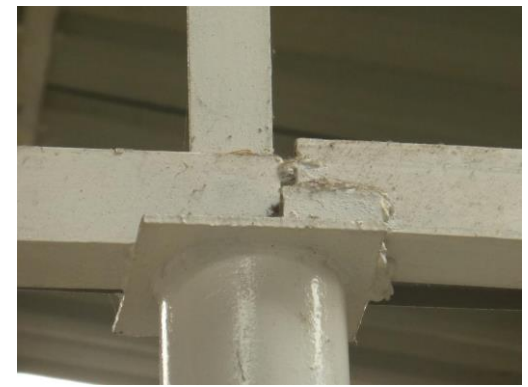
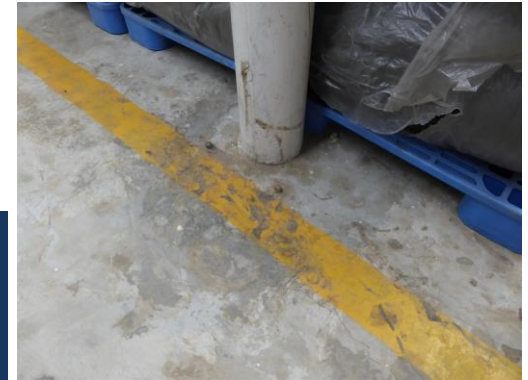
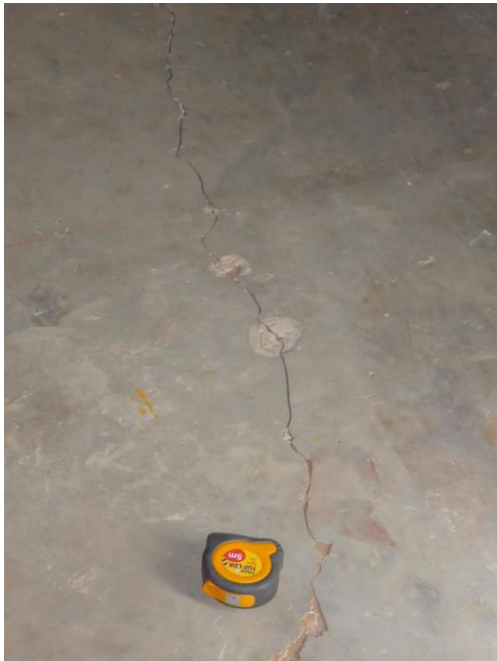
# **Non-engineered warehouses with no structural information; unusual structural arrangements (Buildings 4 & 5)**

- Irregular structural support arrangements for roof trusses.
- No cross-bracing in roof plane to transfer lateral loads to perimeter walls.
- Posts fixed at slab level; no foundation details available.
- Limited capacity of welded details of trusses observed.
- Cracking of floor slabs.
- No relevant structural drawings available.

- Building Engineer to undertake an engineering assessment of the roof and vertical support structures, structural stability and perimeter of Buildings 4 and 5, with calculations and as-built drawings.

- Carry out all recommendations from the engineering assessment.
- Undertake strengthening as required.
- Finalise appropriate structural as-built drawings incorporating any strengthening works to the structural frame.

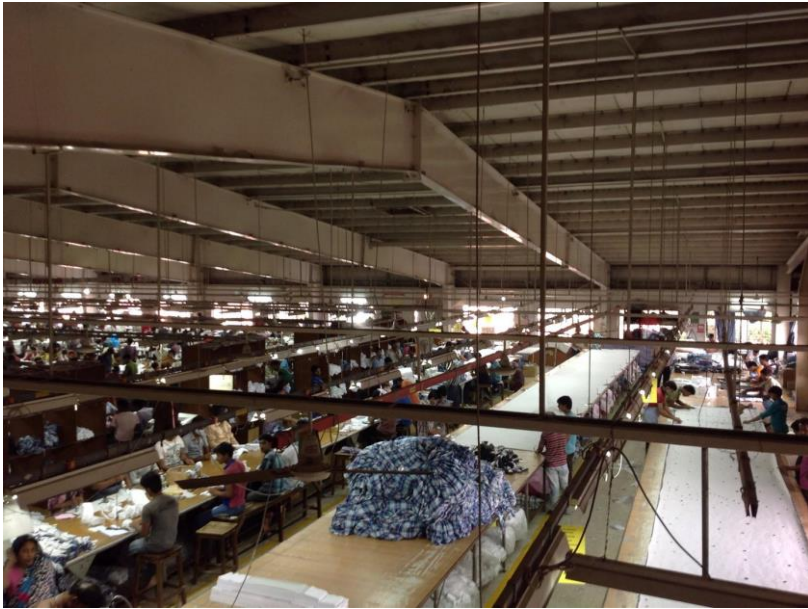
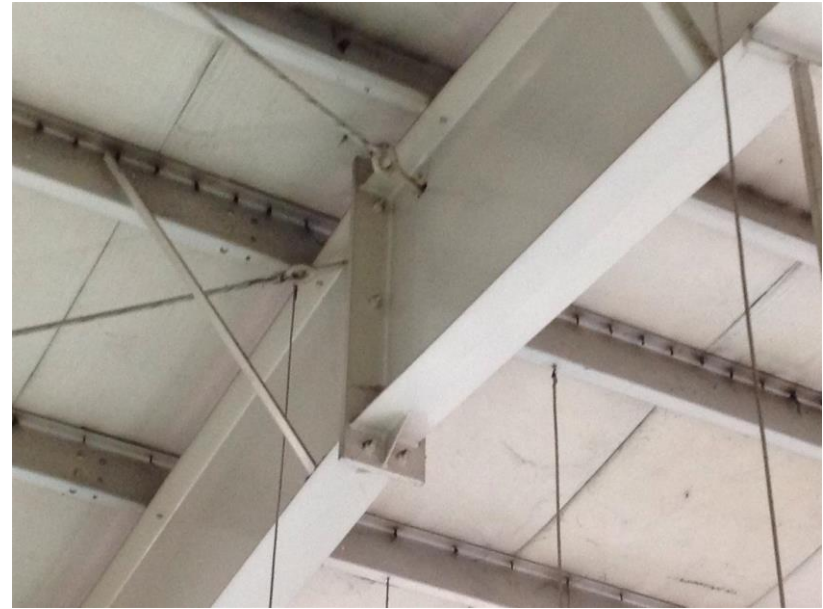
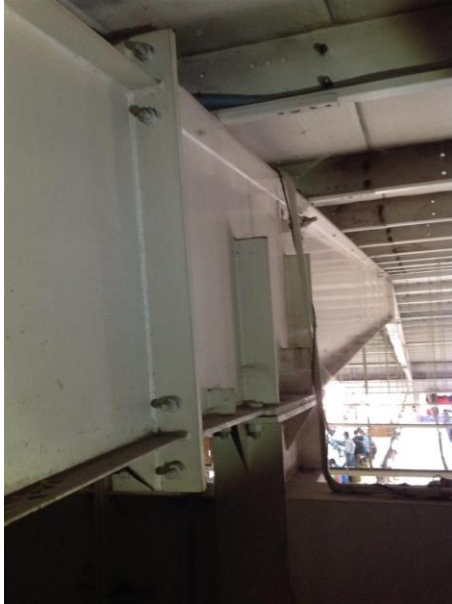
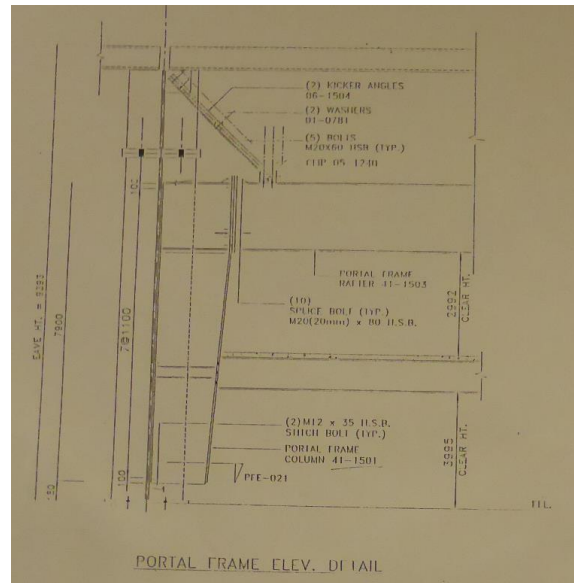
## Steel Frame details (Building 2)

**Connection details generally (and specifically the splice and connection details for the main structural frame) do not appear to match the structural drawings:**

- **Significantly fewer bolts provided;**
- **Connections do not appear to be appropriate to achieve the full capacity of the steel section size provided.**

- Building Engineer to undertake an engineering assessment of the as-built steelwork connections and splice details, with calculations and drawings.

- Carry out any strengthening or remedial works arising from the engineering assessment.
- Complete relevant as-built drawings.

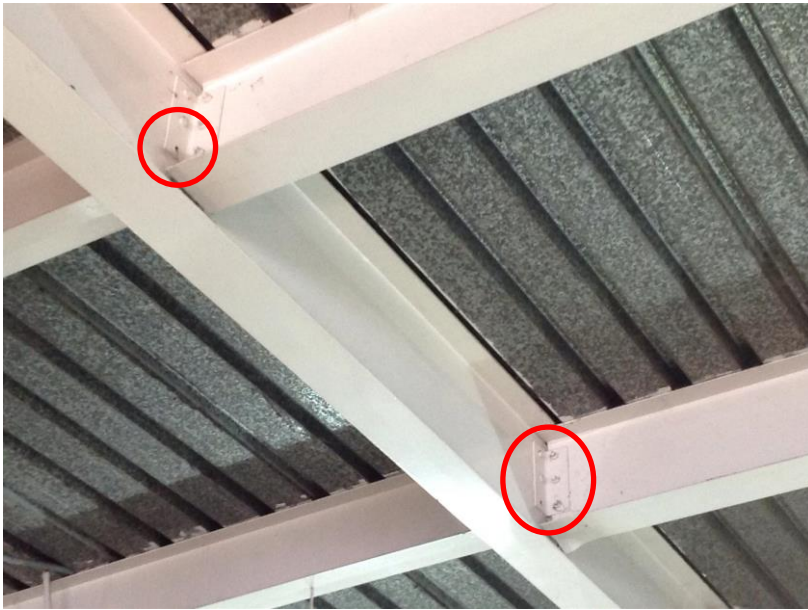
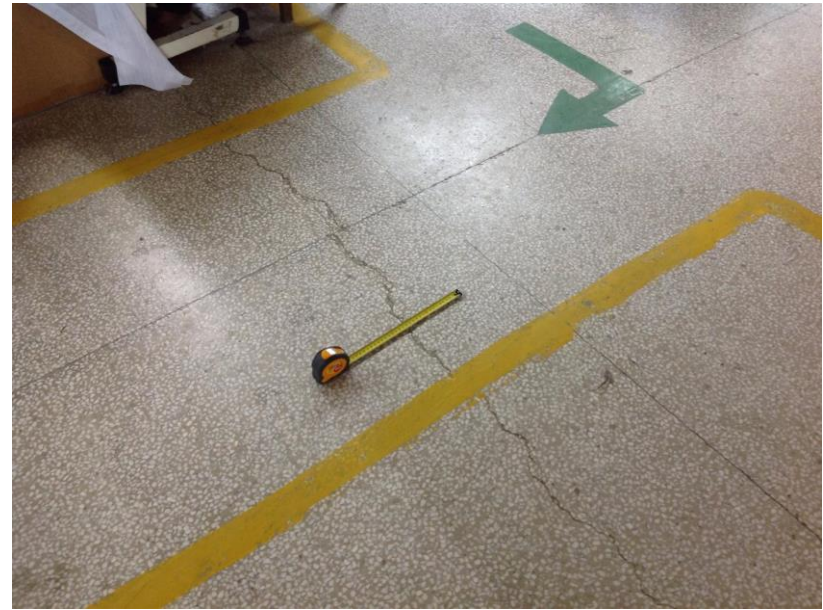
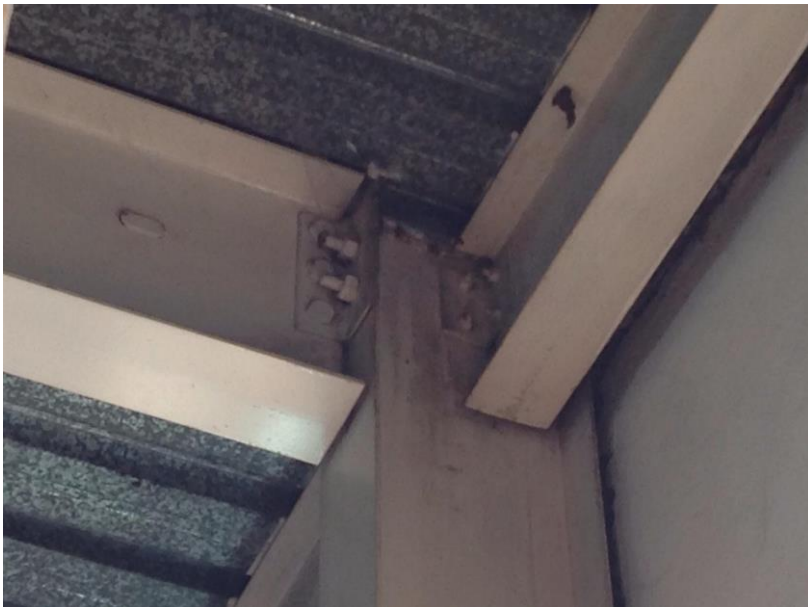
- Bolts missing from beams supporting mezzanine floor.
- Structural capacity of 4-bolt connections for floor loading is not clear.
- Cracking of floor finish over mezzanine steel beam position in a number of locations, indication structural distress of slab.

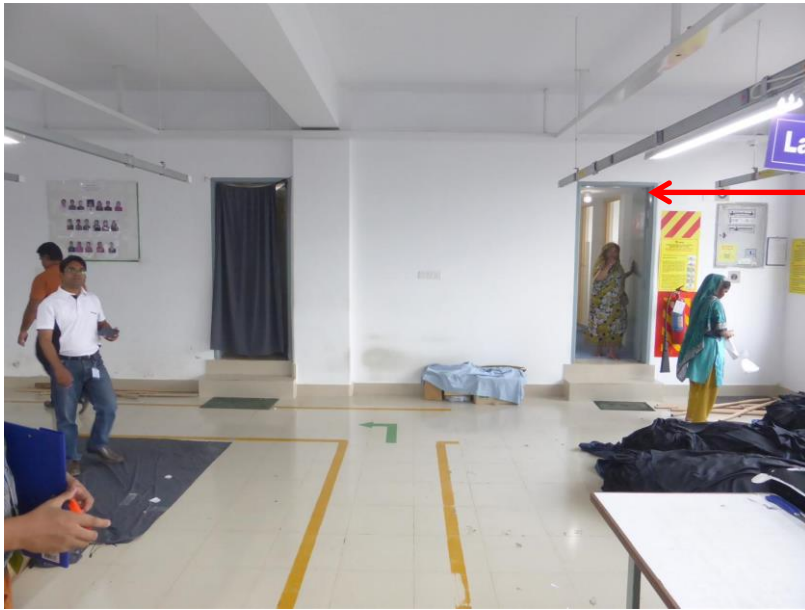
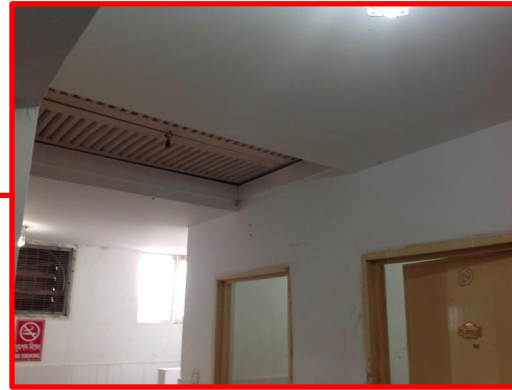
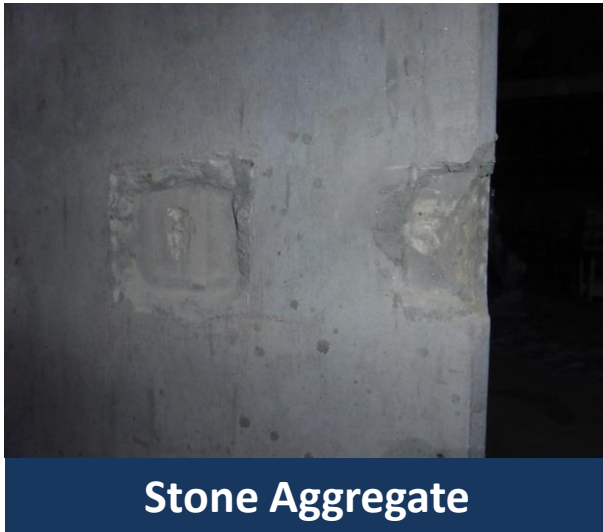
# High column stresses for toilet core loading (Building 1)

- Solid build-up at stacked toilet cores includes solid partitions, secondary soffit slab and additional build-up on floor at ground level.
- Cursory calculations indicate high working stress in columns supporting toilet areas.

Engineer is to perform detailed calculations and concrete tests to prove column as-built is sufficient.  
Pending the outcome of this assessment, discontinue construction of additional toilet cores on upper floors.

- Construction of new toilet core fit-out (solid partitions and secondary slabs) on upper incomplete levels **to cease immediately** pending design check.

- Building Engineer to review design, loads and column stresses at the toilet core areas in Building 1, accounting for all solid partitions, build-ups and secondary slabs.
- Check column capacity for applied loading taking account of concrete cylinder tests as appropriate.

- Modify toilet design or column strengthening based on findings of engineering assessment of columns.
- Produce and actively manage a loading plan for all floor plates within the Building, giving consideration to floor capacity and column capacity.

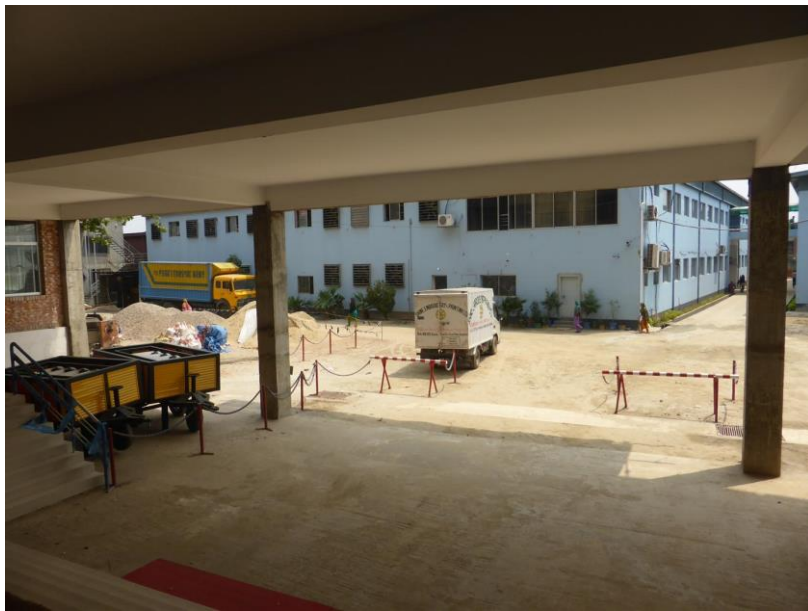
# **Protection of key structural elements from vehicle impact (Buildings 1 & 3)**

Potential impact of truck with building support columns in Building 1 is currently mitigated with lightweight fences and bollards.

- Maintain temporary traffic measures to warn vehicles of potential impact with columns (Building 1).
- Install warning measures / bollards for columns to front of Building 3 – Building Engineer to review and advise.

- Building Engineer to review column designs for strength & building durability for vehicle impact load on loading bay columns (Buildings 1 and 3).
- A permanent / solid impact protection solution to prevent truck impact is suggested.

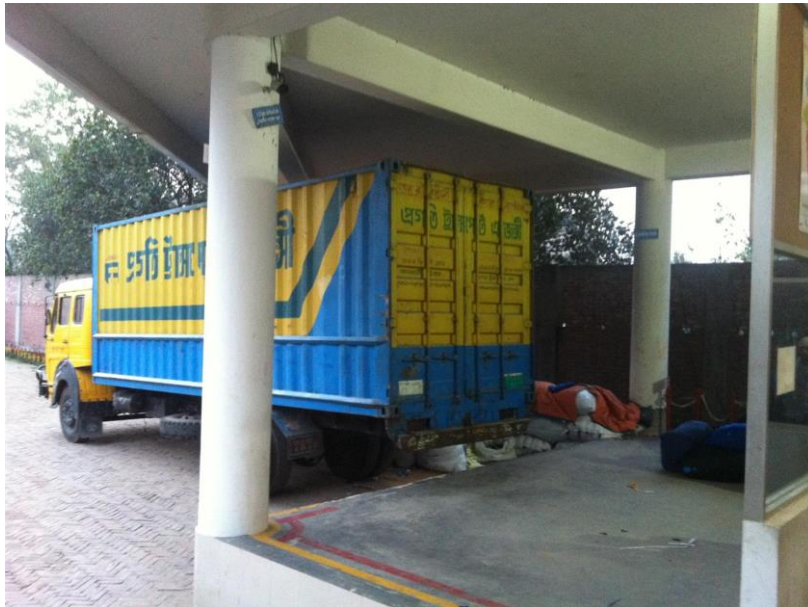
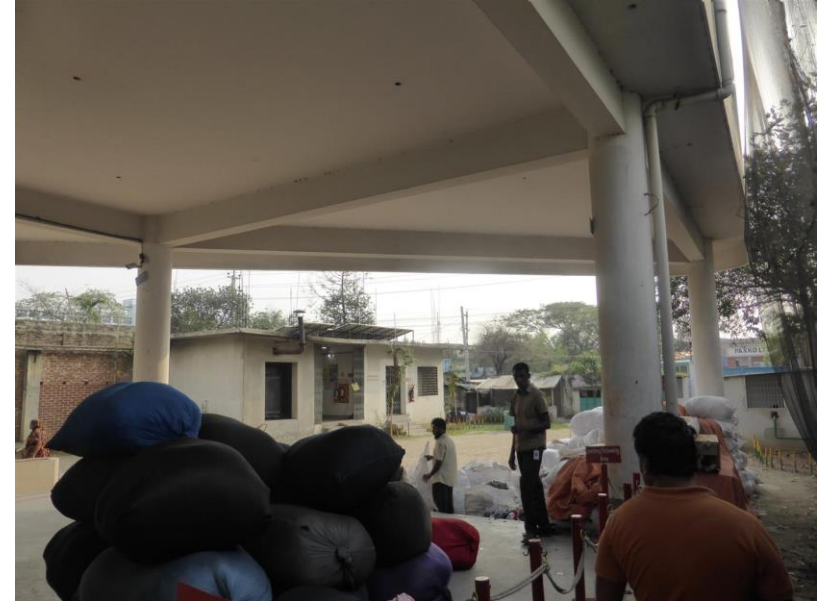
Potential impact of truck with building support columns in Building 3 would be onerous for undocumented extension / loading bay with 3 columns to front section (no redundancy for columns apparent).

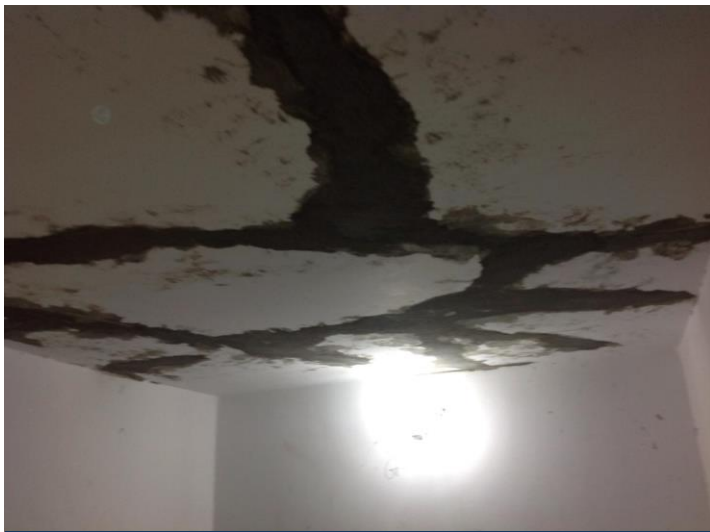
# **Loading and structural distress of secondary slabs in toilets (Buildings 1 and 2)**

**Evidence of distress on soffit of secondary ceiling slab (Building 1). Loading above not confirmed.**

- Building engineer to check toilet ceiling slab design and determine cause of cracking (Building 1).
- Building Engineer to undertake design check on slab for water tank loading applied (building 2).

- Repair cracks and move heavy loads on Building 1 secondary slabs above toilets as required.
- Undertake actions arising from assessment of secondary toilet slabs supporting water tanks in Building 2.

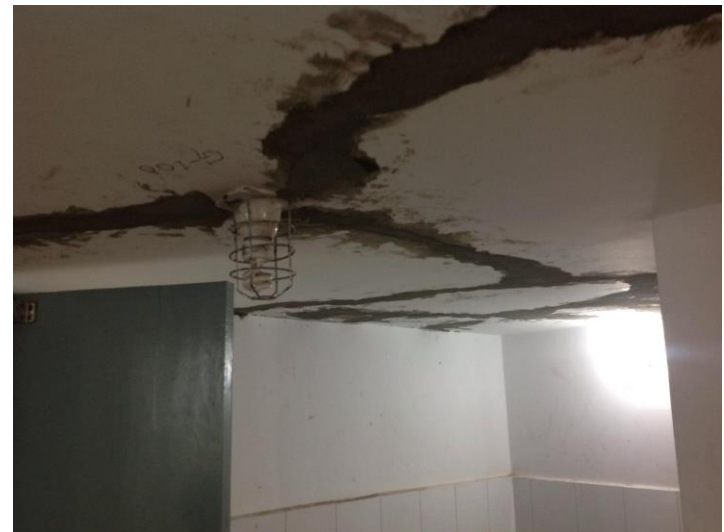
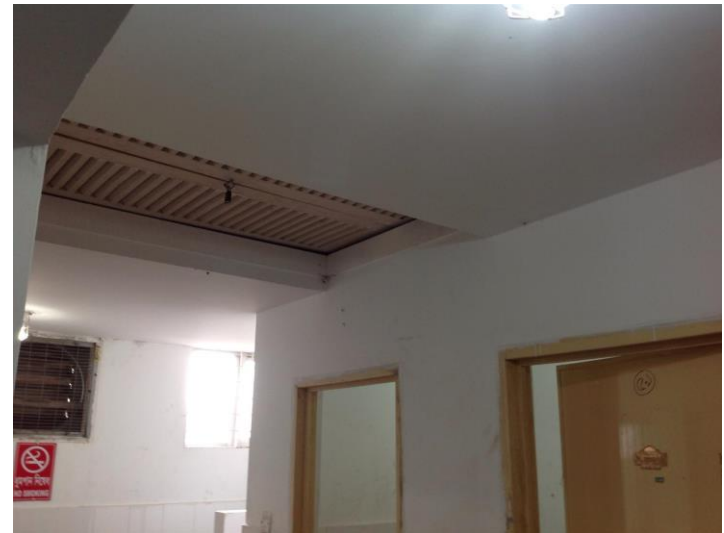
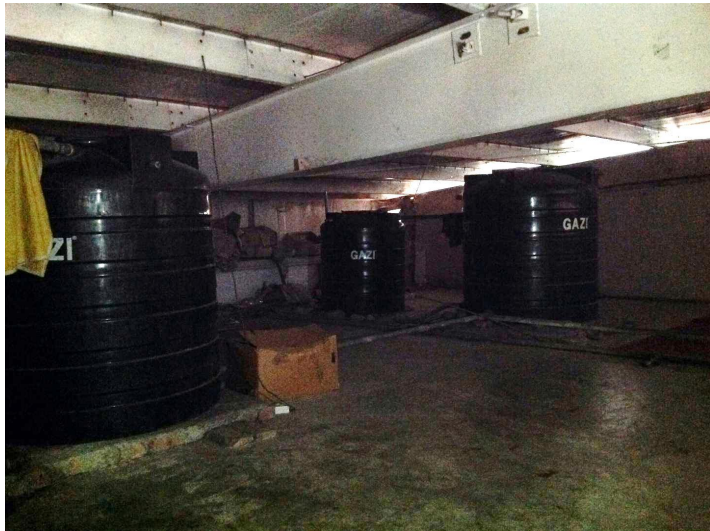
**Water tank loading on shallow secondary slab above toilet areas in Building 2.**

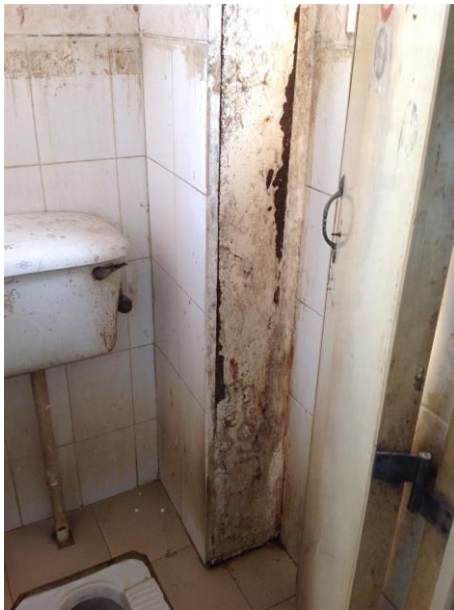
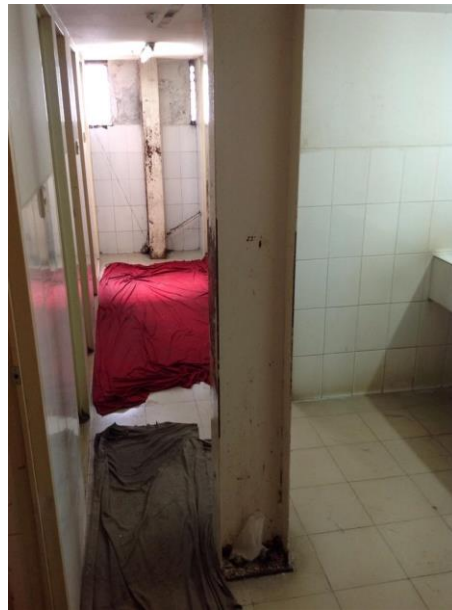
# **Corrosion of structural steelwork (Building 2)**

- Corrosion of steelwork and deterioration of the corrosion protection noted in a number of locations in Building 2.
- Corrosion most evident in toilet areas where steel is exposed.

- Engineer to assess extent of corrosion of steelwork in Building 2.
- Where section capacity has been compromised, structural capacity of the corroded section should be assessed.
- Causes of corrosion to be determined and repaired (e.g. leaks around toilet drainage points).

- Corroded steelwork to be thoroughly cleaned and remediated as required following engineering assessment.
- Corrosion protection to be repaired.

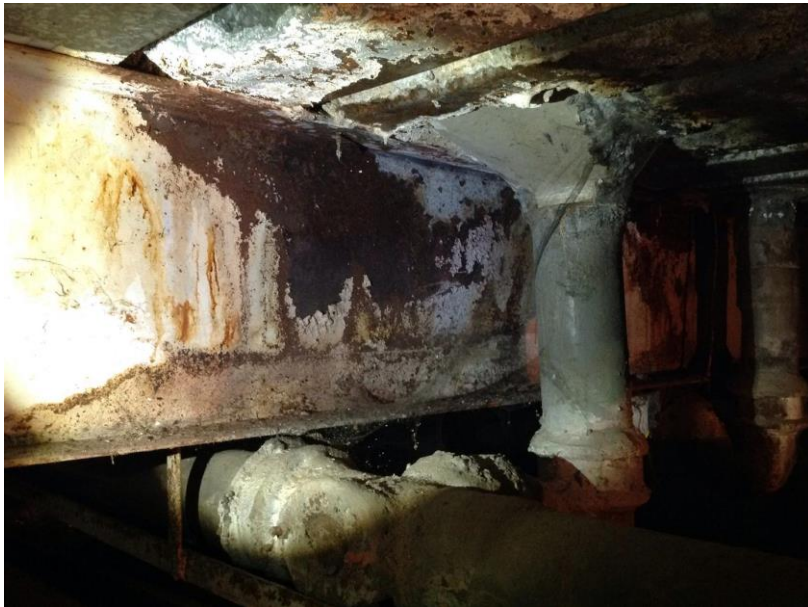
Example of mezzanine support beam (as viewed from top of secondary shallow ceiling slab above Building 2 toilets) and metal deck showing signs of significant corrosion due to leaking at drainage drop.

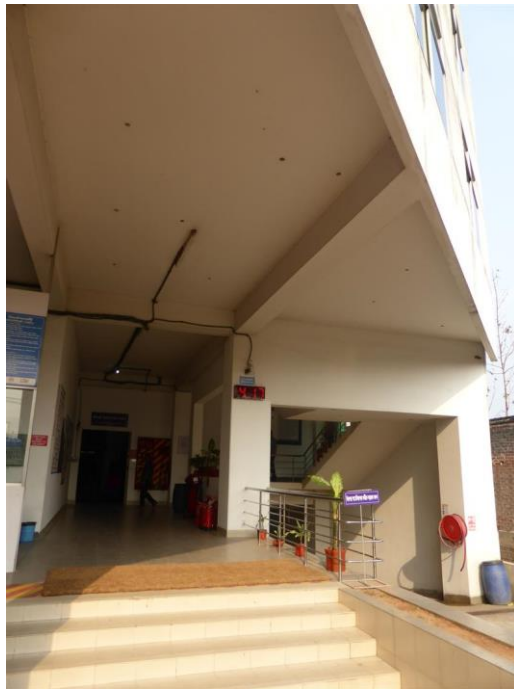
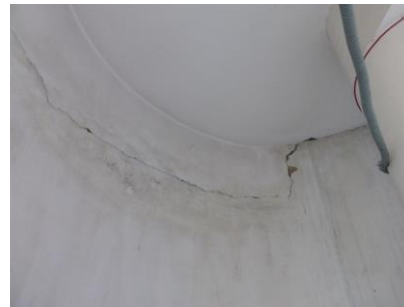
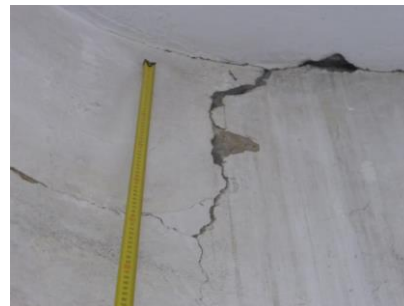
## Undocumented structure to the south-west of Building 3

- No structural or permit drawings available.
- Some irregular structural arrangements, including 5.8m cantilever beam.
- Evidence of distress of façade due to deflection of cantilevers.

- Undertake a Detail Engineering Assessment of the undocumented portion of Building 3 (see above) as per the scope outlined on the following page.
- Particular attention to be paid to the long-span cantilever on the front façade and slab cantilevers supporting facades which are demonstrating significant distress.

- Undertake any strengthening or modification of the undocumented extension arising from the Detail Engineering Assessment.

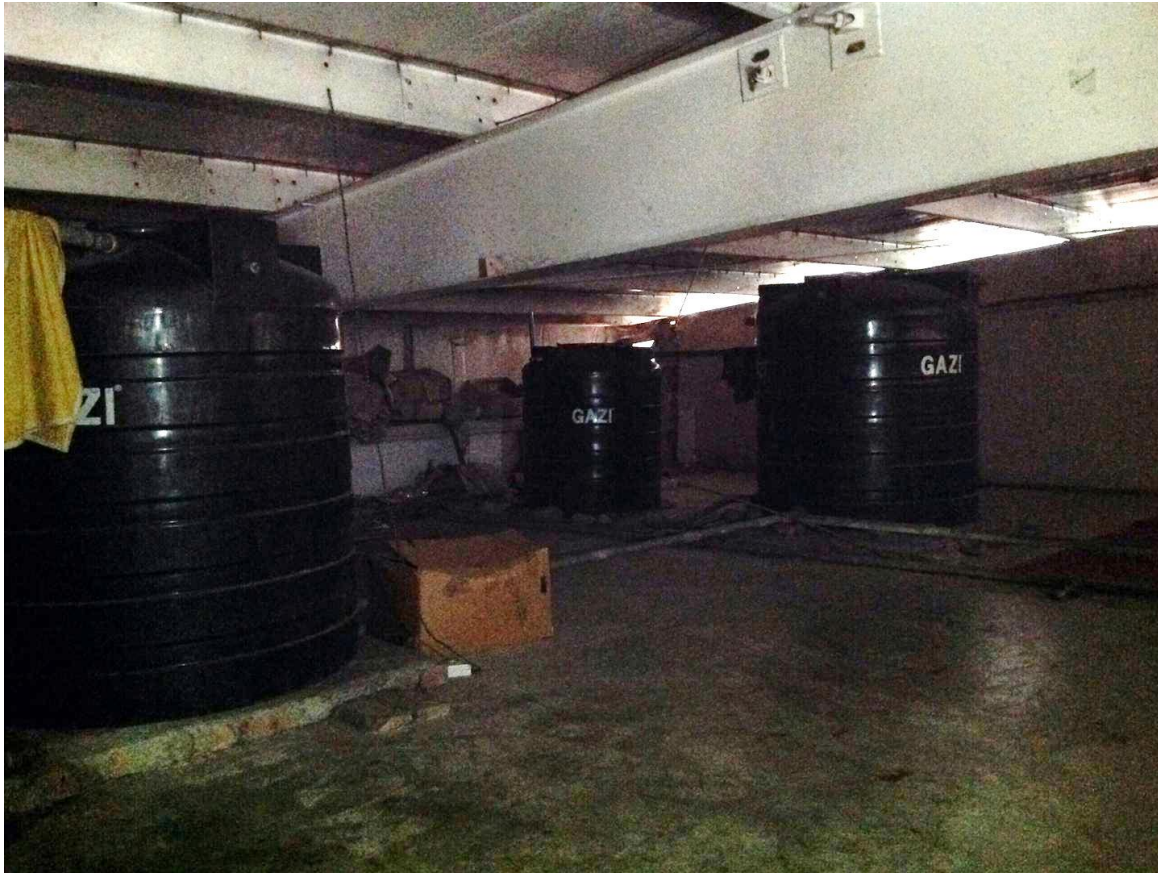
## Undocumented slab over roof of toilets in Building 2

- Water tanks on slab

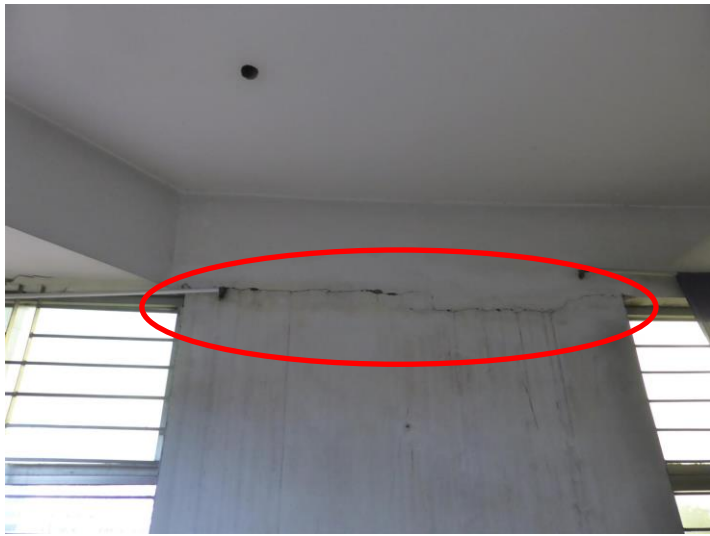
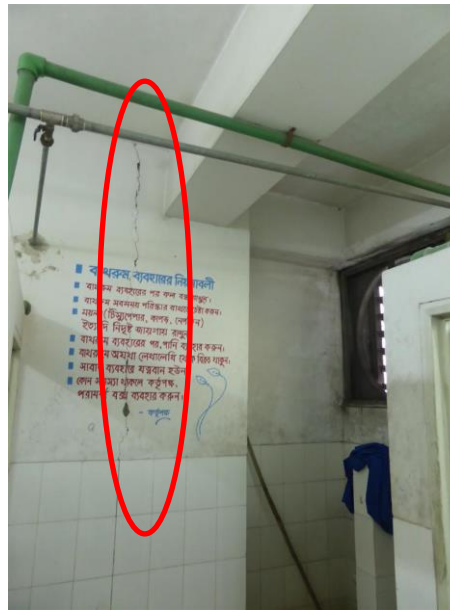
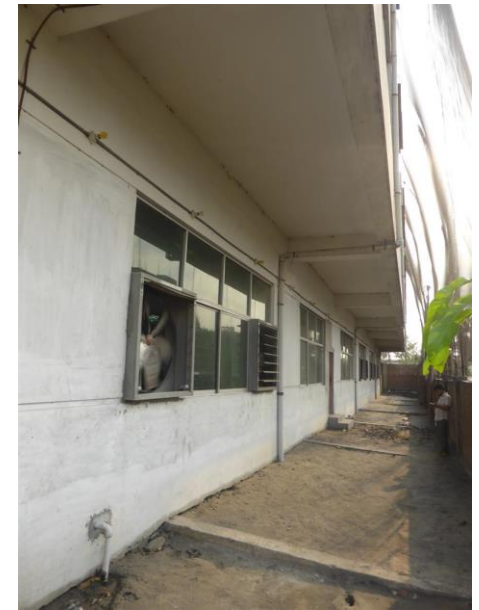
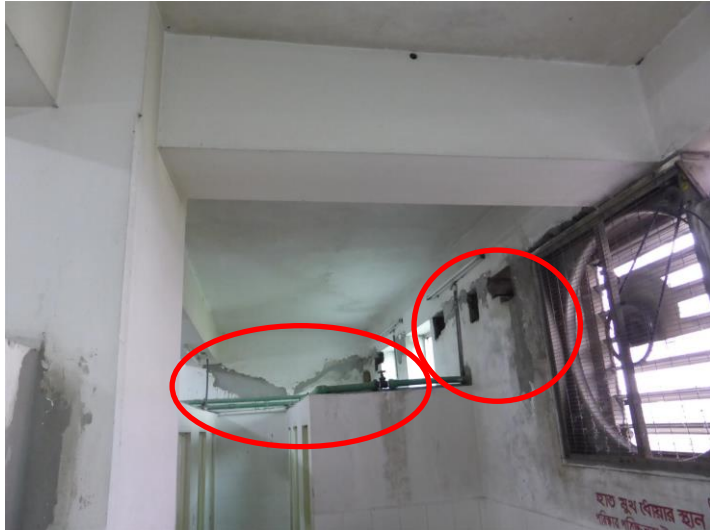
# **Building cantilevers with distress evident on supported facades (Building 3)**

Numerous examples of damage or repair to facades which appears to be related to excessive deflections of building edge cantilevers.

- Engineer to assess capacity of slab cantilever for applied factory and façade loads (including assessment of as-built reinforcement and concrete material strengths).

- Undertake any strengthening required from the engineering assessment.
- Limit loading on cantilever slabs based on findings of design assessment.

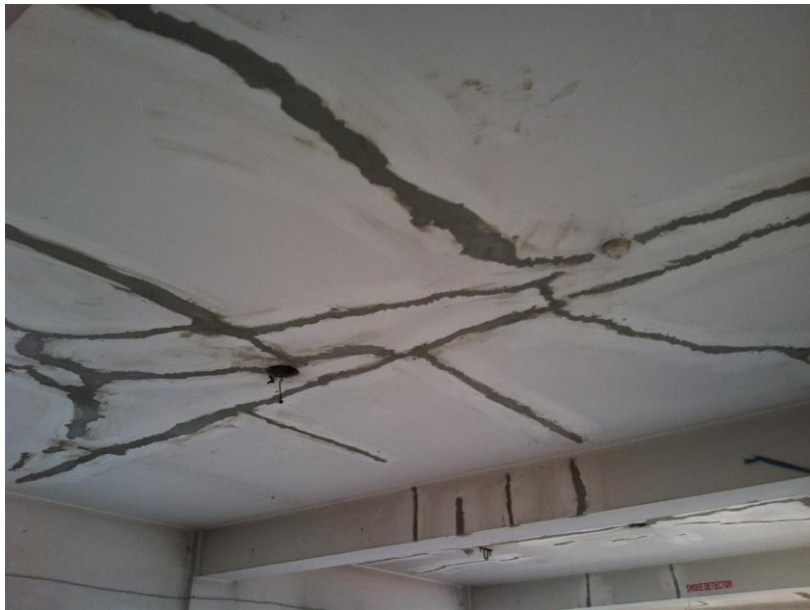
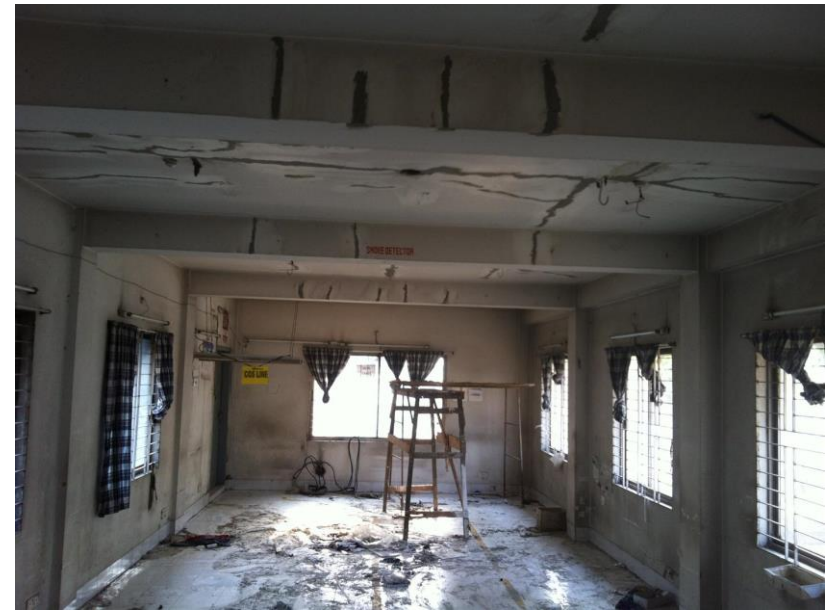
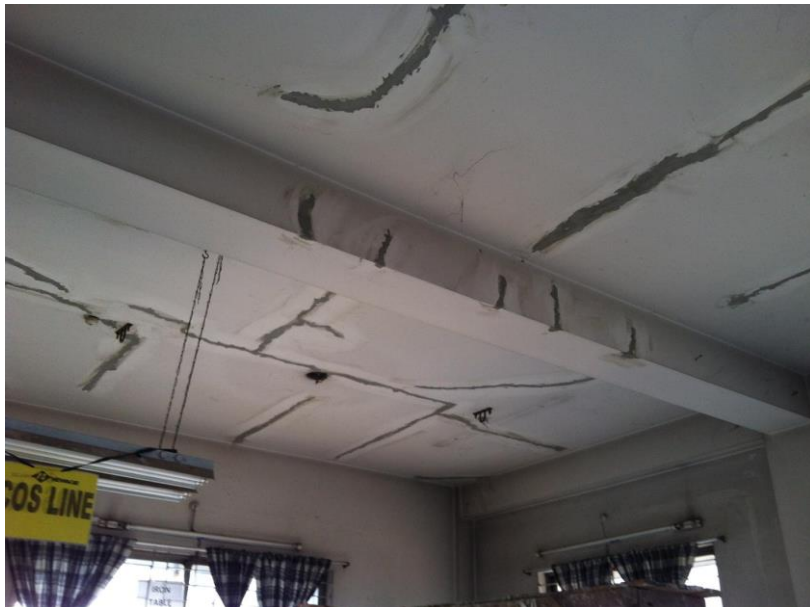
# Cracking in undocumented Generator Building

**Evidence of repair to numerous cracks in suspended floor levels in generator building. Suspended levels are currently unoccupied.**

- Do not occupy spaces currently under repair.

- Undertake an engineering assessment of the reinforced concrete structure prior to occupying space on suspended floor slabs.
- Produce calculations and as-built drawings as part of the assessment.

- Limit loading or undertake strengthening based on findings of assessment.
