# New Age Garments Ltd New Age Apparels Ltd Kei Lock Garments Ltd

Nishchintopur, Asulia, Savar, Dhaka  
(23.924895, 90.308234)  
9<sup>th</sup> April 2014

# Executive Summary (continued)

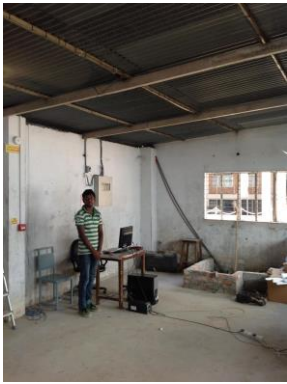
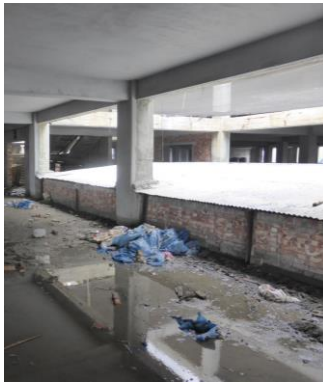
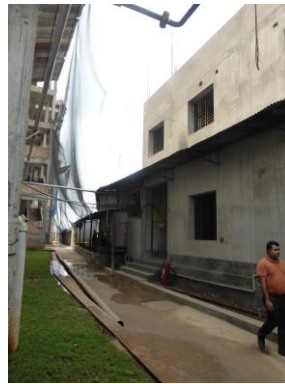
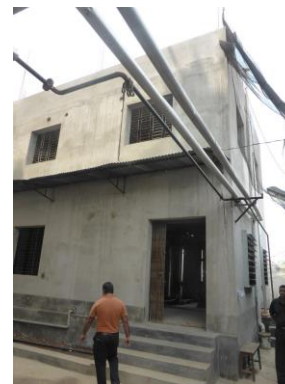
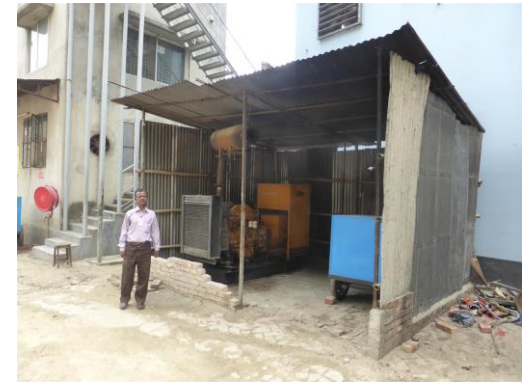
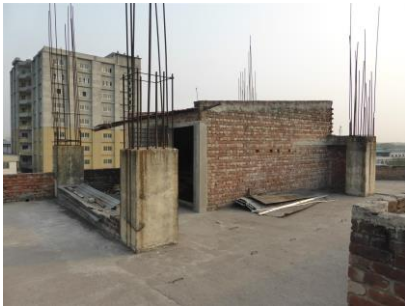
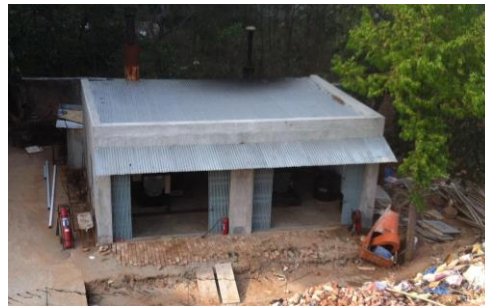
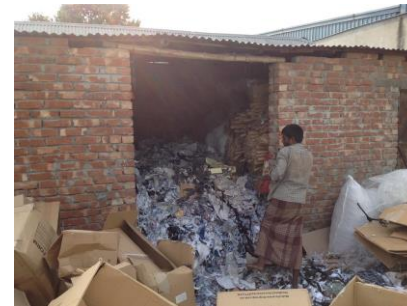
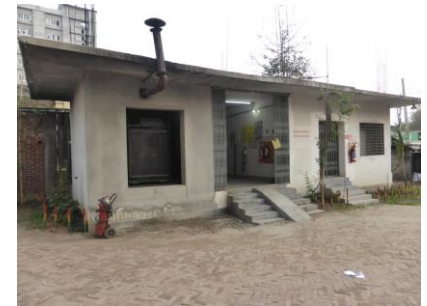
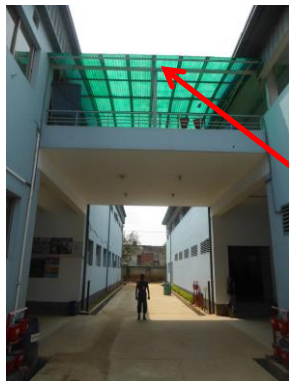
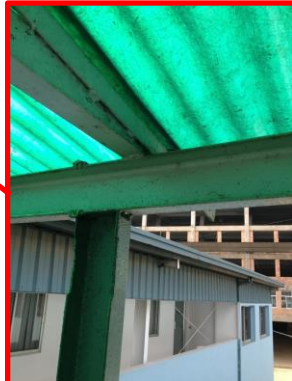
# **Non-engineered structures within and around principal buildings**

Numerous non-engineered structures on site including plant sheds, waste sheds, security rooms, shelters to staircore over-runs, shelters over suspended walkways and a temporary atrium roof cover to Building.

Structures were generally not occupied and not focused on during rapid visual assessment.

- Building engineer to assess non-engineered structures within the complex, with particular attention to roof tie-down details and structural stability.
- Strengthen occupied buildings as required.
