# FIRE SAFETY INSPECTION REPORT

**NINE 2 NINE INTIMATES LIMITED**

**ACCORD ID: 12867**

**Date: 18 June, 2017**

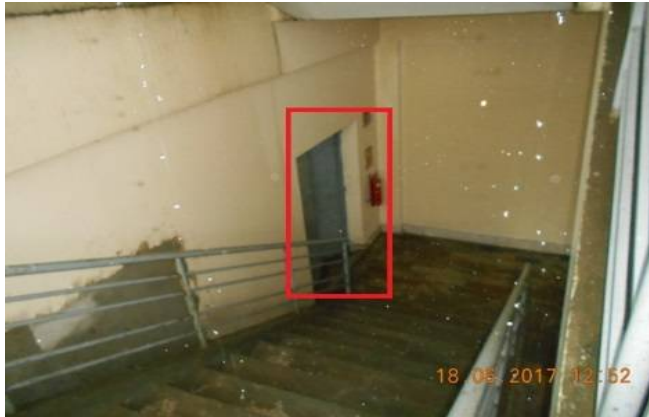
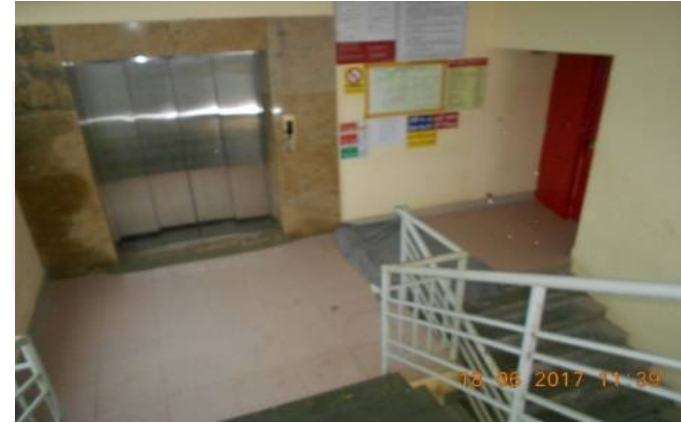
SI No.	Category	Findings	Required Action	Remediation Time Frame
1	Fire Rated Construction	The exit stairs enclosures are not separated from work areas and other spaces on each floor by fire-rated construction(Non rated doors, unsealed penetrations and openings etc.).	Provide minimum 1-hr rated doors for buildings with 3 or fewer stories and 1.5-hr fire rated doors for buildings that are 4 or more stories. Seal all unprotected openings to separate the exit stairs from work areas and other building spaces on all floor levels. Ensure that the fire doors are self-closing and positive latching and that they are provided with fire exit (panic) hardware where serving production floors. If fire doors are required to be held open for functional reasons, provide automatic closing devices tied to the fire alarm system. Once fire doors are installed, every door in a stair enclosure serving more than 5 stories shall be provided with re-entry unless it meets.	Within 3 months

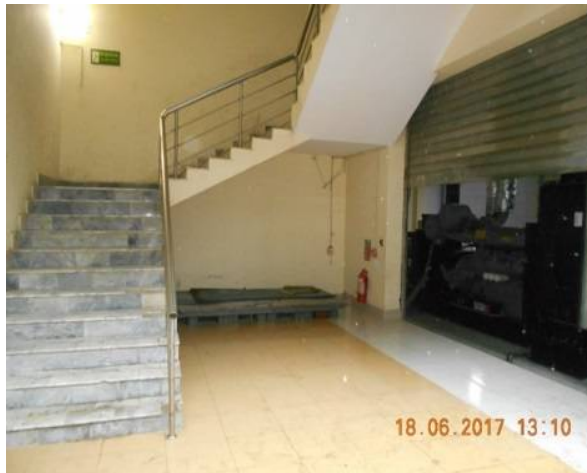
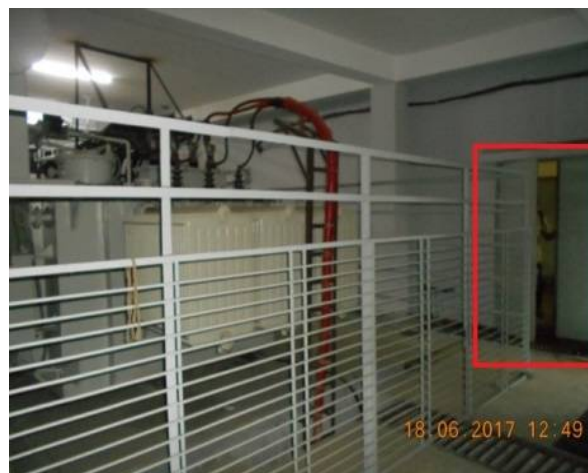
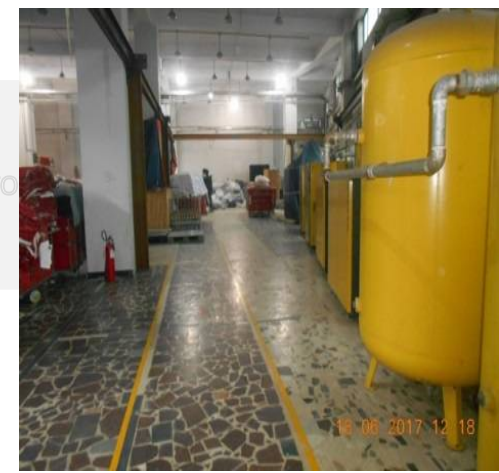
2	Fire Rated Construction	<p>The generator, sub-station &amp; air compressor rooms are not separated by fire rated construction (openings, non-rated doors, penetrations) Specify location(s) <b>Location:</b> Generator-Utility building, Sub-station-N-W &amp; N-E &amp; compressor-North side of the main building.</p>	<p>Separate the generator, sub-station &amp; air compressor room by a minimum 2-hr fire rated construction. Seal and/or protected all openings to maintain fire separations.</p>	<p>Within 3 months</p>
---	-------------------------	--	--	------------------------

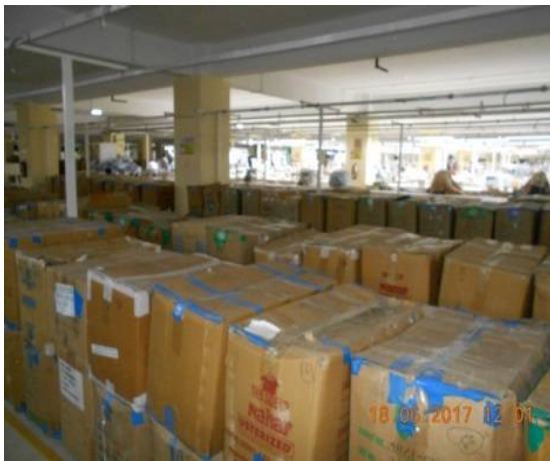
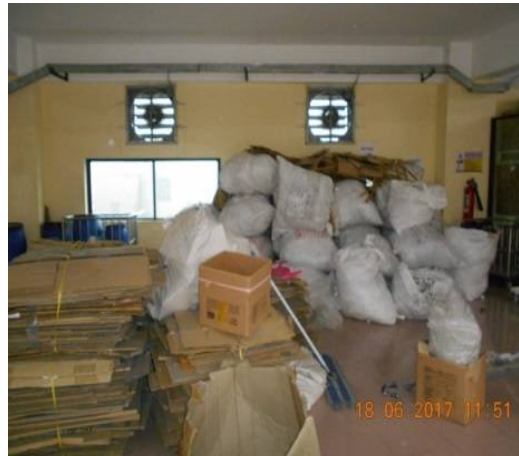
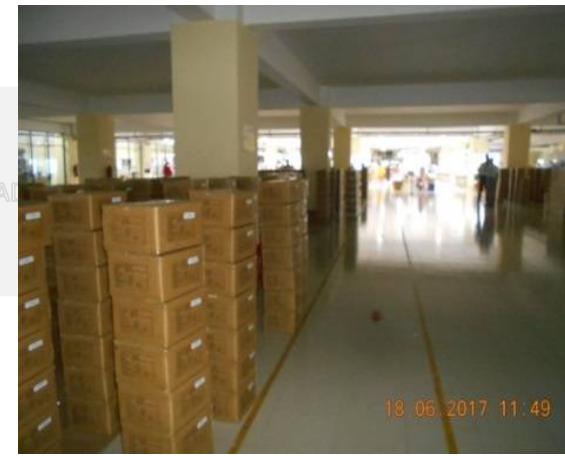
3	Fire Rated Construction	<p>Areas used for combustible storage are not separated by fire rated construction.</p> <p><b>Location:</b> 2nd floor.</p>	<p>Provide dedicated storage rooms separated by minimum 1-hr fire-rated construction.</p> <p>Where separate storage rooms are not feasible, provide defined storage areas and limit the storage arrangement as follows:</p> <ul style="list-style-type: none"> <li>- Maximum height of 2.4m and maximum area of 23m<sup>2</sup></li> <li>- If sprinkler protected: maximum height of 3.66m and maximum area of 93m<sup>2</sup></li> </ul> <p>Separate areas of unenclosed combustible storage by a minimum clear distance of 3m.</p>	Within 3 months
---	-------------------------	--	--	-----------------

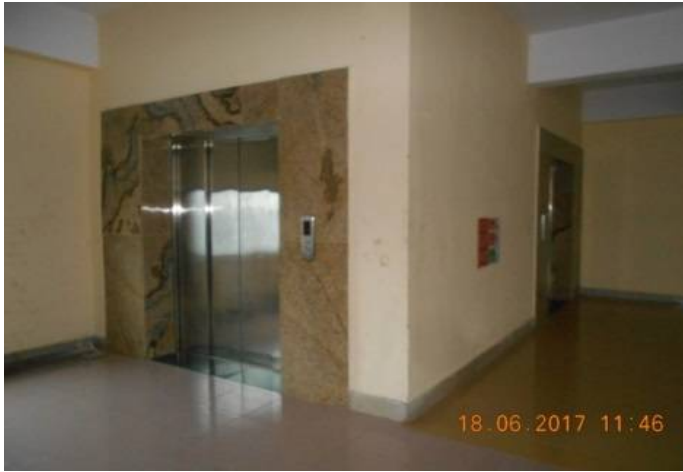
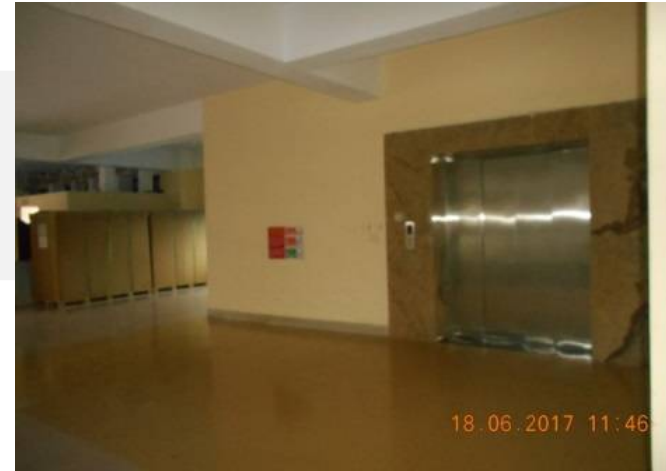
4	Fire Rated Construction	<p>The elevator shafts (Cargo lift) discharges inside the production floor. [Unsealed penetrations &amp; openings]</p> <p><b>Location:</b> S-W side of the building.</p>	<p>Provide a minimum 2-hr fire rated construction to separate the elevator shaft from each floor level. Seal all penetrations and openings in floors/ceiling assemblies to maintain the fire separation.</p>	Within 3 months
---	-------------------------	--	--	-----------------

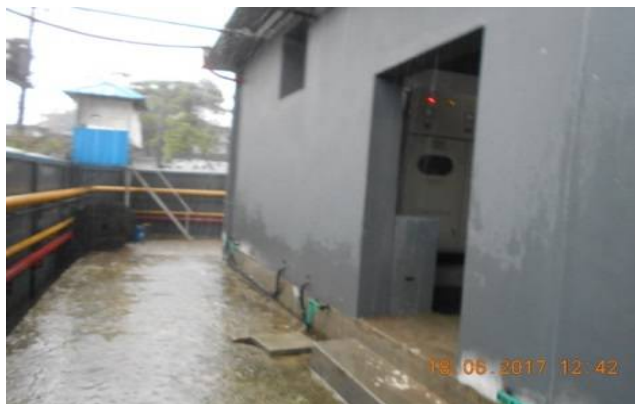
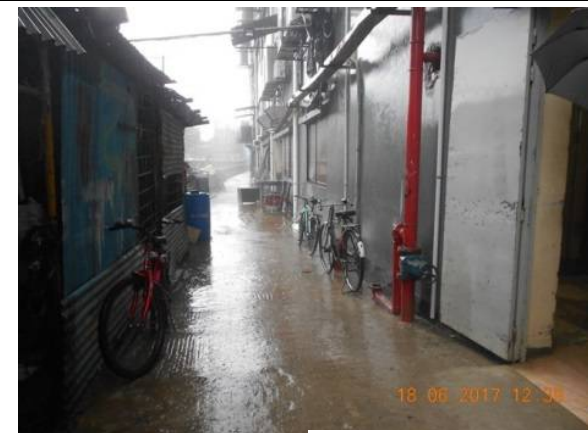
5	Fire Rated Construction	<p>The exit discharge path (serving N-E exit) is less than 10 ft. wide and is not separated from the sub-station room.</p> <p><b>Location:</b> West side of the building.</p>	<p>Seal all penetrations and openings to the interior of the building along the discharge path, up to a height of 10 ft., to provide a minimum 1-hr fire separation.</p>	<p>Within 6 months</p>
---	-------------------------	---	--	------------------------

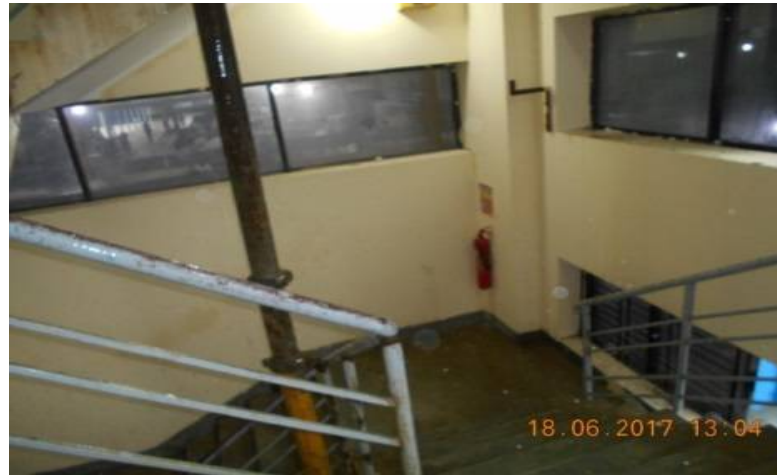
6	Fire Rated Construction	Unsealed penetrations and openings are located in the exit stair enclosures <b>Location:</b> South-East side stair.	Seal all penetrations and openings in exit stair enclosure walls to maintain the fire separations.	Within 3 months
---	-------------------------	--	--	-----------------

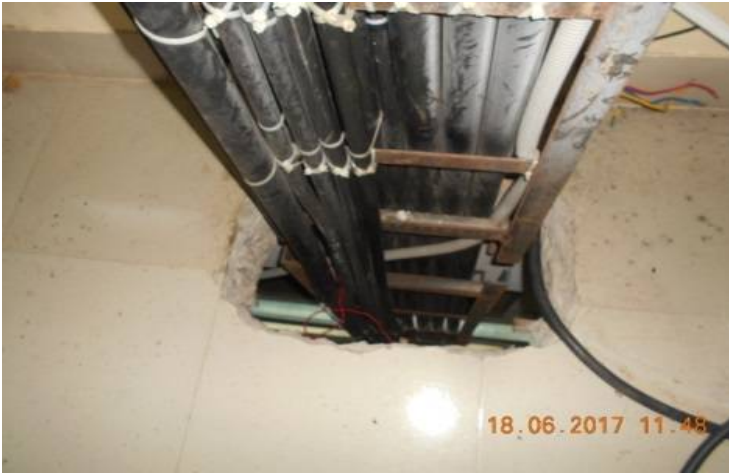
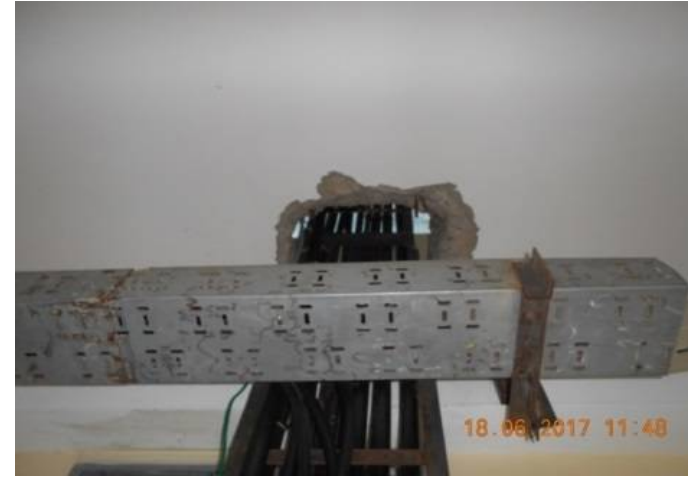
7	Fire Rated Construction	Unsealed penetrations and openings are located in the fire rated floor/ceiling assemblies. <b>Location:</b> East side of the electrical riser.	Seal all penetrations and openings in floors/ceiling assemblies to maintain the fire separation.	Within 3 months
---	-------------------------	---	--	-----------------

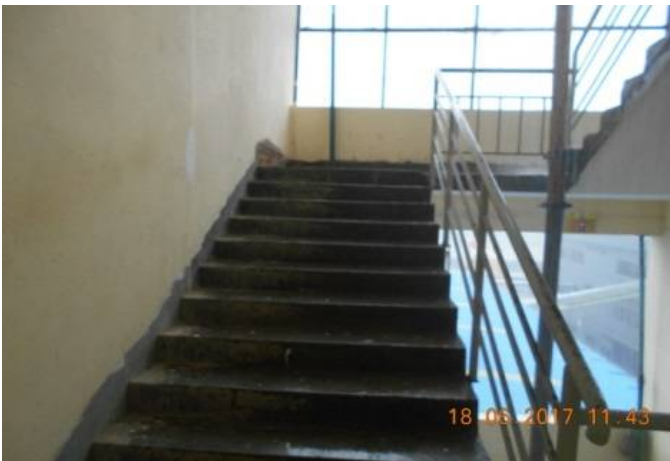
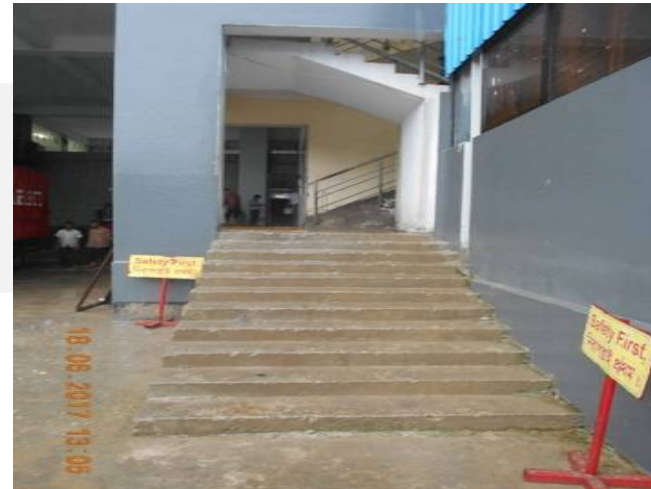
8	Egress	Handrails are not provided on both sides of each exit stairs on all floors. Having handrails on one side of said staircase, may pose as a falling hazard during evacuation. Or, Handrails are not provided at exit stairs.	Provide handrails on both sides of the exit stair. New handrails shall have a minimum height of 865 mm (34 in.) and a maximum height of 965 mm (38 in.) as measured from the leading edge of the tread. Intermediate handrails shall be provided when the stair width exceeds 2.2 m (87 in.)	Within 3 months
---	--------	---	---	-----------------

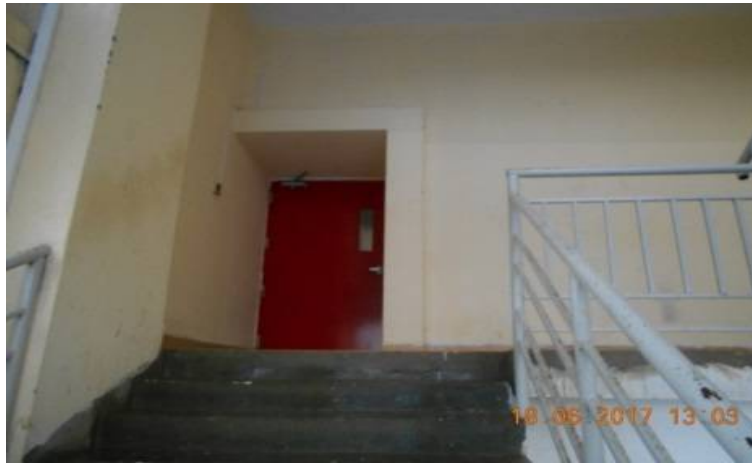
9	Egress	Building did not have stair designation signs or occupant load signs at the required location.	Provide stair designation signs and occupant load signs at the required locations.	Immediate
---	--------	--	--	-----------

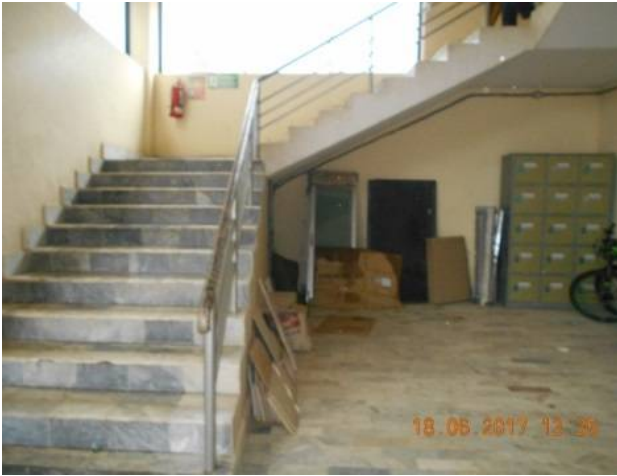
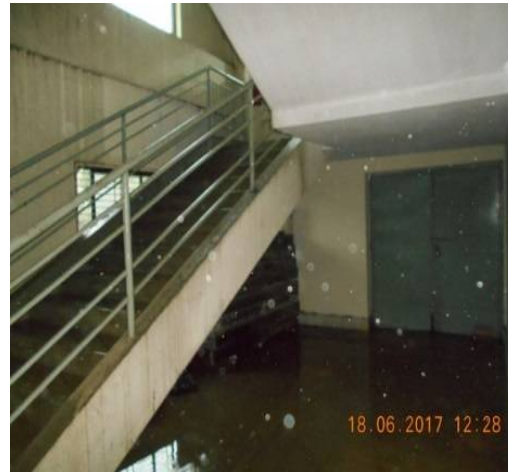
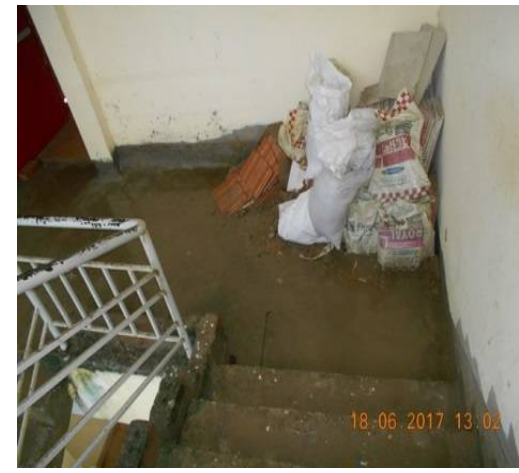
10	Egress	Storage was located in exit stairs enclosure.	Remove storage from the exit stairs and egress path	Immediate
----	--------	---	---	-----------

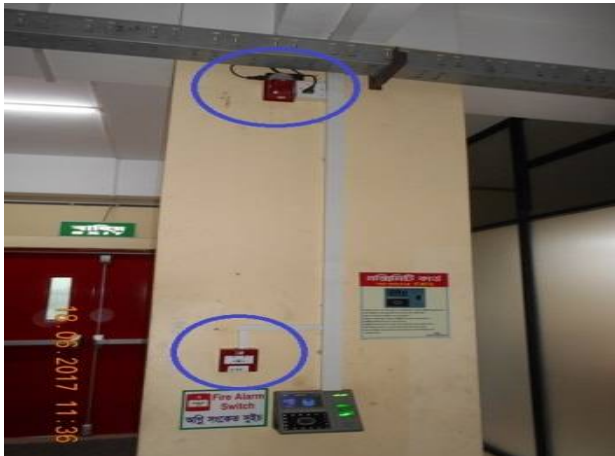
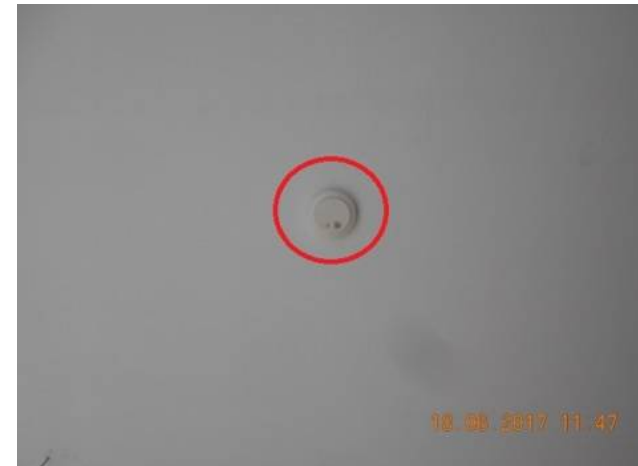
11	Fire Detection and Alarm System	The fire detection and alarm system is antiquated, not a listed system and does not provide alarm and notification features consistent with acceptable standards.	Replace the fire detection system with a new, listed addressable fire detection system in accordance with NFPA 72.	Design within 4 months, Install within 9 months
----	---------------------------------	---	--	---

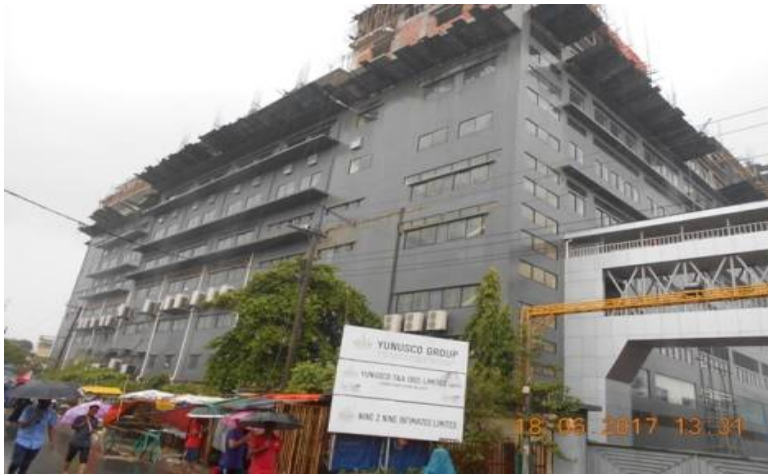
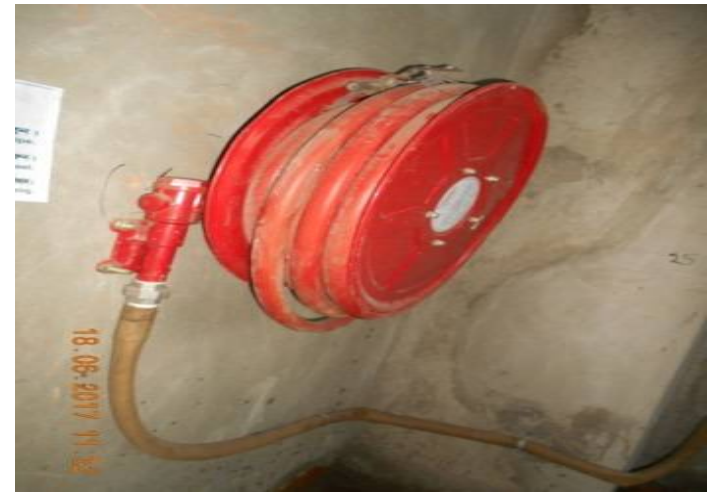
12	Fire Protection System	The high-rise building has an occupied floor greater than 23 meter (75 feet) and is not provided with automatic sprinkler protection system. The large occupant loads, heavy fuel loading, and anticipated extended egress times warrant sprinkler protection.	Install a new combined sprinkler & standpipe protection system, fire pump & fire department connection in accordance with NFPA 13, 14, 20, 22 & 24. A class I system shall be permitted in buildings protected throughout by an automatic sprinkler system.	Design within 6 months, install within 12 months
----	------------------------	--	---	--

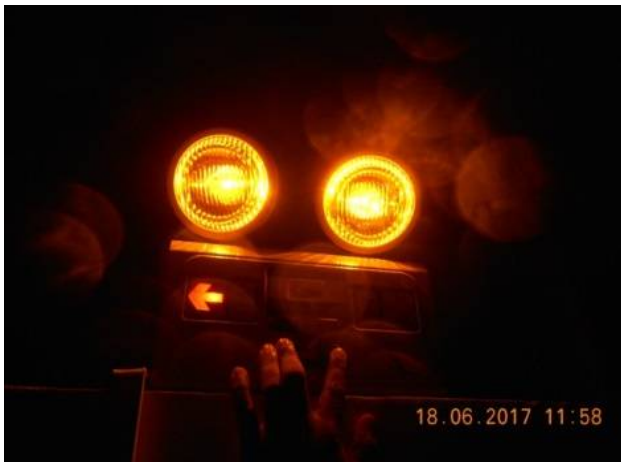
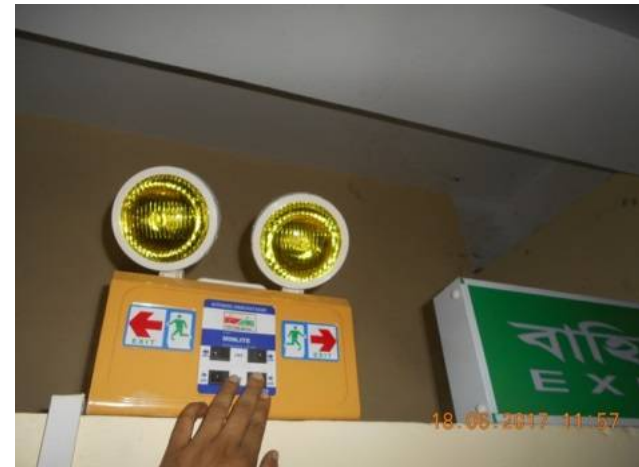
15	Fire Extinguishers (ITM)	Inspection, testing and maintenance of portable fire extinguishers is not in accordance with NFPA 10.	Inspect, test and maintain the portable fire extinguishers and keep written records onsite, in accordance with NFPA 10 and ACCORD standards.	Within 3 months
16	Egress Lighting	Manual on-off switch facility available for emergency lights.	Remove manual on/off switches from emergency lighting units/ exit signs to prevent them from being switched off.	Within 1 month

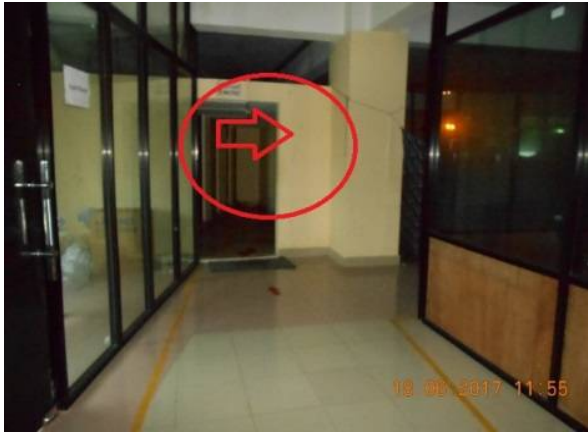
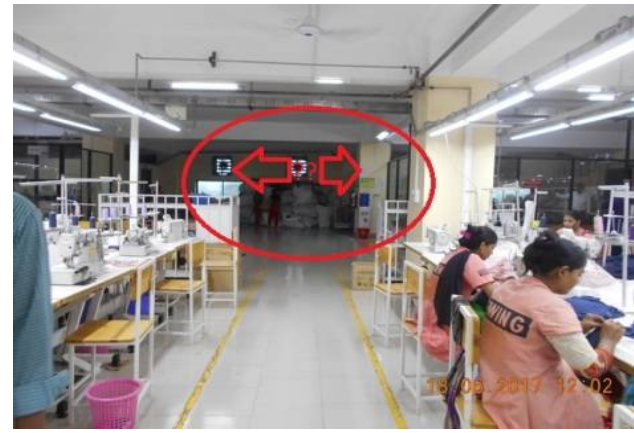
18	Egress Lighting	<p>The directional signs are not provided where there is a change in direction and where the continuation of the egress path is not obvious.</p> <p>Location: North side of the 2nd floor of the main building.</p>	<p>Install illuminated directional sign where there is a change in the direction of the path of travel.</p>	<p>Within 1 month</p>
----	-----------------	---	---	-----------------------

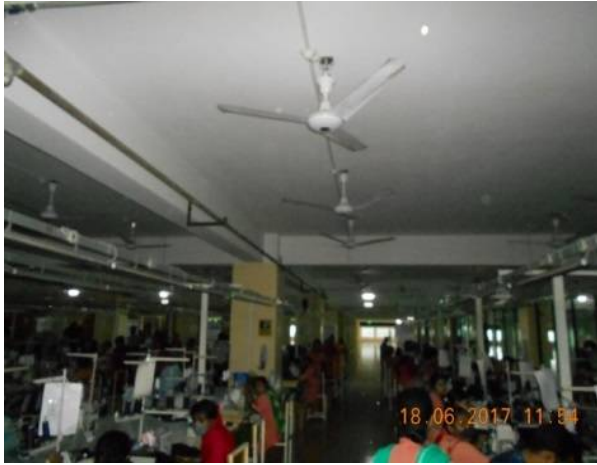
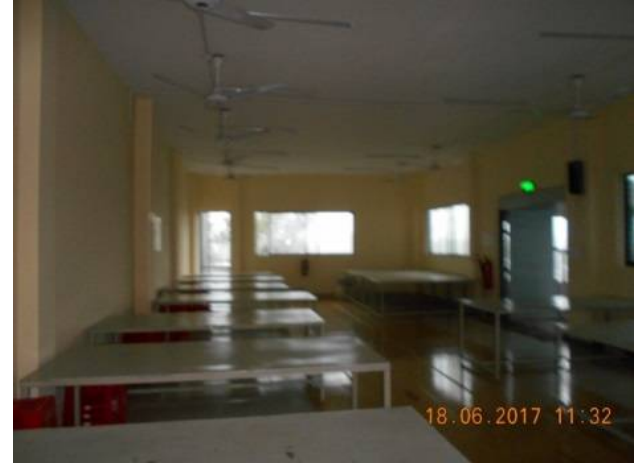
19	Egress Lighting	<p>Based on the number and location of emergency lights/exit signs observed, adequate illumination levels are not anticipated along egress routes.</p> <p><b>Location:</b> 2nd floor &amp; exit stair of the main building &amp; dining of PFL building.</p>	<p>Test the emergency lighting system on each floor and provide additional emergency fixtures to provide adequate illumination along the means of egress. Provide a minimum illumination of 10 lux at the floor level within exit stairs and exit discharge paths and minimum 2.5 lux along exit access aisles.</p>	<p>Within 3 months</p>
----	-----------------	--	---	------------------------
