# Gartex Garments Ltd.

1731, Mostofa Hakim College Road, Cornel Hat, North Kattali, Pahartali, Chittagong.  
(22.372642N, 91.769580E)

17<sup>th</sup> May 2014

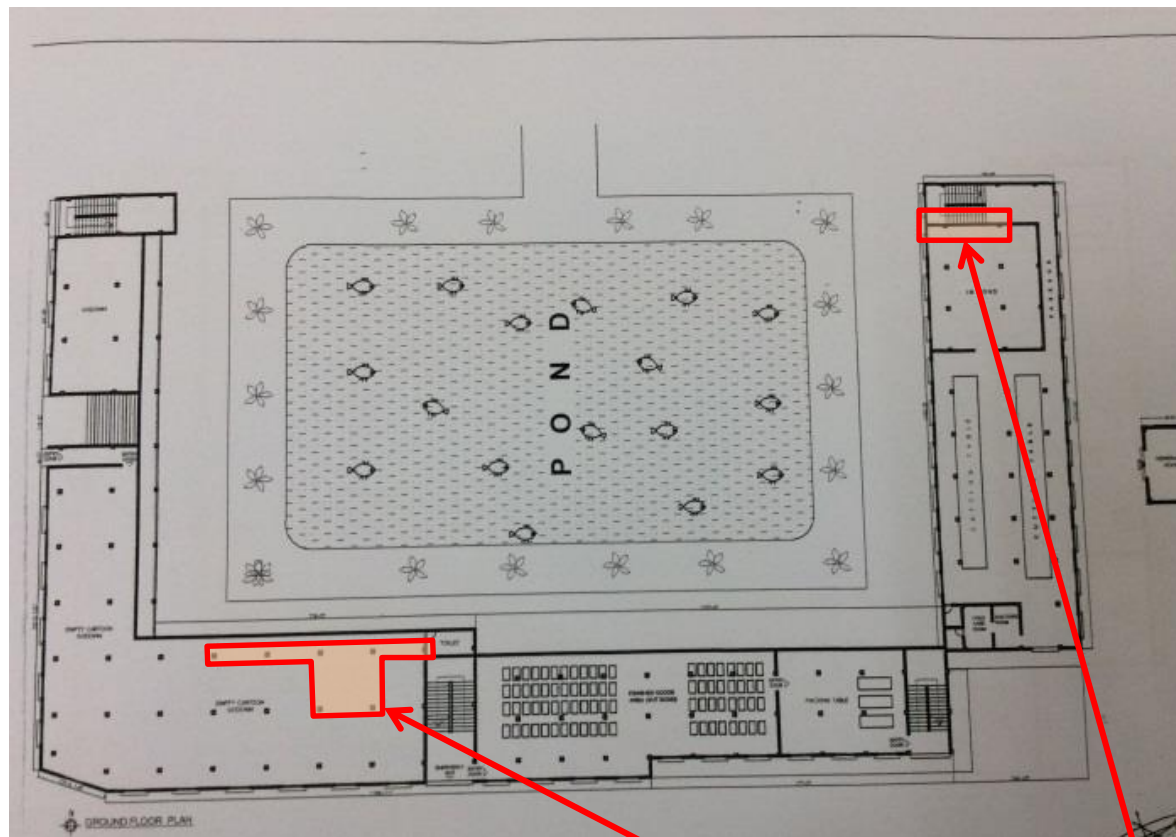
**High stress levels  
in some columns**

Stress levels were calculated to be high in specific areas within the building.

High stress levels in these locations

| Item No. | Observation | Recommended Action Plan | Recommended Timeline |
|---|---|---|---|
| 1 | Stress levels in Columns | Building Engineer to review design, loads and stresses in columns in the area noted. | 6-weeks |
| 2 | Stress levels in Columns | Building Engineer to verify insitu concrete strength by taking 100mm diameter cores from 4 columns. | 6-weeks |
| 3 | Stress levels in Columns | Building Engineer to verify grade of steel reinforcement and no. and diameter of main column bars. | 6-weeks |
| 4 | Stress levels in Columns | Make structural alterations if required as advised by Engineer. | 6-months |

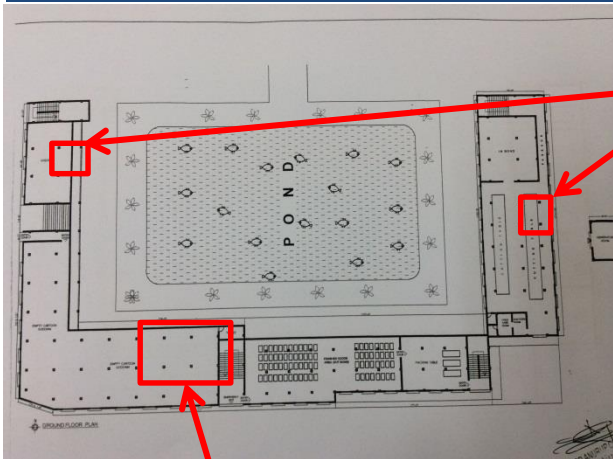
Various areas across the building see significantly increased loadings relative to the typical factory-floor loads – most notably this can be seen beneath the water tank, which is elevated on a concrete stand above the roof level and 2 tanks placed on the roof slab.

Water Tanks  
on roof slab

Concrete stand for water tank above

| Item No. | Observation | Recommended Action Plan | Recommended Timeline |
|---|---|---|---|
| 7 | High Loading due to Water Tanks and toilets | Building engineer to check the capacity of the slab to carry the concentrated loading and remove/reduce the loading | 6-weeks |

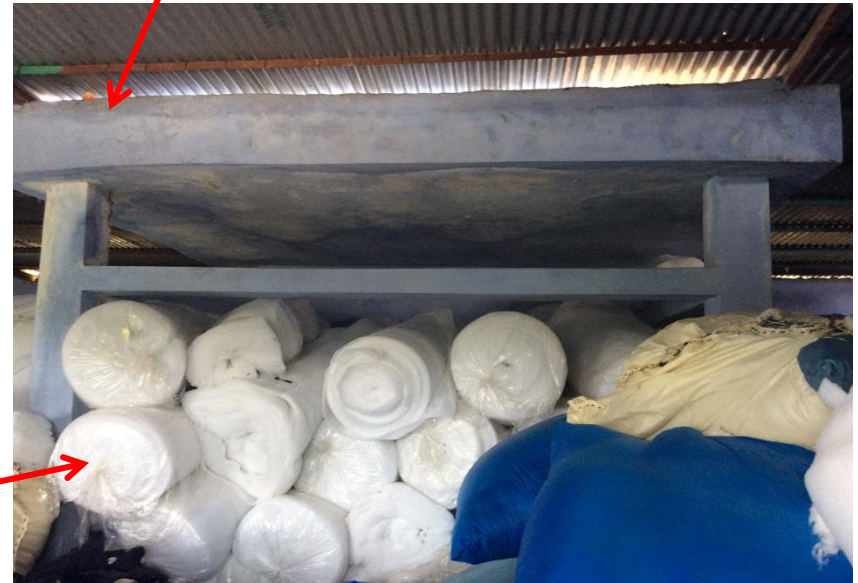
Area in which water tank loading (roof level) and concrete build-up for toilets (Level 2 and Roof) are situated.

Storage below

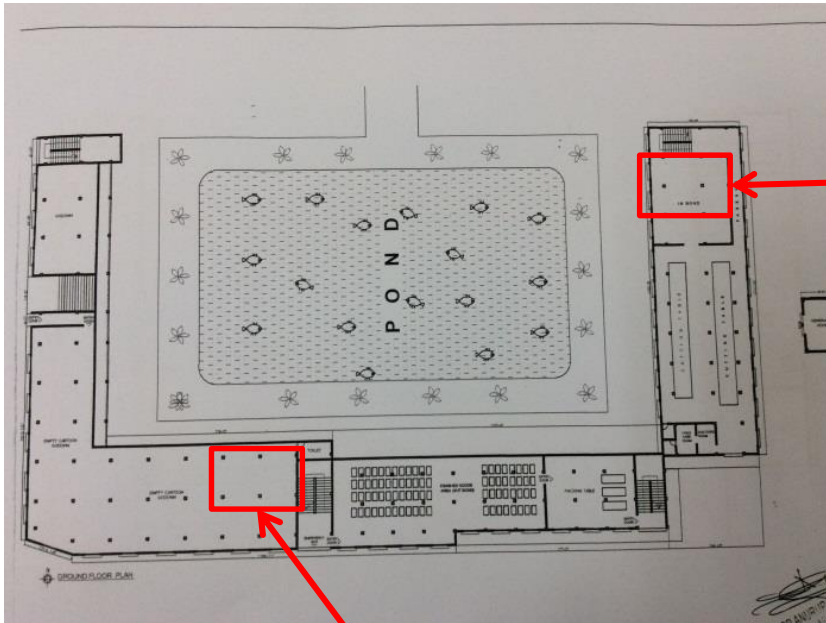
Toilet areas, which contain masonry partitions and significant build-up at floor level, are inflicting significantly higher loads in certain locations.

Toilet area situated next to masonry wall for staircase, resulting in increased loads on Levels 1 & 2

Typical build-up arrangement

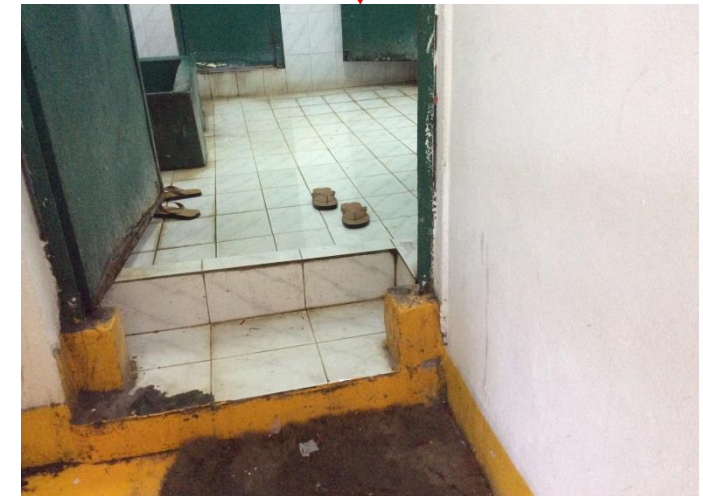
Area in which water tank loading (roof level) and concrete build-up for toilets (Level 2 and Roof) are situated.

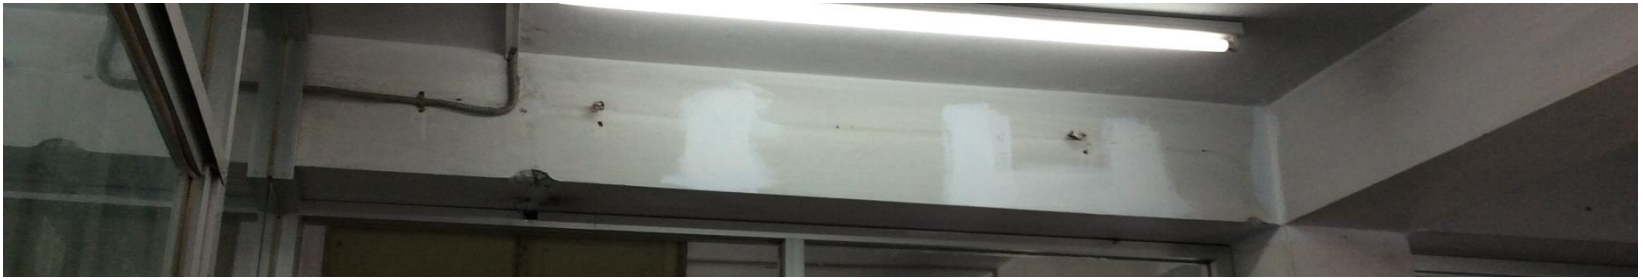
Vertical cracks (possibly resulting from thermal effects) appear in a significant number of beams, although the majority have been painted over. These occur more frequently at higher levels than lower down the building.

| Item No. | Observation | Recommended Action Plan | Recommended Timeline |
|---|---|---|---|
| 5 | Hairline cracking on beams and some slab soffit areas | Monitor cracks on beams. Building Engineer to investigate if cracks are only in the plastering. | 6-months |
| 6 | Hairline cracking on beams and some slab soffit areas | Building Engineer to advise on load reduction and repair and strengthening if required. | 6-months |

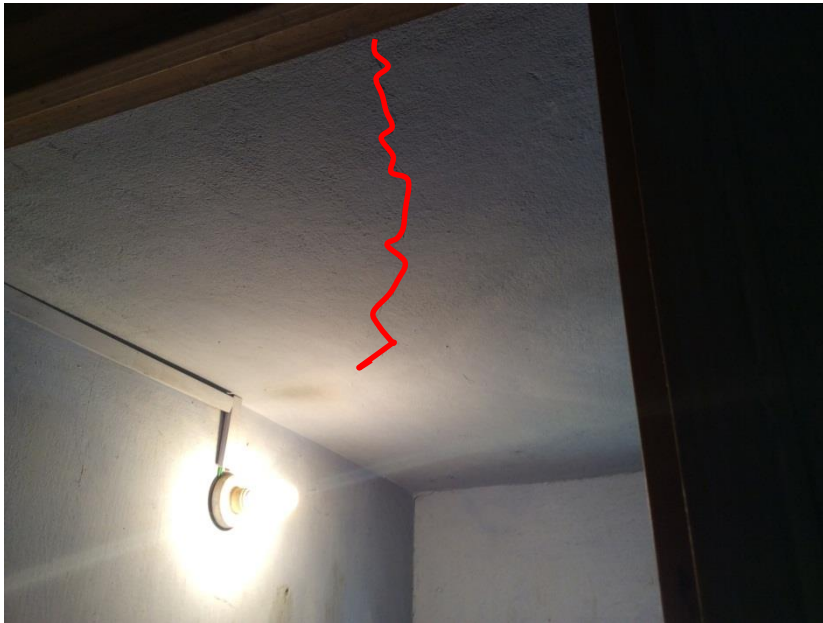
A small number of cracks were found in slabs. This crack was observed on the ceiling of Level 2, directly beneath the Roof Level Toilets, which were actually used as storage space.

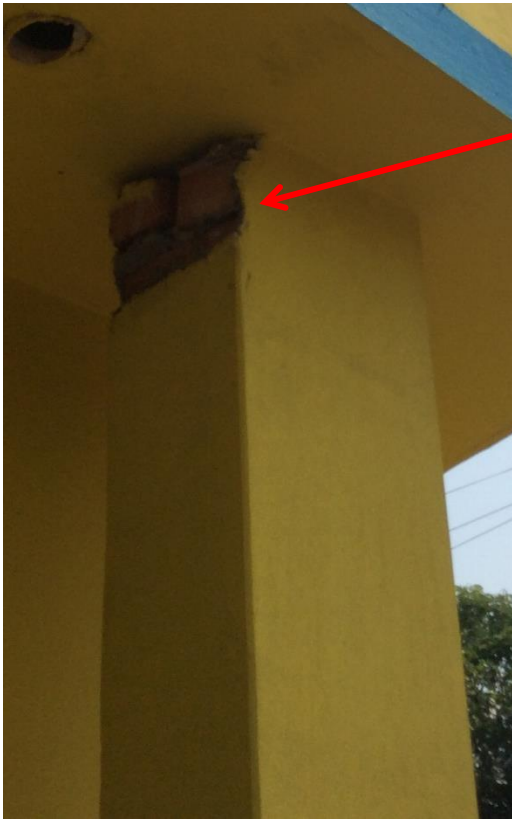
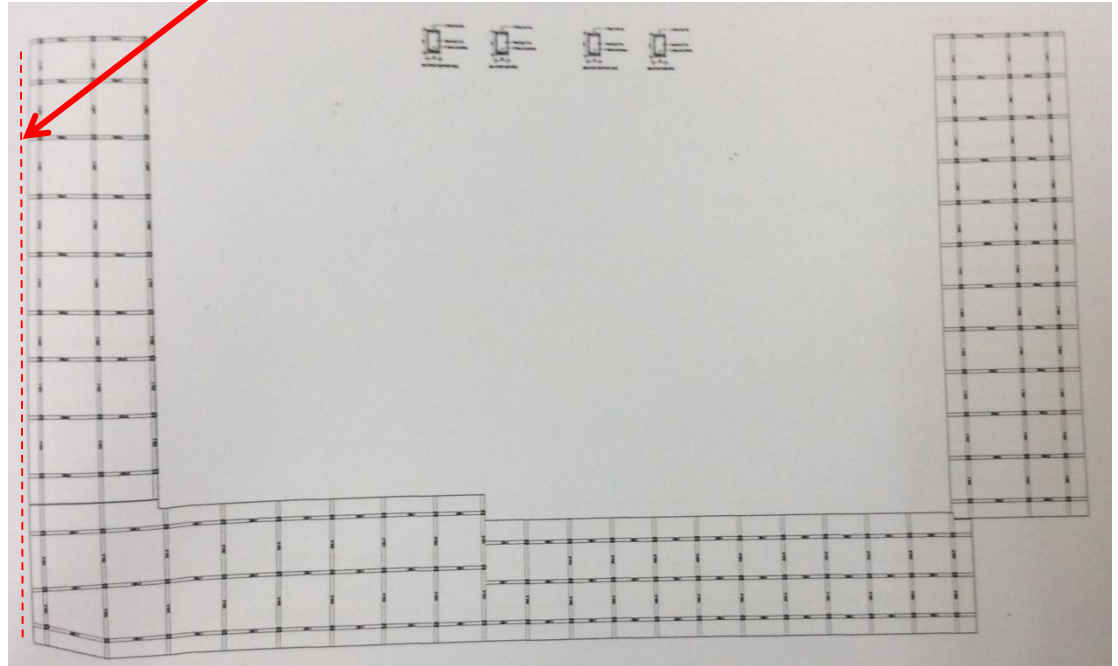
Rendered brick columns have been constructed beneath cantilevers at ground level on this line.

| Item No. | Observation | Recommended Action Plan | Recommended Timeline |
|---|---|---|---|
| 8 | Differences between actual construction and information on design drawings | Building Engineer to survey the structure and prepare a full set of “as-constructed” drawings. | 6-months |

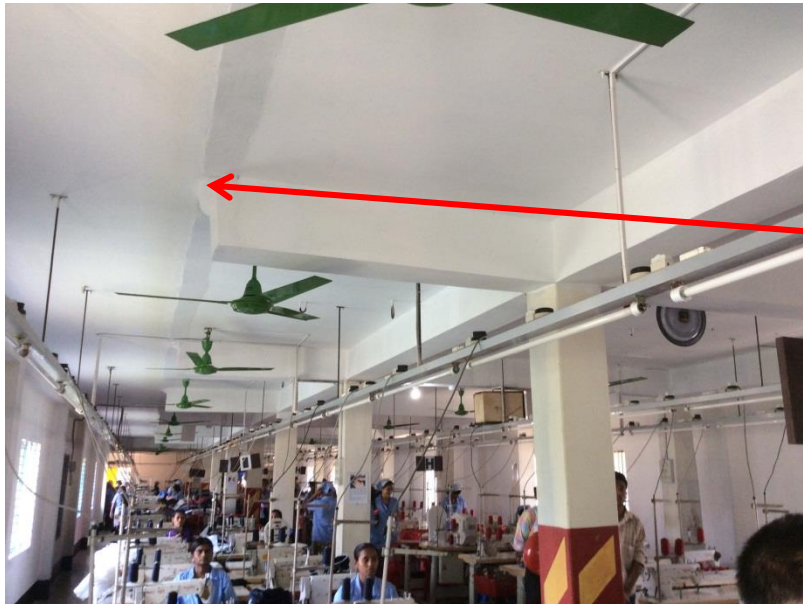
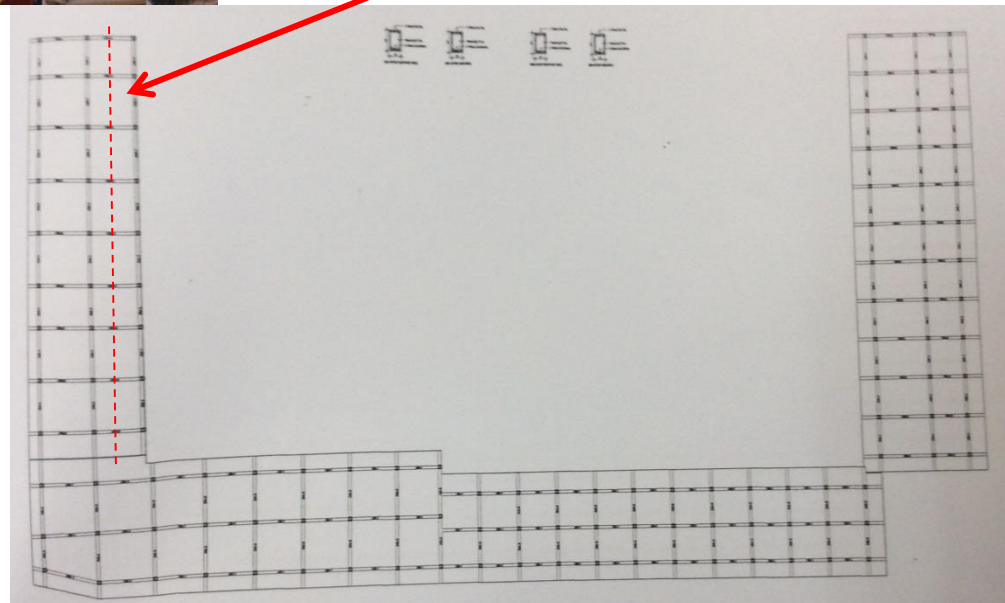
Beams are discontinued at the line indicated here on Level 1 and 2, indicating that the building may originally have been constructed to this line.

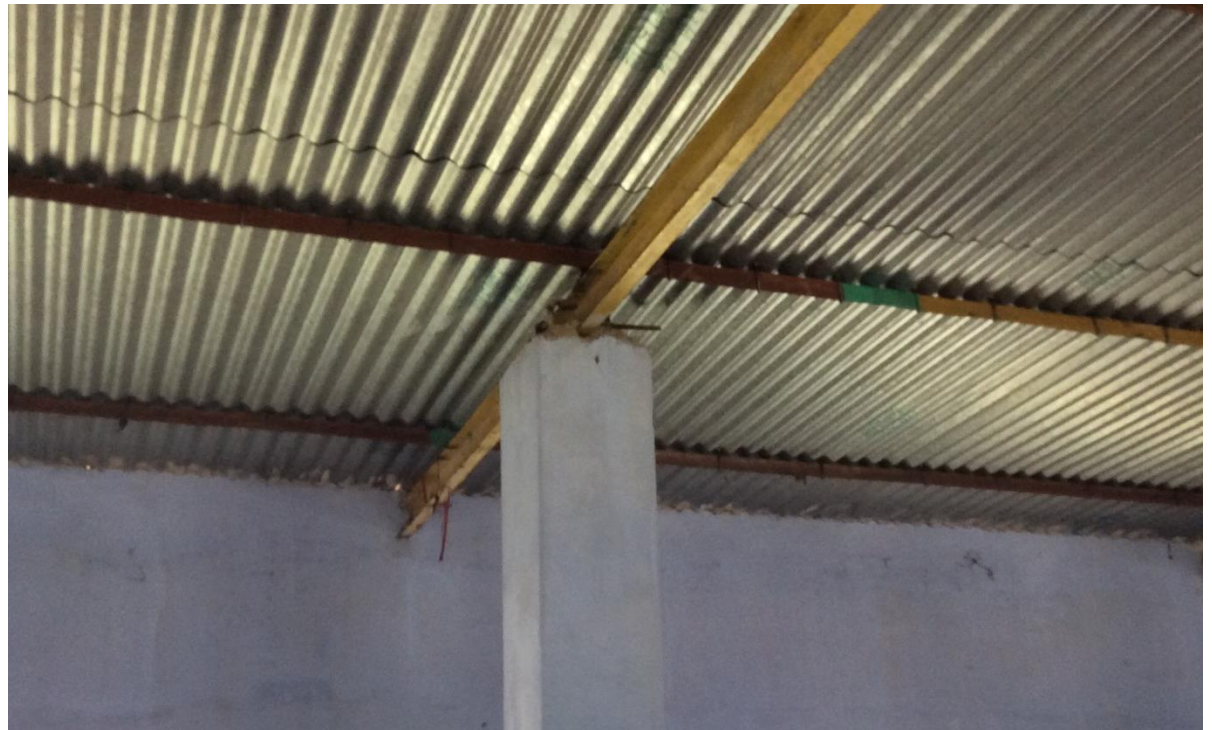
# **Steel roof connections to columns appear non-engineered**

These connections are formed by welds between the steel beams and the reinforcement protruding from the columns.

| Item No. | Observation | Recommended Action Plan | Recommended Timeline |
|---|---|---|---|
| 9 | Steel roof connections to columns appear non-engineered | Building Engineer to check the capacity of the lightweight roofs and make any necessary alterations. | 6-months |
