# **FIRE SAFETY INSPECTION REPORT**

**MAS Intimates Bangladesh (Pvt.) Ltd.(Unit-03)**

**ACCORD ID: 12869**

**Inspected By: Dilip Kumar Mondal & Md. Ferdaus Jaman**  
**Date: 19th June, 2017**

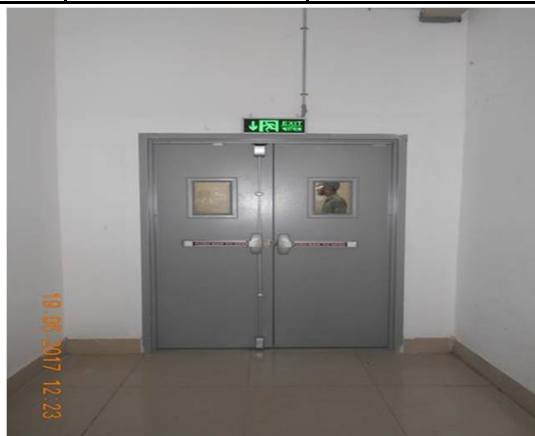
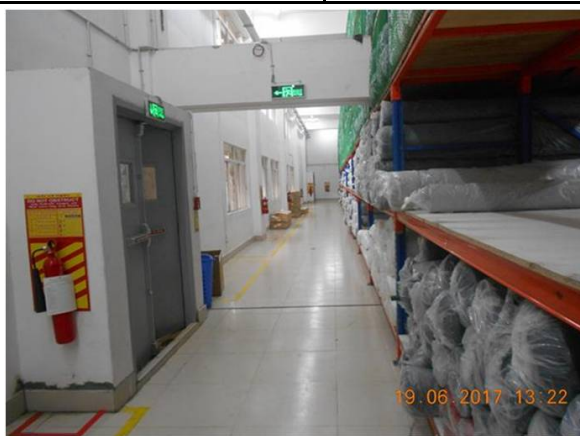
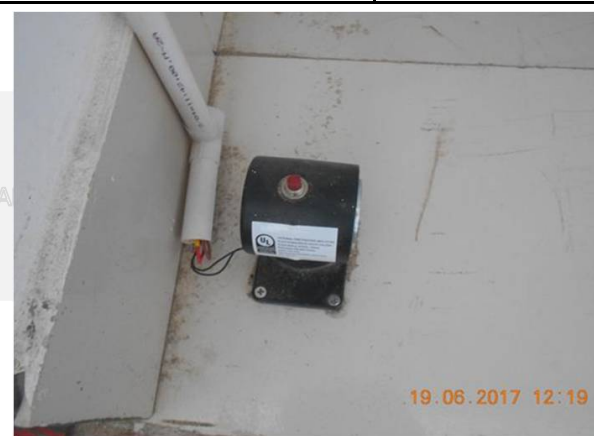
| Sl No. | Category | Findings | Required Action | Remediation Time Frame |
|---|---|---|---|---|
| 1 | Fire Rated Construction | Certificates of installed fire rated door to separate stairs, ramp and storage rooms were not found during initial inspection. | Submit proper certifications for installed fire doors to the ACCORD for verification. If not available, or certification is not approved, install new, properly certified fire rated doors in accordance with ACCORD standard. | Within 1 month |

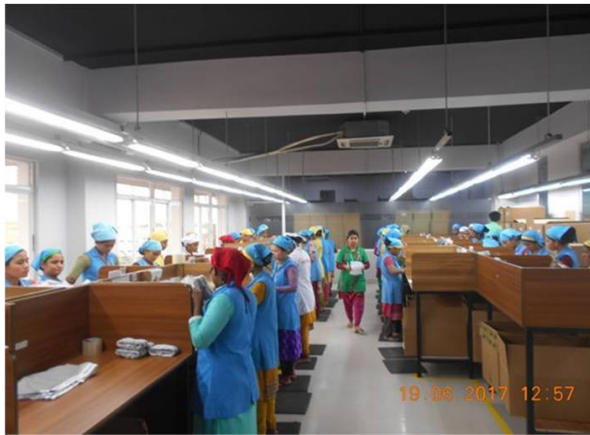
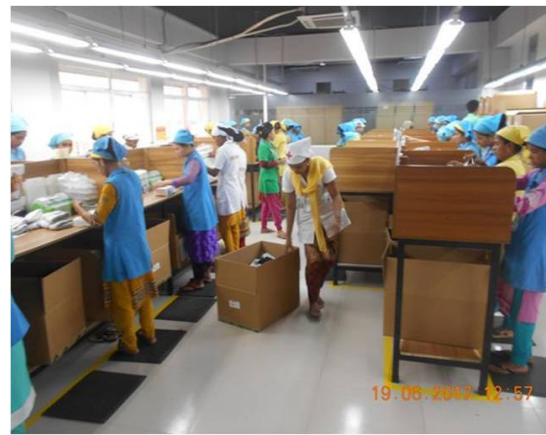
2

Unprotected dryer/packing section is located within the finished goods store on 3rd floor where more than 50 persons working.

Provide minimum 2-hr fire-rated construction to separate the dryer/packing section.

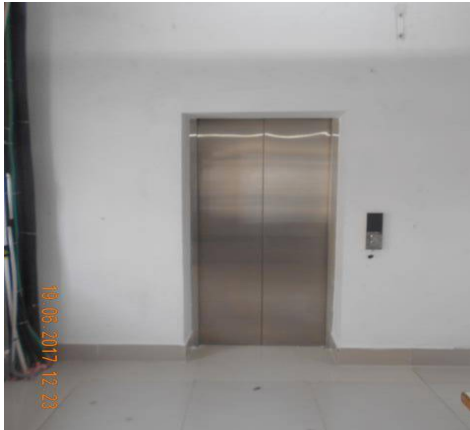
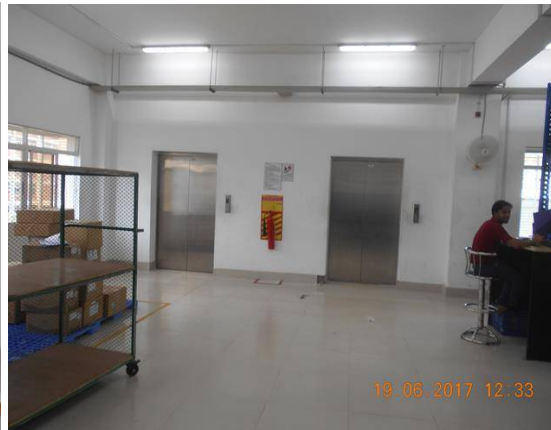
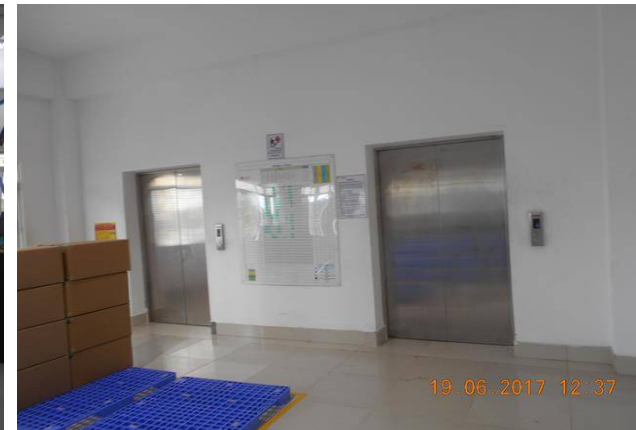
3

There are 4 elevators (north-west, south-west and south-east corner) discharges inside the production floor. (Unsealed penetrations & openings)

Provide a minimum 2-hr fire rated construction to separate the elevator shaft from each floor level. Seal all penetrations and openings in floors/ceiling assemblies to maintain the fire separation.

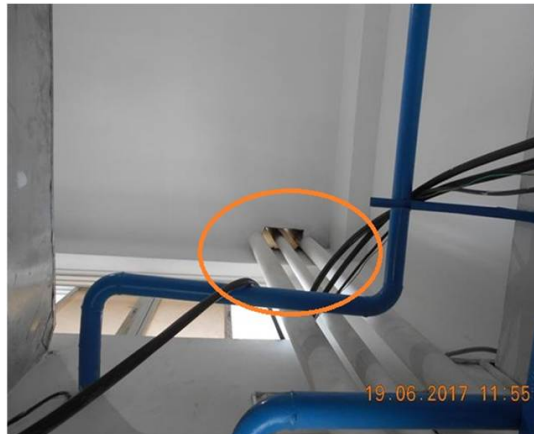
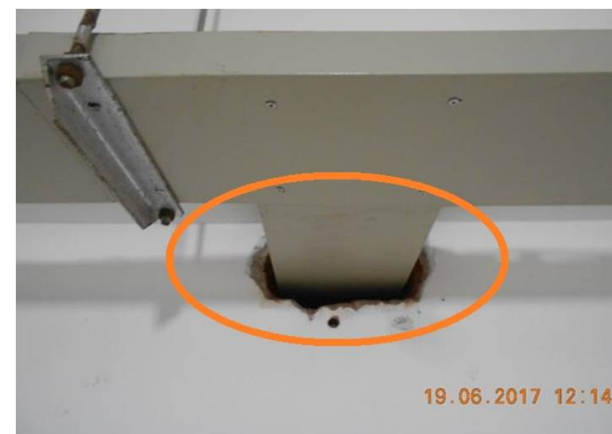
| 4 | Fire Rated Construction | Unsealed penetrations and openings are located in the fire rated floor/ceiling assemblies.<br>Location: Compressor room on ground floor, finished goods store to training school on 1st floor and finished goods store to dining area on 3rd floor. | Seal all penetrations and openings in floors/ceiling assemblies to maintain the required fire separation. | Within 3 months |

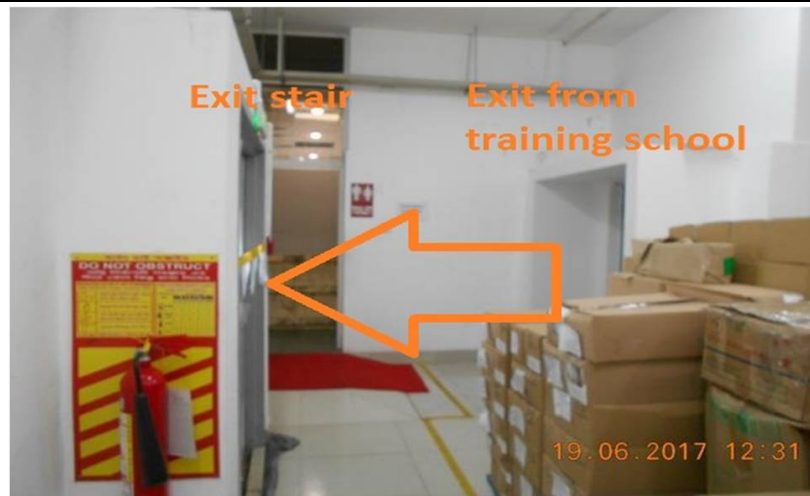
| 5 | Fire Rated Construction | Exit access corridor from training school passes through the finished goods store are not provided with 1 hr. fire resistance rating or approved NFPA 13 sprinkler system on the 1st floor. | Provide exit access corridors with 1 hr. fire resistance rating or approved NFPA 13 sprinkler system. | Within 3 months |

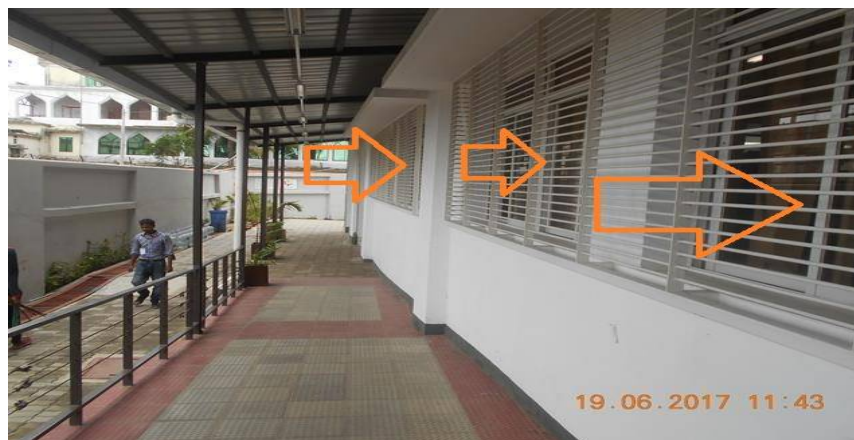
| 6 | Fire Rated Construction | The exit discharge path of ramp is less than 10 ft. wide and is not separated from the building interior on ground floor. | <p>Seal all penetrations and openings to the interior of the building along the discharge path, up to a height of 10 ft., to provide a minimum 1-hr fire separation.</p> <p>Alternatively, provide a second remote discharge path to the public way (only include this if feasible).</p> | Within 6 months |

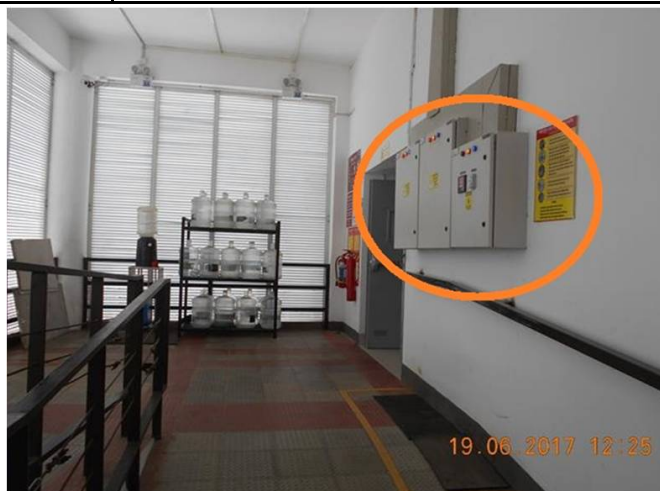
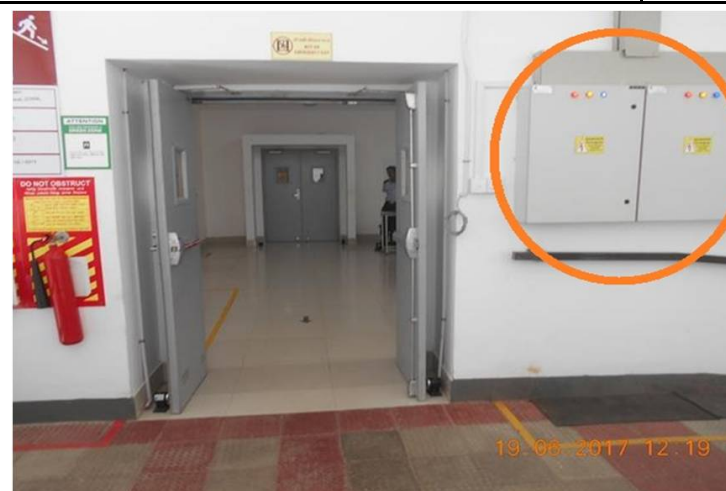
| 7 | Egress | Electrical DB panels are located in the ramp on ground, 1st, 2nd and 3rd floor. | Remove/relocate the electrical DB panel from the ramp, exit stairs and egress path to safe location. | 1 month |

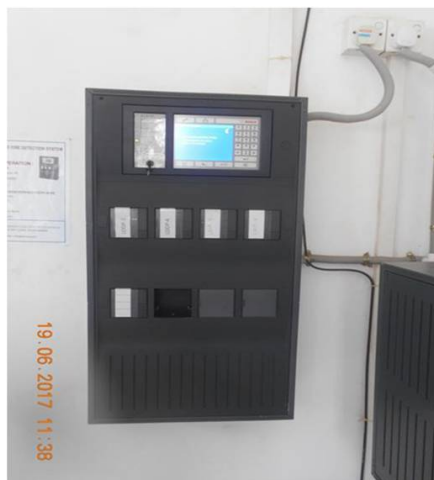
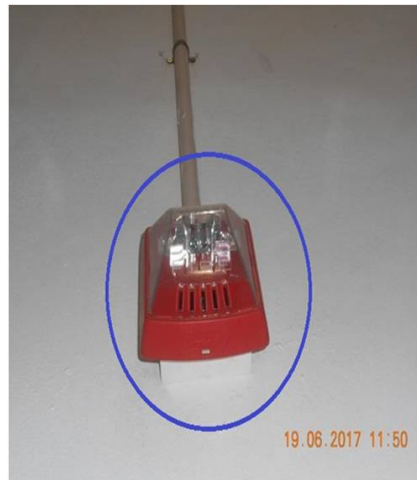
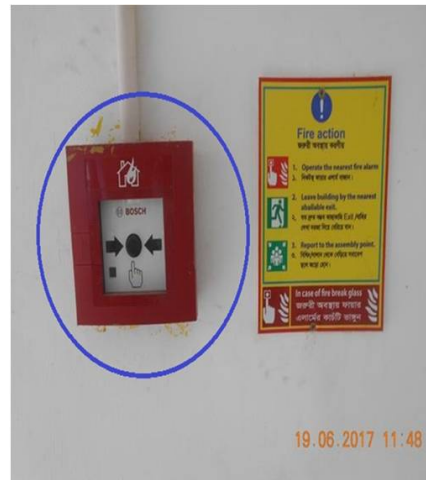
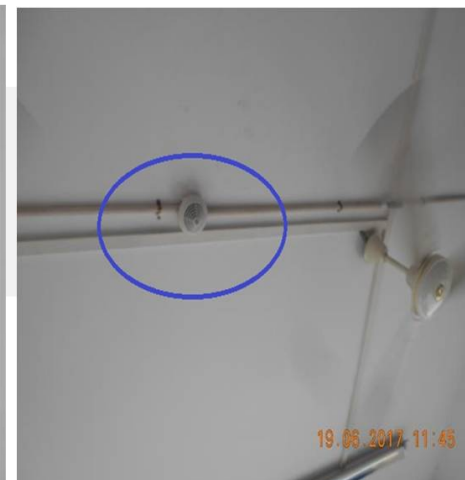
| 8 | Fire Detection and Alarm System | Automatic fire alarm & detection system installation requires detailed review to confirm compliance with NFPA 72 and ACCORD standards. Still few areas are out of detection system. | Submit as-built drawings, testing records, equipment certification and other relevant documentation to the ACCORD for review and approval. | Design within 2 months; modification (if required) within 4 months |

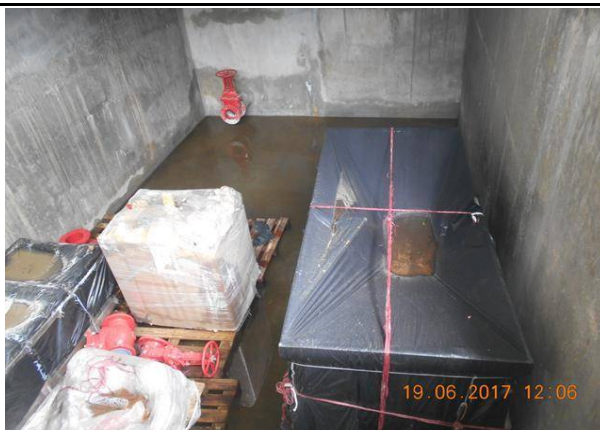
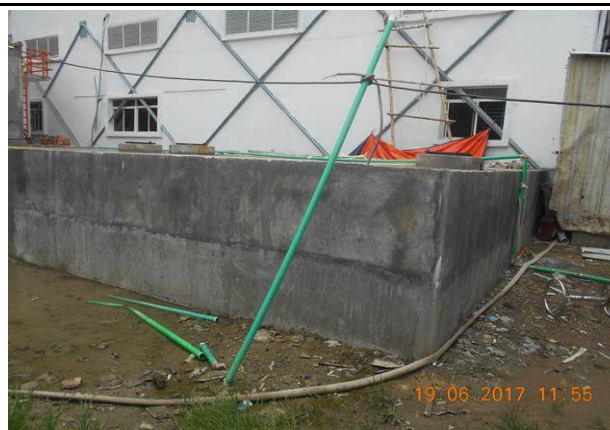
| 9 | Fire Protection System | The existing building has an occupied floor greater than 10 meter (33 feet) and is not provided with standpipe protection. | Install a new class III or class I & II standpipe system and fire department connection in accordance with NFPA 14, 20, 22 & 24. A class I system shall be permitted in buildings protected throughout by an automatic sprinkler system. | Design within 3 months, Install within 6 months |

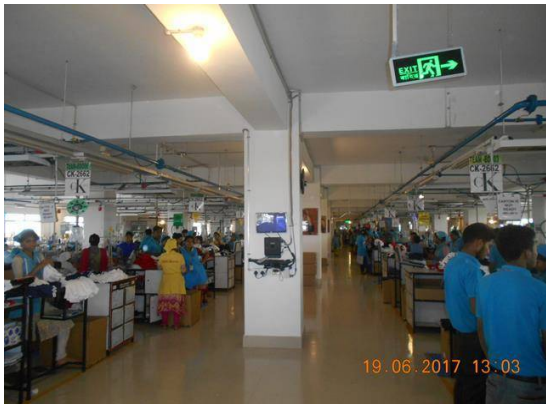
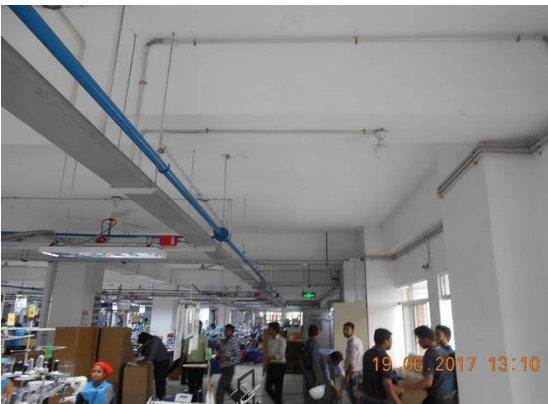
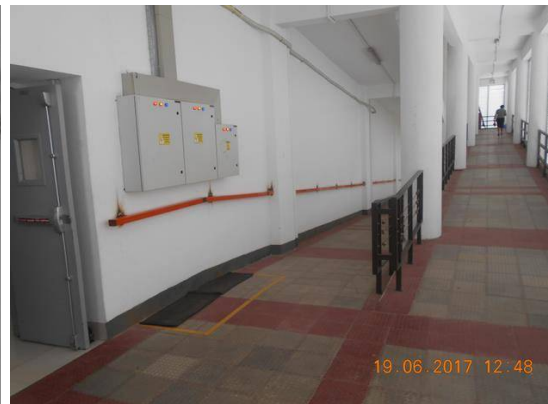
| 13 | Egress Lighting | Based on the number and location of emergency lights observed, adequate illumination levels are not anticipated along egress routes.<br>Location: All floors and stairs except 4th floor. | Test the emergency lighting system on each floor and provide additional emergency fixtures to provide adequate illumination along the means of egress. Provide a minimum illumination of 10 lux at the floor level within exit stairs and exit discharge paths and minimum 2.5 lux along exit access aisles. Install illuminated directional sign where there is a change in the direction of the path of travel. | Within 3 months |

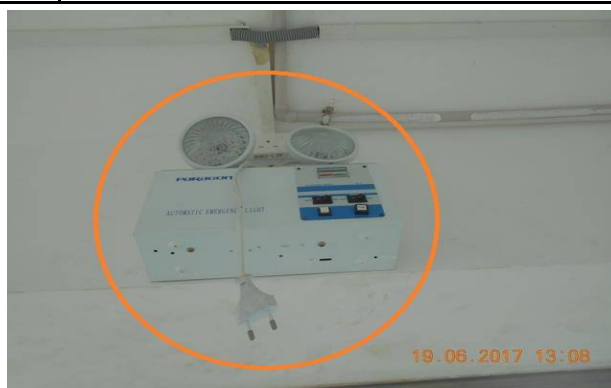
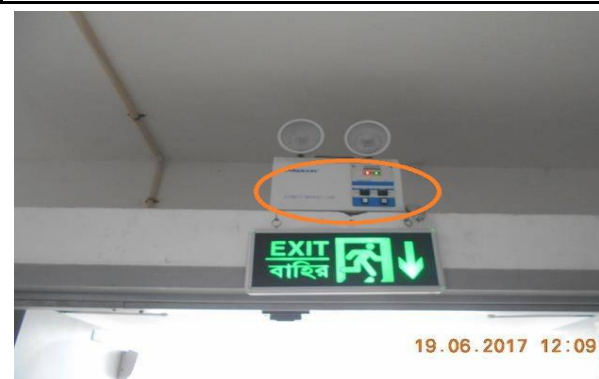
| 14 | Egress Lighting | Manual on-off switch facility available for emergency lights/exit signs. | Remove manual on/off switches from emergency lighting units/ exit signs to prevent them from being switched off. | Within 1 month |
