# **FIRE SAFETY INSPECTION REPORT**

**Factory Name: Comptex Textiles Ltd. (New Building)**

**ACCORD ID: 12577**

**Date: 16th February, 2017**

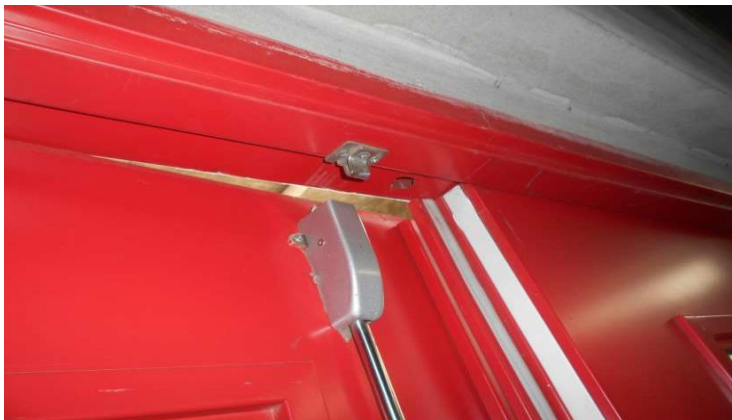
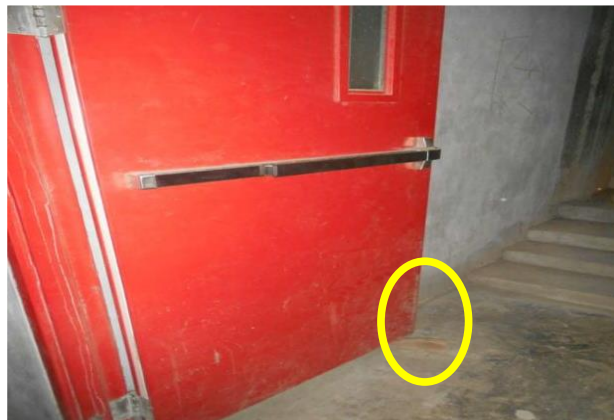
| Sl No. | Category | Findings | Required Action | Remediation Time Frame |
|---|---|---|---|---|
| 1 | Fire Rated Construction | Fire door has been installed without proper hardware. <b>(Door coordinators were missing from double leaf door, Automatic hold-open-closing devices were missing)</b> | Install fire doors with proper hardware's and maintain checklist as per Accord's recommendation.<br>And<br>If fire doors are required to be held open for functional reasons, provide automatic-closing devices tied to the fire alarm system. | Within 3 months |

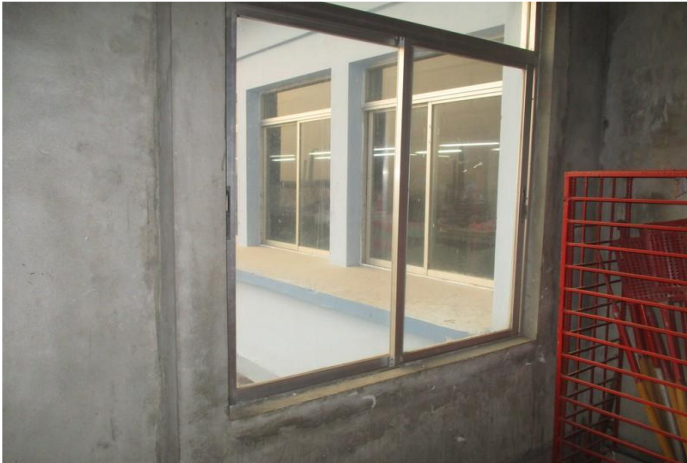
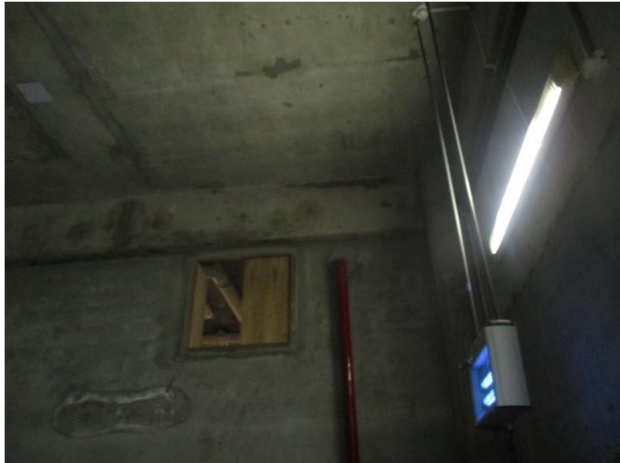
| Sl No. | Category | Findings | Required Action | Remediation Time Frame |
|---|---|---|---|---|
| 2 | Fire Rated Construction | Unsealed penetrations and openings are located in exit stair enclosures.<br><b>Location- South exit stair and East exit stair</b> | Seal all penetrations and openings in the wall of exit enclosure walls (full thickness of the wall) by fire rated materials to maintain the fire resistance rating. | <b>Within 3 months</b> |

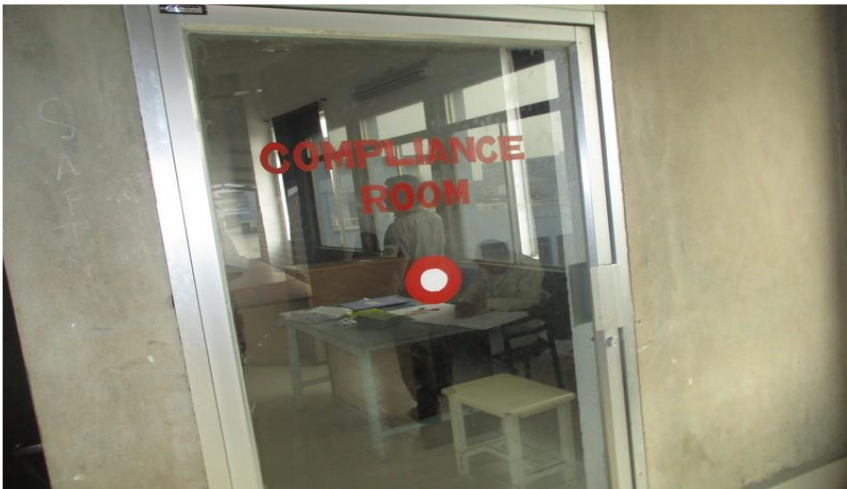
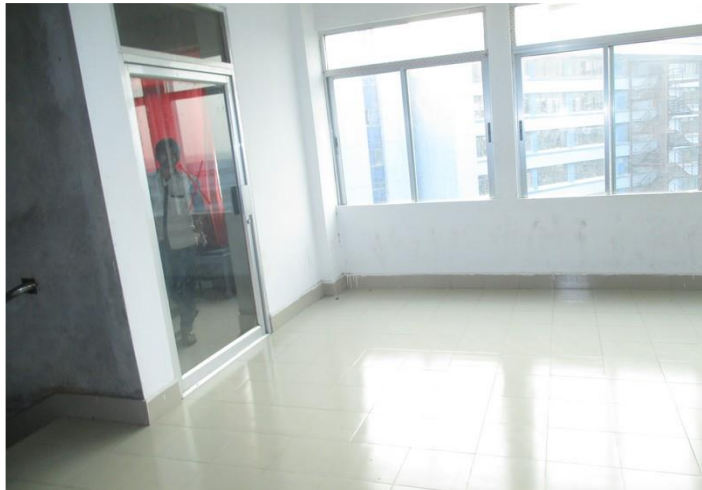
| Sl No. | Category | Findings | Required Action | Remediation Time Frame |
|---|---|---|---|---|
| 3 | Fire Rated Construction | The exit stairs are not separated from miscellaneous spaces on each floor by fire-rated construction.<br><b>Location: West exit stair and South exit stair</b> | <p>Stair shall be enclosed with a minimum 2-hr fire-rated construction. Seal all unprotected openings and provide minimum 1.5-hr fire rated doors to separate the exit stairs from work areas and other building spaces on all floor levels. Ensure that the fire doors are self-closing, positive latching and that they are provided with fire exit (panic) hardware where serving production floors.</p> <p>If fire doors are required to be held open for functional reasons, provide automatic-closing devices tied to the fire alarm system.</p> | Within 3 months |

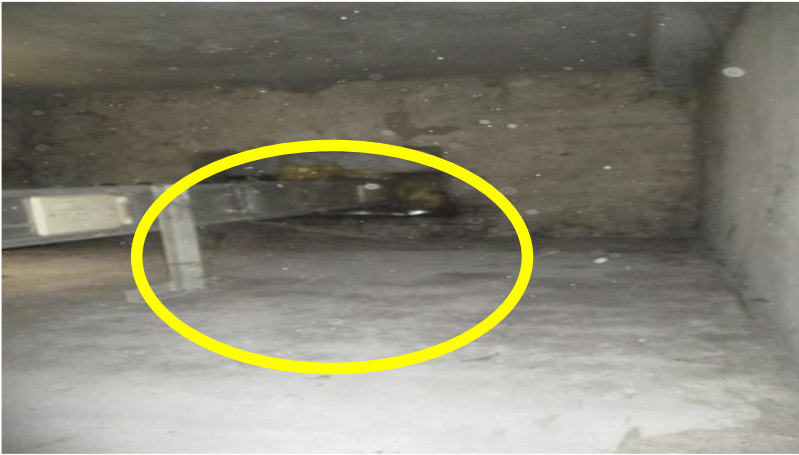
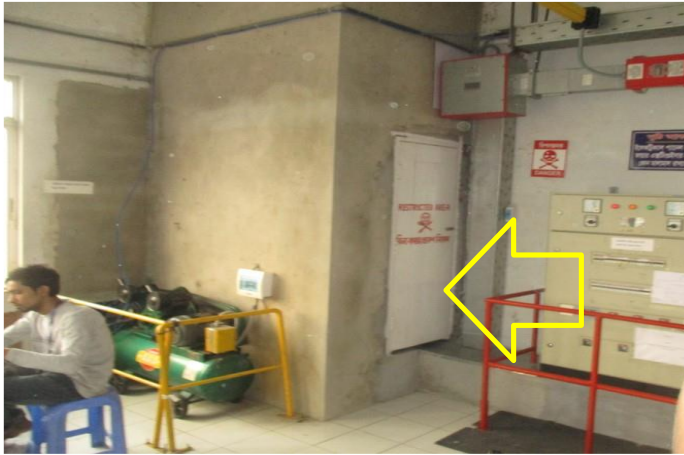
| SI No. | Category | Findings | Required Action | Remediation Time Frame |
|---|---|---|---|---|
| 4 | Fire Rated Construction | <p>Penetrations through floor/ceiling assemblies are found unsealed.</p> <p><b>Location: Electric Shaft for Bussbar system near North-East exit stair.</b></p> | <p>Seal all penetrations and openings in floor/ceiling (full thickness of the floor/ceiling) assemblies by fire rated materials to maintain the fire resistance rating.</p> <p>Provide a minimum <b>2-hr fire</b> rated shaft to separate the utility risers from each floor if required.</p> | Within 3 months |

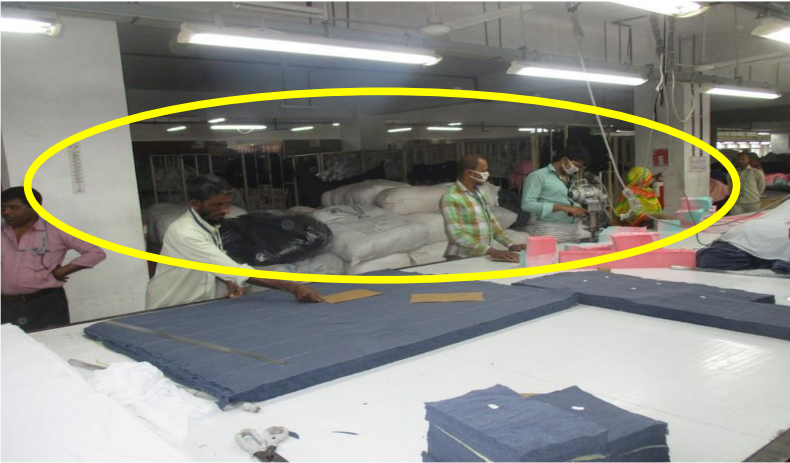
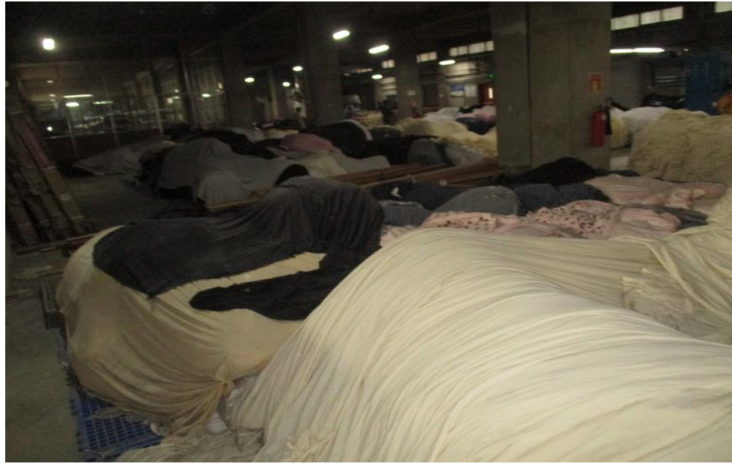
| Sl No. | Category | Findings | Required Action | Remediation Time Frame |
|---|---|---|---|---|
| 5 | Fire Rated Construction | <p>Areas used for in-process storage of combustible materials are open to the surrounding occupancy.</p> <p><b>Location: Ground floor &amp; Cutting section at 2nd floor.</b></p> | <p>Provide defined storage areas and limit the storage arrangement as follows:-</p> <p>Maximum height of 2.4m and maximum area of 23m<sup>2</sup>. Separate areas of unenclosed combustible storage by a minimum clear distance of 3m.</p> <p>If sprinkler protected: maximum height of 3.66m and maximum area of 93m<sup>2</sup>. Separate areas of unenclosed combustible storage by a minimum clear distance of 3m.</p> <p>or</p> <p>3. Enclose the storage area from the surrounding occupancy with a minimum 1 hour construction.</p> | Within 3 months |

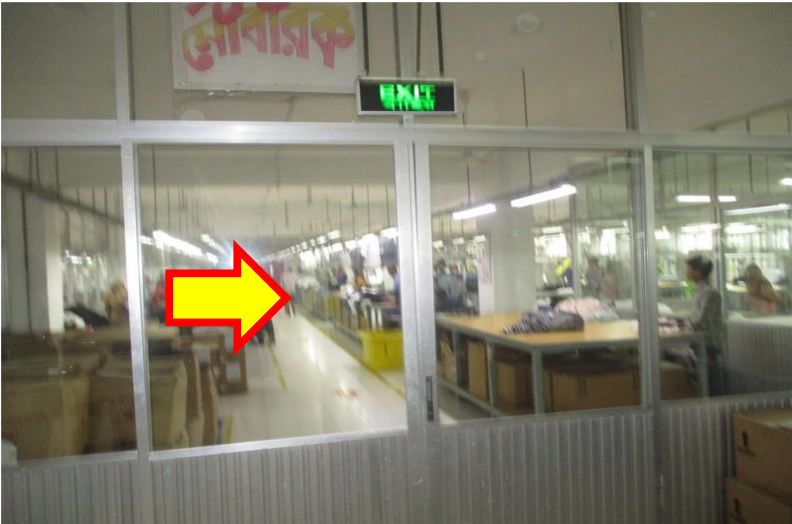
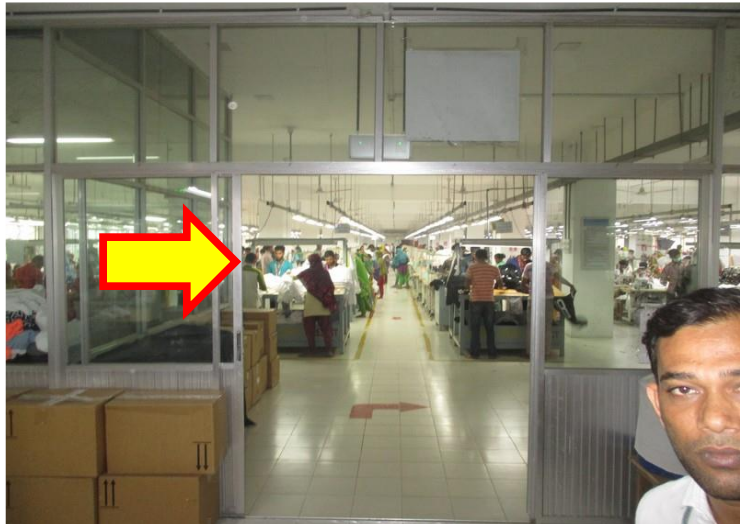
| Sl No. | Category | Findings | Required Action | Remediation Time Frame |
|---|---|---|---|---|
| 6 | Egress | Sliding type doors have been provided along means of egress.<br><b>Location: 3rd and 4th floor egress route between Sewing and Finishing section.</b> | Replace all collapsible/sliding/shutter type doors & gates by the side-hinged swinging type doors. | Within 3 months |

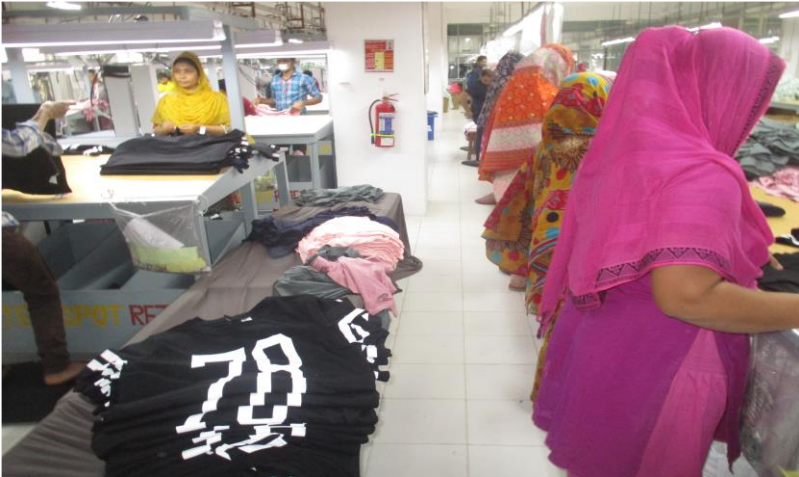
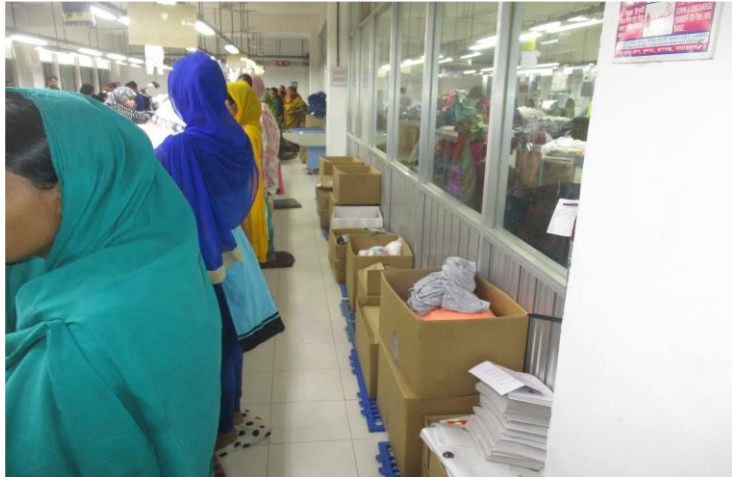
| SI No. | Category | Findings | Required Action | Remediation Time Frame |
|---|---|---|---|---|
| 9 | Fire Protection | <p>Fire detection and alarm system has not been installed as per NFPA-72.</p> <p><b>(Heat detectors were installed without maintaining minimum listed spacing at Ground floor, Detectors and MCP were missing in places.)</b></p> | <p>Modify the fire alarm system in accordance with NFPA 72.</p> | <p><b>Within 3 months</b></p> |

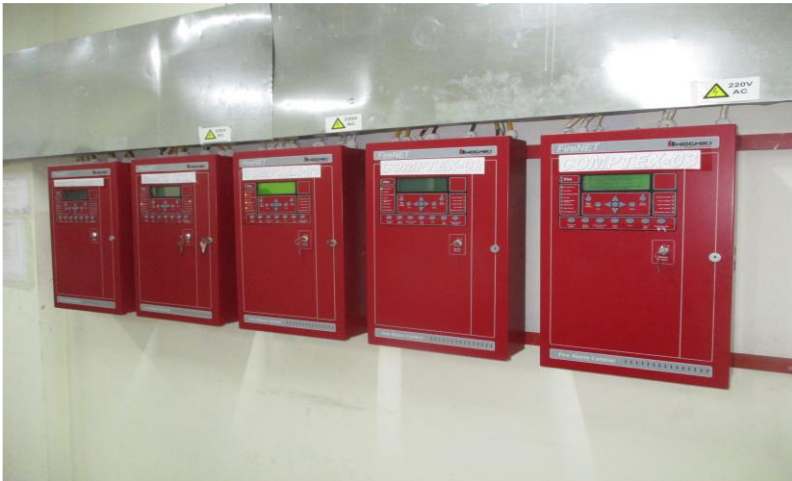
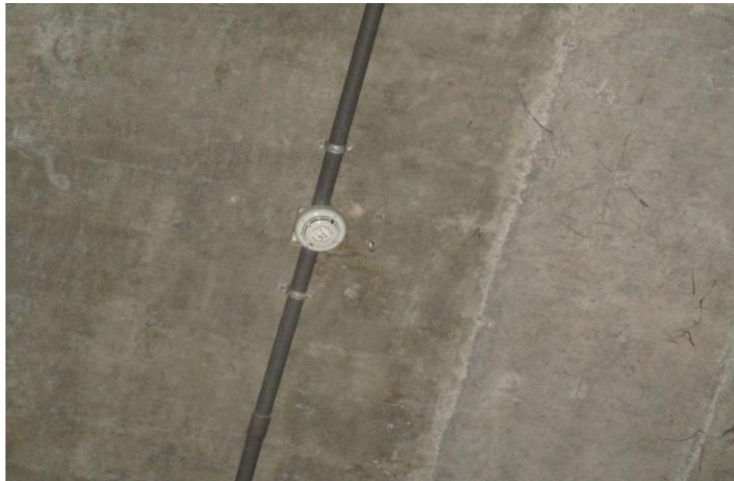
| Sl No. | Category | Findings | Required Action | Remediation Time Frame |
|---|---|---|---|---|
| 10 | Fire Protection | <p><b>For Individual building Comptex Textiles Ltd. (New BLDG)</b></p> <p>Inspection, testing, and maintenance for the fire alarm system is not in accordance with NFPA 72 or as per Accord standard.</p> | <p>Inspect, test and maintain the fire alarm system, and keep written records on-site, in accordance with NFPA 72 or as per Accord standard.</p> | <p><b>Within 3 months</b></p> |

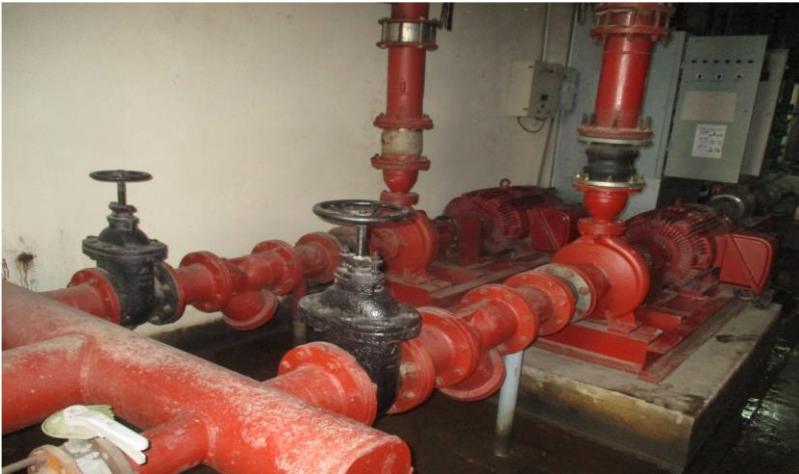
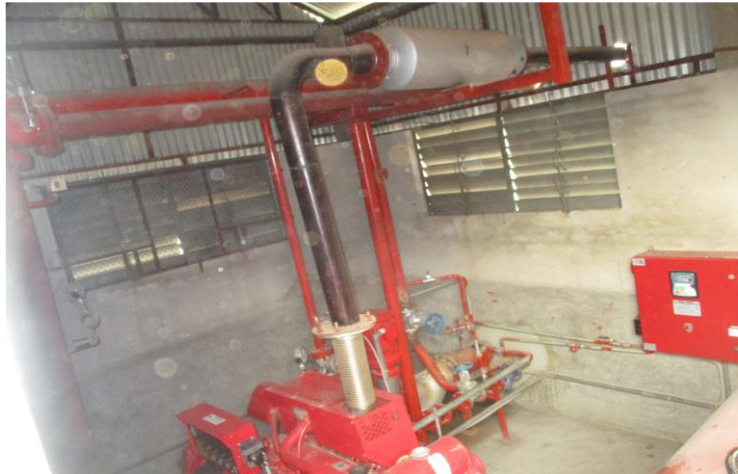
| SI No. | Category | Findings | Required Action | Remediation Time Frame |
|---|---|---|---|---|
| 14 | Fire Protection | Inspection, testing, and maintenance for the stand-pipe system is not maintained in accordance with NFPA 14 or as per Accord standard. (Only Weekly documents maintained) | Routinely Inspect, test and maintain the stand-pipe system, and keep written records on-site, in accordance with NFPA 14 or as per Accord standard. | Within 3 months |

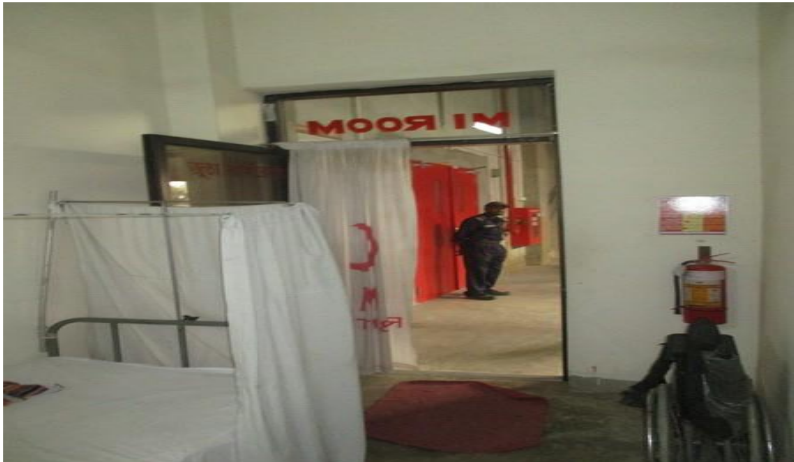
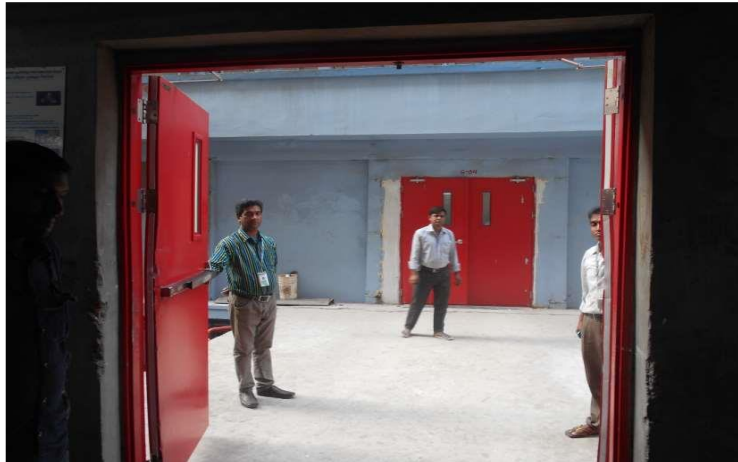
| SI No. | Category | Findings | Required Action | Remediation Time Frame |
|---|---|---|---|---|
| 19 | Egress Lighting | <p><b>For Individual building Comptex Textiles Ltd. (New BLDG)</b></p> <p>Inspection, testing, and maintenance for the exit sign and emergency lighting system was not in accordance with The ACCORD standard.</p> | <p>Inspect, test and maintain the exit sign and emergency lighting system in the accordance with The ACCORD standard. Keep written records on-site.</p> | <p><b>Within 3 months</b></p> |
