Marma Composite LTD

Tongabari, Ashulia, Savar, Dhaka-1341, Bangladesh

27th May 2014

Observations

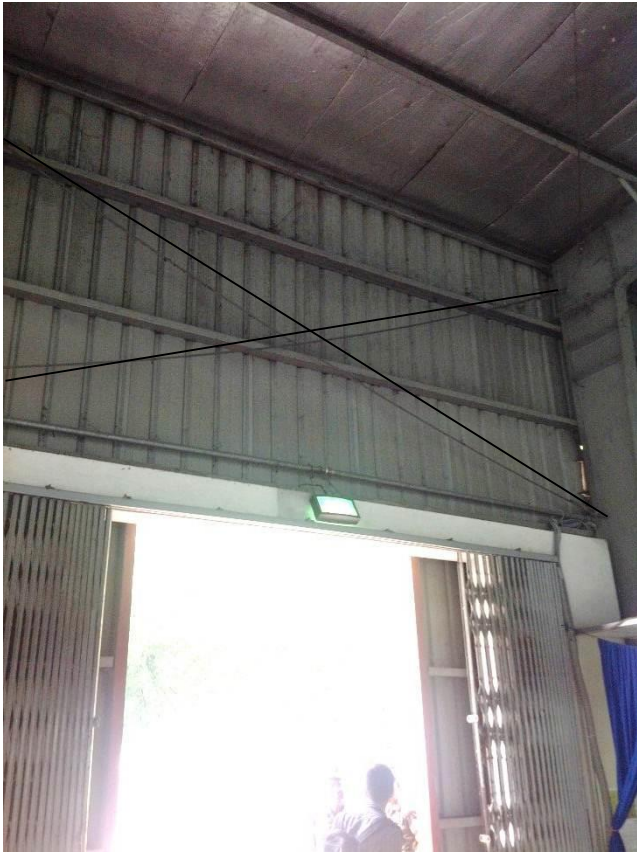
North Face Wall Bracing

The Main factory Wall Bracing does not continue to ground level. It is not obvious where the bracing on the south face of the main factory structure terminates.

Item No.	Observation	Recommended Action Plan	Recommended Timeline
1	Inadequate bracing systems	Structural engineer to check the capacity of the steel frames under horizontal and vertical loading and make any necessary alterations.	6-months
2	Steel connections appear non-engineered	Structural engineer to check the capacity of all connections and make any necessary alterations.	6-weeks
3	Increased span for the reinforced concrete beam in the generator room	Building manager to temporarily prop the beam.	6-weeks
4	Increased span for the reinforced concrete beam in the generator room	Structural engineer to check the capacity of the beam to ensure it can span the additional length. Structural engineer to recommend any building alterations if required.	6-weeks
5	Lightweight roof structures appear non-engineered	Lightweight roof structure to be reconstructed/upgraded to ensure adequacy for code vertical and wind loads by the Building Engineer.	6-months

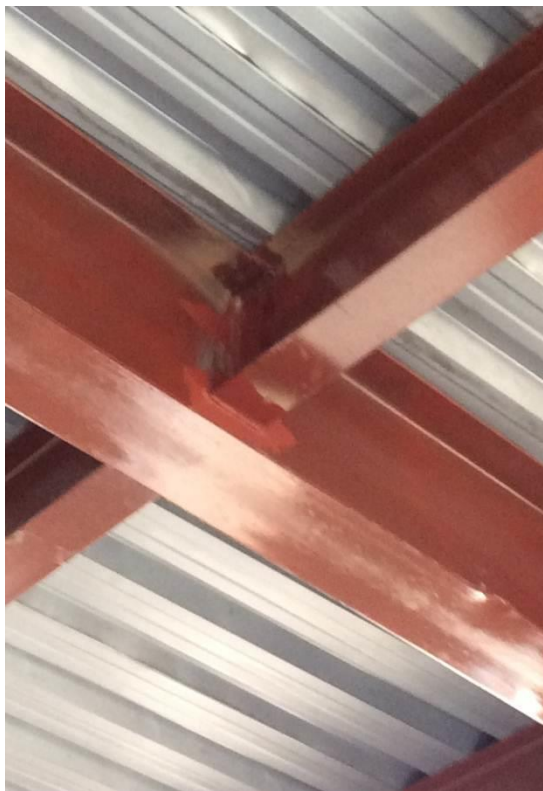
**Typical Mezzanine
Welded Connection**

Various steel connections appear non-engineered such as the welded connections for the mezzanine structure in the main factory building, the truss to column connection in the original factory building and the portal frame apex moment connection in the original building extension.

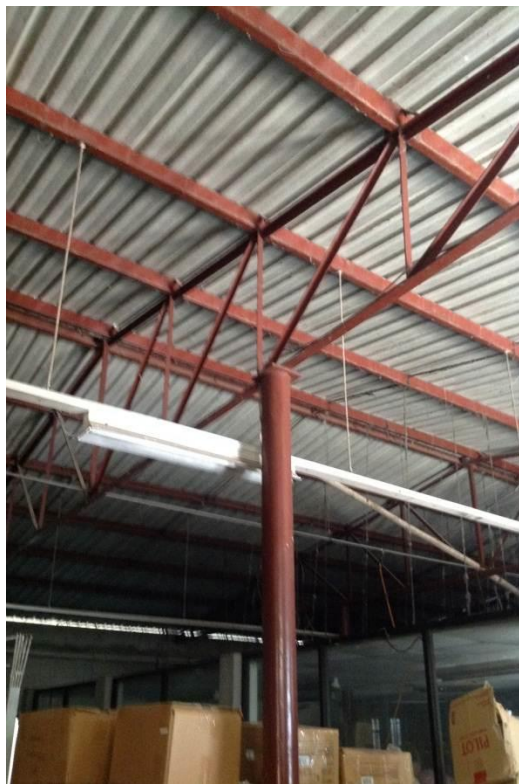
**Original building truss
to CHS Connection**

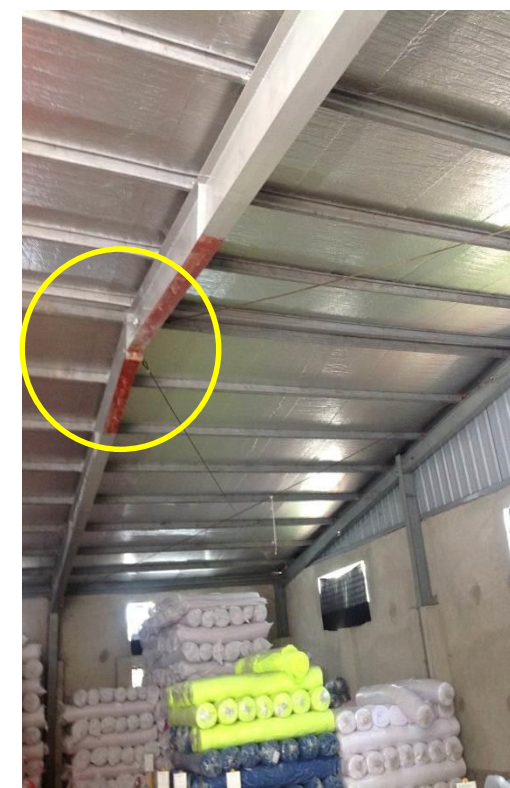
**Original building
extension portal
moment connection**

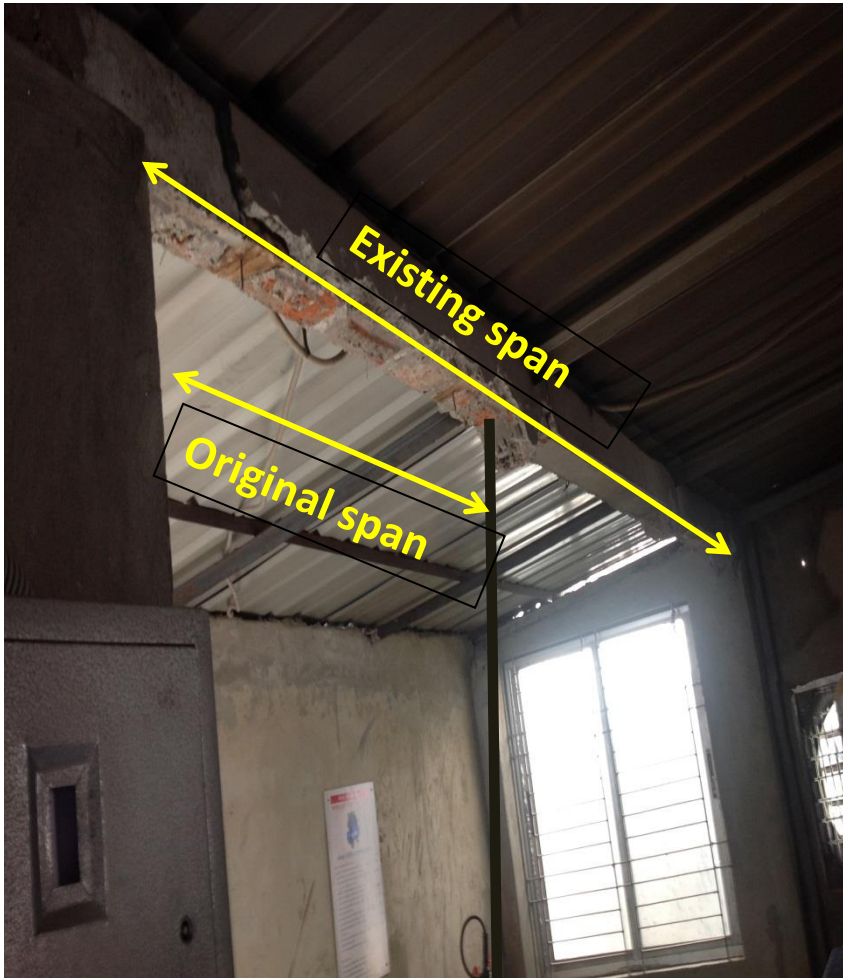
Generator room

The original concrete beam span has almost doubled. It is unlikely this beam has been designed to cater for this additional span. This beam should be checked by a suitable qualified structural engineer to ensure the beam can span the additional length.

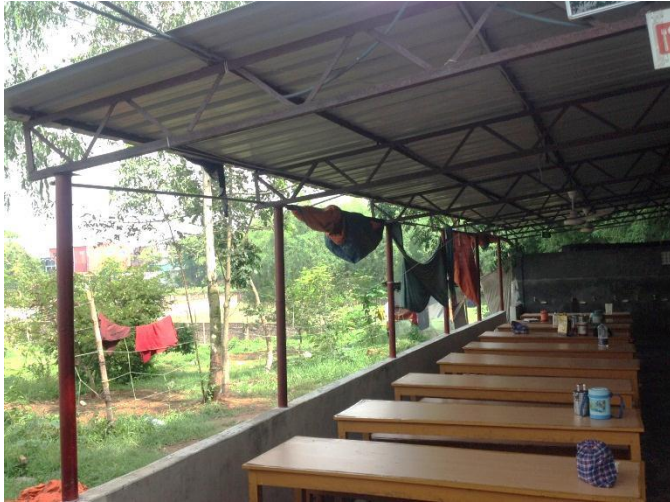
Canteen

Various Roof structures in the complex, such as that to the dining shed, generator room, boiler Room and main factory offices appear non-engineered.

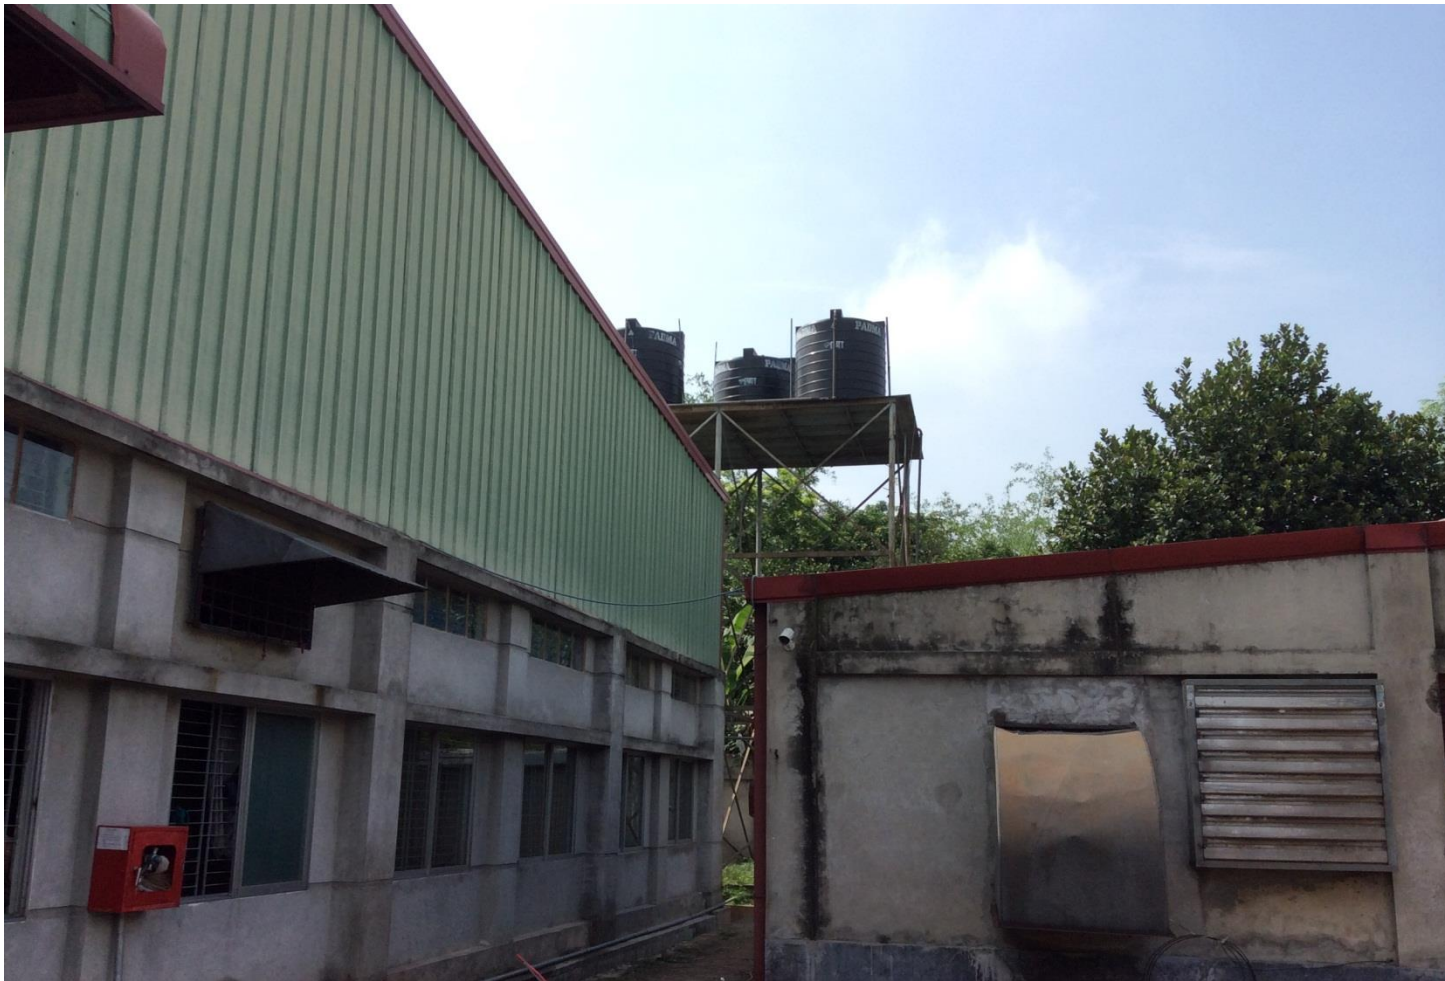
The steel structure supporting 15000 Litres of water appears to be too slender to cater for accidental damage, particularly from possible vehicle impact.

6	Steel structure supporting water tanks appears too slender	Structural Engineer to check the capacity of the steel structure to take into account any accidental load damage and make any necessary alterations.	6-months
