# Dragoni Fashions Ltd.

Kulgaon, Baluchara, Chittagong  
(22.410032N, 91.820060E)

21<sup>st</sup> May 2014

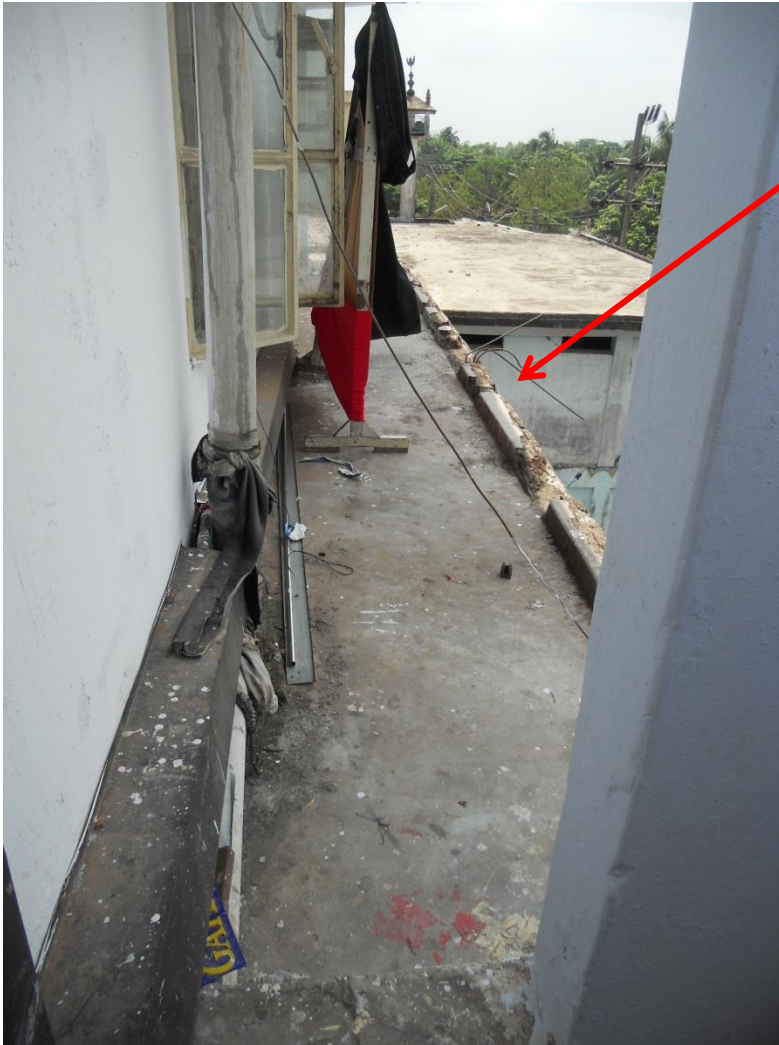
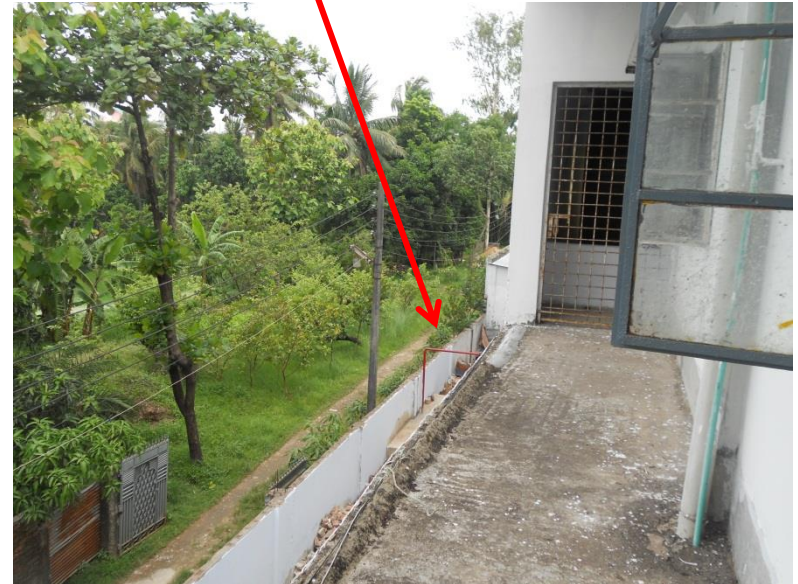
# **Lack of Edge Protection at Roof Level**

An immediate concern was raised with factory management regarding the lack of edge protection at the balconies on the building.

**Lack of edge protection**

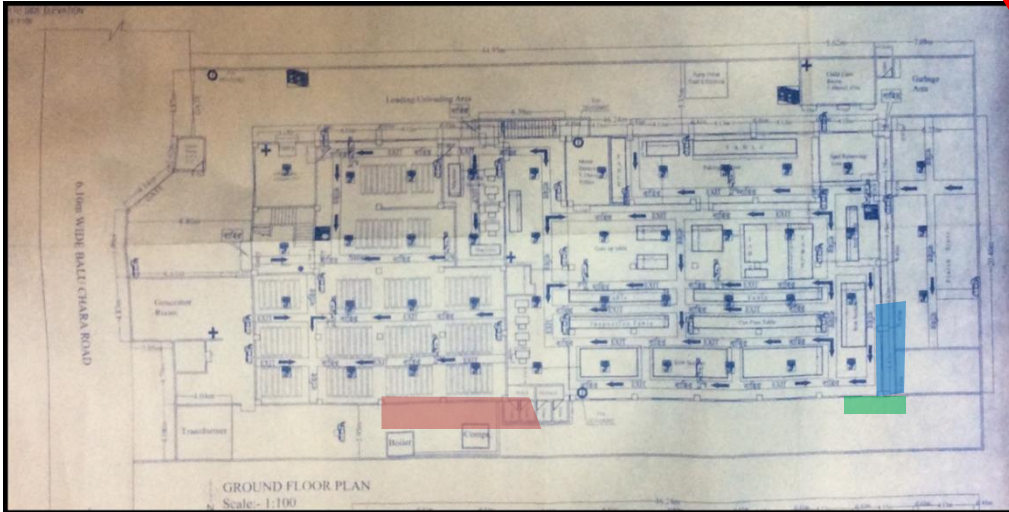
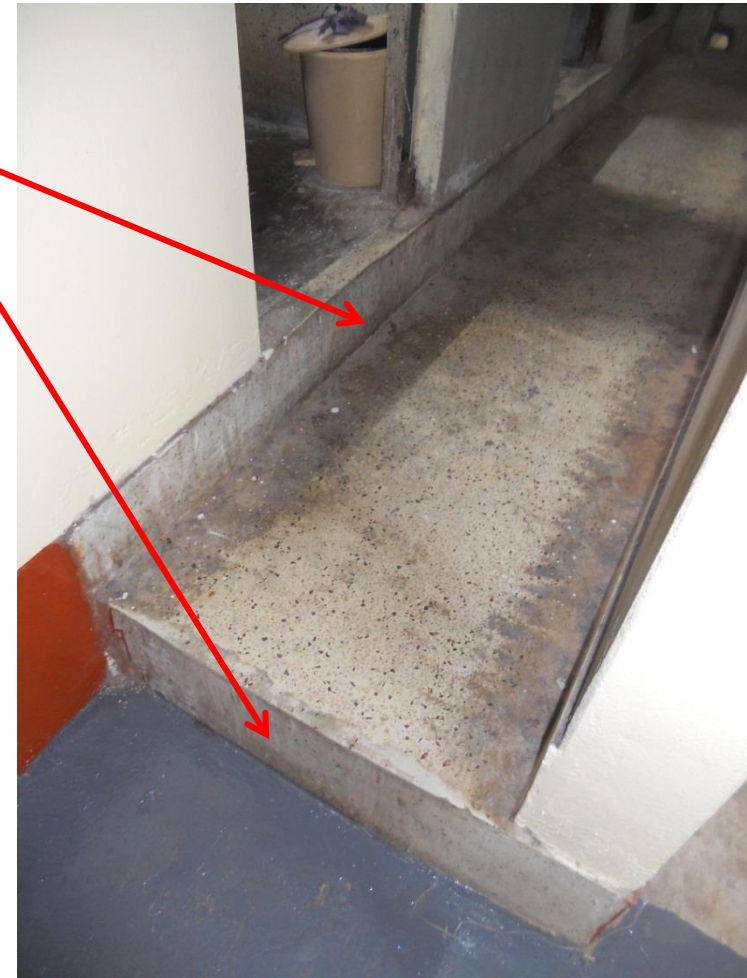
High Loading in Toilet Areas on Cantilevers

High loading was observed on cantilevers, especially in toilet areas with floor build-up.

Toilets at Levels 1, 2 & 3

Toilets at Levels 1, 2, 3, 4 (toilets are positioned at different locations within this zone at each level)

Toilets at Levels 4 only

| Item No. | Observation | Recommended Action Plan | Recommended Timeline |
|---|---|---|---|
| 8 | High loading in toilet areas on cantilevers | As part of the Detail Engineering Assessment (see Item 1), Factory Engineer to investigate if the applied loading can be safely carried by the slabs, beams and by the columns,. | <b>6-weeks</b> |
| 9 | High loading in toilet areas on cantilevers | Carry out load reduction and/or any remedial work as directed by the Factory Engineer. | <b>6-months</b> |

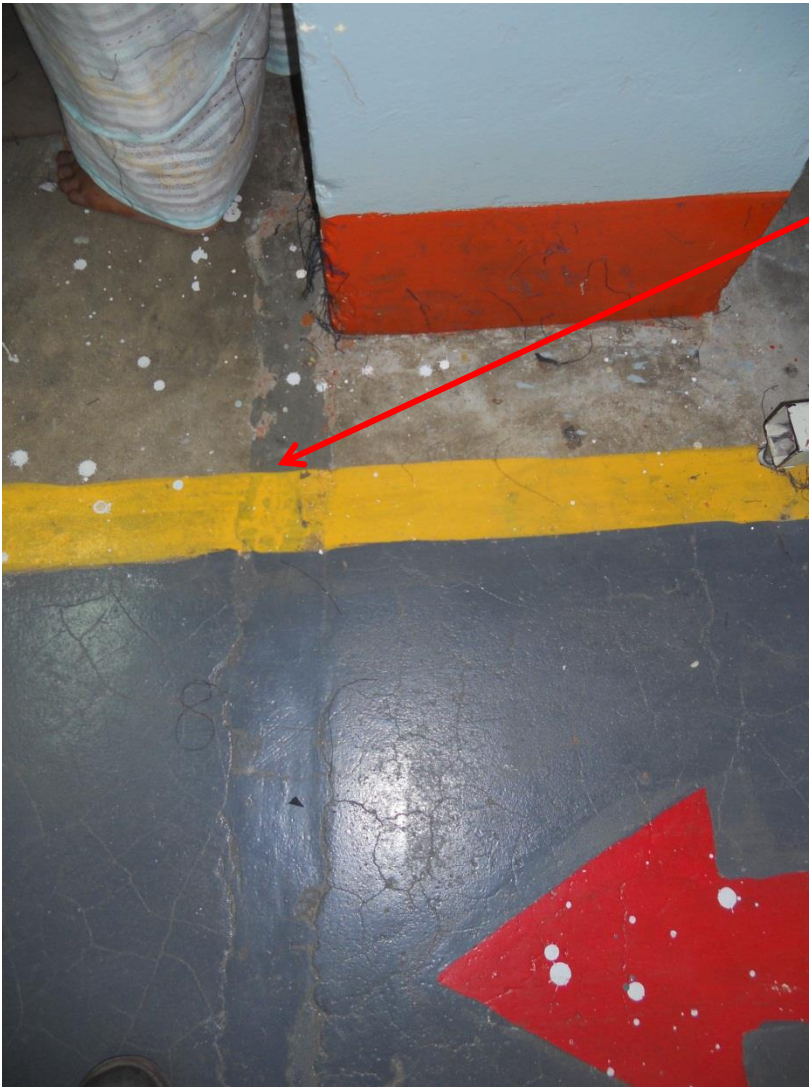
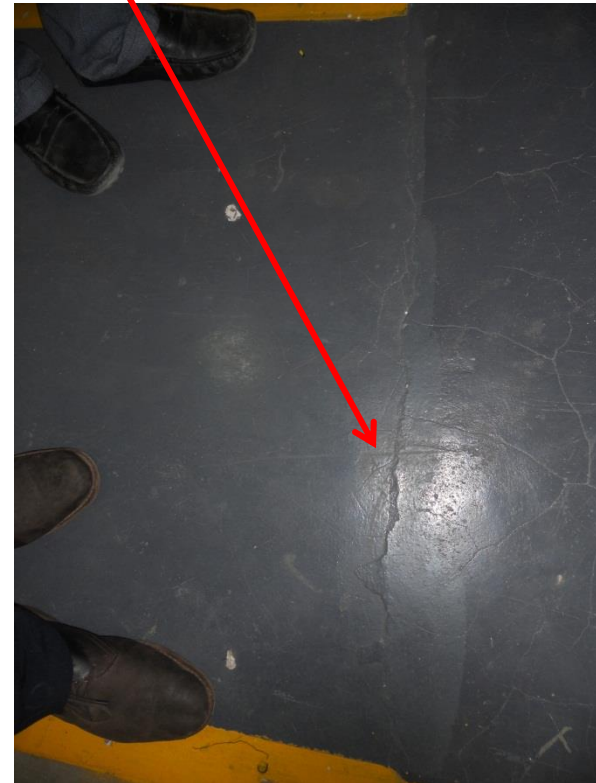
**Cracking in Floor Slab Surface**

Cracking was observed in the surface of the floor slab finish generally along the lines between columns.

| Item No. | Observation | Recommended Action Plan | Recommended Timeline |
|---|---|---|---|
| 10 | Cracking on floor surface | As part of the Detail Engineering Assessment (see Item 1), Factory Engineer to investigate if the cracking is structural or exists only in the screed finish | 6-weeks |
| 11 | Cracking on floor surface | Carry out any remedial work as directed by the Factory Engineer. | 6-months |

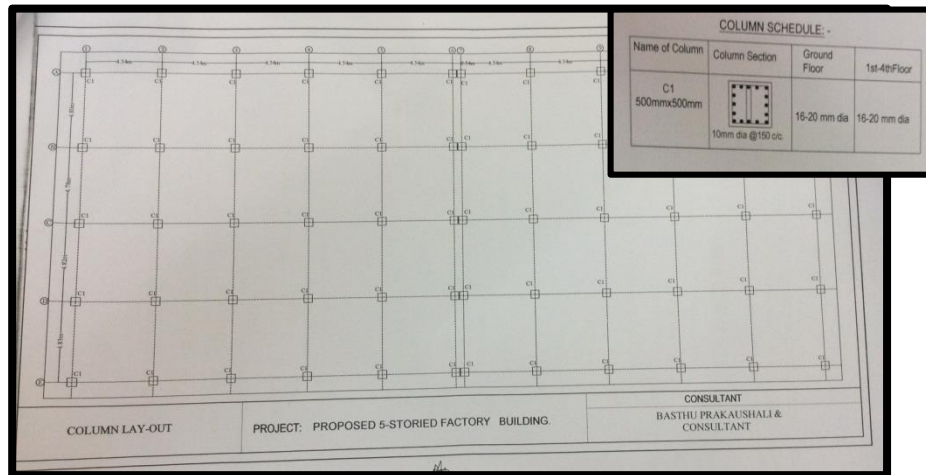
**Column layout drawing**

- The structural drawings showed columns of 500 x 500 across the entire grid; however, 300 x 380 internal columns and 300 x 300 perimeter columns were observed. The number of bars scanned in columns also differed from the drawings.
- Structural drawings neglected to show cantilevers which extended from all four faces of the building.
- Pile layout was provided, whilst the site investigation recommended pad foundations.
- Architectural drawings misrepresented the locations of some toilet areas and stairs.

| Item No. | Observation | Recommended Action Plan | Recommended Timeline |
|---|---|---|---|
| 12 | Discrepancies between site observations and information on drawings | As part of the Detail Engineering Assessment (see Item 1), Factory Engineer to update the engineering drawings. | 6-weeks |

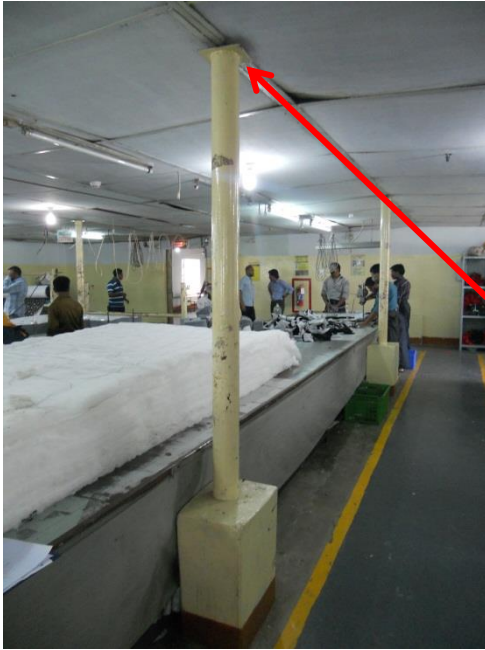
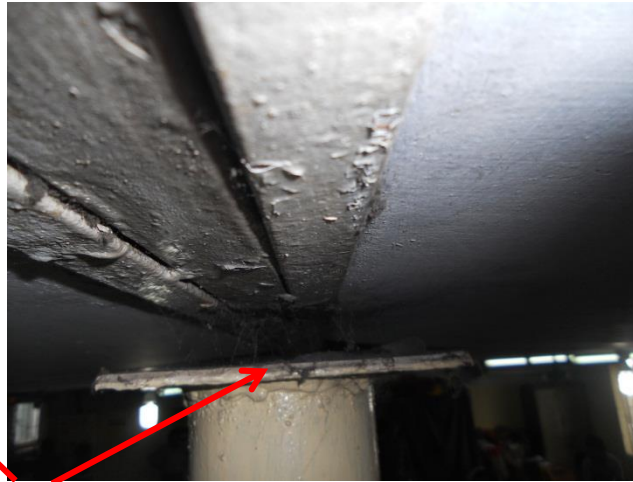
Circular post does not provide any support to roof frame.

| Item No. | Observation | Recommended Action Plan | Recommended Timeline |
|---|---|---|---|
| 13 | Apparently non-engineered roof structures | Building engineer to check the capacity of the lightweight roofs and make any necessary alterations. | 6-months |

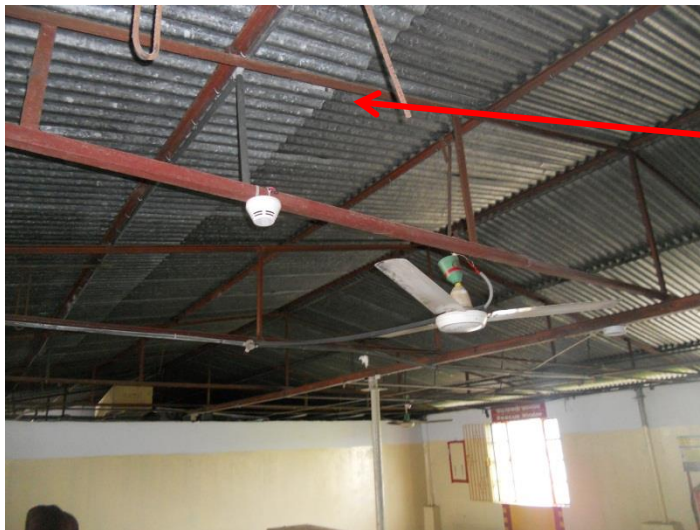
Roof trusses in Canteen area appear to lack internal members and have deflected.

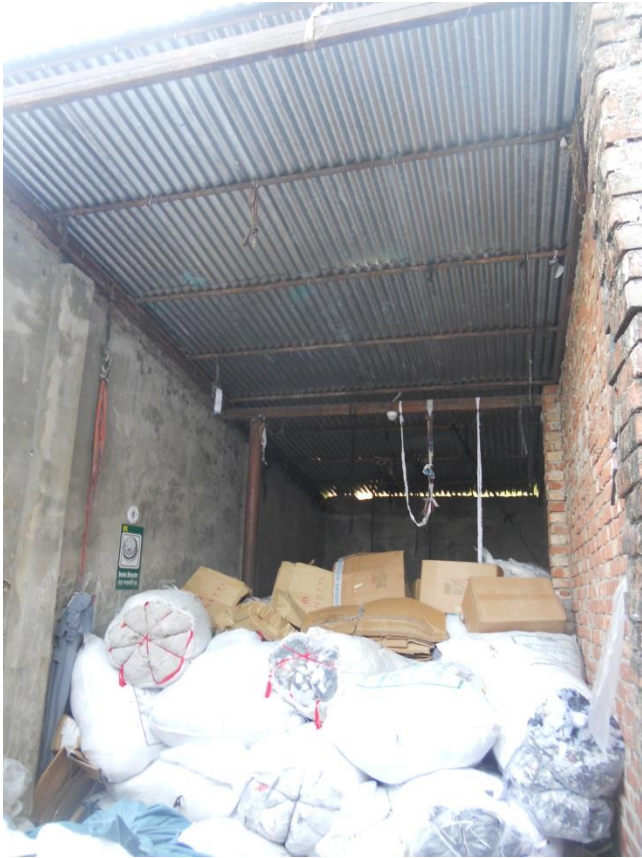
Waste Store Roof - sagging in roof beams.

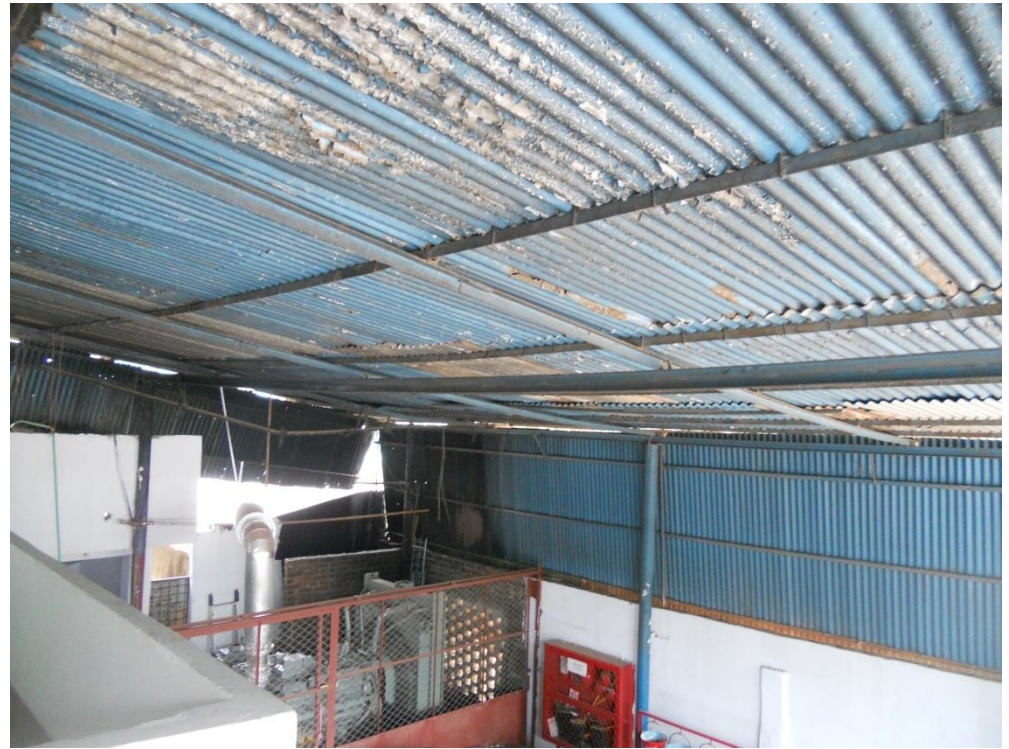
Roof to canopy at main entrance – deflection of roof supports.
