Haesong Korea Ltd.

Han Complex, Bara Rangamatia, Zirabo, Savar, Dhaka, Bangladesh
(23.909859, 90.303641)
10th June, 2014

Observations

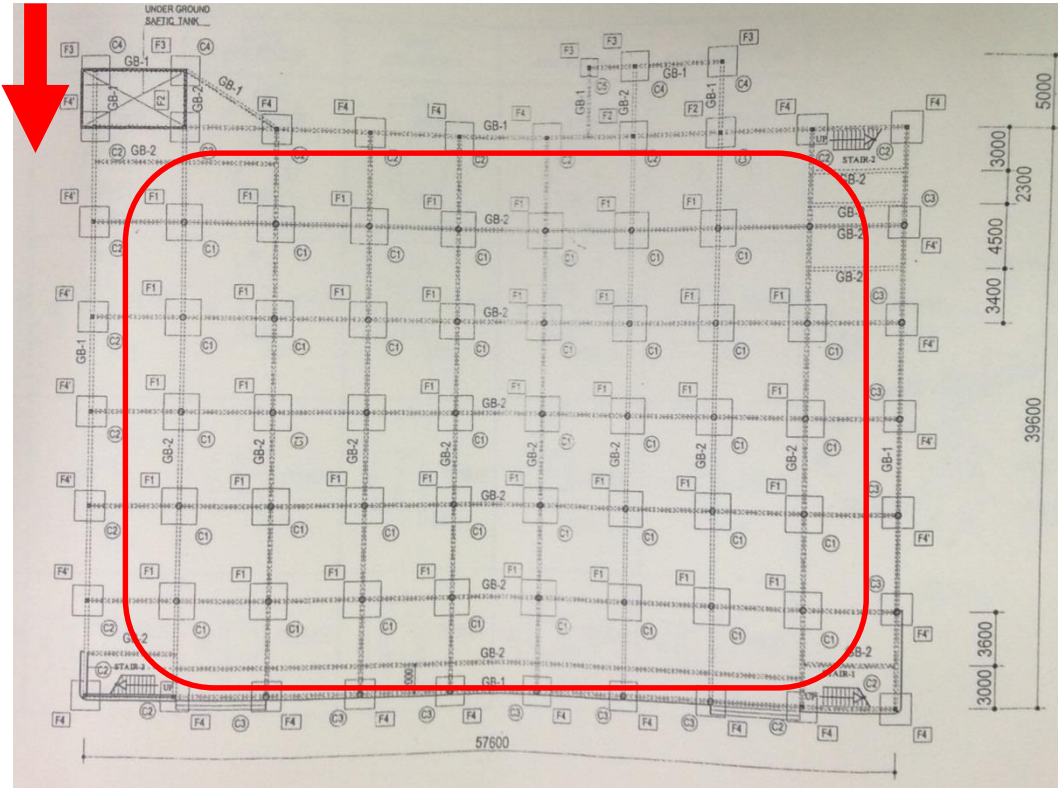
Ground Floor Column Layout

- cursory calculations indicate that column size appears to be smaller than required by code for the applied dead and live load, assuming typical concrete strength
- In the absence of testing certificates, concrete strengths are assumed based on historical BUET data.
- As built concrete strength and as built reinforcement to be surveyed and used to verify the column capacities

High concrete stress in columns

Item No.	Observation	Recommended Action Plan	Recommended Timeline
1	High concrete stress in some columns	Empty roof level water tank	Immediate - Now
2	High concrete stress in some columns	The imposed load in all areas on all levels must not exceed 1.5 kN/m ²	Immediate - Now
3	High concrete stress in some columns	Qualified Structural Engineer to review design, loads and stresses in all columns as part of a Detailed Engineering Assessment (DEA) (see scope below).	Immediate - Now
4	High concrete stress in some columns	Verify in-situ concrete strength by testing 100mm diameter cores taken from 4 no. columns (minimum). Qualified Structural Engineer to determine safe locations for coring. Prior to coring, the floor beams supported by the column should be propped through all levels to ground floor. The column reinforcement should be exposed to ensure that it will not be damaged during coring. Following coring, the column should be repaired using suitable repair mortar before de-propping the floor beams.	Immediate - Now

Item No.	Observation	Recommended Action Plan	Recommended Timeline
5	High concrete stress in some columns	Detailed Engineering Assessment to be completed.	6-weeks
6	High concrete stress in some columns	Provide calculations showing the structural adequacy of all columns. Provide results of concrete strength tests.	6-weeks
7	High concrete stress in some columns	Develop remediation measures as required by findings of DEA.	6-weeks
8	High concrete stress in some columns	Produce and actively manage a loading plan for all floor plates within the factory giving consideration to floor capacity and column capacity.	6-weeks
9	High concrete stress in some columns	Continue to implement load plan	6-months

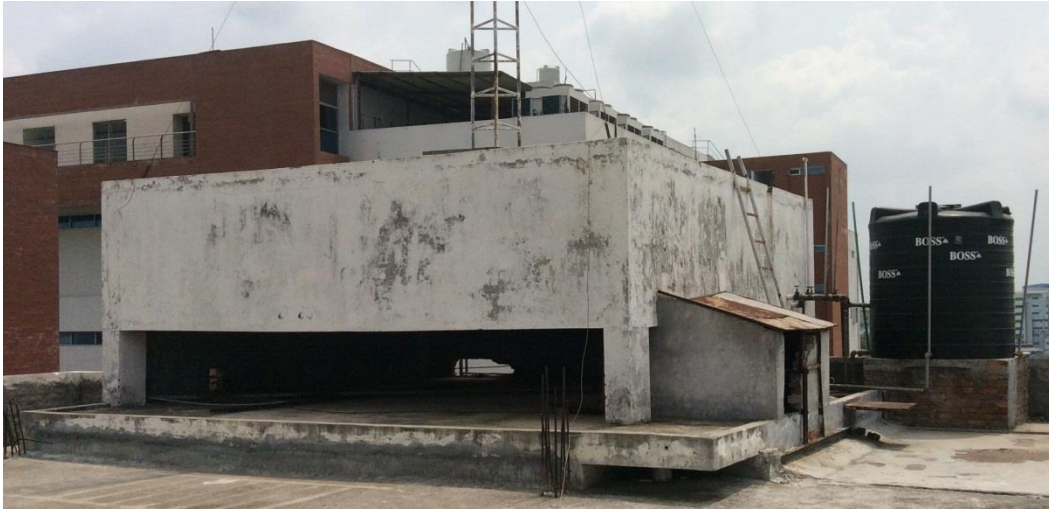
RC Tank over North East Stair Core

- Cursory calculations indicate that weight of roof-top concrete tank and its contents contribute significantly to the potential overloading of supporting columns, assuming typical concrete strength

Weight of Tank over North-East Stair Core

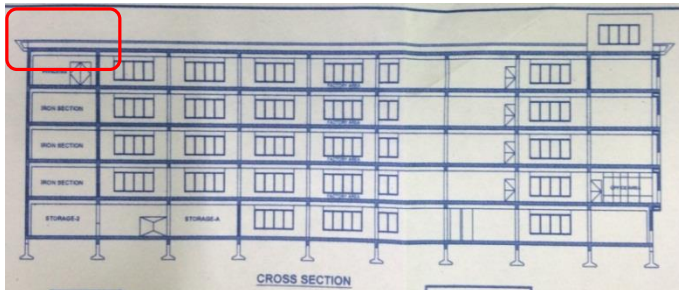
Permit Drawing Cross Section

- Permit drawings show a 5 storey building and Slab & Beam construction to Roof Slab, similar to typical floor slabs, and no water tank.
- As constructed:
 - Roof slab (A) has not yet been constructed over full building footprint
 - Flat Slab has been used in lieu of Slab & Beam construction to roof slab (A)
 - North-east stair core lid (B) is higher than roof slab (A)
 - Steel roof frames have been installed to dining and prayer rooms (C)
 - Area of the Fourth Floor Slab is acting as a roof to the Third Floor (D)
 - Two additional columns constructed at 4th Floor to support Flat Slab roof edges near raised stair core lid. These columns bear on 4th Floor beams.

Building permit drawings do not match as-built building details

Item No.	Observation	Recommended Action Plan	Recommended Timeline
10	Building permit drawings do not match as-built building details: * North-East Stair Core Lid and Concrete Roof * Metal roof frames to Dining and Prayer Rooms * Childcare and Residence Building	Building engineer to check, collect information and produce accurate and complete as-built documentation as part of the Detailed engineering Assessment (refer to item 1 above).	6-weeks
11	Building permit drawings do not match as-built building details: * North-East Stair Core Lid and Concrete Roof * Metal roof frames to Dining and Prayer Rooms * Childcare and Residence Building	Building Engineer to review as-built structure and if required, prescribe relevant structural improvements to ensure these meets BNBC requirements for stability, strength and serviceability under all gravity and lateral loads	6-weeks
12	Building permit drawings do not match as-built building details: * North-East Stair Core Lid and Concrete Roof * Metal roof frames to Dining and Prayer Rooms * Childcare and Residence Building	Building Engineer to develop accurate and complete as-built structural drawings	6-months

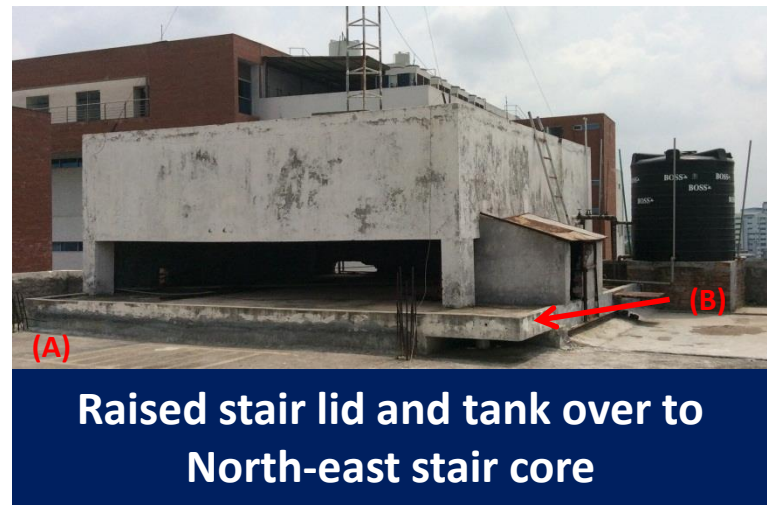
Raised stair lid and tank over to North-east stair core

- Minor differential movement observed to short infill walls between main roof slab (A) and stair core lid (B)
- No moment continuity exists between the two roof surfaces
- Two columns constructed to support main roof slab bear on Fourth Floor beams
- Minor flexural cracking observed to main roof slab (A) approximately between additional columns

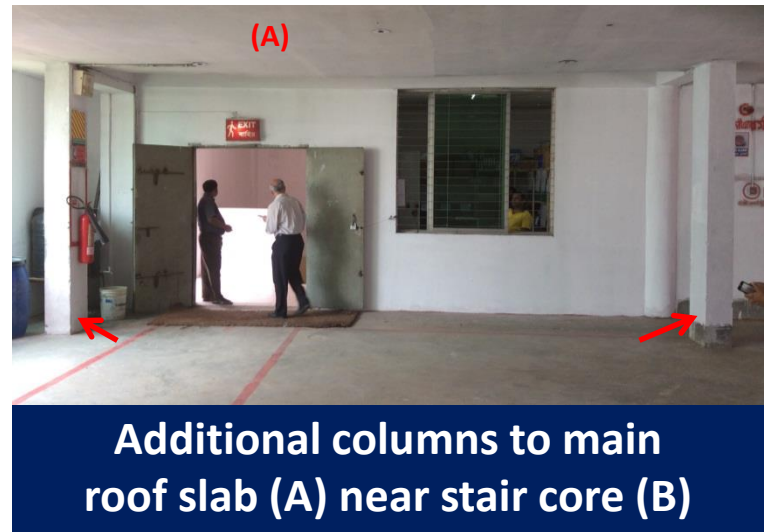
Additional columns to main roof slab (A) near stair core (B)

Building permit drawings do not match as-built building details

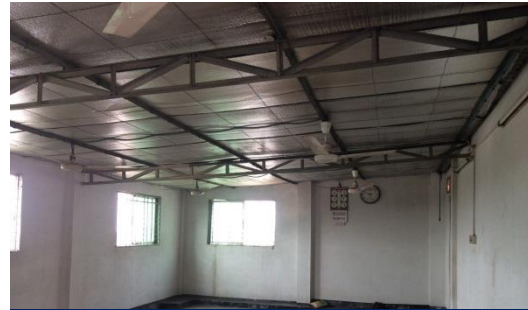
Small Prayer Room

- Light metal roof frames have been installed over columns and walls to prayer and dining areas
- Lateral stability and tie down details do not appear to be engineer-designed

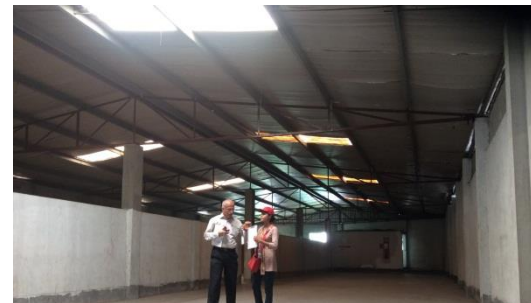
Large Prayer Room

Building permit drawings do not match as-built building details

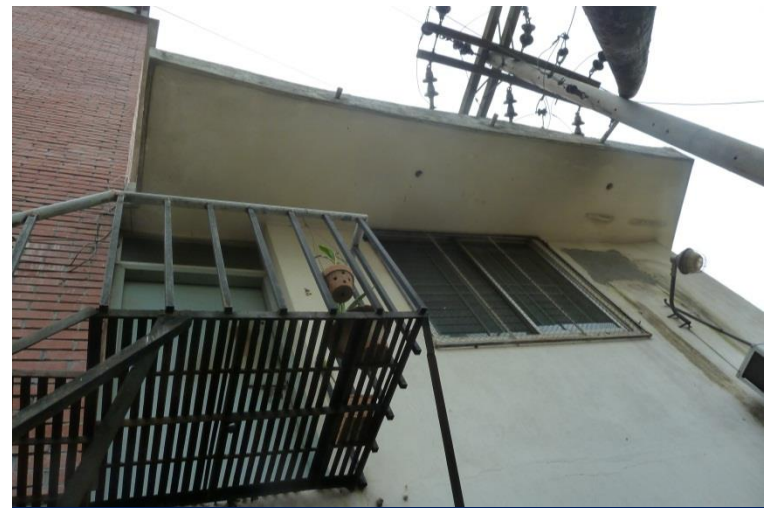
Two storey Residence and Child Care addition

- A two storey extension has been constructed, beyond what is shown on the Building Permit Drawings
- The extension appears to be structurally independent of the main factory building

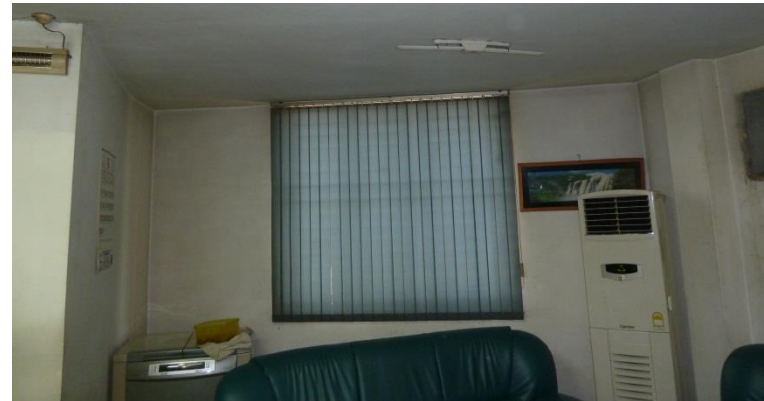
Residence Interior (1st Floor)

Building permit drawings do not match as-built building details

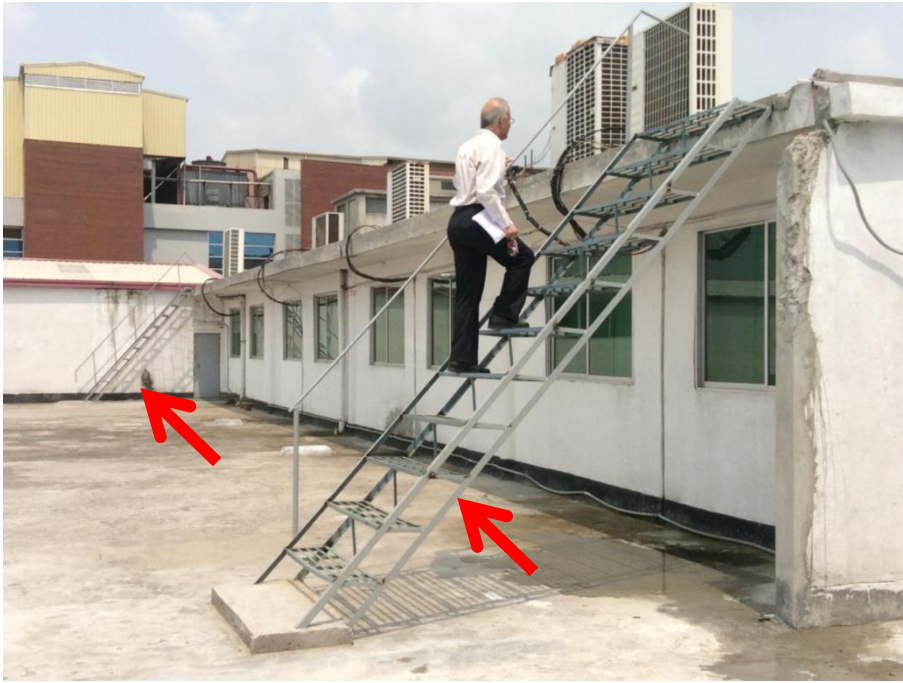
Stairs to Main Roof Slab

Structural integrity of light steel roof access stairs

- Two sets of stairs have been constructed to allow access from Fourth Floor to Roof
- A similar stair has been constructed to access the Residence over the Child Care room
- All stairs appear non-engineered and are constructed from welded light-gauge steel Equal Angle elements
- Element sizes, balustrade details and connection details appear non-engineered and potentially unsafe

13	Structural integrity of light steel stairs	Building Engineer to review as-built light steel stairs structure and if required, prescribe relevant structural improvements to ensure these meets BNBC requirements for stability, strength and serviceability	6-months
