Naba Knit Composite Ltd.

Zamgora EPZ Road Ashulia, Dhaka
(23.5609.7 N, 90.1711.2 E)

15th APRIL 2014

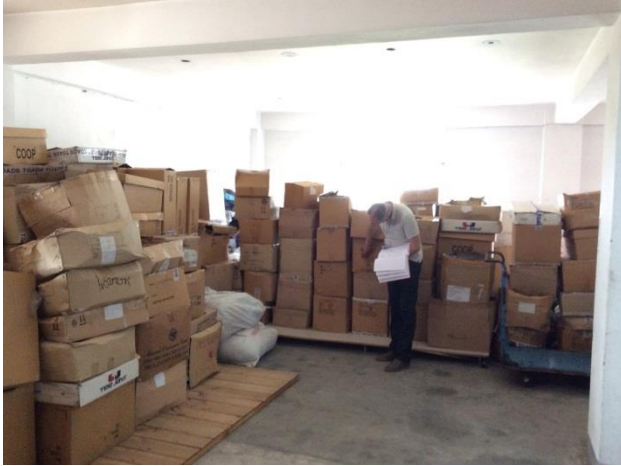
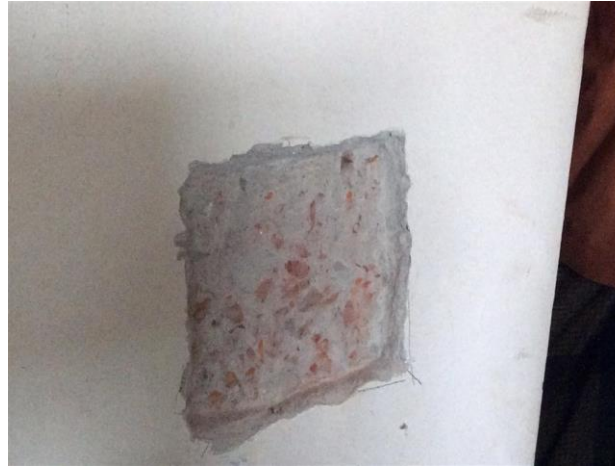
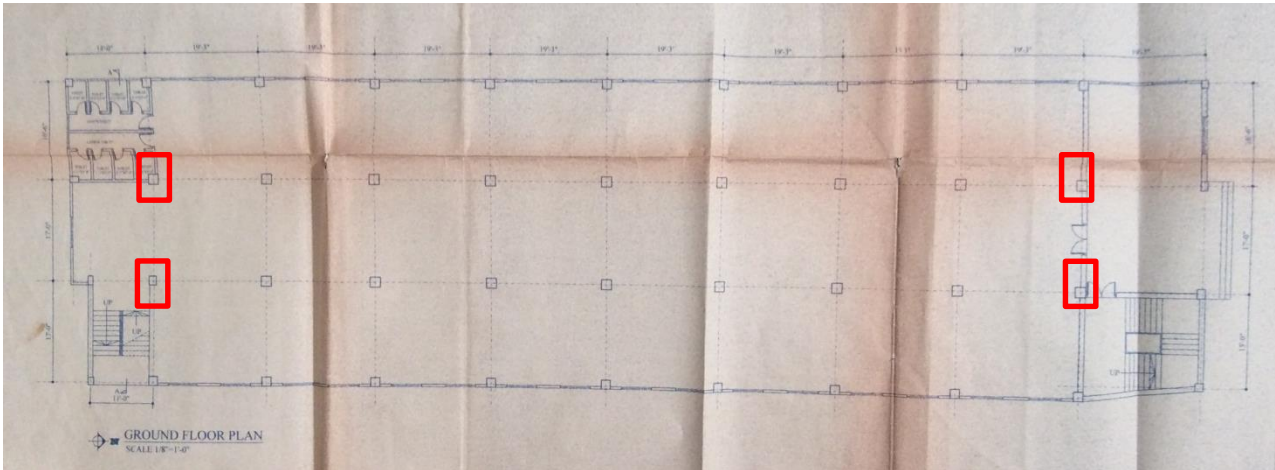
Stress in concrete columns

Areas with storage, masonry walls and increased floor finishes lead to significant axial stresses in columns.

Preliminary calculations show that finished garment storage and masonry walls around toilets lead to high column stresses in columns marked.

Concrete aggregate was observed as being brick at the ground floor.

The column capacity should be verified once the concrete strength in the identified columns has been confirmed at ground floor level.

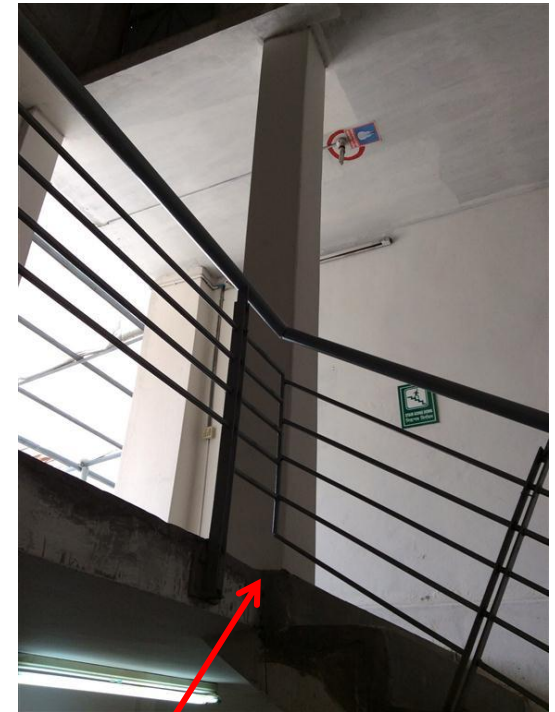
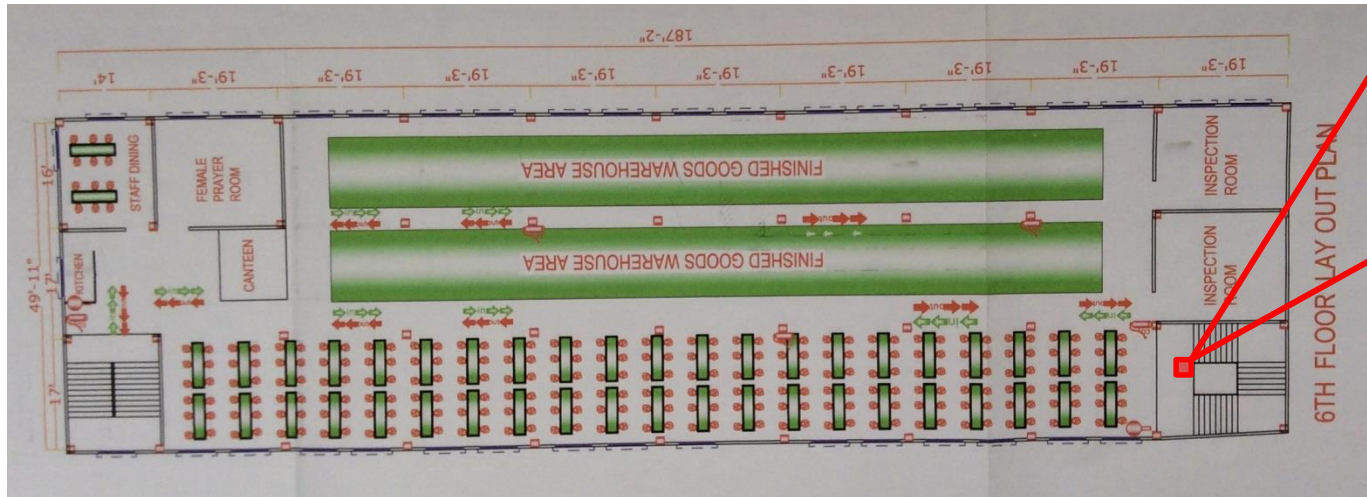
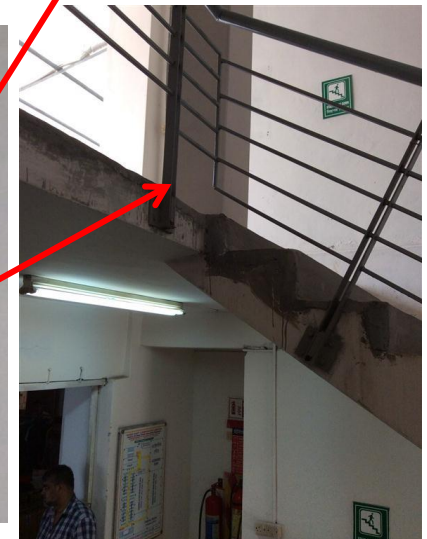
Additional column at sixth floor level

An additional column has been built between sixth floor and the roof over-run which is not shown on the layout drawings. This column is being supported by the stair landing at fifth floor only (no column below).

The column construction should be checked by removing the plaster finishes. The column design should be checked by the building engineer. The engineer should also confirm that the fifth floor slab is capable of supporting the column load.

17	Additional column between sixth floor and roof over-run	Engineer to confirm that the fifth floor slab is capable of supporting the column loads.	6-months

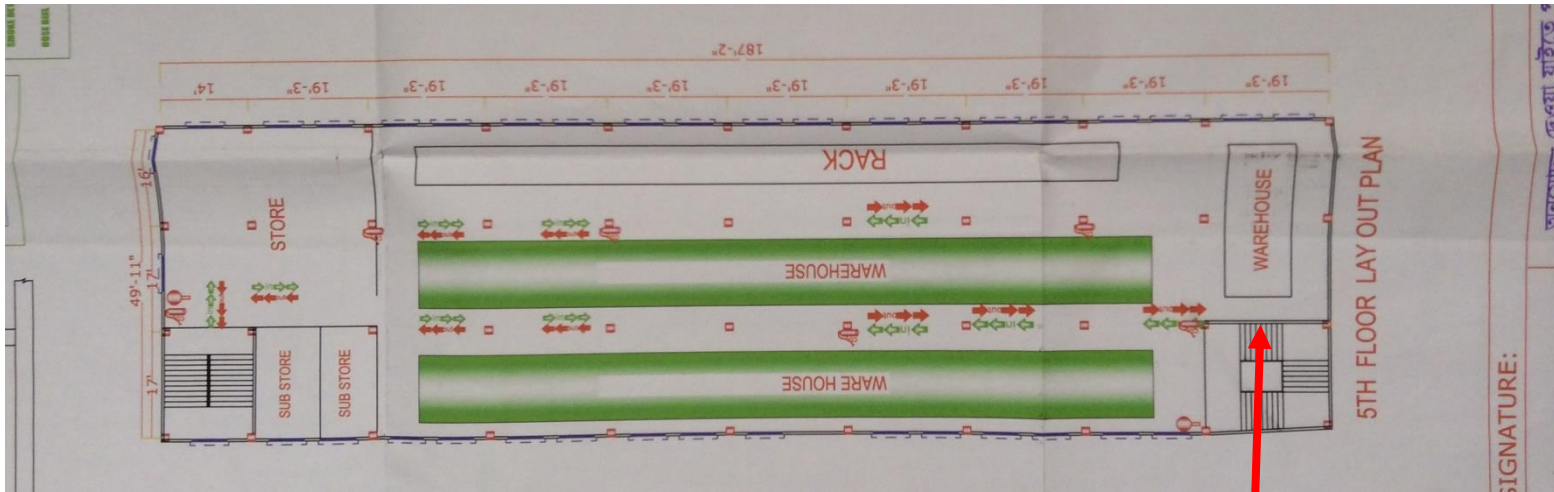
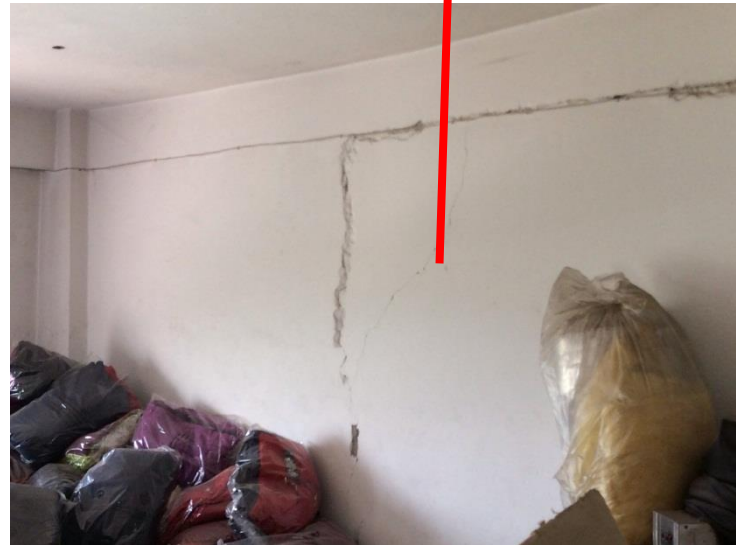
Brick wall on 5th floor

Cracking was observed in a masonry wall panel at fifth floor in the location shown.

There were no signs of distress below in either the slab or other similar masonry walls.

Crack to be monitored to ensure it does not grow and repaired to prevent on-going maintenance issues.

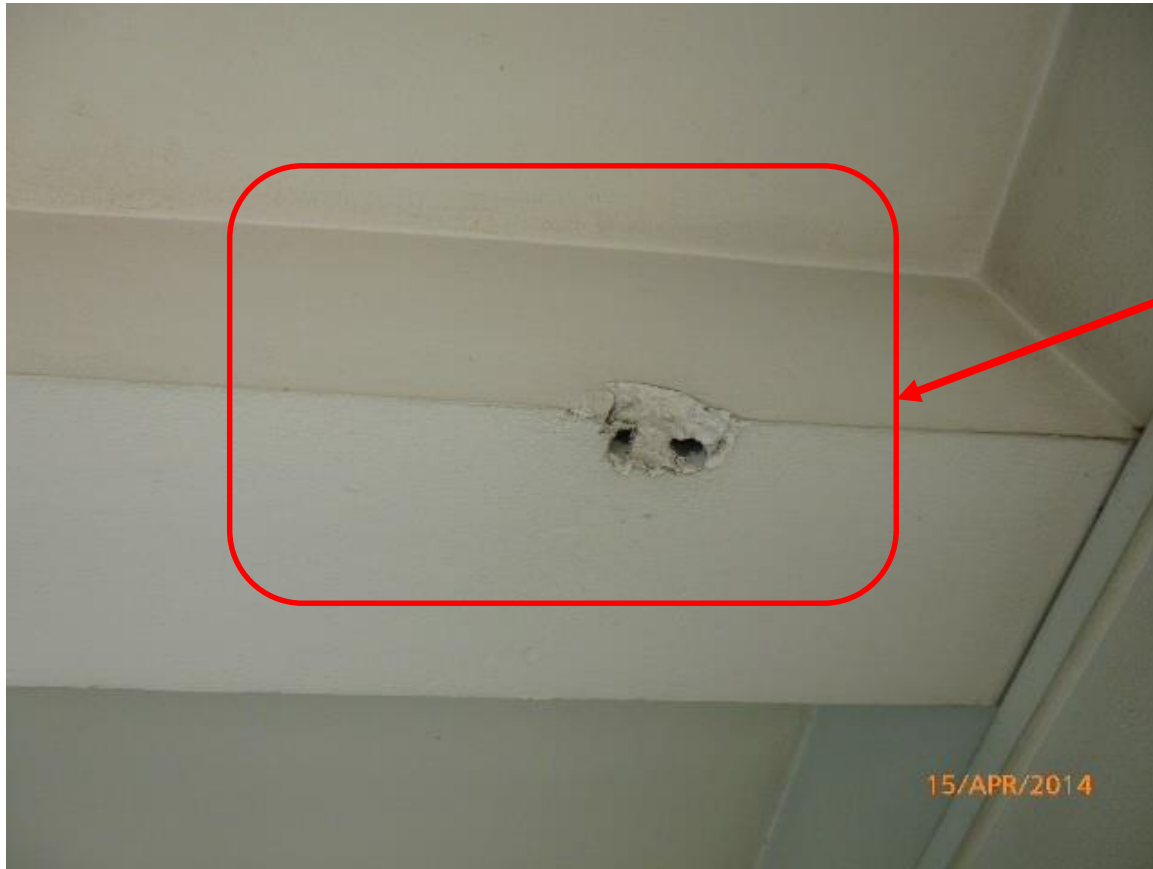
Services cast through beams

Conduits cast through third floor beam.

Building engineer to confirm that beam still has sufficient capacity for applied loads.

Conduit is not in use and could be grouted up.

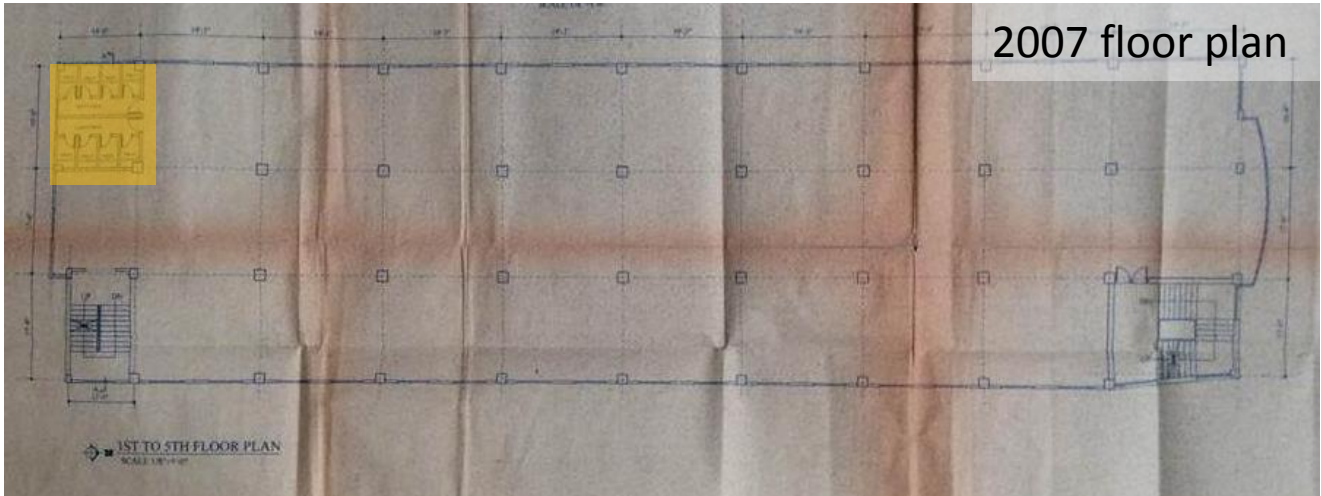
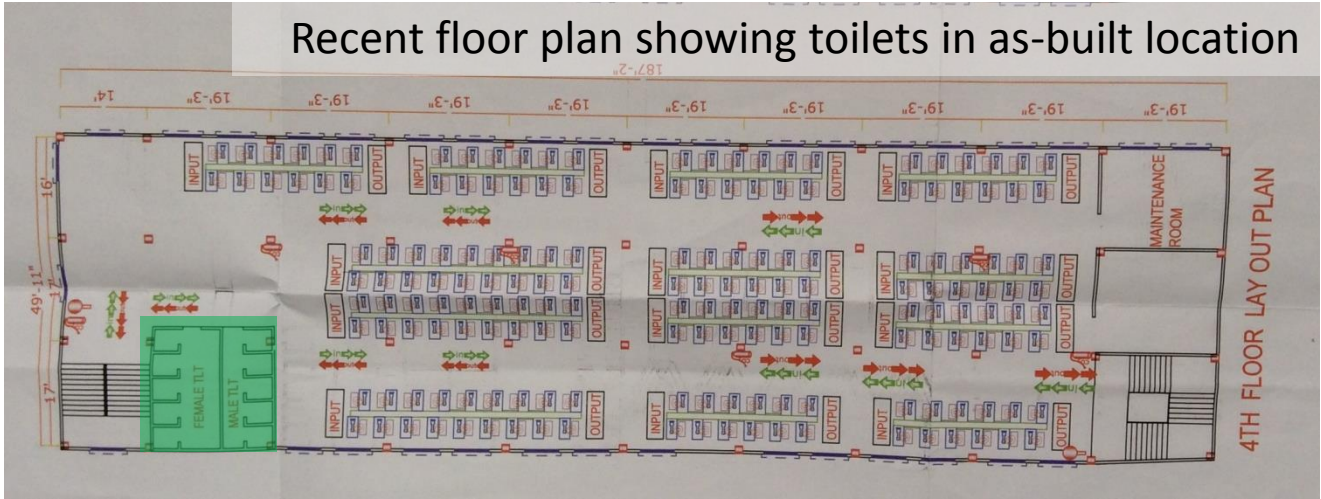
Toilet locations

Toilets are located in a different position to that shown on layout drawings from 2007 (note that the location is shown correctly on recent factory layout drawings).

Building engineer to confirm that structure supporting toilets has been designed for increased finishes load and masonry walls.

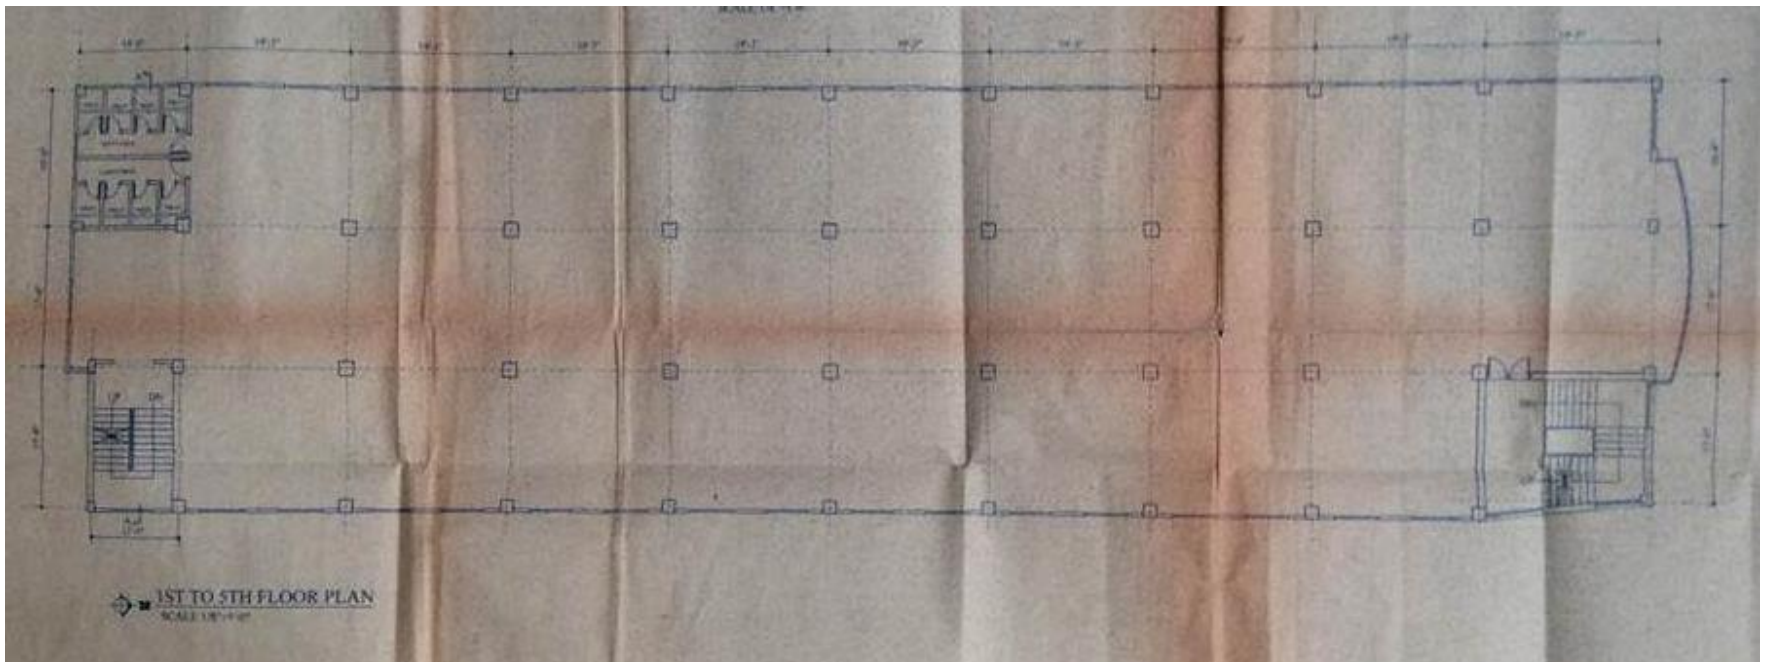
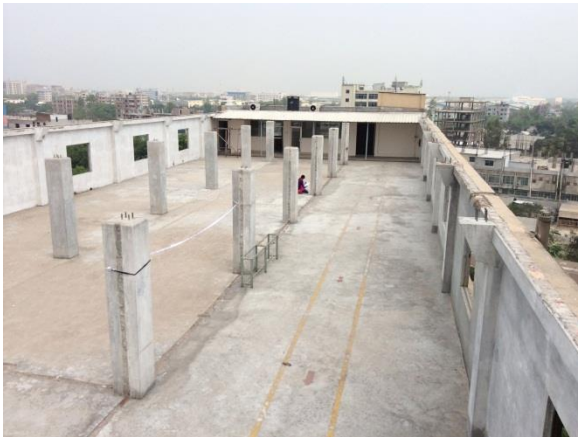
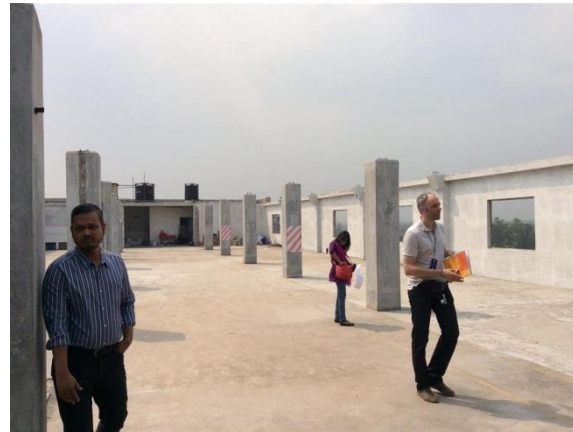
Drawings show additional bay

Structural drawings show total of 10x3 bays, frame constructed has 9x3 bays. Accurate as-built floor plans to be produced that reflect structural frame.

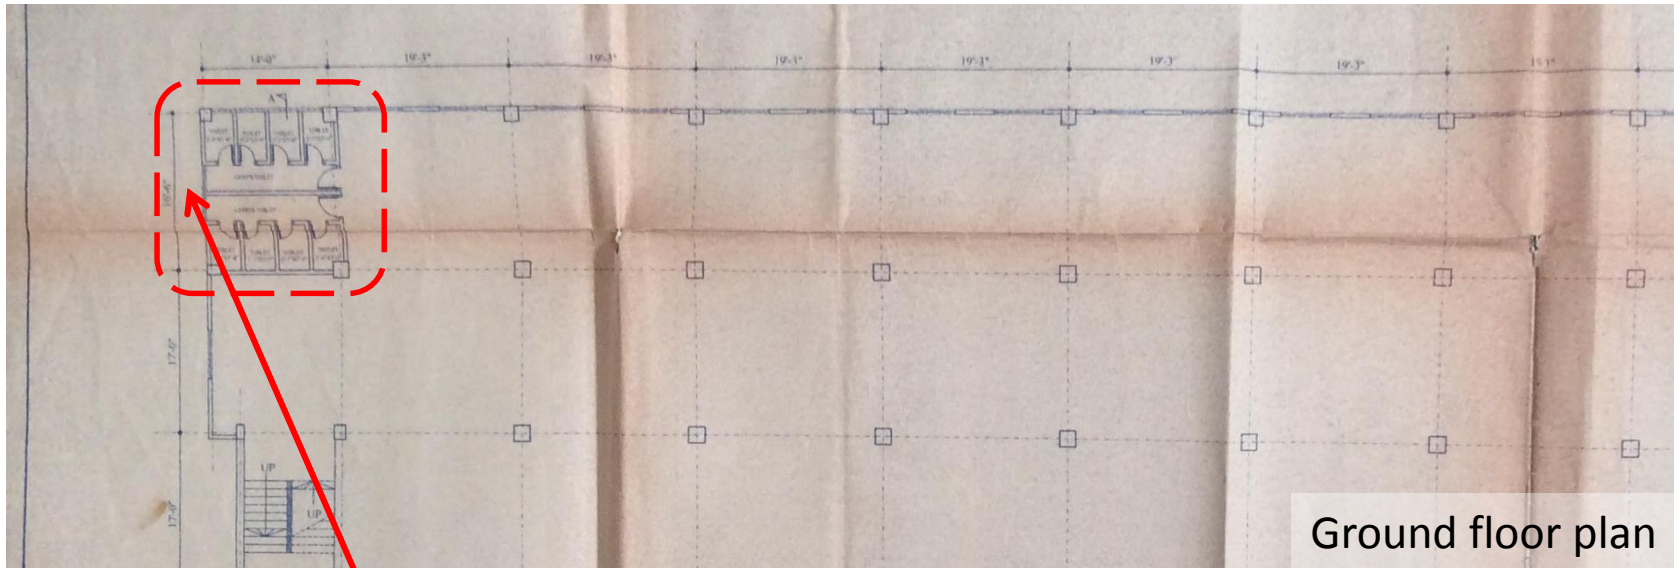
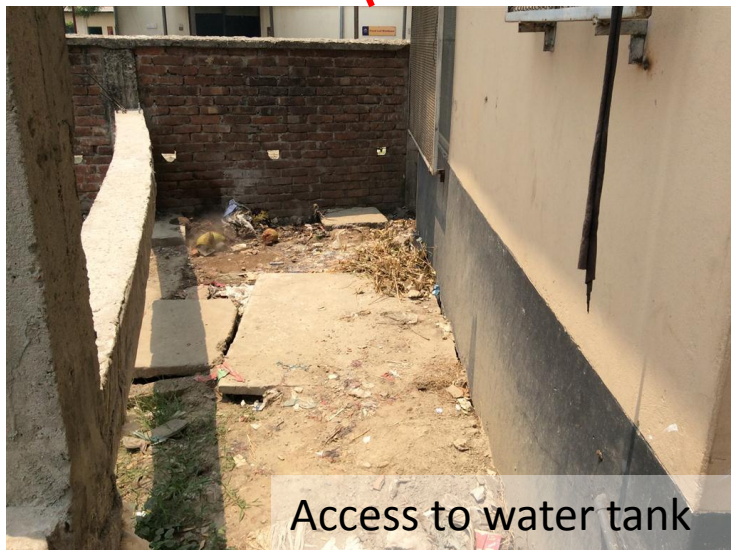
No record of basement water tank

There is a water tank below one bay of the ground floor slab. Water tank is reported to be approximately 4.5m sq., 4.5m deep

Engineer to confirm that excavation for water tank does no affect foundation design. Water tank should be recorded in accurate as built drawings that have been requested above.

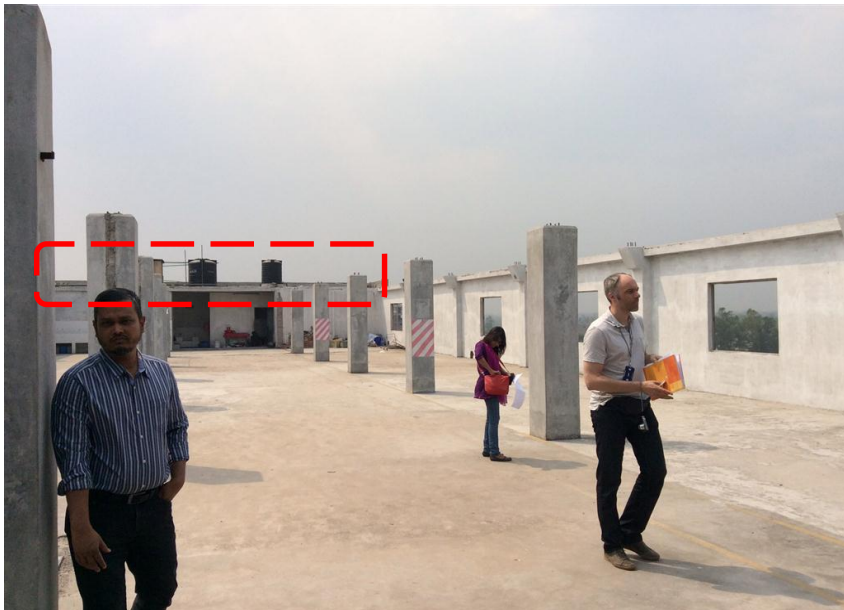
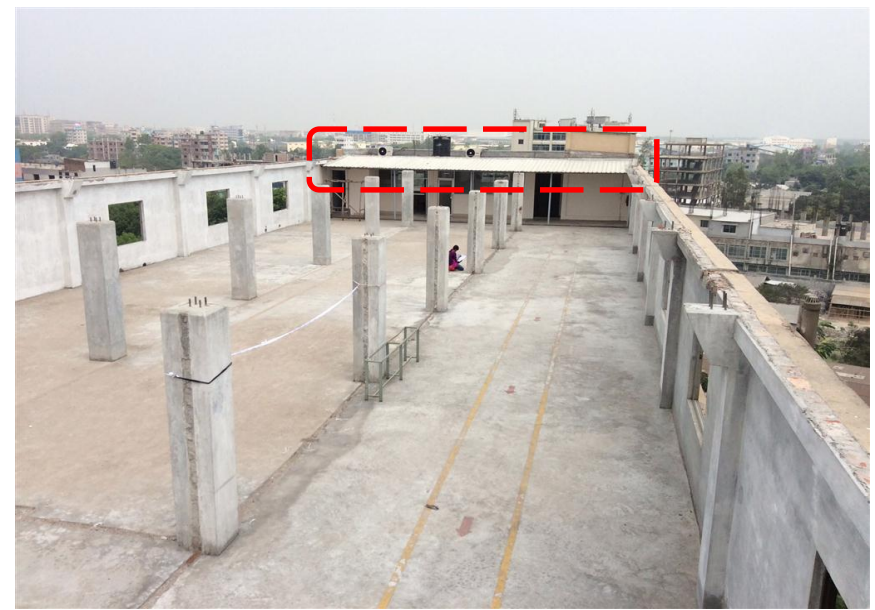
Former tin shed roof

We understand that a lightweight steel structure that previously covered the sixth floor (roof) was recently dismantled following advice from a qualified engineer. The RC flat slab roof at either end of the sixth floor (highlighted) is undocumented.

The masonry façade is cantilevering above slab level. An engineering check should be carried out to check it has sufficient capacity under horizontal wind load.

The building permit is for 5 stories only. The roof should not be replaced unless an engineering assessment of the current structure is carried out and the relevant permits are granted. Rainwater Drainage and a protective barrier to be installed to prevent water damage to structure
