# Al Islam Textile Ltd.

9 Kornopara, Savar, Dhaka-1340  
(23.824207N, 90.256342E)

27 APRIL 2014

# Observations

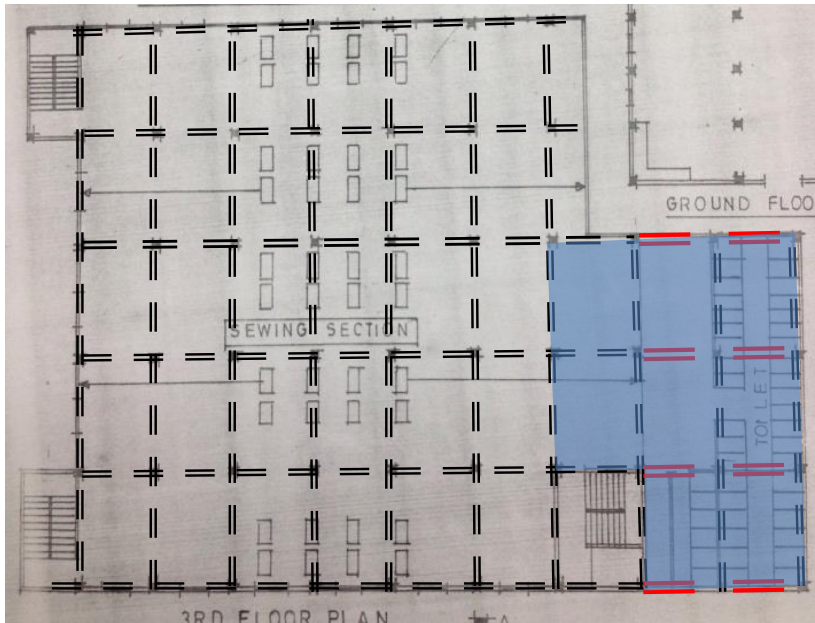
# Item 1 observation

Column loads in excess of design loads

Preliminary calculations suggest high stresses in columns.

Empty or relocate water tanks above area shaded in blue at roof level. Live load in area shaded in blue to maintained below  $1\text{kN/m}^2$  at all levels (ie toilet access only – no production or storage) until DEA proves adequacy of column design

| Item No. | Observation | Recommended Action Plan | Recommended Timeline |
|---|---|---|---|
| 1 | Column loads in excess of design loads<br>Verify concrete strengths in columns for all columns | NO further levels to be built. Water tanks at roof level in blue area should be removed or relocated | <b>Immediate - Now</b> |
| 2 | Column loads in excess of design loads<br>Verify concrete strengths in columns for all columns | Live load in area shaded blue to be maintained below 1kN/m2 at all floor levels (ie toilet access only – no production or storage) | <b>Immediate - Now</b> |
| 3 | Column loads in excess of design loads<br>Verify concrete strengths in columns for all columns | Factory Engineer to review design, loads and columns stresses of all columns. | <b>Immediate - Now</b> |
| 4 | Column loads in excess of design loads<br>Verify concrete strengths in columns for all columns | Verify insitu concrete stresses by 100mm diameter cores from minimum 4 columns in the building part from 1996 and 2 columns in the building part from 2011 (recent extension). All cores to be taken at Ground Floor. | <b>Immediate - Now</b> |
| 5 | Column loads in excess of design loads<br>Verify concrete strengths in columns for all columns | A Detail Engineering Assessment (DEA) of Factory to be commenced, see attached Scope | <b>Immediate - Now</b> |

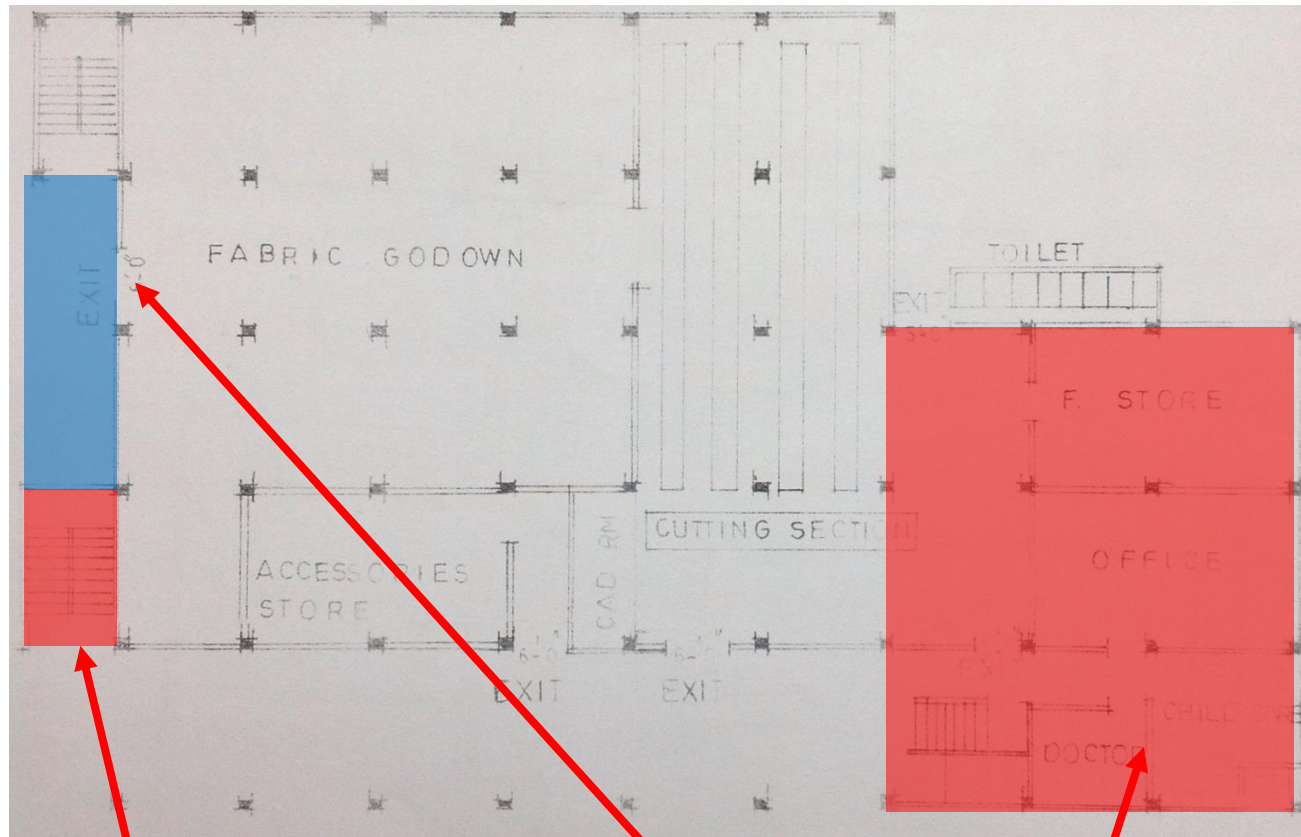
# Item 2 observation

Documentation issues, Steel stair design and additional building was not shown.

No structural information was provided for the areas shown.

The owner informed us that the second and third floors were constructed using the original designs.

The steel shed recently built for storage (not shown in this sketch) is also not documented

No structural documentation of steel stair

No structural documentation of Generator room

No structural documentation of the 4 storey Building extension

| Item No. | Observation | Recommended Action Plan | Recommended Timeline |
|---|---|---|---|
| 9 | Documentation issues<br>Steel stair design and additional building was not shown | Building engineer to check, collect information and produce accurate and complete as-built documentation as part of DEA | 6-weeks |
| 10 | Documentation issues<br>Steel stair design and additional building was not shown | As-built documentation to be complete. | 6-months |

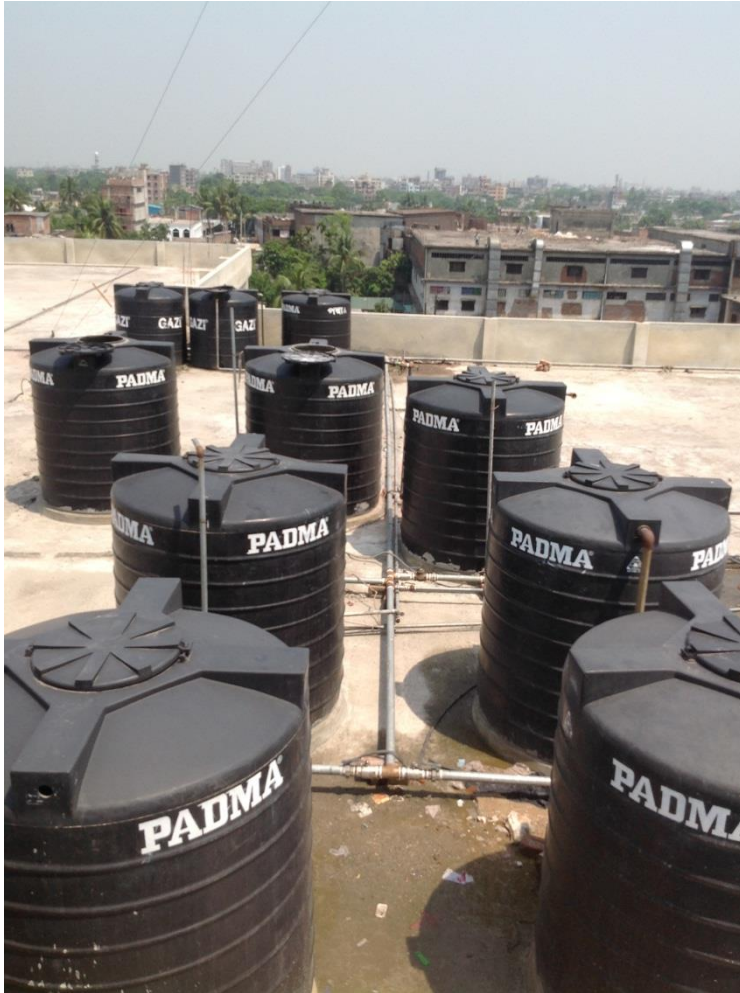
# Item 3 observation

localized high loading from water tanks

Water tanks observed on roof.

- 3no. 2000 lt. tanks by parapet
- 7no. 3000 lt. tanks by stairwell

Hairline cracking observed on underside of supporting beam.

| Item No. | Observation | Recommended Action Plan | Recommended Timeline |
|---|---|---|---|
| 11 | localized high loading from water tanks | Reduce water storage on the roof as much as possible – see Item 1 | Immediate - Now |
| 12 | localized high loading from water tanks | Disperse cluster of water tanks and place one tank per supporting column. | Immediate - Now |
| 13 | localized high loading from water tanks | As a result of the DEA the building engineer may advise where the water storage can be placed safely without distressing any structural elements (slabs / beams and columns). | 6-weeks |

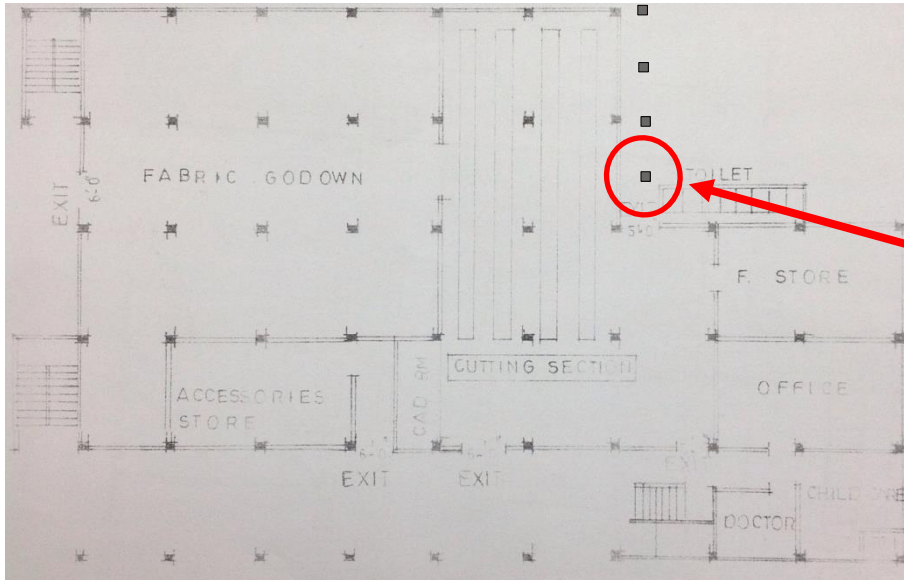
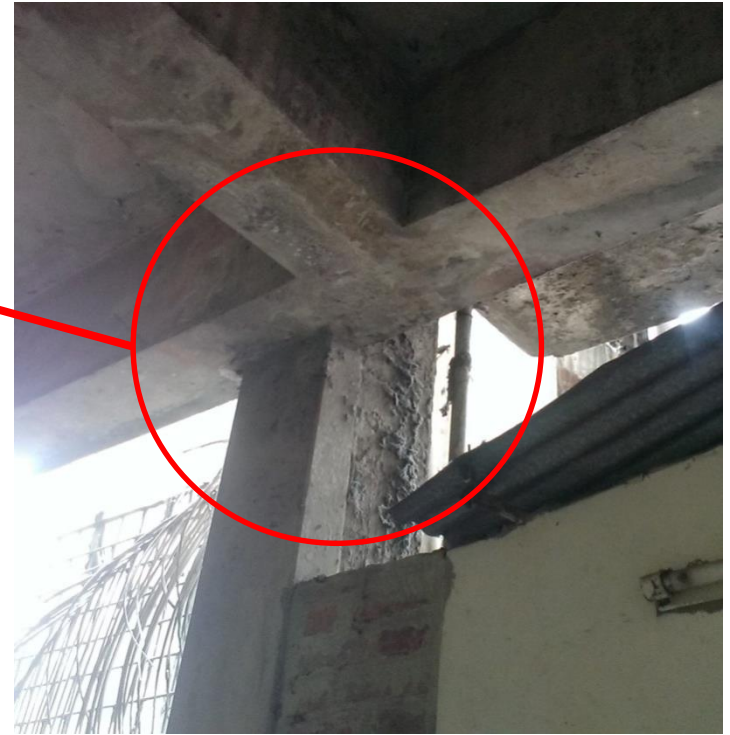
# Item 4 observation

Offset column/beam connection detail is a concern.

Concern with connection detail between primary and secondary beams with columns – limited bearing

Columns offset from beam centerline

| Item No. | Observation | Recommended Action Plan | Recommended Timeline |
|---|---|---|---|
| 14 | Offset column/beam connection detail is a concern | Carry out detail calculation for offset beam/column connection and provide additional column to foundation level if necessary | 6-weeks |

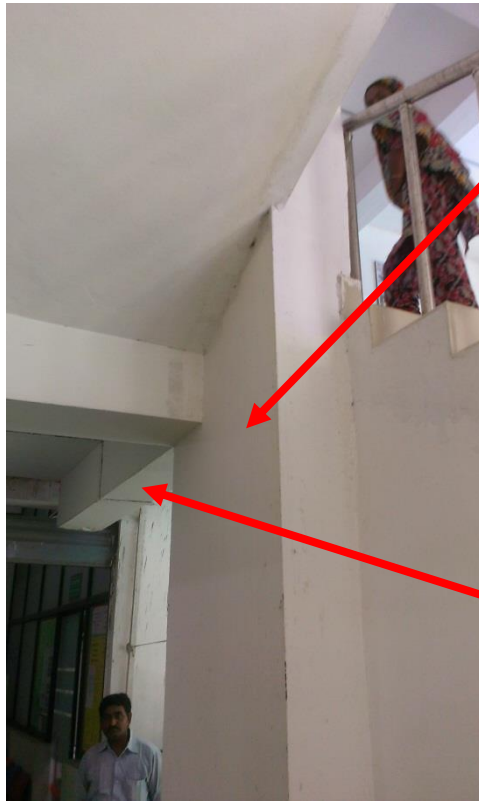
# Item 5 observation

Cantilever landing between ground and first floor stairwell.

Supporting column  
subjected to  
bending from  
cantilever moment

Cantilever  
beam

| Item No. | Observation | Recommended Action Plan | Recommended Timeline |
|---|---|---|---|
| 15 | Cantilever landing between ground and first floor stairwell | Building engineer to check the capacity of the supporting column and propose additional reinforcements and stability system, if required. | 6-weeks |

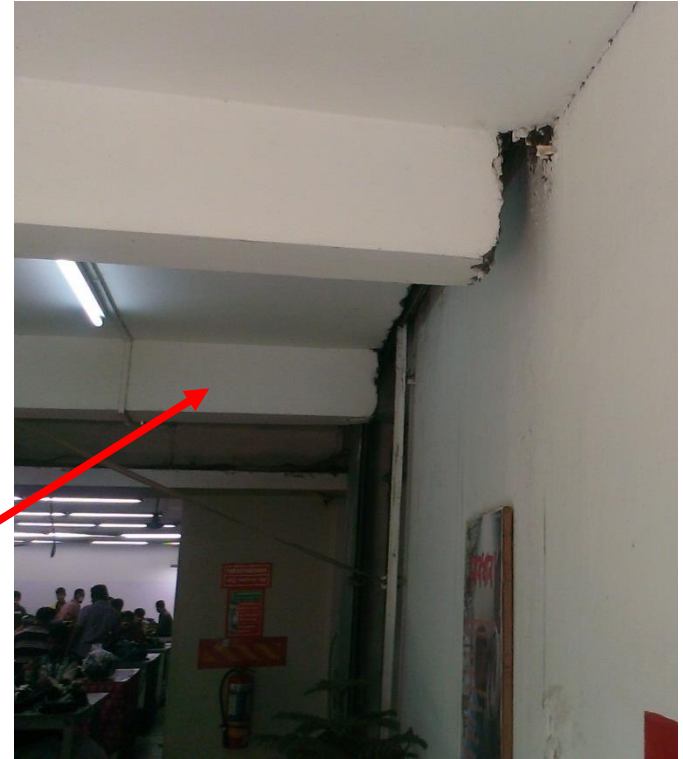
No support provided at one end of landing between ground and first floor stairwell. The landing acts as a cantilever structure supported by a central beam.

No support to beams

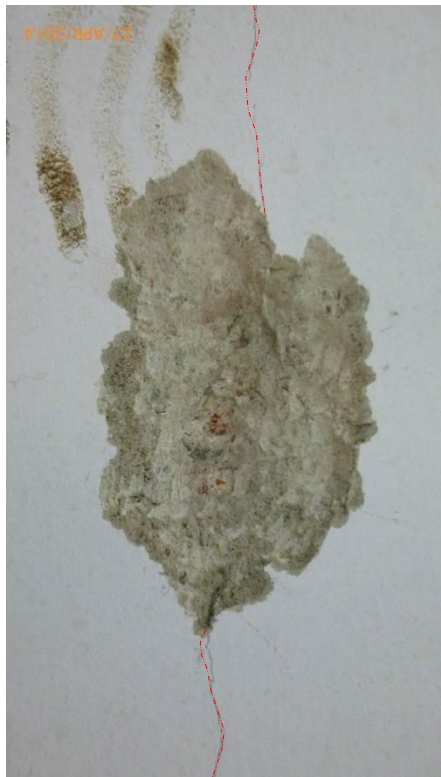
Hairline cracks in beams on the underside of all floors.

Numerous hairline cracks observed in beams on **all** floor levels. Some appeared to be painted over at first and second floor level.

Two cracks inspected by removal of plaster

Crack 1  
Did not run through plaster layer

| Item No. | Observation | Recommended Action Plan | Recommended Timeline |
|---|---|---|---|
| 17 | Hairline cracks in beams on the underside of all floors | Continue to monitor all cracks. | <b>6-weeks</b> |
| 18 | Hairline cracks in beams on the underside of all floors | If cracks increase in size or length sections of plaster finish to be removed to investigate if cracks penetrate the building structure. | <b>6-weeks</b> |
| 19 | Hairline cracks in beams on the underside of all floors | Building Engineer to carry out design check on beams to confirm that these cracks are non-structural. | <b>6-months</b> |

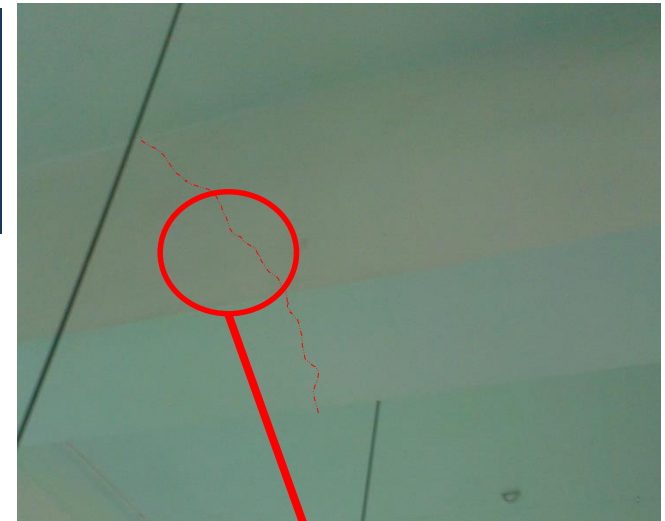
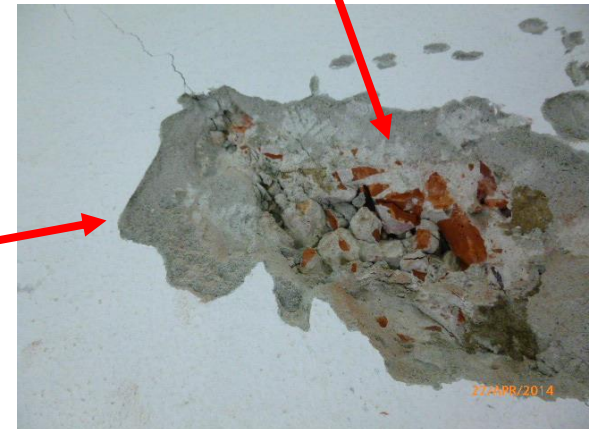
Crack 2  
Ran through plaster through to other side of beam. Occurred due to large cluster of poorly mixed aggregate (honeycomb cluster)

| Item No. | Observation | Recommended Action Plan | Recommended Timeline |
|---|---|---|---|
| 16 | Hairline cracks in beams on the underside of all floors | Repair honeycomb cluster as advised by building engineer | <b>Immediate - Now</b> |

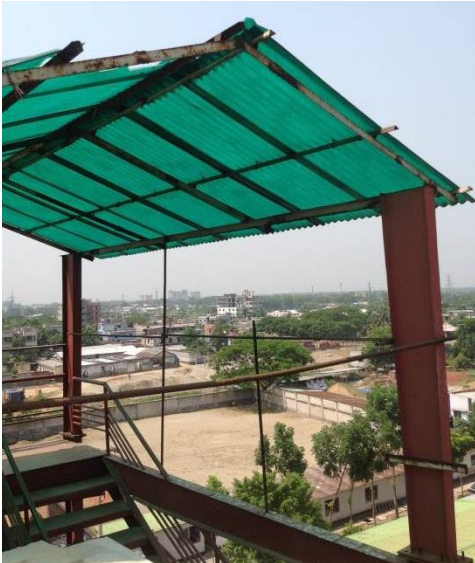
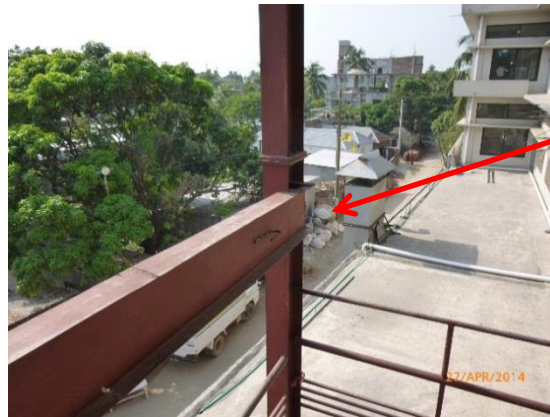
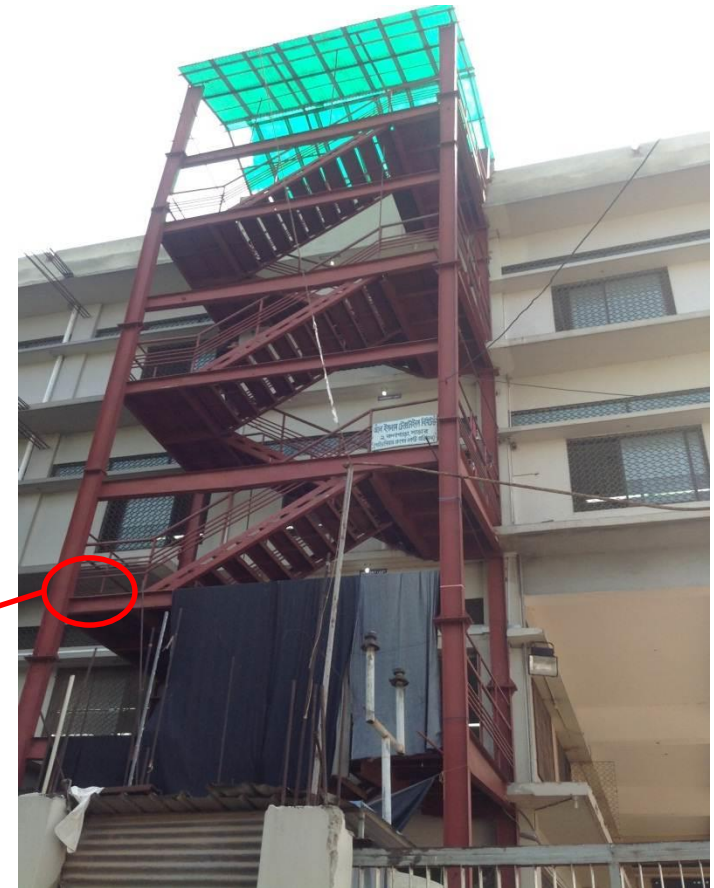
# Item 7 observation

## Stability of steel staircase

Beam to column connections not meeting at centerlines.  
Interaction between / connection of steel structure to building unclear; no evidence of building providing restraint to the steel structure  
No bracing provided to provide lateral stability.  
No documentation provided on design.

| Item No. | Observation | Recommended Action Plan | Recommended Timeline |
|---|---|---|---|
| 21 | Stability of steel staircase | Steel structure design should be checked to support code vertical and wind loads by the Building Engineer and strengthened if necessary. | <b>6-weeks</b> |
| 22 | Stability of steel staircase | Provide proper fixation of steel structure to building | <b>6-weeks</b> |
| 23 | Stability of steel staircase | Strengthenings / modifications to be carried out in accordance to design by building engineer. | <b>6-months</b> |

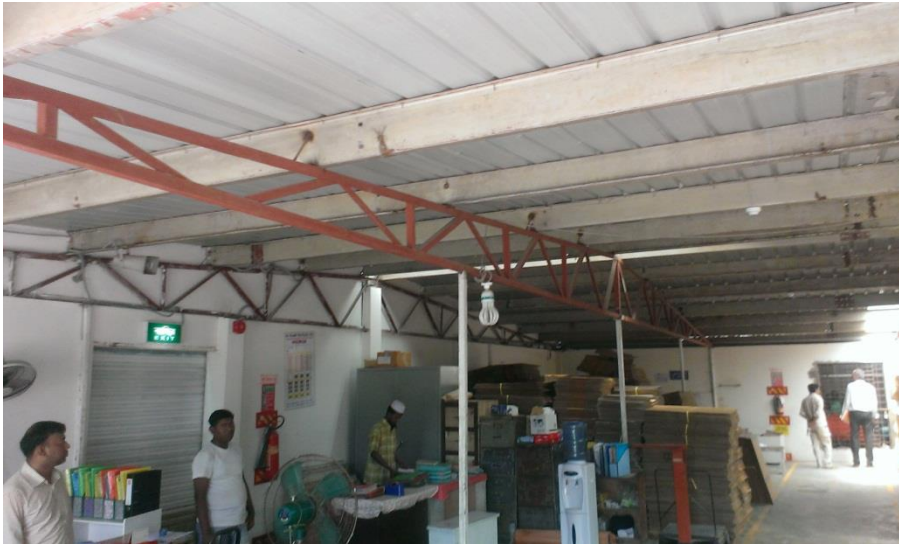
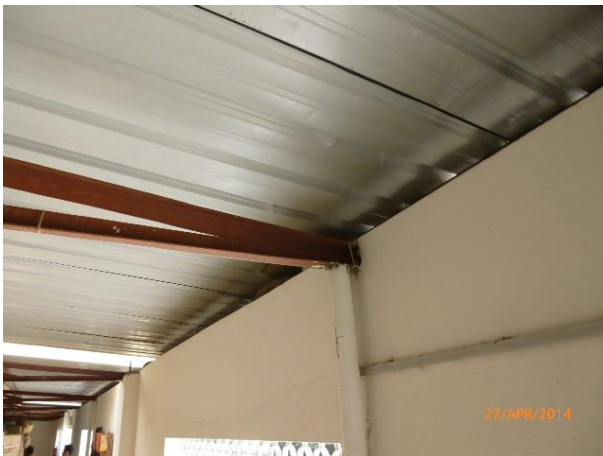
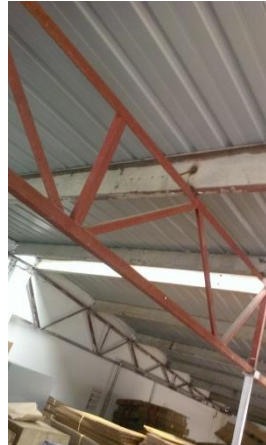
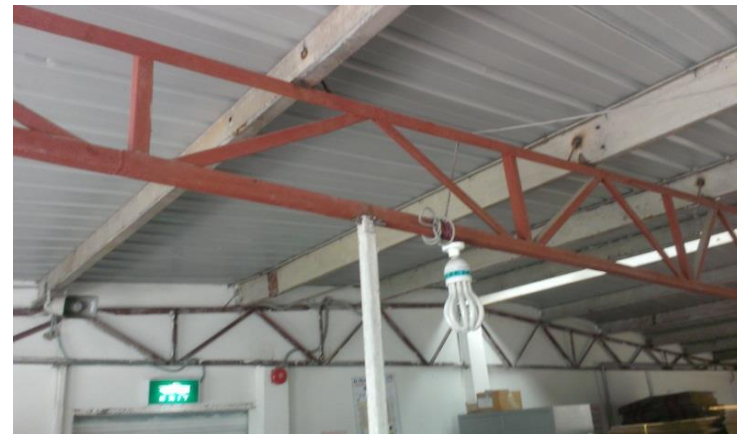
# Item 8 observations

Non engineered structure shed.

Non engineered truss supports.  
- Bottom chord is supported directly on the column head.

Internal columns are slender and not restrained at the top.

Purlins not adequately secured to top boom of truss.

No stability provided for wind loads  
(horizontal / vertical bracings missing)

| Item No. | Observation | Recommended Action Plan | Recommended Timeline |
|---|---|---|---|
| 24 | Non engineered structure shed | Building engineer to check the structures and propose additional reinforcements of stability system. | 6-weeks |
| 25 | Non engineered structure shed | Strengthening as instructed by building engineer or removal of shed. | 6-months |

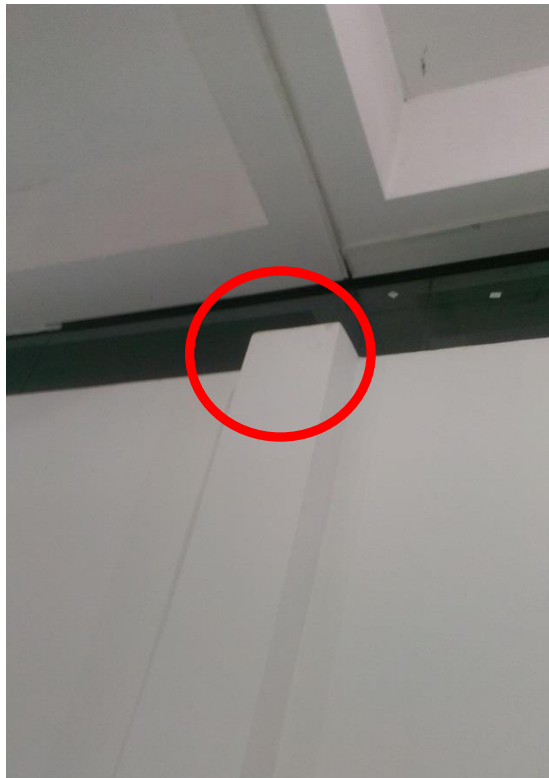
Ground floor between  
childcare and medical room  
(Internal wall)

Some piers of internal / external brick wall partitions / façade not extending to soffit of beam and by that not horizontally restrained at their top. Reduced resistance to horizontal loads (e.g. wind loads)

| Item No. | Observation | Recommended Action Plan | Recommended Timeline |
|---|---|---|---|
| 26 | Brick columns/Piers not extending to soffit of beam at ground level between medical room and childcare, at first floor level between work area and stairwell and external façade on first floor level in office area | Building Engineer to review piers | 6-weeks |
| 27 | Brick columns/Piers not extending to soffit of beam at ground level between medical room and childcare, at first floor level between work area and stairwell and external façade on first floor level in office area | If required, extend piers to soffit of second floor beam or provide other adequate means for making the walls resistant to wind loads. | 6-months |

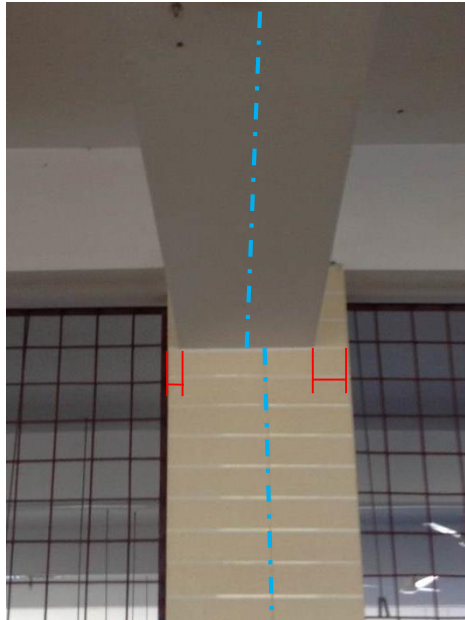
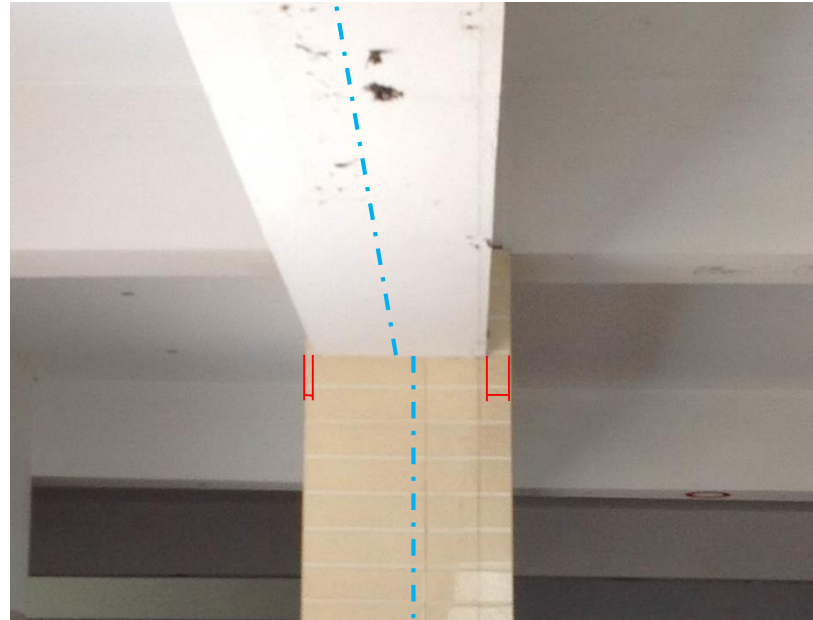
# Item 10 observation

Eccentric connections between beams and columns observed at third floor level.

Several columns were observed not to line up with the center of the beams they intersected with.

This eccentricity should be included in any further analysis of the structure

| Item No. | Observation | Recommended Action Plan | Recommended Timeline |
|---|---|---|---|
| 28 | Eccentric connections between beams and columns observed at third floor level | Address as part of the general DEA and take eccentricity into account when doing the column checks. | 6-weeks |

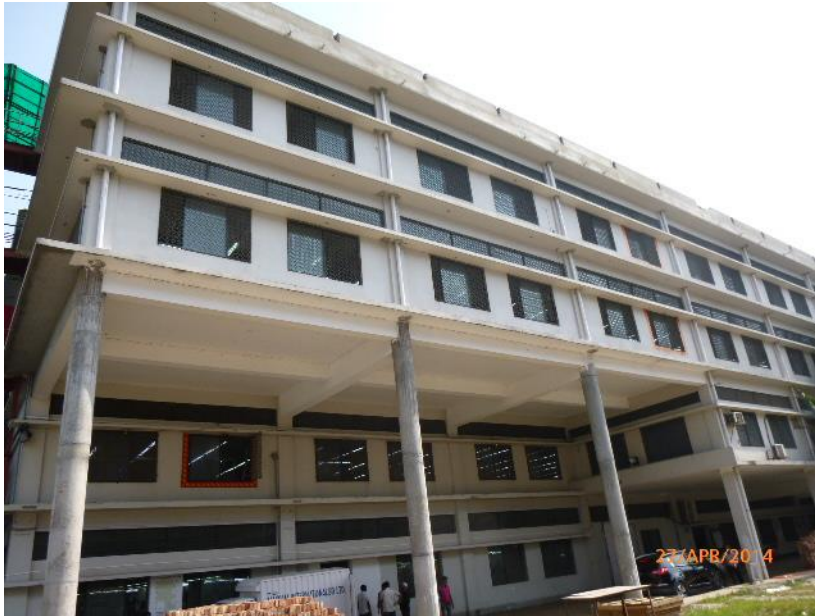
# Item 11 observation

Columns exposed to impact

**Impact protection not provided to columns on south elevation. Columns are susceptible to impact loading from vehicles.**

| Item No. | Observation | Recommended Action Plan | Recommended Timeline |
|---|---|---|---|
| 29 | Impact protection to columns | Building Engineer to review column design and potential for vehicle impact to columns on south elevation. If appropriate impact protection to be provided. | 6-weeks |

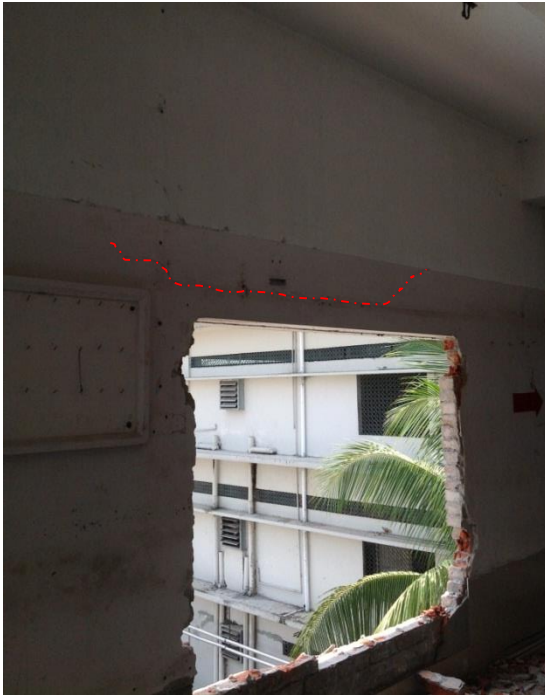
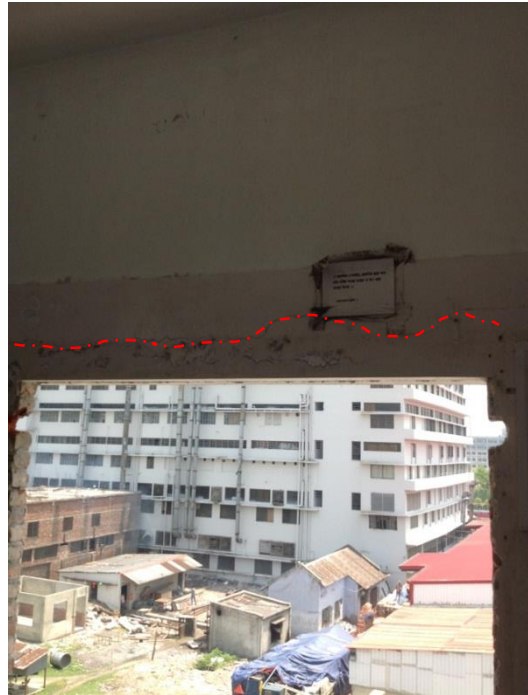
# Item 12 observation & actions

Cracking in lintels on third floor

Cracking observed at top of lintels in third floor where window frames were removed. Floor is currently under construction. Management assured us that the façade panels are to be removed and replaced within the next six weeks => no further actions required
