# Cherry Intimate Ltd

Plot No 105 Dhaka Export Processing Zone, Ganakbar, Ashulia, Savar, Dhaka  
Bangladesh  
(23.952002N, 90.266265E)  
04 May 2014

# Observations

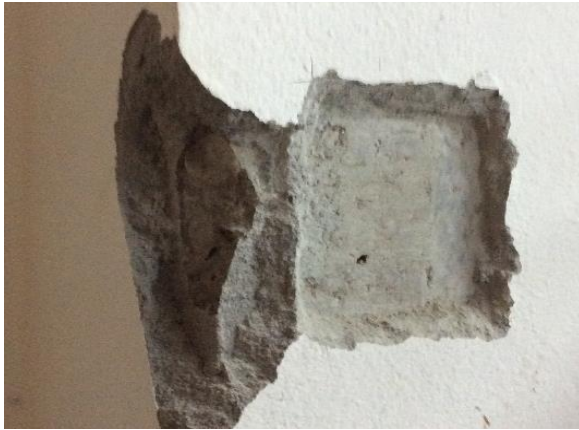
Column investigations indicated stone aggregate. Reinforcement was investigated using a ferros scanner. Cursory calculations indicate that the working stress in the columns are at a high level.

Tested Column showing brick aggregate.

| Item No. | Observation | Recommended Action Plan | Recommended Timeline |
|---|---|---|---|
| 1 | Stress levels in Columns | Factory Engineer to review design, loads and columns stresses in all columns. | Immediate - Now |
| 2 | Stress levels in Columns | Verify insitu concrete strength either by 100mm diameter cores from 4 columns or existing cylinder strength data. Verify grade of steel reinforcement used. | Immediate - Now |
| 3 | Stress levels in Columns | A Detailed Engineering Assessment of Factory to be commenced, see attached Scope. | Immediate - Now |

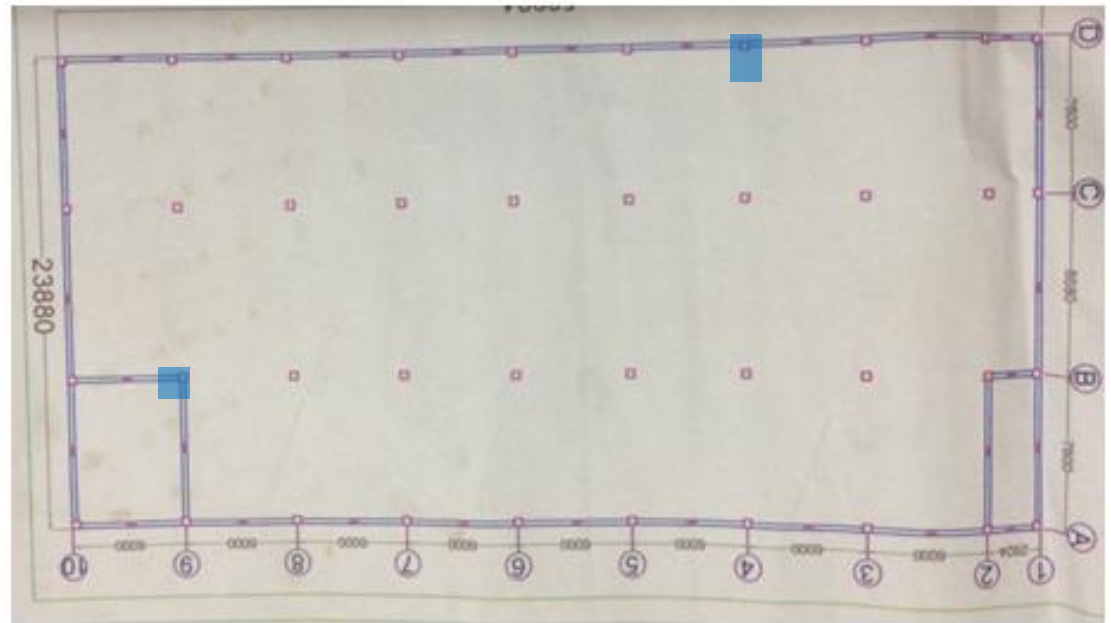
Ground Floor: Floor Plan

Tested Columns

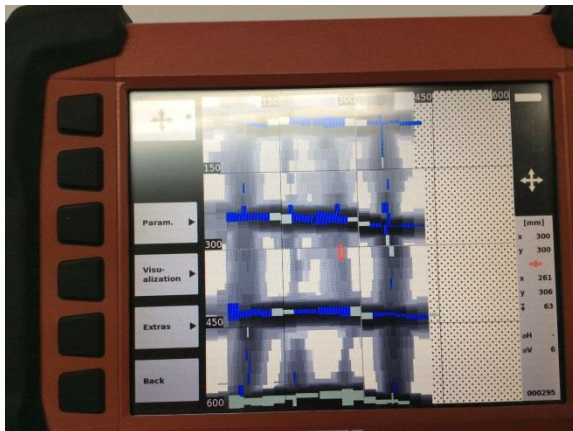
Reinforcement investigation

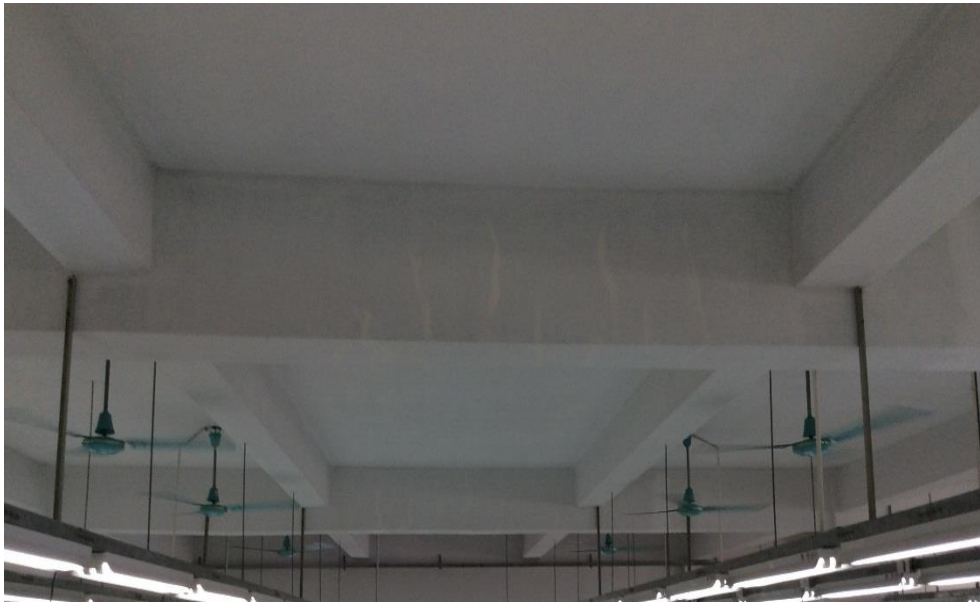
Numerous cracks and evidence of crack repair was observed in primary and secondary beams at every Floor level.

Cracks Repaired to side of the beam

| Item No. | Observation | Recommended Action Plan | Recommended Timeline |
|---|---|---|---|
| 8 | Numerous cracks and evidence of crack repair in primary and secondary beams | Building Engineer to investigate if the cracking is structural or exists only in the render and to carry out flexural and shear checks on the beams, as part of the Detailed Engineering Assessment. | 6-weeks |
| 9 | Numerous cracks and evidence of crack repair in primary and secondary beams | Carry out any remedial work as directed by the Building Engineer. | 6-months |

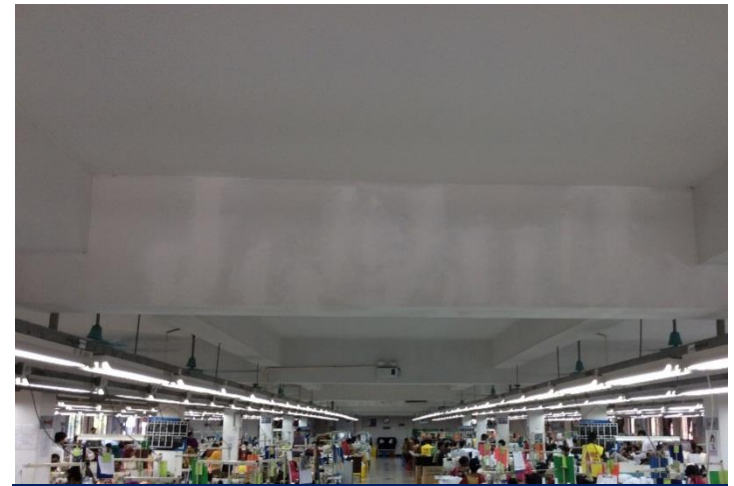
Cracks Repaired to side of the beam

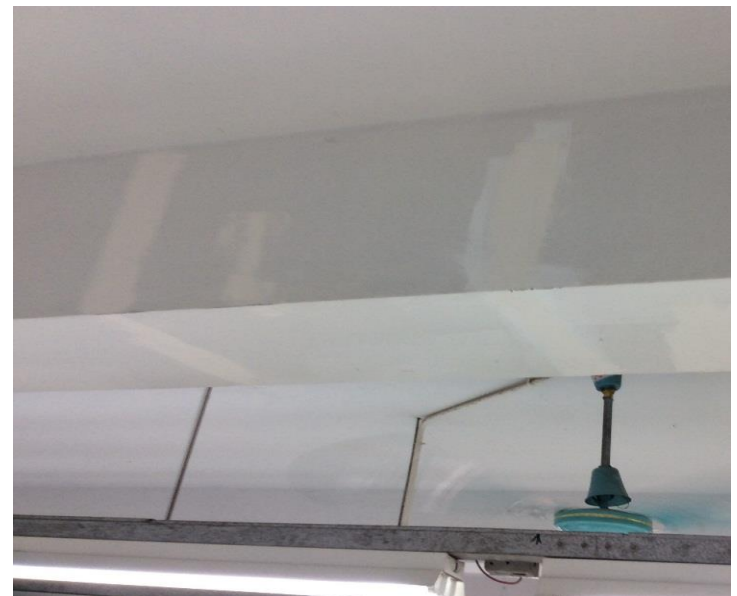
Cracks Repaired to underside and side of the beam

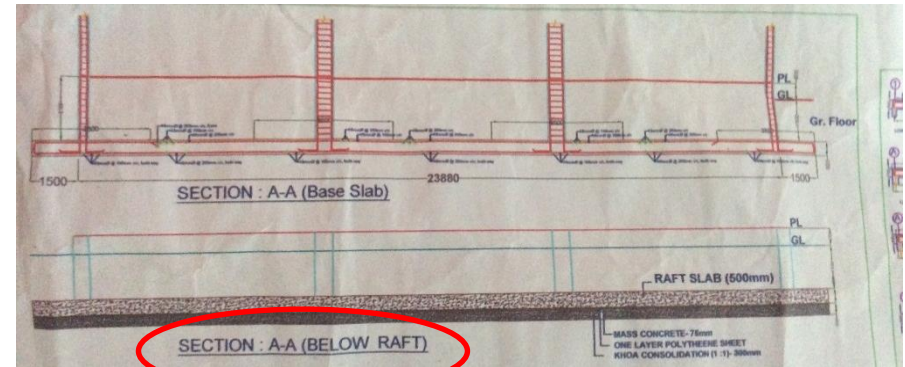
Section of mat/raft foundation

- Inconsistent column sizes were shown on different drawings. Both 500X500 and 400X400mm columns were shown. Actual column size is 430X430 mm with plaster
- There is confusion about the foundation type in the building. Different structural drawings provided, showed both raft foundation and isolated pad foundation systems.

Conflicting foundation drawings are shown below

| Item No. | Observation | Recommended Action Plan | Recommended Timeline |
|---|---|---|---|
| 10 | Differences between actual construction and information on design drawings | Engage an Engineer to prepare full “as built” engineering drawings , as part of the Detailed Engineering Assessment (refer to Priority Action 1 above). | 6-weeks |

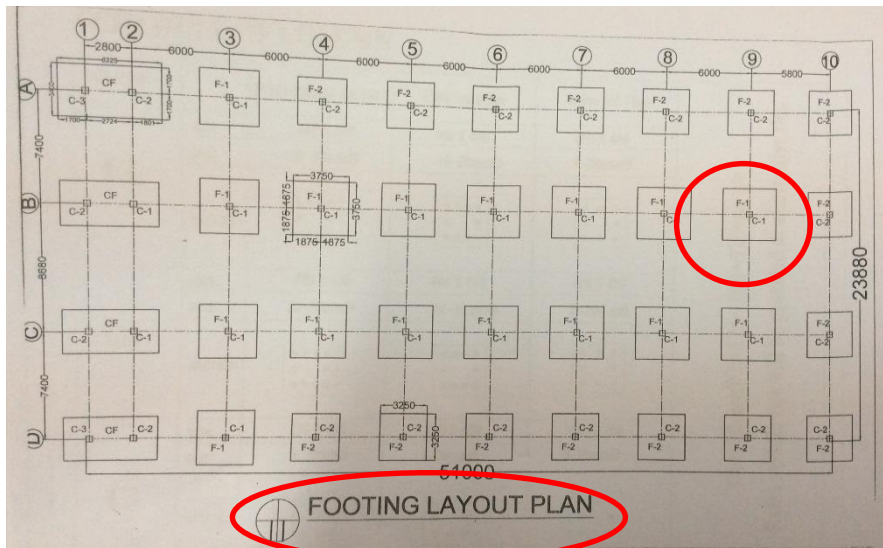
Plan of isolated pad foundations

Type of foundation was confirmed by building contractor as isolated pad foundations which may not comply with the recommendations in the Site Investigation Report.

| Item No. | Observation | Recommended Action Plan | Recommended Timeline |
|---|---|---|---|
| 11 | Foundation construction may not comply with recommendations of Site Investigation Report | Building Engineer to investigate if the applied loading can be safely carried by the foundations as constructed, as part of the Detailed Engineering Assessment. | 6-weeks |
| 12 | Foundation construction may not comply with recommendations of Site Investigation Report | Carry out any remedial work as directed by the Building Engineer. | 6-months |

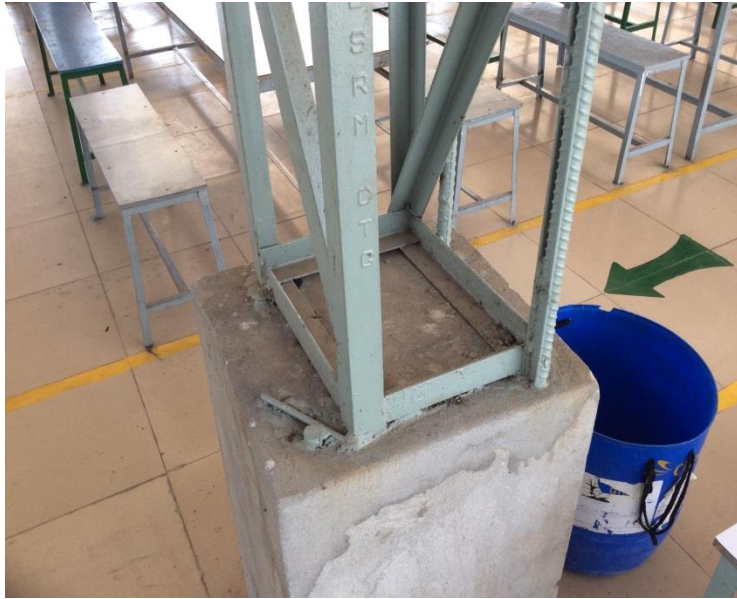
**Light weight roof structures lack bracing and  
appear non-engineered**

Apparently non-engineered connections at base of steel roof structure.

Building Engineer to review the design of the lightweight structure on roof and over ground level wastage material storage area to the west of the building. Light weight roof structures lack bracing and appear non-engineered

| Item No. | Observation | Recommended Action Plan | Recommended Timeline |
|---|---|---|---|
| 13 | Lightweight roof structures lack bracing and appear non-engineered | Building engineer to check the capacity and stability system of the lightweight roofs and stairs and make any necessary alterations. | 6-months |

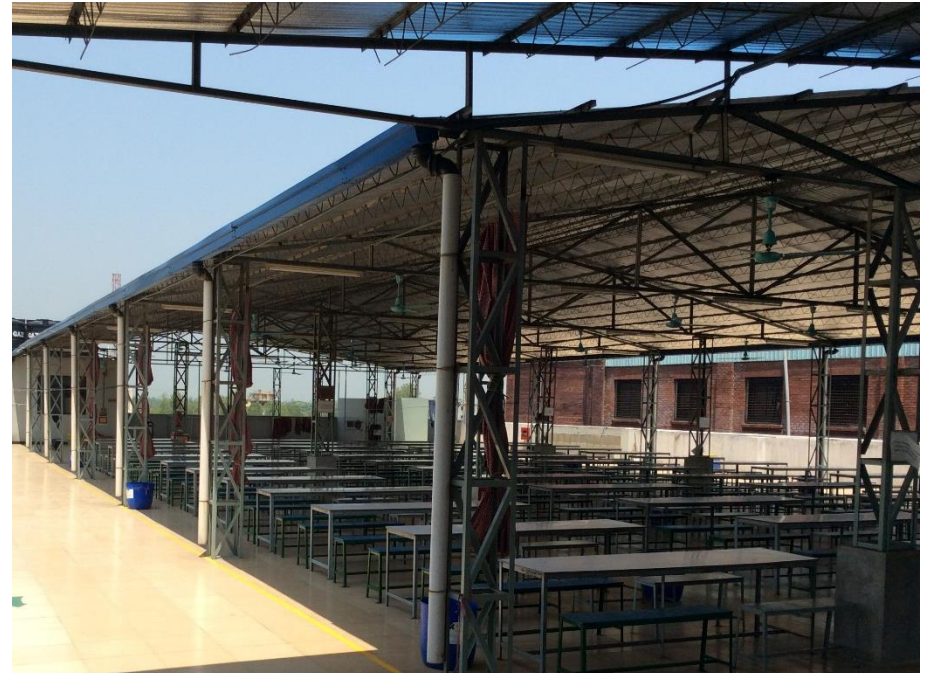
Light weight metal sheeting at Roof level.
