# Epyllion Style Ltd

Bahadurpur, P.O - Bhawal Mirzapur , Gazipur Sadar, Gazipur 1703.

6<sup>th</sup> May 2014

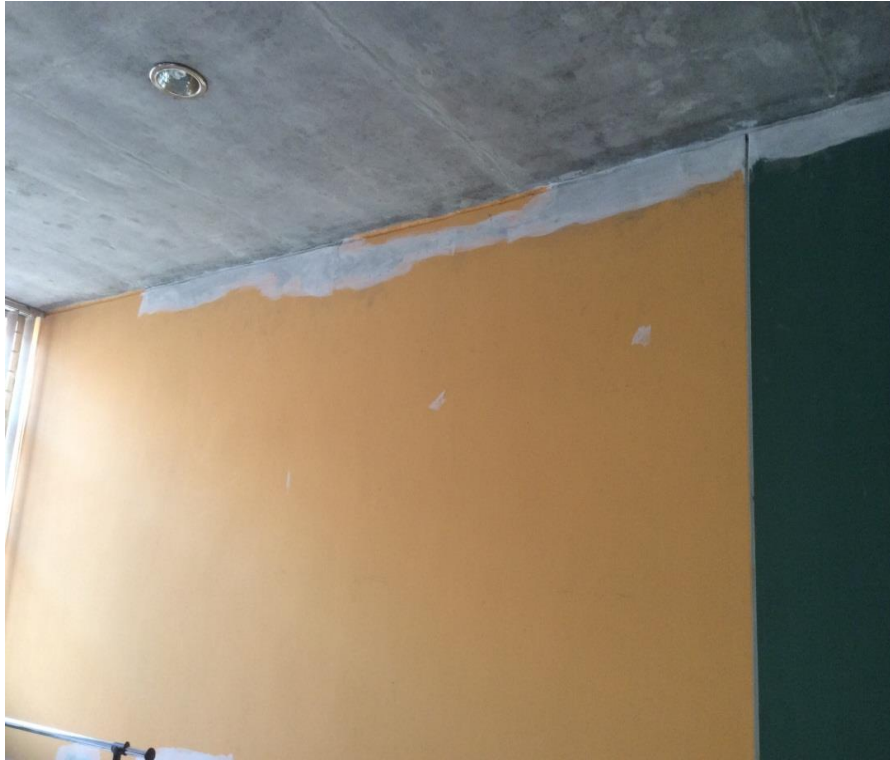
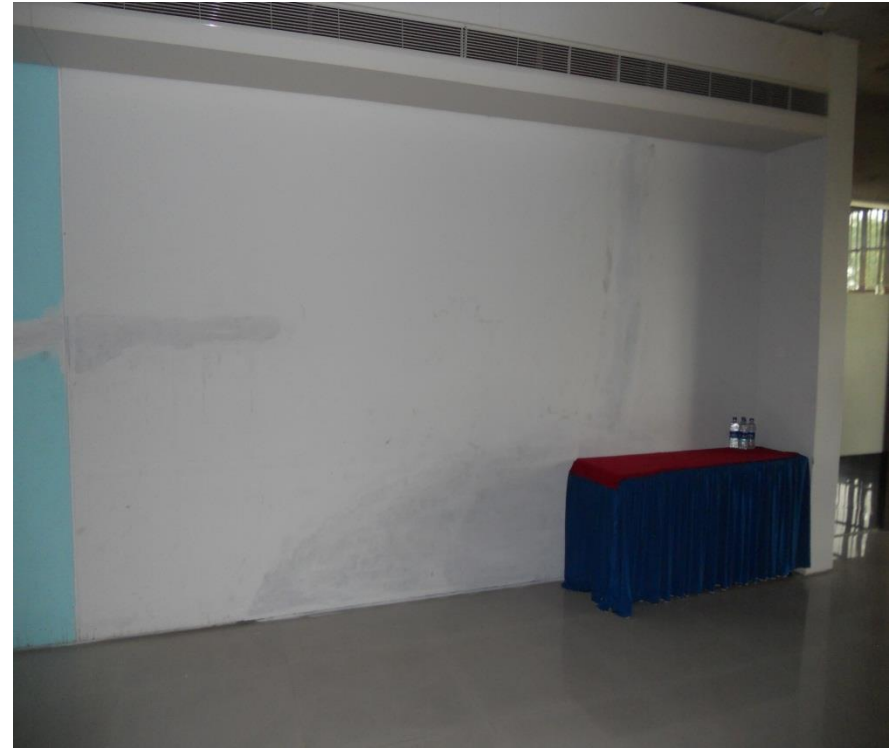
**Numerous cracks in non structural masonry walls (Concrete Section- Building 1).**

In the concrete section of Building 1 there were numerous cracks and crack repairs in non structural masonry walls

| Item No. | Observation | Recommended Action Plan | Recommended Timeline |
|---|---|---|---|
| 1 | Numerous cracks in non structural masonry walls (Concrete Section- Building 1) | Engage an Engineer to carry out flexural and shear checks on the flat slabs (first floor and roof). | 6-weeks |
| 2 | Numerous cracks in non structural masonry walls (Concrete Section- Building 1) | Engage an Engineer to investigate if the cracking is the result of excessive deflection in the flat slabs. | 6-weeks |

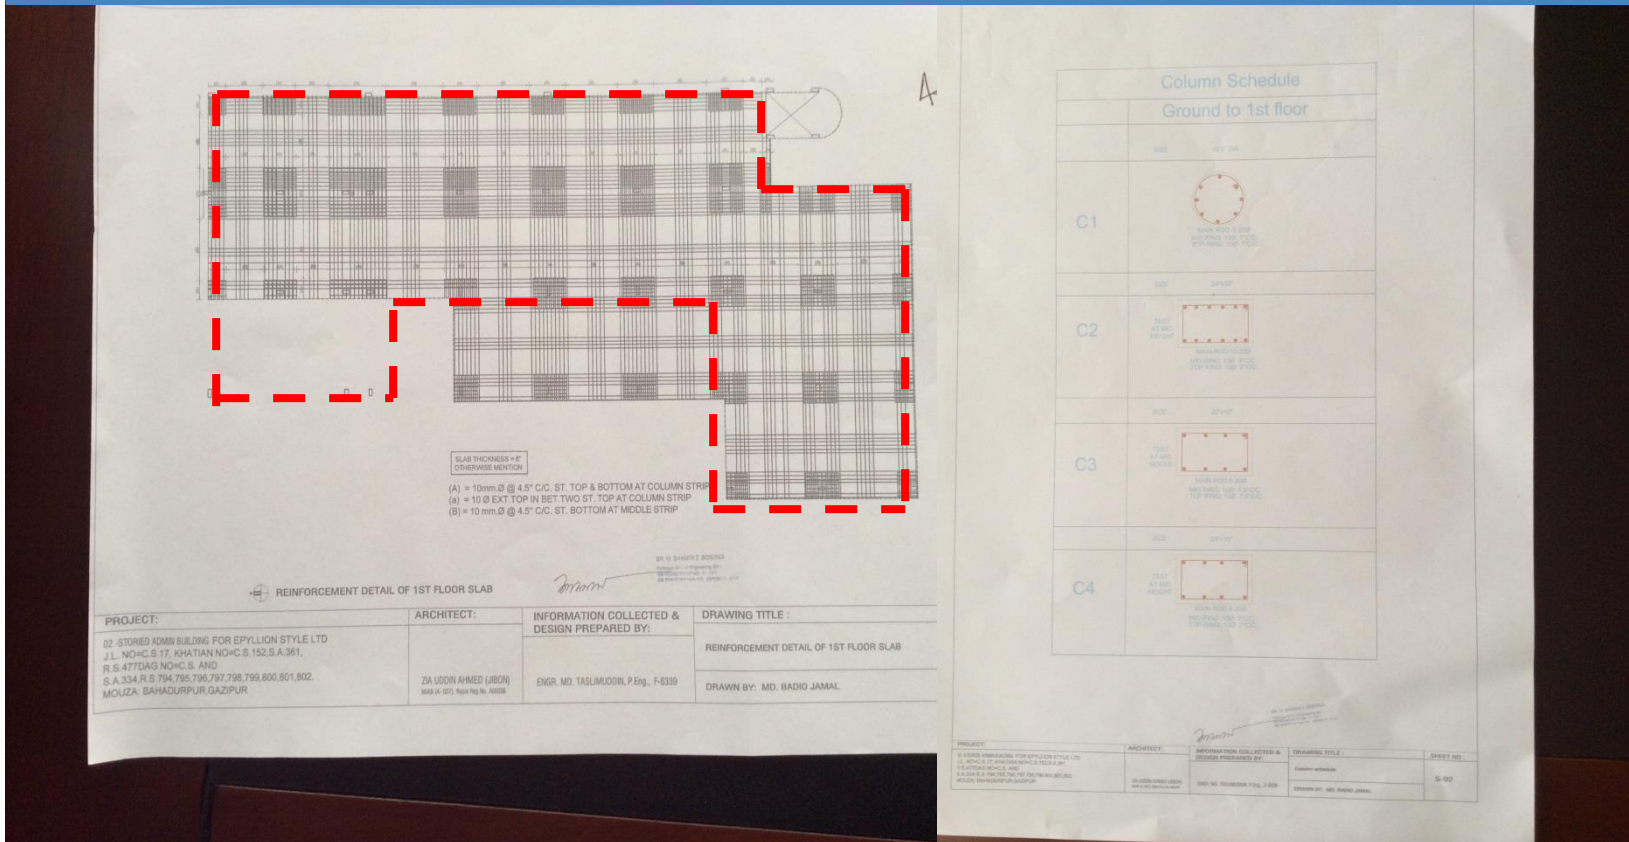
Actual First Floor slab layout

Inadequate structural drawings were provided for concrete section of Building 1. These consisted of a single reinforcement detail for first floor slab and stairs and a column schedule. The slab thickness shown on 1<sup>st</sup> floor slab reinforcement drawing was 150mm. The actual slab thickness measured including finishes was 300mm. The extent of 1<sup>st</sup> floor shown on the drawing is incorrect.

| Item No. | Observation | Recommended Action Plan | Recommended Timeline |
|---|---|---|---|
| 3 | Inadequate structural drawings (Concrete Section- Building 1) | Engage an Engineer to prepare full “as built” engineering drawings. | 6-weeks |

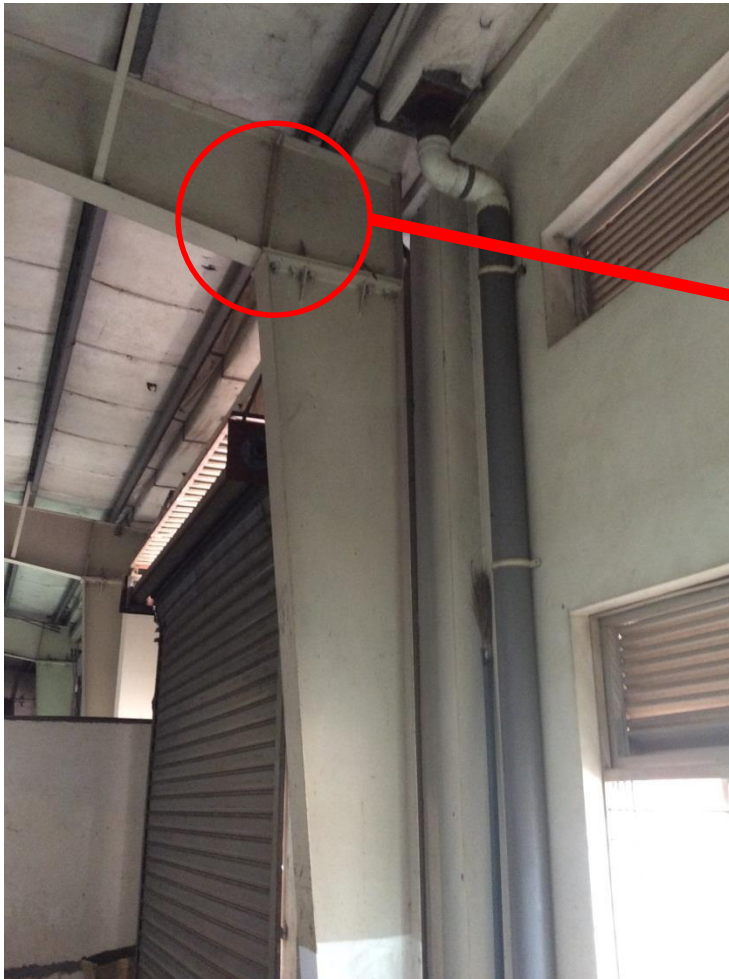
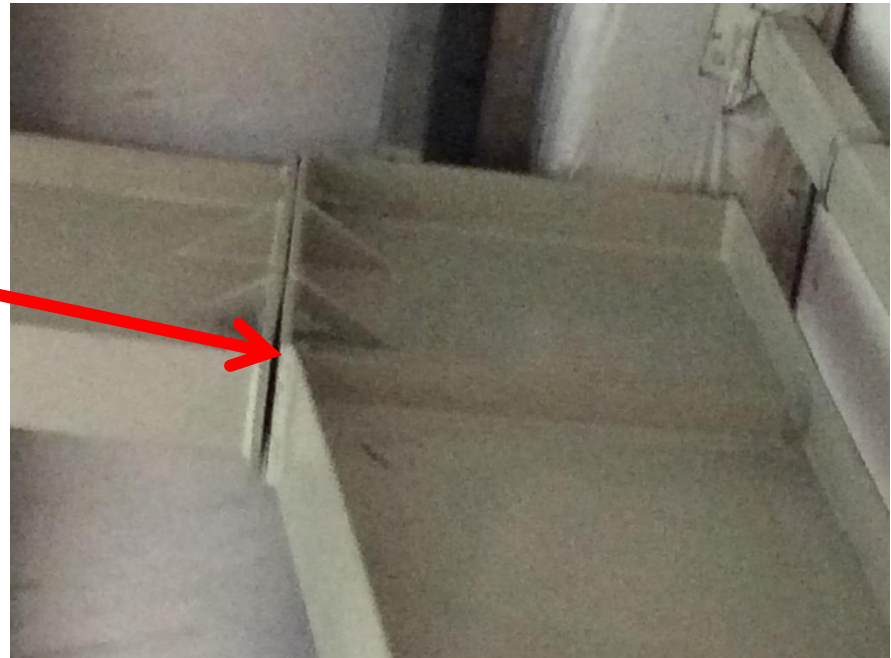
**Large gaps between bearing plates in steelwork (Shed 1 and Shed 2- Building 1).**

In both Sheds 1 and 2 of Building 1 there are large gaps between bearing plates of the stanchions and rafters (eaves connection of the portal frames).

| Item No. | Observation | Recommended Action Plan | Recommended Timeline |
|---|---|---|---|
| 4 | Large gaps between bearing plates in steelwork (Shed 1 and Shed 2- Building 1) | Engage an Engineer to check that the eaves connections are structurally adequate. | 6-months |

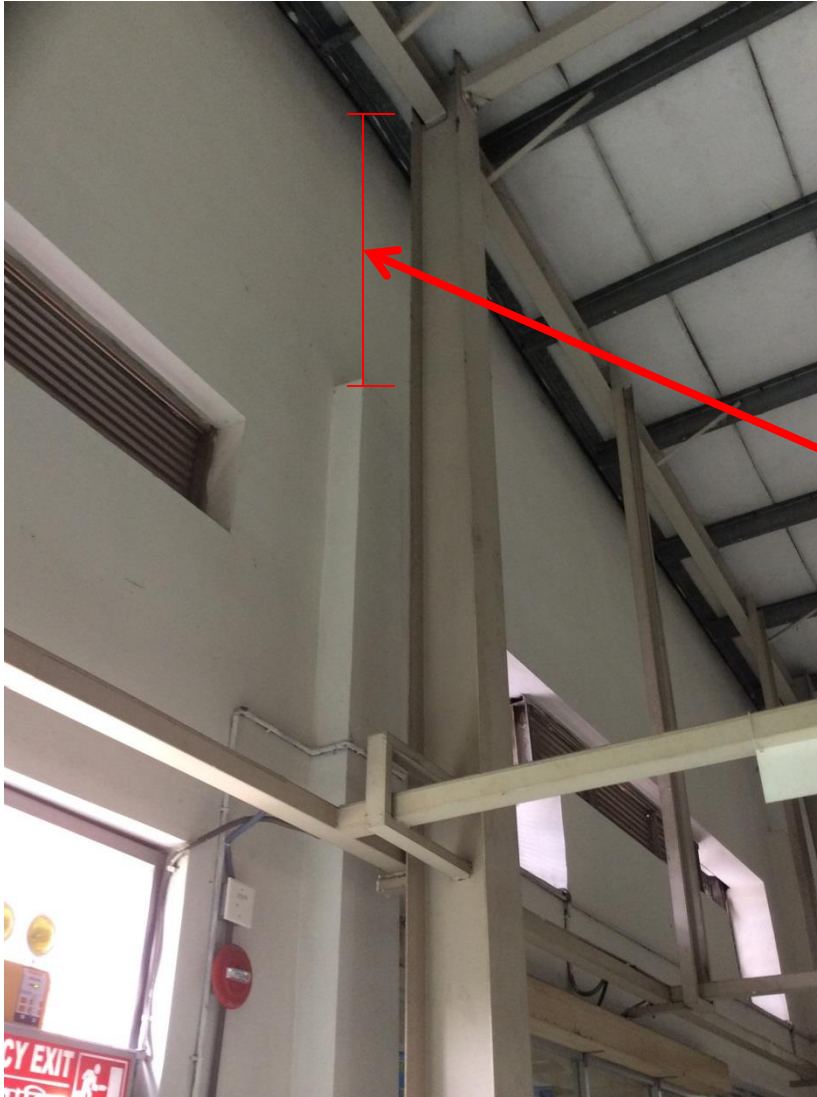
**High gable walls appear unrestrained (Shed 1 and Shed 2 – Building 1).**

Perimeter walls are independent of portal frame structure. Wind posts in Gable walls of Sheds 1 and 2 did not go full height.

Unrestrained wall height of gable wall

| Item No. | Observation | Recommended Action Plan | Recommended Timeline |
|---|---|---|---|
| 5 | High gable walls appear unrestrained (Shed 1 & Shed 2 Building 1) | Engage an Engineer to investigate the stability of the external masonry walls. | 6-months |
