# **Textown Limited (9704)**

## **Ornate Knit Garments Industries Ltd (9701)**

Dewan Idris Road, Bara Rangamatia, Ashulia, Savar, Dhaka, Bangladesh.

11.MARCH.2014

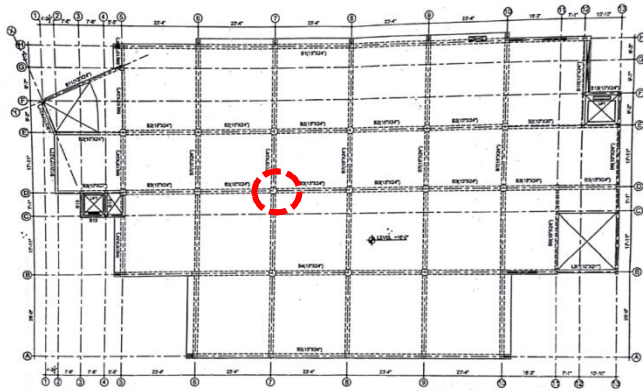
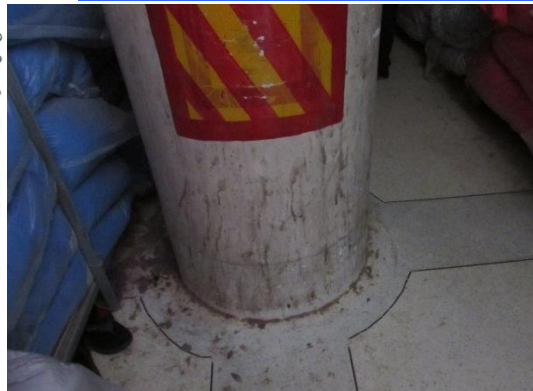
**Column Load Exceeds Allowable Limit by Code  
Building 01**

Based on the load rundown analysis following the live load intensity (4.78kPa) prescribed by design (the entire Building 01 is claimed to be designed for all floors achieving live load capacity of 100psf (4.78kPa)), the column portion below 1/F level seems to have a much lower F.O.S than the column portion below ground level (AMBER warning). If based on building code loading of 3.0kPa, the column in question reverts to YELLOW status.

- Factory Engineer to review design, loads and columns stresses in entire building
- Verify insitu concrete stresses either by 100mm dia. cores or existing cylinder strength data for the structure.
- A Detail Engineering Assessment of Factory to be commenced, see attached Scope

- Produce and actively manage a loading plan for all floor plates within the factory
- Detail Engineering Assessment to be completed

- Continue to implement load plan

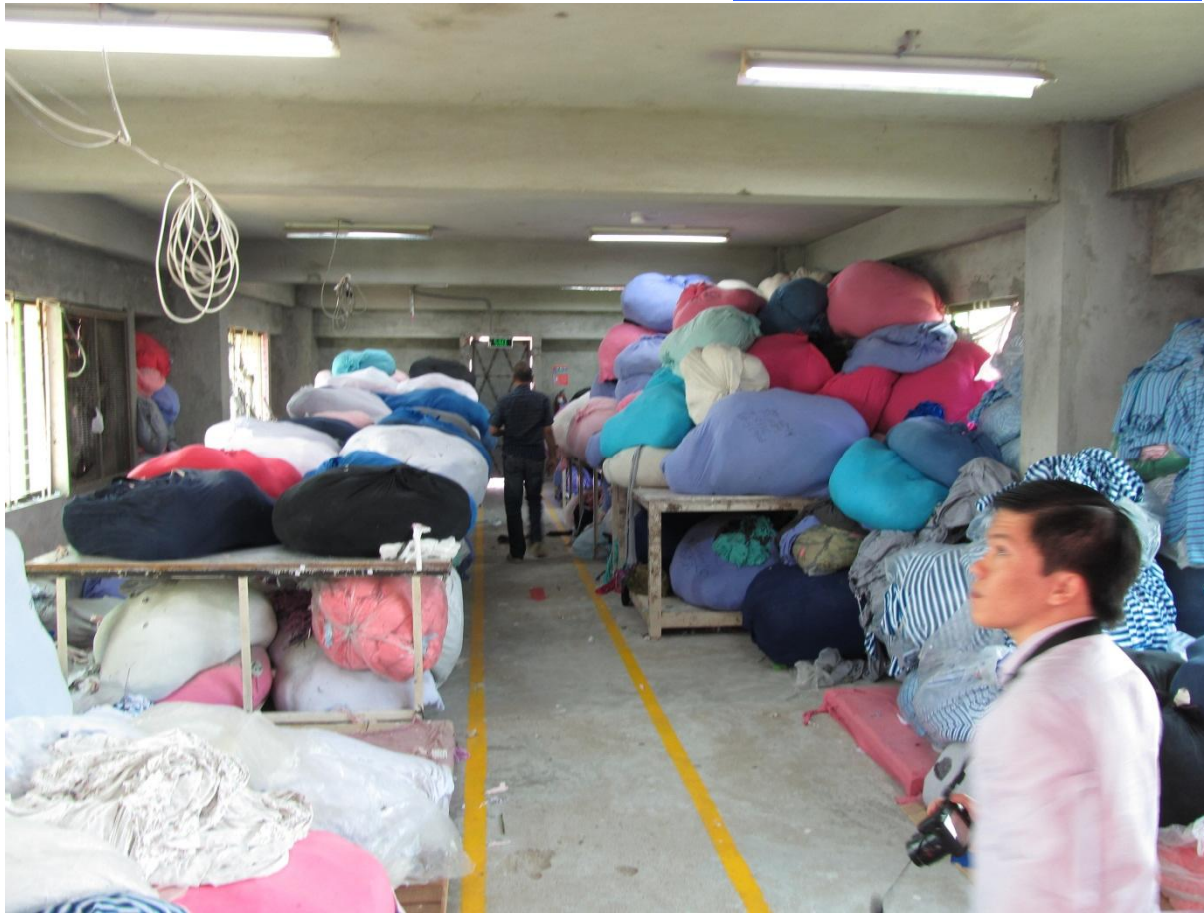
**Excessive Storage Height a on Level 4 at Building 03**

On Level 4 of Building 03, the room is used to store fabric. It was observed that many of the bags of fabric were quite heavy, and that the bags had been stacked to almost ceiling height.

The permissible live load for this building is 3.0 kPa only. It was calculated that the loading from the stacks of fabric had exceeded this permissible loading limit.

- Immediately reduce stacking height of fabric to ensure total load does not exceed 3.0kPa

- Mark the maximum allowable height of fabric stacking to ensure full compliance

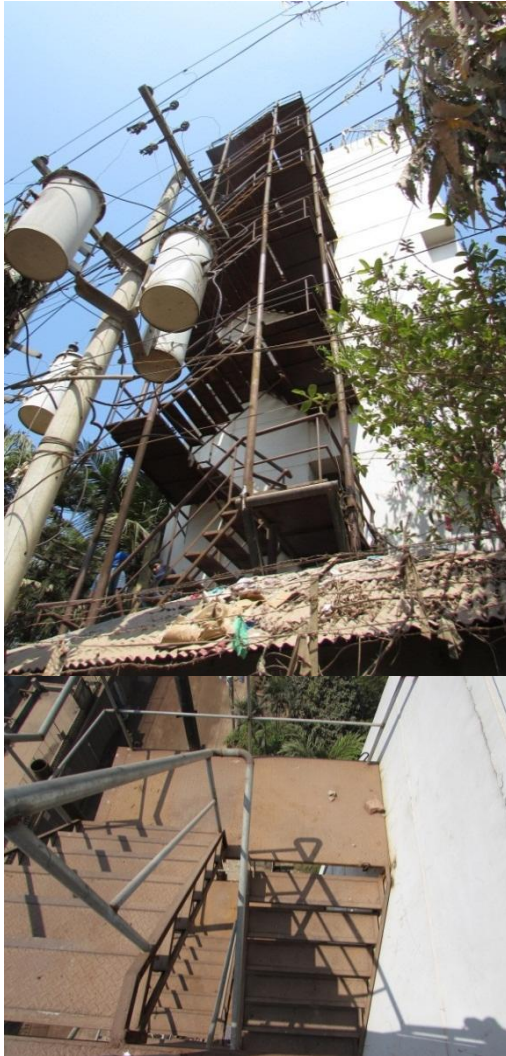
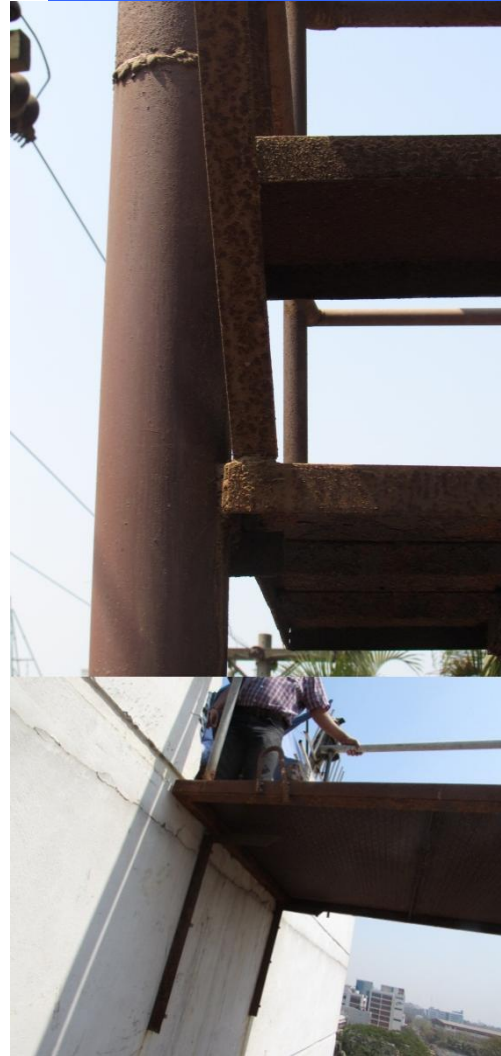
**Escape Staircase is in Poor Condition**

The staircase at the side of Building 03 is meant to be a fire escape staircase. This means that there is a potential for crowds of people to use this stair in the event of emergency. However, the stair was built from very small steel members, and had not been properly galvanised, and therefore had rusted very badly. The structural stability of this staircase is questionable, and appears unsafe for its intended purpose

- Consider the renewal of this staircase, using suitable corrosion-resistant materials, and of a design suitable for emergency and panic loading.

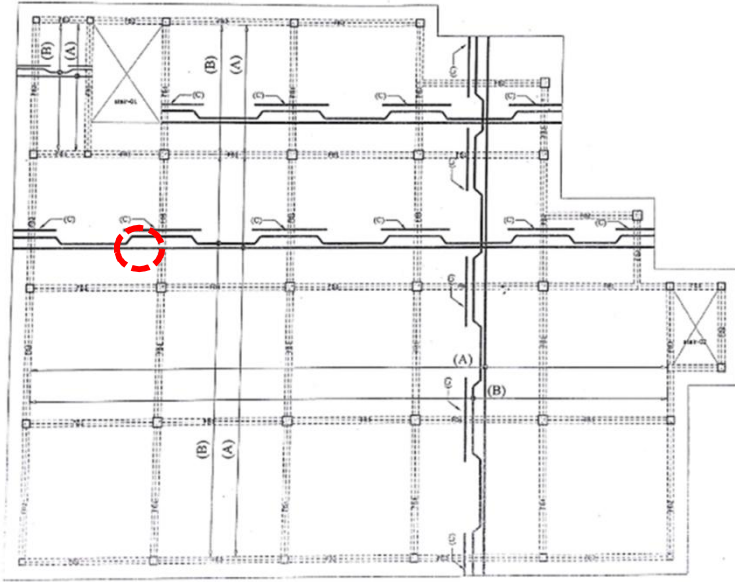
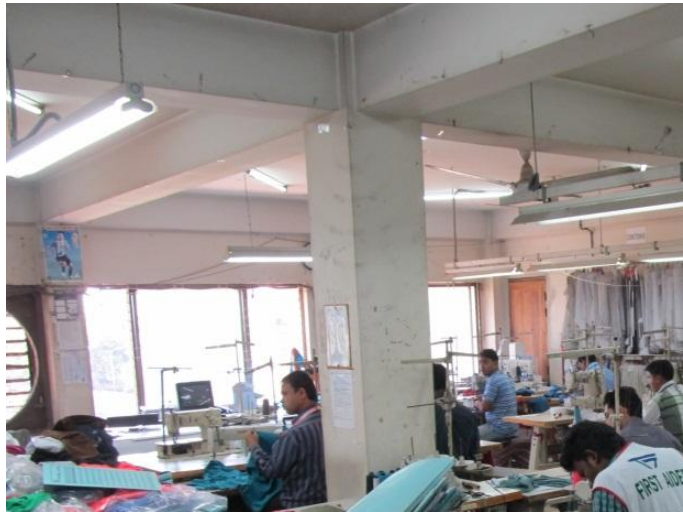
**Column Load Exceeds Allowable Limit by Code**  
**Building 02**

Similar to Building 01, the capacity of the column above ground level appears to possess a smaller FOS in design than the portion of column below G/F level. Although it is only a YELLOW warning, a full review of loads and concrete design strength should be carried out. The portion of the column below G/F possesses sufficient capacity to maintain material stresses to very low limits.

- Factory Engineer to review design, loads and columns stresses in area identified above.
- Verify insitu concrete stresses either by 100mm dia. cores or existing cylinder strength data
- Produce and actively manage a loading plan for all floor plates within the factory giving consideration to floor and column capacity
