# **FIRE SAFETY INSPECTION REPORT**

**METRO DYEING AND KNITTING LTD**

**ACCORD**  
on Fire and Building Safety in Bangladesh

April 8, 2014

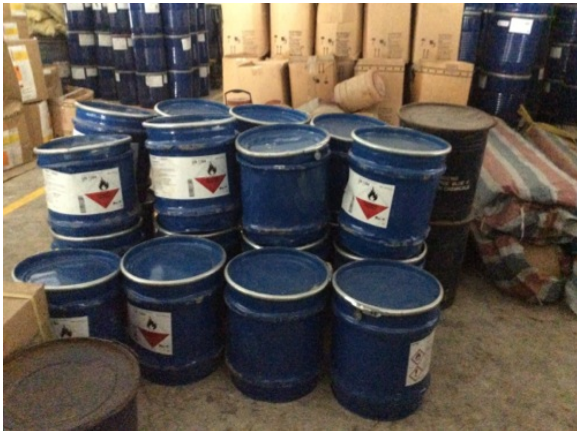
| No. | Category | Finding | Recommendation | Remediation Timeframe |
|---|---|---|---|---|
| F-1 | Fire Rated Construction | Hazardous material and flammable liquid storage area was not separated by fire rated construction in 6th floor of building 4. | Separate the hazardous materials and flammable liquid storage room by a minimum 2-hr fire-rated construction. Seal and protect all openings to maintain the required fire separations. | Within 3 months |

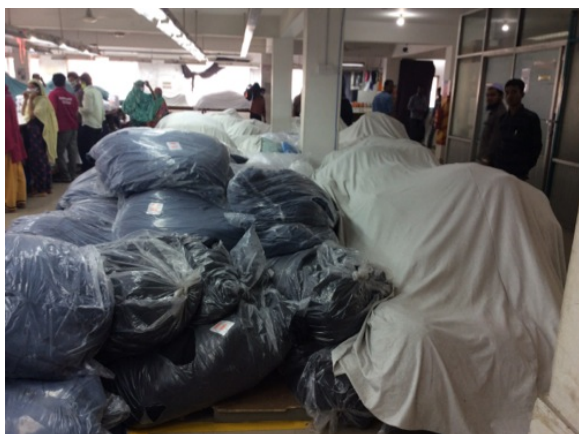
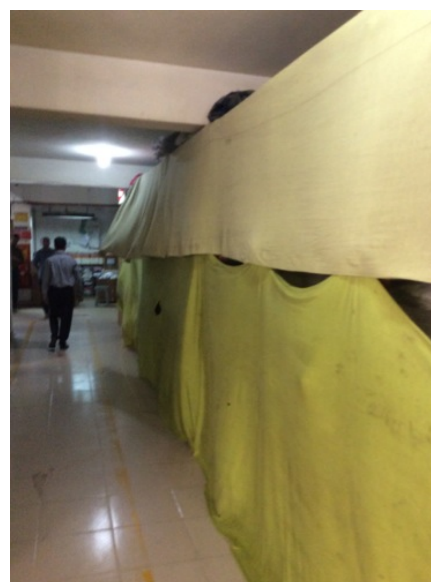
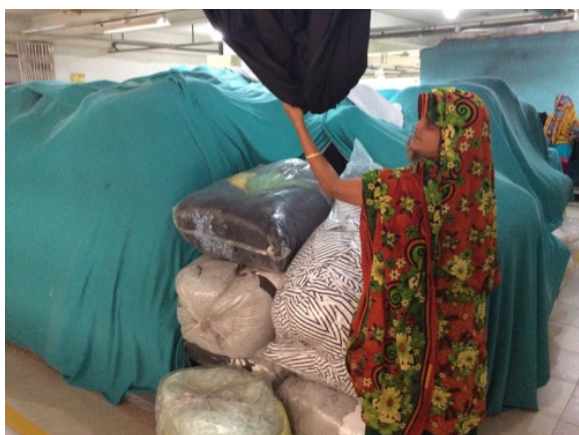
| F-3 | Fire Rated Construction | All the floors of Building no 1 (except the first floor) and all the floors of Building no 4 had combustible storage that were not separated by fire-rated separation. | Provide dedicated storage rooms separated by minimum 1-hr fire-rated construction.<br><br>Where separate storage rooms are not feasible, provide defined storage areas and limit the storage arrangement as follows:<br>- Maximum height of 2.4m and maximum area of 23m <sup>2</sup> | Within 3 months |

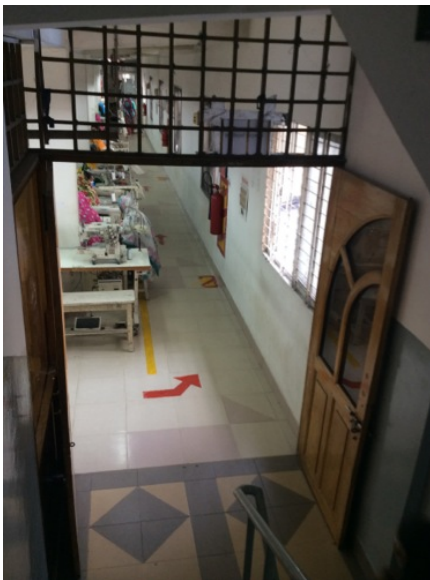
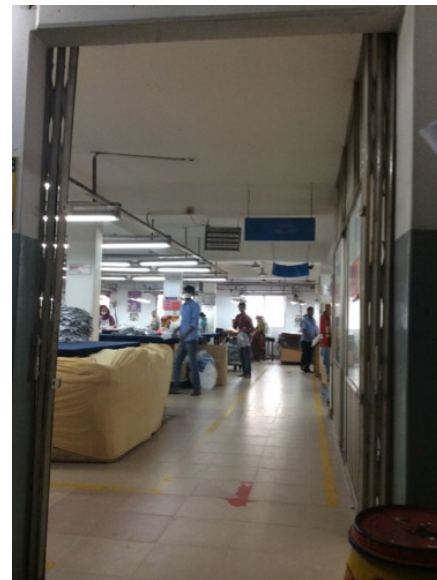
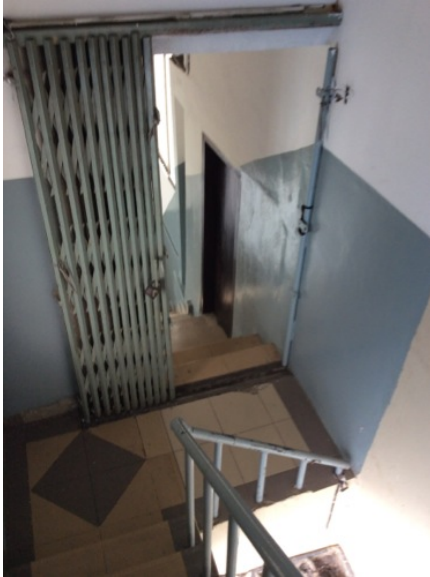
| F-4 | Fire Rated Construction | The exit stairs were not separated from work areas, other spaces on each floor by fire-rated construction. | Provide minimum 1.5-hr fire rated doors and seal all unprotected openings to separate the exit stairs from work areas and other building spaces on all floor levels. Ensure that the fire doors are self-closing and positive latching and that they are provided with fire exit (panic) hardware where serving production floors. | Within 3 months |

If fire doors are required to be held open for functional reasons, provide automatic-closing devices tied to the fire alarm system.

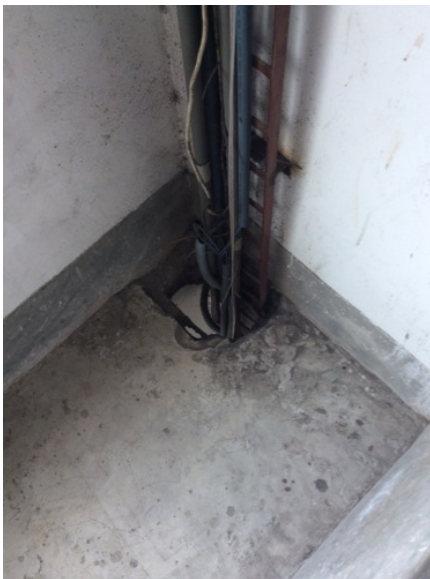
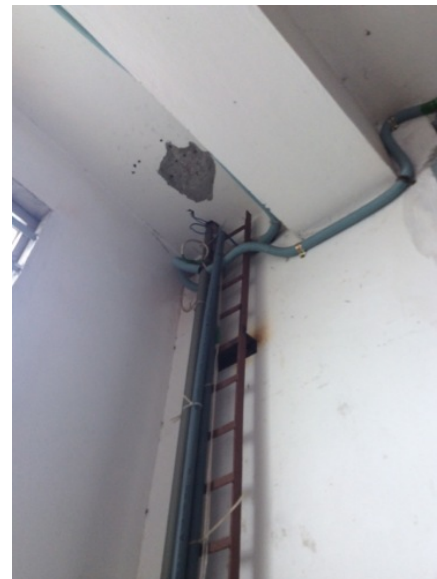
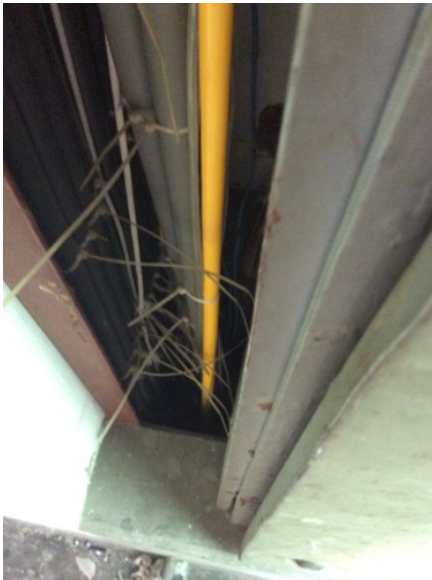
| F-5 | Fire Rated Construction | Unsealed penetrations and openings were located in the fire-rated floor/ceiling assemblies. | Provide a minimum 2-hr fire-rated shaft to separate the utility risers from each floor level. | Within 3 months |

Seal all penetrations and openings in floor/ceiling assemblies to maintain the fire separation.

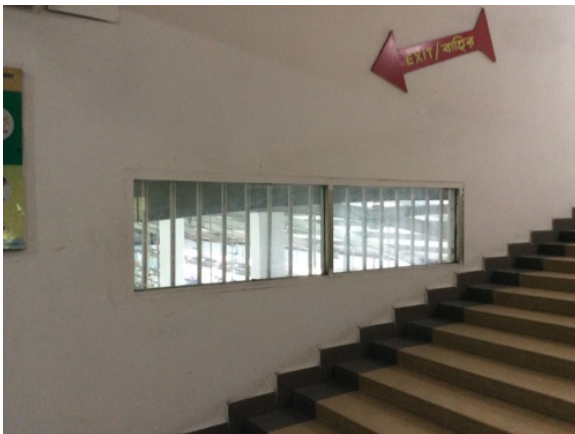
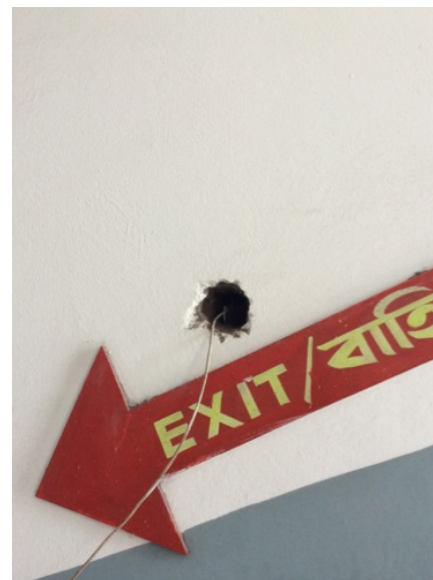
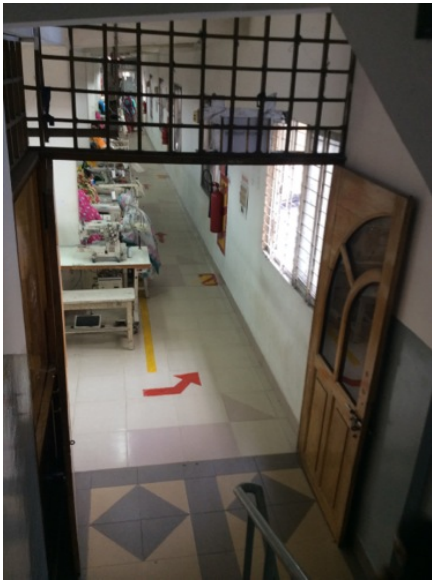
| F-6 | Fire Rated Construction | Unsealed penetrations and openings were located in exit stair enclosures. | Seal all penetrations and openings in exit stair enclosure walls to maintain the fire separation. | Within 3 months |

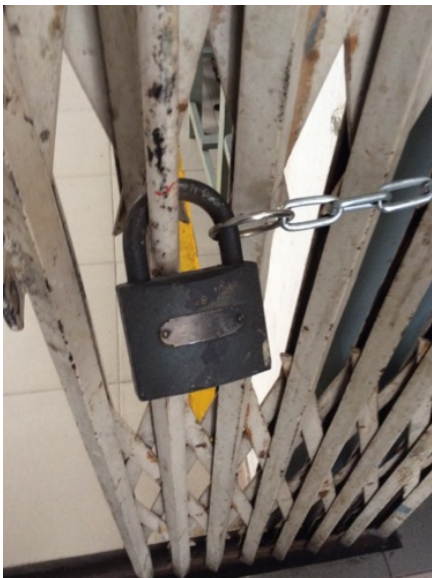
| F-7 | Egress | All the exit doors and building exits had locking features. The exit of a storage room in building 4 was locked during inspection and could not be open. | Remove locking features from all egress doors / gates.<br><br>If locks are required for security reasons, utilize special door locking features complying with NFPA 101. | Immediate |

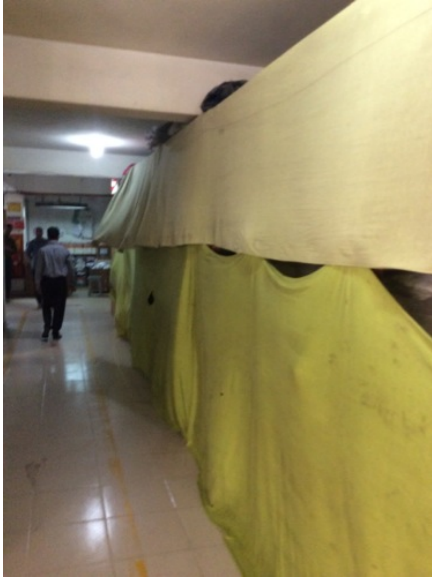
| F-8 | Egress | In the 5th floor storage was located in egress path. | Keep egress paths and stairs clear of storage. | Immediate |

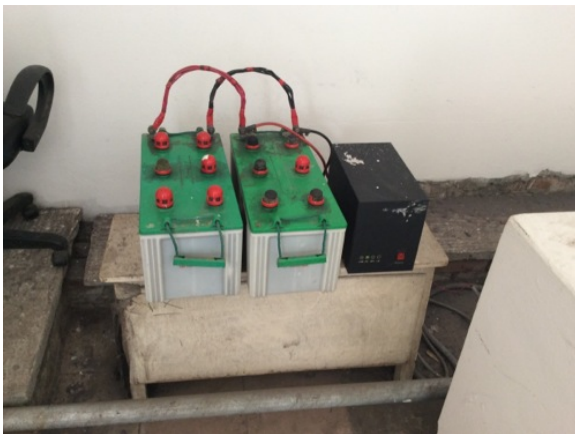
| F-9 | Egress | Storage was located in South west stairwell in 2nd floor, in North west stair well in 2nd, 7th and rooftop. | Remove all storage from exit stairs and egress paths. | Immediate |

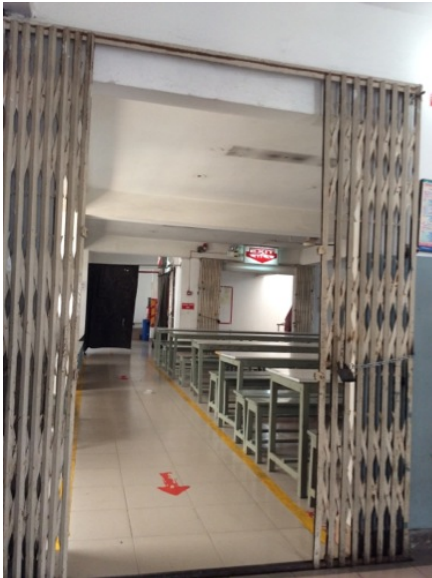
| F-10 | Egress | Collapsible gates and sliding doors were provided at building exit, exit stairs and exit discharges in all the floors of Building no 1 and Building no 4. | Replace all gates / sliding doors along the means of egress with side-hinged, swinging egress doors.<br><br>If locks are required for security reasons, utilize special door locking features complying with NFPA 101. | Within 1 month |

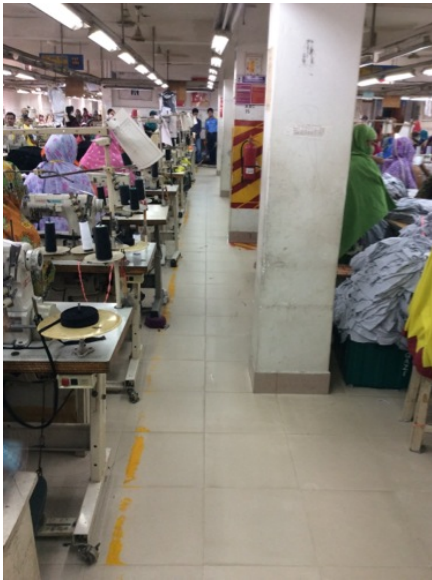
| F-11 | Egress | In 2nd, 3rd, 4th, 5th, 6th floor egress routes were partially obstructed by row of column | Provide minimum aisle widths of 36-in. | Within 3 months |

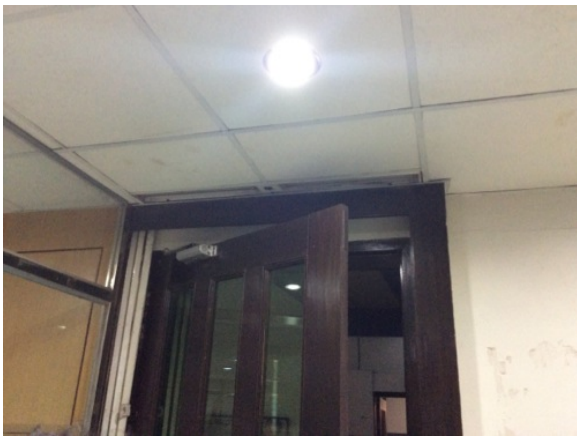
| F-12 | Egress | The East exit stair door of Building no 1 in 1st floor did not swing to the way of egress. | Modify the egress door to swing in the direction of egress travel. | Within 3 months |

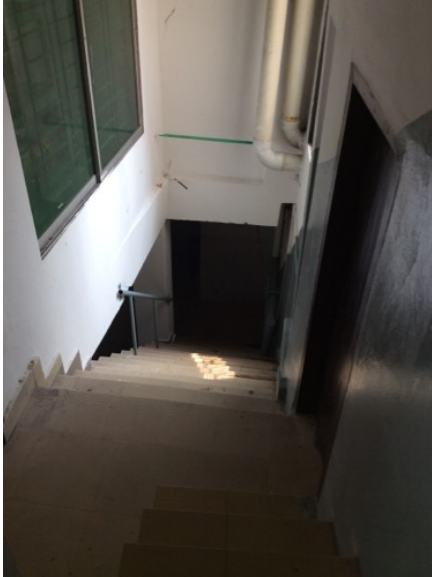
| F-13 | Egress | East exit stair of Building no 1 discharges in the ground floor of Building no 3 which is open to a Dyeing facility. | Provide 2-hr fire-rated exit passageway leading directly outside. | Within 6 months |

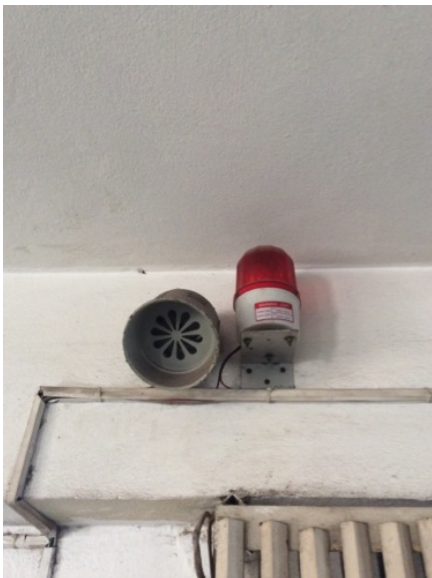
| F-14 | Fire Protection | The fire alarm system was antiquated, not a listed system, and did not provide alarm and notification features consistent with acceptable standards. | Replace the fire alarm system with a new, listed addressable fire alarm system in accordance with NFPA 72. | Design within 4 months, install within 9 months. |

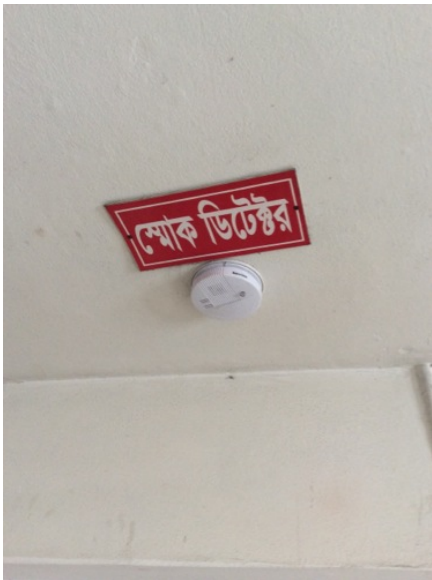
| F-16 | Fire Protection | The building was equipped with single-station smoke alarms. Smoke alarm activation sounded only a local alarm and did not provide automatic fire alarm notification to the occupants. | Replace the single-station smoke alarms with automatic smoke detectors tied into the fire alarm system. Configure the fire alarm system to initiate occupant notification upon activation of any two smoke detectors in addition to the manual fire alarm stations. | Within 6 months |

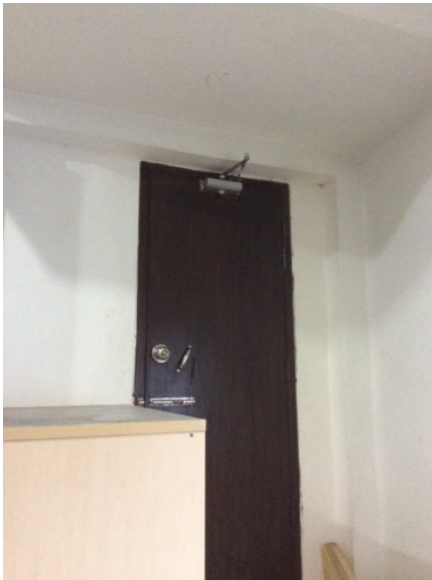
| F-17 | Egress Lighting | Exit signs were not provided at the exits from the 1st floor. | Provide exit signs above all exits to the exterior and all doors to the exit stairs. | Within 1 month |

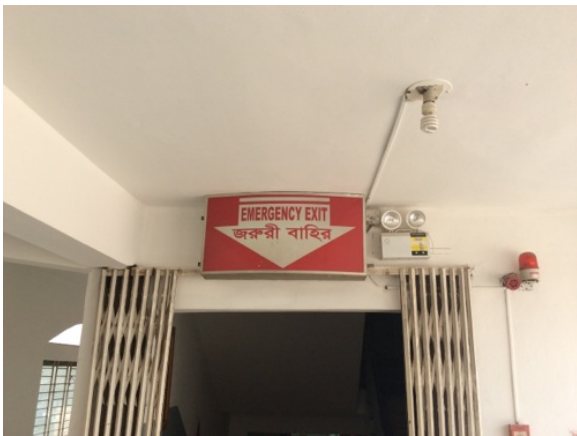
| F-18 | Egress Lighting | Exit signage was not illuminated in multiple location of Building no 1 and Building no 4 | Regularly inspect all exit signage and replace/install lights as needed to illuminate signs. | Within 1 month |

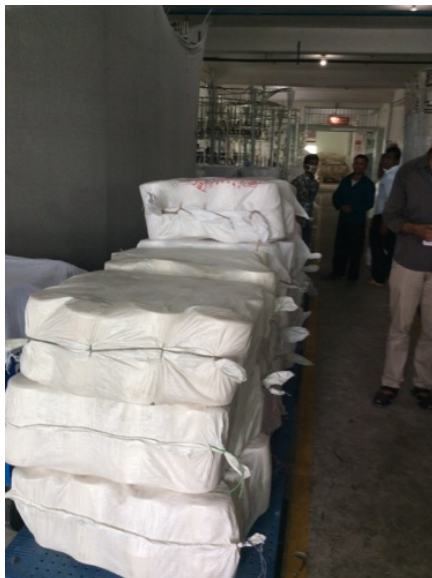
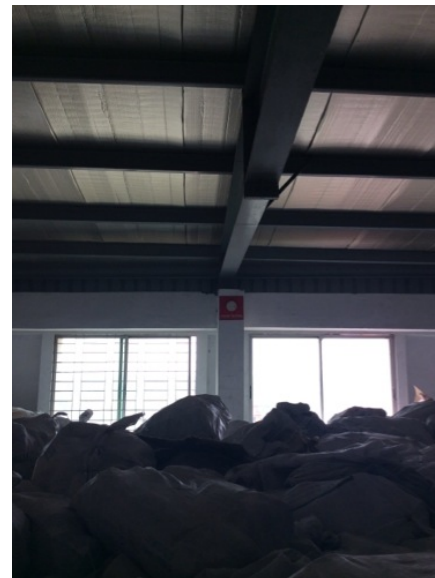
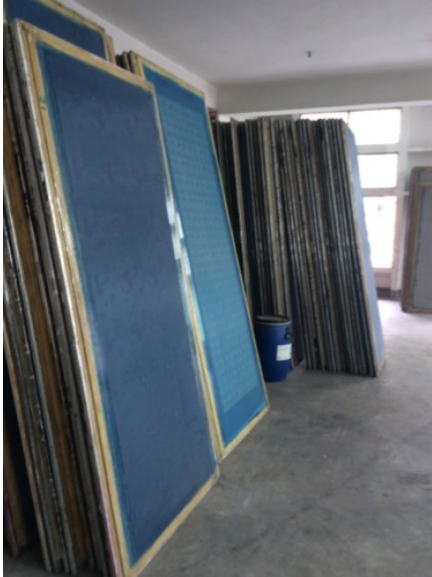
| No. | Category | Finding | Recommendation | Remediation Timeframe |
|---|---|---|---|---|
| F-1 | Fire Rated Construction | All the floors had combustible storage areas which were open to the production area. | <p>Provide dedicated storage rooms separated by minimum 1-hr fire-rated construction.</p> <p>Where separate storage rooms are not feasible, provide defined storage areas and limit the storage arrangement as follows:</p> <ul style="list-style-type: none"> <li>- Maximum height of 2.4m and maximum area of 23m<sup>2</sup></li> </ul> <p>Separate areas of unenclosed combustible storage by a minimum clear distance of 3m.</p> | Within 3 months |

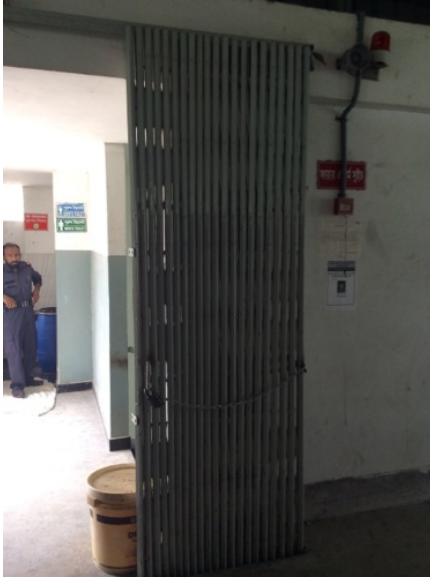
| F-2 | Fire Rated Construction | The exit stairs were not separated from work areas on each floor by fire-rated construction. | <p>Provide minimum 1.5-hr fire rated doors and seal all unprotected openings to separate the exit stairs from work areas and other building spaces on all floor levels. Ensure that the fire doors are self-closing and positive latching and that they are provided with fire exit (panic) hardware where serving production floors.</p> <p>If fire doors are required to be held open for functional reasons, provide automatic-closing devices tied to the fire alarm system.</p> | Within 3 months |

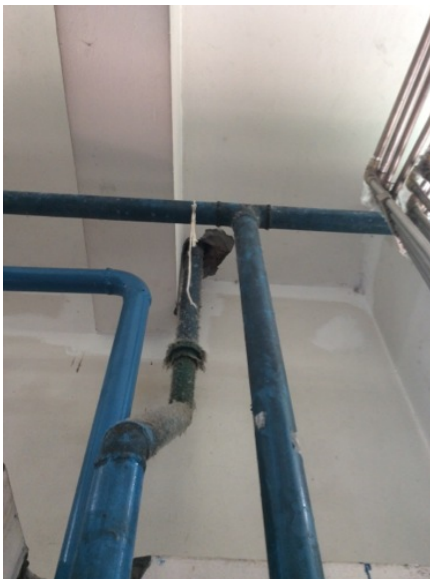
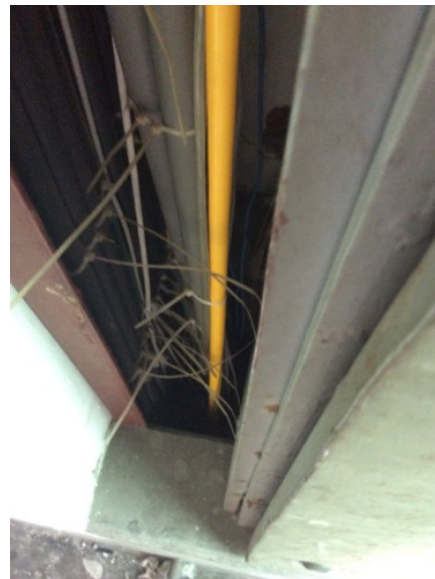
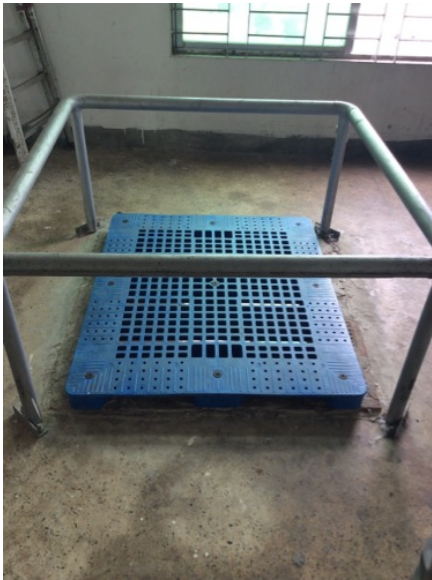
| F-3 | Fire Rated Construction | Unsealed penetrations and openings were located in the fire-rated floor and ceiling assemblies. | Provide a minimum 2-hr fire-rated shaft to separate the utility risers from each floor level.<br><br>Seal all penetrations and openings in floor/ceiling assemblies to maintain the fire separation. | Within 3 months |

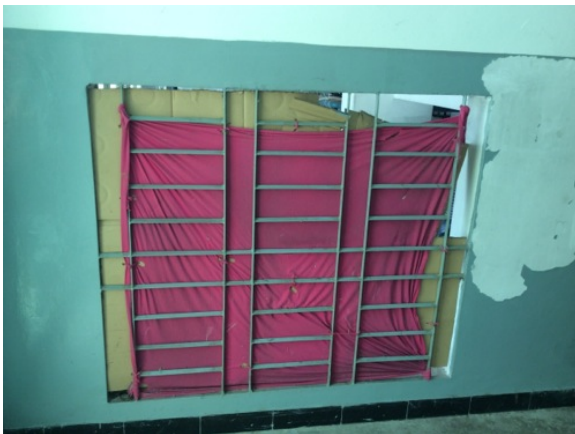
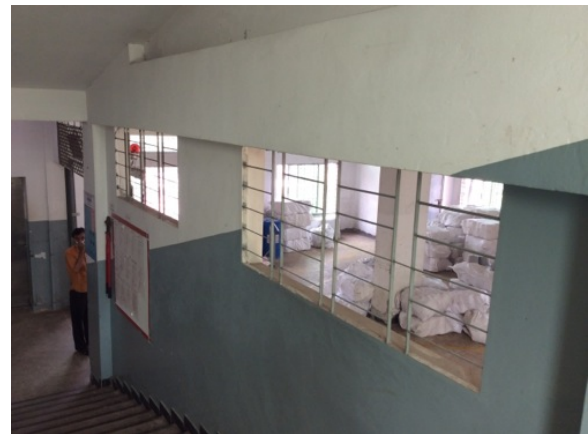
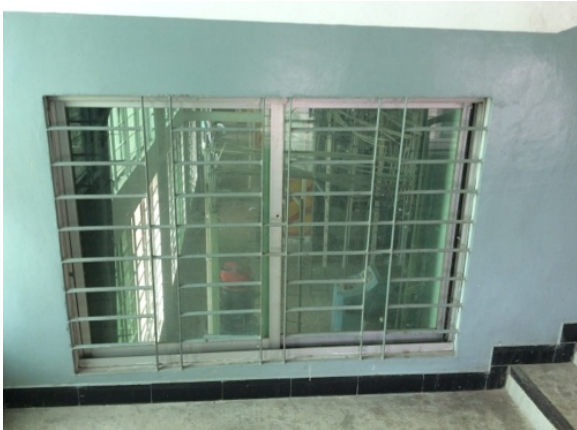
| F-4 | Fire Rated Construction | Unsealed penetrations and openings were located in exit stair enclosures. | Seal all penetrations and openings in exit stair enclosure walls to maintain the fire separation. | Within 3 months |

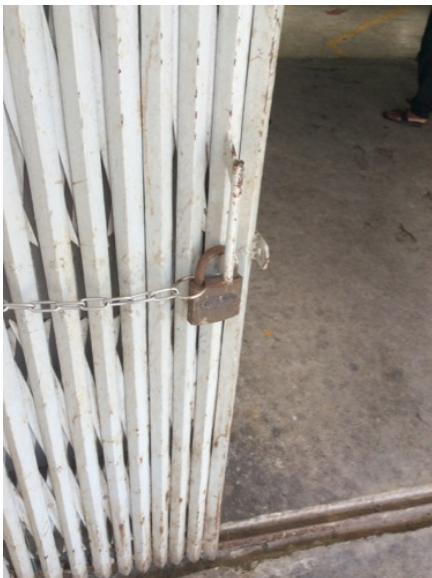
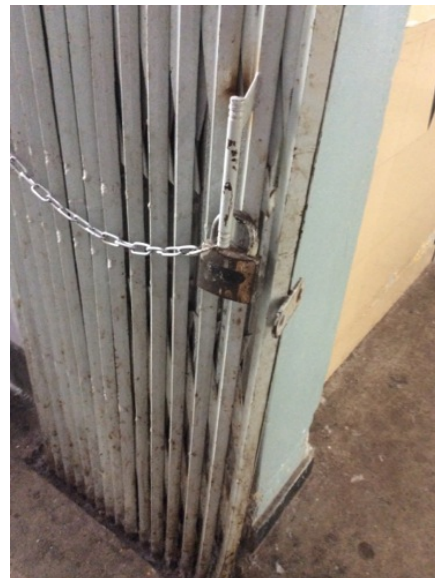
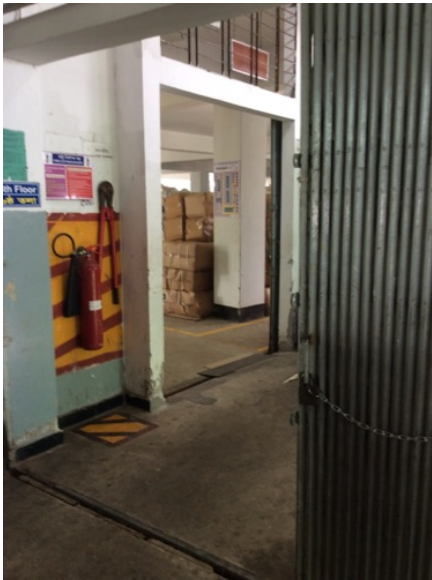
| F-5 | Egress | All the doors and gates had lockable features and were open and locked during the inspection. | Remove locking features from all egress doors / gates.<br><br>If locks are required for security reasons, utilize special door locking features complying with NFPA 101. | Immediate |

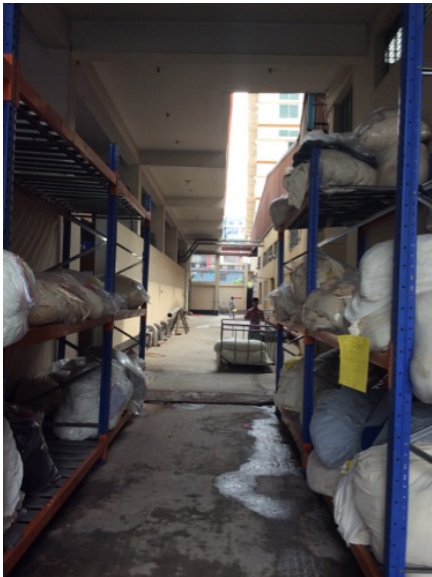
| F-6 | Egress | Storage was located in the egress path in the ground floor | Keep egress paths and stairs clear of storage. | Immediate |

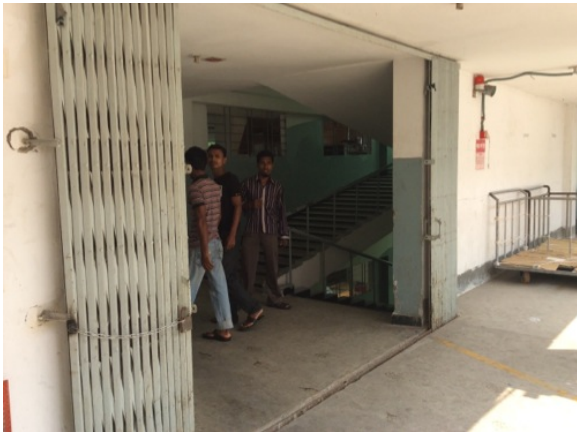
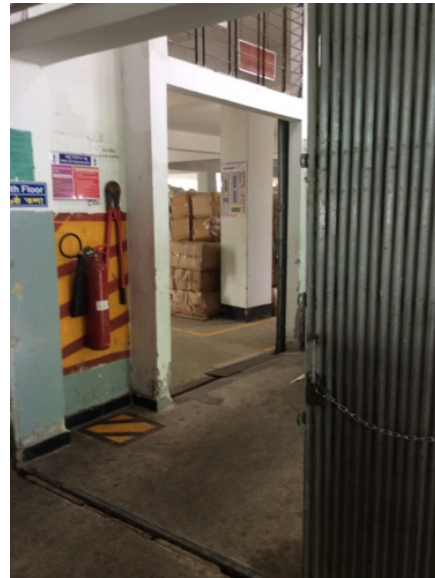
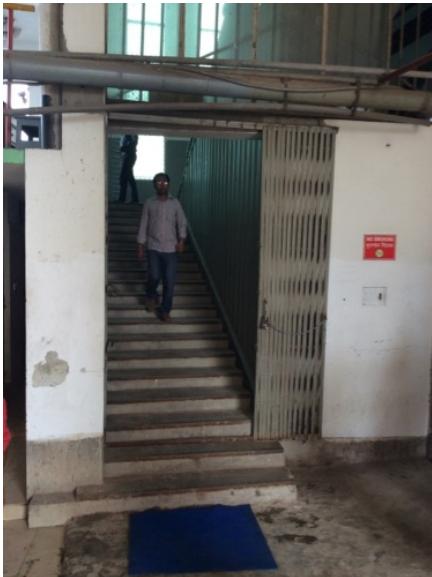
| F-7 | Egress | Collapsible gates were provided in all the floors and North exit discharge. | Replace all gates / sliding doors along the means of egress with side-hinged, swinging egress doors.<br><br>If locks are required for security reasons, utilize special door locking features complying with NFPA 101. | Within 1 month |

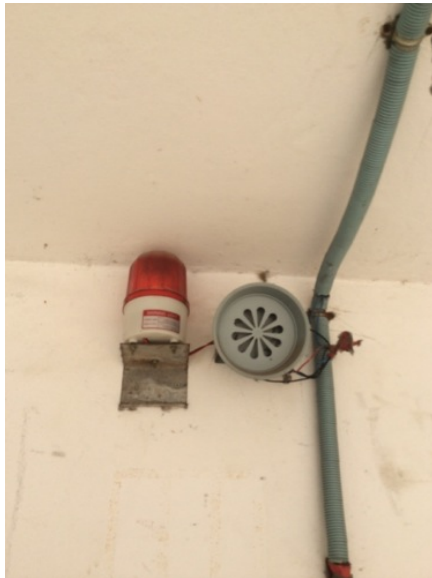
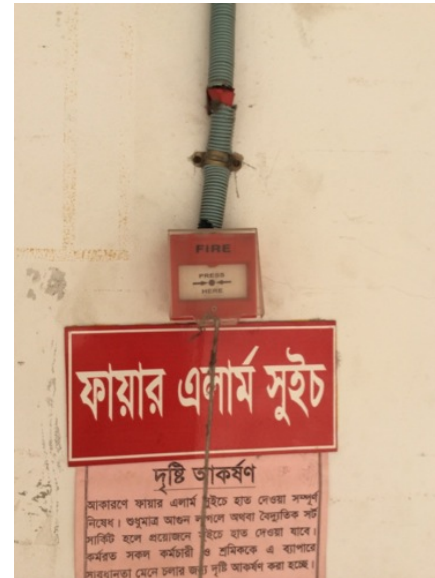
| F-8 | Fire Protection | The fire alarm system was antiquated, not a listed system, and did not provide alarm and notification features consistent with acceptable standards. | Replace the fire alarm system with a new, listed addressable fire alarm system in accordance with NFPA 72. | Design within 4 months, install within 9 months |

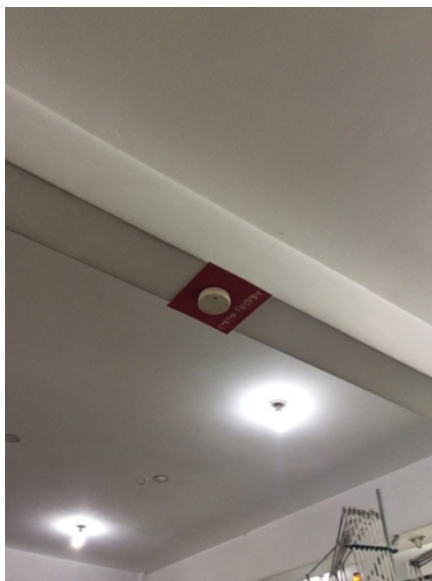
| F-9 | Fire Protection | <p>The building was equipped with single-station smoke alarms. Smoke alarm activation sounded only a local alarm and did not provide automatic fire alarm notification to the occupants.</p> | <p>Replace the single-station smoke alarms with automatic smoke detectors tied into the fire alarm system. Configure the fire alarm system to initiate occupant notification upon activation of any two smoke detectors in addition to the manual fire alarm stations.</p> | Within 6 months |

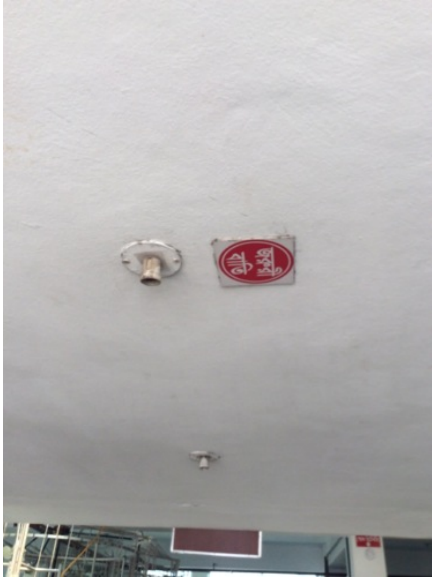
| F-10 | Egress Lighting | Emergency lights were missing on the 6th floor. | Regularly test the emergency lighting system on each floor and replace/repair lights as needed. | Within 1 month |
