FIRE SAFETY INSPECTION REPORT

A-PLUS IND LTD

ACCORD
on Fire and Building Safety in Bangladesh

March 10, 2014

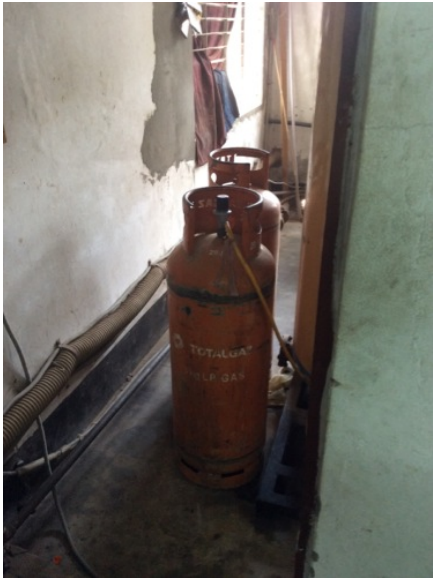
No.	Category	Finding	Recommendation	Remediation Timeframe
F-1	Fire Rated Construction	Hazardous materials storage area is not separated by fire-rated construction openings, non-rated doors and penetrations all present	Separate the hazardous materials / flammable liquid storage room by a minimum 2-hr fire-rated construction. Seal and/or protected all openings to maintain the required fire separations.	Within 3 months

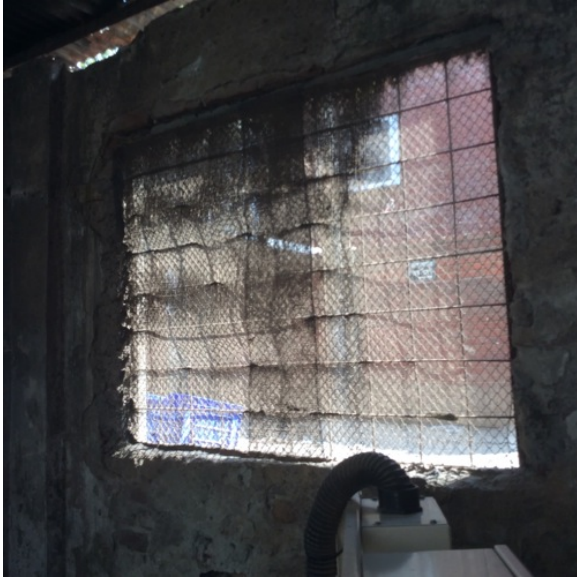
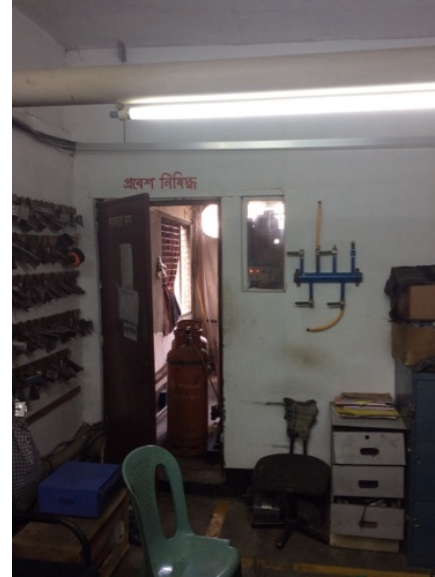
F-2	Fire Rated Construction	The boiler room is not separated by fire-rated construction (openings, non-rated doors, penetrations all present	Separate the boiler room by a minimum 2-hr fire-rated construction. Seal and/or protected all openings to maintain the required fire separations	Within 3 months

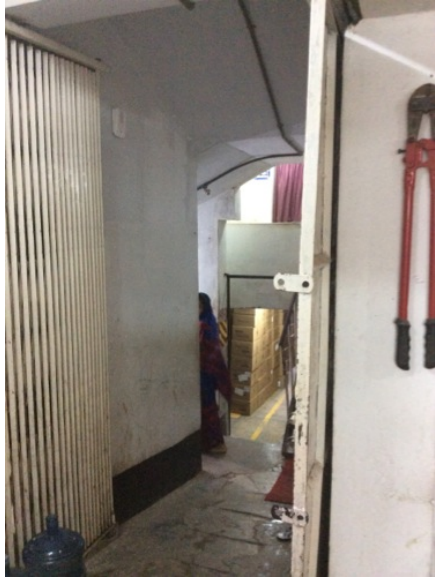
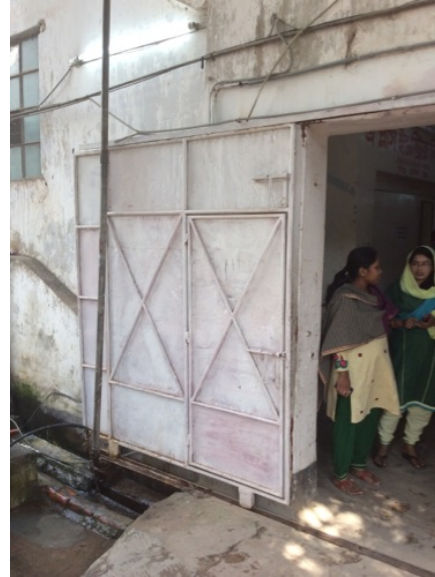
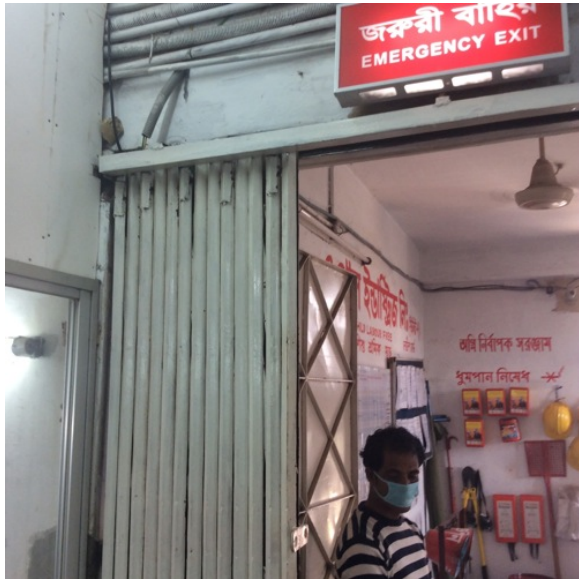
F-3	Fire Rated Construction	The exit stairs are not separated from work areas on each floor by fire-rated construction.	<p>Provide minimum 1.5-hr fire rated doors and seal all unprotected openings to separate the exit stairs from work areas and other building spaces on all floor levels. Ensure that the fire doors are self-closing and positive latching and that they are provided with fire exit (panic) hardware where serving production floors.</p> <p>If fire doors are required to be held open for functional reasons, provide automatic-closing devices tied to the fire alarm system.</p>	Within 3 months
-----	-------------------------	---	--	-----------------

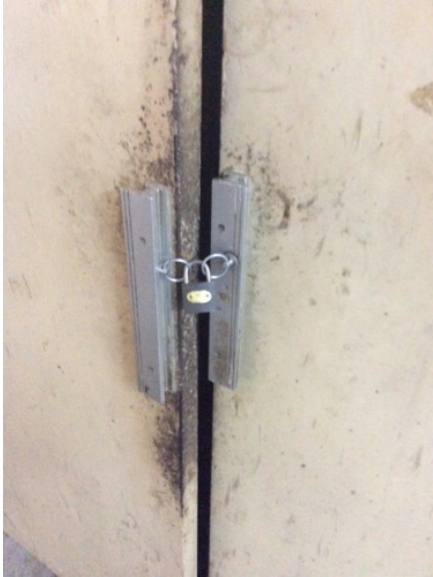
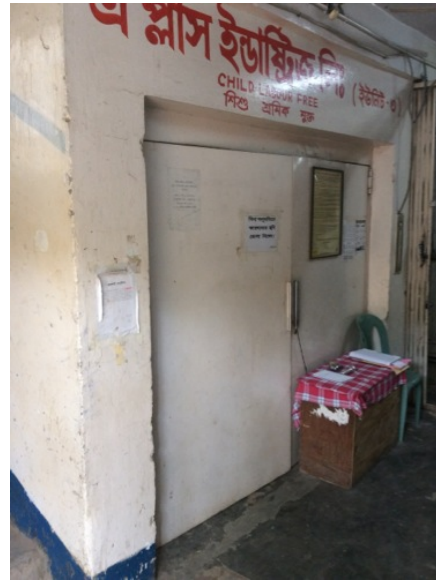
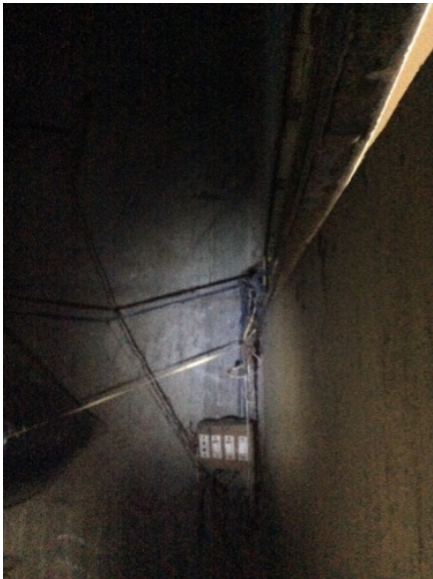
F-4	Fire Rated Construction	Unsealed penetrations and openings are located in exit stair enclosures.	Seal all penetrations and openings in exit stair enclosure walls to maintain the fire separation.	Within 3 months
-----	-------------------------	--	---	-----------------

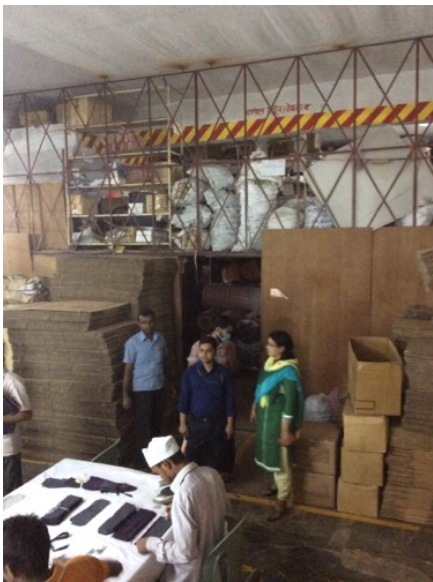
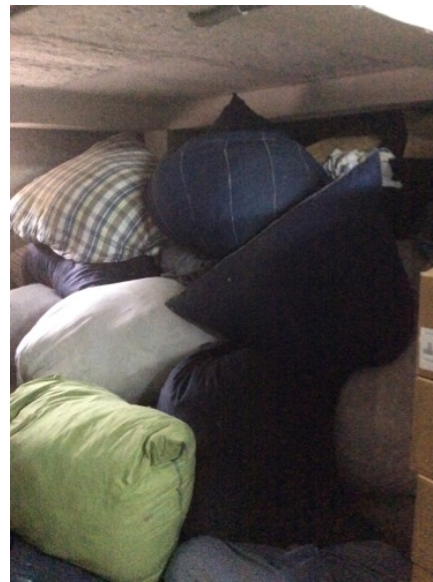
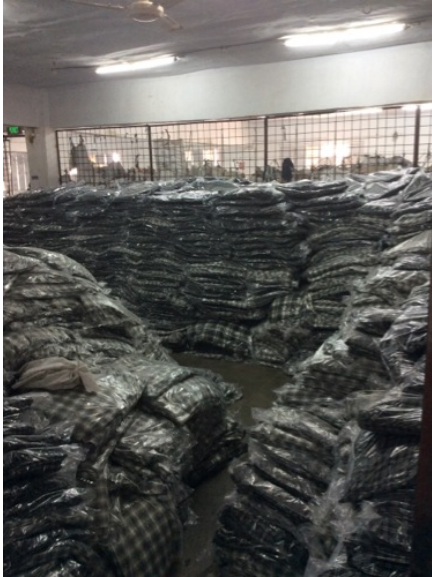
F-5	Fire Rated Construction	Each floor had extensive amounts of fabric and stored goods piled above storage guidelines, Combustible storage is not separated by fire-rated construction throughout factory.	Provide dedicated storage rooms separated by minimum 1-hr fire-rated construction. Where separate storage rooms are not feasible, provide defined storage areas and limit the storage arrangement as follows: - Maximum height of 2.4m and maximum area of 23m ² - If sprinkler protected: maximum height of 3.66m and maximum area of 93m ² Separate areas of unenclosed combustible storage by a minimum clear distance of 3m.	Within 3 months
-----	-------------------------	---	--	-----------------

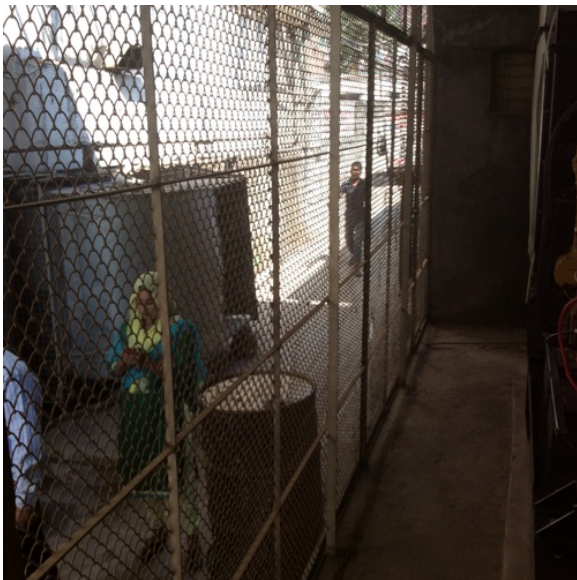
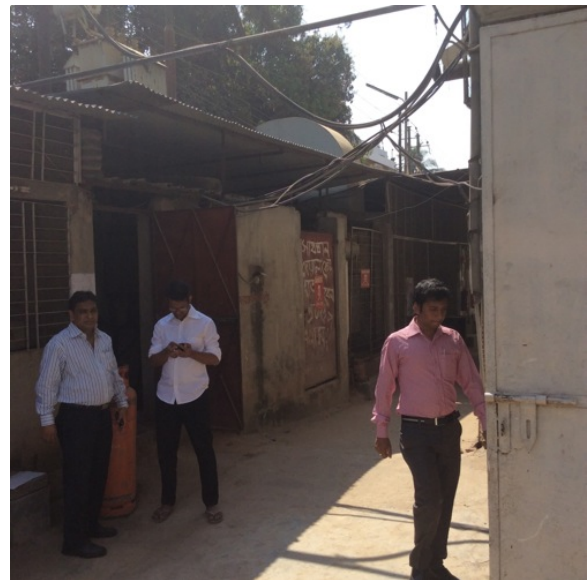
F-6	Fire Rated Construction	The generator and transformer room is not separated by fire-rated construction openings, non-rated doors, penetrations all present.	Separate the generator and transformer room by a minimum 2-hr fire-rated construction. Seal and/or protected all openings to maintain the required fire separations	Within 6 months
		Located at outbuildings

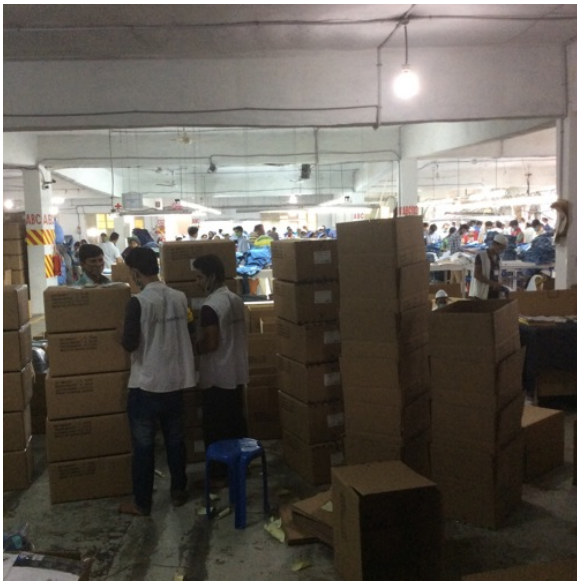
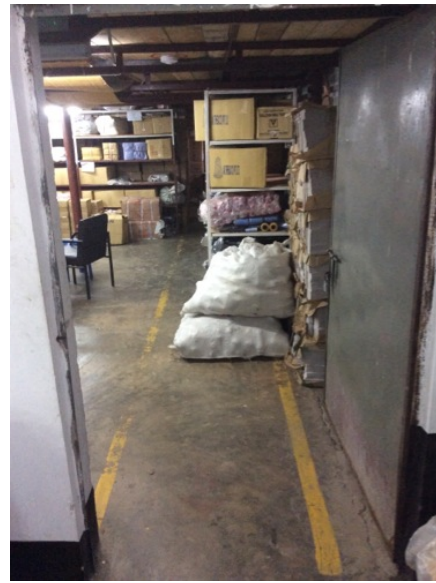
F-7	Egress	Storage was located in the egress paths throughout all of the factory floors, this needs to be kept clear at all times, in cases storage over spilling or above 9ft in height stacked in close proximity with main egress routes most notably basement, ground, fourth and fifth.	Keep egress paths and stairs clear of storage.	Immediate
-----	--------	---	--	-----------

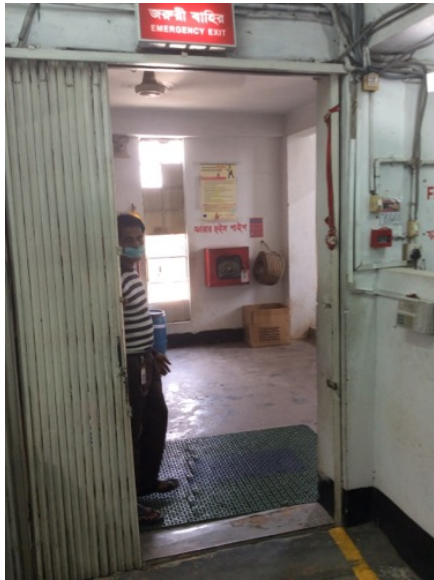
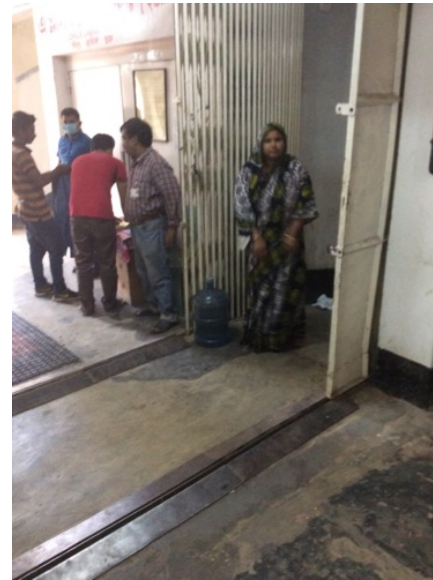
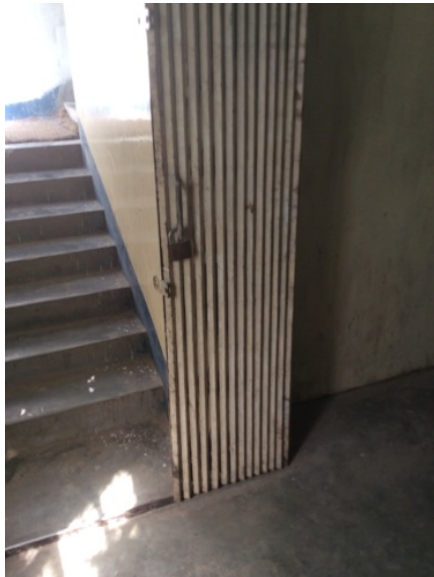
F-8	Egress	Collapsible steel sliding gated doors are provided at building exits, exit stairs, along egress routes on the first floor and main exit discharge at ground level. All egress doors were open with locks in sealed position.	Replace all gates / sliding doors along the means of egress with side-hinged, swinging egress doors. If locks are required for security reasons, utilize special door locking features complying with NFPA 101.	Within 1 month
-----	--------	--	--	----------------

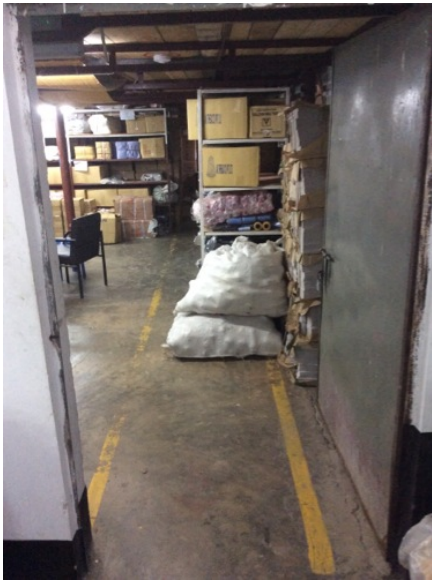
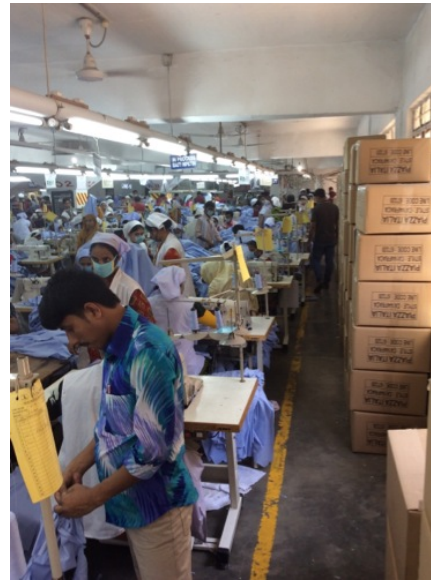
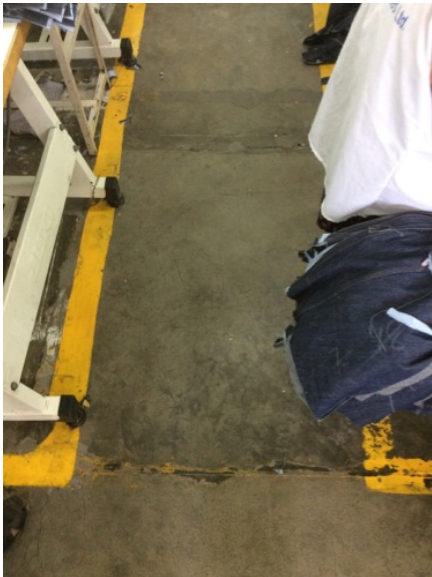
F-9	Egress	The width of egress aisles is less than 36-in at certain locations throughout the factory floors were internal columns meet work station desks	Provide minimum aisle widths of 36-in.	Within 3 months
-----	--------	--	--	-----------------

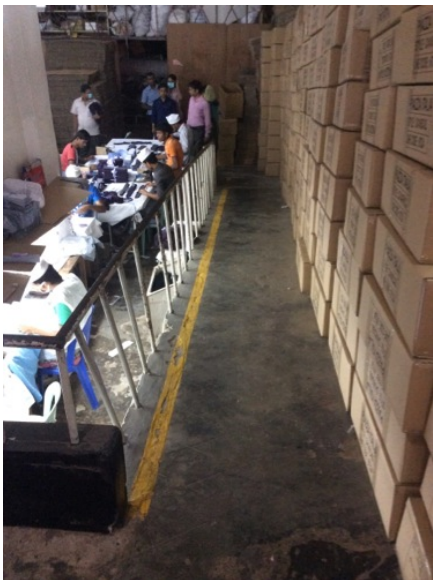
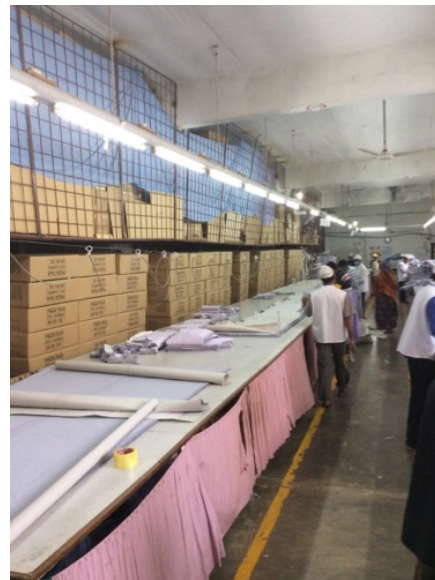
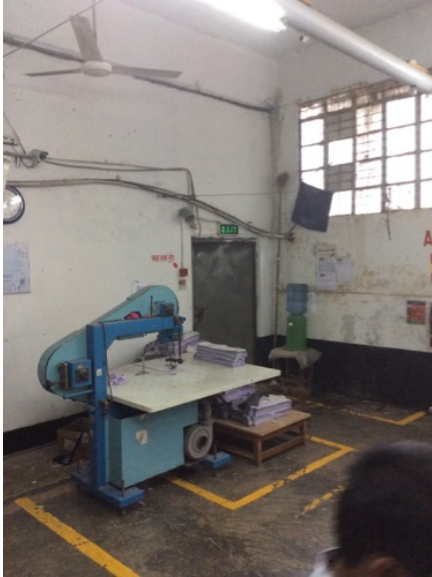
F-11 Egress

Common path of egress travel exceeds 30 m. The Basement/Ground level, the 2 exits to the main egress exit is within 15ft of each other with a common path of travel more than 30m

Reconfigure the egress arrangement to reduce the maximum common path of travel to not more than 30 m.

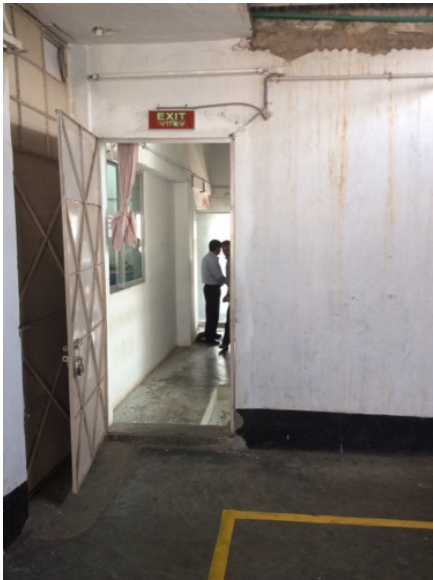
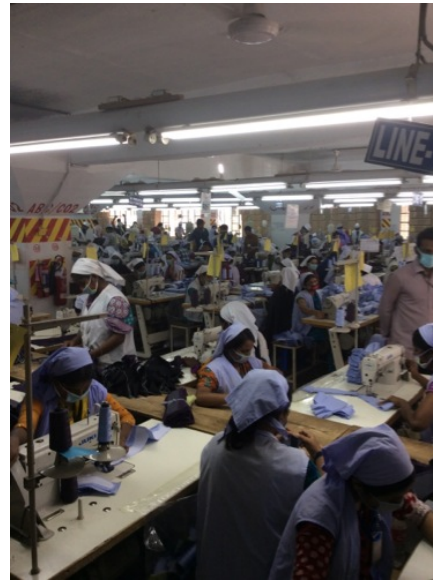
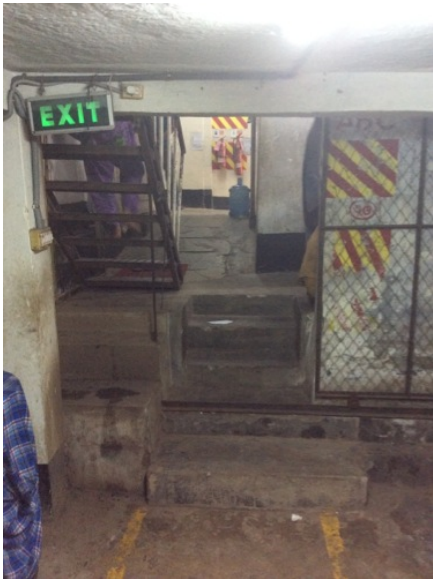
F-12 Egress

Exit capacity is not adequate for the occupant load. Having calculated the exit capacity for each floor, the occupant load is excessively more than allowed due to there being only two main exit stairs and the door widths being narrow on the South most facing stair 5th floor and North most stair 3rd floor.

Specify appropriate upgrade based on conditions:
- Provide additional exits.

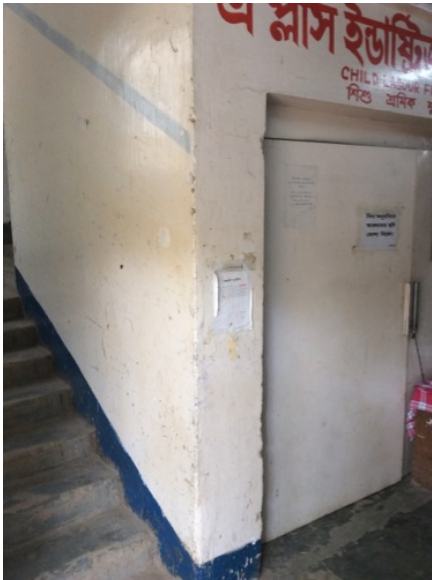
F-13 Egress

Handrails are not provided in either of the exit stairs.

Provide handrails on at least one side of exit stair.

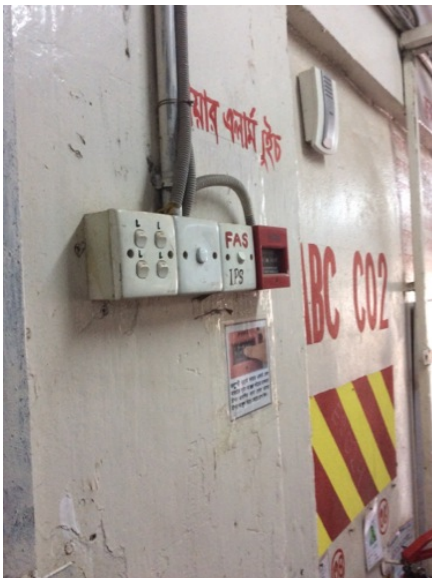
F-14	Fire Protection	The fire alarm system is antiquated, not a listed system, and does not provide alarm and notification features consistent with acceptable standards.	Replace the fire alarm system with a new, listed addressable fire alarm system in accordance with NFPA 72.	Design within 4 months, install within 9 months
------	-----------------	--	--	---

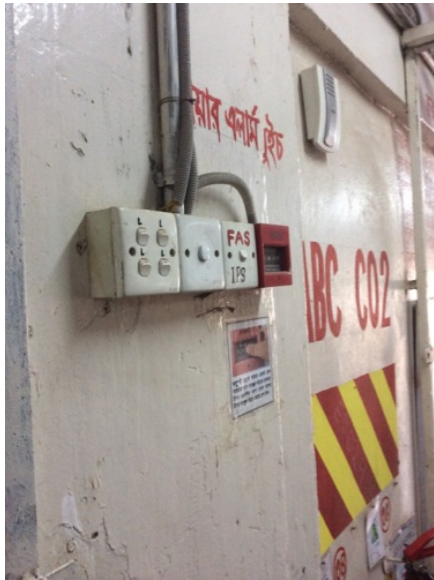
F-15	Fire Protection	Inspection, testing, and maintenance records for the fire alarm system were not available.	Inspect, test and maintain the fire alarm system, and keep written records on-site, in accordance with NFPA 72.	Within 3 months
------	-----------------	--	---	-----------------

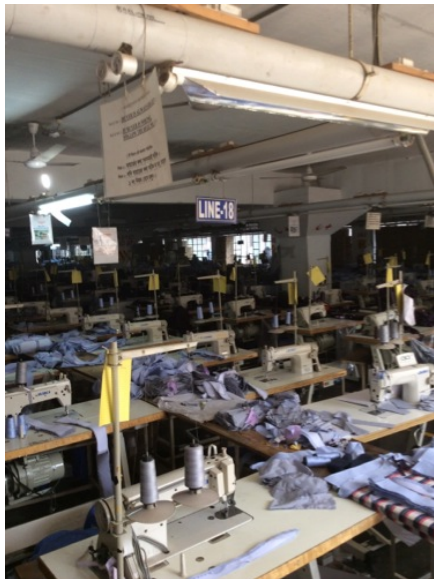
F-16	Fire Protection	The fire alarm system does not appear to provide adequate audible notification coverage.	Provide additional notification appliances such that the fire alarm system is audible throughout the building in accordance with NFPA 72.	Within 6 months
------	-----------------	--	---	-----------------

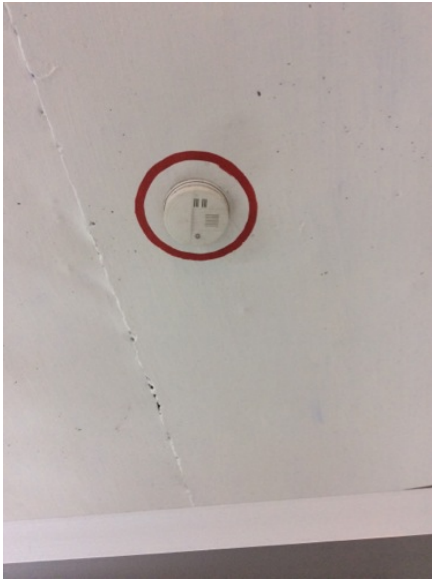
F-17	Fire Protection	The building is equipped with single-station smoke alarms. Smoke alarm activation sounds only a local alarm and does not provide automatic fire alarm notification of occupants.	Replace the single-station smoke alarms with automatic smoke detectors tied into the fire alarm system. Configure the fire alarm system to initiate occupant notification upon activation of any two smoke detectors in addition to the manual fire alarm stations.	Within 6 months
------	-----------------	--	---	-----------------

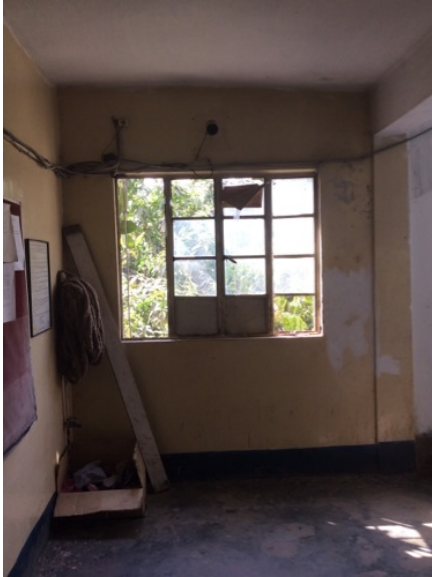
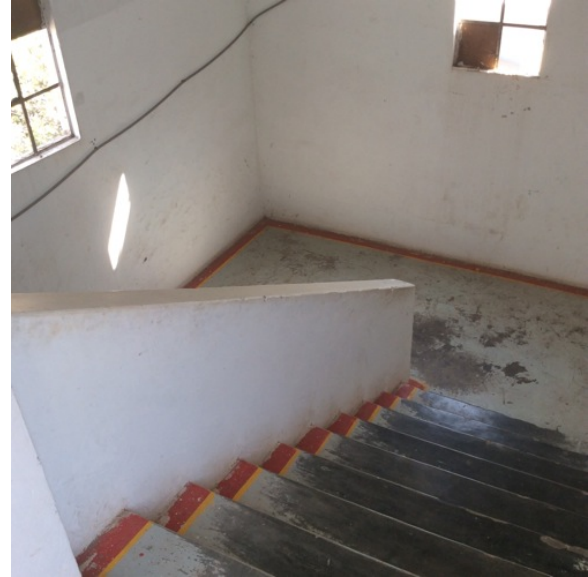
F-18	Egress Lighting	Exit signage was not adequate in line with Bangladesh building regulations throughout factory stairwells and floor plates	Provide exit signs above all exits to the exterior and all doors to the exit stairs.	Within 1 month
------	-----------------	---	--	----------------

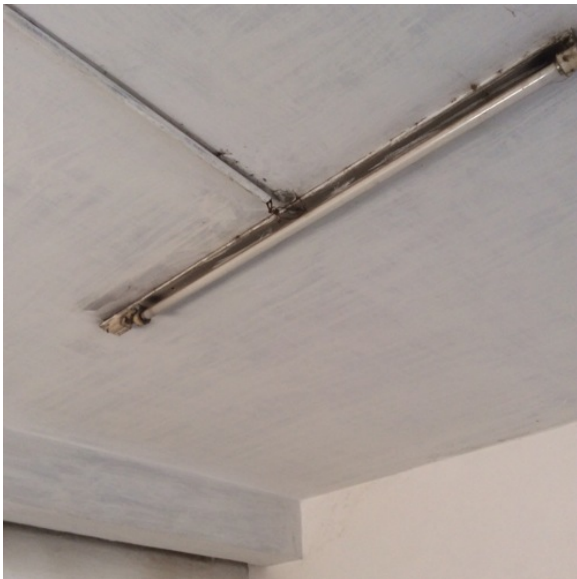
F-19	Egress Lighting	A number of Emergency lights did not function in test mode bulbs possibly burned out, no maintenance schedules provided.	Regularly test the emergency lighting system on each floor and replace/repair lights as needed.	Within 1 month
------	-----------------	--	---	----------------

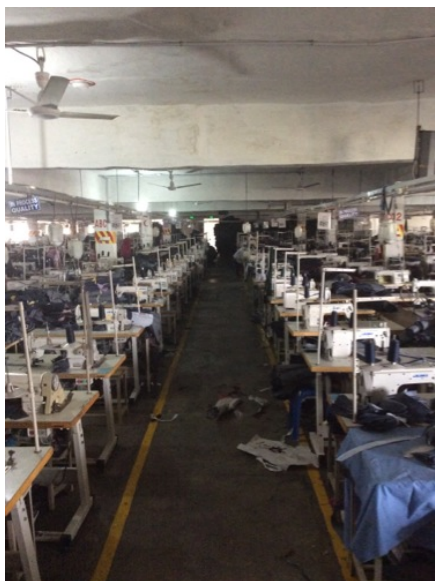
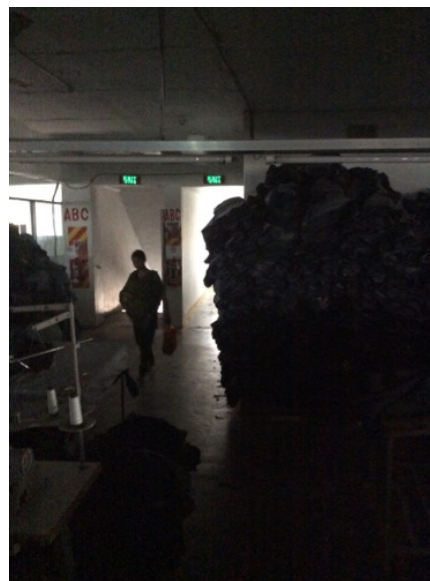
F-20	Egress Lighting	Based on the number and location of emergency lights observed, adequate illumination levels are not anticipated along egress routes throughout factory floors, the lighting on exit routes was sufficient however on floor plates the lighting was not adequate for safe egress.	Test the emergency lighting system on each floor and provide additional emergency fixtures to provide adequate illumination along the means of egress. Provide a minimum illumination of 10 lux at the floor level within exit stairs and exit discharge paths and minimum 2.5 lux along exit access aisles.	Within 3 months
------	-----------------	--	--	-----------------
