Parkscene Bangladesh Ltd

Mouza Kunia . JL No,. 406, Gazipur Sadar. Gazipur

(23.934767N, 90.387349E)
20th April 2014

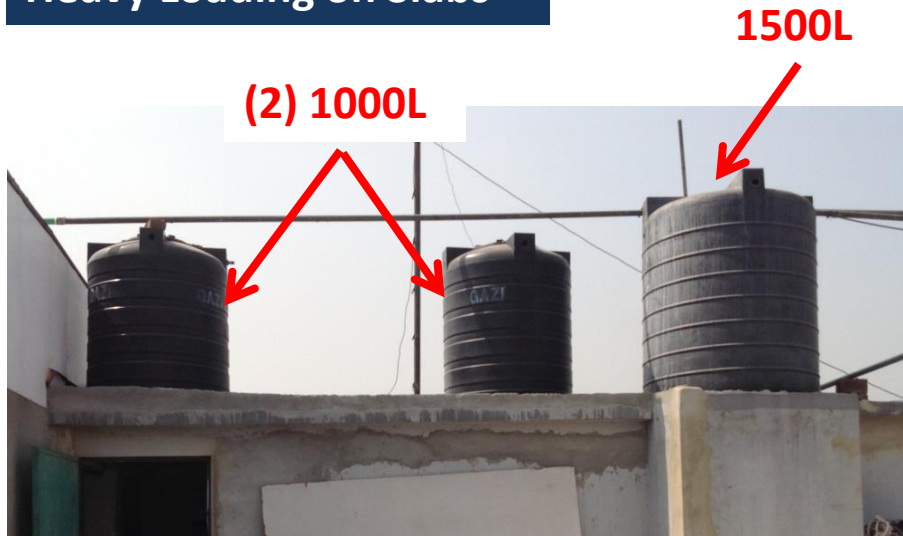
Water tanks on roof slab

Heavy loading was observed in several locations on floor and roof slabs:

16	Water tanks on stair core roof	Engineer to check roof slab and columns under tanks	6-weeks
17	Water tanks on stair core roof	Move tanks if required to suitable location following Engineers study if required	6-months

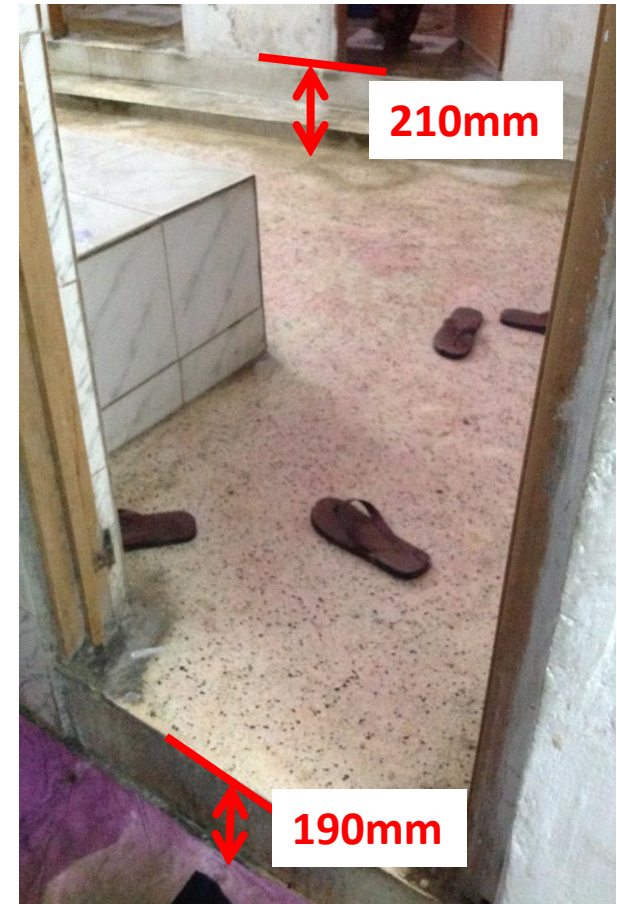
Toilet Areas

Heavy dead load due to toilet build-up

Item No.	Observation	Recommended Action Plan	Recommended Timeline
10	Heavy loading due to build up of material in toilets	As part of the DEA (see Item1)Engineer to carry out calculations to justify floor slab in the area of the toilets. Large build up of load noted as a result of raised floor	Immediate - Now
11	Heavy loading due to build up of material in toilets	Complete assessment	6-weeks
12	Heavy loading due to build up of material in toilets	Carry out alterations as a result of the engineering study	6-months
13	Non – permitted additional storey and associated non engineered structure	As-built documents to be completed as part of DEA	6-weeks
14	Non – permitted additional storey and associated non engineered structure	Engineer inspect and design and detail remedial works	6-weeks
15	Non – permitted additional storey and associated non engineered structure	Carry out remedial works as required	6-months

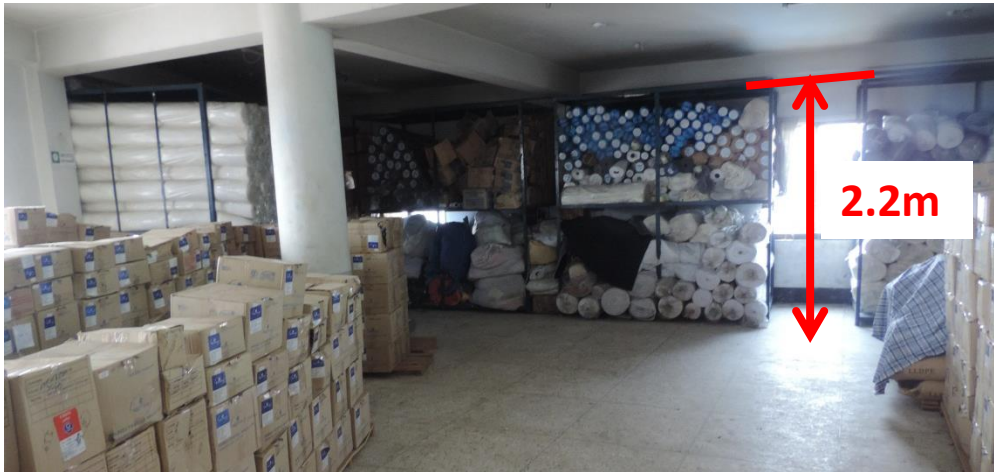
Storage areas

5 kN/m²
estimated live load

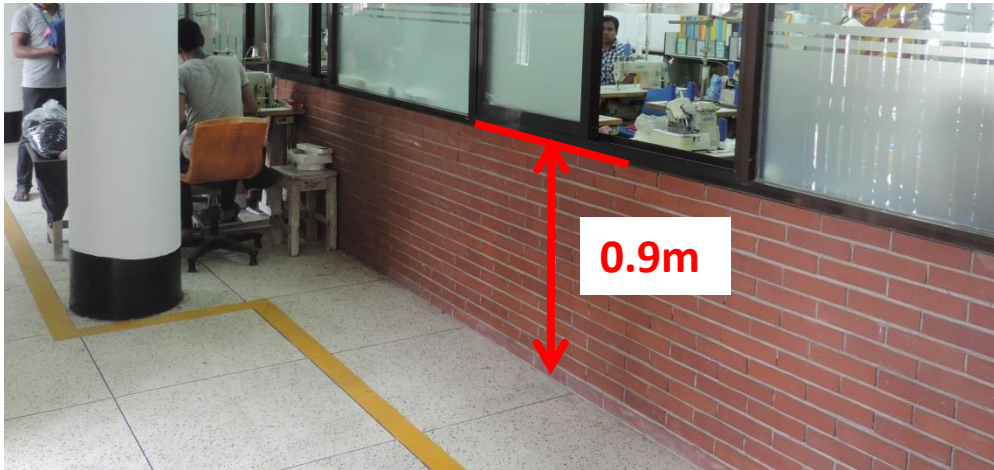
Masonry partition walls

2 kN/m estimated
superimposed dead load

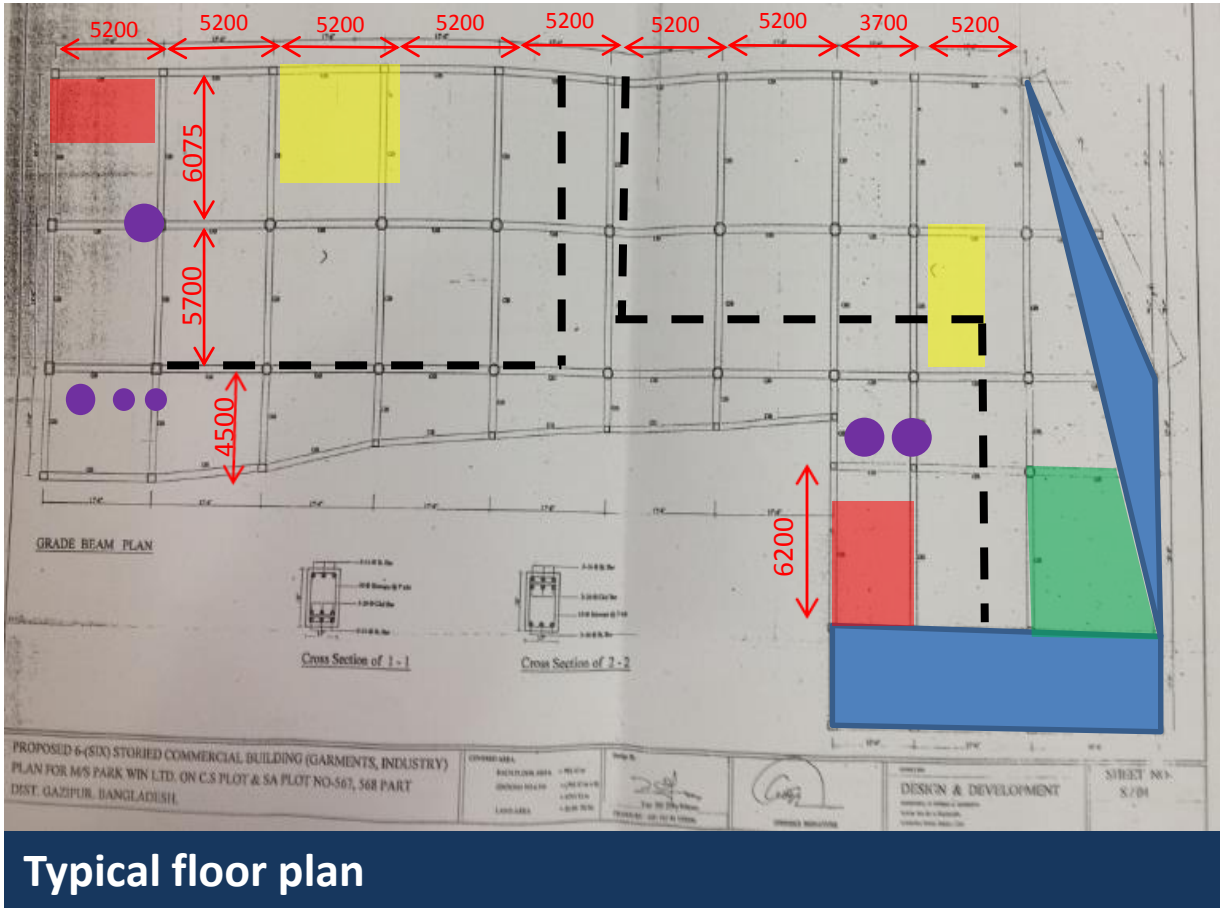
- Not Built**
- Toilet Areas
Ground – 5th Floor**
- Storage Areas
Ground – 5th Floor**
- Storage Areas
4th Floor**
- Masonry Partition
2nd Floor**
- Water tank
Stair Roof, 6th Floor**

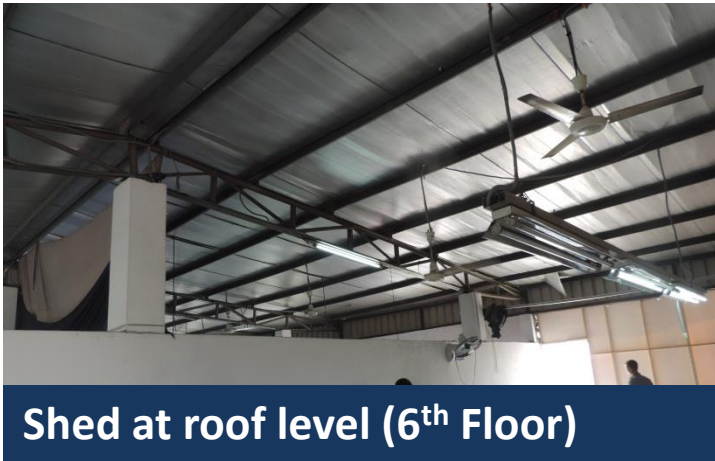
A shed roof has been erected over the former R.C. roof to create a usable floor space at the roof level (6th Floor), so the building now has seven (7) occupied storeys. The Building Permit is for a 6-storey building. The 6th Floor is currently being used for sewing and prayer, and it has also been used for dining.

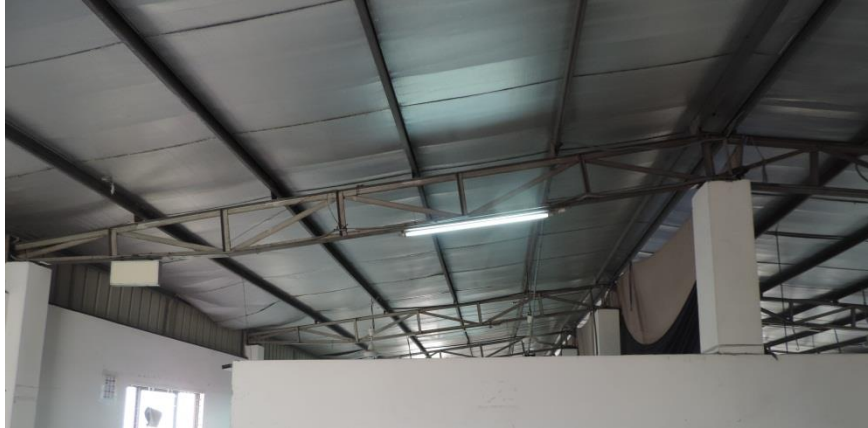
Lack of horizontal bracing in roof

Two observations of the roof shed require engineering verification:

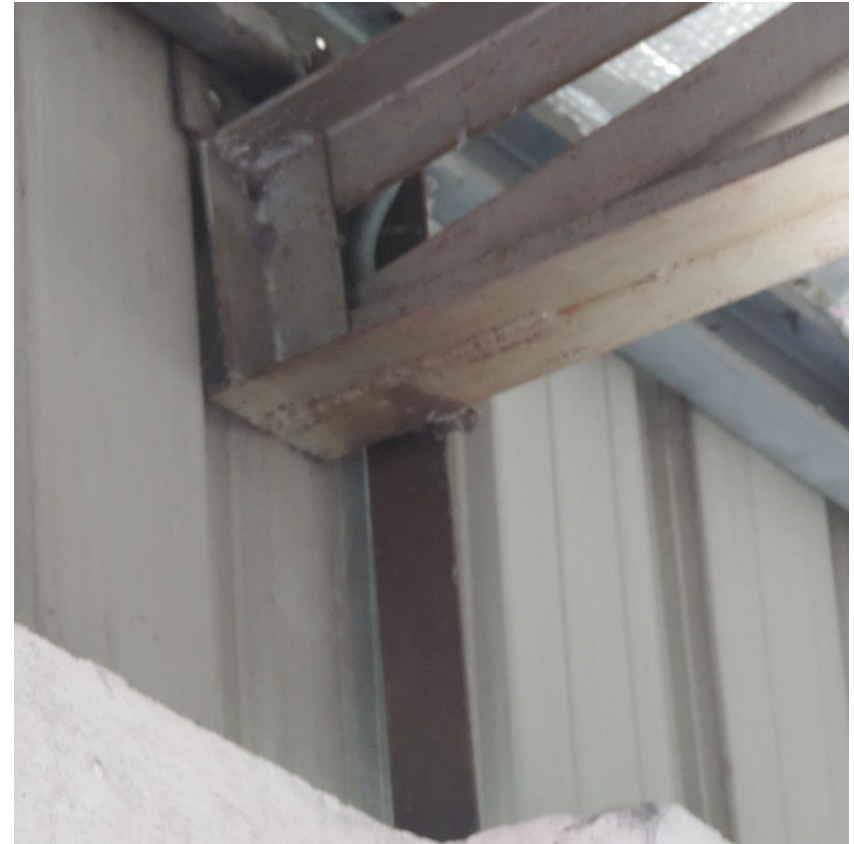
Non-engineered connection to column

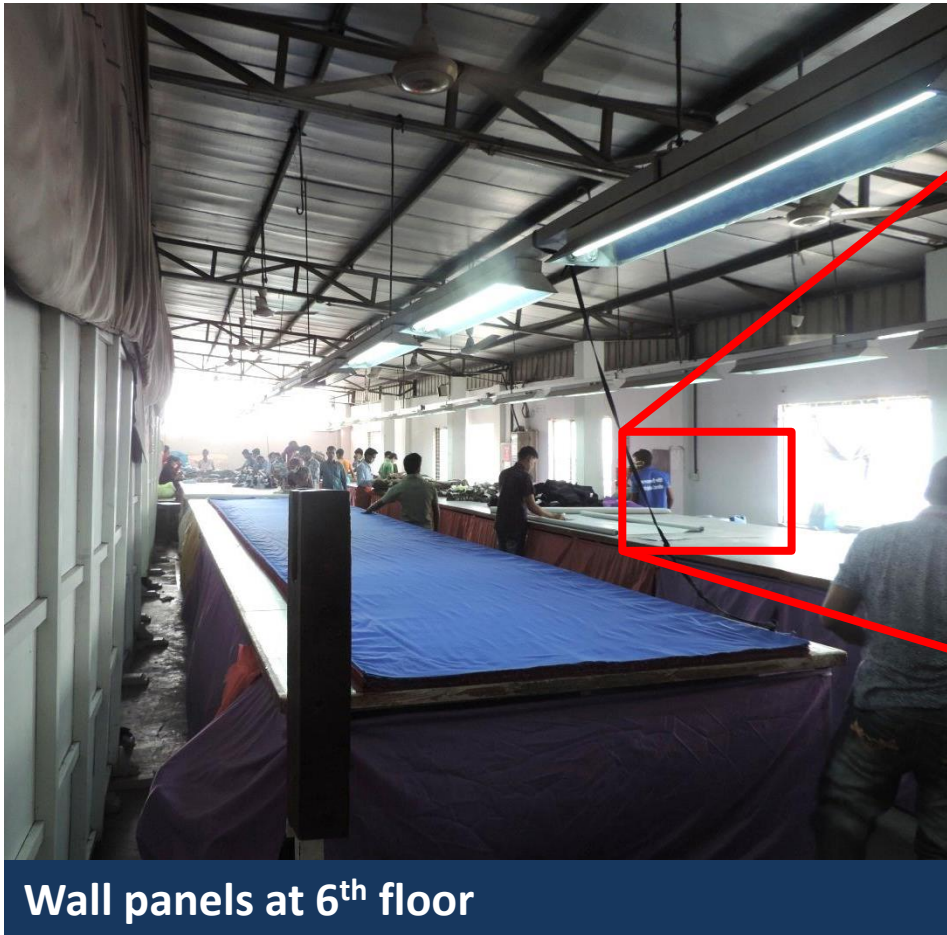
Wall panels at 6th floor

A crack was observed in the masonry wall panel below a window between the roof trusses at the 6th floor.
This was an isolated area

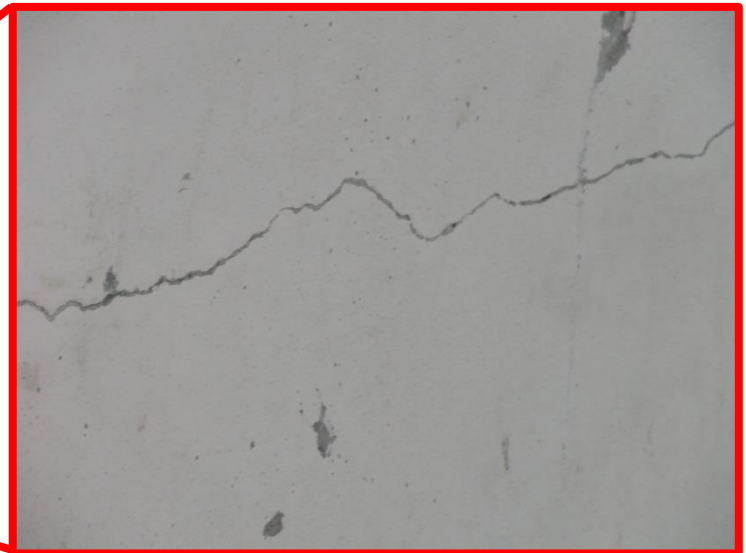
Crack in wall panel

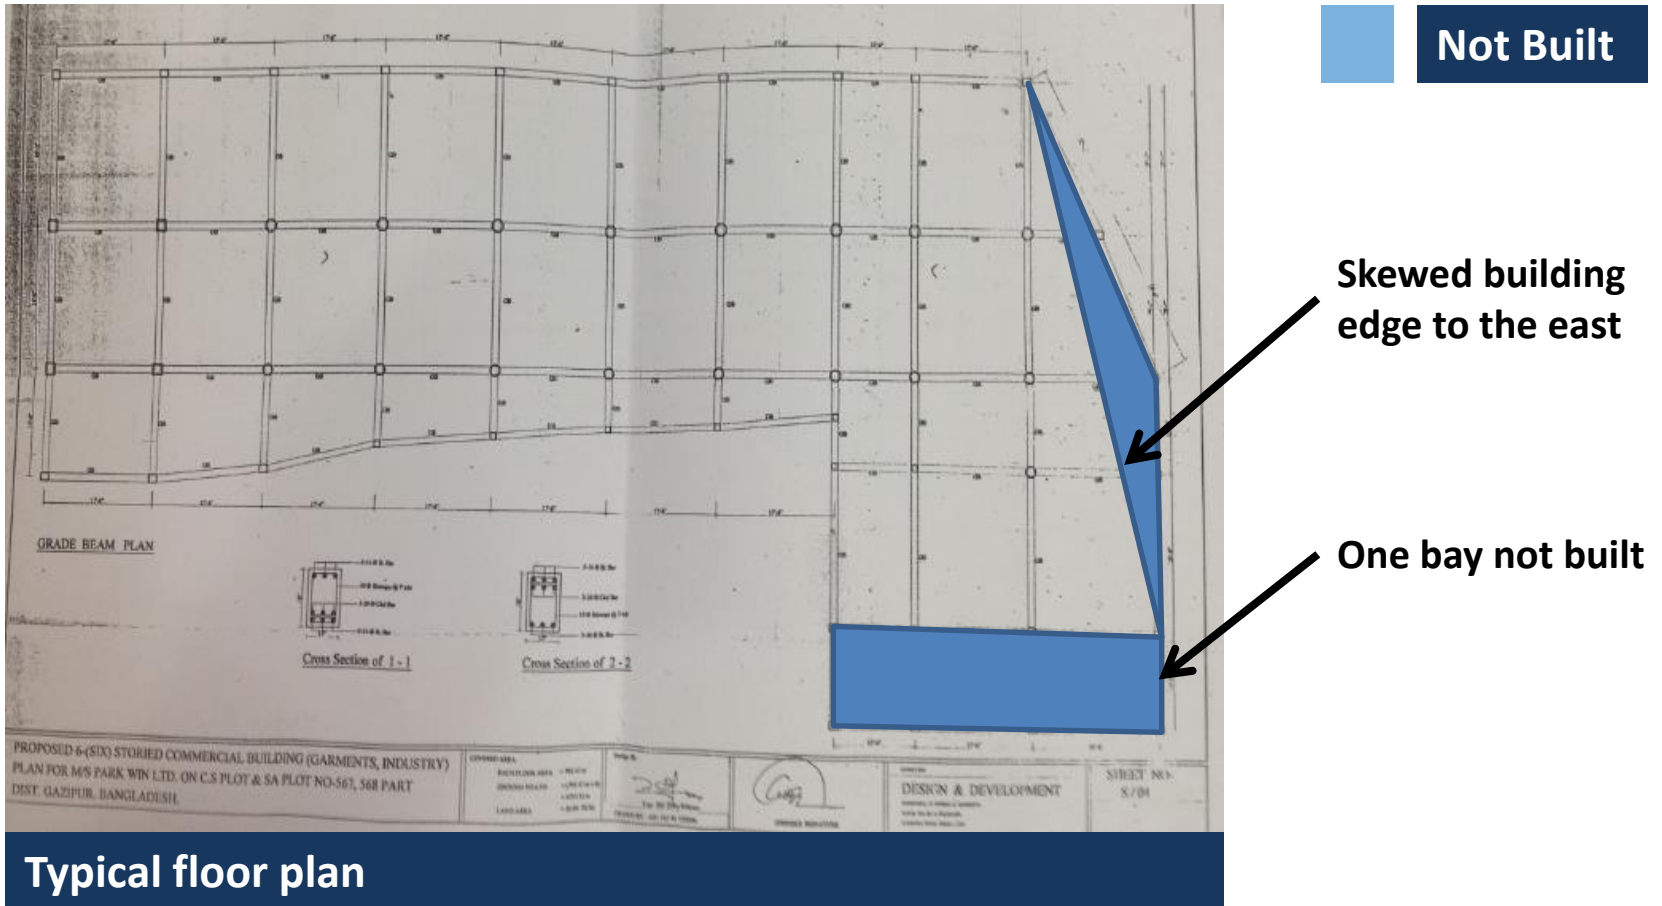
The typical floor plan which was built differs from the Permit Drawings. One bay at the south end of the building was not built, and the profile of the building edge to the east is skewed.

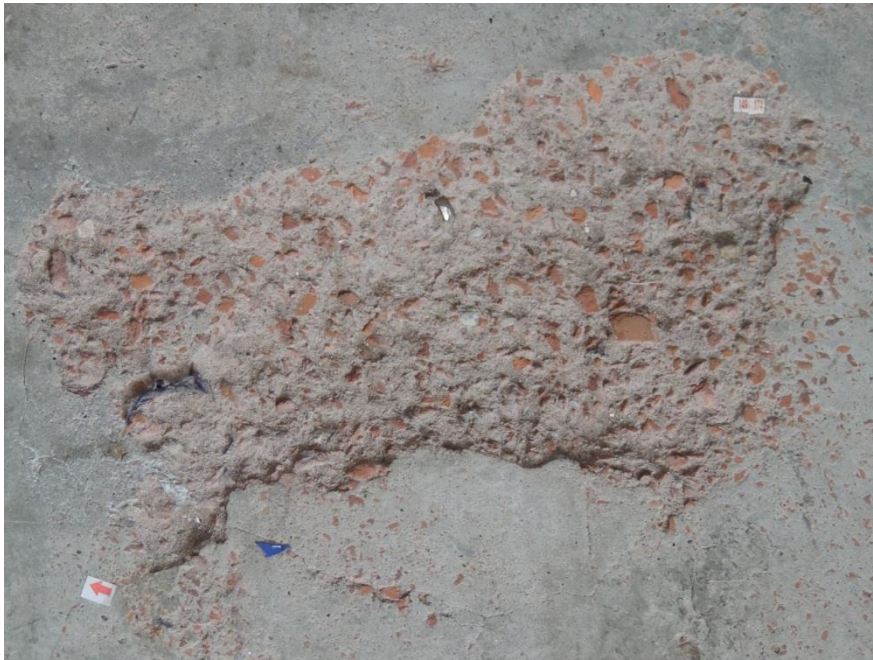
Brick aggregate was observed in the 6th Floor slab and in columns at the Ground Floor.

Brick aggregate in slab

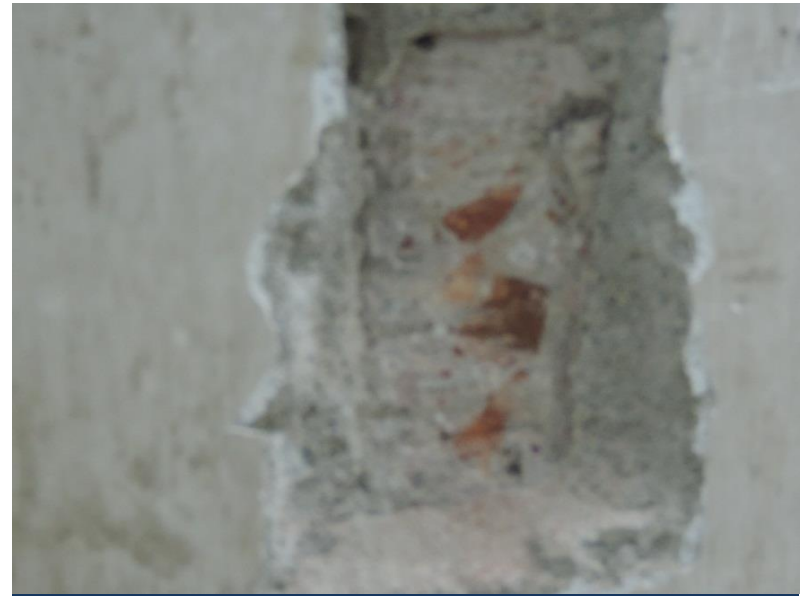
Brick aggregate in column

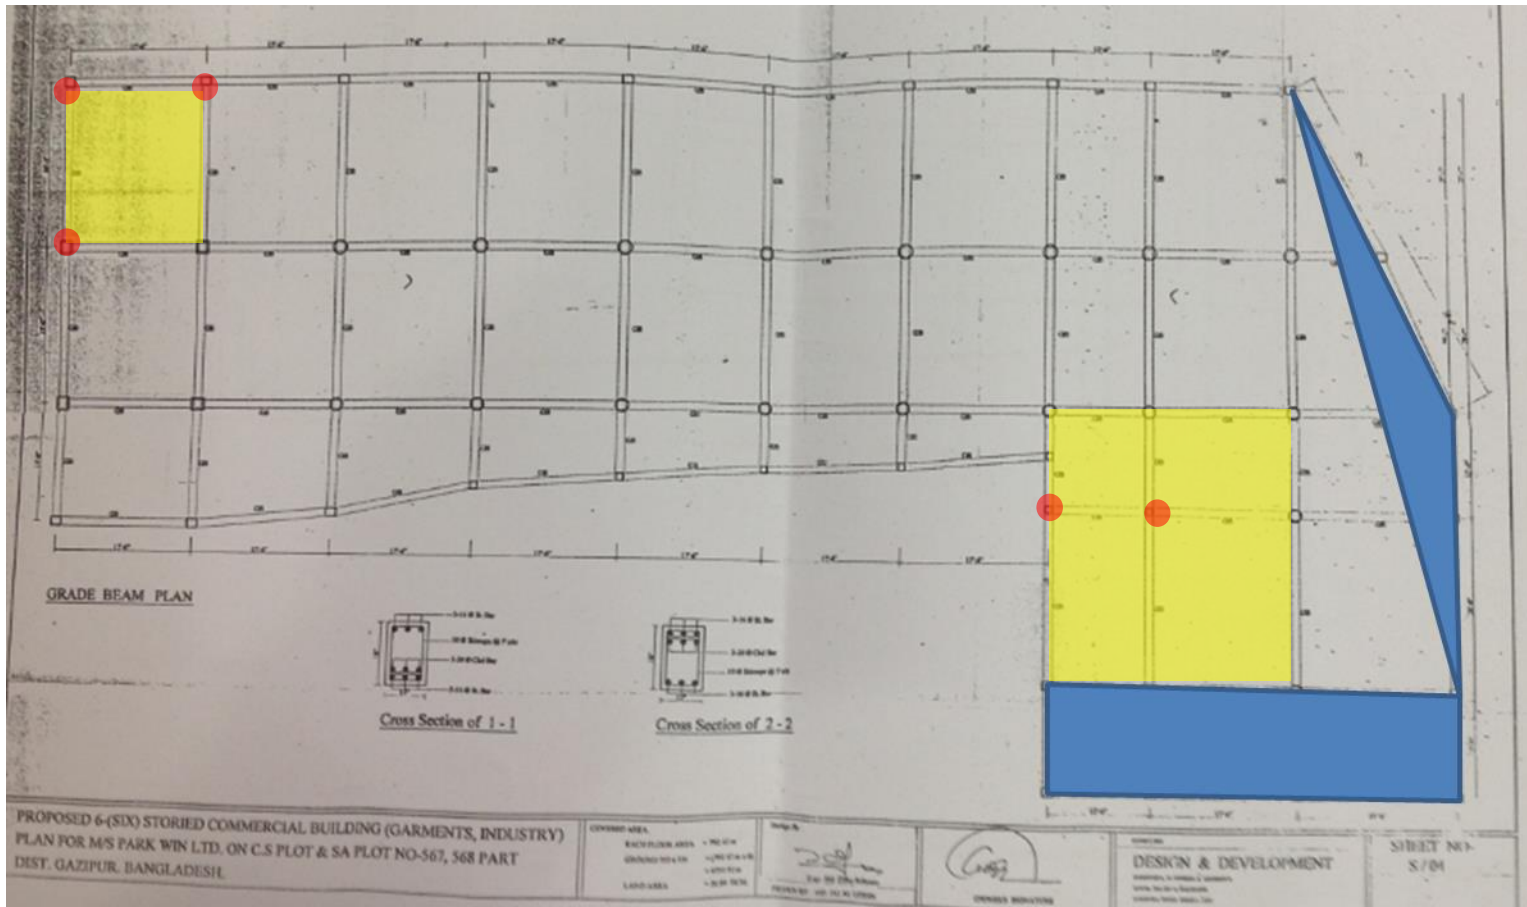
Heavy loaded columns

- Heavy Loaded columns
- Area where loading is not to exceed 1.0kN/m² prior to completion of DEA

Item No.	Observation	Recommended Action Plan	Recommended Timeline
1	Heavily loaded columns in toilet areas	Live load to be controlled as per limits on following page	Immediate - Now
2	Heavily loaded columns in toilet areas	Detail Engineering Assessment of as-built structure to be commenced as per attached scope.	Immediate - Now
3	Heavily loaded columns in toilet areas	Verify insitu concrete strengths (using min. 4 no. 100mm dia. Cores and/or assessment of available concrete strength data) and existing reinforcement for all columns	Immediate - Now
4	Heavily loaded columns in toilet areas	Detail Engineering Assessment to be completed	6-weeks
5	Heavily loaded columns in toilet areas	Produce and actively manage a loading plan for all floor plates within the factory giving consideration to floor capacity and column capacity.	6-weeks
6	Heavily loaded columns in toilet areas	Make alterations to the toilets as required.	6-weeks

7	Heavily loaded columns in toilet areas	Continue to implement load plan for all floor plates within the factory.	6-months
8	Heavy loading noted in isolated areas of some floor plates	Building engineer to produce loading plans to be displayed at each floor level.	6-weeks
9	Heavy loading noted in isolated areas of some floor plates	Factory manager to actively manage floor usage in accordance with the loading plan.	6-months
