FIRE SAFETY INSPECTION REPORT

TEMAKAW FASHION LIMITED
808/1-2, BEGUM ROKEYA SHARONI, SHEWRAPARA,
MIRPUR

ACCORD
on Fire and Building Safety in Bangladesh

April 26, 2014

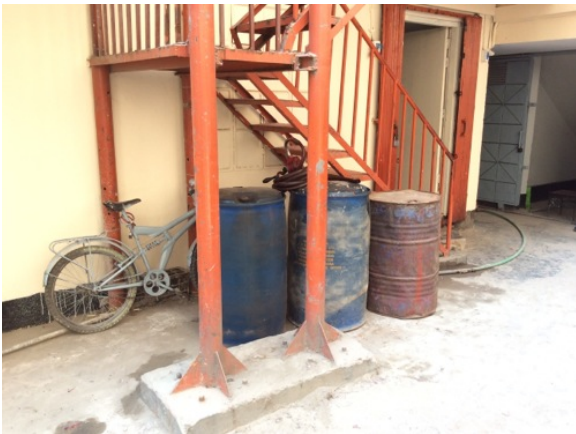
No.	Category	Finding	Recommendation	Remediation Timeframe
F-1	Fire Rated Construction	Barrels of diesel fuel were stored at the base of the exterior fire escape.	<p>Immediately remove all combustible liquid storage from under the fire escape.</p> <p>Move all flammable and combustible liquid storage to a separate room with a minimum 2-hr fire-rated construction. Seal and/or protected all openings to maintain the required fire separations.</p>	Immediate

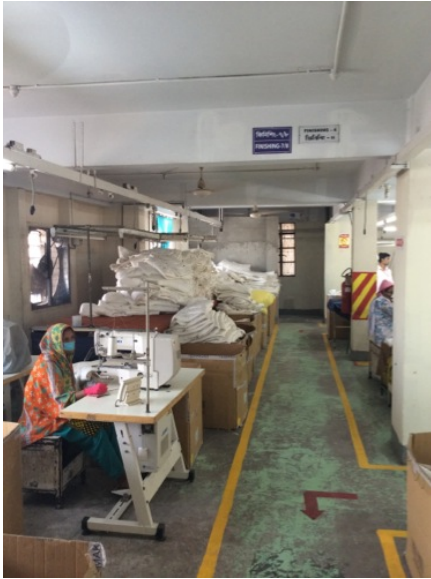
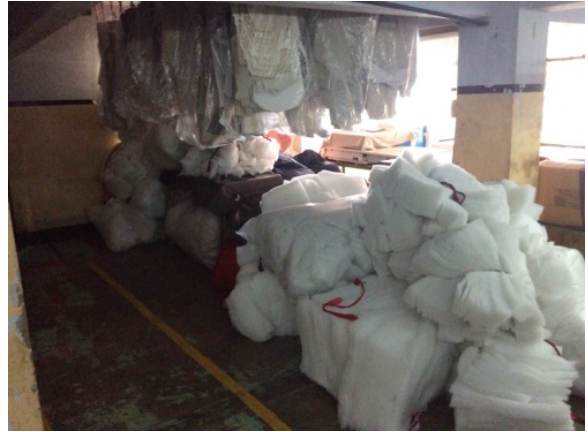
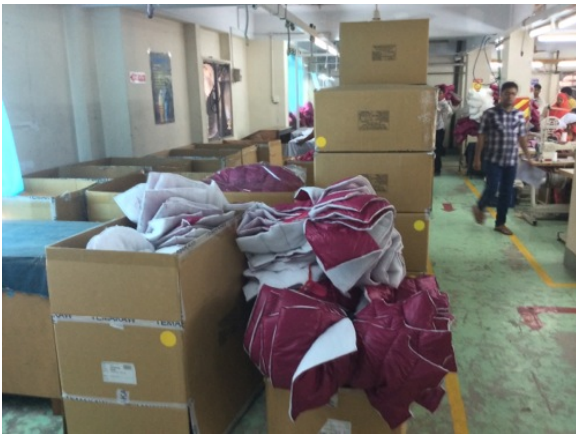
F-2	Fire Rated Construction	Unseparated large quantity storage areas were present on most floors.	<p>Provide dedicated storage rooms separated by minimum 1-hr fire-rated construction.</p> <p>Where separate storage rooms are not feasible, provide defined storage areas and limit the storage to a maximum height of 2.4m and maximum area of 23m².</p>	Within 3 months
-----	-------------------------	---	--	-----------------

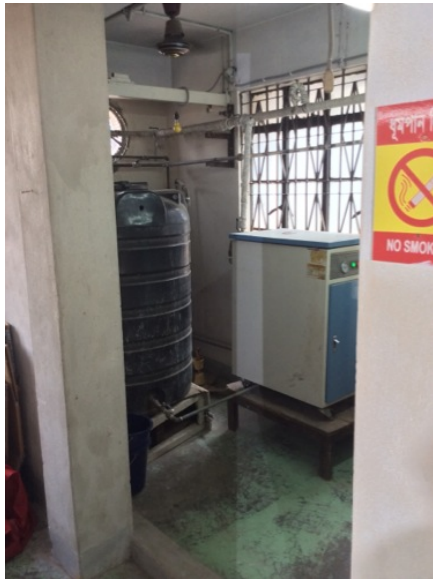
F-3	Fire Rated Construction	The boilers were not separated by fire-rated construction and were open to factory floors on floors 2,3,6.	Separate the boiler by a minimum 2-hr fire-rated construction. Seal and/or protected all openings to maintain the required fire separations	Within 3 months
-----	-------------------------	--	---	-----------------

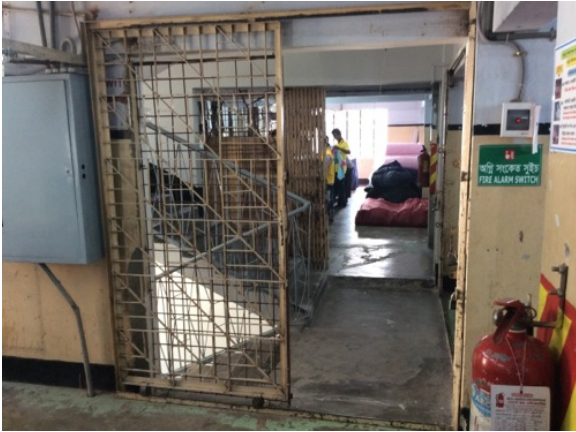
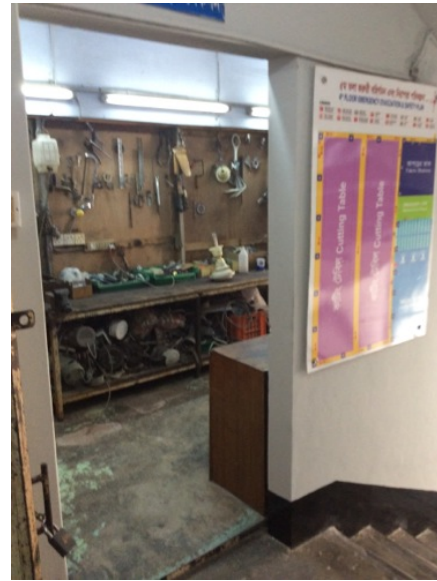
F-4	Fire Rated Construction	The exit stairs are not separated from work or storage areas on each floor by fire-rated construction.	Provide minimum 1.5-hr fire rated doors and seal all unprotected openings to separate the exit stairs from work areas and other building spaces on all floor levels. Ensure that the fire doors are self-closing and positive latching and that they are provided with fire exit (panic) hardware where serving production floors.	Within 3 months
			If fire doors are required to be held open for functional reasons, provide automatic-closing devices tied to the fire alarm system.

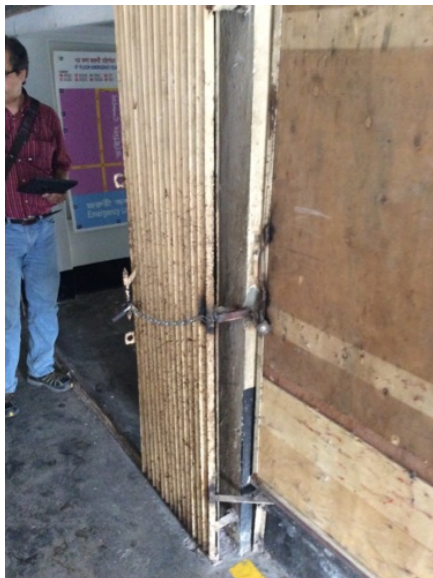
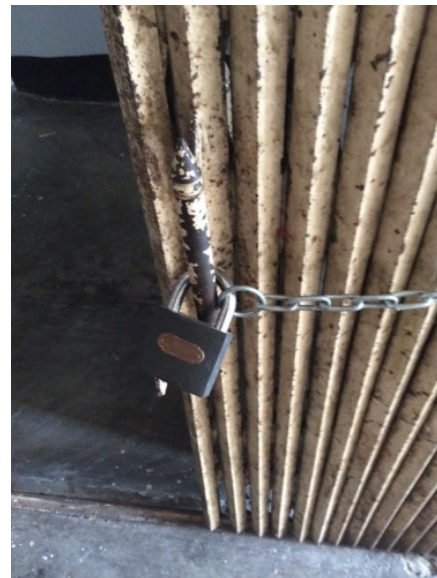
F-5 Egress

Egress doors and gates with locking features are provided at building exits, exit stairs, along egress routes, and at exit discharge at various locations throughout the building. All gates/doors were open and unlocked during the inspection.

Remove locking features from all egress doors and gates.

If locks are required for security reasons, utilize special door locking features complying with NFPA 101.

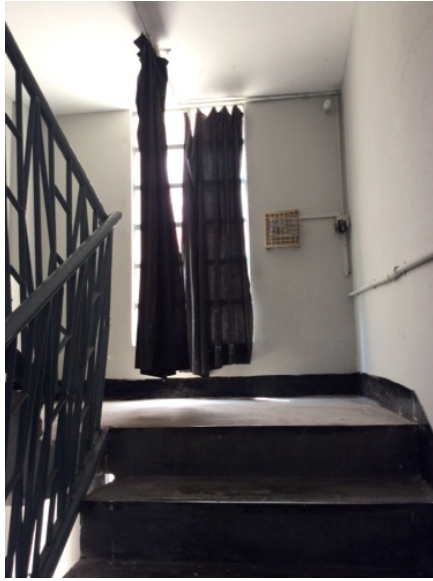
F-6 Egress

Curtains were located in exit stairs on the ground floor landing, serving as a check station.

Remove all curtains from exit stairs, as they are combustible and can impede egress.

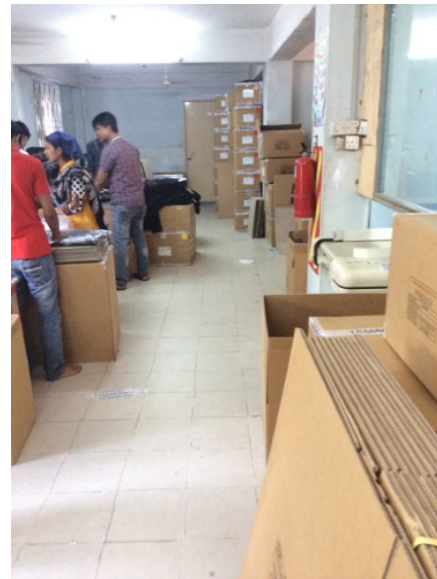
F-7	Egress	Storage was located in the egress path, specifically in the first floor packing area.	Keep egress paths and stairs clear of storage.	Immediat
-----	--------	---	--	----------

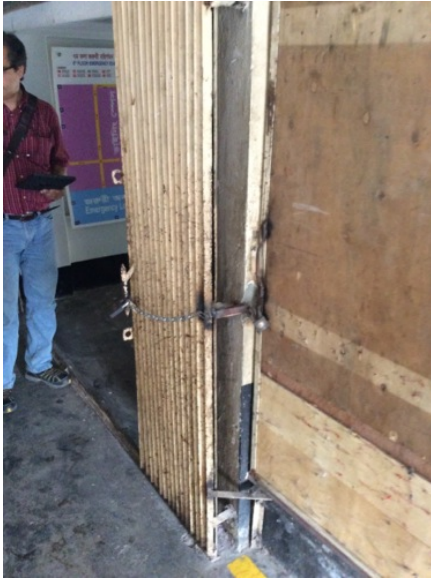
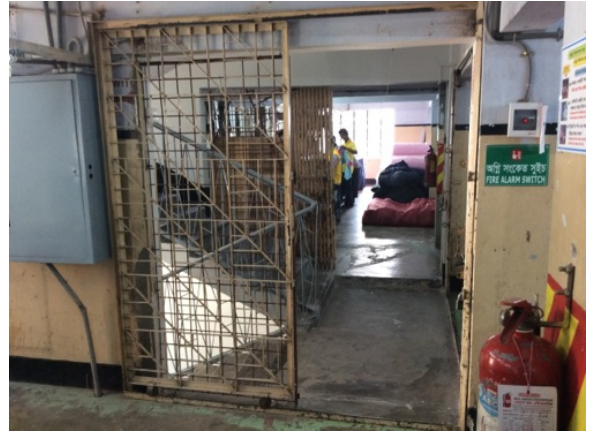
F-8	Egress	Collapsible gates are provided at building exits, exit stairs, along egress routes, and at exit discharge at various locations throughout the building.	Replace all gates / sliding doors along the means of egress with side-hinged, swinging egress doors. If locks are required for security reasons, utilize special door locking features complying with NFPA 101.	Within 1 month
-----	--------	---	--	----------------

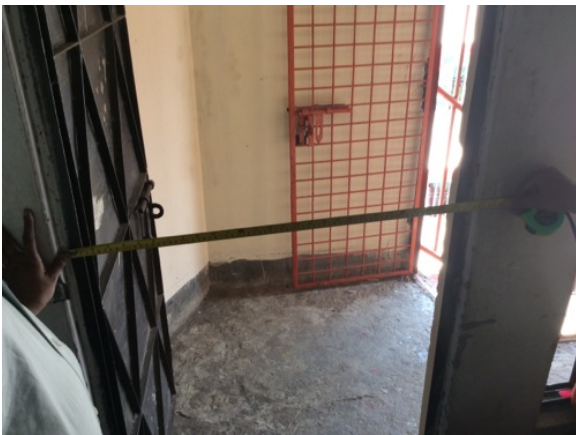
F-9	Egress	Egress doors at fire escape and between building sections swing opposite the direction of egress.	Modify the egress door to swing in the direction of egress travel.	Within 3 months
-----	--------	---	--	-----------------

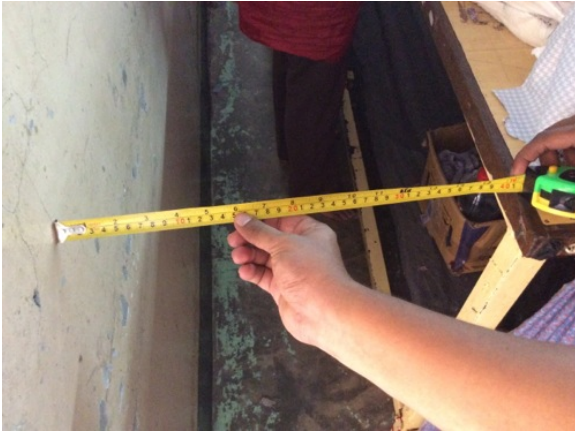
F-10	Egress	The width of egress aisles is less than 36-in between the cutting tables and the wall in all cutting locations.	Provide minimum aisle widths of 36-in.	Within 3 months
------	--------	---	--	-----------------

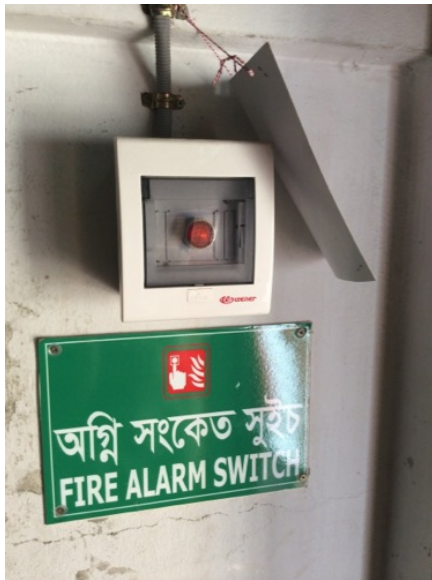
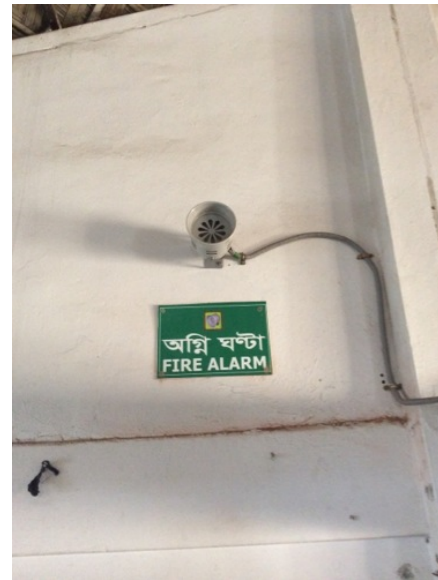
F-11	Fire Protection	The fire alarm system is antiquated, not a listed system, and does not provide alarm and notification features consistent with acceptable standards.	Replace the fire alarm system with a new, listed addressable fire alarm system in accordance with NFPA 72.	Design within 4 months, install within 9 months
------	-----------------	--	--	---

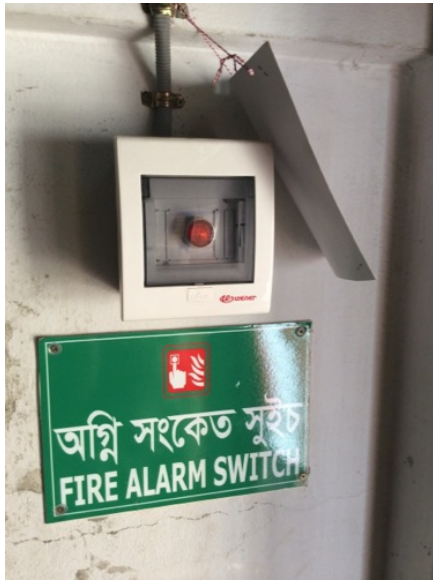
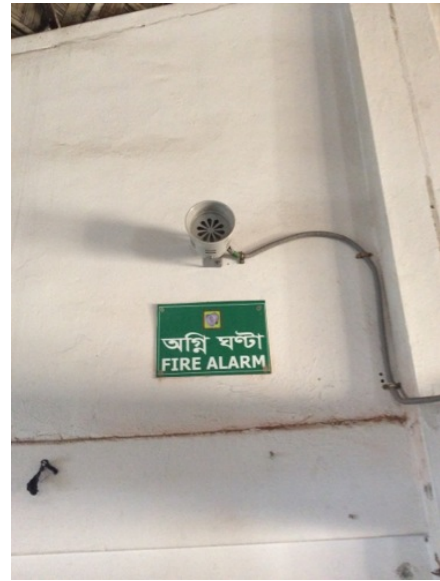
F-12	Fire Protection	Inspection, testing, and maintenance for the fire alarm system was not in accordance with NFPA 72.	Inspect, test and maintain the fire alarm system, and keep written records on-site, in accordance with NFPA 72.	Within 3 months
------	-----------------	--	---	-----------------

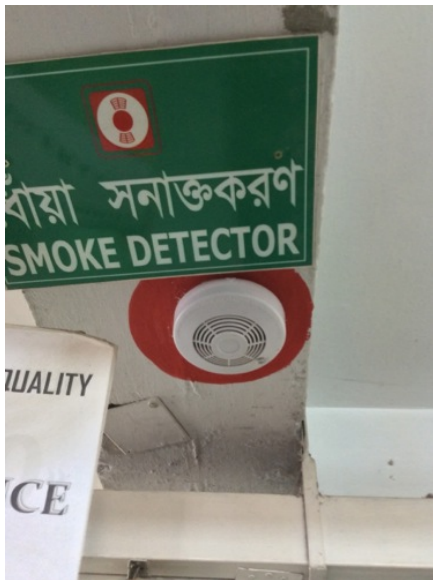
F-13	Fire Protection	The building is equipped with single-station smoke alarms. Smoke alarm activation sounds only a local alarm and does not provide automatic fire alarm notification of occupants.	Replace the single-station smoke alarms with automatic smoke detectors tied into the fire alarm system. Configure the fire alarm system to initiate occupant notification upon activation of any two smoke detectors in addition to the manual fire alarm stations.	Within 6 months
------	-----------------	--	---	-----------------

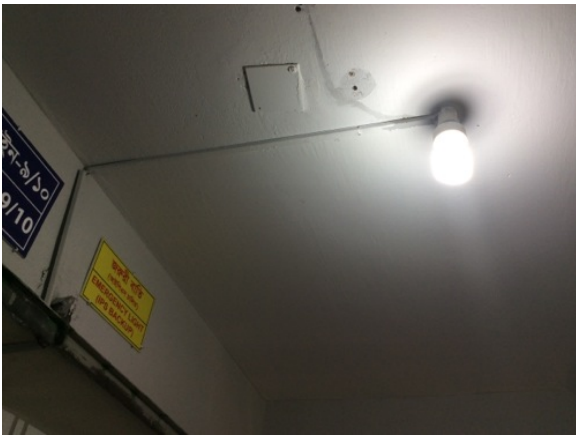
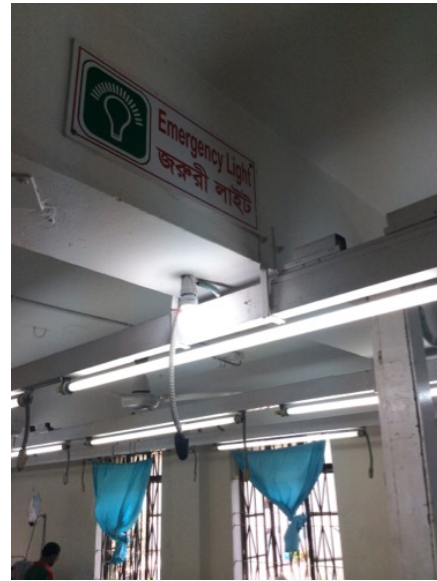
F-14	Egress Lighting	Based on the number and location of emergency lights observed, adequate illumination levels are not anticipated along egress routes on all floors.	Test the emergency lighting system on each floor and provide additional emergency fixtures to provide adequate illumination along the means of egress. Provide a minimum illumination of 10 lux at the floor level within exit stairs and exit discharge paths and minimum 2.5 lux along exit access aisles.	Within 3 months
------	-----------------	--	--	-----------------

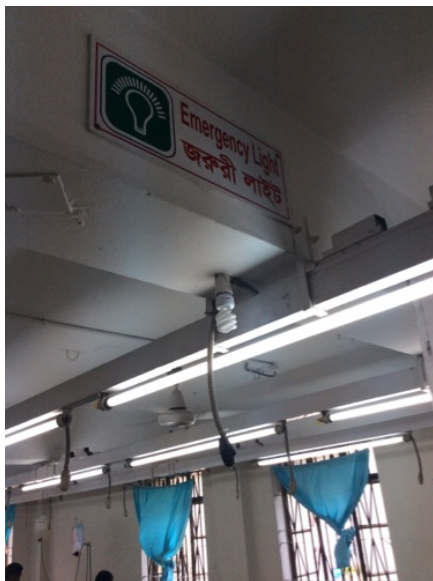
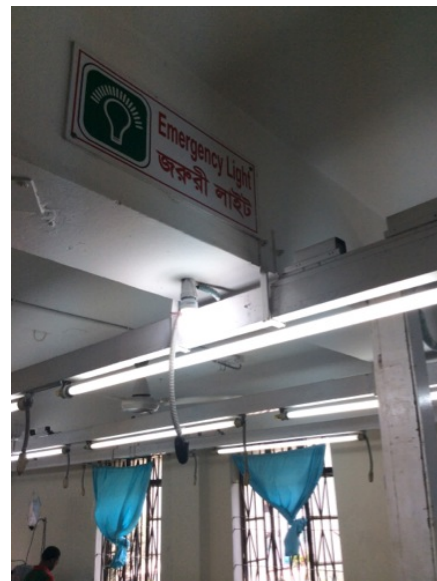
F-15	Egress Lighting	Manual on-off switch is provided for emergency lighting on the second floor.	Remove manual on/off switches from emergency lighting units to prevent them from being switched off.	Within 3 months
------	-----------------	--	--	-----------------

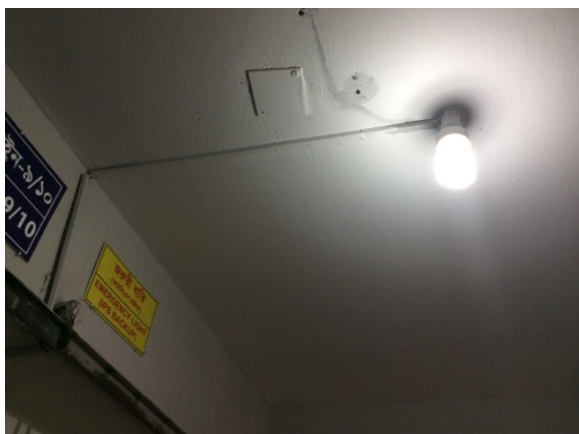
F-16	Egress Lighting	Inspection, testing, and maintenance records for the emergency lighting system were not available.	Inspect, test and maintain the emergency lighting system in accordance with The ACCORD standard. Keep written records on-site.	Within 3 months
------	-----------------	--	--	-----------------
