# Four H Apparels Ltd.

295, Jalalabad, Hathazari Road, Chittagong  
(22.405448N, 91.818235E)

20<sup>th</sup> May 2014

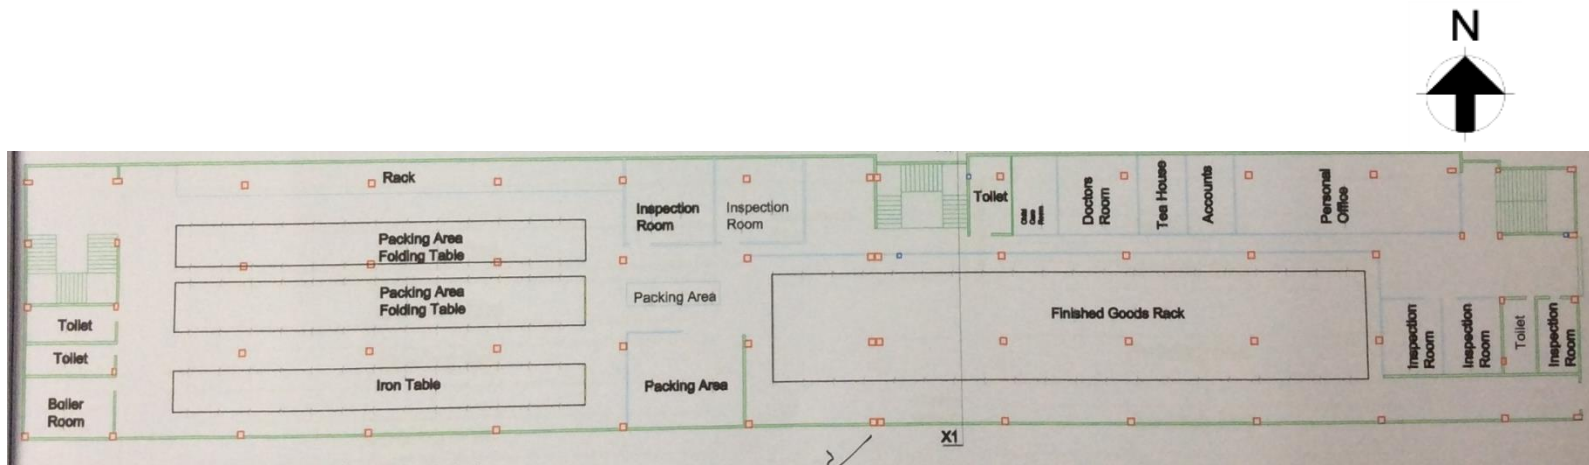
High stress levels in columns  
throughout the building

| Item No. | Observation | Recommended Action Plan | Recommended Timeline |
|---|---|---|---|
| 1 | Stress levels in Columns | Building Engineer to review design, loads and stresses in columns in the area noted. | 6-weeks |
| 2 | Stress levels in Columns | Building Engineer to verify insitu concrete strength by taking 100mm diameter cores from 4 columns. | 6-weeks |
| 3 | Stress levels in Columns | Building Engineer to verify grade of steel reinforcement and no. and diameter of main column bars. | 6-weeks |
| 4 | Stress levels in Columns | Make structural alterations if required as advised by Engineer. | 6-months |

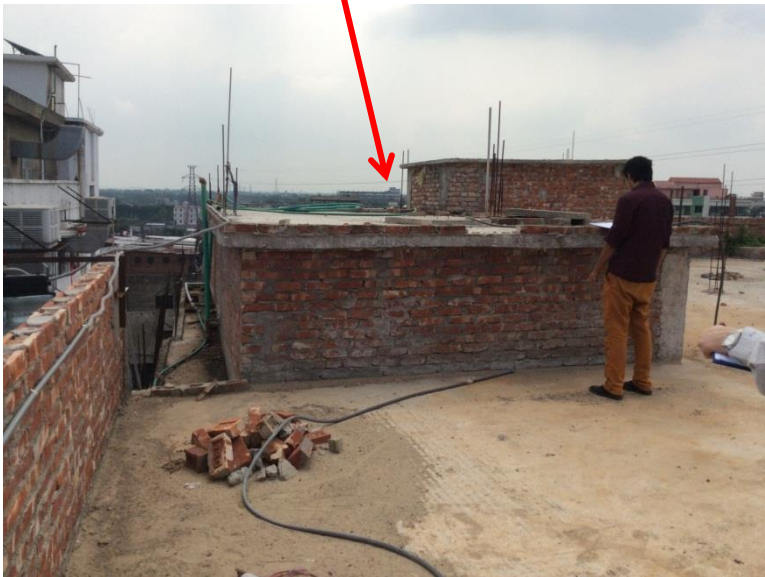
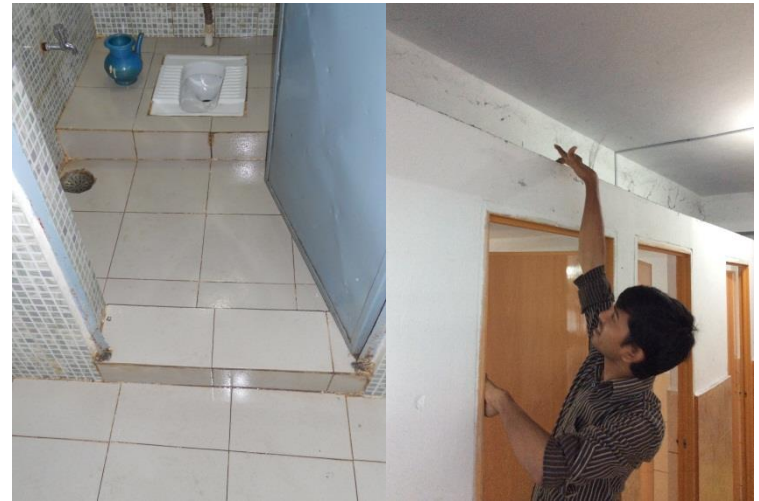
Various areas across the building see significantly increased loadings relative to the typical factory-floor loads.

The water tank situated on the roof transfers significant load onto the columns underneath. Columns in this area are smaller than typical columns.

Build-up and top slabs in toilet areas (particularly on Level 1) result in significantly increased loads on columns. Columns in this area are smaller than typical columns.

| Item No. | Observation | Recommended Action Plan | Recommended Timeline |
|---|---|---|---|
| 5 | High loading in toilet areas and under water tank | Engage an Engineer to investigate if the applied loading can be safely carried by the slabs and beams and by the columns. | 6-weeks |
| 6 | High loading in toilet areas and under water tank | Carry out load reduction and/or any remedial work as directed by the Engineer. | 6-months |

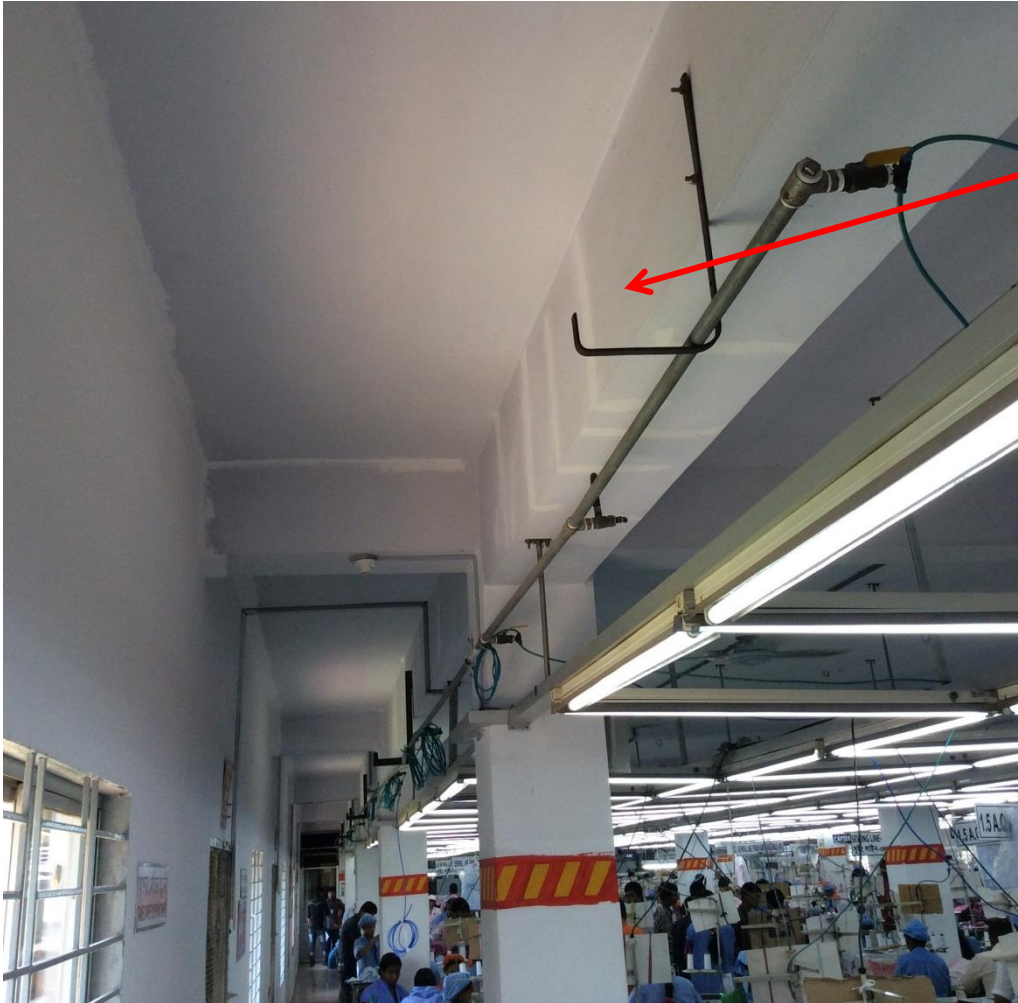
Cracks were visible along one beam on Level 1. These were painted over on one side of the beam, but visible on the opposite side.

| Item No. | Observation | Recommended Action Plan | Recommended Timeline |
|---|---|---|---|
| 7 | Slight hairline cracking in beams at Level 1 | Engage an Engineer to investigate if the cracking is structural or exists only in the render. | 6-weeks |
| 8 | Slight hairline cracking in beams at Level 1 | Carry out any remedial work as directed by the Engineer. | 6-months |

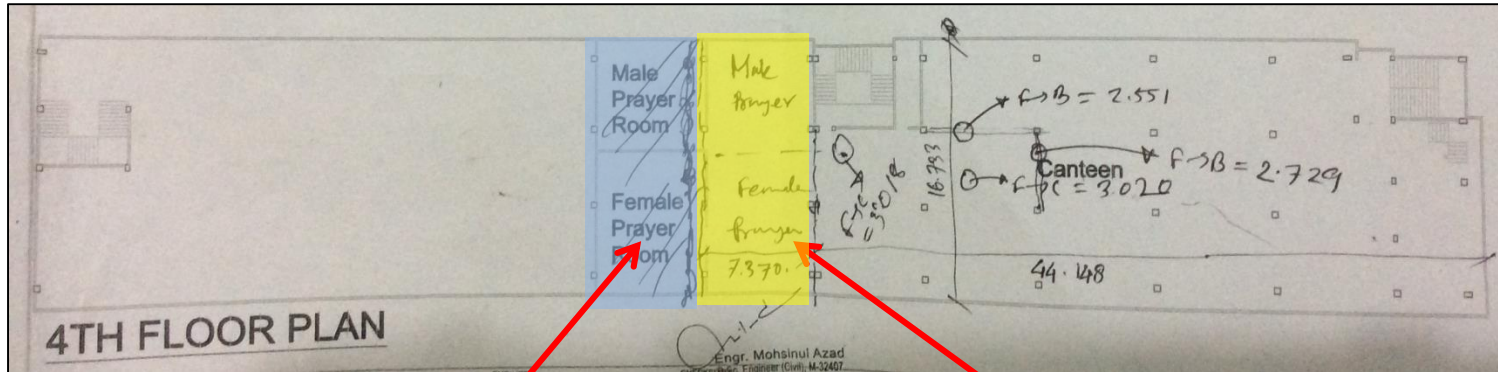
As-built drawings indicate that the prayer rooms on Level 4 are positioned one bay further out onto the level 4 roof area than what was observed.

| Item No. | Observation | Recommended Action Plan | Recommended Timeline |
|---|---|---|---|
| 9 | Discrepancies between site observations and information on drawings | Engage an Engineer to update “as built” engineering drawings. | 6-weeks |

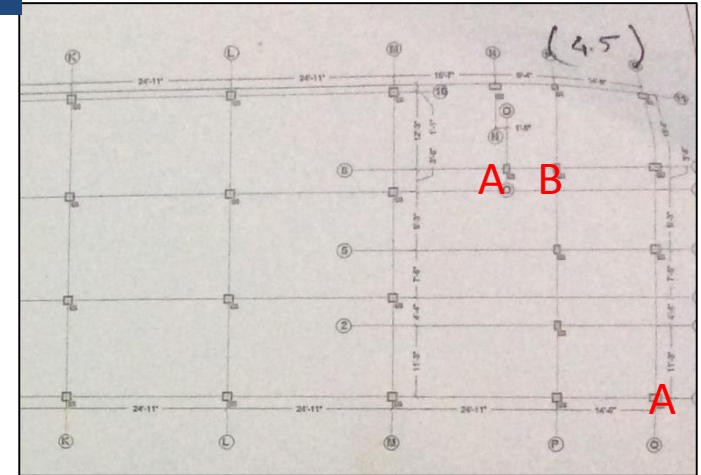
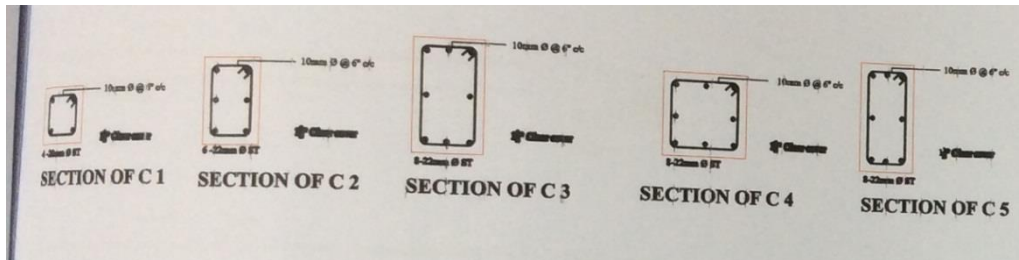
## Original Drawing Column Sizes

Column layouts did not appear to be entirely accurate – some columns (A) were different size to the drawings, and another (B) was indicated to be orientated in the wrong direction in the drawings.

Column sizes differed between the two sets of structural drawings provided. Reinforcement scanned on site differed from column details shown on drawings.
