# D. S. Fashion Ltd.

Mamun Nagar, Bara Vabanipur, Kasimpur, Gazipur  
(23.81179, 90.25374)

10<sup>th</sup> May 2014

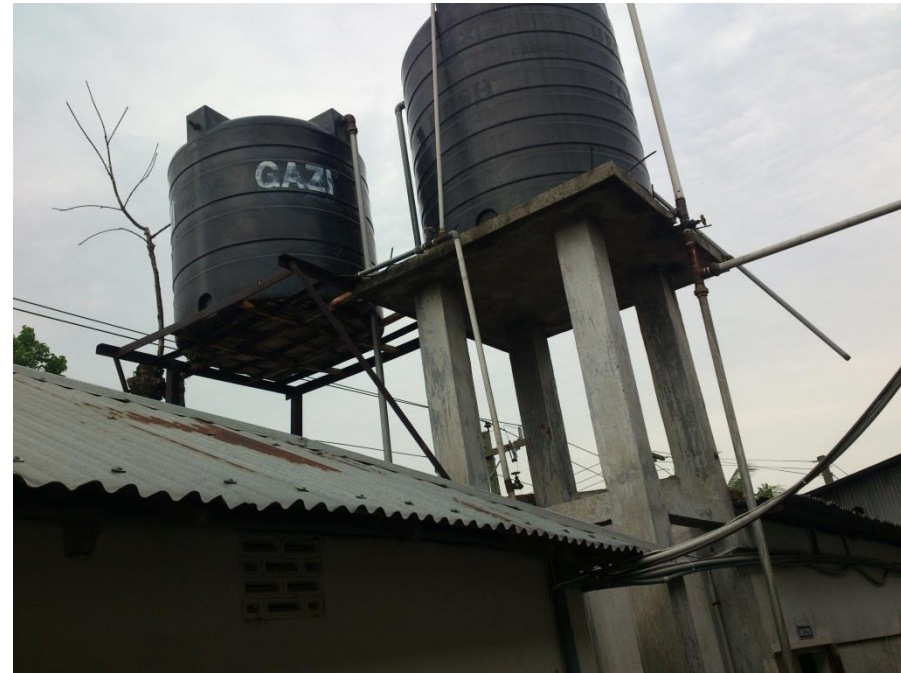
- Support structures for two 2000-litre water tanks were observed on the eastern side of the site, between the Office and the Sample Room.
- The support structure to one tank is concrete framed.
- The other tank is supported by a non-engineered steel frame. This tank is to be emptied to reduce the load until such time as the steel-framed structure is strengthened or replaced as advised by the Building Engineer.

Water tank support structures

| Item No. | Observation | Recommended Action Plan | Recommended Timeline |
|---|---|---|---|
| 1 | Non-engineered water tank support structure | Empty the water tank which is supported on the steel structure. | Immediate - Now |
| 2 | Non-engineered water tank support structure | Building Engineer to design and detail a new support structure or carry out appropriate strengthening works to the existing support structure to the water tank, taking into consideration all the code-defined vertical and horizontal loads imposed. | 6-weeks |

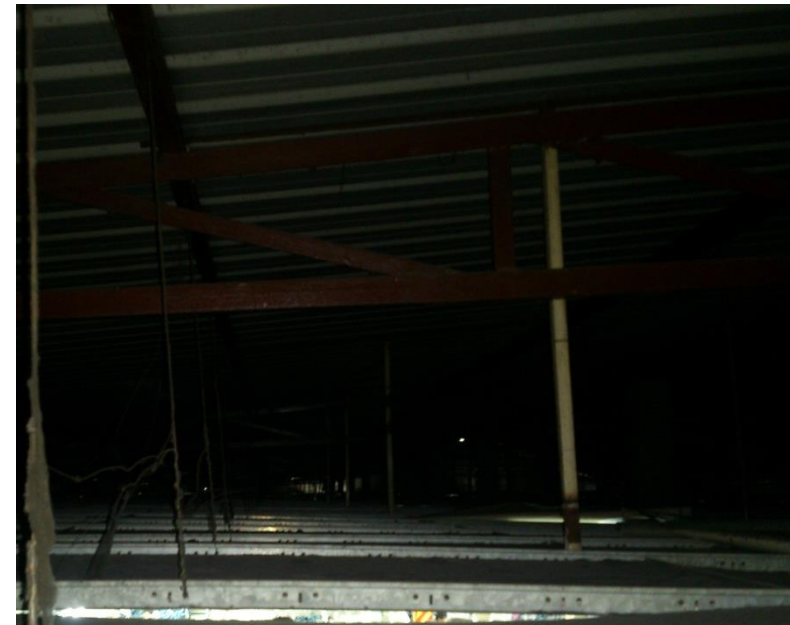
- The lateral stability system to the all buildings on the site is unclear – no vertical or horizontal bracing has been provided.
- Provision for lateral stability is not highlighted in the as-built drawings.
- It is likely that the reinforced columns currently provide lateral stability through cantilever action.
- Building Engineer to carry out a lateral stability analysis of the buildings to review the design of the cantilevered columns, to assess if they can adequately resist the horizontal loads imposed
- If necessary, provide details of remedial works for the provision of vertical and horizontal bracing.

Even though suspended tile ceilings were present in the main building, the cutting room, the sample room and the offices, it was possible to see that there was no roof bracing present.

| Item No. | Observation | Recommended Action Plan | Recommended Timeline |
|---|---|---|---|
| 5 | Lateral stability system unclear | Building Engineer to provide guidance on the requirement for horizontal bracing in the plane of the roof, so that the horizontal wind loads can be transferred to foundation level. | 6-weeks |

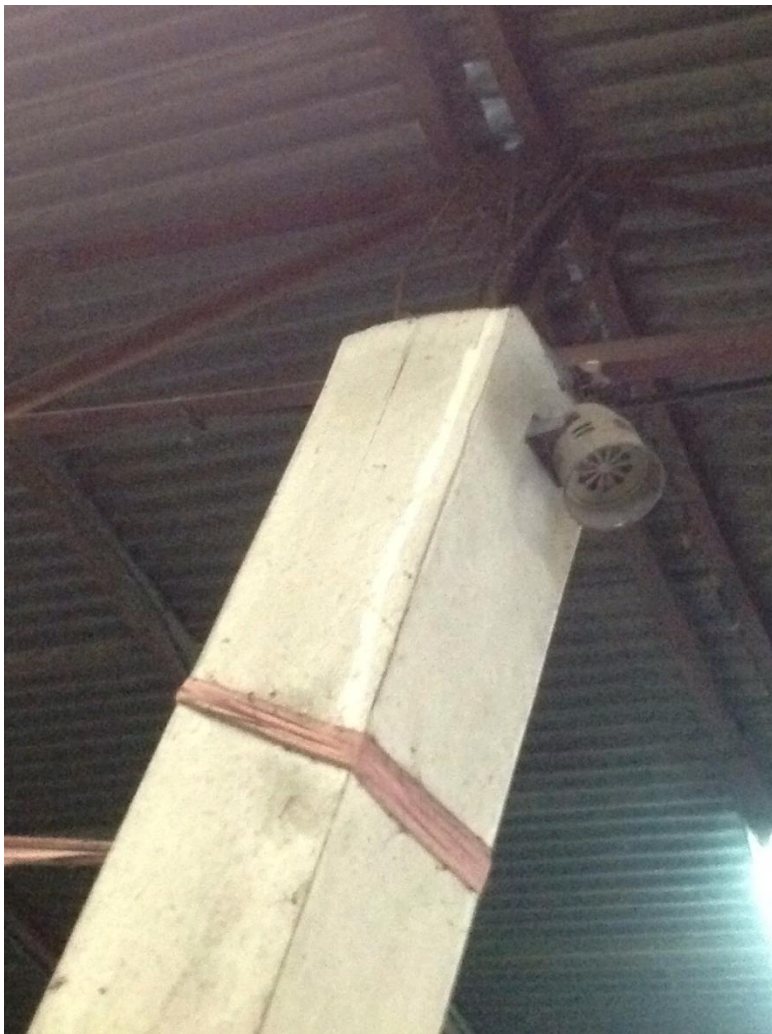
Pin connection between portal frame and cantilevering RC columns – the horizontal force transferred into the top of the columns will need to be transferred into the foundation through cantilever action

| Item No. | Observation | Recommended Action Plan | Recommended Timeline |
|---|---|---|---|
| 4 | Lateral stability system unclear | Building Engineer to assess whether the cantilever concrete columns are adequate to carry the horizontal loads | 6-weeks |

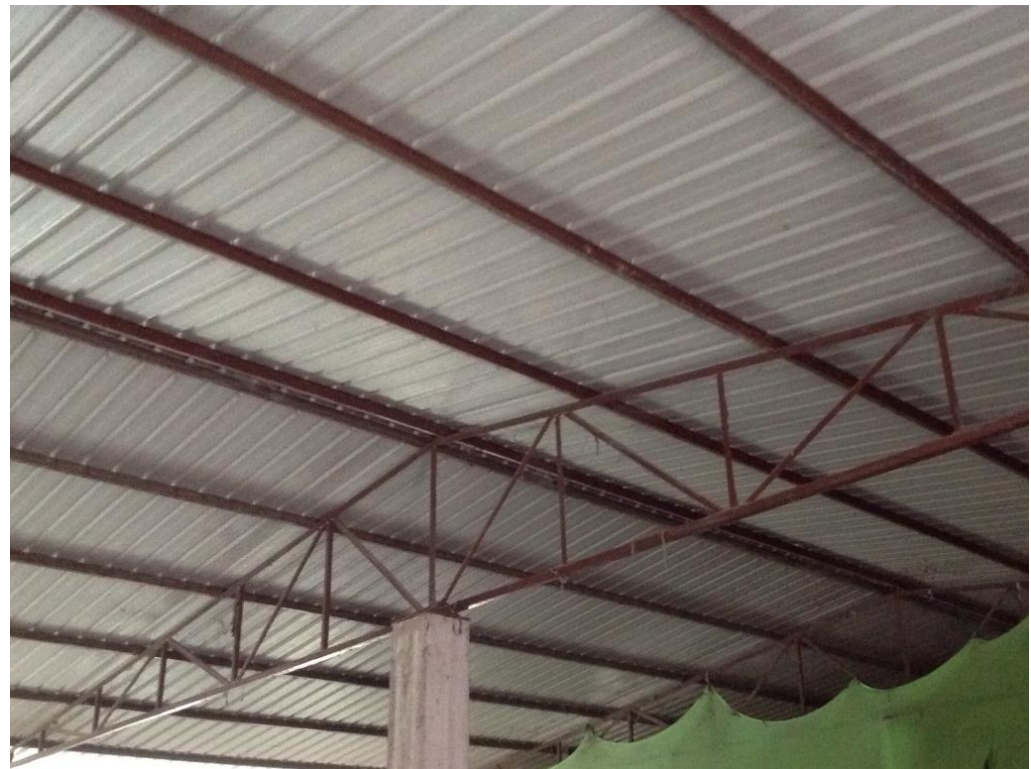
No horizontal bracing provided in the roof (fabric store)

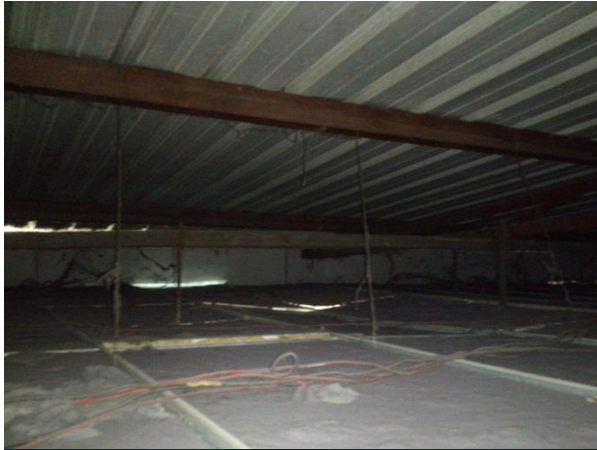
Shed 1

- All of the buildings on the site have lightweight roof structures.
- These roof structures, typically supported on concrete piers, do not appear to be engineered.
- Building Engineer to review the design of these structures, with special emphasis on connections and bracing, and to implement any upgrade works as required.

| Item No. | Observation | Recommended Action Plan | Recommended Timeline |
|---|---|---|---|
| 7 | Lightweight roof structures | All roof structure to be design checked to ensure adequacy for code vertical, horizontal and wind loads by the Building Engineer. | 6-weeks |
| 8 | Lightweight roof structures | Undertake strengthening if required. | 6-months |

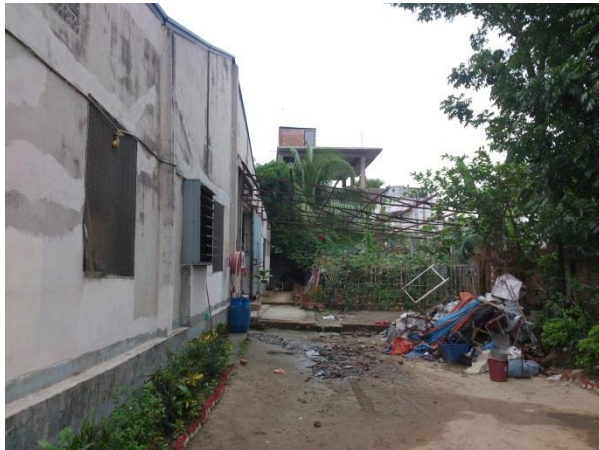
Open lattice to South Elevation –  
Shed 1

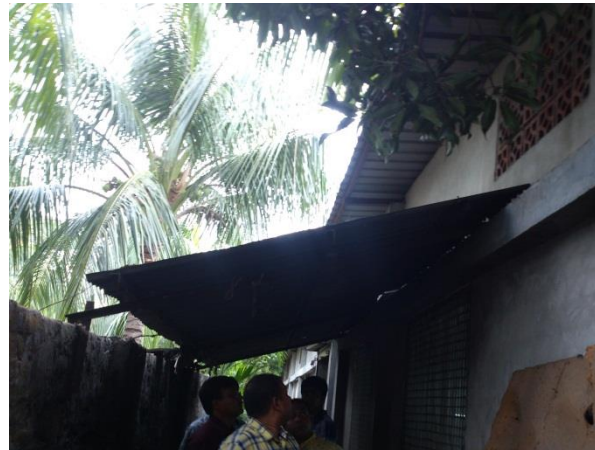
Lean-to cover to the West Elevation  
– Shed 1

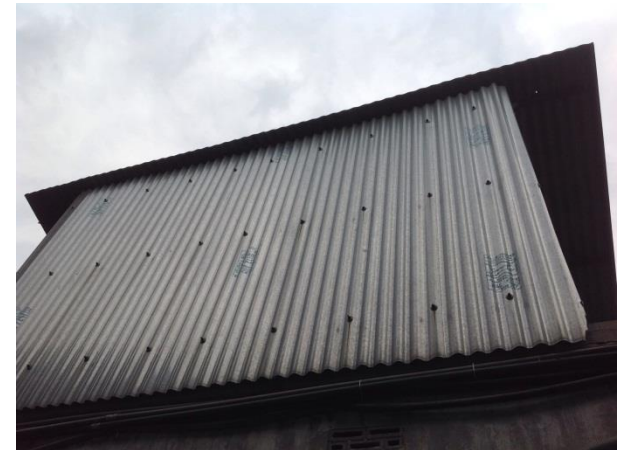
Roof extension over generator
