# Ahsan Composite Ltd.

Ward-08, Pollibidut Road, Chandra, Kaliakoir, Gazipur  
(24.04278N 90.25977E)

27 April 2014

# Observations

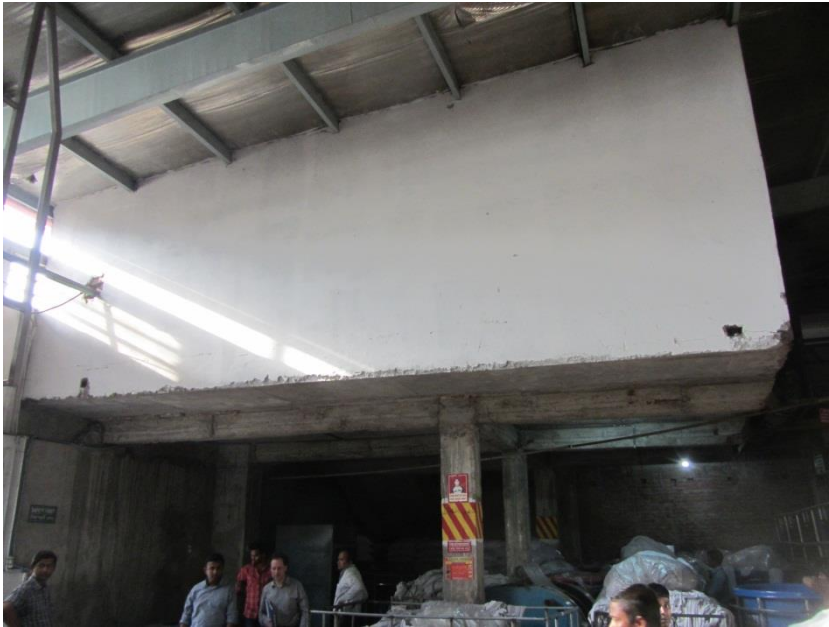
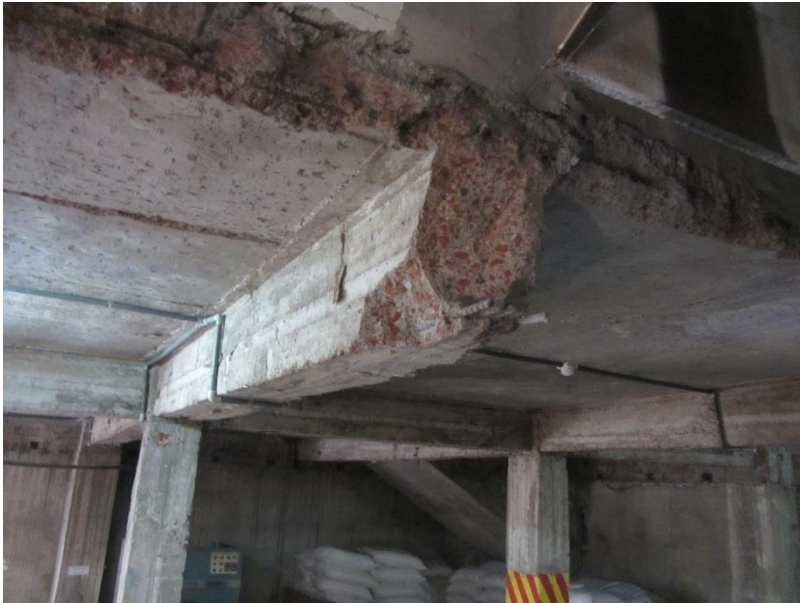
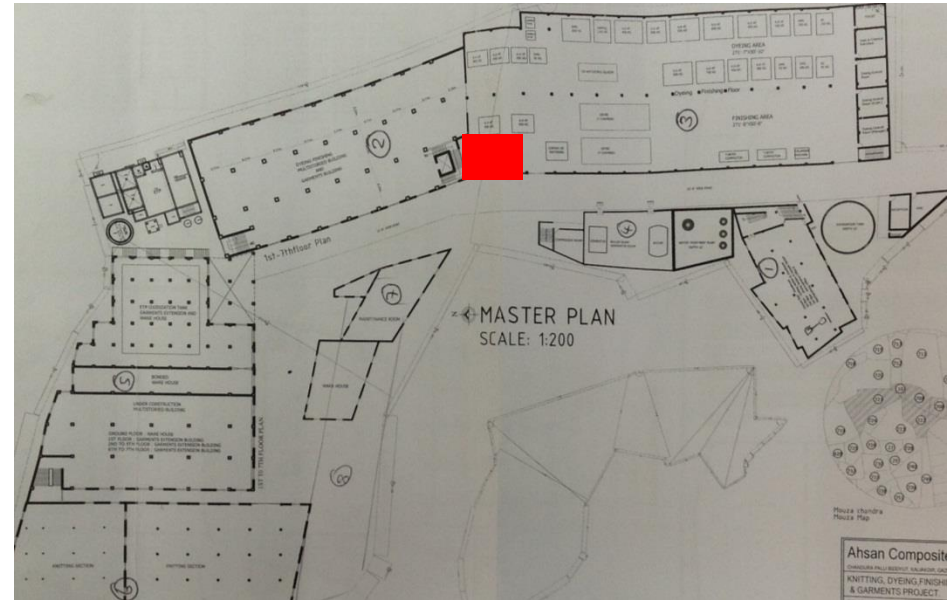
# Building 3 - Columns removed, leaving beams cantilevering

- Columns under ends of beams removed to accommodate ground floor plant.
- The beams are therefore now cantilevering.
- Although beams are currently not live loaded, there is a blockwork wall at the tip of the cantilever and the cantilever is sagging by about 40mm.

6 Columns removed leaving beams cantilevering

10	Building 3 - Columns removed, leaving beams cantilevering	Factory Engineer to undertake engineering assessment of the remaining RC mezzanine structure, paying particular attention to lateral stability.	6-weeks
11	Building 3 - Columns removed, leaving beams cantilevering	Factory Engineer to prepare loading plans.	6-weeks

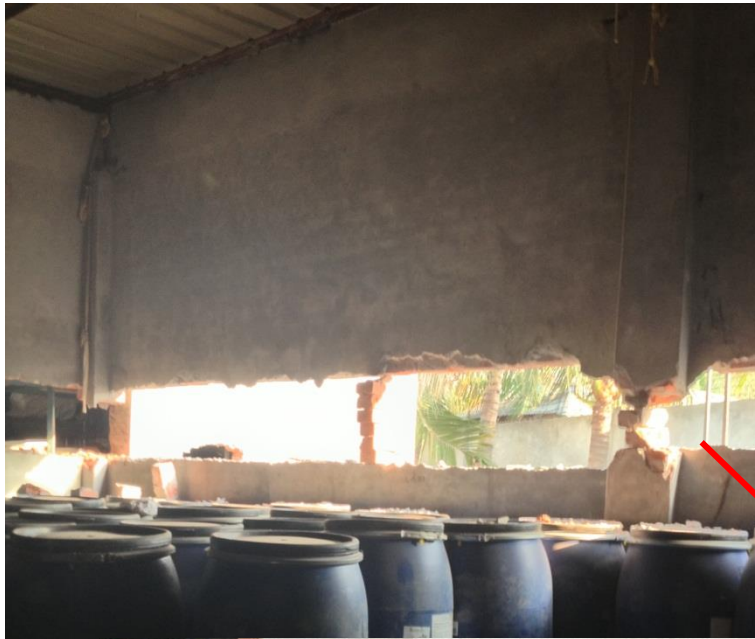
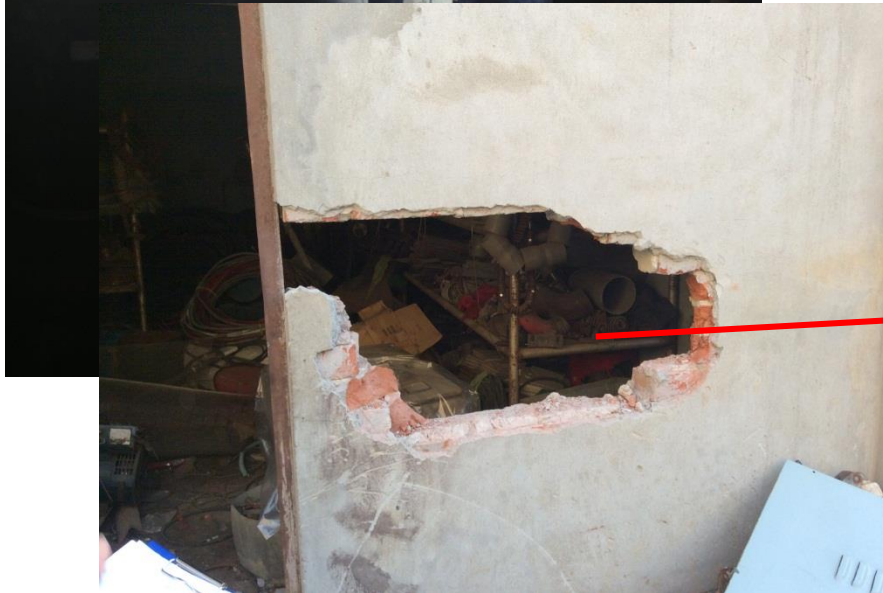
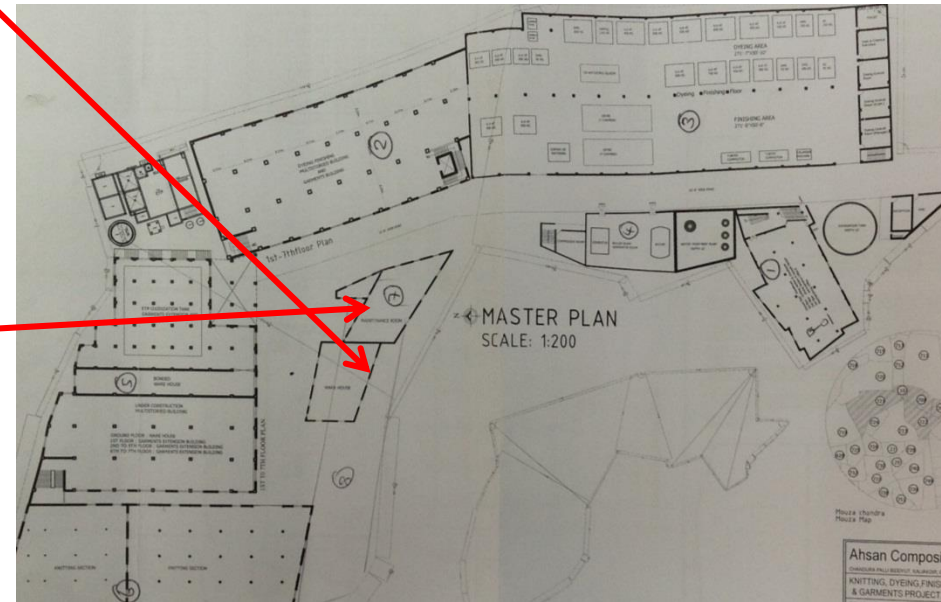
# **Building 7 - Column cut at mid-height and propped with bricks**

## Holes broken through walls.

- In left hand image the broken column on the right supports the roof truss; the adjacent length of brick wall is propped only by a single stack of bricks.
- Although building will shortly be demolished, in the short term it is still accessed and used for storage.

Column cut at mid-height and propped with bricks

Item No.	Observation	Recommended Action Plan	Recommended Timeline
12	Building 7 - Column cut at mid-height and propped with bricks	Since building will shortly be demolished, we recommend temporarily bricking up the wall and then grouting the gaps in the columns.	<b>Immediate - Now</b>
13	Building 7 - Column cut at mid-height and propped with bricks	Works will need to be undertaken very carefully to avoid collapse during the works. Factory Engineer to be present at all times.	<b>Immediate - Now</b>
14	Building 7 - Column cut at mid-height and propped with bricks	Because this was an immediate safety issue it was raised with the factory owner at the close-out meeting, who agreed to repair the wall the next day. The photograph on the following slide was received the next day showing repairs completed.	<b>Immediate - Now</b>
15	Building 5 - Missing beams around stair and discrepancies between as-built and structural drawings	Build brick wall (A) off ground floor to support full width of half landing and (B) to support full length of edge of slab.	<b>Immediate - Now</b>

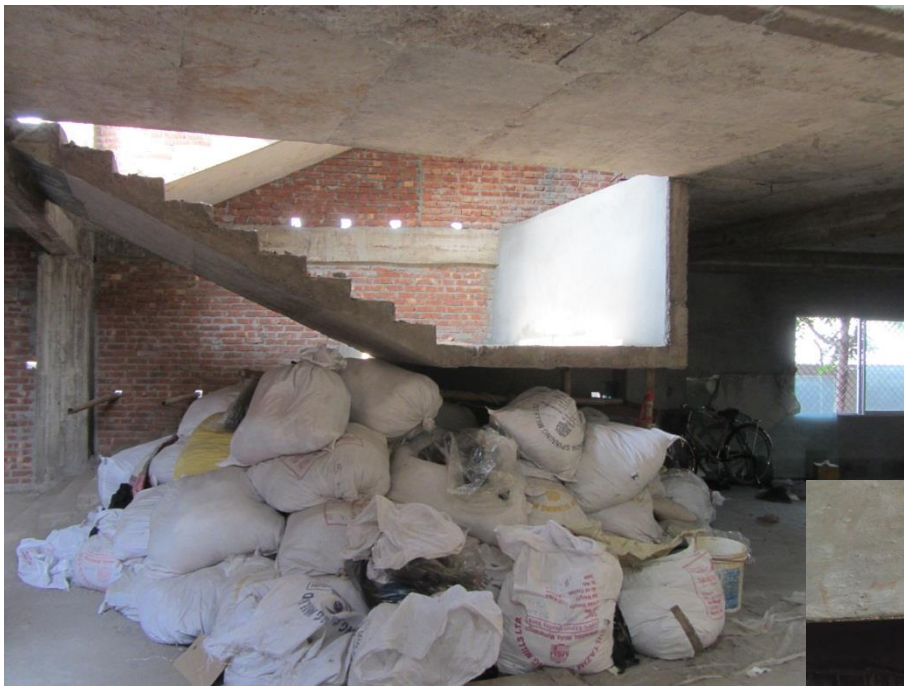
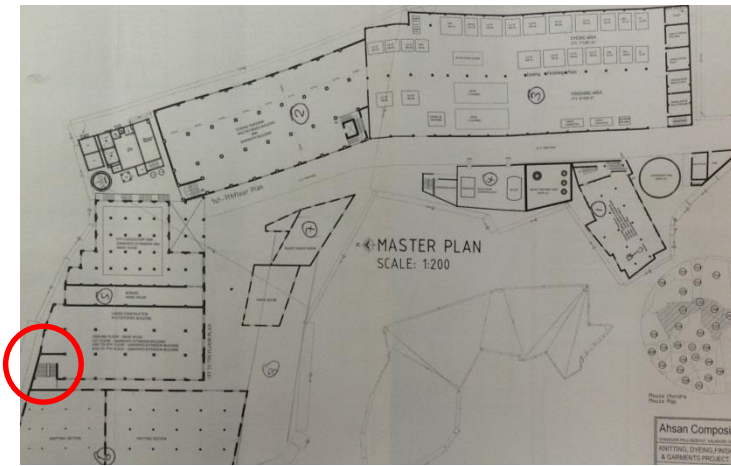
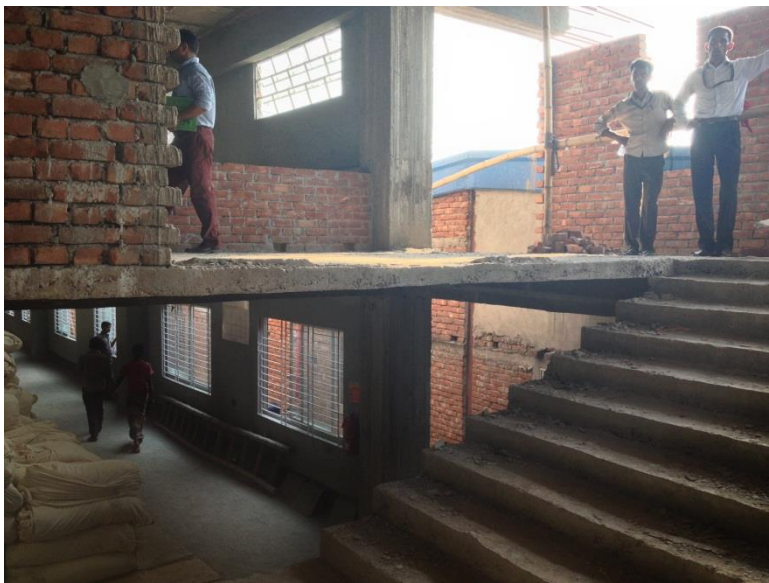
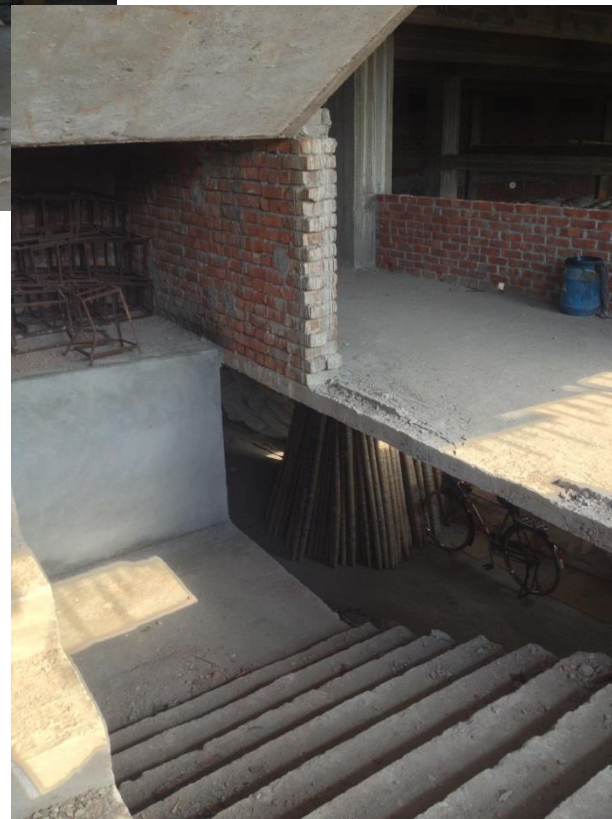
# Building 5 - Missing beams around stair

**At the level above, the stair opening is framed by beams.**

**However, at 1<sup>st</sup> floor there are no beams, meaning that the 105thk slab must span approx. 7m supporting itself, the stair which hangs from it and the wall which is built off it.**

**Missing beams around stair**

16	Building 5 - Missing beams around stair and discrepancies between as-built and structural drawings	Because this was an immediate safety issue it was raised with the factory owner at the close out meeting, who agreed to construct wall A the next day. The photograph on the following slide was received the next day showing construction of wall A already in progress.	<b>Immediate - Now</b>
17	Building 5 - Missing beams around stair and discrepancies between as-built and structural drawings	Engineering assessment of area to be undertaken by Factory Engineer. Assessment also to include location along North side of building where stepped slab edge has been changed to a diagonal (see previously noted observations).	<b>6-weeks</b>

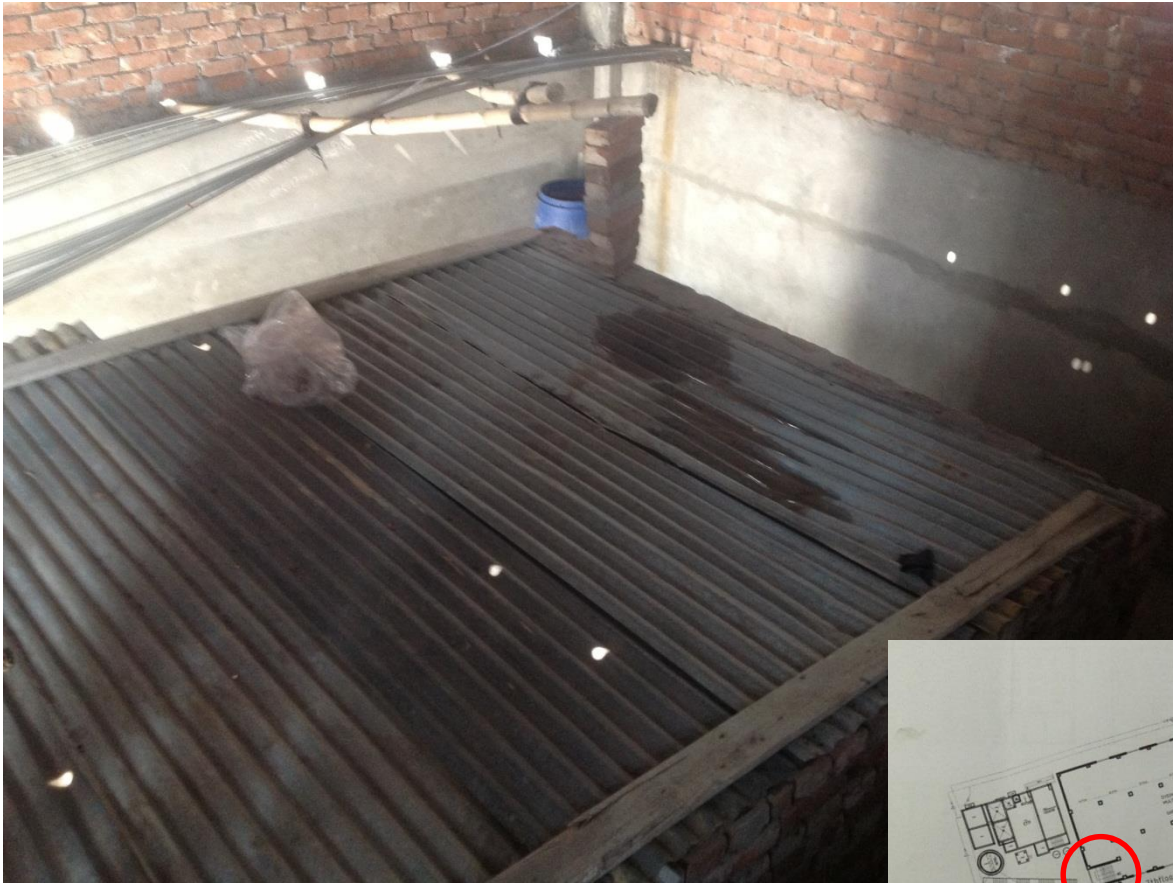
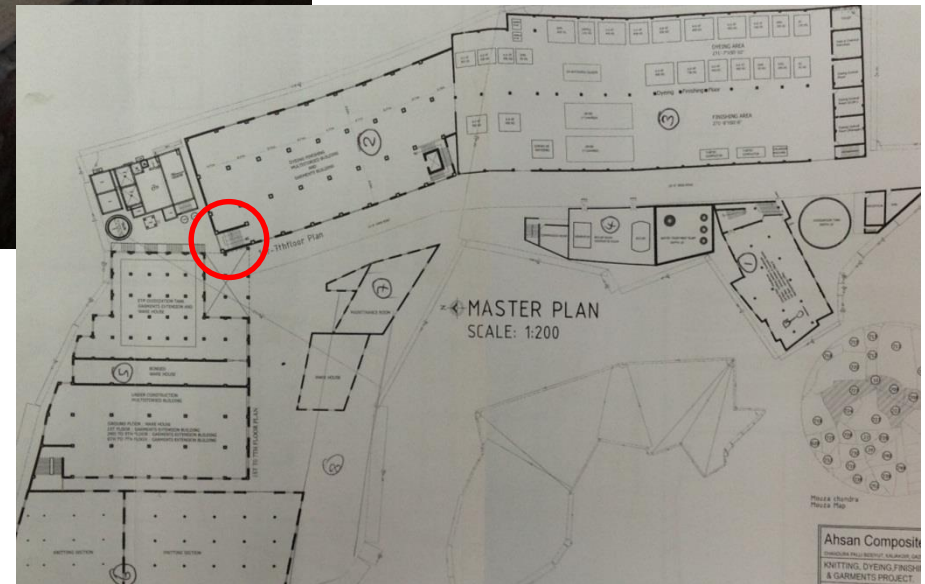
# Building 2 - Loose roof to lift shaft

**Stack of bricks sitting on corrugated sheeting which loosely sits atop unused lift shaft.**

**No balustrade to lift shaft at roof level.**

**Loose roof to lift shaft**

<b>Item No.</b>	<b>Observation</b>	<b>Recommended Action Plan</b>	<b>Recommended Timeline</b>
18	Building 2 - Loose roof to lift shaft & missing balustrade	Balustrade to be installed to avoid falling into lift shaft	<b>Immediate - Now</b>
19	Building 2 - Loose roof to lift shaft & missing balustrade	Loose bricks and corrugated sheeting over lift shaft to be removed.	<b>Immediate - Now</b>
20	Building 5 – Long-span external stair	Engineering assessment of external stair to be undertaken by Factory Engineer.	<b>6-weeks</b>
21	Building 5 – Long-span external stair	Implement actions arising from assessment.	<b>6-months</b>
22	Building 4 - Extension to cantilever slab	Engineering assessment of slab extension to be undertaken by Factory Engineer.	<b>6-weeks</b>
23	Building 4 - Extension to cantilever slab	Implement actions arising from assessment, including strengthening if required.	<b>6-months</b>
24	Building 5 - Columns at risk of vehicle impact	Install temporary warning notices around columns.	<b>Immediate - Now</b>

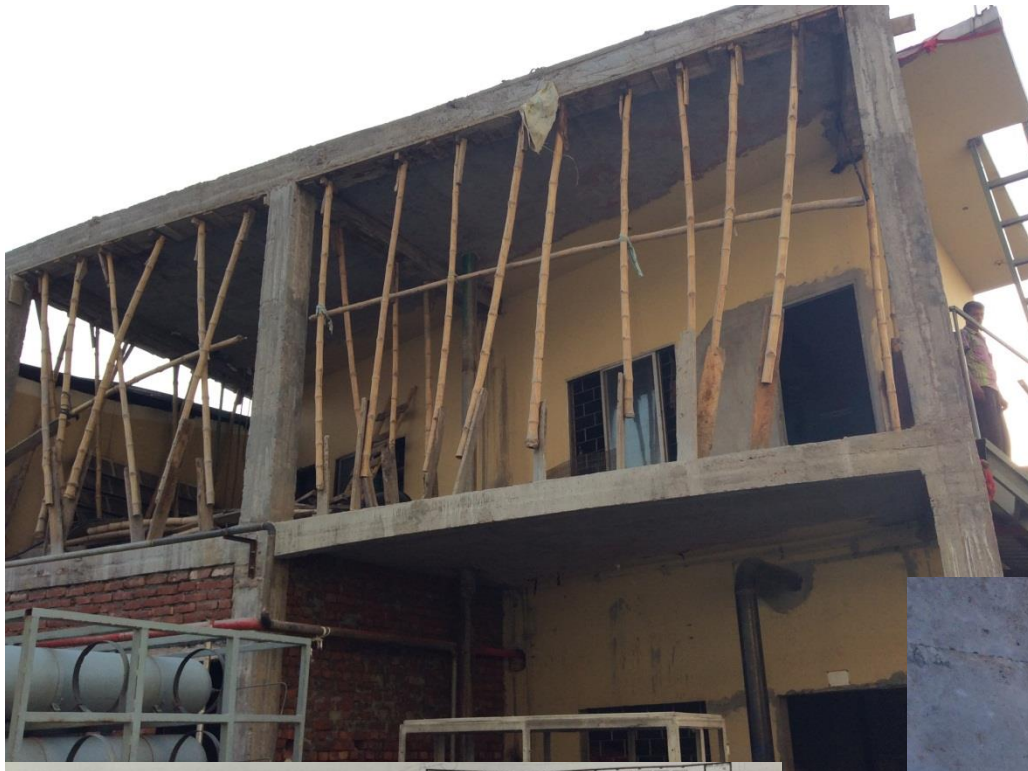
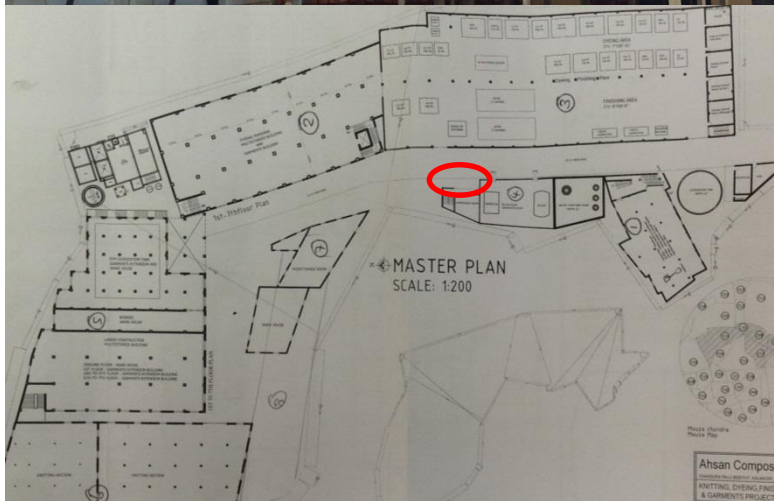
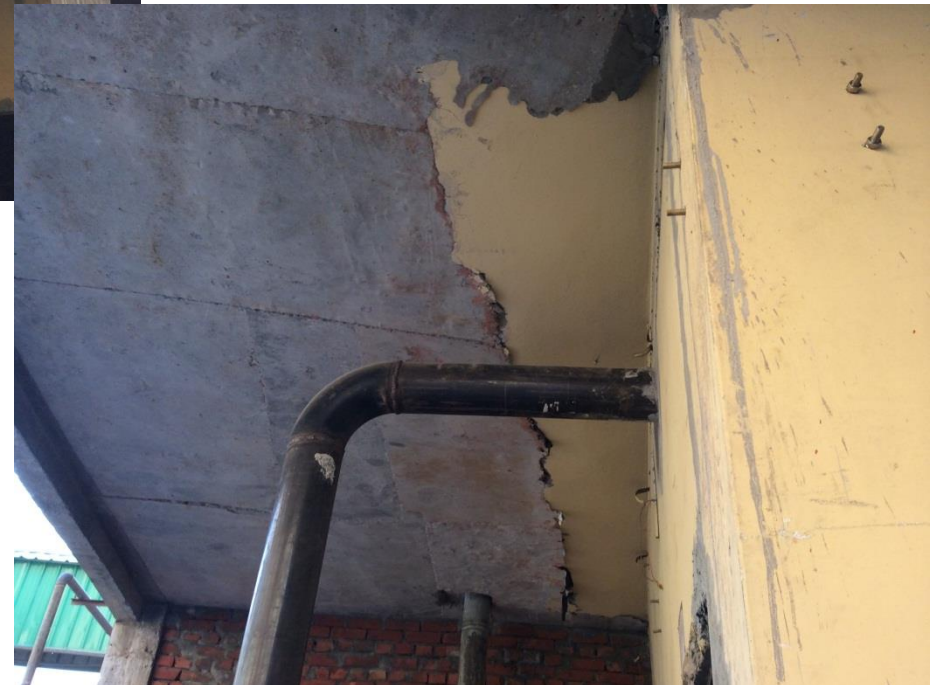
# Building 4 - Extension to cantilever slab

Original cantilever slabs at 1<sup>st</sup> and 2<sup>nd</sup> floors have been extended.

It is difficult to see how the new reinforcement can have been adequately anchored.

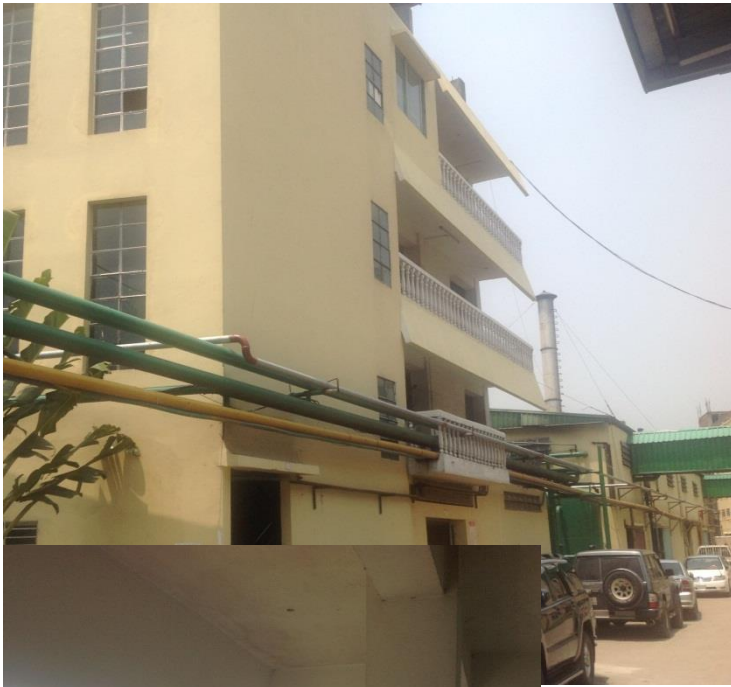
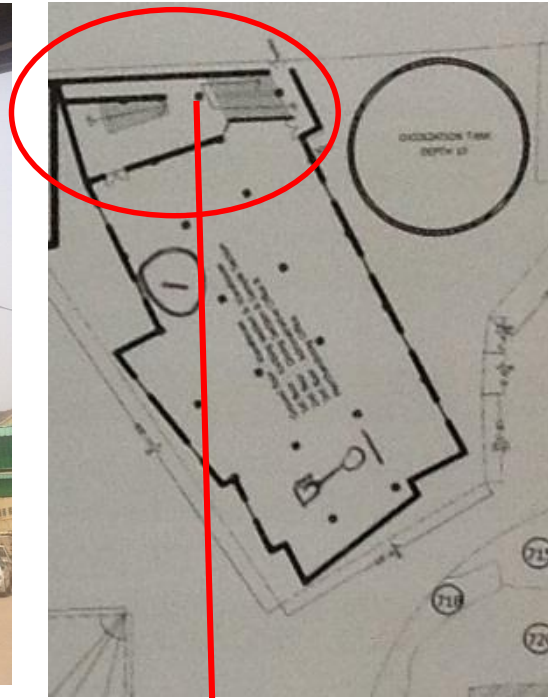
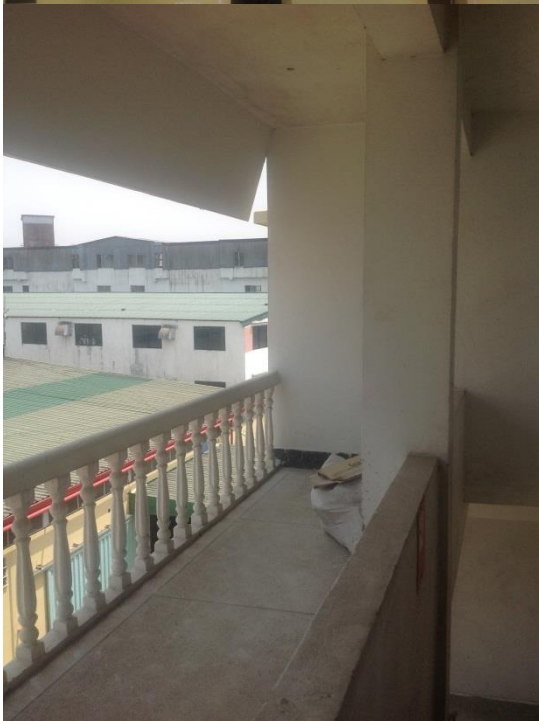
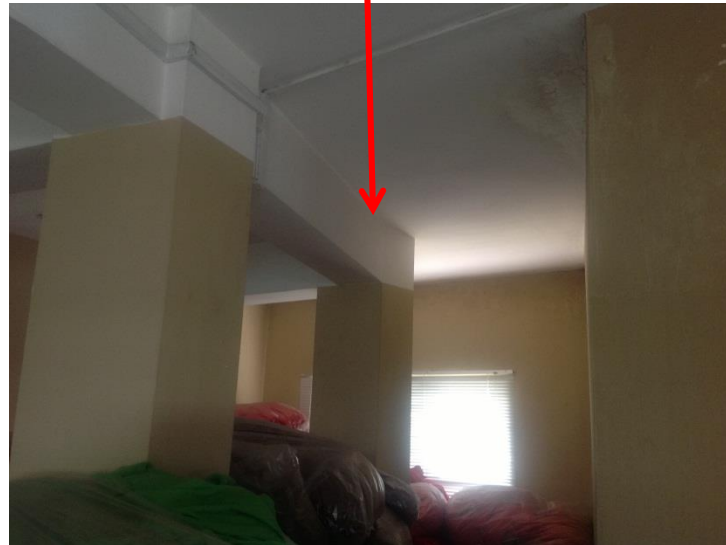
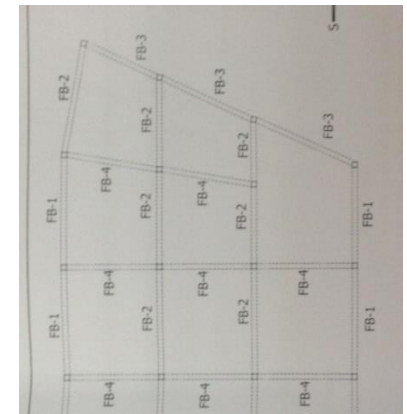
**Buildings not as drawings or permits: including additional structures, missing columns and cantilevers without backspans**

- Along the front elevation, the as-built layout and the architectural drawing (left) are different from the simple structural layout (below).
- Beams and columns have a different layout, and the edge cantilever is missing a backspan (bottom left image) due to the adjacent staircase.

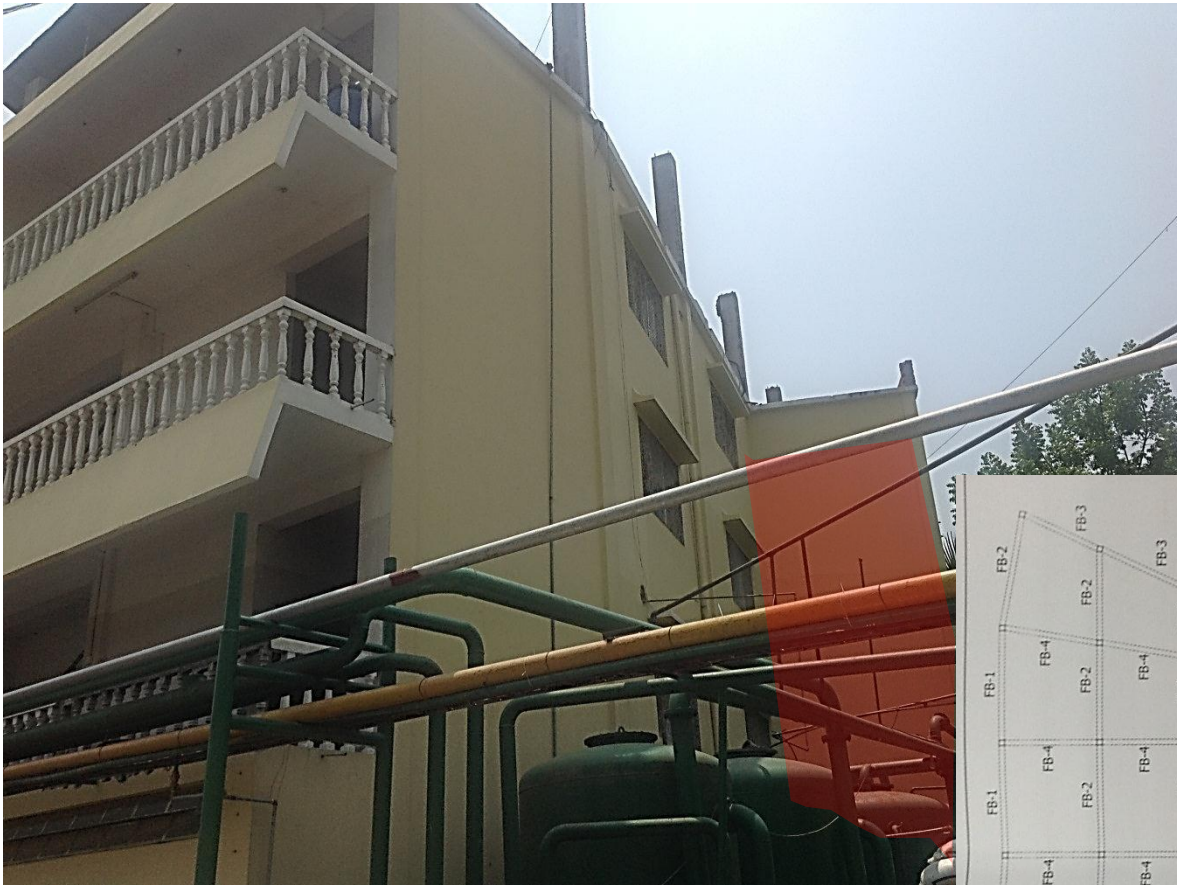
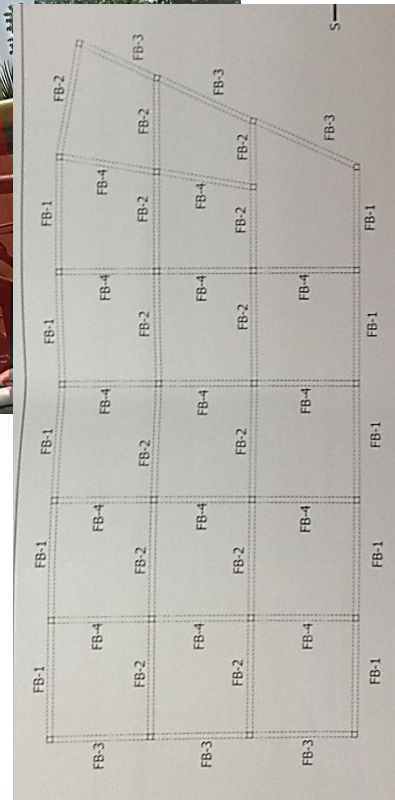
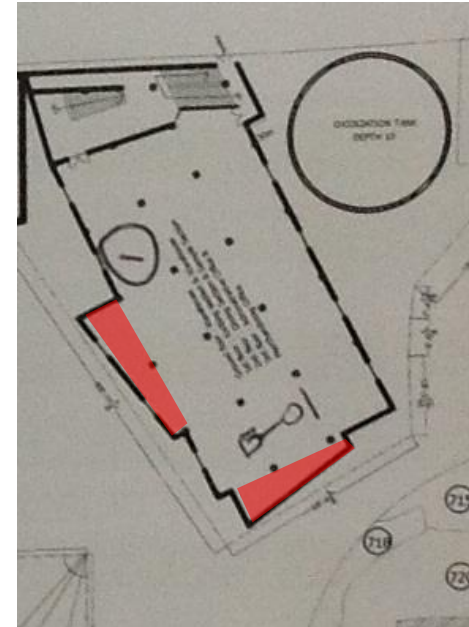
The two red shaded areas on the architectural layout (below) are not reflected on the structural drawing (below left). They appear to be variously supported by RC beams and loadbearing half brick walls.

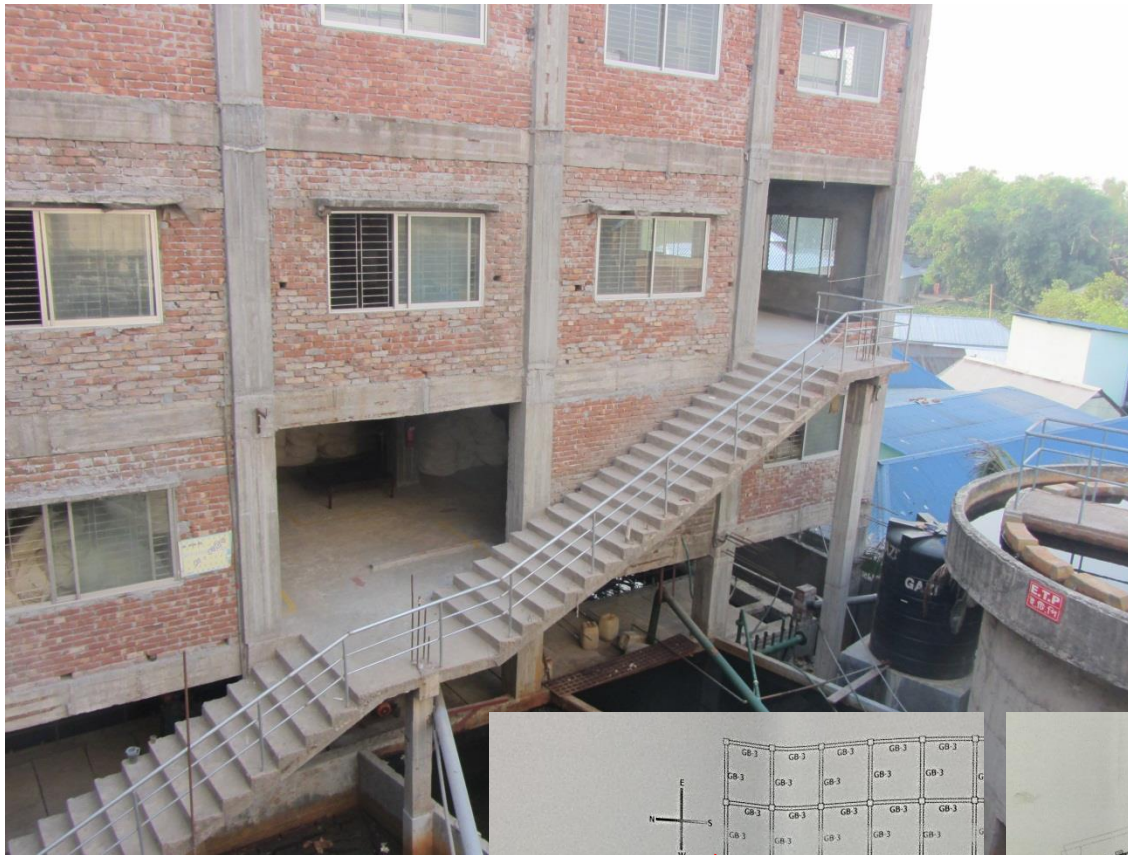
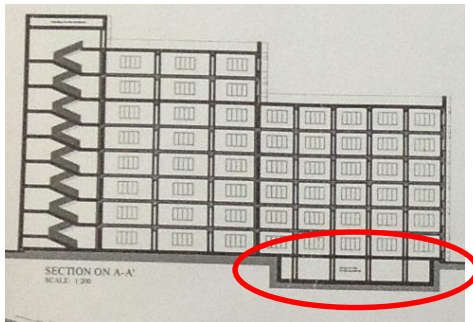
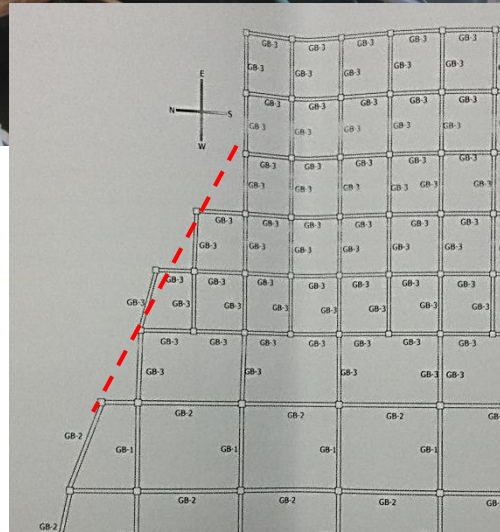
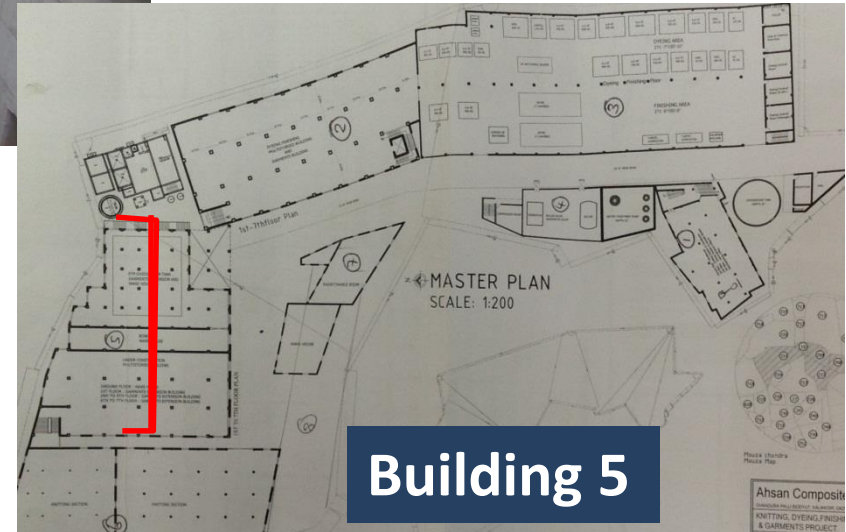
**Building 1 - Floor slabs larger than shown on structural drawing**

Cross-section shows a basement reservoir, but actual reservoir is at ground floor.

Also, the stepped slab edge as drawn at all floors has been changed to a diagonal (see dashed line on plan, bottom centre).

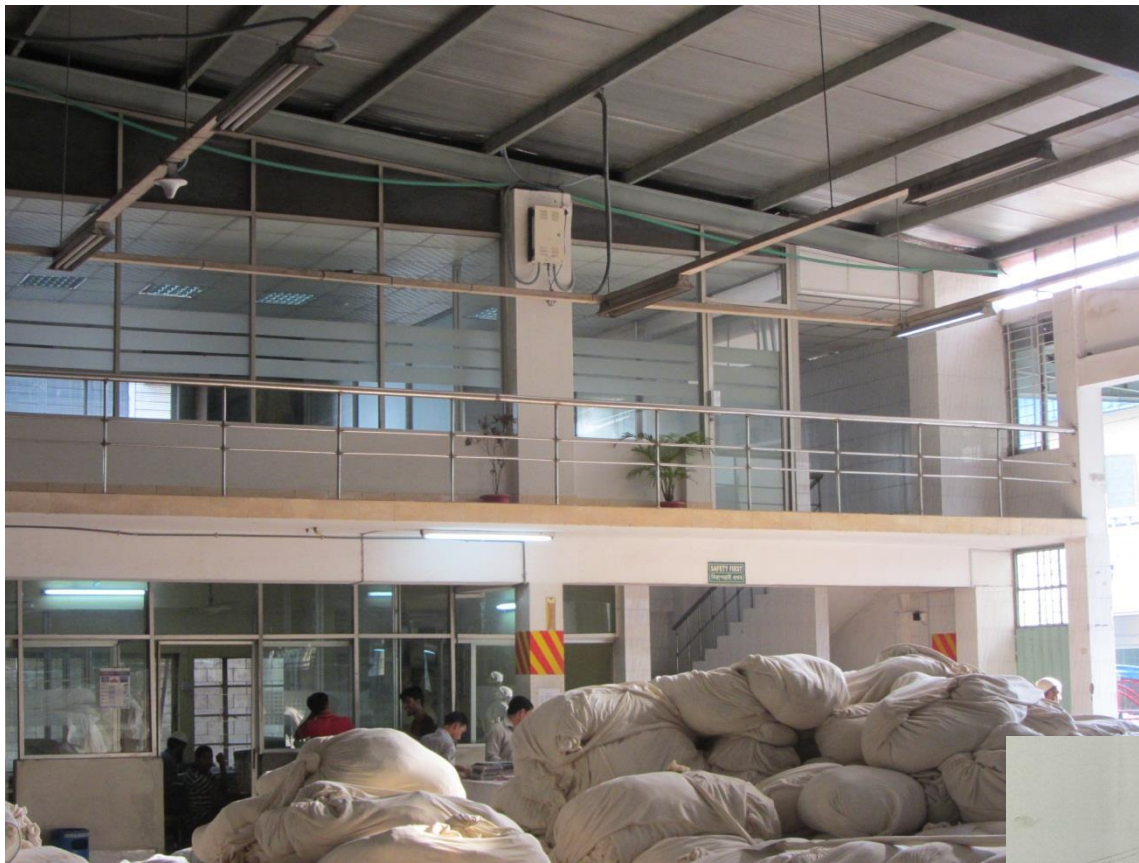
**Building 5**

18 **Basement doesn't appear to exist**

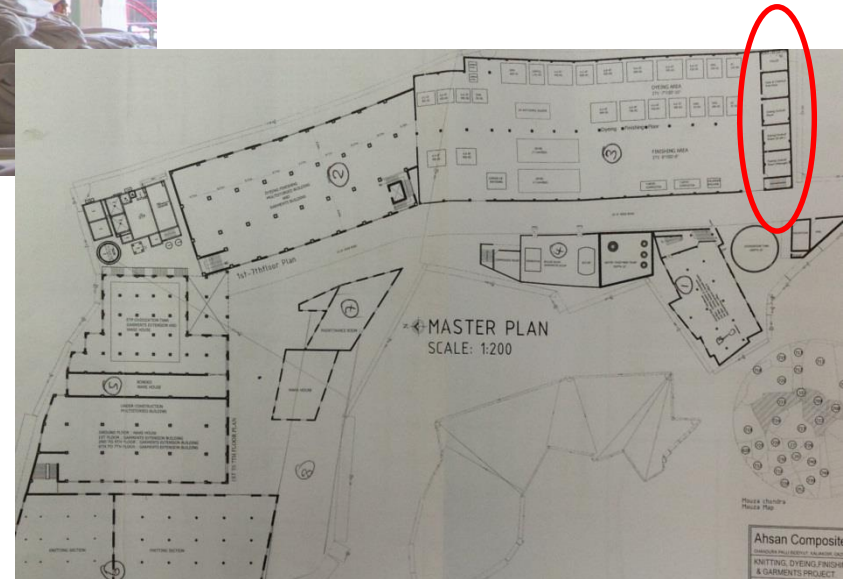
**Building 3 - No structural drawings  
for 2-storey RC structure**

No structural drawings  
for 2 storey RC structure

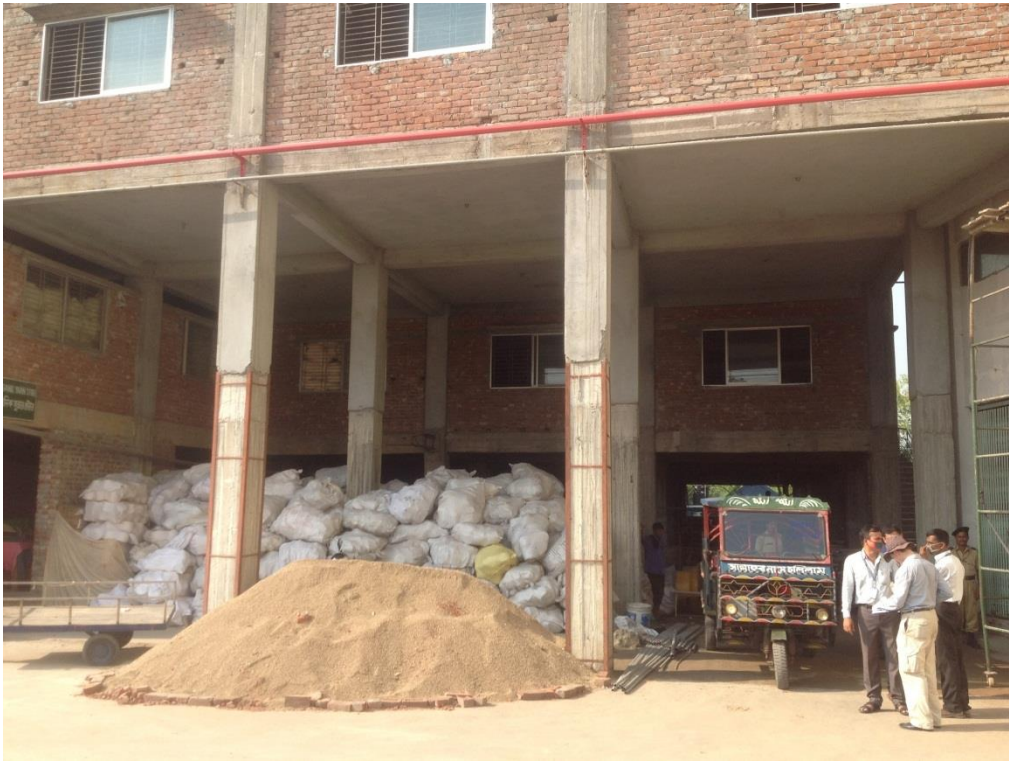
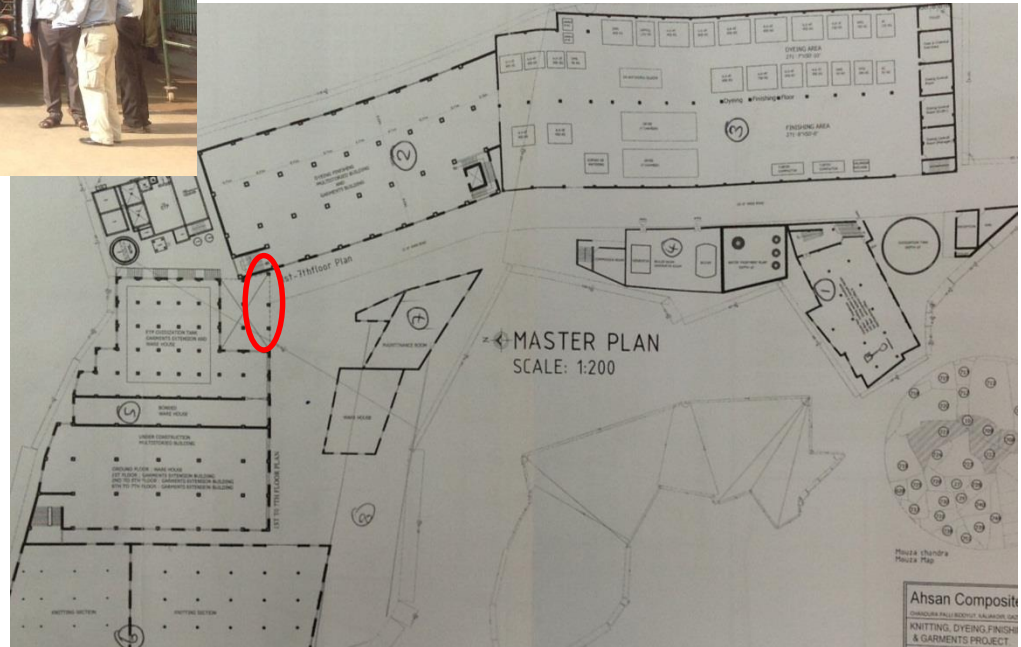
# Building 5 - Columns at risk of vehicle impact

Tall loading bay columns (which carry the building above) have no protection against vehicle impact.

**Building 5 - Columns at risk of vehicle impact**

25	Building 5 - Columns at risk of vehicle impact	Install bollards, spaced away from the columns, to protect the columns from impact.	<b>6-weeks</b>

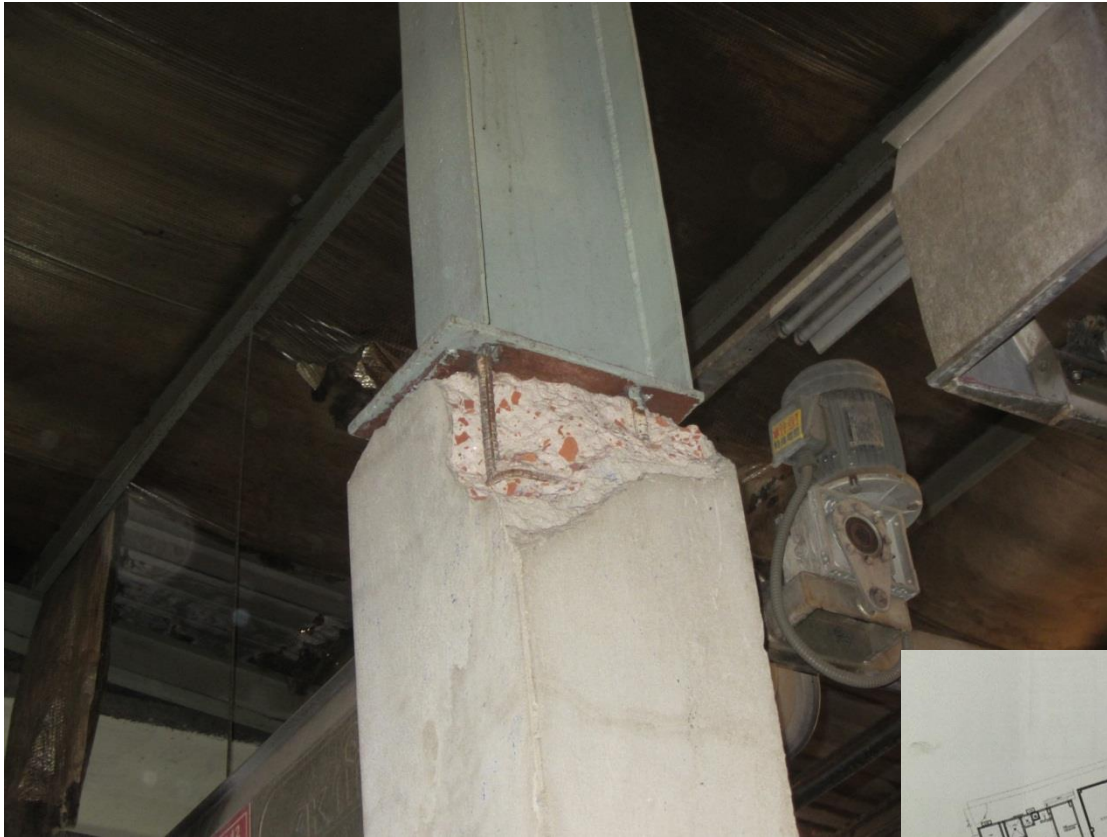
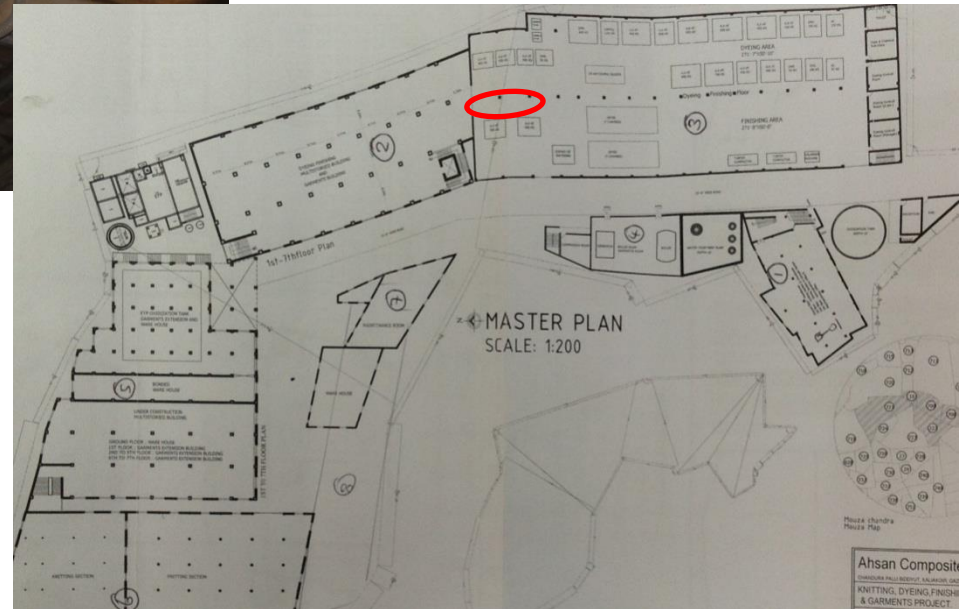
# Building 3 - Columns pinned at mid-height

- Two steel columns supporting roof are built off 2.5m high RC columns.
- Steel baseplate has inadequate fixing into the RC column.
- It is also unlikely that the RC column was designed as a cantilever, in which case the column is effectively pinned at mid-height.

## Building 3 - Columns pinned at mid-height

Item No.	Observation	Recommended Action Plan	Recommended Timeline
26	Building 3 - Columns pinned at mid-height	Engineering assessment of columns to be undertaken by Factory Engineer.	6-weeks
27	Building 3 - Columns pinned at mid-height	Implement actions arising from assessment, including strengthening if required.	6-months
28	Building 5 - Poorly compacted beam	Provide structural repair under supervision of Factory Engineer.	6-weeks
29	Buildings 1 & 2 - Rubble and bricks on roofs	Bricks and rubble to be removed.	6-weeks
30	Building 2 - Structurally unsafe access ramp	Replace with new ramp, to be designed by Factory Engineer.	6-weeks
31	Buildings 3 & 6 - Non-engineered steel sheds including weak roof connections, no roof bracing and potentially missing lintels and unrestrained brick facades	Engineering assessment of steel sheds to be undertaken by Factory Engineer.	6-weeks
32	Buildings 3 & 6 - Non-engineered steel sheds including weak roof connections, no roof bracing and potentially missing lintels and unrestrained brick facades	Implement actions arising from assessment, including strengthening if required.	6-months

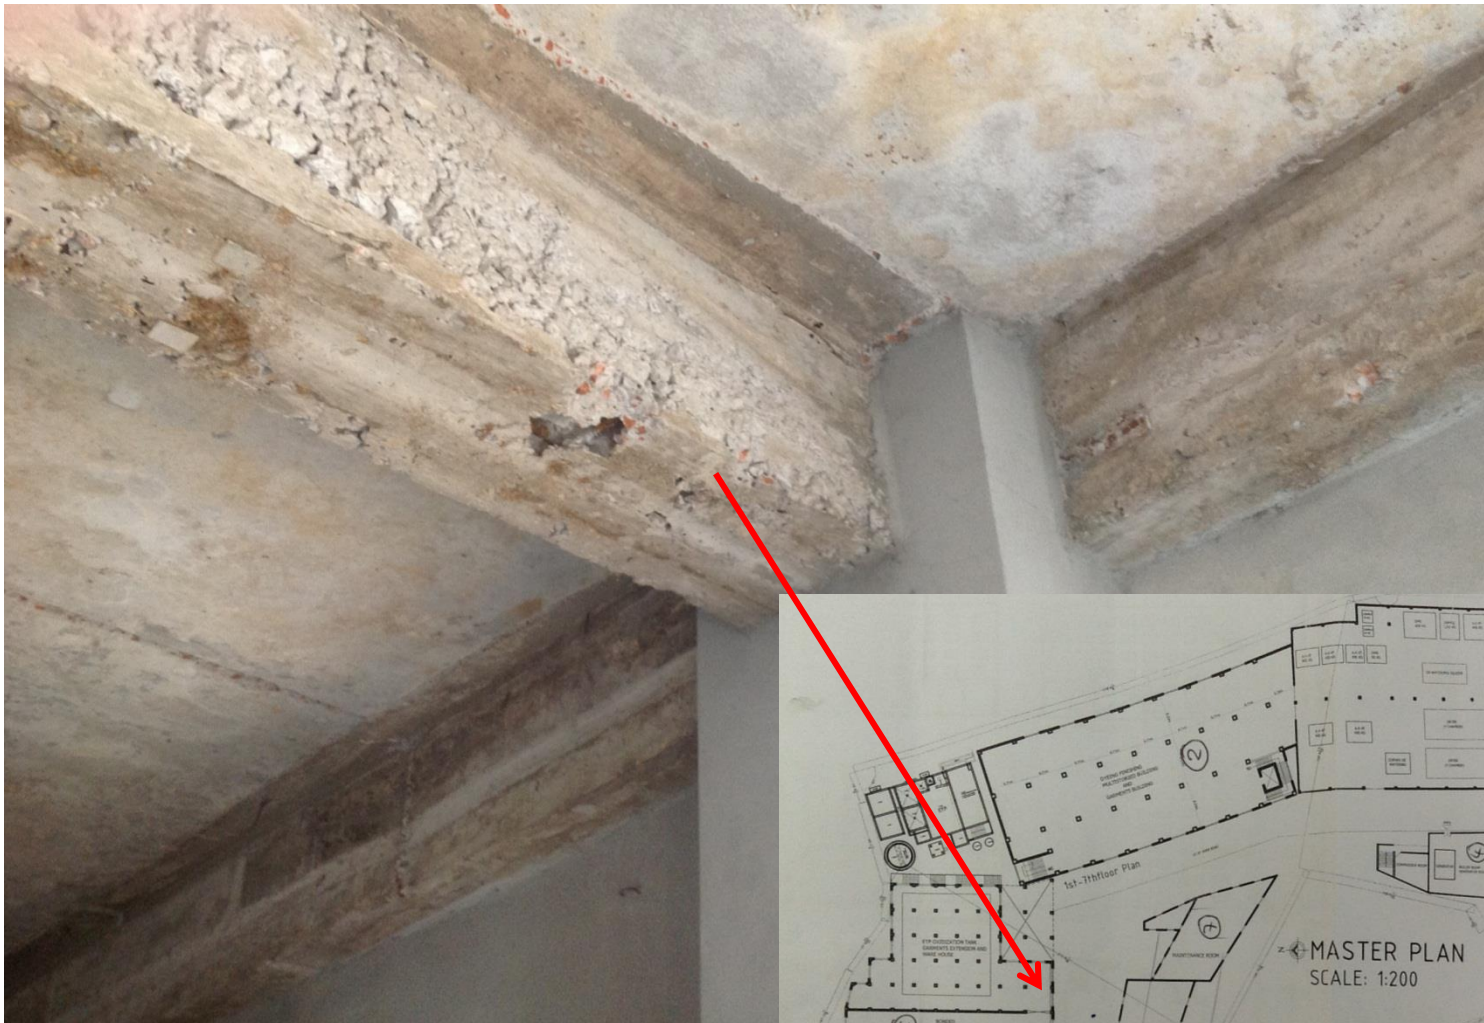
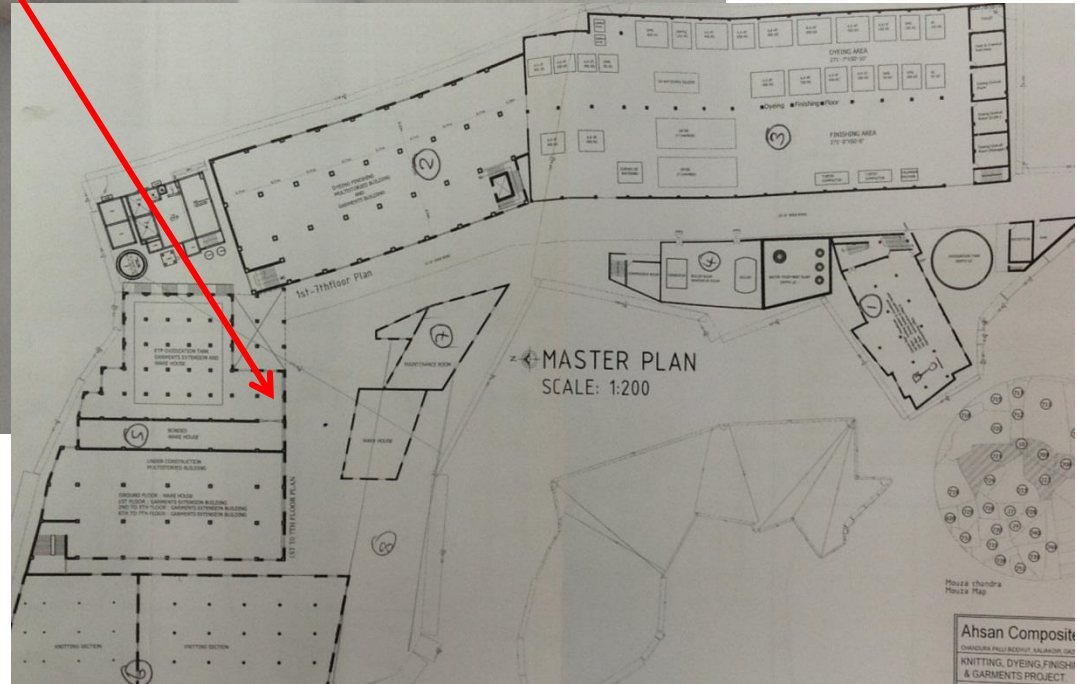
# Building 5 - Poorly-compacted beam

**Coarse aggregate is exposed along full length of the beam, suggesting lack of vibration.**

**Building 5 –  
Very poorly compacted beam**
