# Ahsan Composite Ltd.

Ward-08, Pollibidut Road, Chandra, Kaliakoir, Gazipur  
(24.04278N 90.25977E)

27 April 2014

# Observations

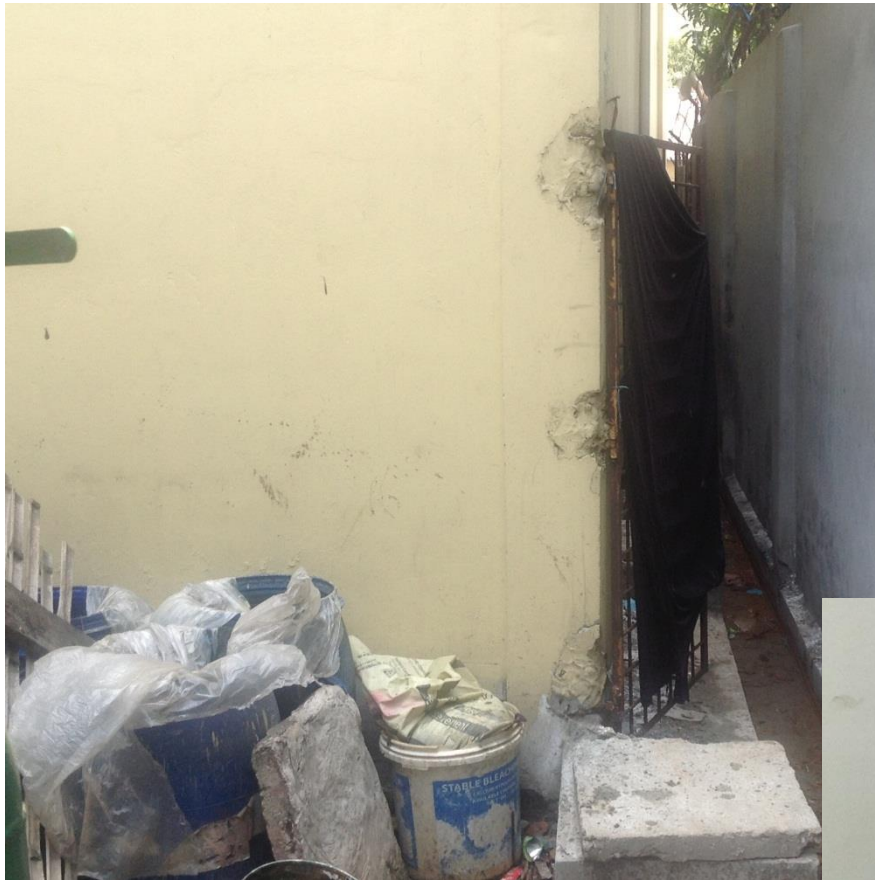
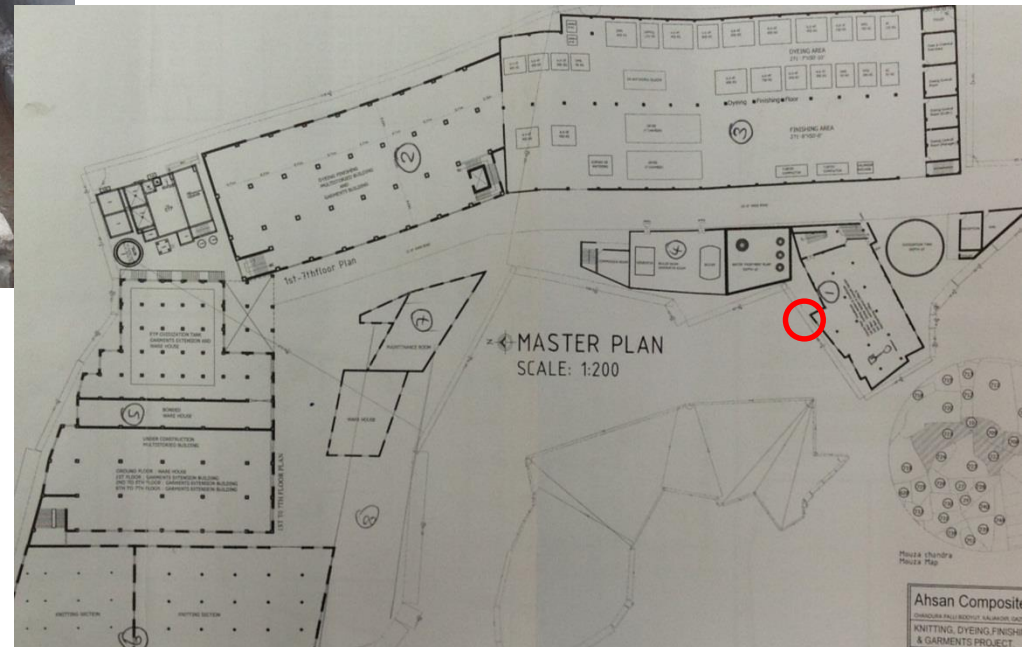
# Building 1 - RC column damaged by fixings

Gate hinges had been fixed to small RC column supporting corner of building. Concrete has been poorly made good at hinge locations and is spalling, suggesting corrosion of the reinforcement.

## Building 1 – RC column damaged by fixings

Item No.	Observation	Recommended Action Plan	Recommended Timeline
33	Building 1 - RC column damaged by fixings	Factory Engineer to inspect damage to columns.	6-weeks
34	Building 1 - RC column damaged by fixings	Repairs to column to be made under direction of Factory Engineer.	6-months
35	Building 3 - Office building framing not consistent with drawings; adjacent leaning partition	Engineering assessment to be undertaken by Factory Engineer.	6-months
36	Building 3 - Office building framing not consistent with drawings; adjacent leaning partition	Carry out actions arising from assessment.	6-months
37	Building 3 - Office building framing not consistent with drawings; adjacent leaning partition	Drawings to be amended to show as-built condition (after any remedial works).	6-months
38	ETP - Very large and heavily loaded RC water tanks	Engineering assessment of water tanks to be made by Factory Engineer.	6-months

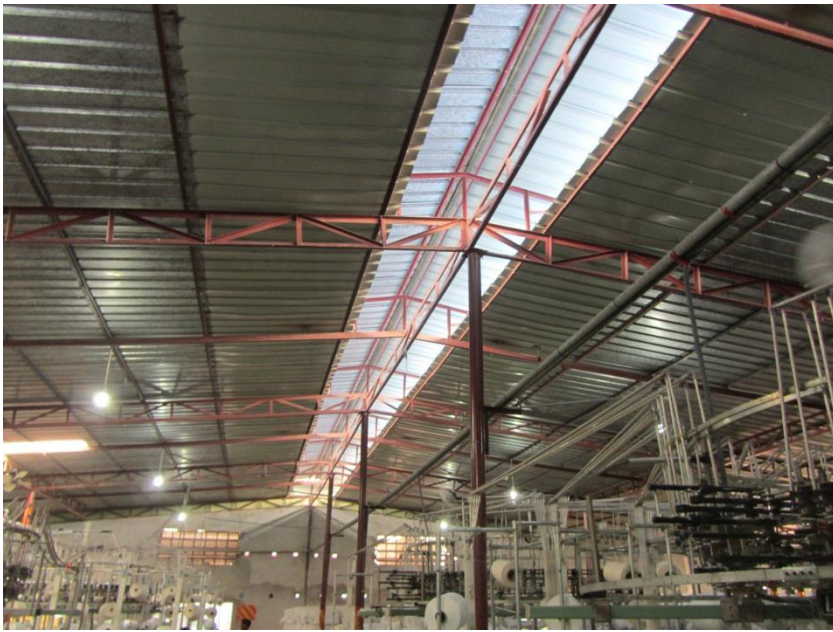
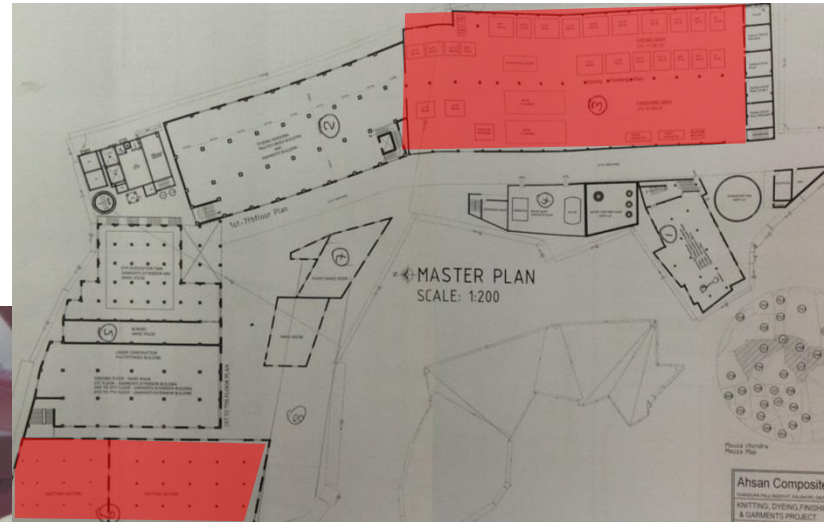
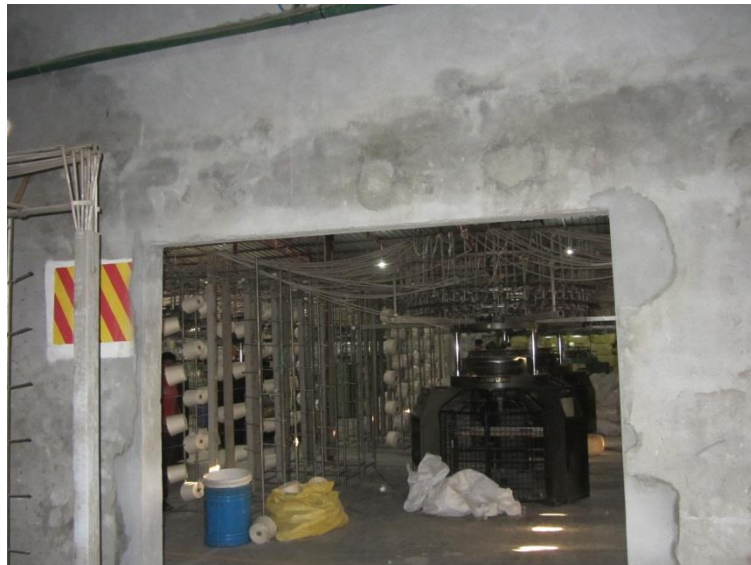
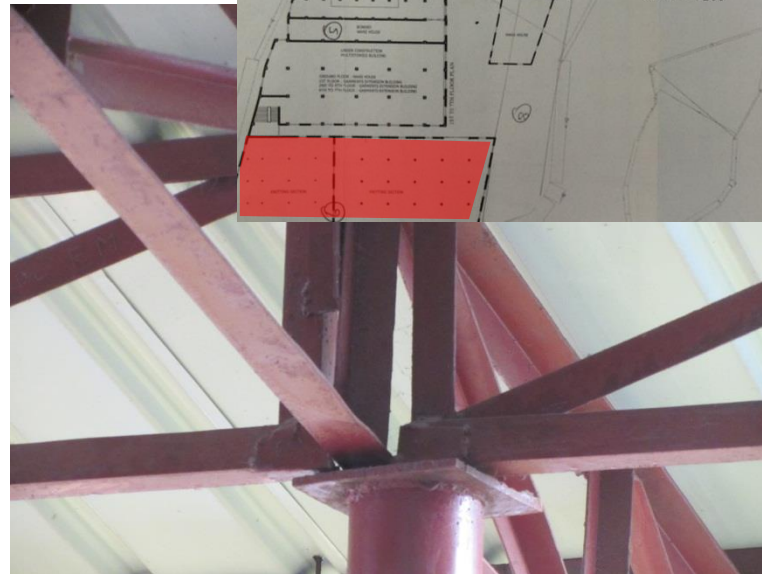
**Buildings 3 and 6 –  
Non-engineered steel sheds including weak roof  
connections, no roof bracing, potentially missing  
lintels and unrestrained brick facades**

Non-engineered steel sheds including weak roof connections, no roof bracing, potentially missing lintels and unrestrained brick facades.

# Non-engineered steel sheds

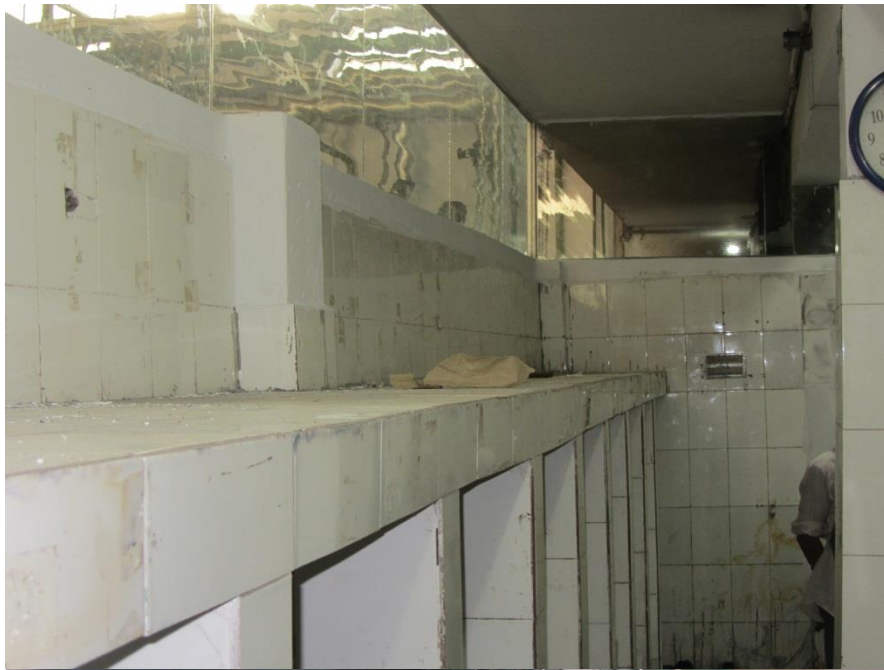
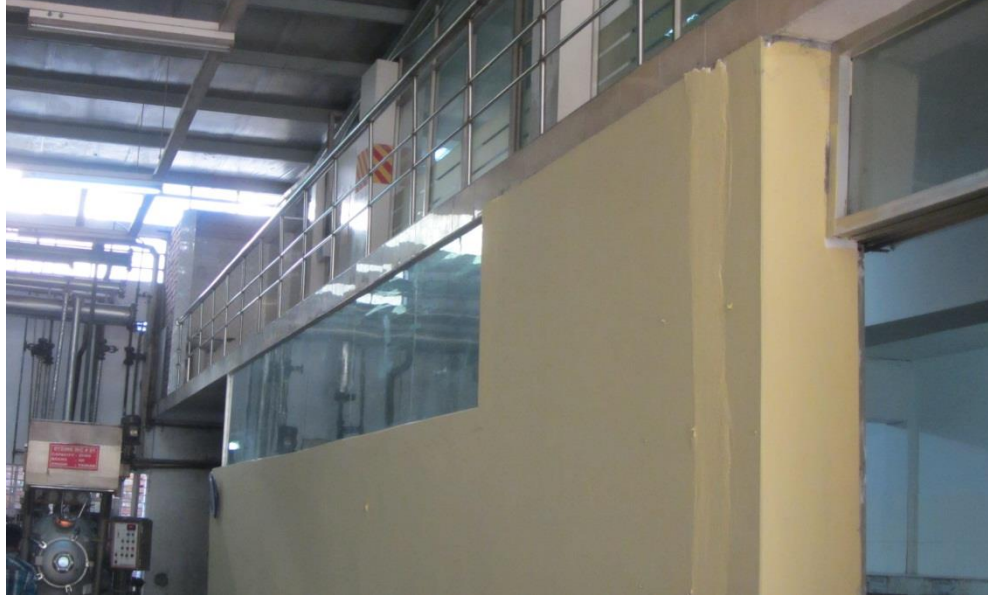
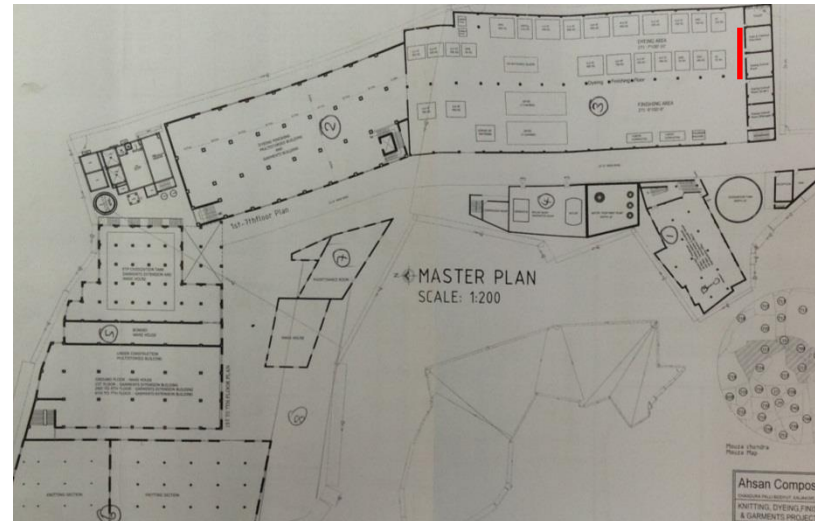
# Building 3 - Leaning partition

Partition (bottom left) is visibly leaning outwards. Stability will depend on degree of bonding to the buttresses built against the rear face.

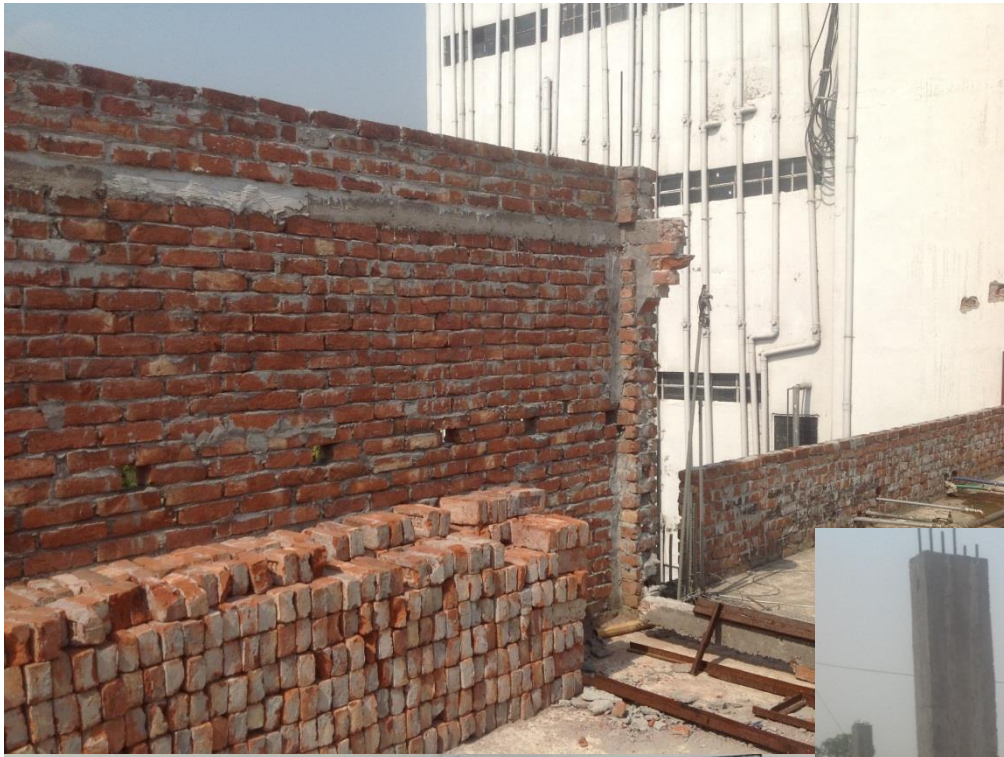
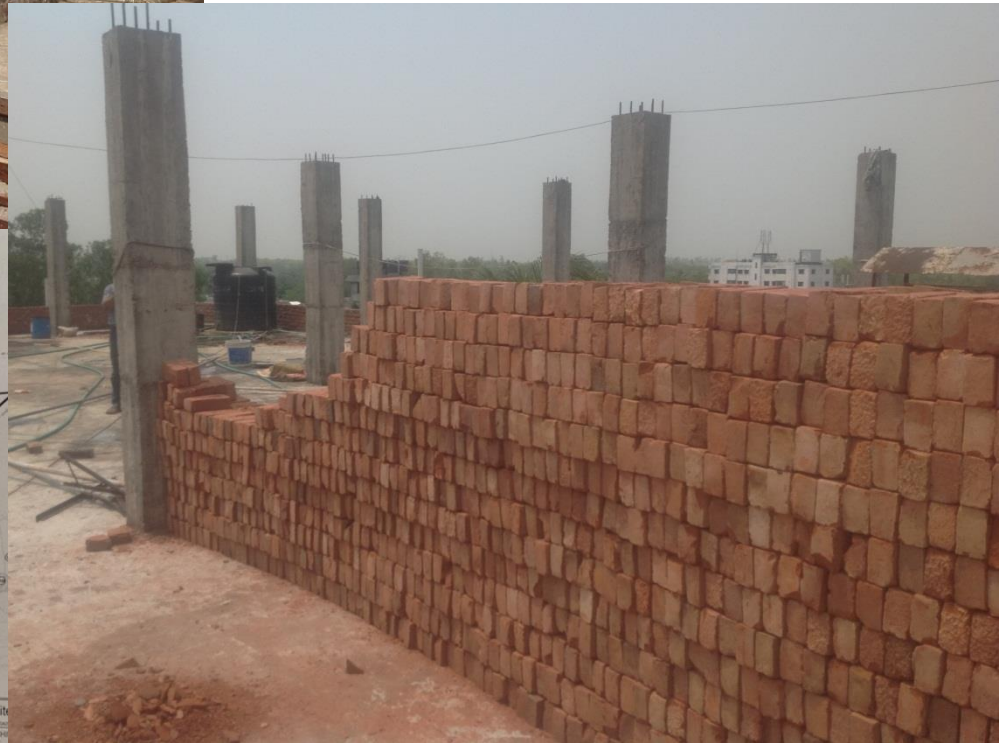
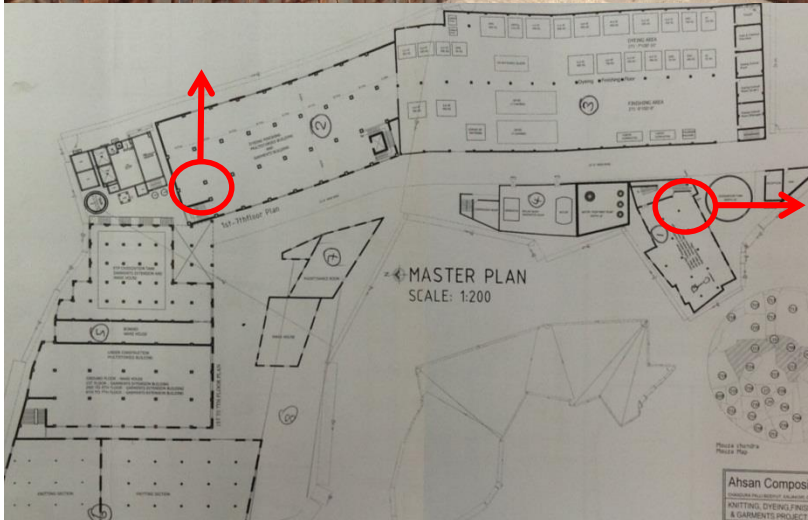
# Buildings 1 and 2 - Rubble and bricks on roof

Heavy brick loading on roofs (left, where brick structure has been demolished, and right, where bricks are being stored during construction of roof parapets).

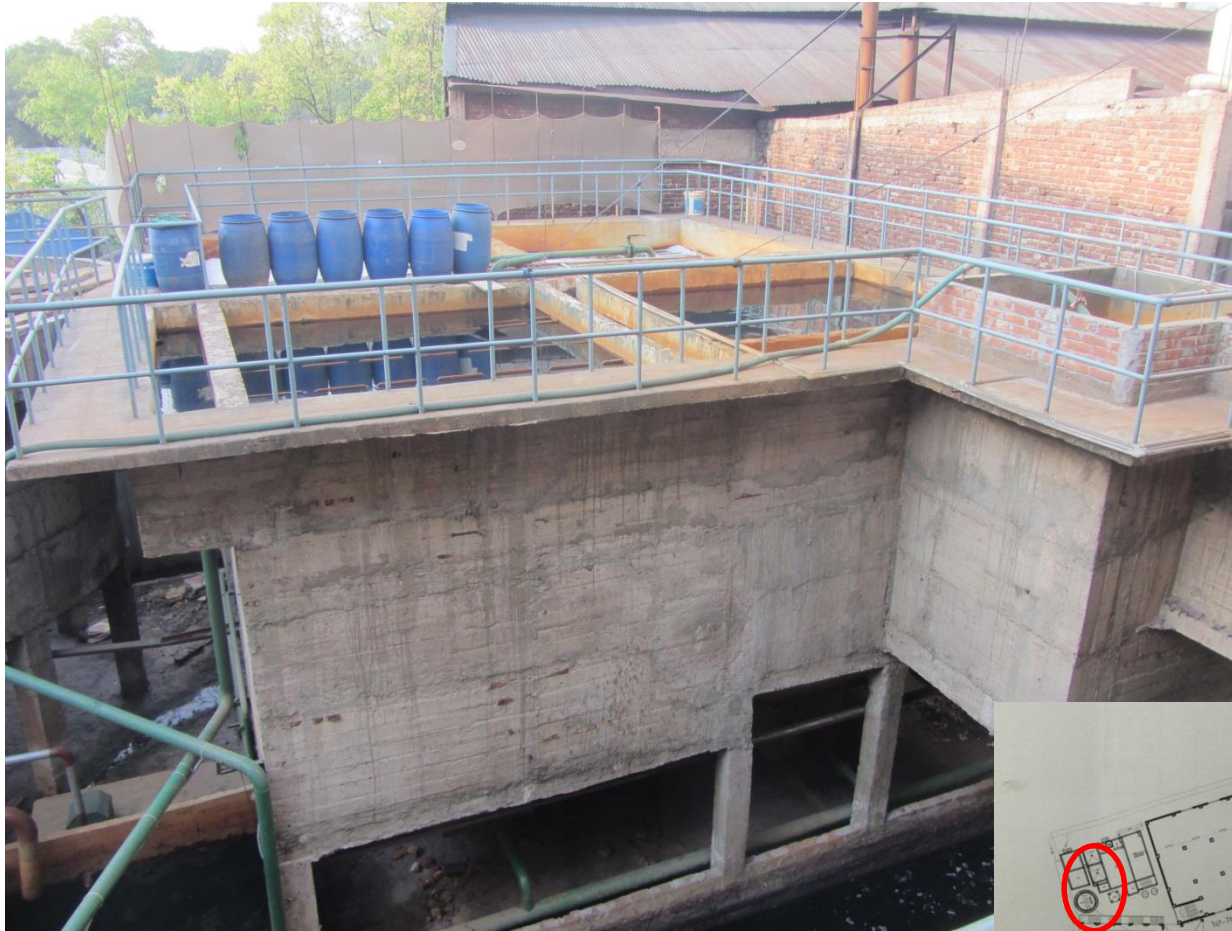
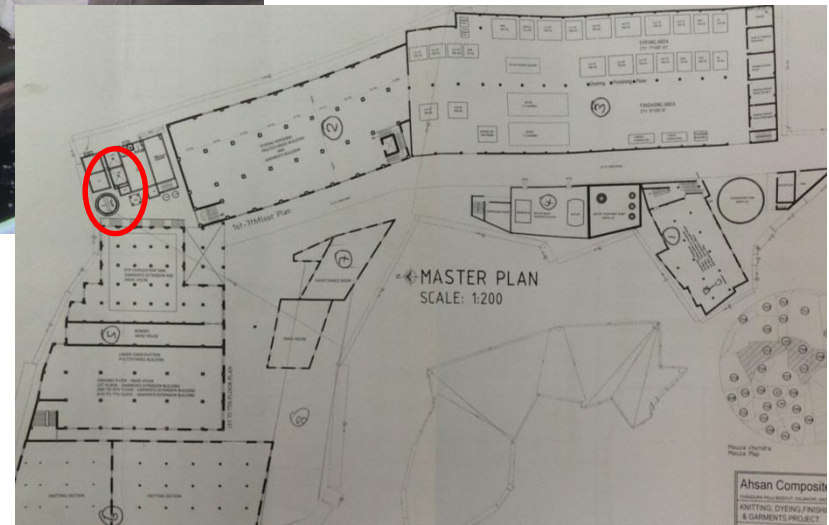
# ETP - Very large and heavily-loaded RC water tanks

Vertical and lateral loads on RC tanks will be significant.

Large RC water tanks

39	ETP - Very large and heavily loaded RC water tanks	Implement actions arising.	6-months

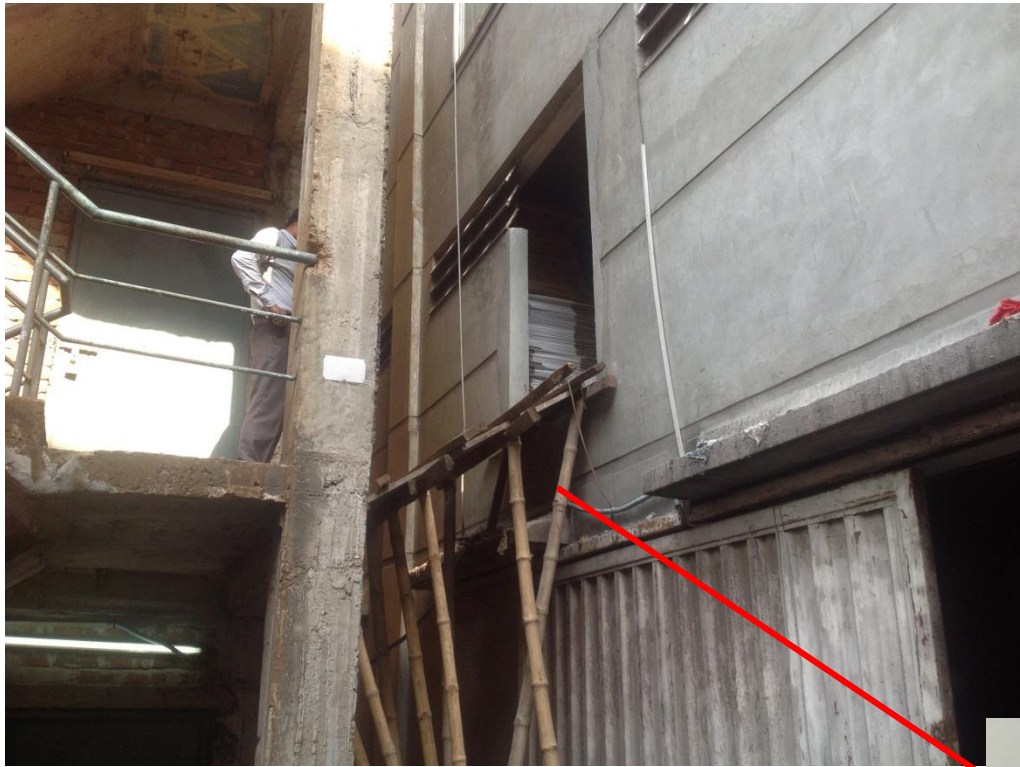
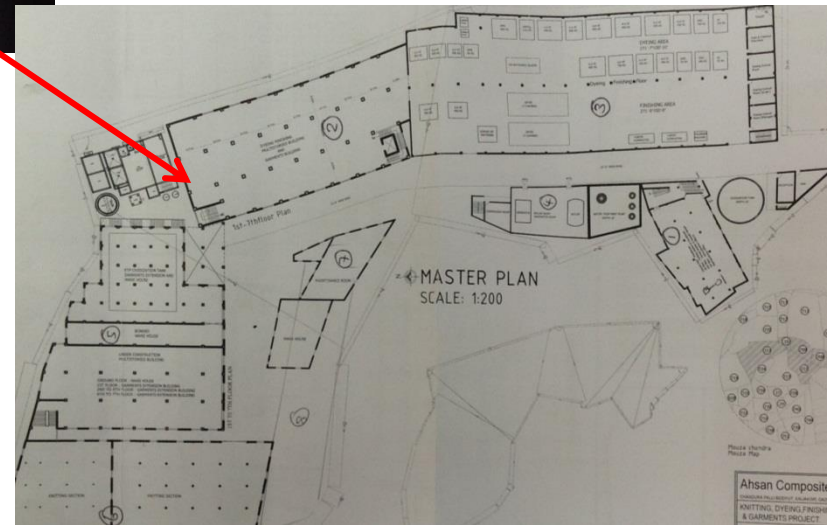
# Building 2 - Structurally unsafe access ramp

Access to mezzanine storage area is via a structurally unsafe timber ramp, loosely propped by bamboo.

Structurally unsafe access ramp

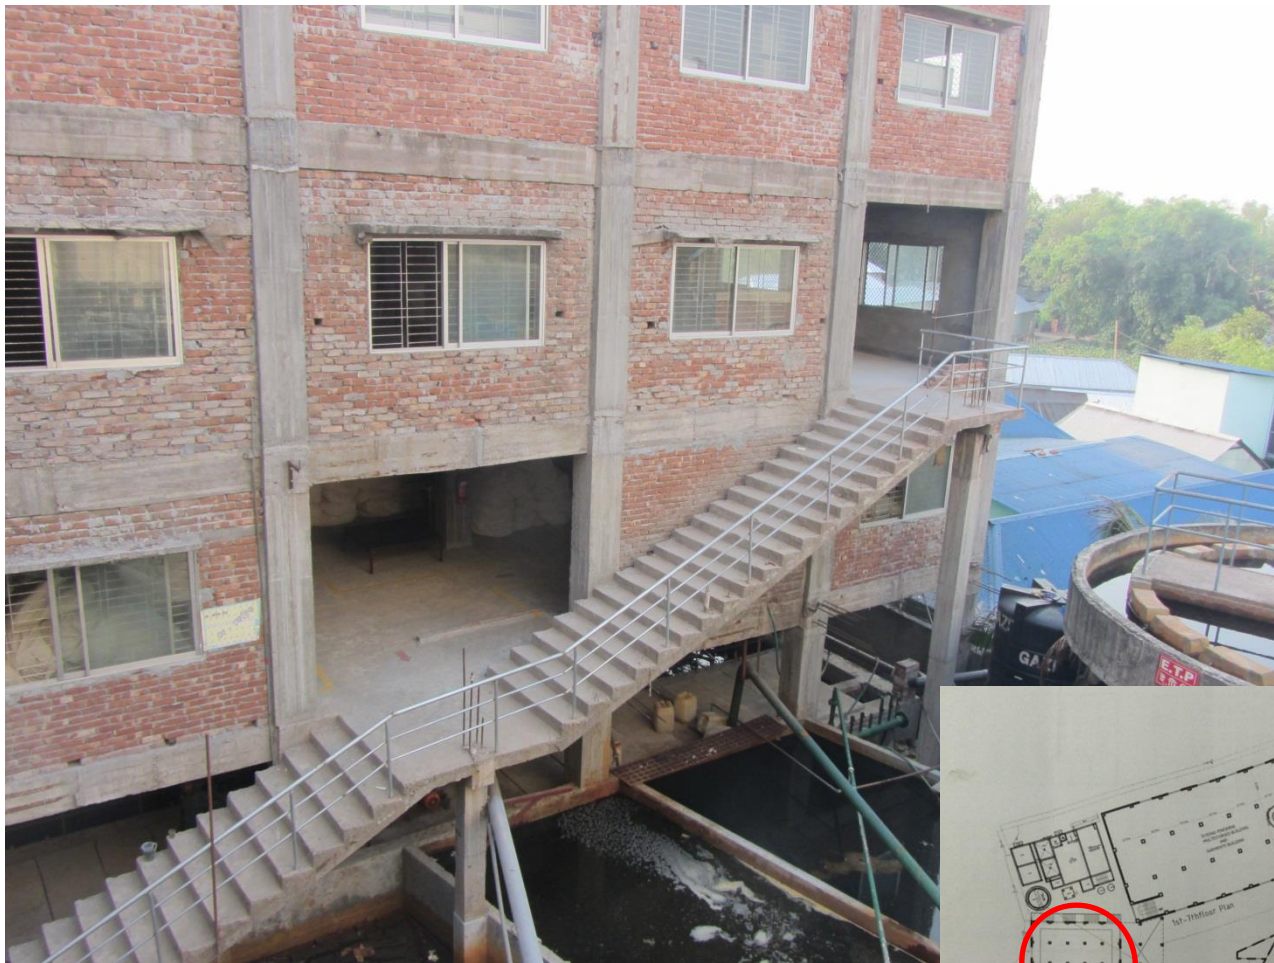
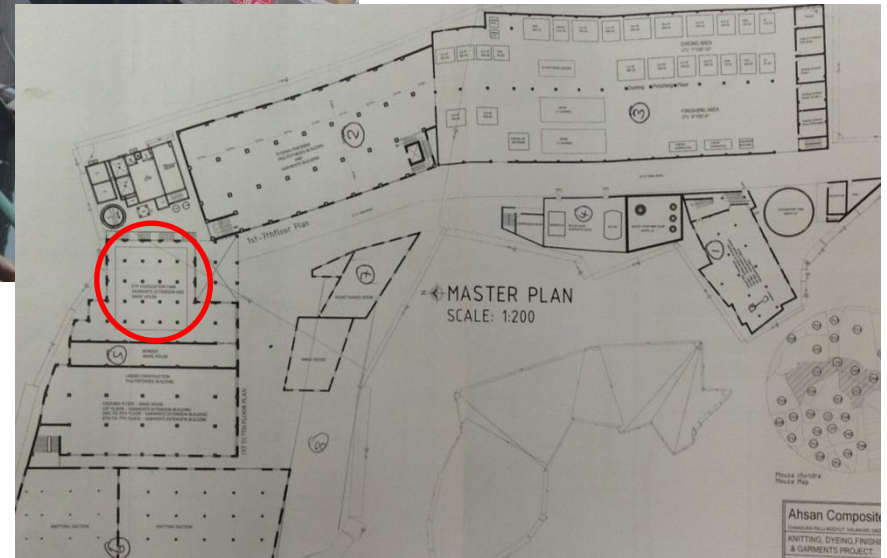
# Building 5 - Columns standing in water

Ground floor columns are standing in reservoir. Depending on cover and cement content this could lead to corrosion and affect strength of columns.

**Columns standing in water**

Item No.	Observation	Recommended Action Plan	Recommended Timeline
40	Building 5 - Columns standing in water	Tests to be undertaken on liquid to assess if it is corrosive; if liquid is corrosive, detailed checks to be made on concrete for evidence of damage.	6-months
41	Building 5 - Columns standing in water	Detailed inspection to be made by Factory Engineer to check for evidence of spalling. Repeat annually.	6-months
42	Building 1 - Minor settlement cracking to facades	Factory Engineer to inspect annually to check for evidence of any ongoing movement.	6-months

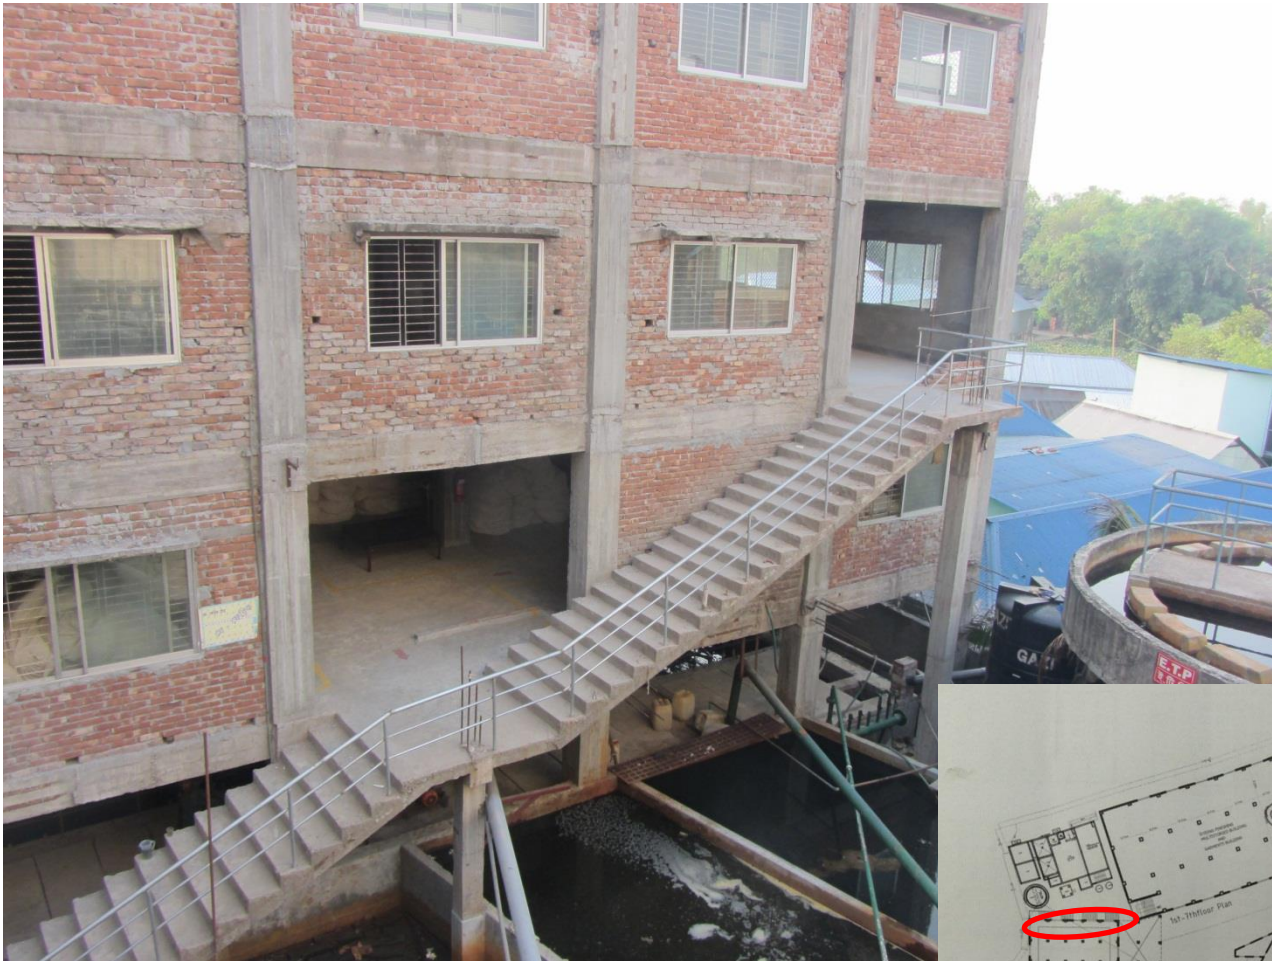
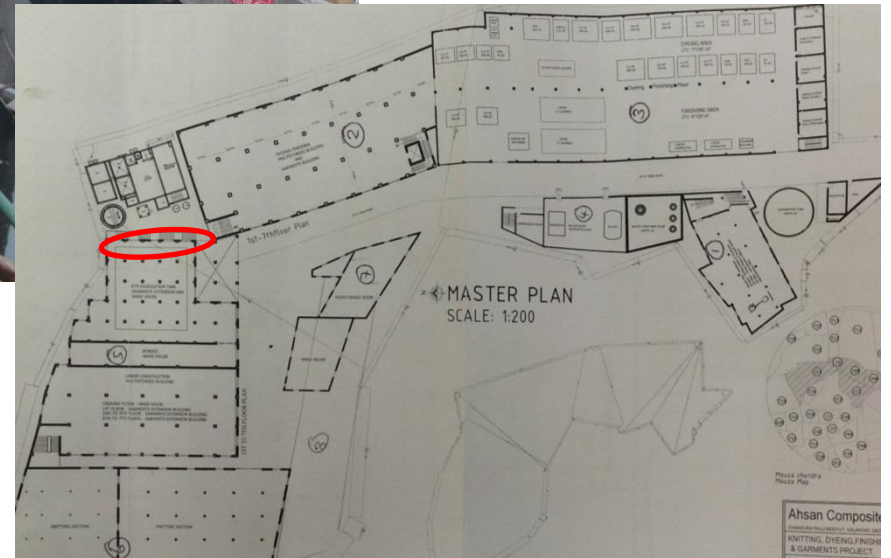
# Building 5 - External long-span stair

**External long-span stair**

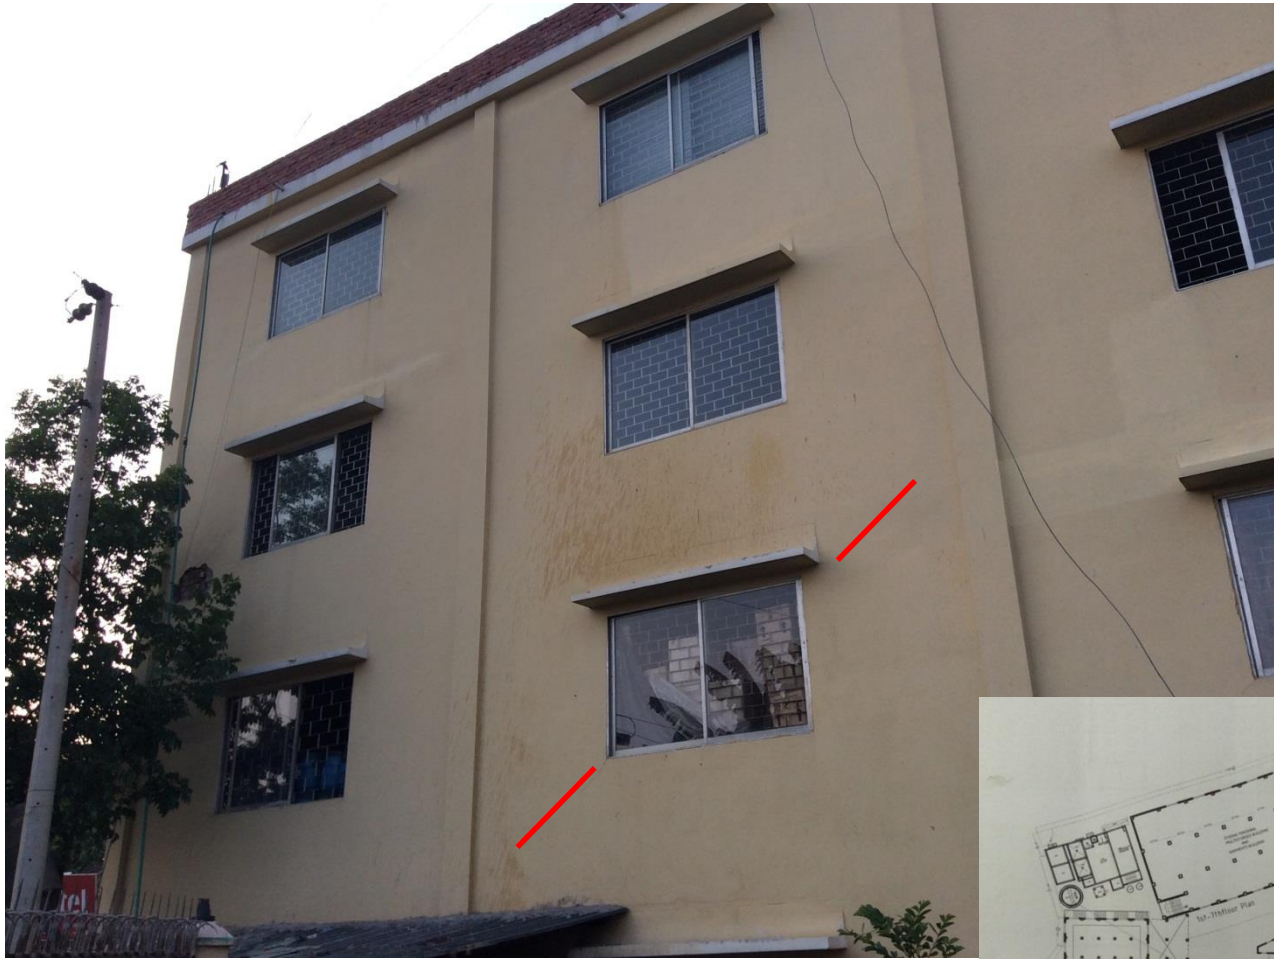
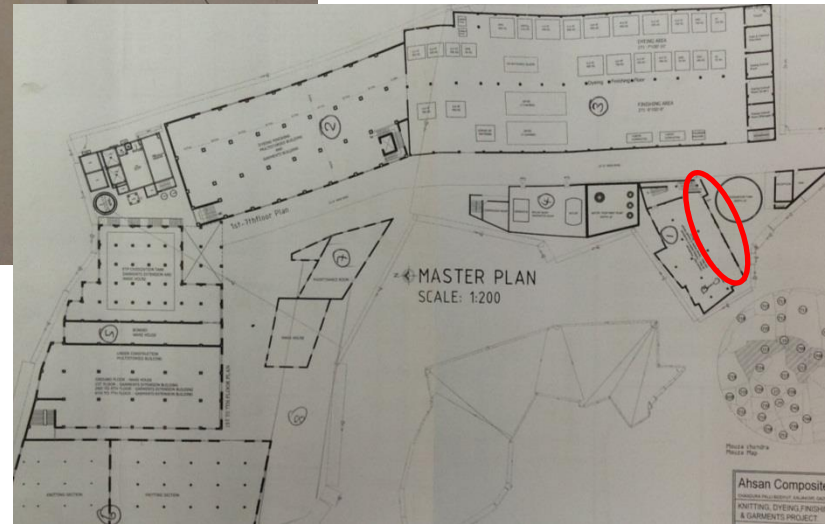
# Building 1 - Minor settlement cracking to facades

Red lines showing typical hairline cracking which is evident to all windows.

Minor settlement cracking to facades

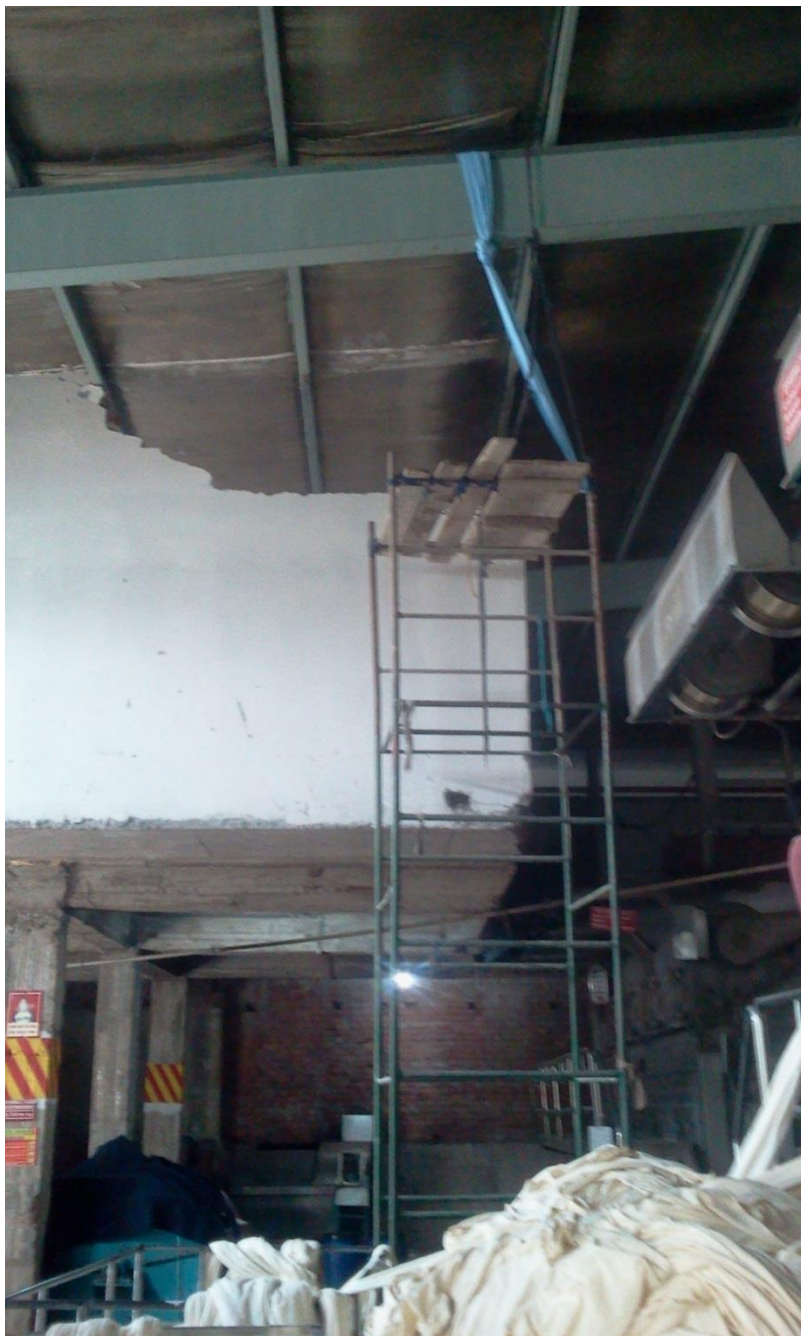
## Photograph and email from factory owner received day after Arup survey

*It was nice to have you in our factory Ahsan Composite Ltd on the date of 27<sup>th</sup> April. We are grateful to you that you come to ensure the structural safety for factory. We are really honored for this. During your visit you highlight three weak points for the factory. We ensure that among those three points we already repair the temporary tin shed wall (Please see the Attach file Pic 1). Secondly the stair slab support wall is under construction (Please see the Attach file Pic 2). Thirdly we already start to demolish the extension slab in main Dye House. Right now the wall on the extended portion has been removed (Please see the Attach file Pic 3).*

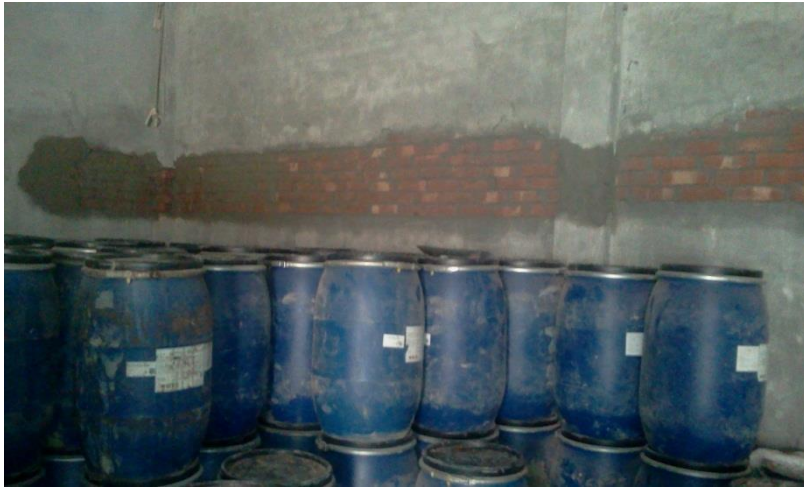
## Photograph and email from factory owner received day after Arup survey

*It was nice to have you in our factory Ahsan Composite Ltd on the date of 27<sup>th</sup> April. We are grateful to you that you come to ensure the structural safety for factory. We are really honored for this. During your visit you highlight three weak points for the factory. We ensure that among those three points we already repair the temporary tin shed wall (Please see the Attach file Pic 1). Secondly the stair slab support wall is under construction (Please see the Attach file Pic 2). Thirdly we already start to demolish the extension slab in main Dye House. Right now the wall on the extended portion has been removed (Please see the Attach file Pic 3).*

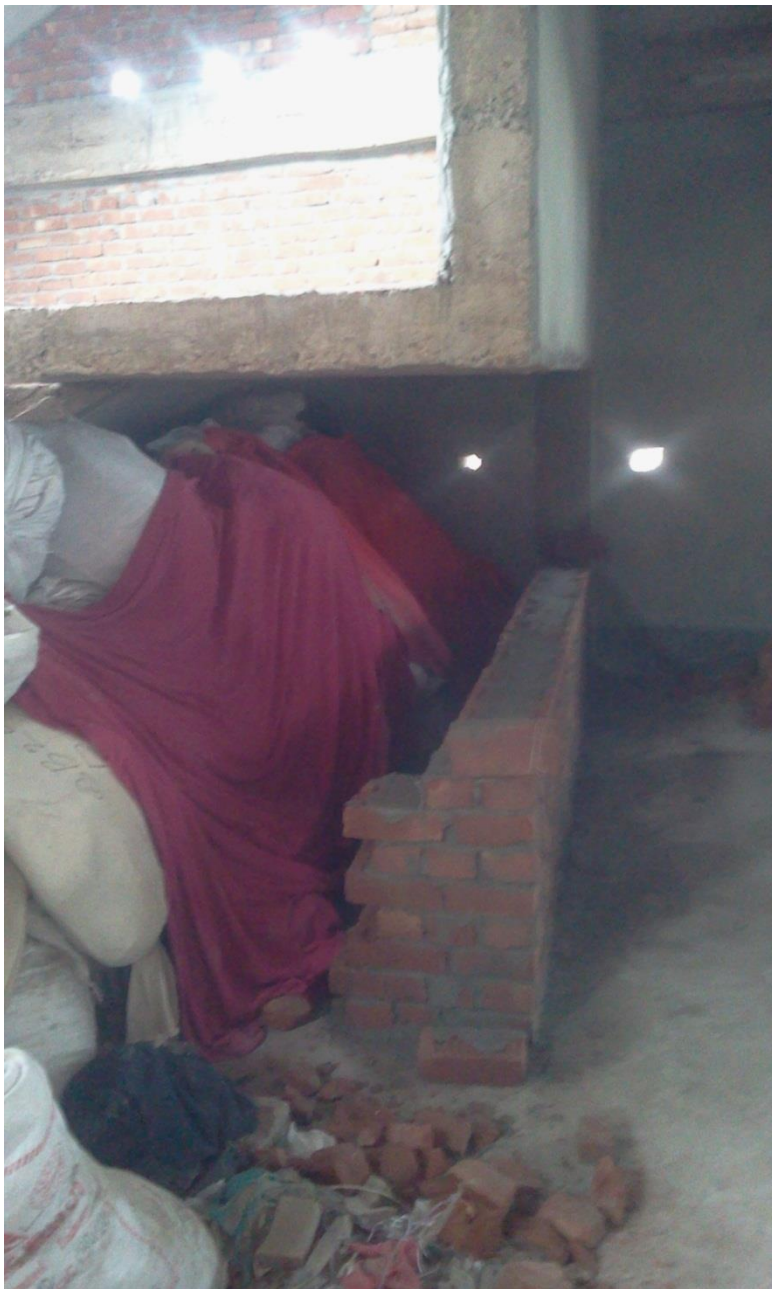
## Photograph and email from factory owner received day after Arup survey

*It was nice to have you in our factory Ahsan Composite Ltd on the date of 27<sup>th</sup> April. We are grateful to you that you come to ensure the structural safety for factory. We are really honored for this. During your visit you highlight three weak points for the factory. We ensure that among those three points we already repair the temporary tin shed wall (Please see the Attach file Pic 1). Secondly the stair slab support wall is under construction (Please see the Attach file Pic 2). Thirdly we already start to demolish the extension slab in main Dye House. Right now the wall on the extended portion has been removed (Please see the Attach file Pic 3).*
