# **FIRE SAFETY INSPECTION REPORT**

## **BILLAH RESOURCES LTD**

**ACCORD**  
on Fire and Building Safety in Bangladesh

April 12, 2014

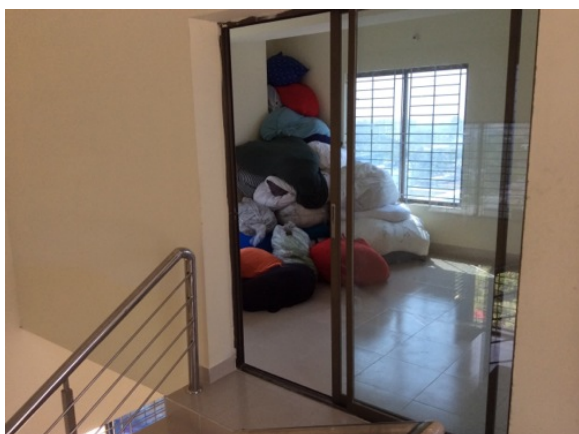
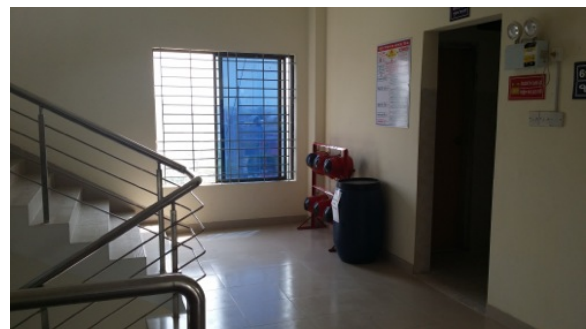
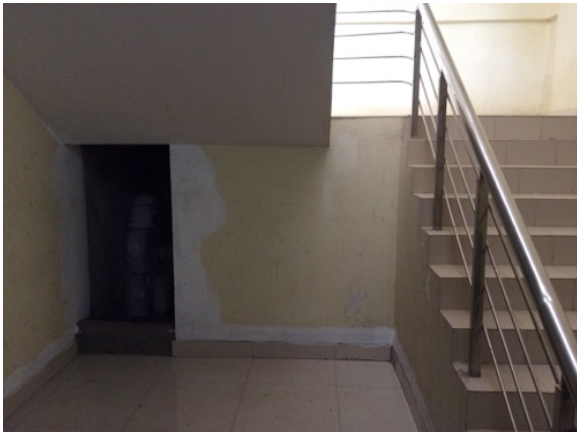
No.	Category	Finding	Recommendation	Remediation Timeframe
F-1	Fire Rated Construction	<p>The East exit stairwells are not properly separated from storage spaces on the roof floor, and all floors preceding it, with acceptance to the basement floor by fire-rated construction. The West stairwell, ground floor had a storage room underneath the stairwell. In addition to the storage rooms, both stairwells were not properly separated from production floors.</p>	<p>Provide minimum 1.5-hr fire rated doors and seal all unprotected openings to separate the exit stairs from work areas and other building spaces on all floor levels. Ensure that the fire doors are self-closing and positive latching and that they are provided with fire exit (panic) hardware where serving production floors.</p>	Within 3 months

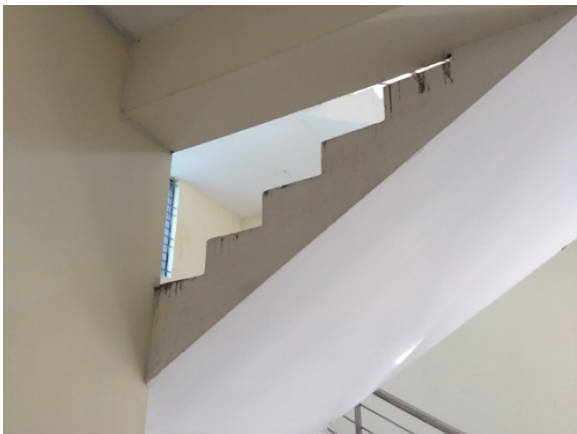
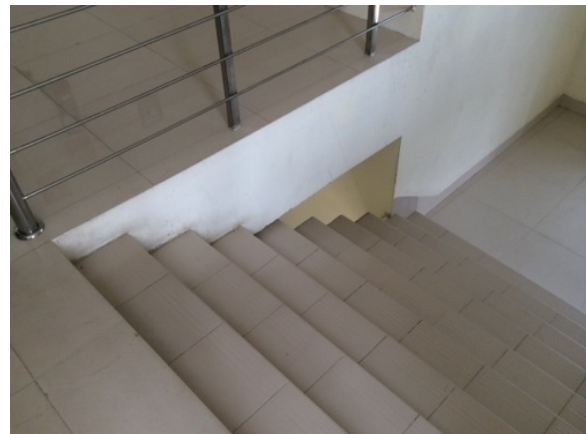
F-2	Fire Rated Construction	Unsealed penetrations and openings are located in exit stair enclosures. Specifically located on the ground floor, east stairwell.	Seal all penetrations and openings in exit stair enclosure walls to maintain the fire separation.	Within 3 months
-----	-------------------------	--	---	-----------------

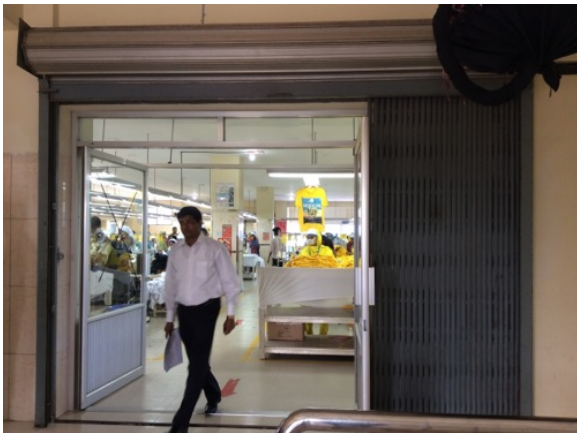
F-3	Egress	Egress doors / gates with locking features are provided at building exits, exit stairs, along egress routes, exit discharge. This was apparent on all floors within the East stairwell.	Remove locking features from all egress doors / gates.  If locks are required for security reasons, utilize special door locking features complying with NFPA 101.	Immediate
-----	--------	---	--	-----------

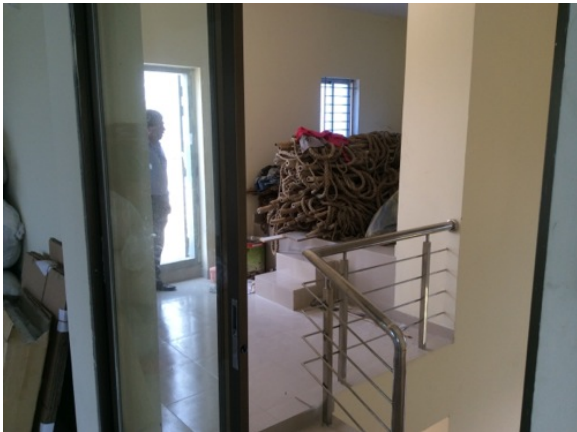
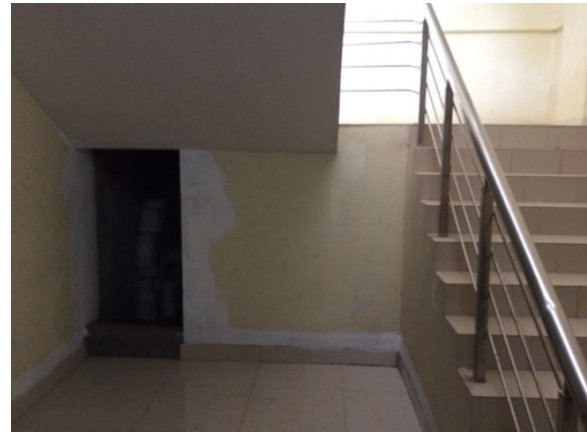
F-4	Egress	East and West stairwell specifically on the roof floors, had storage rooms within egress stairwell enclosures, it was also found specifically in the west stairwell in all floors that offices and restrooms shared the stairwell. Also at basement level West stairwell had a storage room underneath the stairwell.	Remove all storage from exit stairs and egress paths.	Immediate
-----	--------	---	---	-----------

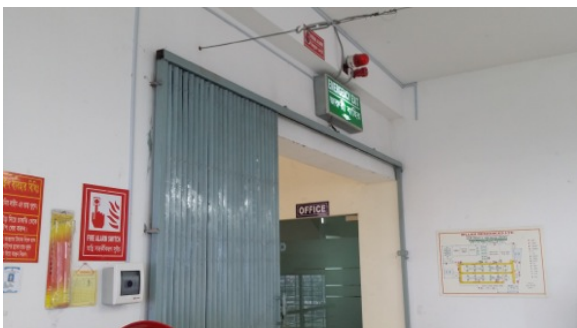
F-5	Egress	Collapsible gates / sliding doors are provided at building exits, exit stairs, along egress routes, and at exit discharge points primarily within the East stairwell.	<p>Replace all gates / sliding doors along the means of egress with side-hinged, swinging egress doors.</p> <p>If locks are required for security reasons, utilize special door locking features complying with NFPA 101.</p>	Within 1 month
-----	--------	---	---	----------------

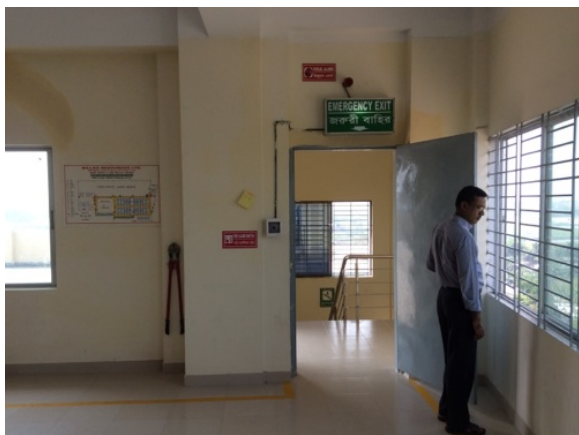
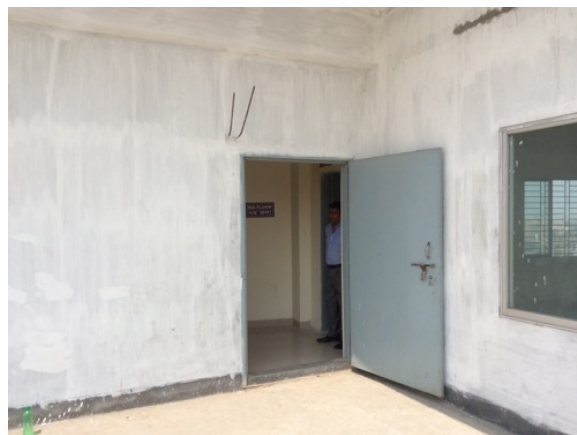
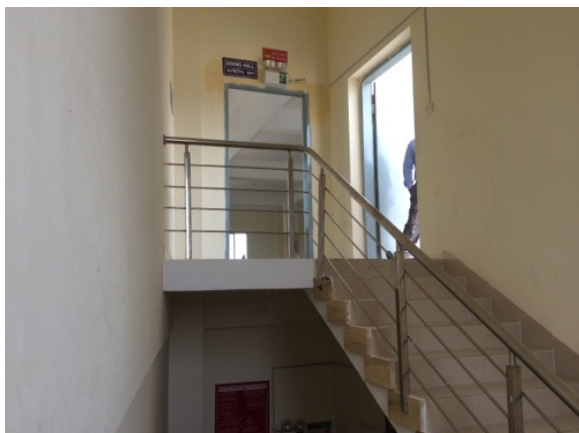
F-6	Egress	Exit stairwell doors do not swing in the direction of egress. This was reflected on all floors.	Modify the egress door to swing in the direction of egress travel.	Within 3 months
-----	--------	---	--	-----------------

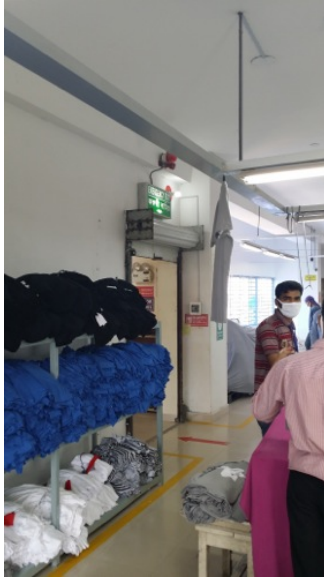
F-7	Fire Protection	The fire alarm system is antiquated, not a listed system, and does not provide alarm and notification features consistent with acceptable standards.	Replace the fire alarm system with a new, listed addressable fire alarm system in accordance with NFPA 72.	Design within 4 months, install within 9 months
-----	-----------------	--	--	---

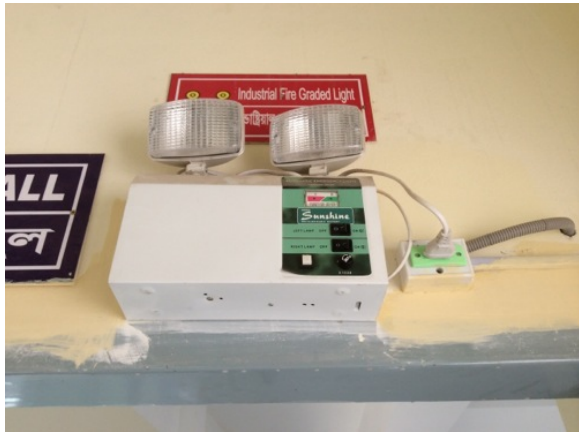
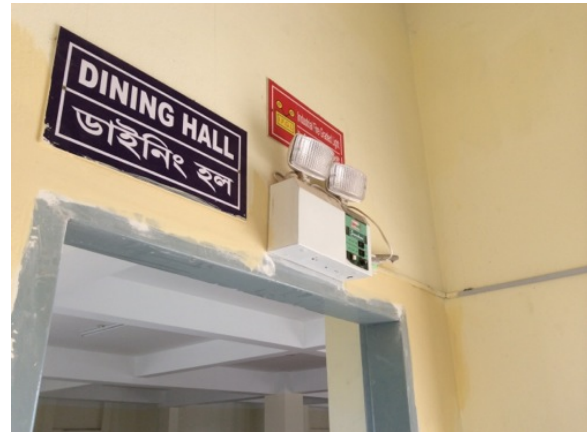
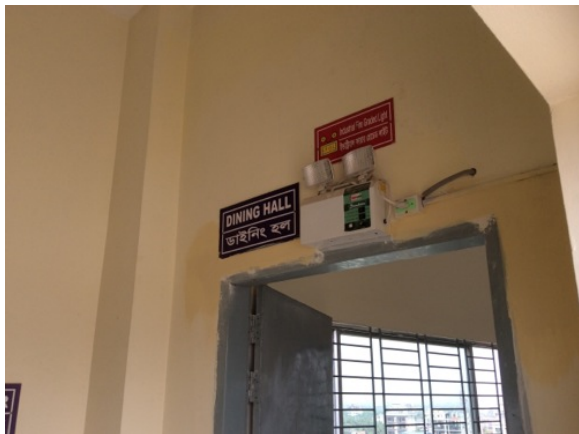
F-8	Fire Protection	Inspection, testing, and maintenance for the fire alarm system was not in accordance with NFPA 72.	Inspect, test and maintain the fire alarm system, and keep written records on-site, in accordance with NFPA 72.	Within 3 months
F-9	Fire Protection	The building is equipped with single-station smoke alarms. Smoke alarm activation sounds only a local alarm and does not provide automatic fire alarm notification of occupants.	Replace the single-station smoke alarms. Provide automatic smoke detection throughout the building in accordance with NFPA 72	Within 6 months
F-10	Egress Lighting	Manual on-off switch is provided for emergency lighting units.	Remove manual on/off switches from emergency lighting units to prevent them from being switched off.	Within 1 month
