# A-One Polar Ltd

Bhulta, Rupgonj, Narayangonj.  
(23.754782, 90545710)  
27th April 2014

# Observations

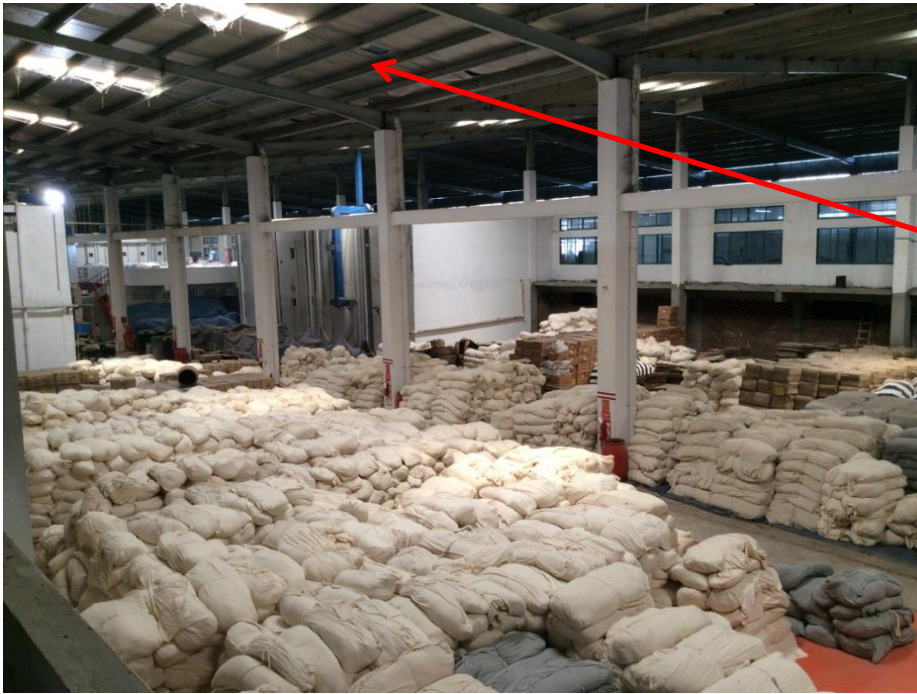
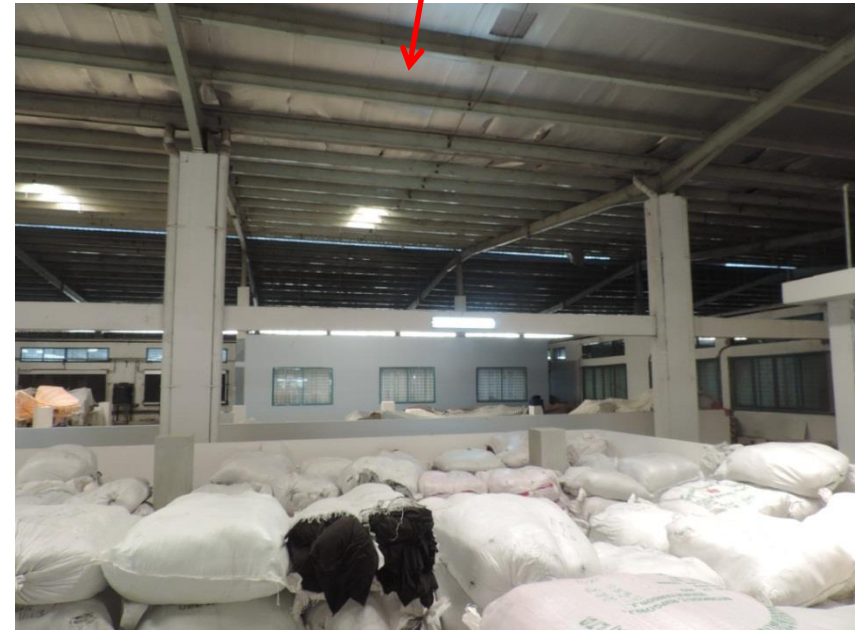
# Roof structure: no roof bracing

Stability: No roof bracing observed  
Structure relies on roof deck for  
transferring horizontal loads to  
façade walls.

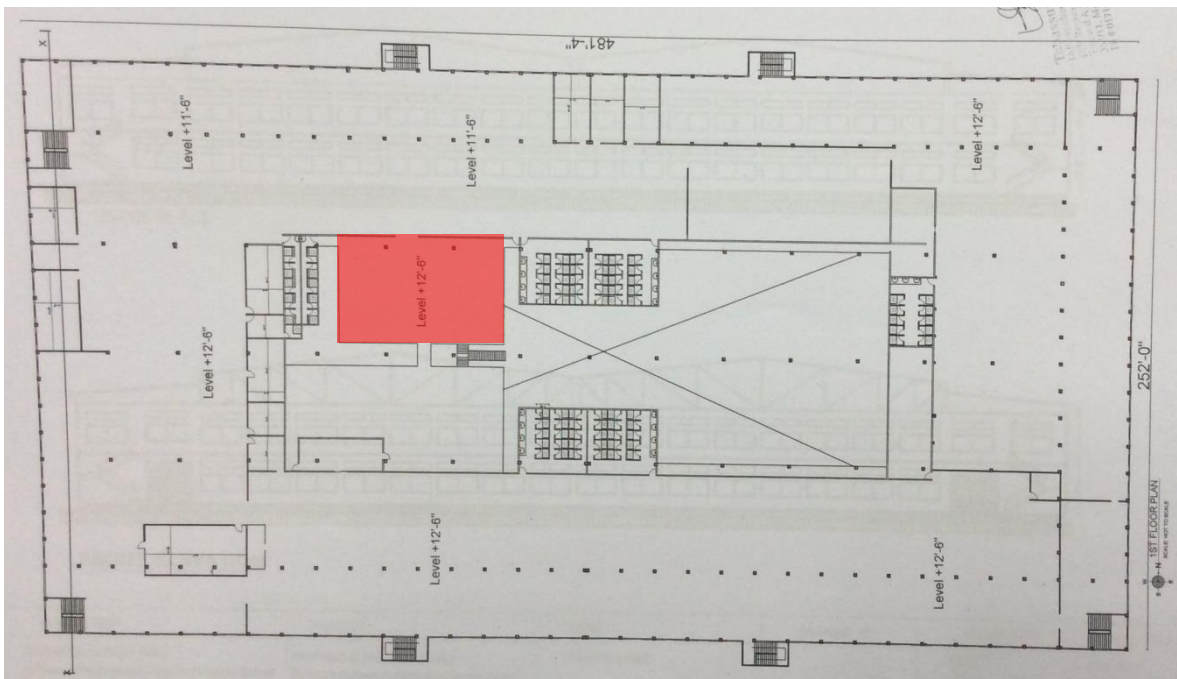
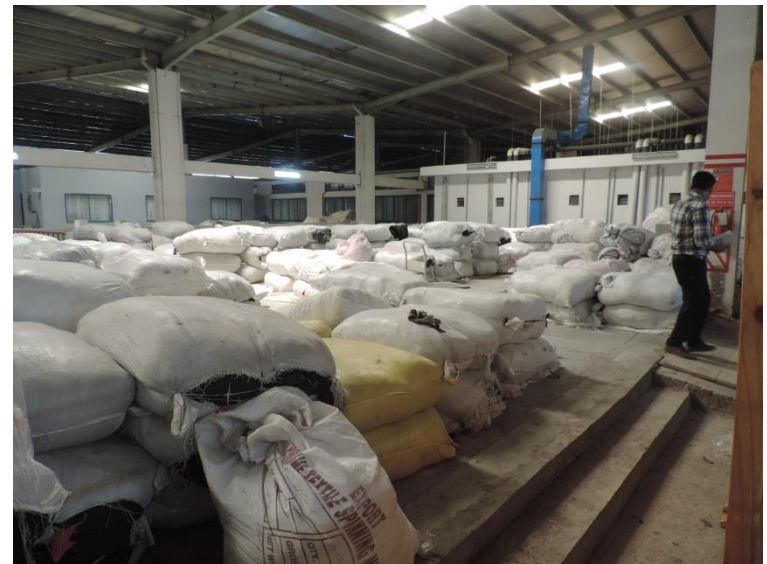
**1st floor**

**Heavy loadings on 1<sup>st</sup> floor slab**

**Storage ± 3 kN/m<sup>2</sup>**

Loading plan provided dated 25-03-14

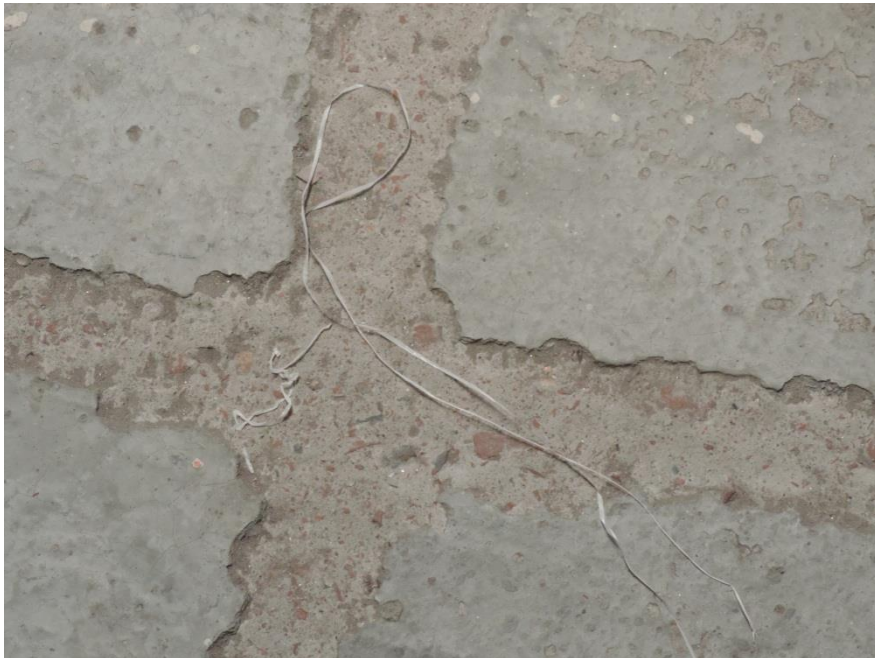
**Brick aggregate was observed in columns  
at ground floor and in slab 1<sup>st</sup> floor**

**Brick aggregate in slab 1<sup>st</sup> floor**

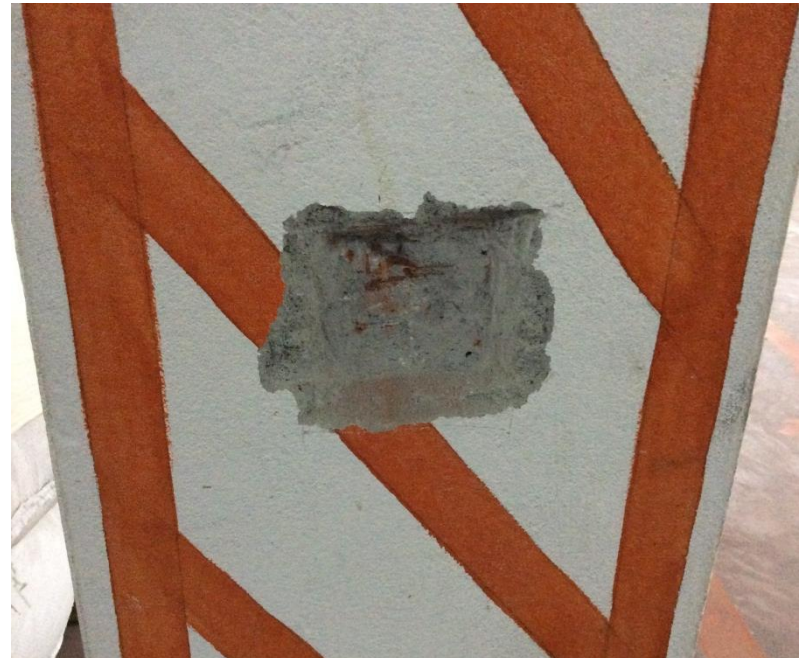
**Brick aggregate in column**

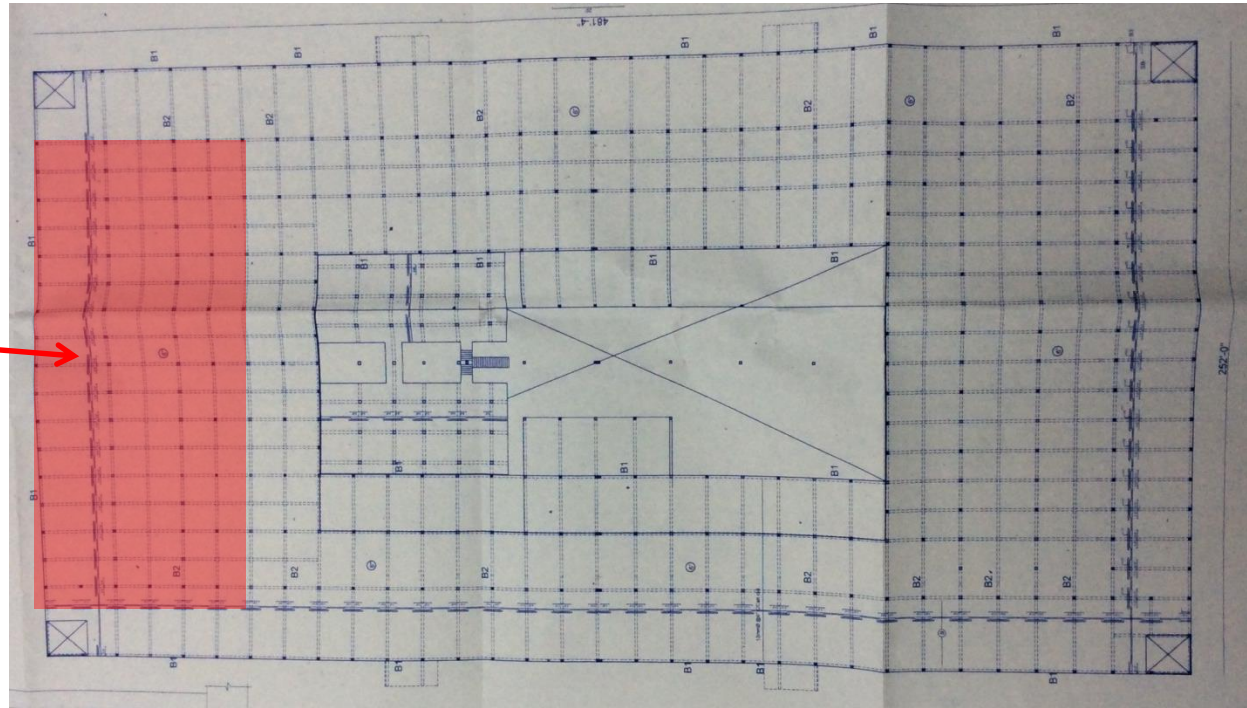
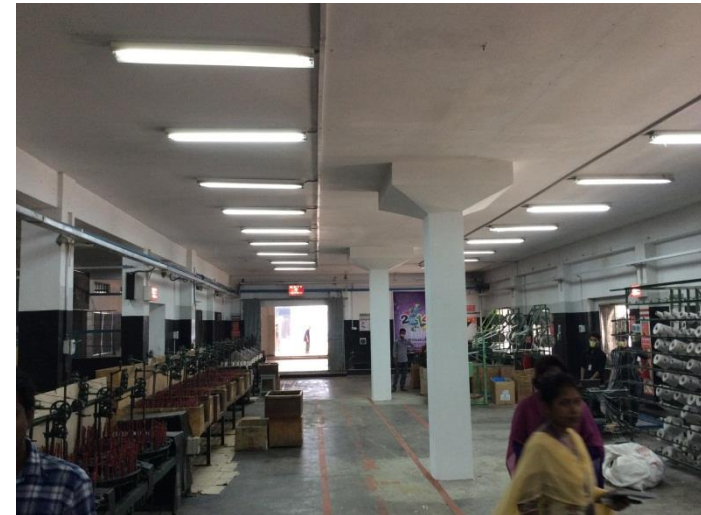
**Observed area**

**Discrepancies between structural drawings and as-built situation:**

- Flat slab used instead of beam and slab used in two bays
- Grid and column location on ground floor do not match drawings

Item No.	Observation	Recommended Action Plan	Recommended Timeline
1	Differences between the as constructed and the structural drawings	Building engineer to check, collect information and produce accurate and complete as-built documentation.	6-weeks
2	Differences between the as constructed and the structural drawings	Building Engineer to assess what impact these differences have on the structural integrity of the building.	6-weeks
3	The lack of bracing in the roofs of all the building with reliance on the roof sheeting	Building engineer to review lateral stability of steel roof structure.	6-weeks
4	The lack of bracing in the roofs of all the building with reliance on the roof sheeting	Building engineer to design any additional structure deemed necessary.	6-weeks
5	The lack of drawings for the Water treatment building under construction	Engineer to analysis and design using verified material strengths and as built structural arrangement (E.g. reinforcement grade, concrete compression capacity for the structure prior to any loading of the building	6-weeks

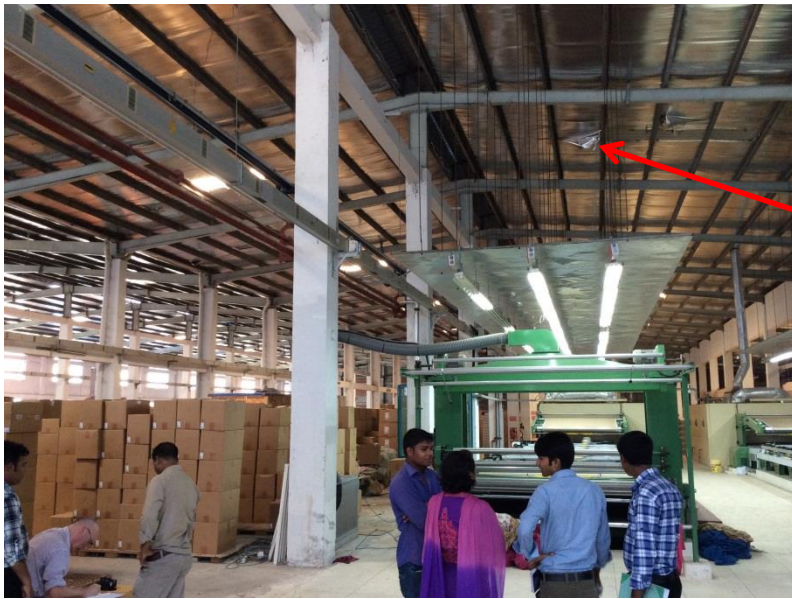
# Roof structure: no roof bracing

**Stability: No roof bracing observed  
Structure relies on roof deck for  
transferring horizontal loads to  
façade walls.**

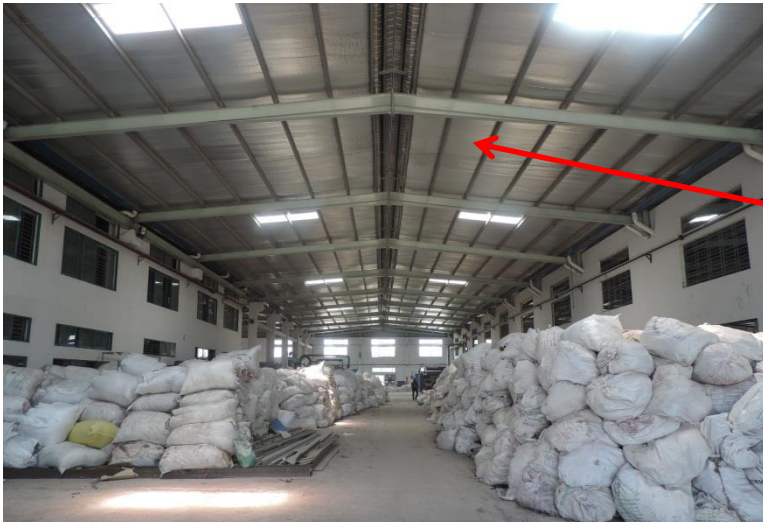
New shed

# Roof structure: no roof bracing

Stability: No roof bracing observed  
Structure relies on roof deck for  
transferring horizontal loads to  
façade walls.

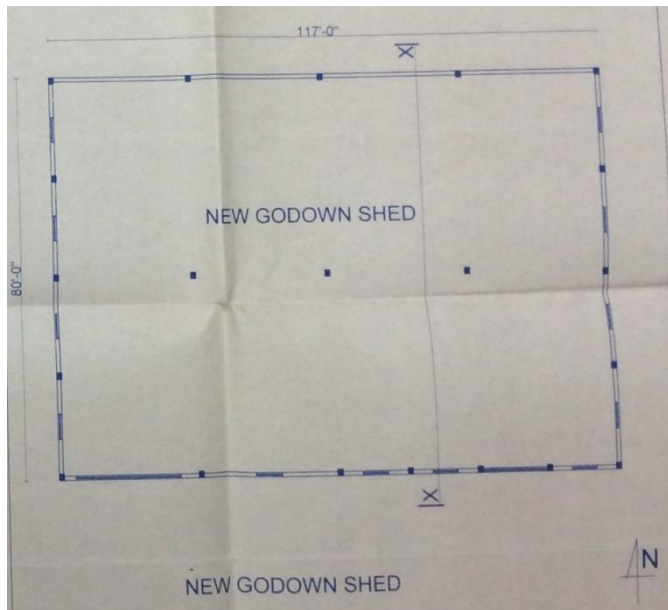
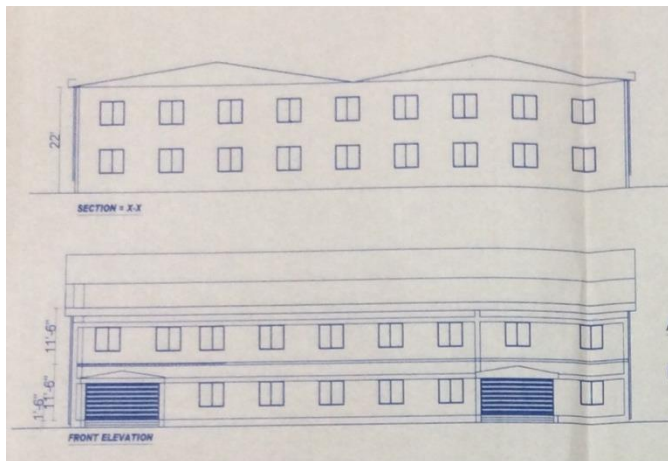
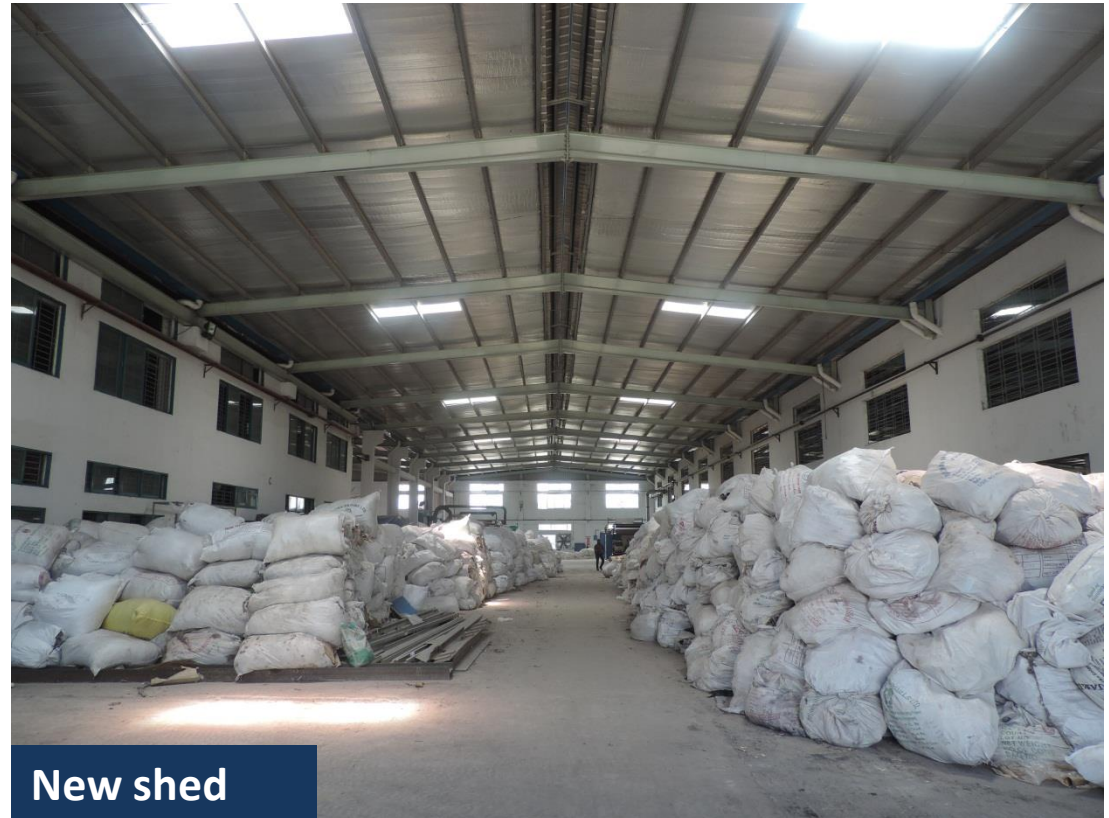
New shed

## Discrepancies between structural drawings and as-built situation of New Shed:

- Size and layout building do not match the drawings

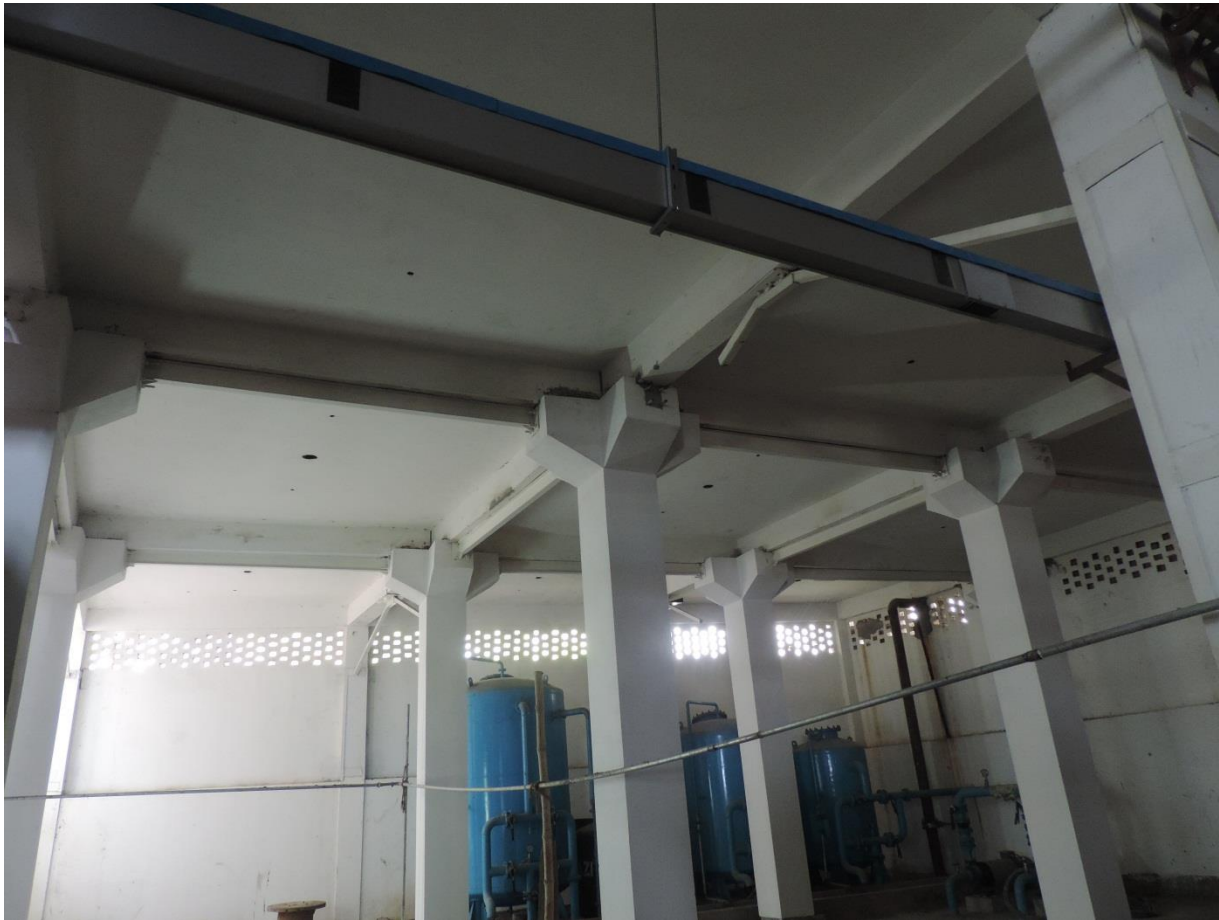
We were informed that as-constructed columns were made larger (collar of concrete cast around original columns) with addition corbels to facilitate higher floor loading. This was to enhance the capacity of the original cast beams and columns.

No permit drawing

6	The lack of drawings for the Water treatment building under construction	Loading of current constructed floor plates not to exceed the above analysis and justified design.	6-months

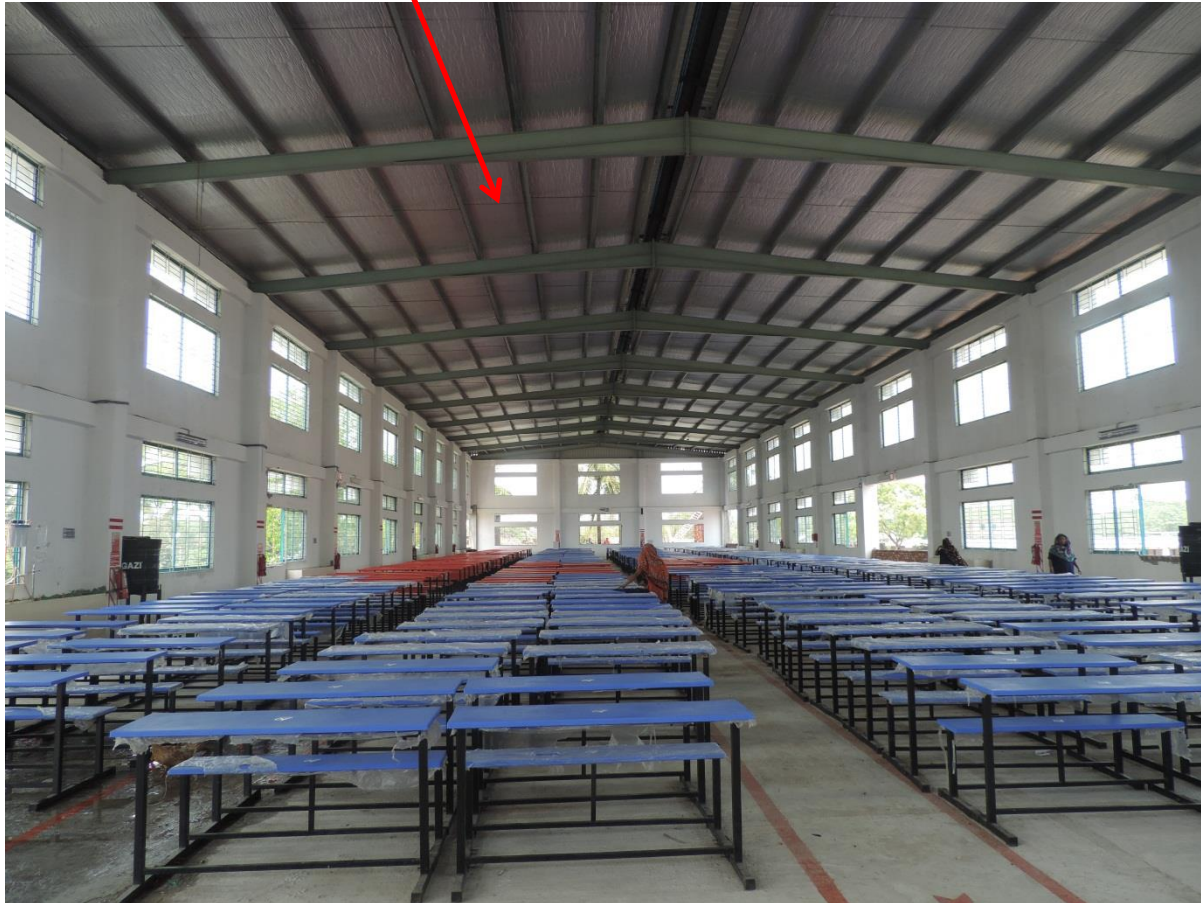
# Roof structure: no roof bracing

**Stability: No roof bracing observed  
Structure relies on roof deck for  
transferring horizontal loads to  
façade walls.**

**No permit drawing**
