# **GH Haewae Co. Ltd.**

Sector-8, Plot-19-24, CEPZ, Chittagong, Bangladesh  
(22.28172N 91.77527E)

22 APRIL 2014

# Observations Main Building 1

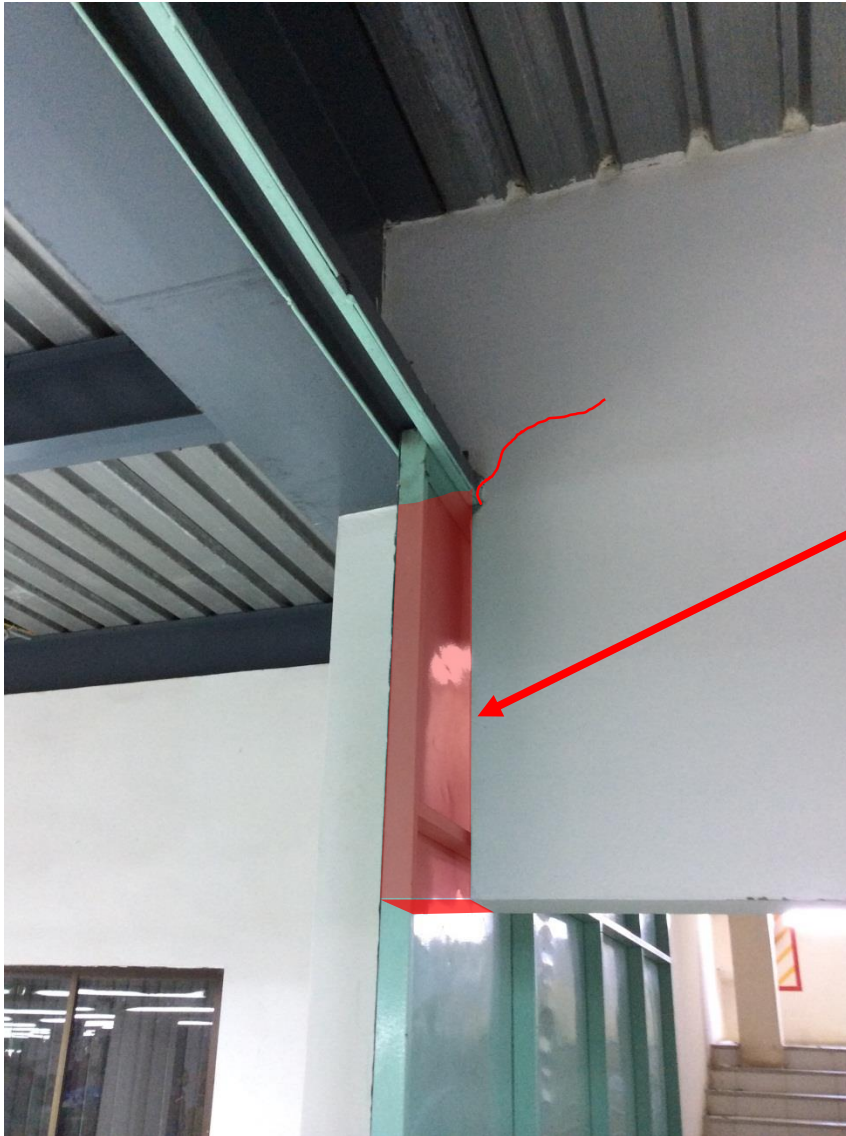
## Slot made in wall on Level 1

Partly removed wall requires engineering assessment

| Item No. | Observation | Recommended Action Plan | Recommended Timeline |
|---|---|---|---|
| 1 | Slot in wall in 5-storey main building on 1st floor | Building Engineer to open up wall and assess its safety. | Immediate - Now |
| 2 | Slot in wall in 5-storey main building on 1st floor | If wall is not needed, cut back the entire wall to the underside of the slab above. | Immediate - Now |
| 3 | Slot in wall in 5-storey main building on 1st floor | If there are reasons for the wall to be kept, provide any necessary additional support on the unsupported side. | Immediate - Now |

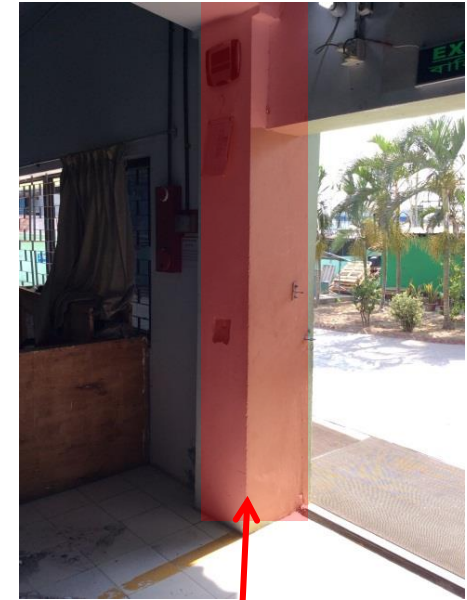
- No evidence of steel sections inside the columns.
- The corbel details supporting the primary steel beams indicate that the columns in the 5-storey building may well be just conventionally reinforced concrete columns.
- Ferro-scanning of the columns also indicated rebar inside rather than solid steel section.
- Outline check on column stresses based on concrete only and with a minimum reinforcement of 1.25%.
- Based on this, the columns under design loads (3kPa) would exceed the allowable stresses.
- A full Detail Engineering Assessment for Main Buildings 1 and 2 is strongly recommended including a thorough load-take down, core sampling and testing of the concrete in the columns, exposing of bars in some columns to establish the bar diameter and to establish the stress level.

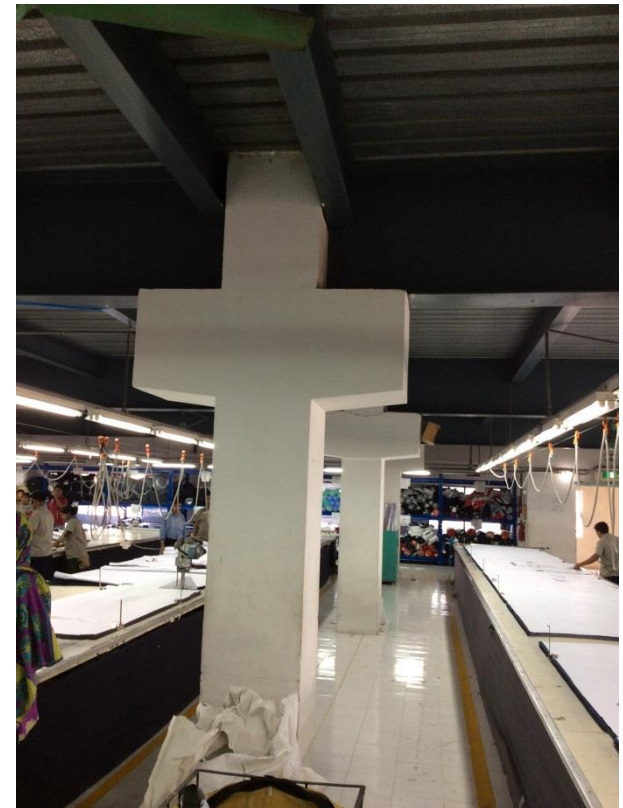
- In Building 1 it appears that the primary steel beams are not rigidly connected to the columns (pinned connections on corbels). Hence no frame-action is provided.
- In the transverse direction, the secondary beams are not connected to the columns but only to the primary beams. Again no frame action is provided.
- The stability seems to rely entirely on the brickwork infill around the perimeter. The Detail Engineering Assessment should therefore include stability calculations to justify the current system. It should be noted that the infill walls include a number of window openings which diminish their ability to act as shear panels.
- The roof structure consists of a portal frame, but this provides lateral stability between 4<sup>th</sup> floor and roof only.

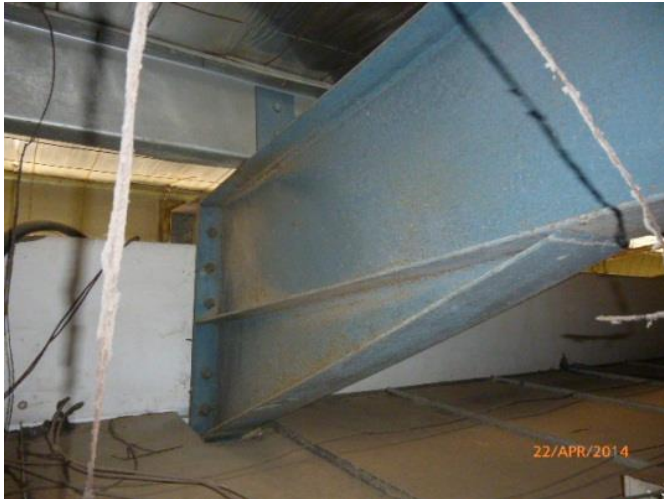
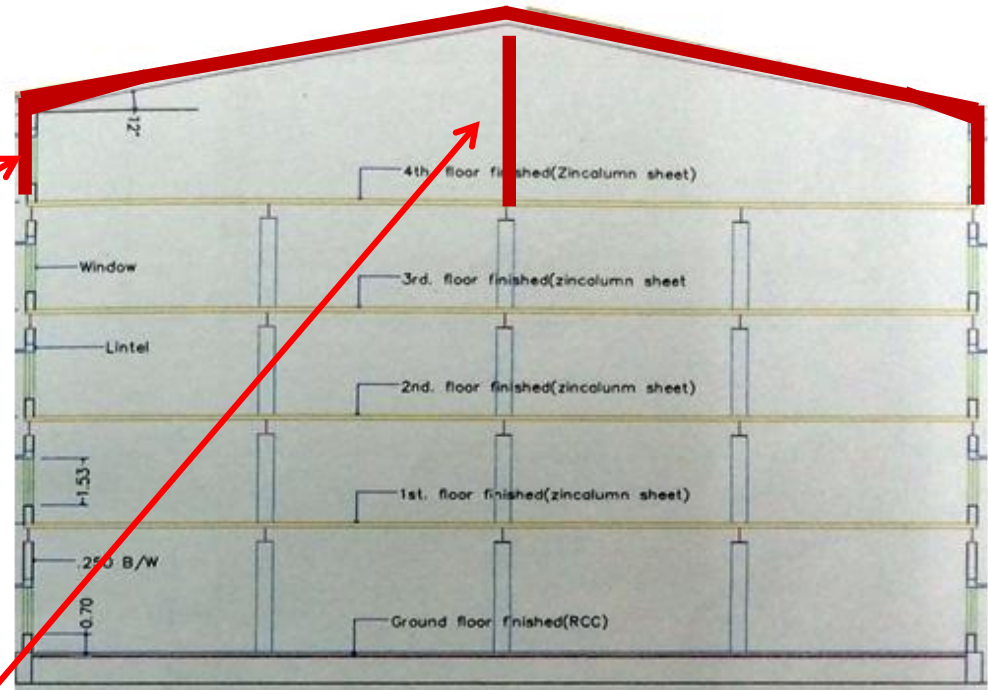
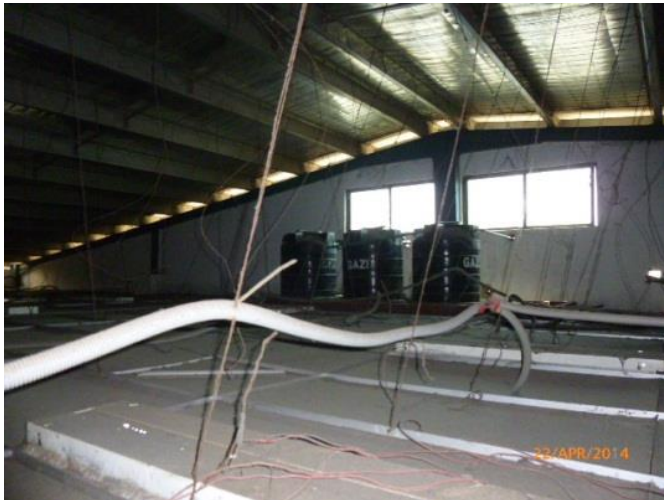
- Stability of the 4<sup>th</sup> floor to roof structure is provided in the cross direction by portal frame action, i.e. moment connection between roof beams and perimeter columns.
- In the longitudinal direction, external walls provide lateral rigidity.

**Stability system not clear**

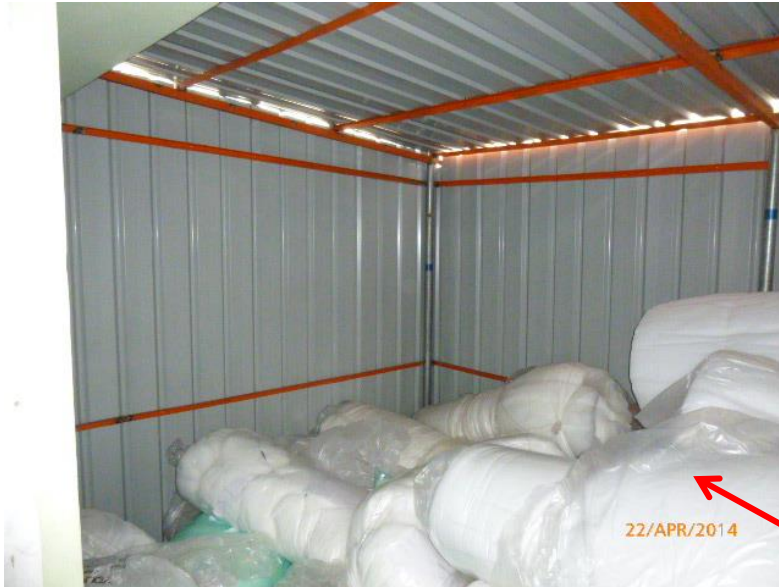
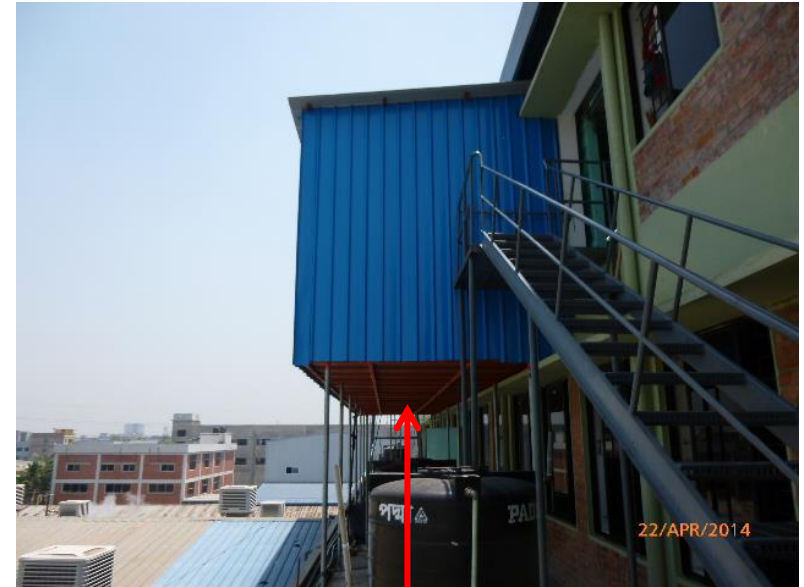
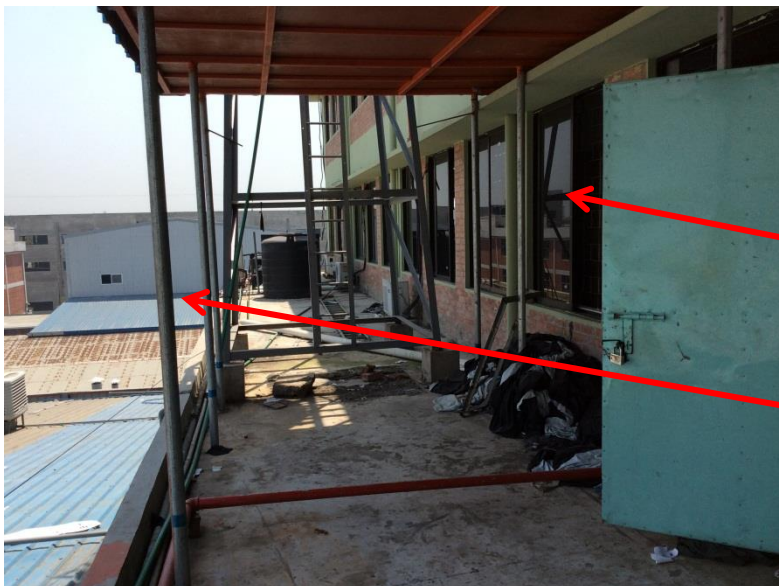
Non-engineered steel shed  
used for storage

Absence of bracing:  
horizontal and vertical

Small "formwork" props

Non-engineered steel shed on extension roof

| Item No. | Observation | Recommended Action Plan | Recommended Timeline |
|---|---|---|---|
| 4 | Non-engineered steel shed and access ladder on 3rd floor above the building extension between Buildings 1 and 2 | Building Engineer to prepare engineering calculations, including connection details, for the shed structure and its support. | Immediate - Now |
| 5 | Non-engineered steel shed and access ladder on 3rd floor above the building extension between Buildings 1 and 2 | Engineering calculations to be completed. | 6-weeks |
| 6 | Non-engineered steel shed and access ladder on 3rd floor above the building extension between Buildings 1 and 2 | Provide steel bracing for stability as required from calculations. | 6-weeks |
| 7 | Non-engineered steel shed and access ladder on 3rd floor above the building extension between Buildings 1 and 2 | Provide support members as required from calculations. | 6-weeks |
| 8 | Non-engineered steel shed and access ladder on 3rd floor above the building extension between Buildings 1 and 2 | Provide as-built drawings for shed structure, incorporating any remedial works carried out. | 6-months |

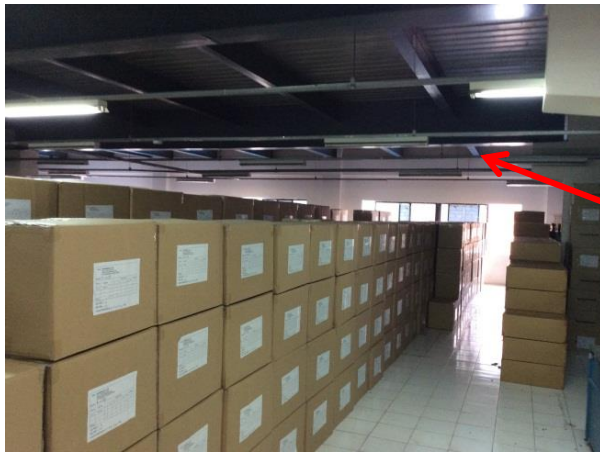
Storage load on 1<sup>st</sup> floor

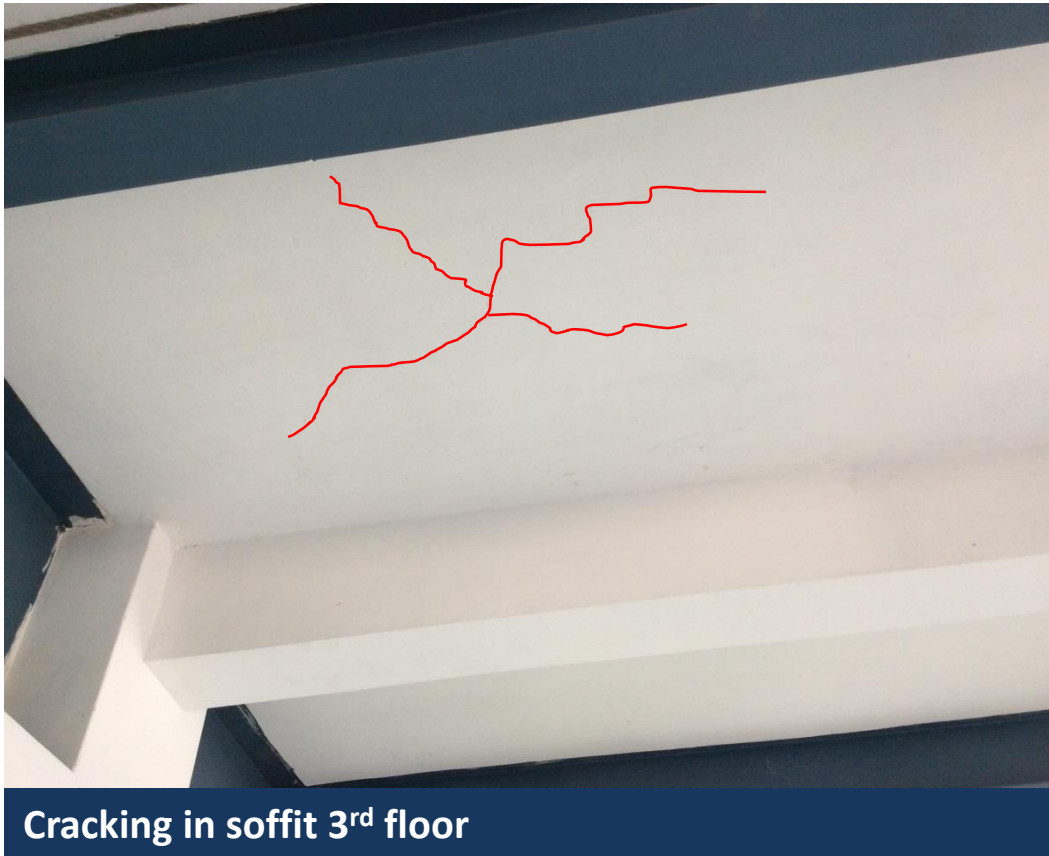
Cracking in soffit 3<sup>rd</sup> floor

| Item No. | Observation | Recommended Action Plan | Recommended Timeline |
|---|---|---|---|
| 27 | Cracking on the underside of 3rd floor slab (Building 1) | Monitor cracks on slab. Conduct regular inspection of cracks. Investigate if cracks are only in the plastering. | 6-months |
| 28 | Cracking on the underside of 3rd floor slab (Building 1) | If cracks grow larger, remove all items above the slab and close working areas below the affected areas. Building Engineer to investigate, repair and strengthen the slab. | 6-months |

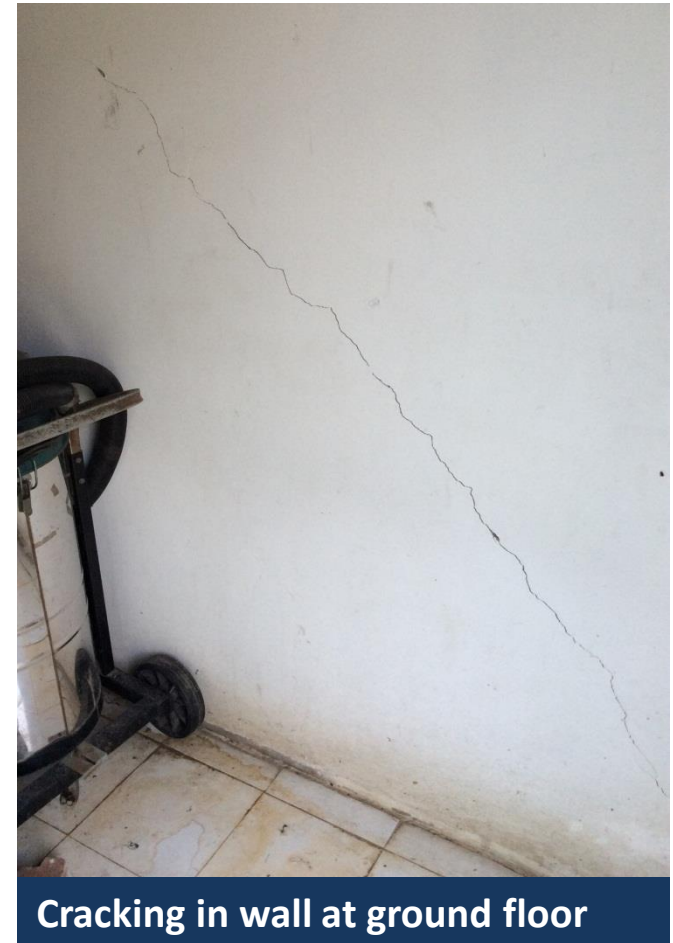
Cracking in wall at ground floor

| Item No. | Observation | Recommended Action Plan | Recommended Timeline |
|---|---|---|---|
| 21 | Cracks in the brick walls at ground floor (Buildings 1 and 2) | Cracks in the brick walls to be repaired (grouted) to make sure the walls continue to act as stability elements. | Immediate - Now |
| 22 | Cracks in the brick walls at ground floor (Buildings 1 and 2) | Assess the role of brick walls in the building's stability as part of the Detail Engineering Assessment (see Item 6). | 6-weeks |
| 23 | Cracks in the brick walls at ground floor (Buildings 1 and 2) | Carry out any works identified in the Detail Engineering Assessment to ensure the building's stability. | 6-months |

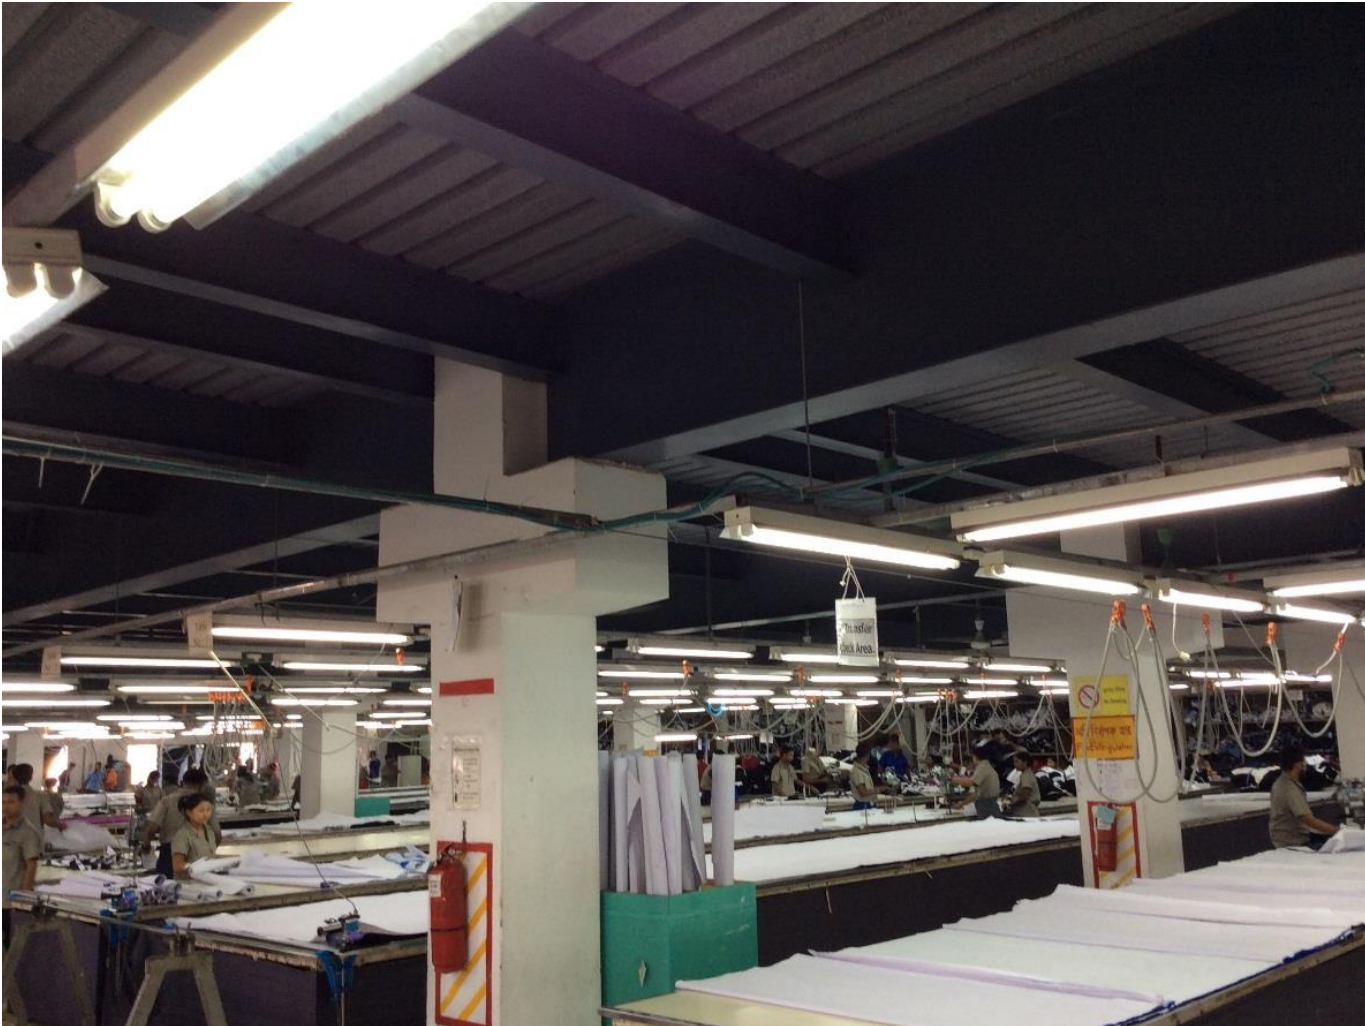
**Fire protection to steel structure not known**

| Item No. | Observation | Recommended Action Plan | Recommended Timeline |
|---|---|---|---|
| 15 | Fire protection to steelwork not known (Buildings 1 and 2) | Building engineer to review adequacy of fire protection to steelwork | 6-weeks |
| 16 | Fire protection to steelwork not known (Buildings 1 and 2) | Any required remediation work to be completed | 6-months |

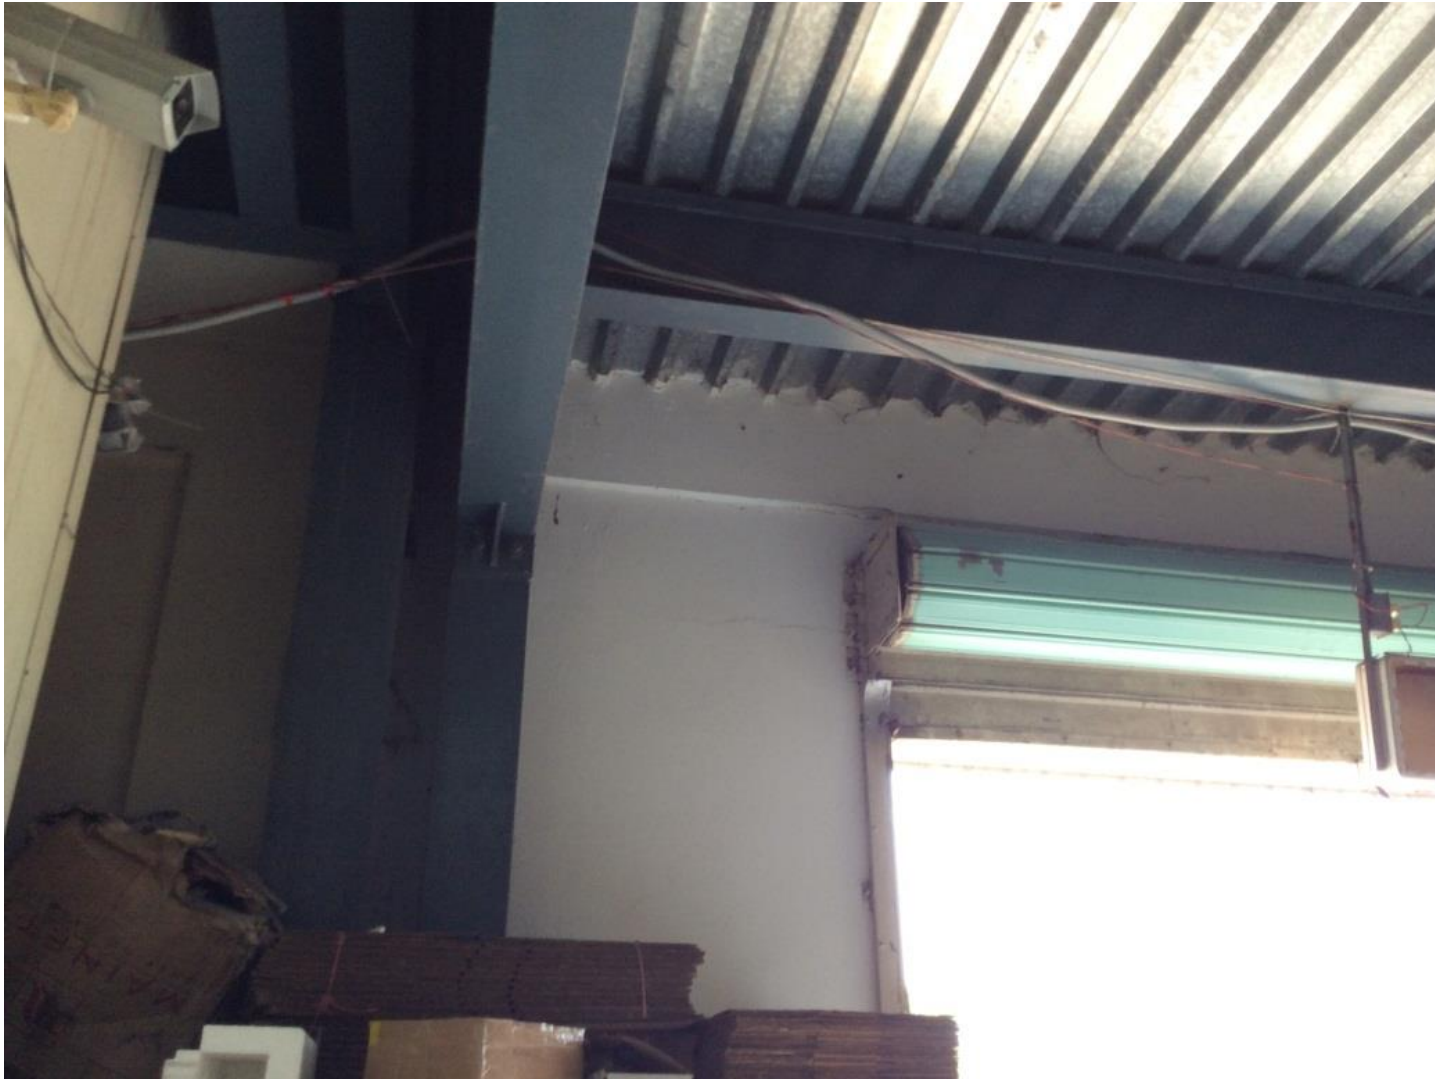
**Fire protection to steel structure not known**

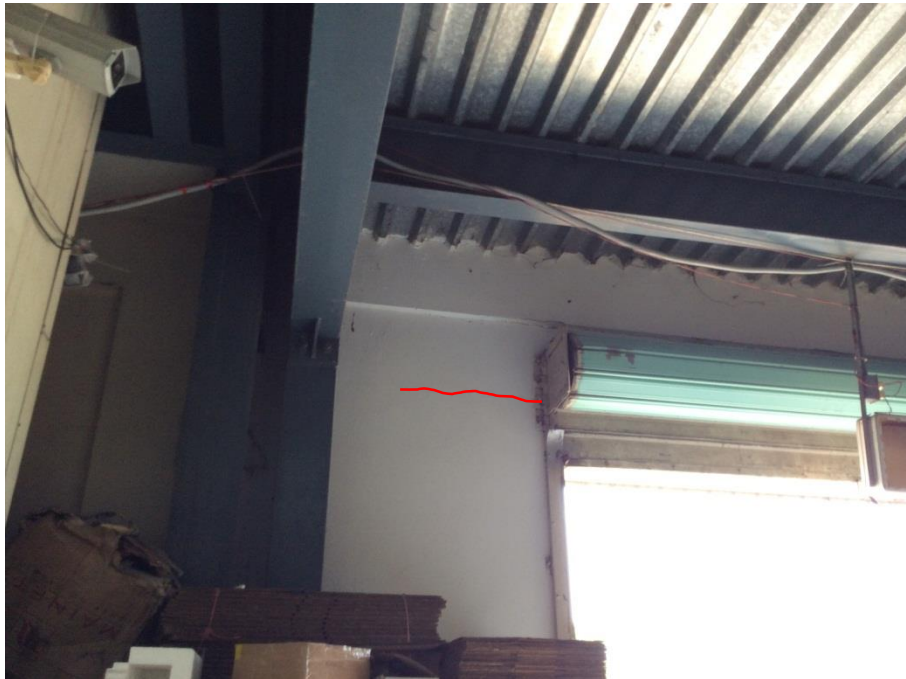
Cracking on ground floor

**Cracking in façade wall**

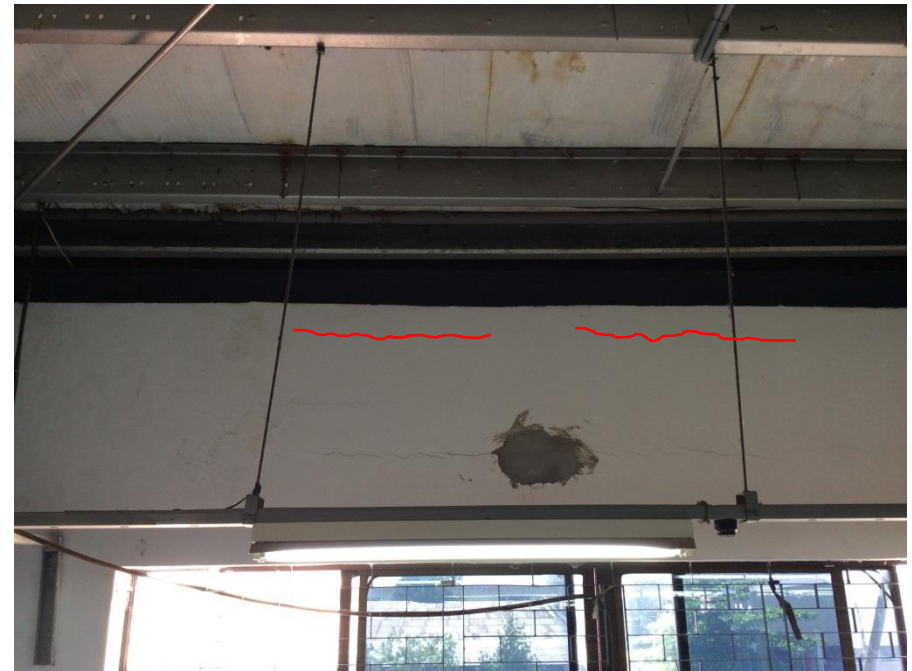
Cracking and signs of repairs on 1<sup>st</sup> floor

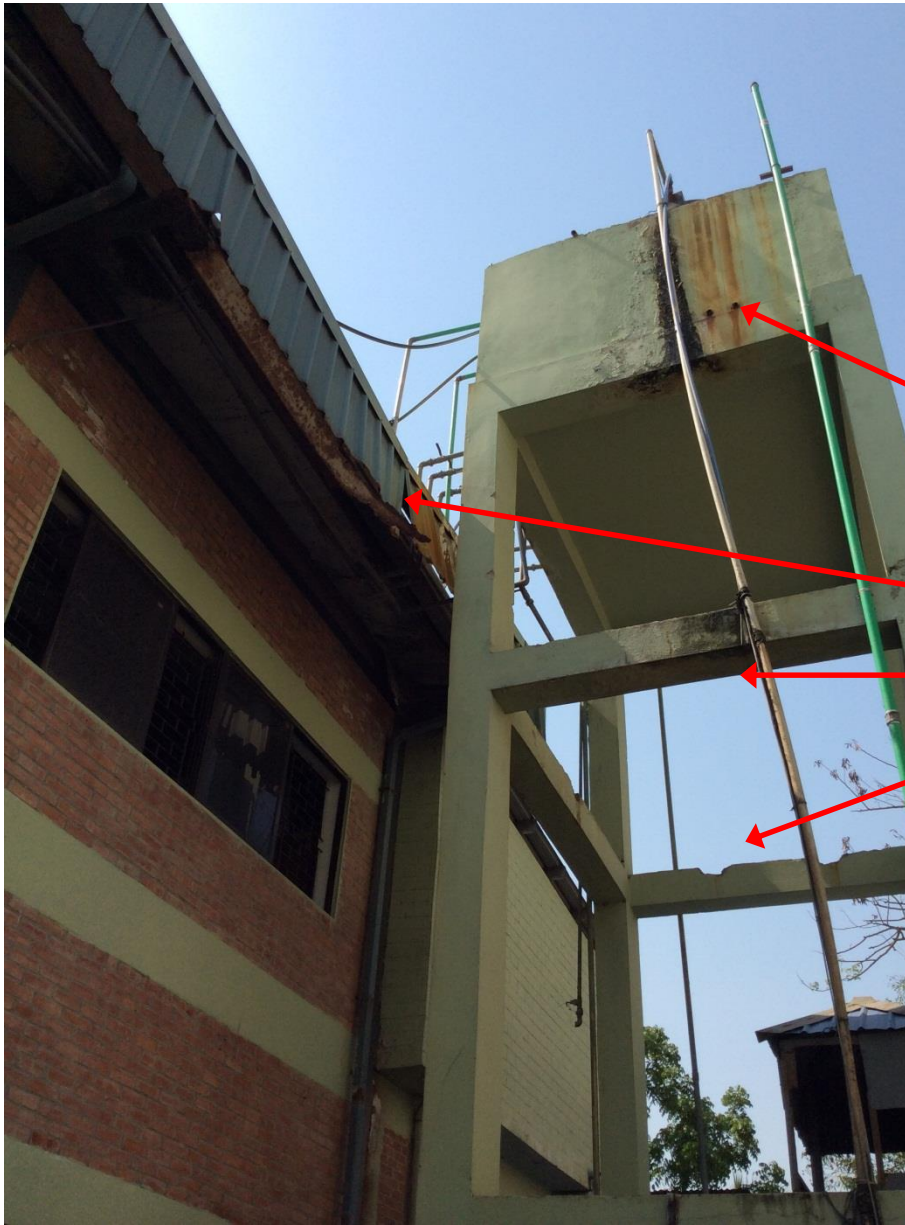
Water tank

Damage on concrete water tank  
and steel roof due to water leakage

| Item No. | Observation | Recommended Action Plan | Recommended Timeline |
|---|---|---|---|
| 9 | Damaged structural elements supporting the high-level RC water tank outside the sewing shed. | Building Engineer to assess the structure supporting the water tanks. | Immediate - Now |
| 10 | Damaged structural elements supporting the high-level RC water tank outside the sewing shed. | Carry out all structural repairs to the support structure arising from engineering assessment. | 6-weeks |
| 11 | Damaged structural elements supporting the high-level RC water tank outside the sewing shed. | Take measures to prevent any further damage to the support structure in the future. | 6-months |

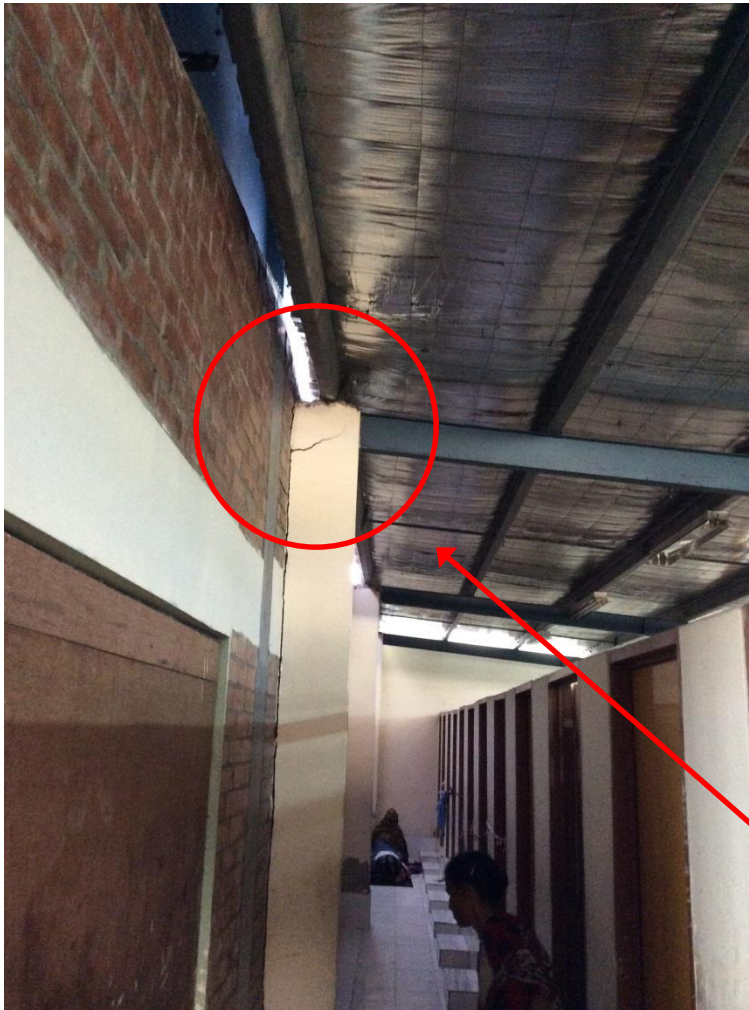
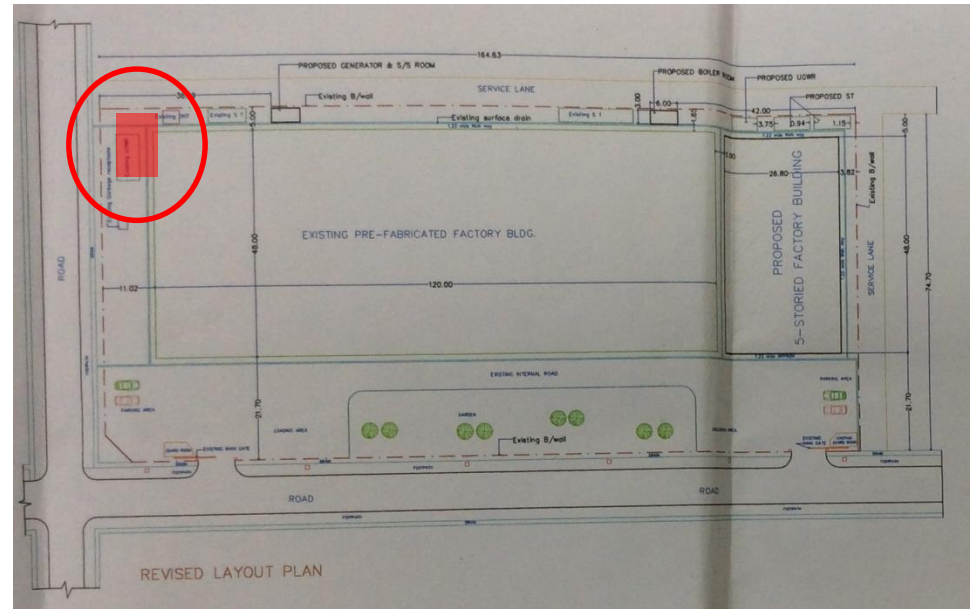
Location of shed

Crack at top of column in shed for toilets, possibly due to poor detailing and possibly due to lateral forces trying to activate a frame action at a point where no moment connection has been considered.

| Item No. | Observation | Recommended Action Plan | Recommended Timeline |
|---|---|---|---|
| 12 | Crack at the top of a concrete column in the women's toilet area (extension building to the 2-storey sewing shed at the far end / first floor level) | Building Engineer to assess beam/column connection and crack in column. | 6-weeks |
| 13 | Crack at the top of a concrete column in the women's toilet area (extension building to the 2-storey sewing shed at the far end / first floor level) | Stability system of the extension building to be established as part of the Detail Engineering Assessment (see Item 6). | 6-months |
| 14 | Crack at the top of a concrete column in the women's toilet area (extension building to the 2-storey sewing shed at the far end / first floor level) | Provide horizontal and vertical cross-bracing as required to provide a proper stability system. Carry out all structural works arising from assessment. | 6-months |

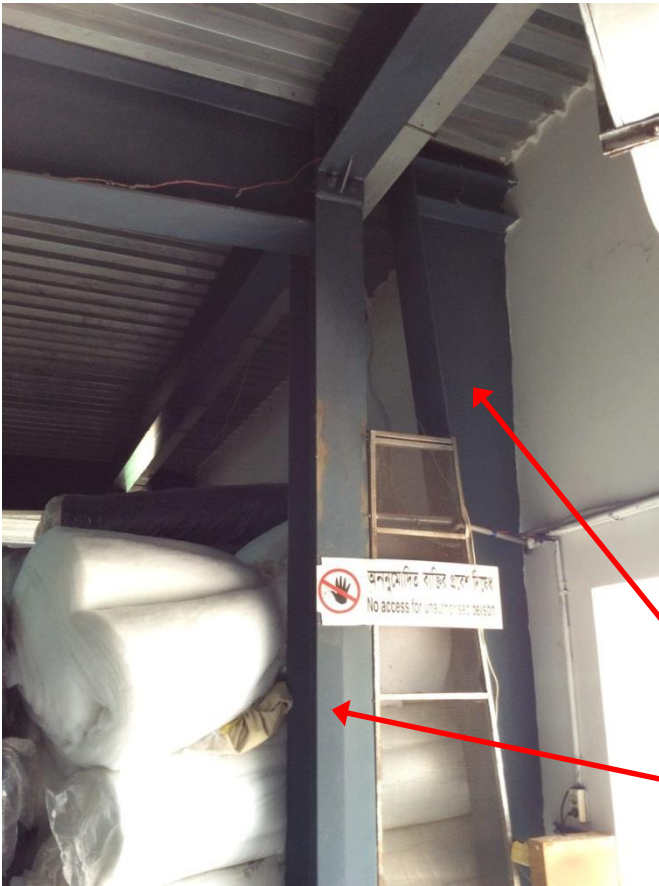
No visible movement joint between the two supposedly independent structures. The external brick wall provides stability in the longitudinal direction for both the roof and the 1st floor slab.

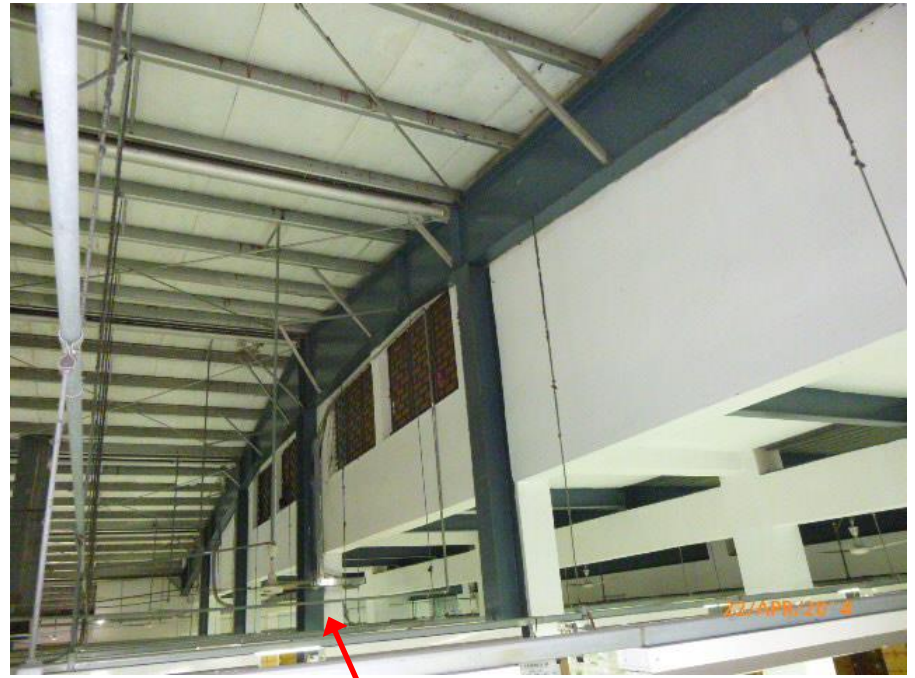
Centre column is used for both systems.

Roof and floor structure seem to have been deliberately separated from each other as the roof column runs passed the first floor. However, the two structures are not separated from each other everywhere, having bearing elements in common.

**No clear movement joint**

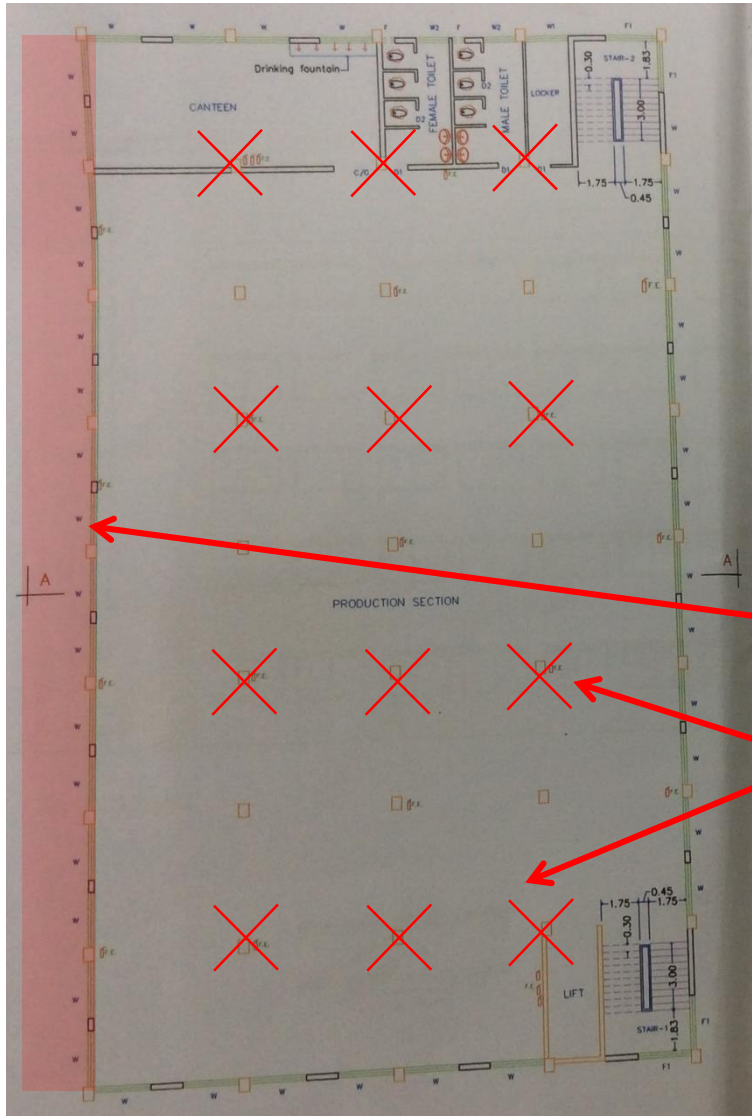
**Missing structural drawings for all buildings**

**Architectural drawings available for 5 storey building only**

**Discrepancies between drawings and as-built situation (not exhaustive):**

- Bay from ground to 2<sup>nd</sup> floor missing on the architectural drawings.
- Drawings show too many columns on plan. The internal column spacing for a typical floor is 6 x 12m, not 6 x 6m.
- We measured the bay width in the transverse direction to be 6m instead of 6.7m.

| Item No. | Observation | Recommended Action Plan | Recommended Timeline |
|---|---|---|---|
| 17 | Lack of structural documentation | Detail Engineering Assessment (in accordance with the scope set out in the following slide) for Buildings 1 and 2 to be commenced, with particular attention to full structural analysis of bearing elements (slab, beams, columns, foundations), stability and as-built drawing information. | Immediate - Now |
| 18 | Lack of structural documentation | Detail Engineering Assessment to be completed. | 6-weeks |

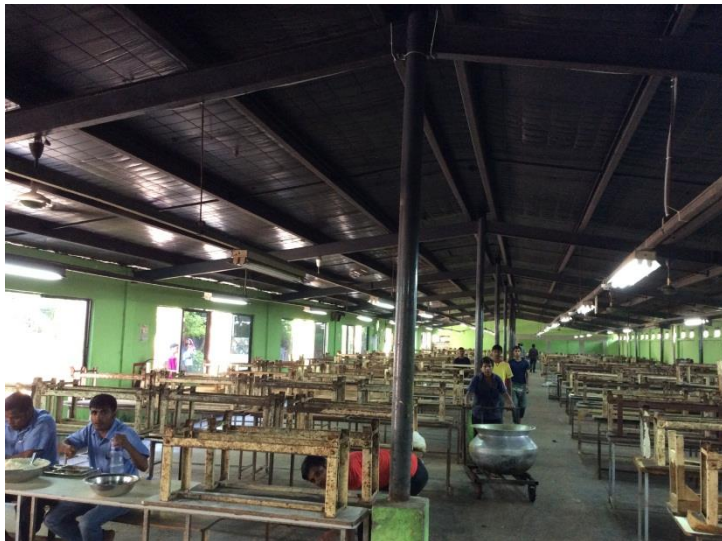
Canteen: missing bracing

| Item No. | Observation | Recommended Action Plan | Recommended Timeline |
|---|---|---|---|
| 24 | Non-engineered steel sheds are unlikely to be able to withstand strong wind events | Building Engineer to assess sheds in terms of lateral stability and resistance to uplift. | 6-weeks |
| 25 | Non-engineered steel sheds are unlikely to be able to withstand strong wind events | Provide structural calculations. | 6-weeks |
| 26 | Non-engineered steel sheds are unlikely to be able to withstand strong wind events | Steel structures to be upgraded as required to support code vertical and wind loads, or they should be vacated and removed. | 6-months |

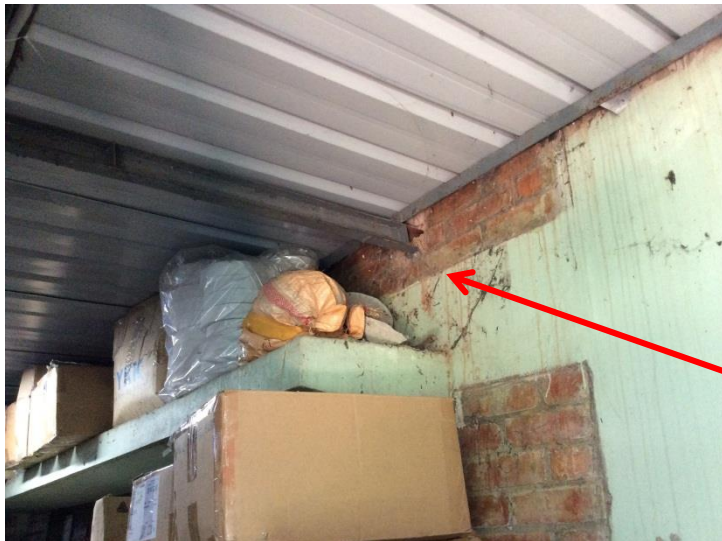
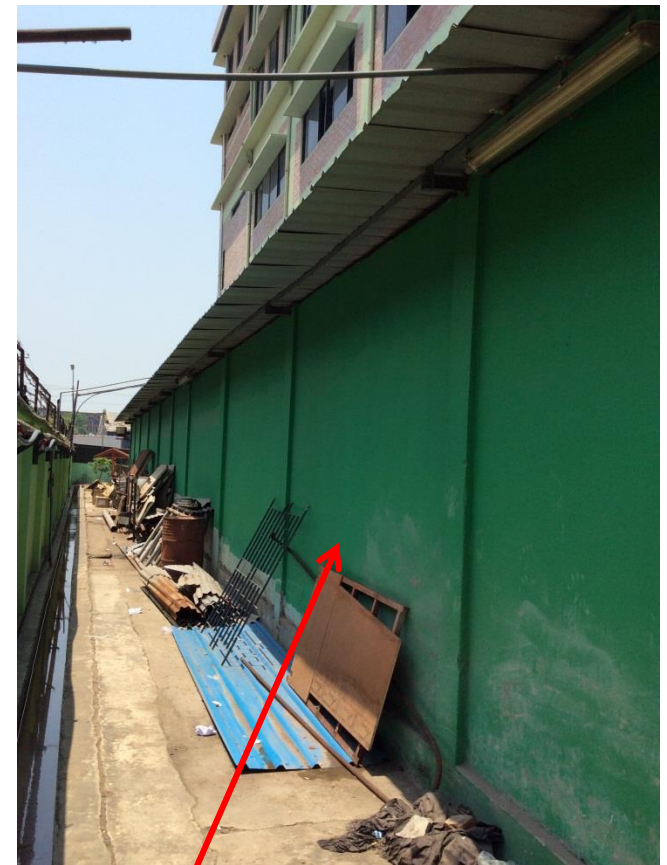
Shed around main buildings: missing bracing and poor detailing.
