# Bottoms Gallery (Pvt) Ltd.

Bulbul Tower, Dighir Chala, Chandana, Gazipur  
(23.994592, 90.382016)

11<sup>th</sup> May 2014

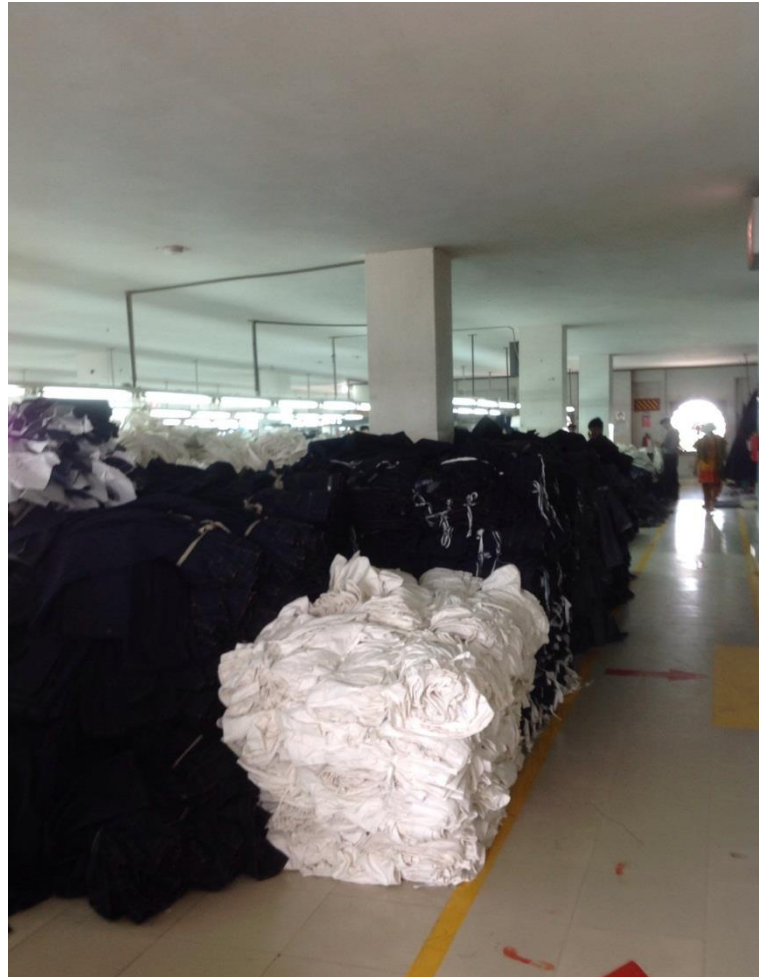
Flat slab at Level 4

# **Punching shear in flat slabs requires immediate action**

- Flat slabs were observed at all levels, some of which were subject to storage loads.
- There were no shear links referred to in the drawings.
- Detail Engineering Assessment required to determine capacity of slab with regard to punching shear.

| Item No. | Observation | Recommended Action Plan | Recommended Timeline |
|---|---|---|---|
| 2 | Heavy loading on slabs | Building Engineer to check the capacity of the flat slab floors and columns against the design loading, particularly punching shear at columns. | Immediate - Now |

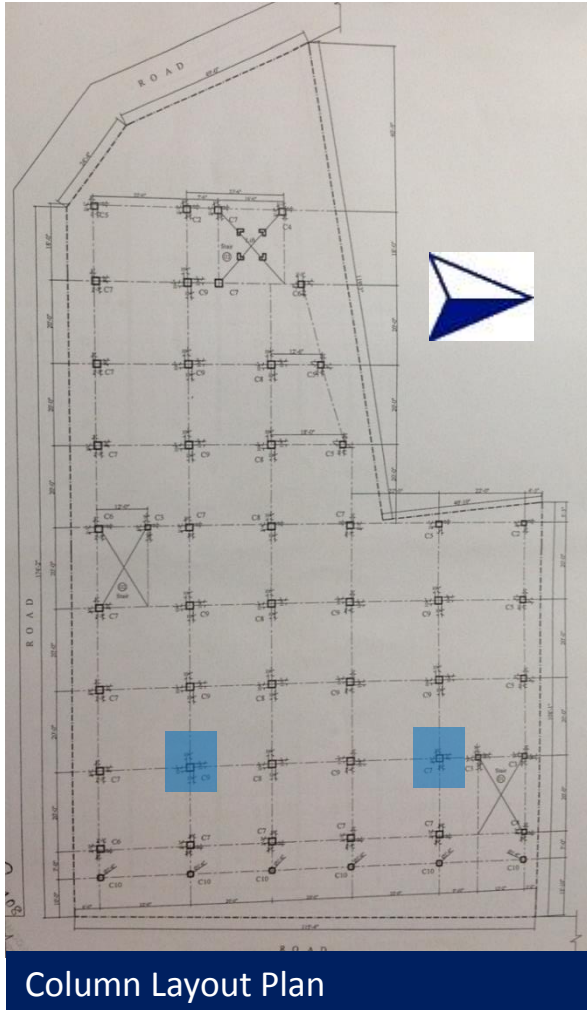
Tested Basement Columns

- Cursory calculations indicate that the working stresses to the Basement columns are highly stressed.

- Grade 60 steel is called up in the structural drawings. The reinforcement quantities recorded at Basement level using the Ferro-scanner appeared to coincide with the values provided in the Column Schedule.
- Brick aggregate was observed in the Basement columns in lieu of the specified stone aggregate.
- No loading plan was provided for the building. From inspection, the critical columns support garment and fabric storage, toilet slab build-up on levels one to six and water tanks at roof level.
- The building was originally approved by Rajuk as a 10-storey industrial building.

| Item No. | Observation | Recommended Action Plan | Recommended Timeline |
|---|---|---|---|
| 9 | Stress levels in basement columns | Verify insitu concrete stresses either by 100mm diameter cores from, or existing cylinder strength data from min. 4 basement columns. Reinforcement quantities also to be confirmed. | <b>Immediate - Now</b> |

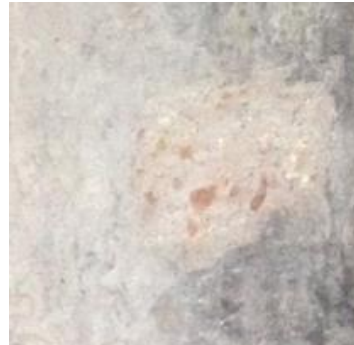
Brick aggregate

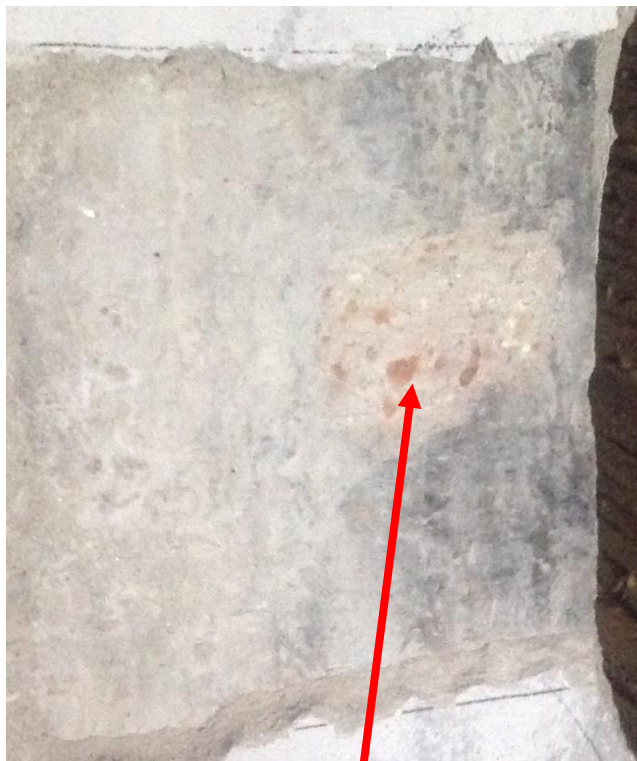
Design drawings indicate stone aggregate concrete was to be used. Basement columns opened up clearly show concrete contains brick aggregate

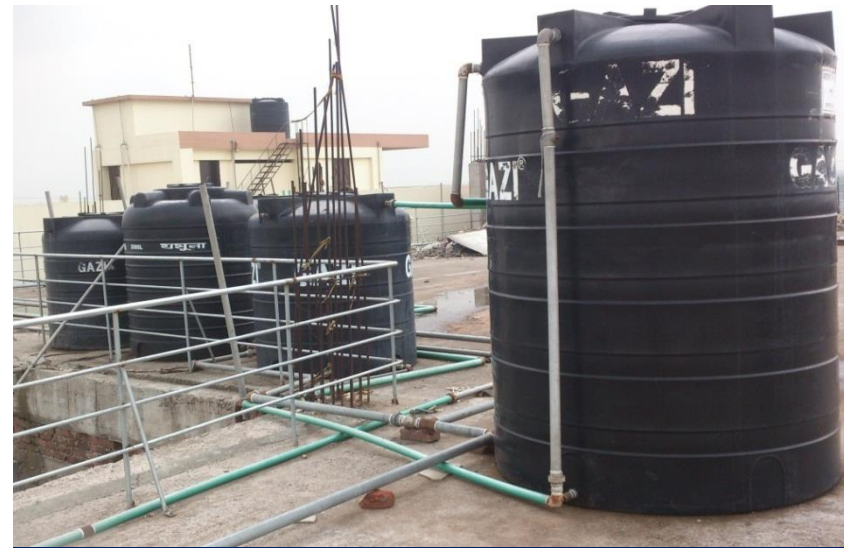
Water tanks on Level 7 (current roof)

- Six water tanks were observed at 7<sup>th</sup> floor (roof). The combined capacity of these tanks is 17,500 litres.
- In addition, a 2000 litre tank is located in a plant room on the Ground Floor.

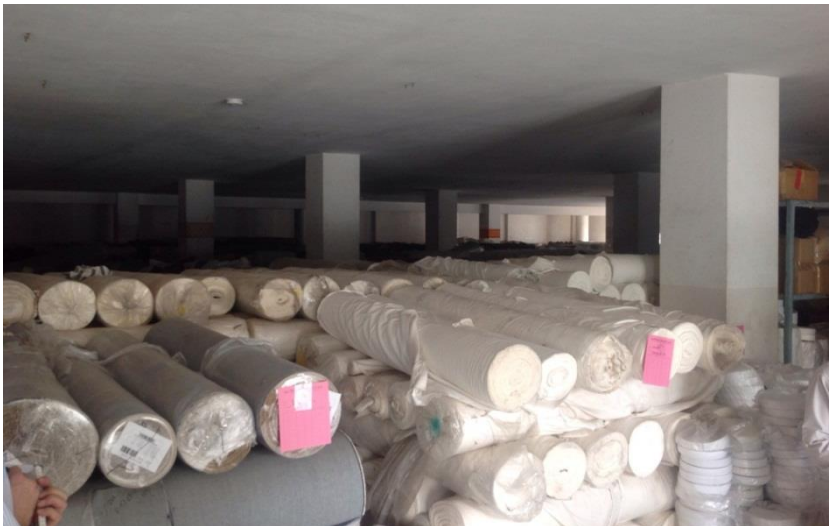
Storage of fabric rolls on Level 1

Storage for rolls of fabric was present on 1<sup>st</sup> floor.

| Item No. | Observation | Recommended Action Plan | Recommended Timeline |
|---|---|---|---|
| 1 | Heavy loading on slabs | Reduce the load in the area highlighted in full report to 2kPa immediately on all suspended floors (this is approximately maximum 4 boxes high or 4 bags high). Do not increase loads in other areas. | Immediate - Now |

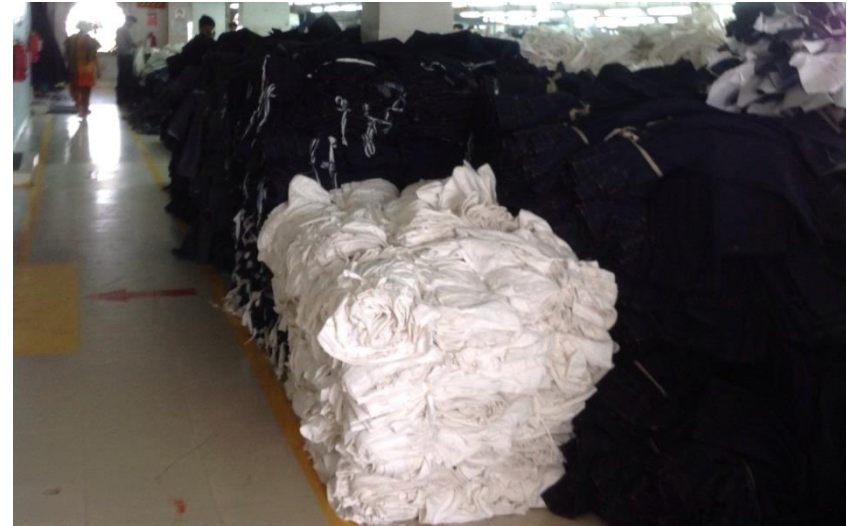
Garment storage at Level 4

The floor load management system was incomplete as no loading plans were observed for any of the levels. Garment storage was present on 2<sup>nd</sup> to 6<sup>th</sup> floors, and fabric storage was present on 1<sup>st</sup> floor.

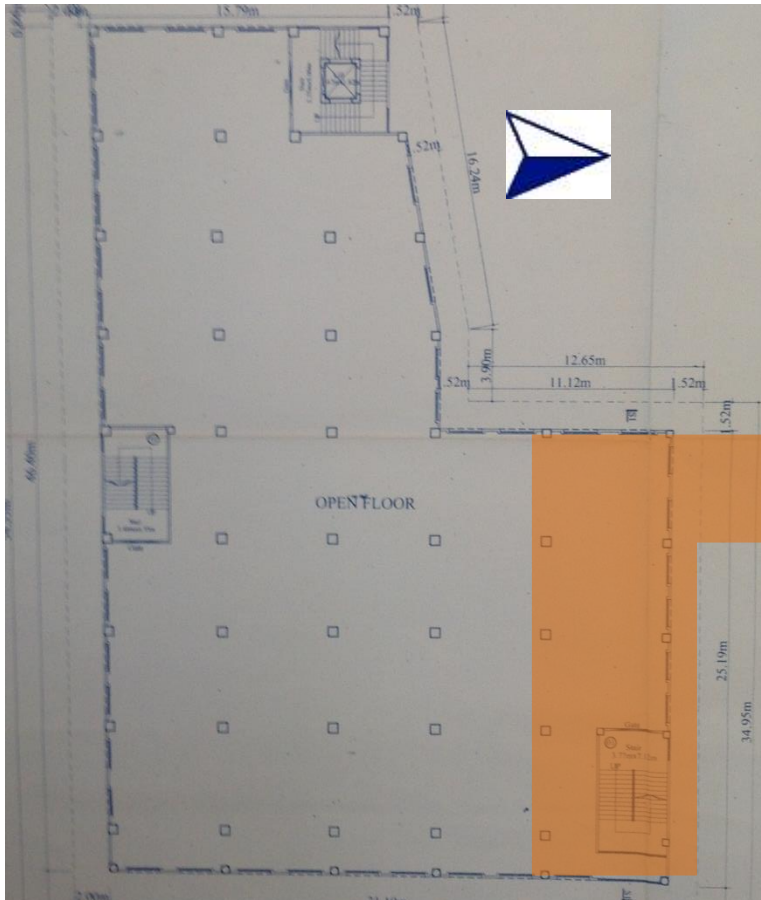
Location of garment storage on 2nd to 6th floors

Location of observed heavy loading  
imposed by garment storage

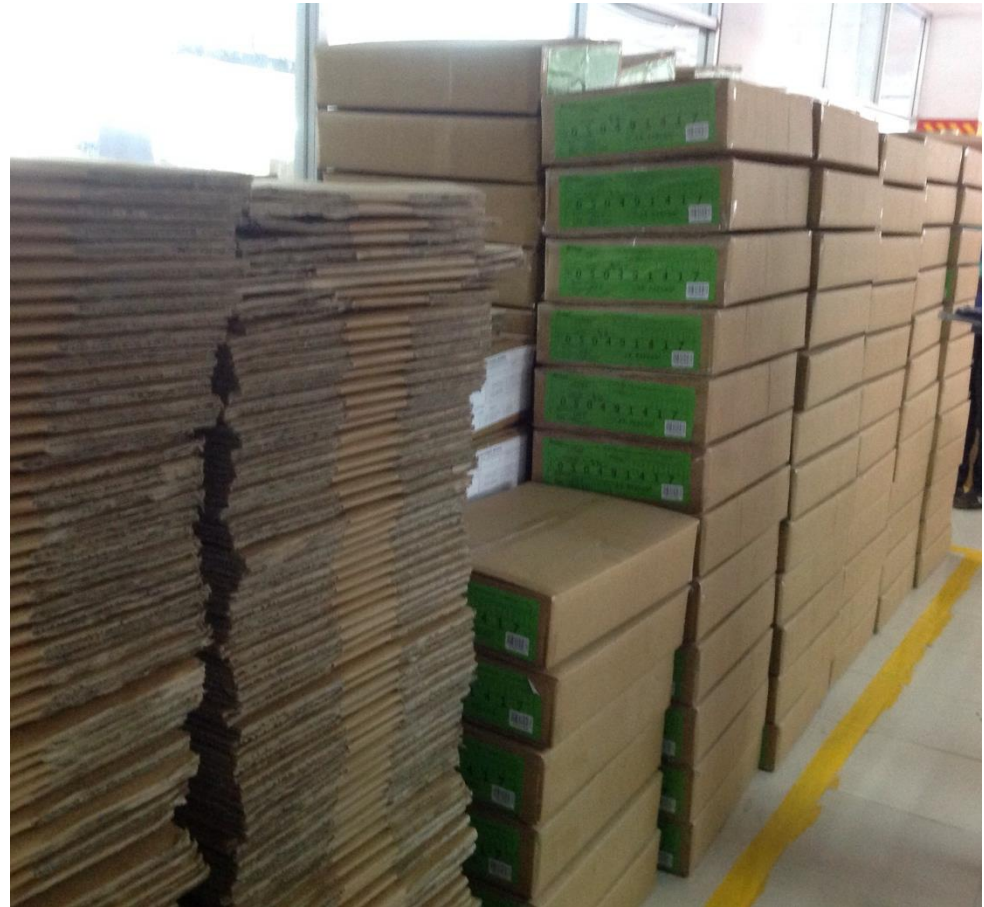
Finished garment storage on 6th floors

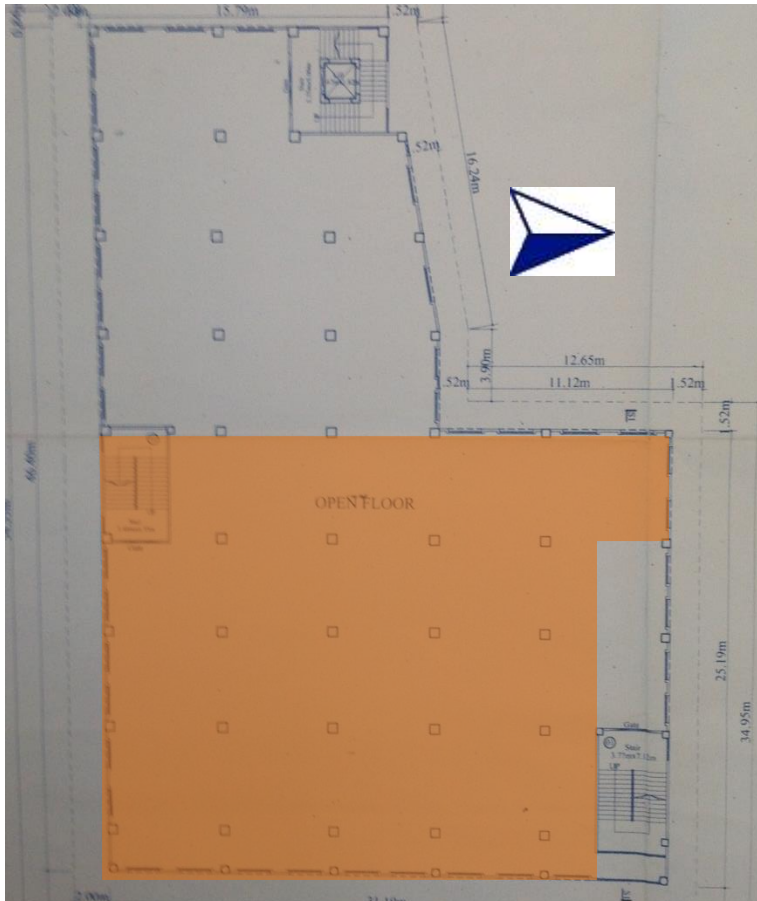
Location of fabric storage on 1<sup>st</sup> floor

Location of observed heavy loading imposed by rolls of fabric

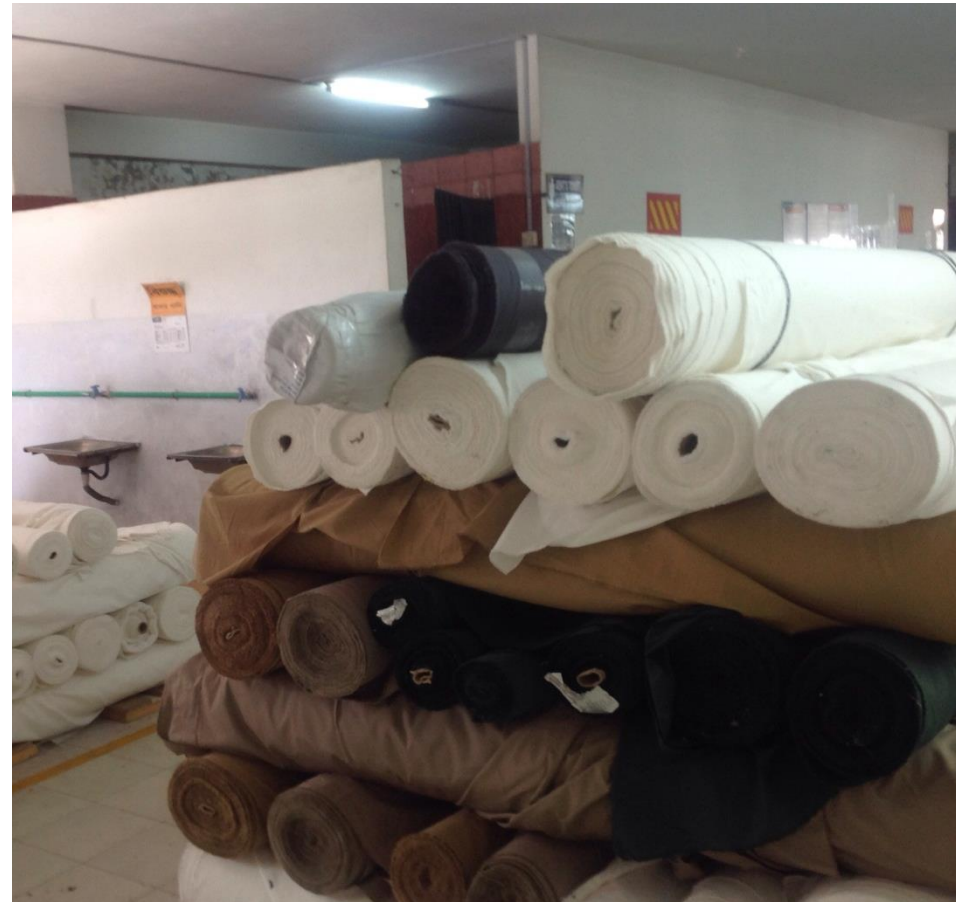
Rolls of fabric stored on 1st floor

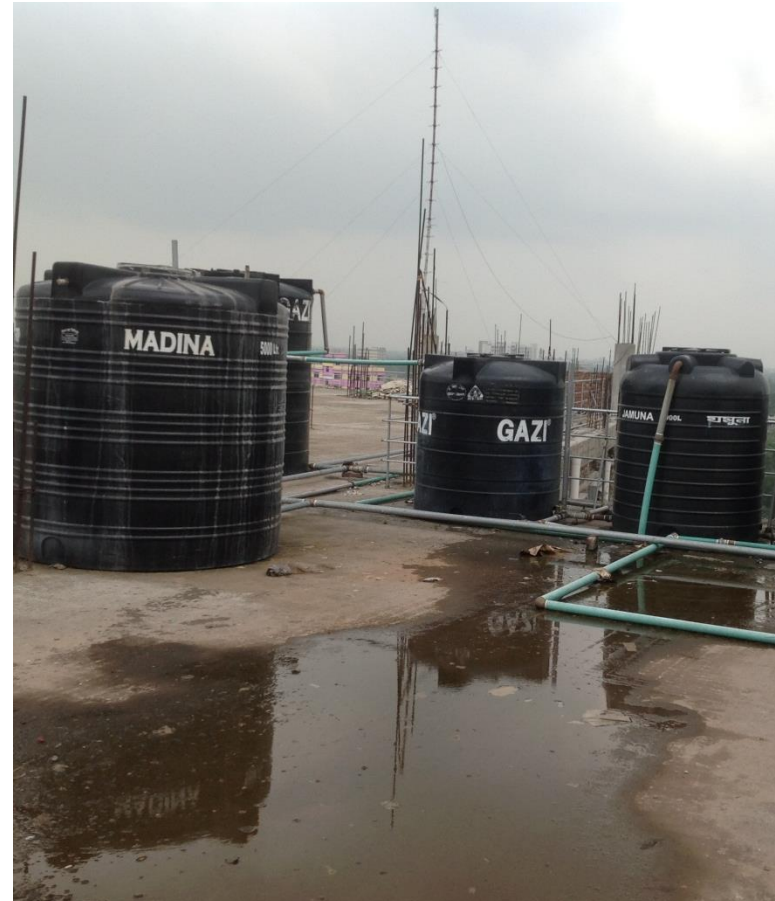
Water tanks on 7<sup>th</sup> floor (current roof)

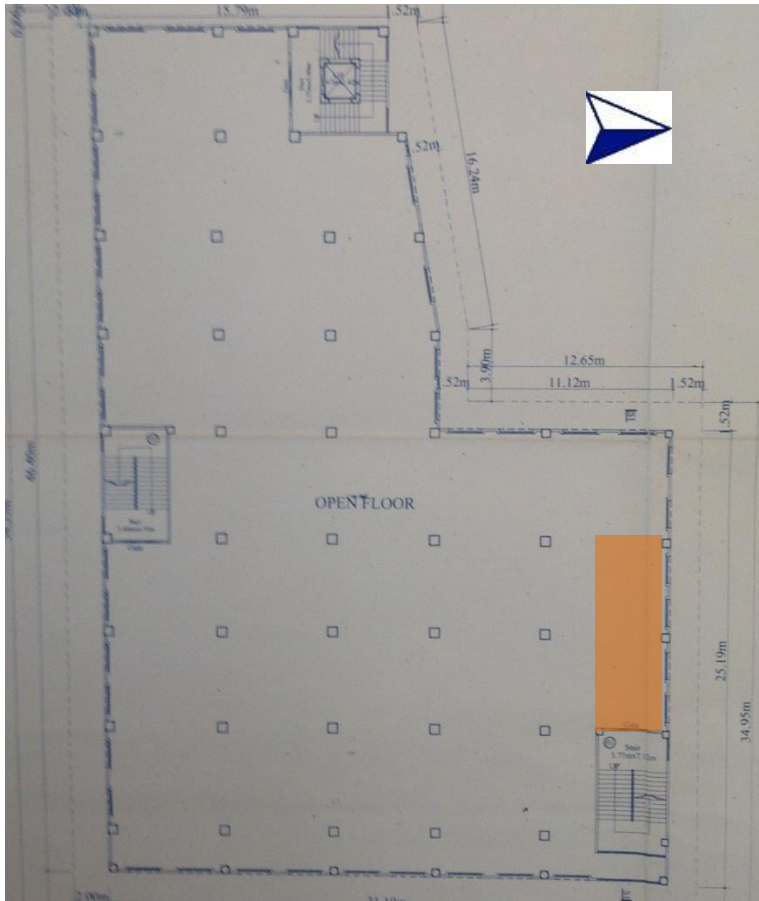
Location of toilets on 1<sup>st</sup> to 6<sup>th</sup> floors

- Slab build up was present in the toilet areas.
- The average build-up depth observed was 308mm.

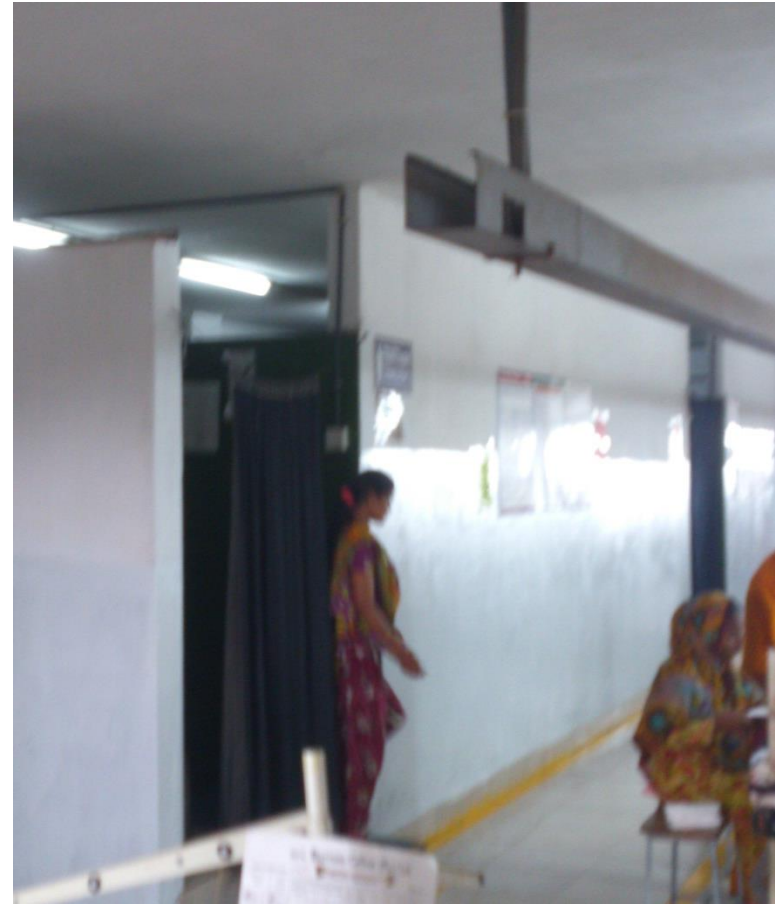
Toilet block on 6th floor

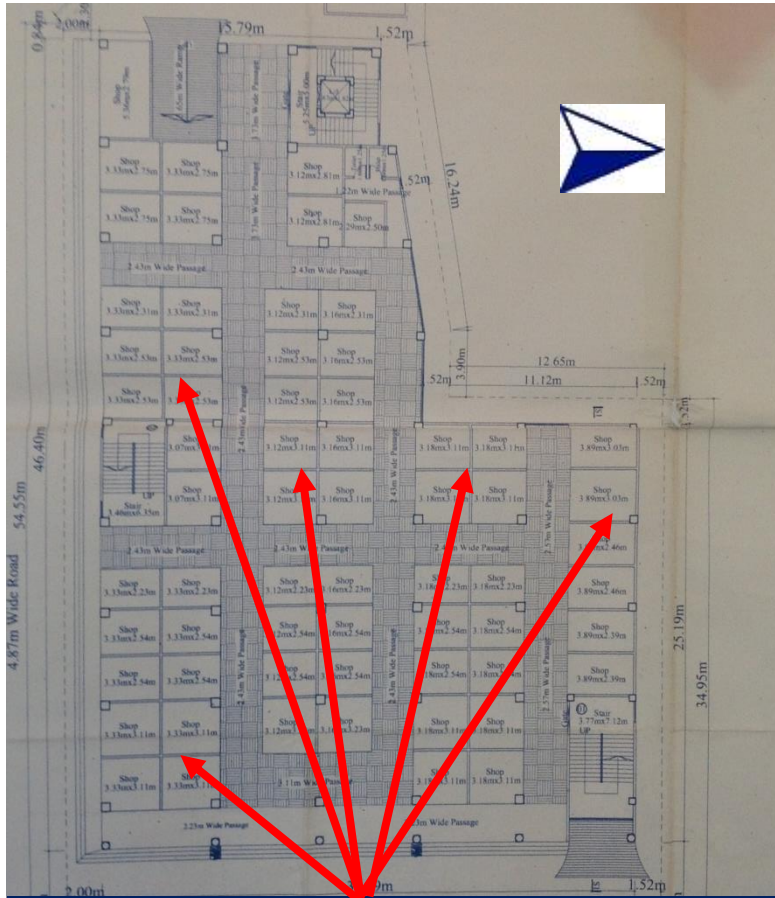
Location of brick wall partitions on Ground Floor

Heavy weight brick partitions were present on the suspended ground floor.  
Demolition of these walls had commenced, and the resulting rubble was observed on ground floor.

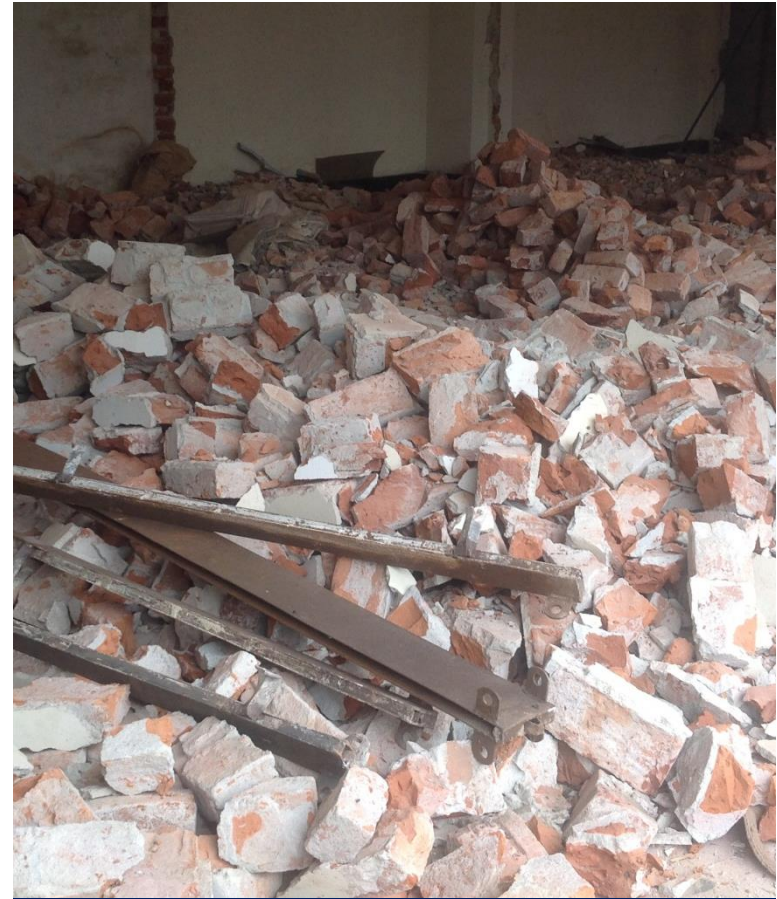
Rubble from brick wall demolition

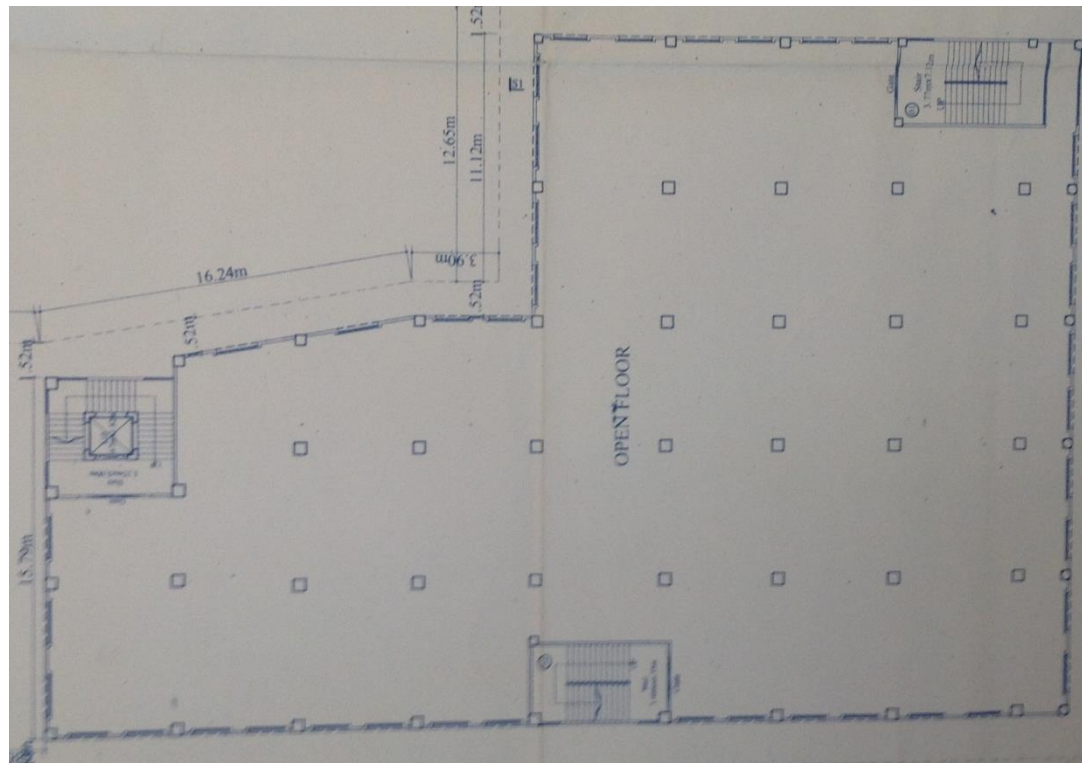
- The lateral stability system to the building is unclear.
- The structural system of the building is flat-slab construction with no drop panels at the column location. There are no shear walls indicated on the provided drawings.
- It is assumed that the lateral stability of the structure is provided through frame action between the slabs and the columns.
- Building Engineer to carry out a lateral stability analysis of the building and provide the necessary remedial works for lateral stability if required.

General arrangement for 1<sup>st</sup> to 7<sup>th</sup> floors with a 212mm flat slab on columns. No shear walls are indicated.

| Item No. | Observation | Recommended Action Plan | Recommended Timeline |
|---|---|---|---|
| 12 | Lateral stability system unclear | As part of Detail Engineering Assessment (see Item 1), Building Engineer to carry out a stability analysis of the full 7 storey building. | <b>6-weeks</b> |
| 13 | Lateral stability system unclear | Propose additional stability works if necessary. | <b>6-weeks</b> |
| 14 | Lateral stability system unclear | Implement remedial action if required. | <b>6-months</b> |

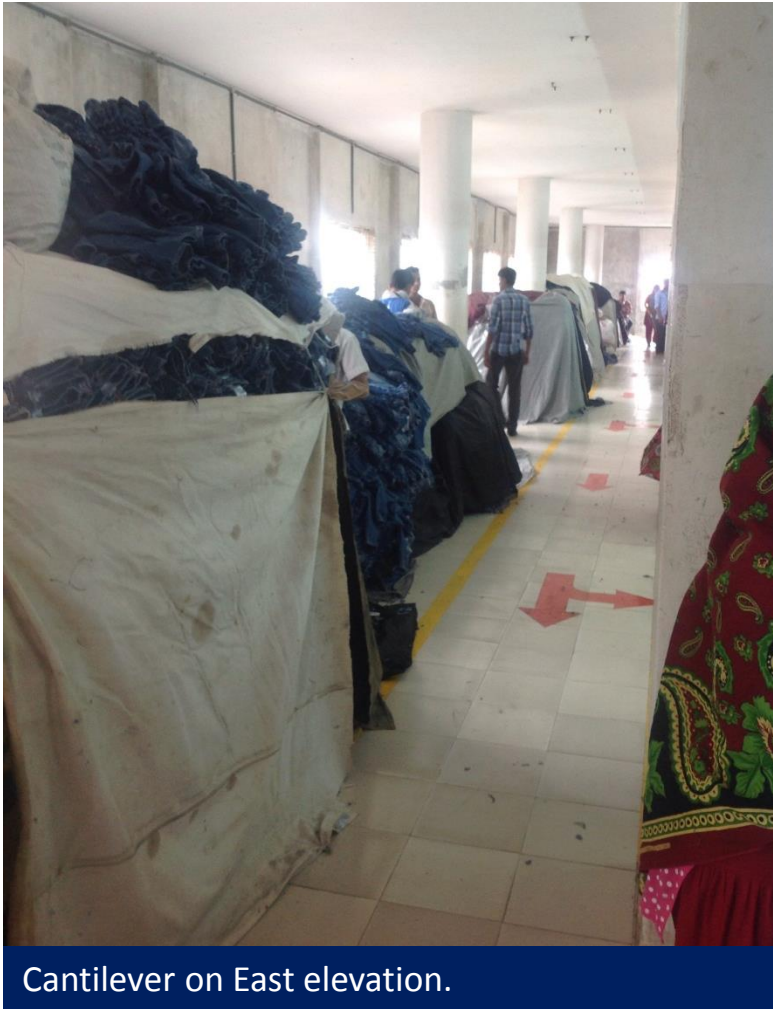
Cantilever slabs were observed on the East and South elevations of the building. Building Engineer to check structural adequacy of the cantilever, and propose and implement any strengthening works if required.

Cantilever on East elevation.

| Item No. | Observation | Recommended Action Plan | Recommended Timeline |
|---|---|---|---|
| 15 | Floor Cantilevers | As part of Detail Engineering Assessment (see Item 1), Building Engineer to assess the cantilever slab design for the floor and façade loads applied. | 6-weeks |
| 16 | Floor Cantilevers | Carry out any remedial or strengthening works as required. | 6-months |

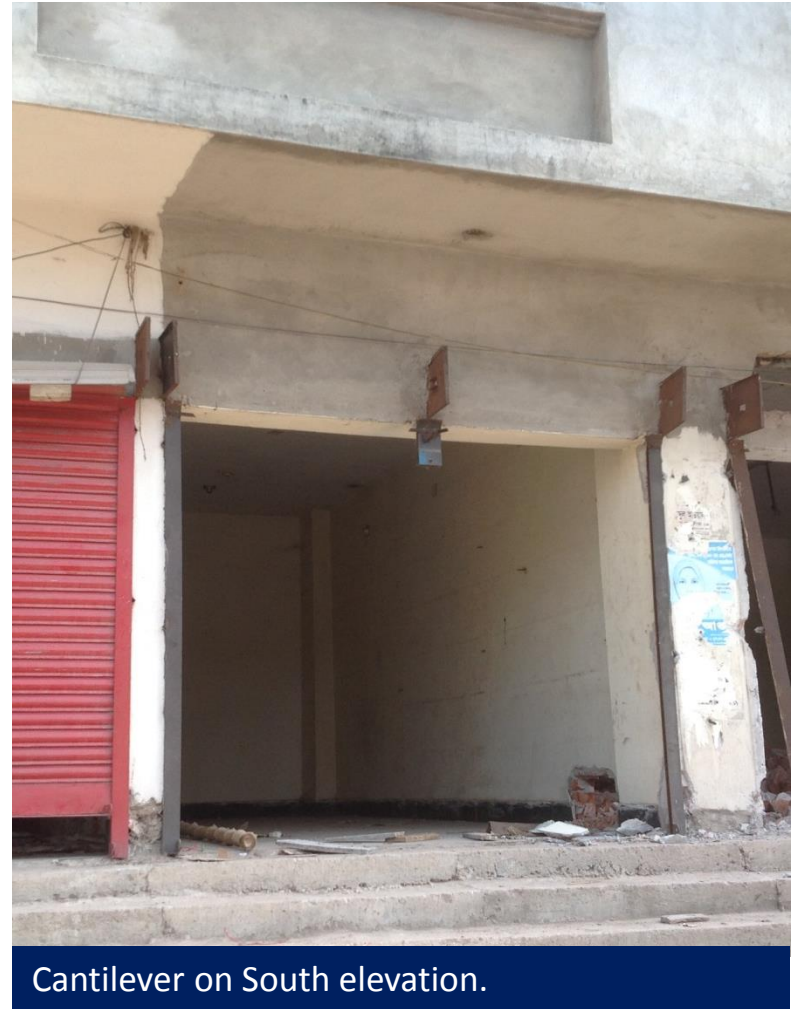
Cantilever on South elevation.

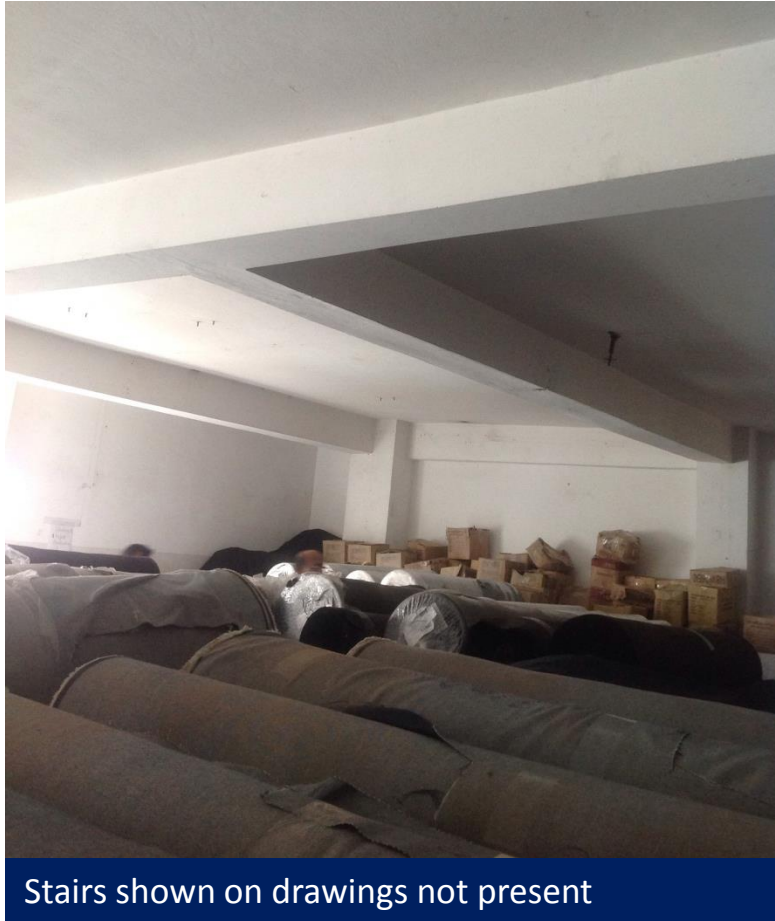
- There are a number of inconsistencies between the permit drawings and the constructed buildings, the principal of which is brick aggregate being used although stone aggregate was specified.
- Building Engineer to provide an updated Permit drawing and a full set of as-built structural and architectural drawings for all of the buildings on the site.

Stairs shown on drawings not present

| Item No. | Observation | Recommended Action Plan | Recommended Timeline |
|---|---|---|---|
| 17 | Inconsistencies in documents provided | Building Engineer to update the structural and architectural drawings to reflect the as-built layouts. | 6-months |

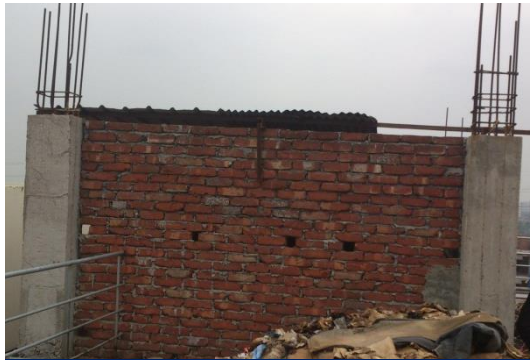
- Additional roof structures were present on level 7 that were not shown on the provided drawings.
- Unreinforced masonry walls were present around the stairwells, there was a steel roof structure at the generator on ground floor, and a rooftop mast structure was cantilevering from a column stub.
- These structures do not appear to be engineered.
- Building Engineer to review the design of these structures and to implement any required strengthening works.

Unreinforced masonry wall

| Item No. | Observation | Recommended Action Plan | Recommended Timeline |
|---|---|---|---|
| 18 | Lightweight roof structures | Lightweight structures to be checked to ensure adequacy for code vertical and wind loads by the Building Engineer. | 6-months |
| 19 | Lightweight roof structures | Undertake strengthening if required. | 6-months |

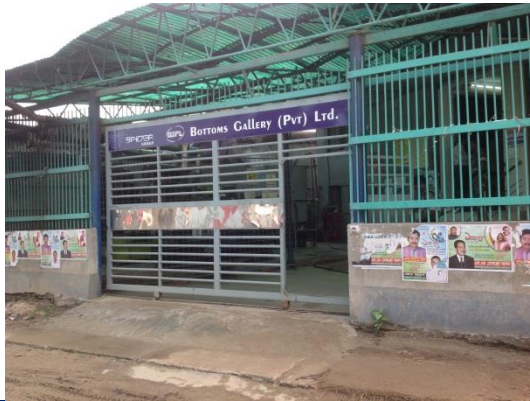
Steel roof to generator

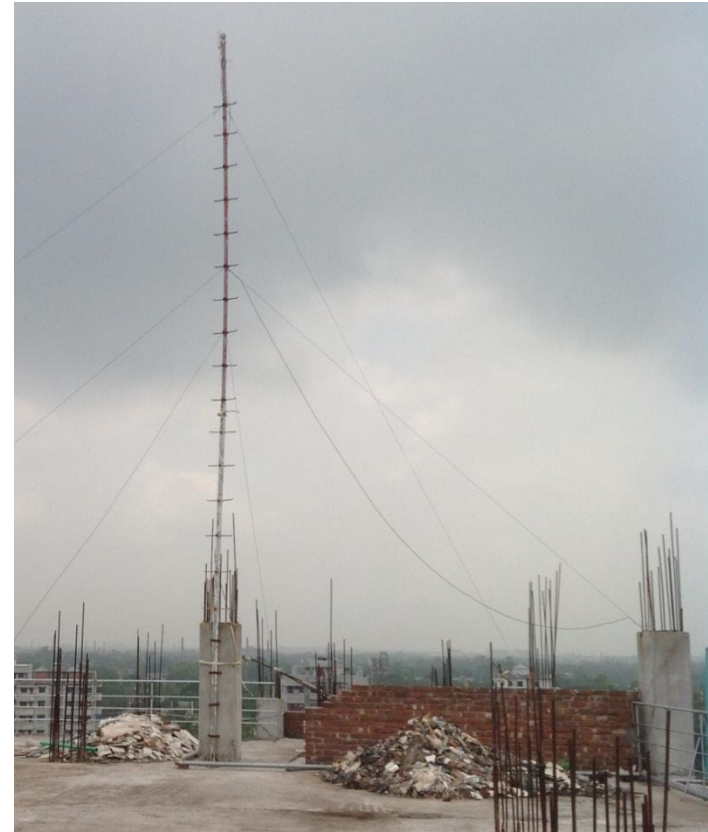
Mast and unreinforced masonry wall
