# Kims Corporation Ltd.

16, Sutar Noardda, Arapara, Savar  
(23.850058, 90.251219)  
03 May 2014

# Observations

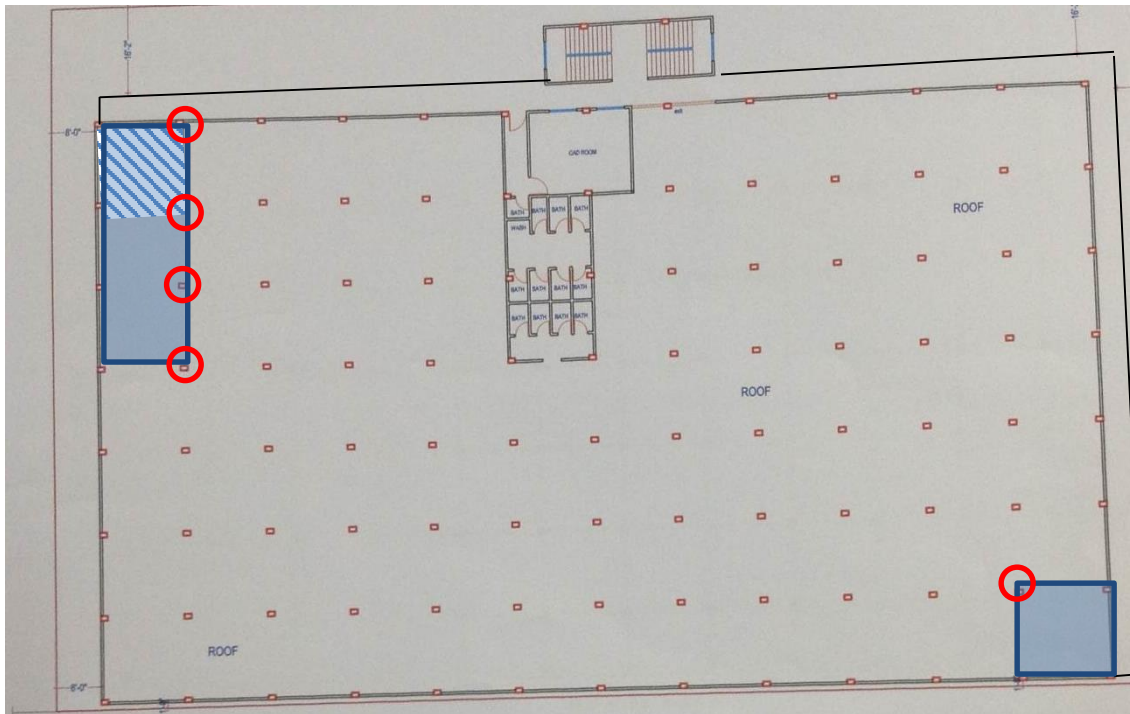
## Observed high loading

**200mm build-up in  
toilet area on 1<sup>st</sup> and  
2<sup>nd</sup> floor toilet areas**

**Concrete water  
tank at roof level**

**Heavily loaded  
columns**

| Item No. | Observation | Recommended Action Plan | Recommended Timeline |
|---|---|---|---|
| 1 | Heavily loaded columns under the water tank and toilet area | Maintain existing activities on the floor plate avoiding any storage of materials in the areas mentioned in full report. | Immediate - Now |
| 2 | Heavily loaded columns under the water tank and toilet area | Building Engineer to verify concrete strength by 100mm dia cores or the existing cylinder strength data for the columns noted under the toilets. | 6-weeks |
| 3 | Heavily loaded columns under the water tank and toilet area | If required reduce the loading on the columns by removing the existing tank and relocate tank from over the toilet area. | 6-weeks |
| 4 | Heavily loaded columns under the water tank and toilet area | Reduce the build-up in the toilets area or strengthen columns should the review of the concrete strength require it. | 6-months |

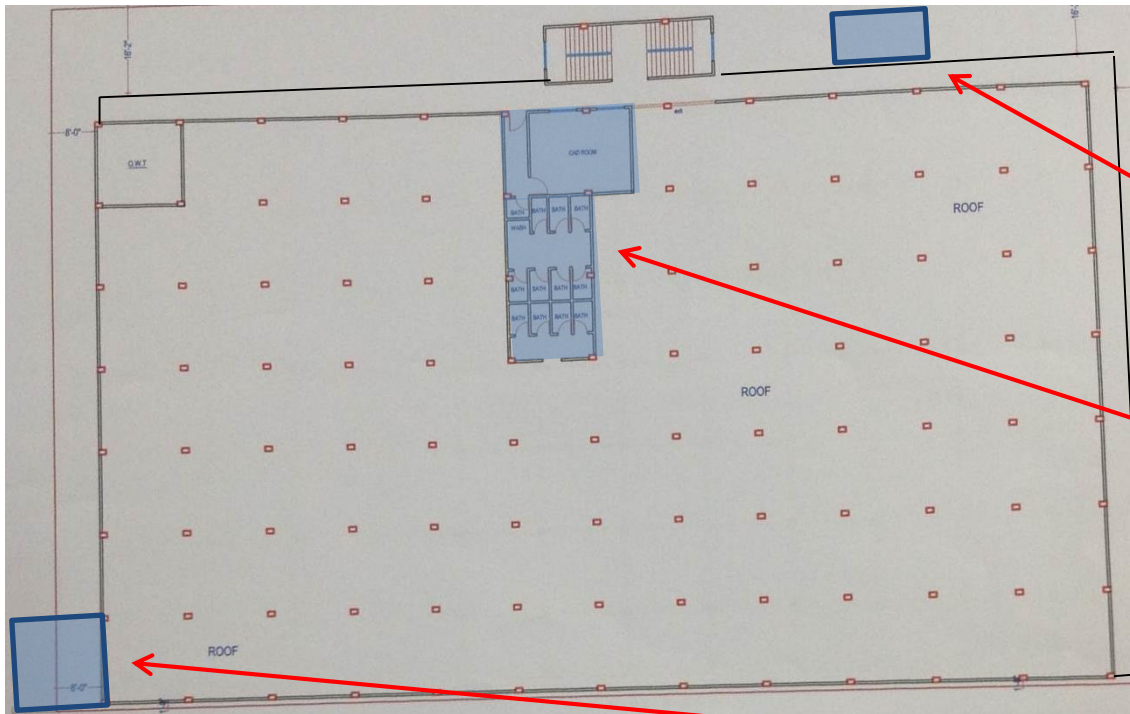
## Documentation: highlighted areas not documented on structural drawings

No building permit was given for the building surveyed on site.

- Steel staircase located adjacent to the primary stair well not present on any drawings.
- CAD room and toilet block not on the original structural drawings.
- Stair well leading to the mosque room located on the southern side of the building not present on either the structural or as-built drawings.

| Item No. | Observation | Recommended Action Plan | Recommended Timeline |
|---|---|---|---|
| 5 | As-built documentation does not reflect the built structure | Building Engineer to survey existing structure and update the existing "As-Built" drawings | 6-weeks |

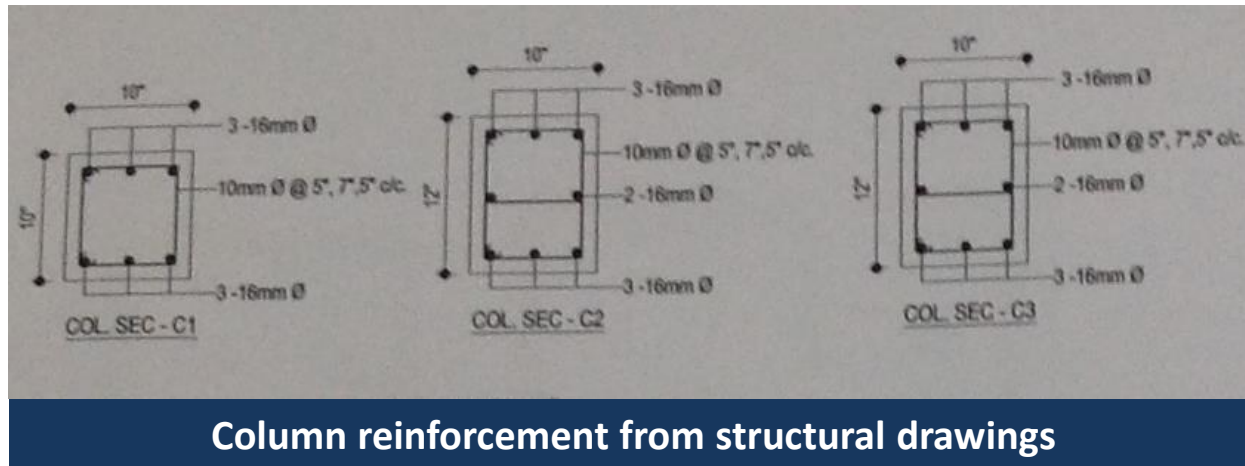
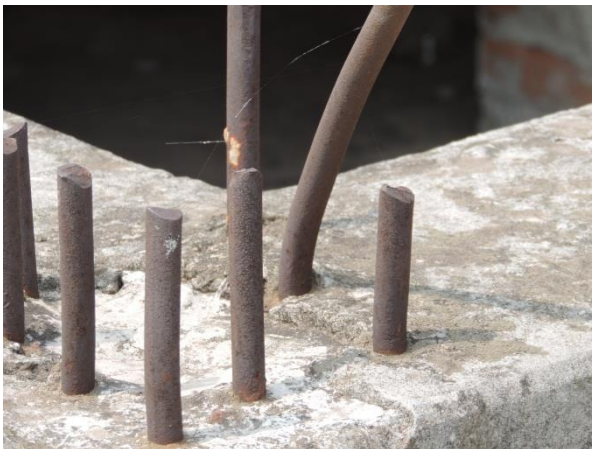
## Rebar quantities observed differ from structural drawings

- Ferro-scanning of column recorded 4 number bars in the columns.
- 6 bars @ 16mm diameter are called up on the structural drawings.
- 4 bars is in agreement with previous NDT carried out.

It was also noted that the reinforcing steel provided was unribbed mild steel bars.

| Item No. | Observation | Recommended Action Plan | Recommended Timeline |
|---|---|---|---|
| 6 | Rebar quantities differ between drawings and built structure | Building Engineer to update As-built drawings with the corrected rebar quantities as outlined in the engineering investigation already carried out by TUV. | 6-weeks |
| 7 | Rebar quantities differ between drawings and built structure | Building Engineer to carry out spot checks to verify findings of the TUV report. | 6-weeks |

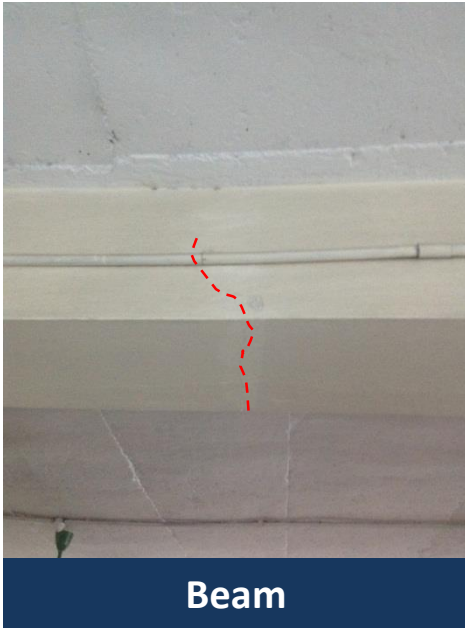
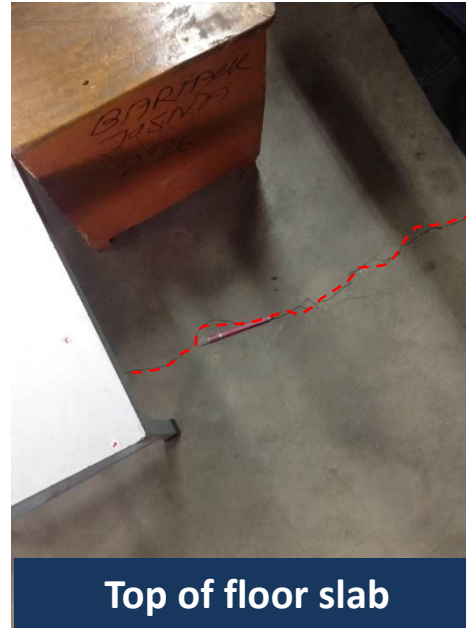
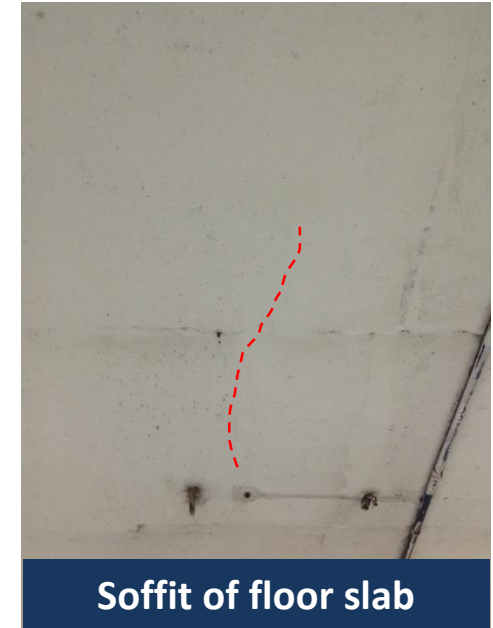
## Flexural cracking in beams and slabs

- Flexural cracks were found in the beams and slabs on all levels.
- Significant cracking was observed in the floor slab screed. These cracks were particularly prevalent over beams, running between columns. This behaviour is consistent with flexural cracking as hairline cracking was also observed in the soffit of the floor slabs.
- Hairline cracks were also observed in the beams.

| Item No. | Observation | Recommended Action Plan | Recommended Timeline |
|---|---|---|---|
| 8 | Flexural cracks noted in the beams and slabs | Building Engineer to carry out study to verify the load capacity of the members as-built. | 6-weeks |
| 9 | Flexural cracks noted in the beams and slabs | Building Engineer to remove plaster/finishes in area of cracking in slabs and beams. | 6-weeks |
| 10 | Flexural cracks noted in the beams and slabs | Review cracking and make recommendations for repair as necessary | 6-weeks |
| 11 | Flexural cracks noted in the beams and slabs | Carry out repairs as necessary. | 6-months |

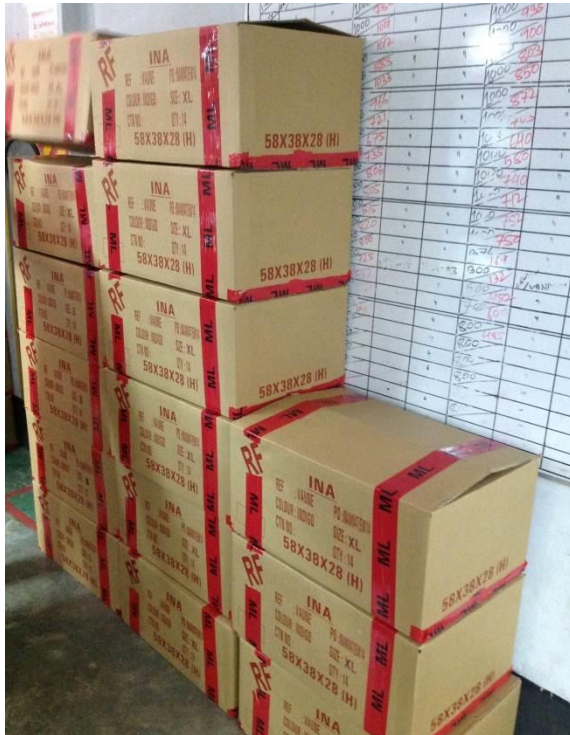
Storage on first floor

- The floor use for 1<sup>st</sup>, 2<sup>nd</sup> and 3<sup>rd</sup> floors was general sewing which is relatively lightly loaded.
- Some evidence of storage was observed on the 1<sup>st</sup> and 2<sup>nd</sup> floors, relating to packaging of products.

| Item No. | Observation | Recommended Action Plan | Recommended Timeline |
|---|---|---|---|
| 12 | Stacking of finished goods on the suspended floors | Building Engineer to produce loading plans to be displayed at each floor level. | 6-weeks |
| 13 | Stacking of finished goods on the suspended floors | Factory Manager to actively manage floor usage in accordance with the loading plan. | 6-weeks |
| 14 | Stacking of finished goods on the suspended floors | Continue to implement load plan. | 6-months |

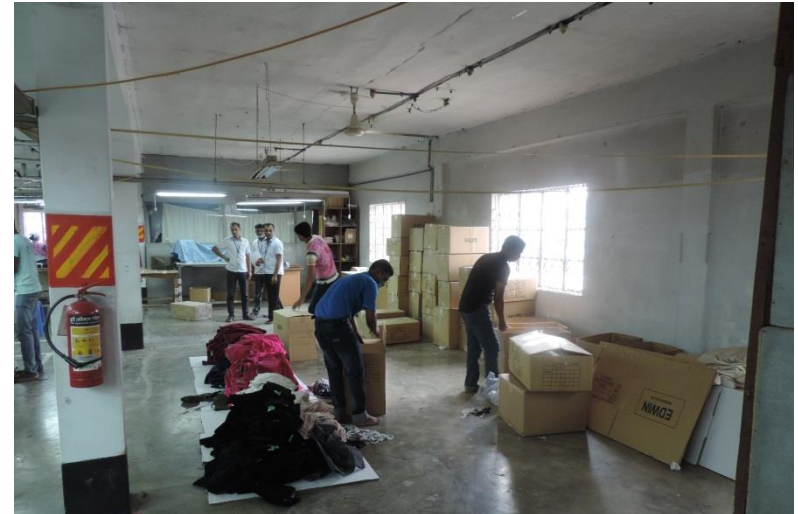
Second floor packaging/storage

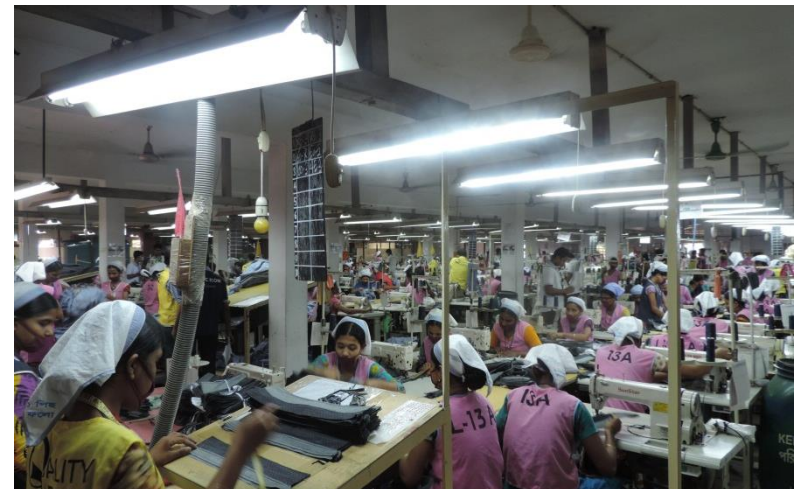
Typical floor load

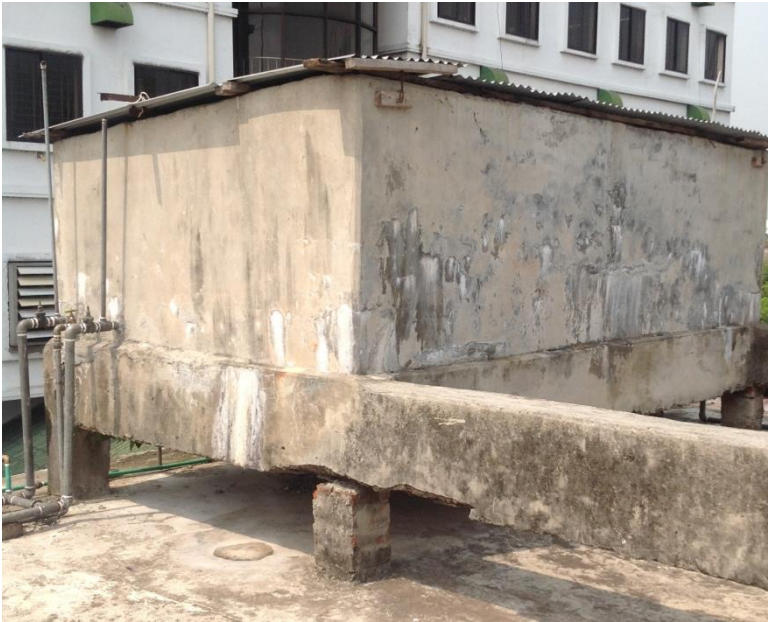
Water tank elevation

- Significant water damage observed to water tank walls, slab and supporting beam.
- Evidence of water ingress also observed in columns below water tank at all levels.

| Item No. | Observation | Recommended Action Plan | Recommended Timeline |
|---|---|---|---|
| 15 | Poor condition of the concrete water tanks | Engineer to investigate the condition of the concrete and rebar of the water tank on the roof. | 6-weeks |
| 16 | Poor condition of the concrete water tanks | Engineer to make recommendations on the repair to the tank. | 6-weeks |
| 17 | Poor condition of the concrete water tanks | Carry out repairs to the water tank as per Engineer's details, or demolish and replace with new tank (same size). | 6-months |

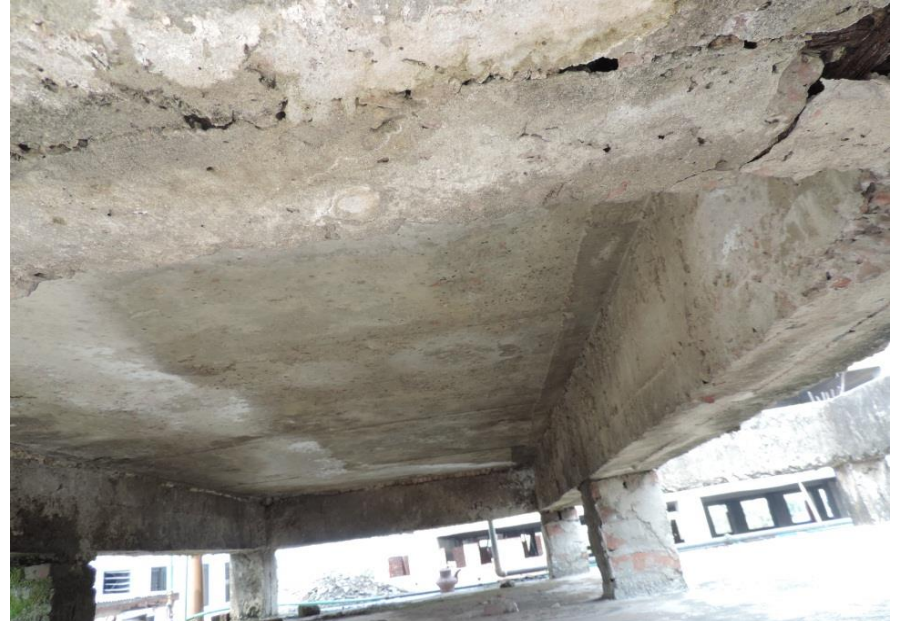
Soffit of water tank with concrete spalling

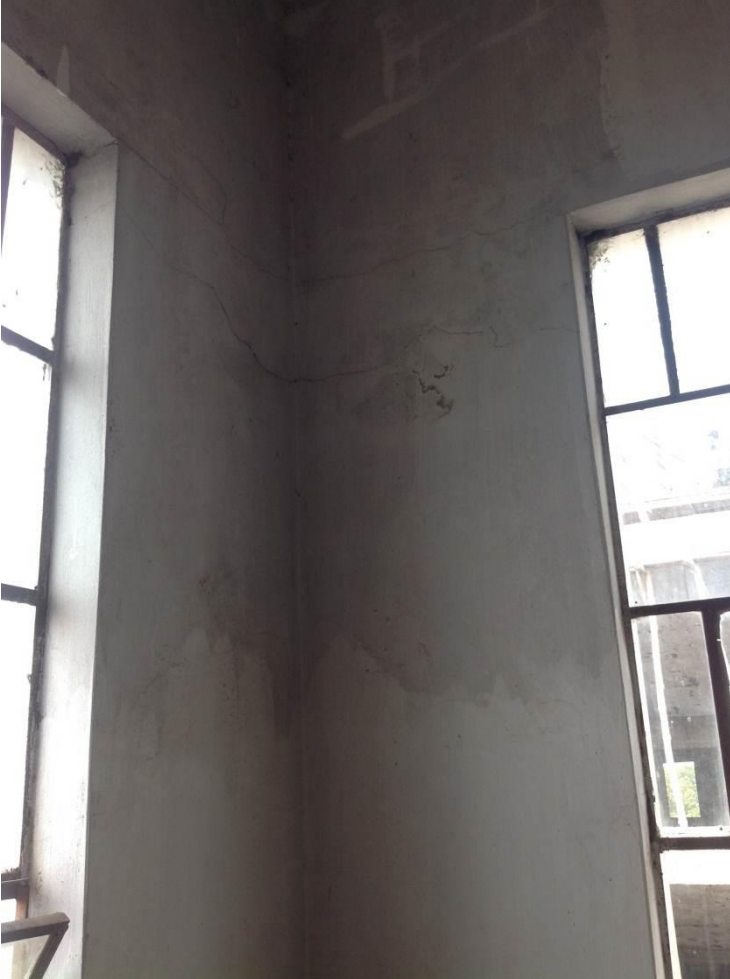
- Numerous cracks were observed in the walls of the main stairwell located on the western face of the building.

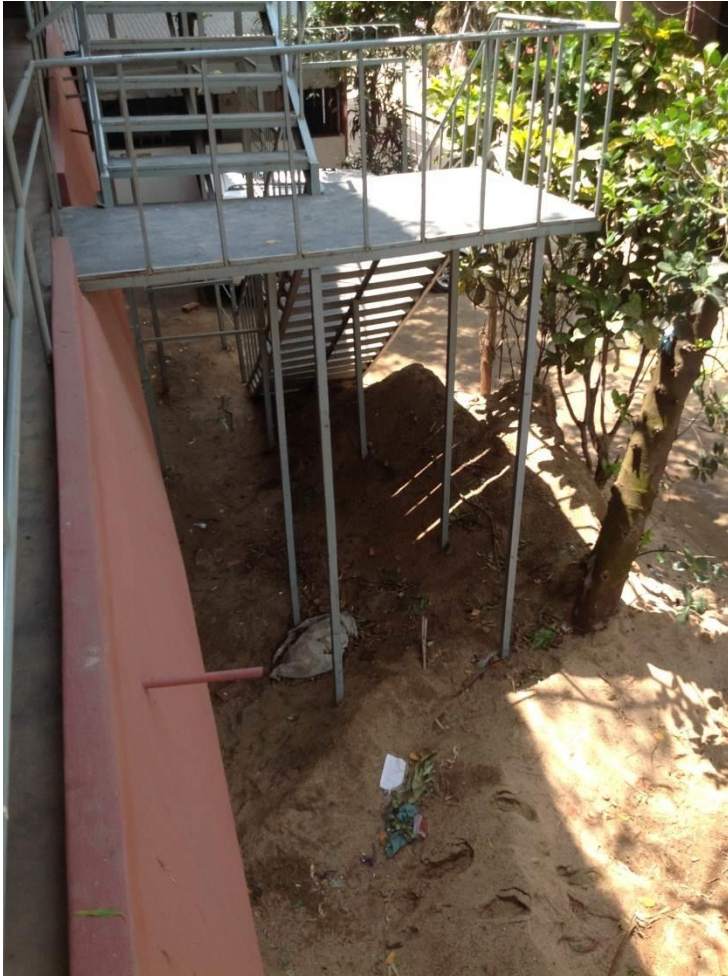
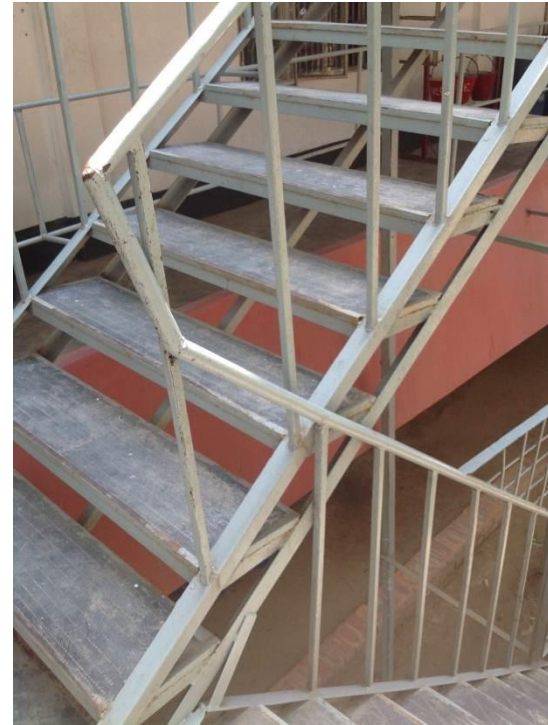
A steel stair providing access to the first and second floors appears to be non-engineered. The main issues observed are:

- No bracing provided to the structure.
- Unequal rise between steps in each flight.
- Section sizes appear to be light.

| Item No. | Observation | Recommended Action Plan | Recommended Timeline |
|---|---|---|---|
| 18 | Non-engineered external steel stairs in the main building and to the roof of the boiler house | Building Engineer to review the two steel stairs. | 6-weeks |
| 19 | Non-engineered external steel stairs in the main building and to the roof of the boiler house | Building Engineer to design any additional structure deemed necessary or replacement engineered stairs | 6-weeks |
| 20 | Non-engineered external steel stairs in the main building and to the roof of the boiler house | Build additional structure as per Building Engineer's recommendations. | 6-months |

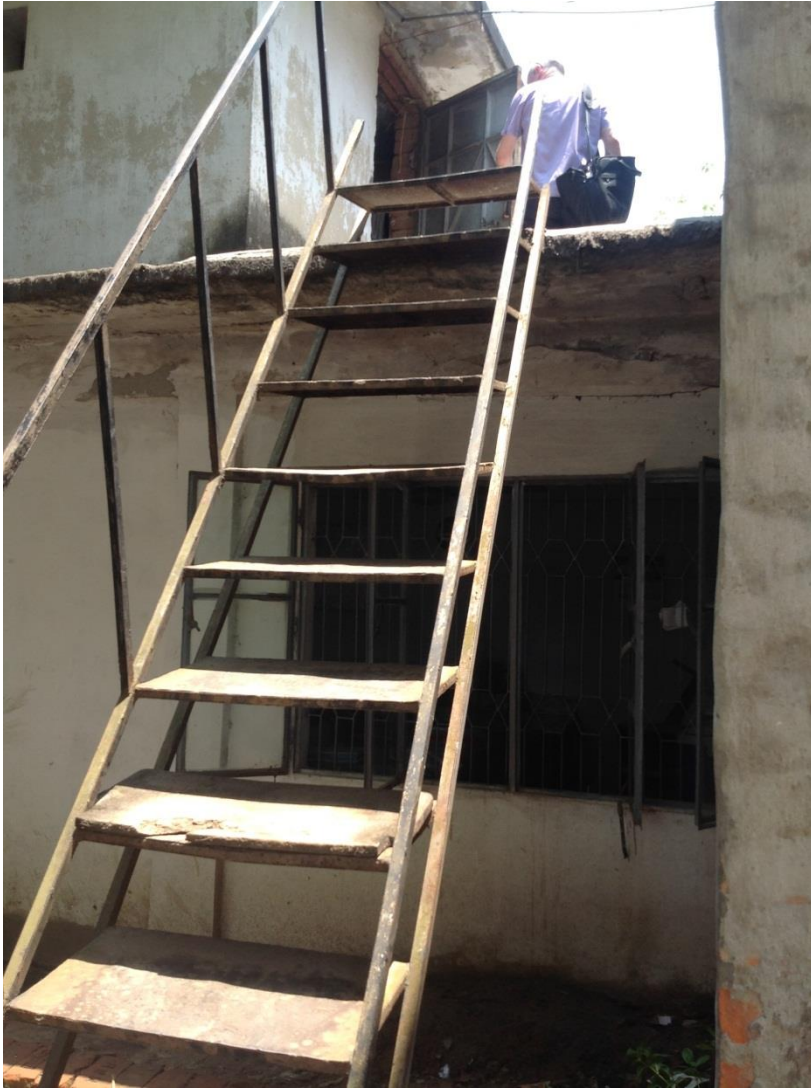
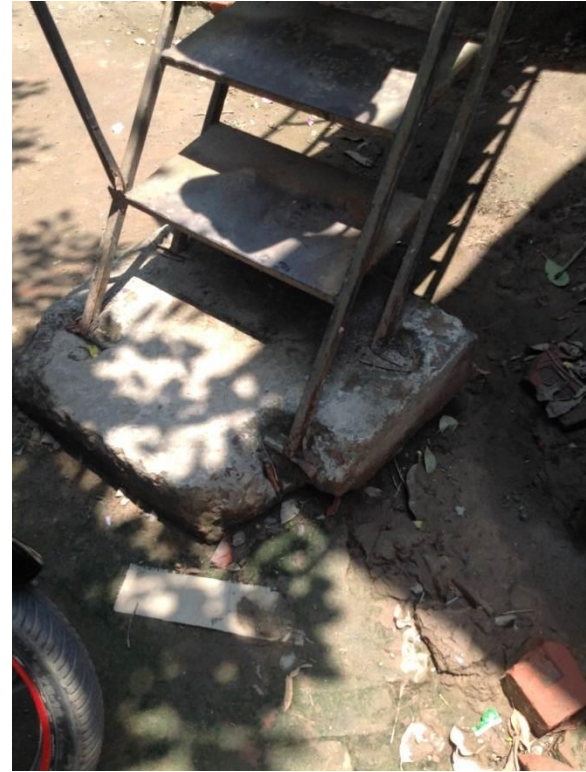
- A steel stair providing access to the first floor of the boiler house appears to be non-engineered and unfit for purpose.
- This stair is a hazard and is in need of replacement.

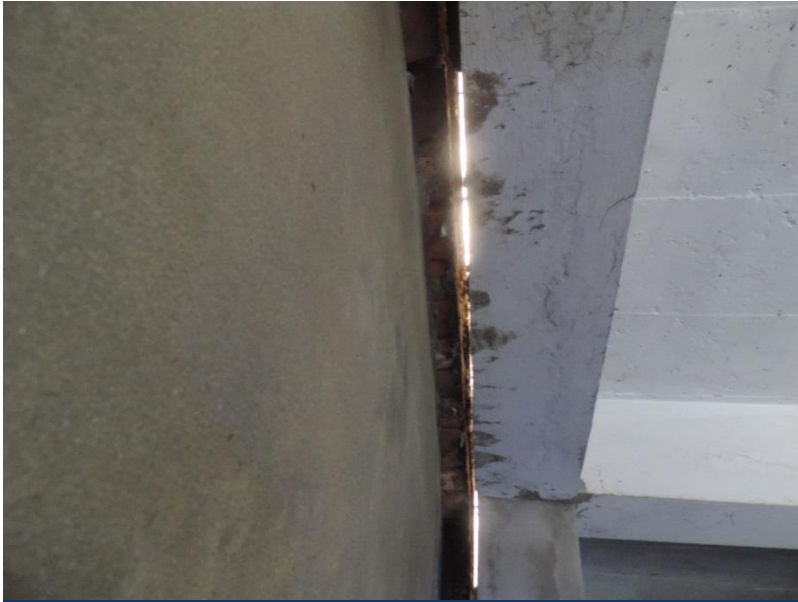
Soffit of 1<sup>st</sup> floor beam

- Front façade of the building on eastern side is not tied into the main structure of the building.
- Wall is constructed from unreinforced brick and is unable to resist any horizontal loads.
- Evidence of separation from cracking developed on northern corner, see photograph

| Item No. | Observation | Recommended Action Plan | Recommended Timeline |
|---|---|---|---|
| 21 | Façade wall on south side at ground floor is not tied into the building | Building Engineer to review lateral stability of the ground floor façade on the east side of the building, facing the existing road. | 6-weeks |
| 22 | Façade wall on south side at ground floor is not tied into the building | Building Engineer to design ties between façade and building as required. | 6-weeks |
| 23 | Façade wall on south side at ground floor is not tied into the building | Build additional structure as per Building Engineer's recommendations. | 6-months |

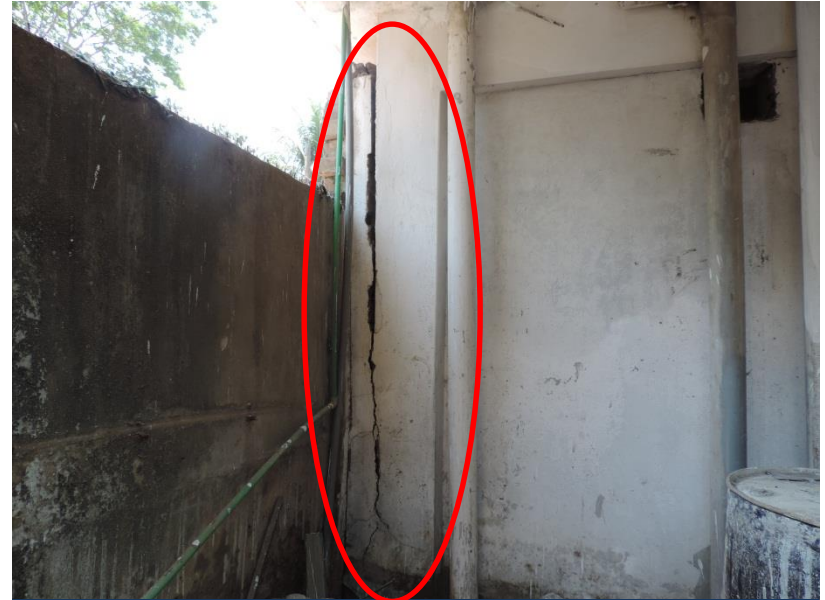
Separation of wall from building

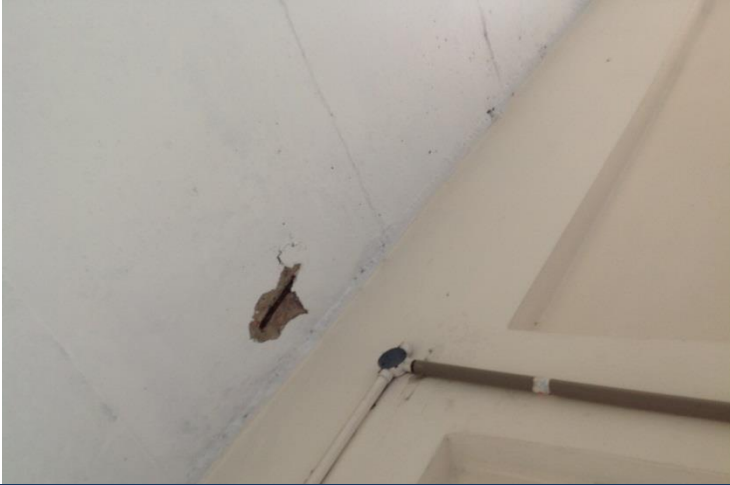
Soffit of cantilever slab

- Rebar has been exposed in several locations due to concrete spalling.
- Significant deterioration of the water tank supporting beams and roof of boiler house was observed, with some localised deterioration of the cantilever slabs.

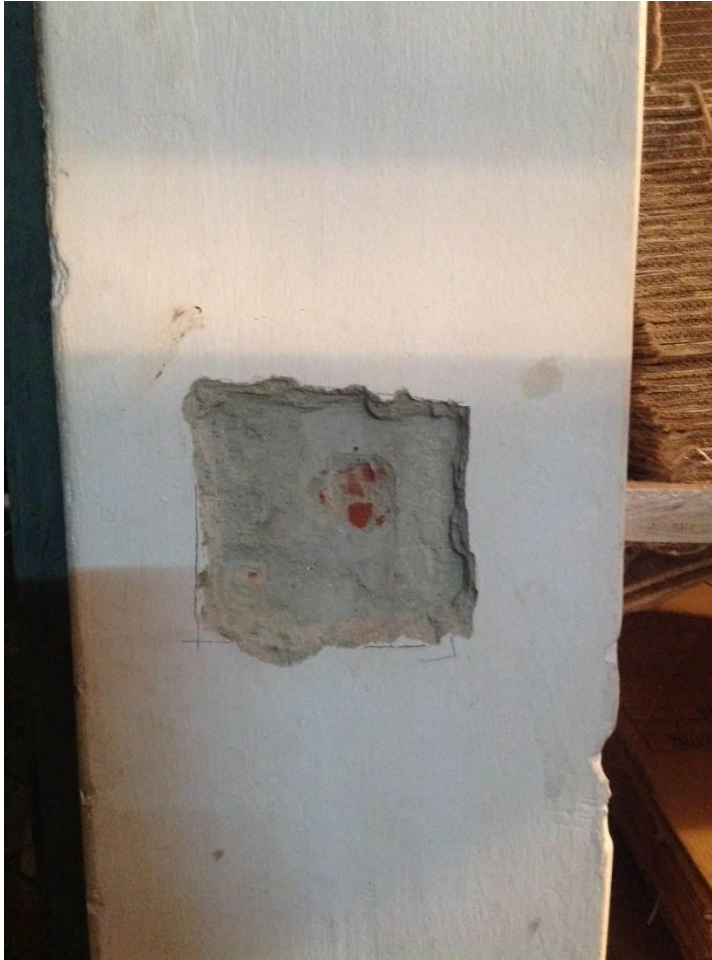
- After removing plaster from a ground floor column, brick aggregate was observed.
