# IFS Texwear (PVT) Ltd. 5S Composite Ltd.

PLOT NO. 631, KUTUBPUR, FATULLAH, NARAYANGANJ, BANGLADESH  
(23.647089N, 90.500948E)  
29 APRIL 2014

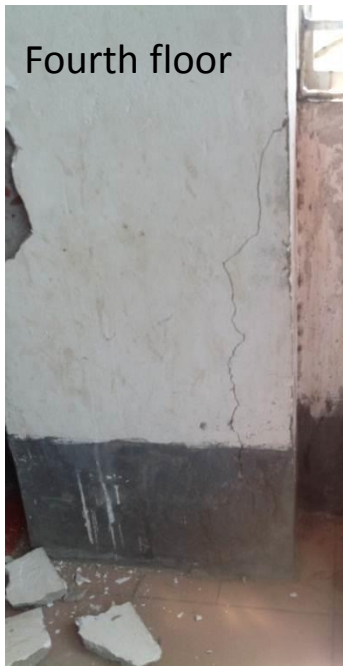
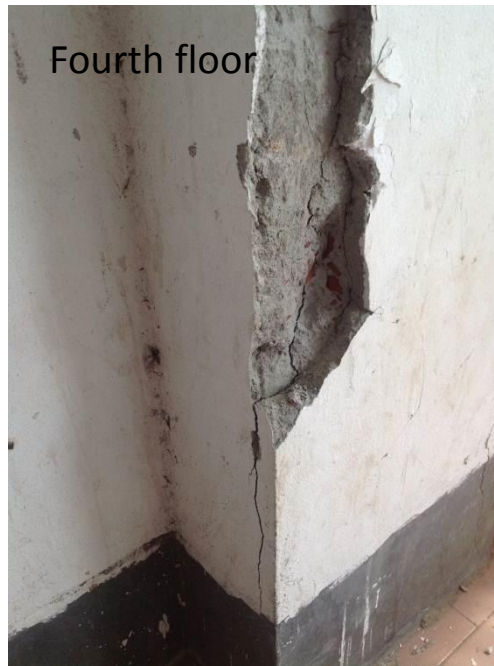
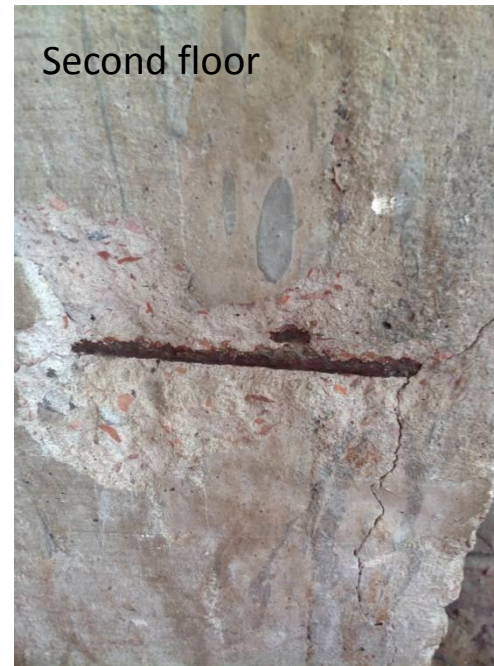
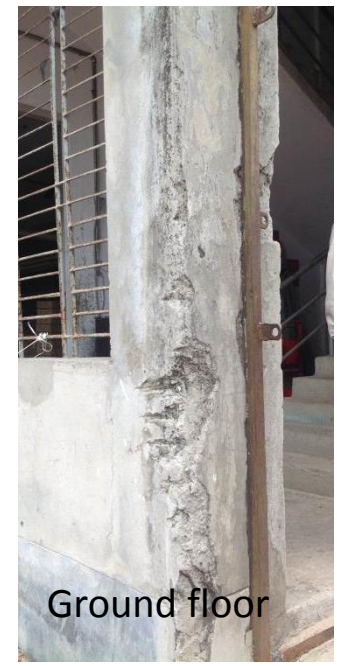
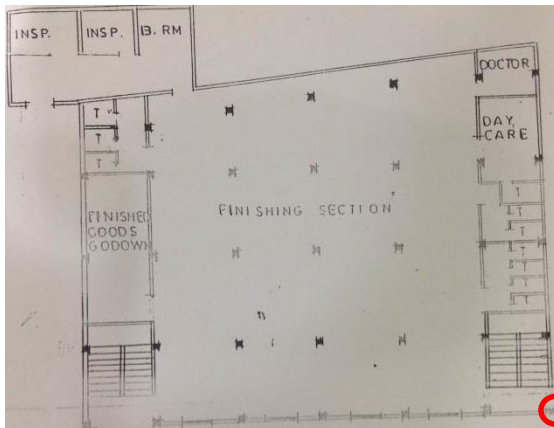
- Significant cracking and damage identified in corner column at three levels shown.
- Crack was opened up at fourth floor level confirming that it extended into the column.
- Similar cracking was observed at second floor level.
- At ground level damage was identified.

**The corner column needs additional temporary support installed and removal of water tank loading.**

| Item No. | Observation | Recommended Action Plan | Recommended Timeline |
|---|---|---|---|
| 1 | Cracking in corner column | Drain water from tanks over stairwell to reduce load carried by columns. | Immediate - Now |
| 3 | Cracking in corner column | If necessary, replace column while providing temporary support to the slabs. Any temporary propping to be designed by Building Engineer. | 6-weeks |
| 5 | Cracking in corner column | Implement actions arising from Detail Engineering Assessment, including possible strengthening or replacement of column as required. | 6-months |

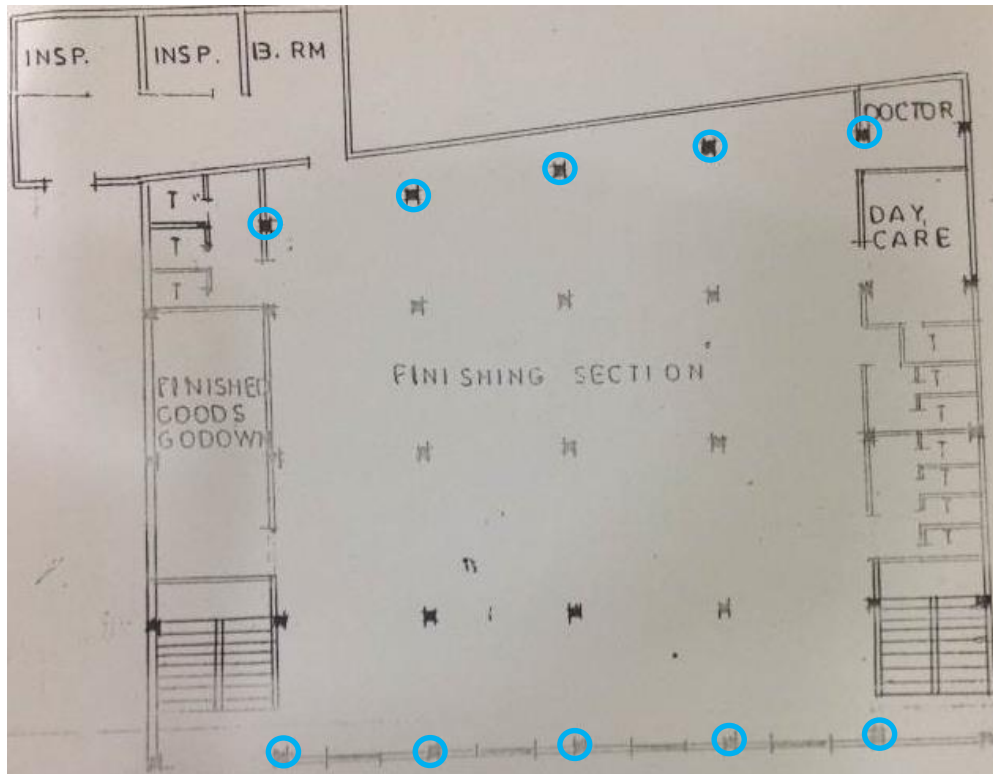
- Preliminary calculations indicate that the working stress for these columns is above that recommended by the code for the given materials and observed loading

| Item No. | Observation | Recommended Action Plan | Recommended Timeline |
|---|---|---|---|
| 6 | Highly-stressed columns at front and rear elevations<br>Verify concrete strengths in columns for all 400 x 280 columns (front and rear facades) | Factory Engineer to review design, loads and column stresses supporting cantilevers at front and rear facades. | Immediate - Now |
| 7 | Highly-stressed columns at front and rear elevations<br>Verify concrete strengths in columns for all 400 x 280 columns (front and rear facades) | Verify insitu concrete stresses by 100mm diameter cores from min. 4 perimeter columns. Cores to be taken at Ground Floor. | Immediate - Now |

| Item No. | Observation | Recommended Action Plan | Recommended Timeline |
|---|---|---|---|
| 9 | Highly-stressed columns at front and rear elevations<br>Verify concrete strengths in columns for all 400 x 280 columns (front and rear facades) | Produce and actively manage a loading plan for all floor plates within the factory giving consideration to floor capacity and column capacity. | 6-weeks |
| 12 | Highly-stressed columns at front and rear elevations<br>Verify concrete strengths in columns for all 400 x 280 columns (front and rear facades) | No further levels to be built (metal sheet roof of shed not to be replaced with concrete roof) | 6-months |

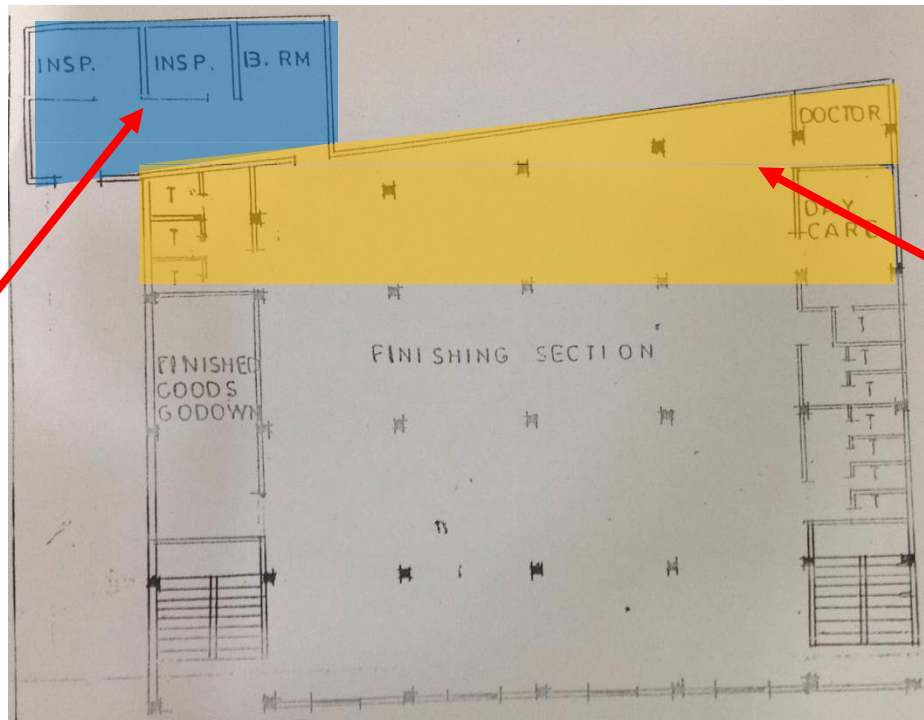
On ground floor only – not shown on structural drawings

Full height of building – not shown on structural drawings

- An additional bay extending out the back of the building was constructed over the entire height of the building.
- There was also an extension constructed to the back at ground level only.
- Both these items were present on the layout drawings but not on the structural drawings.
- It was also observed that grid layout, beam and column sizes on the structural drawings did not match with what had been constructed.

| Item No. | Observation | Recommended Action Plan | Recommended Timeline |
|---|---|---|---|
| 13 | Discrepancies between documentation and as-built structure | As part of Detail Engineering Assessment (see Item 1), ensure structural as-built drawings are produced for the building extent. | 6-weeks |
| 14 | Discrepancies between documentation and as-built structure | Design calculations for the building should be undertaken, with a proposed load plan produced. | 6-weeks |

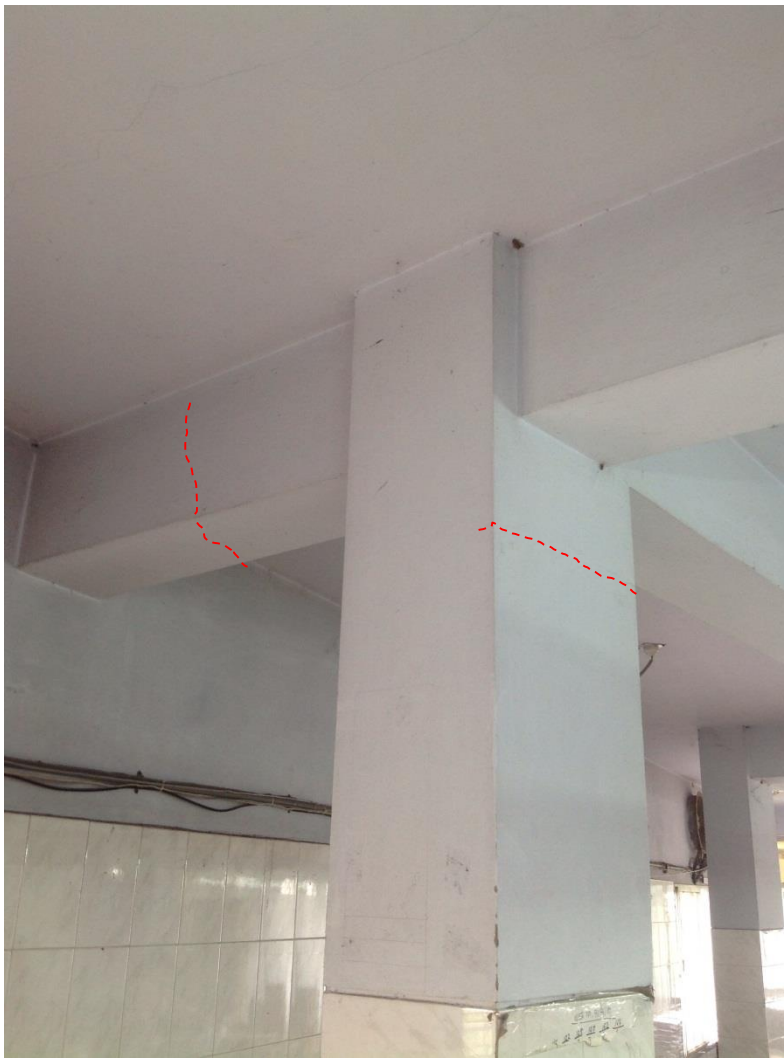
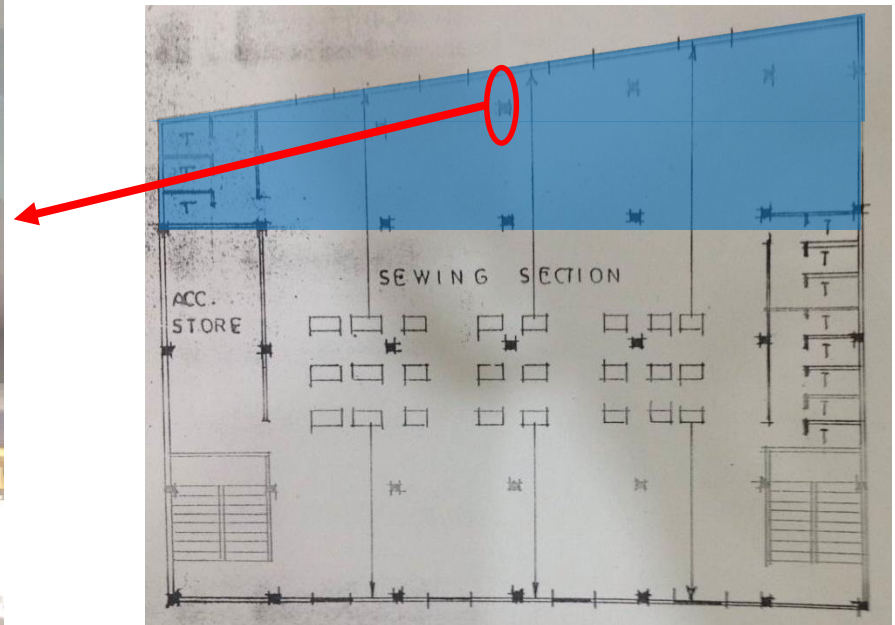
- Cracking was found in beam and column due to cantilevering slab in undocumented area shown below.
- This cracking appears to be due to deflection of the cantilever beam

| Item No. | Observation | Recommended Action Plan | Recommended Timeline |
|---|---|---|---|
| 15 | Beam & column cracking in undocumented area | As part of Detail Engineering Assessment (see Item 1), check capacity of the cantilever beams and the supporting columns. | 6-weeks |
| 15 | Beam & column cracking in undocumented area | Implement actions arising from Detail Engineering Assessment. | 6-months |

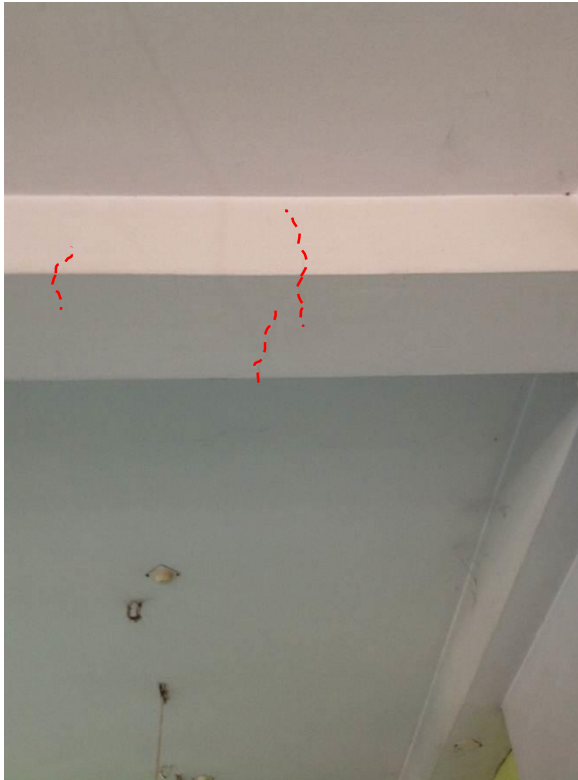
Beam cracking

Cracks were observed in the beams and slabs on all floor levels.

- They occurred on each side of the beam throughout its length. In many locations these cracks extended through the soffit and up both sides of the beam.
- Cracks in the soffit of the floor slab were typically observed in and around the centre of the span. These were particularly visible on the soffit of the second floor.

| Item No. | Observation | Recommended Action Plan | Recommended Timeline |
|---|---|---|---|
| 15 | Cracking in beams & slabs at all levels | As part of Detail Engineering Assessment (see Item 1), investigate if cracks penetrate the building structure. | 6-weeks |
| 15 | Cracking in beams & slabs at all levels | Implement actions arising from Detail Engineering Assessment, including any concrete repairs or strengthening required to beams or slabs. | 6-months |

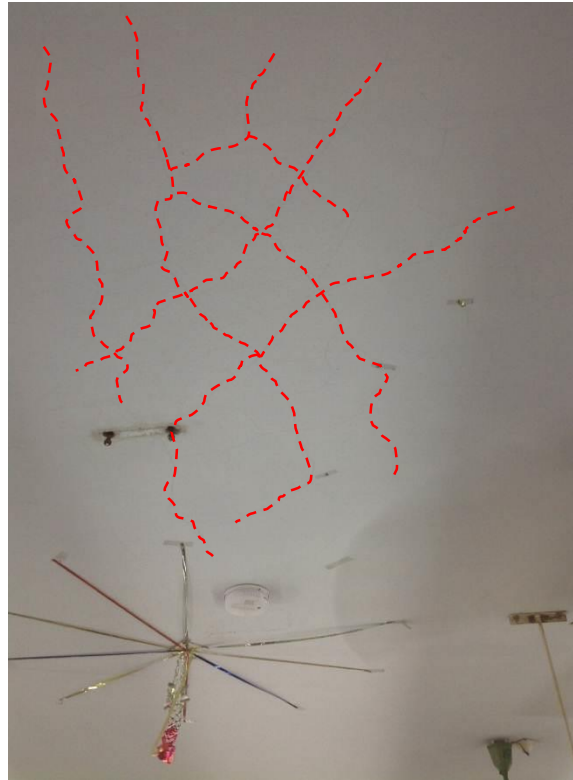
Slab cracking

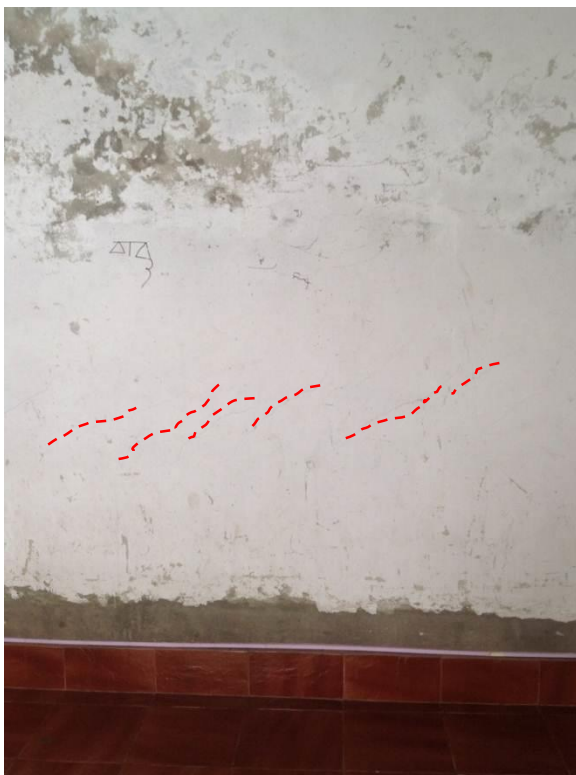
Stairwell side

Cracks were observed in the walls at most levels in both stairwells of the building.

- These cracks were predominately diagonal and extended through the wall to both faces.
- A possible reason for these cracks is due to significant deflection on the inner beam of the stairwell compared with the outer beam. However, this could not be confirmed from visual inspection.

| Item No. | Observation | Recommended Action Plan | Recommended Timeline |
|---|---|---|---|
| 15 | Cracking in walls throughout both stairwells | As part of Detail Engineering Assessment (see Item 1), Identify the cause(s) of the cracking. | 6-weeks |
| 15 | Cracking in walls throughout both stairwells | Rectify the cause(s) of the cracking. | 6-months |
| 15 | Cracking in walls throughout both stairwells | Repair cracks as recommended by the Detail Engineering Assessment | 6-months |

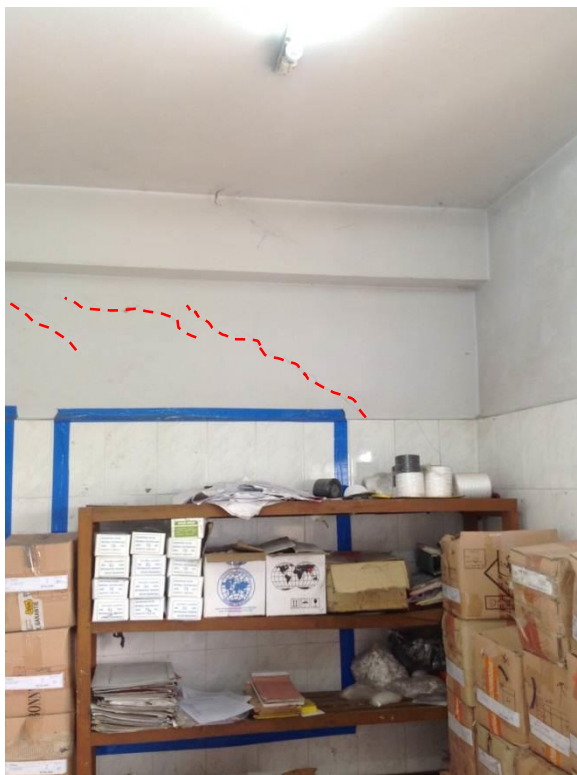
Workshop side

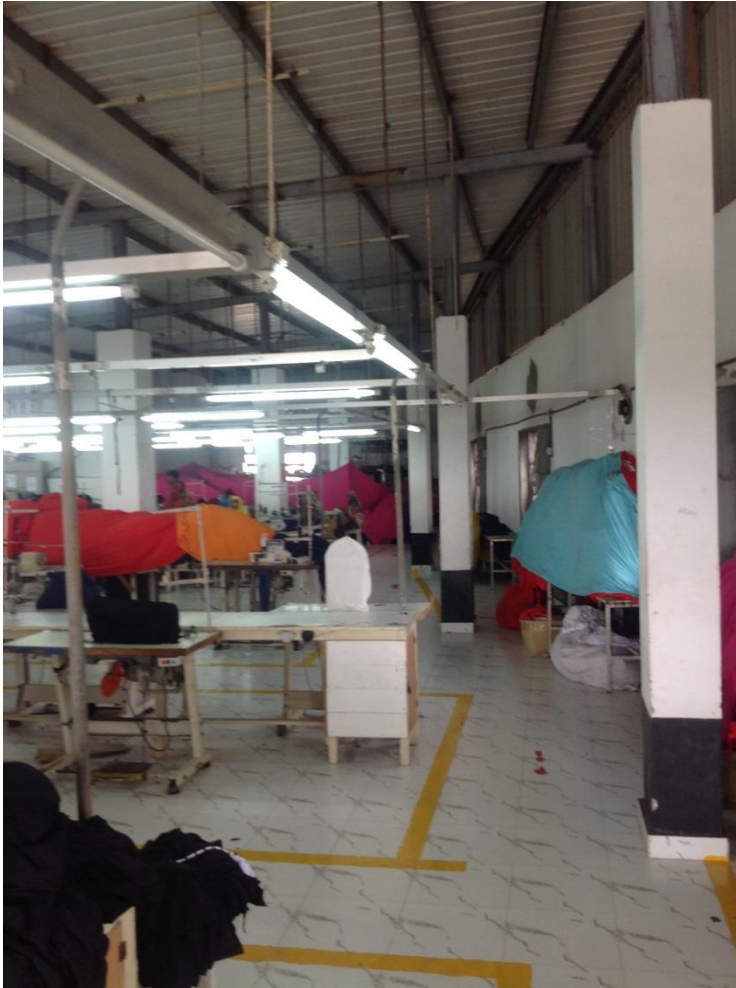
- At 4<sup>th</sup> floor level, a metal roof has been constructed with a brick façade all around.
- Poor horizontal stability due to lack of moment-carrying connections or bracing.
- Roof appears to be non-engineered.

| Item No. | Observation | Recommended Action Plan | Recommended Timeline |
|---|---|---|---|
| 15 | Non-engineered metal roof structure | Stability system in metal roof to be checked as part of Detail Engineering Assessment (see Item 1). | 6-weeks |
| 15 | Non-engineered metal roof structure | Implement actions arising from Detail Engineering Assessment. | 6-months |

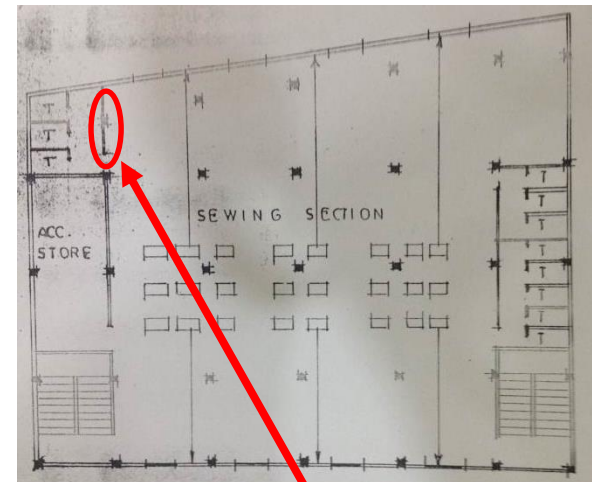
No internal column located in this region at fourth floor level, therefore higher load in edge column. This column bears directly on façade wall.

| Item No. | Observation | Recommended Action Plan | Recommended Timeline |
|---|---|---|---|
| 15 | Non-engineered metal roof structure | The structural behaviour in the area highlighted above is to be checked, including perimeter wall supporting the column. | 6-weeks |

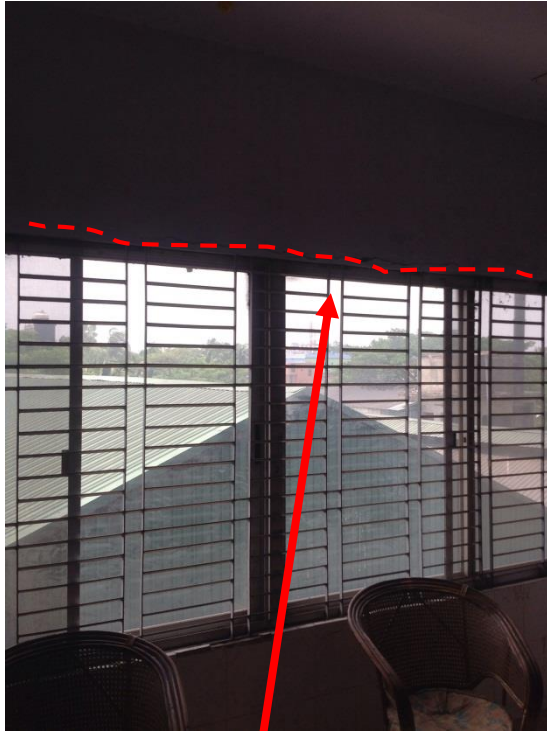
Horizontal cracking over windows

- Significant cracking evident in cantilever area on all upper levels at the front of the building.
- This appears to be due to deflection of the cantilever floors as a result of the parapet loads.

| Item No. | Observation | Recommended Action Plan | Recommended Timeline |
|---|---|---|---|
| 15 | Cracking at cantilevers at front of building | As part of Detail Engineering Assessment (see Item 1), check the capacity of the cantilever slab to withstand the façade loads. | 6-weeks |
| 15 | Cracking at cantilevers at front of building | Implement actions arising from Detail Engineering Assessment. | 6-months |

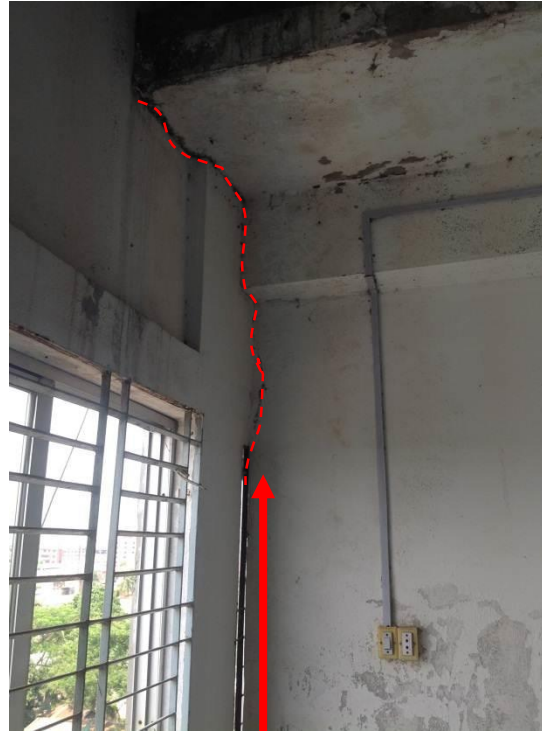
Vertical cracking at intersecting walls/floors

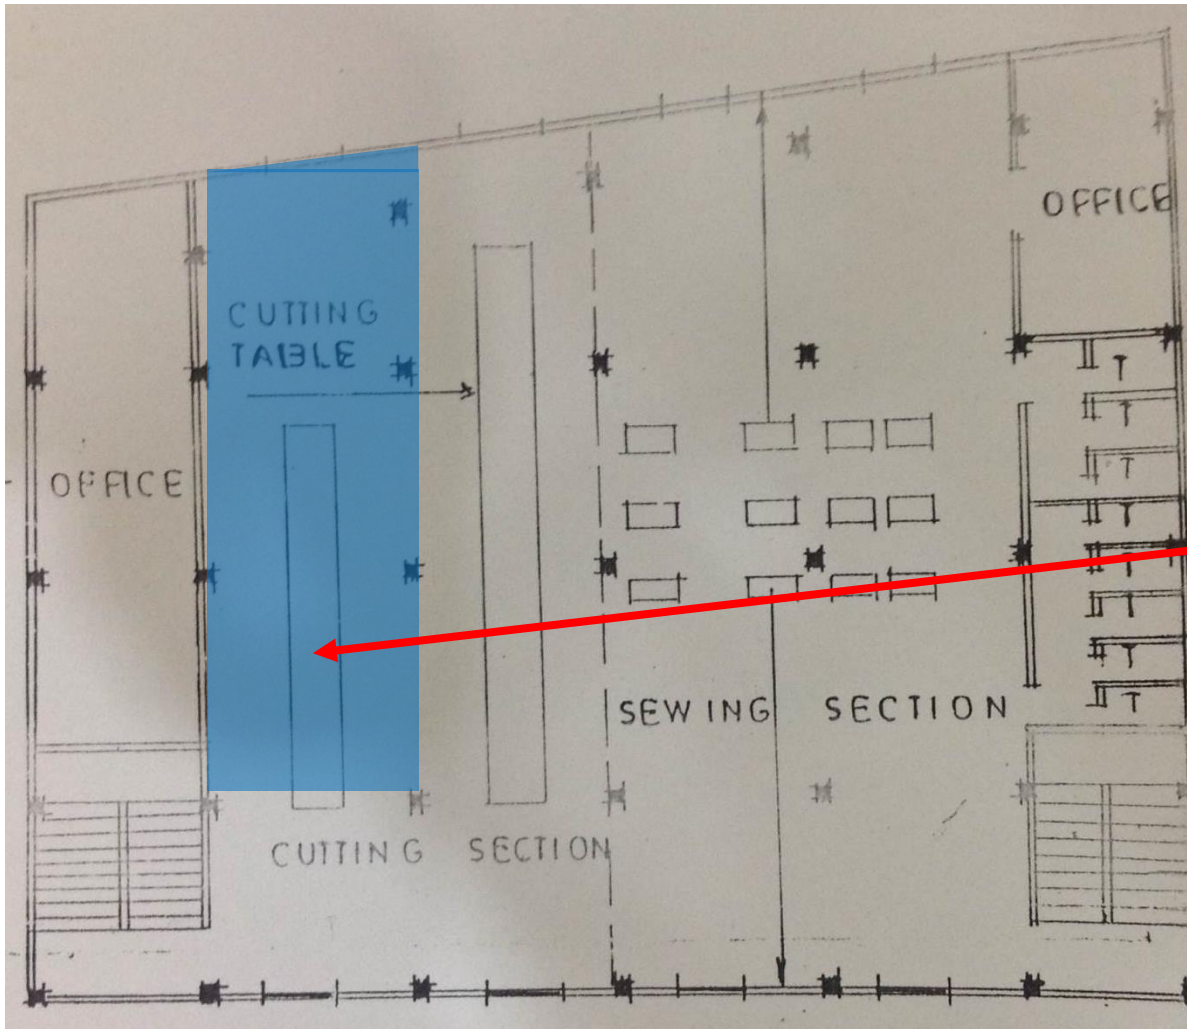
Brickwork cubicle partitions were found in office area shown

| Item No. | Observation | Recommended Action Plan | Recommended Timeline |
|---|---|---|---|
| 15 | Brick partitions in office area | As part of Detail Engineering Assessment (see Item 1), consider additional load placed on floor by brick partitions. | 6-weeks |
| 15 | Brick partitions in office area | Implement actions arising from Detail Engineering Assessment. | 6-months |

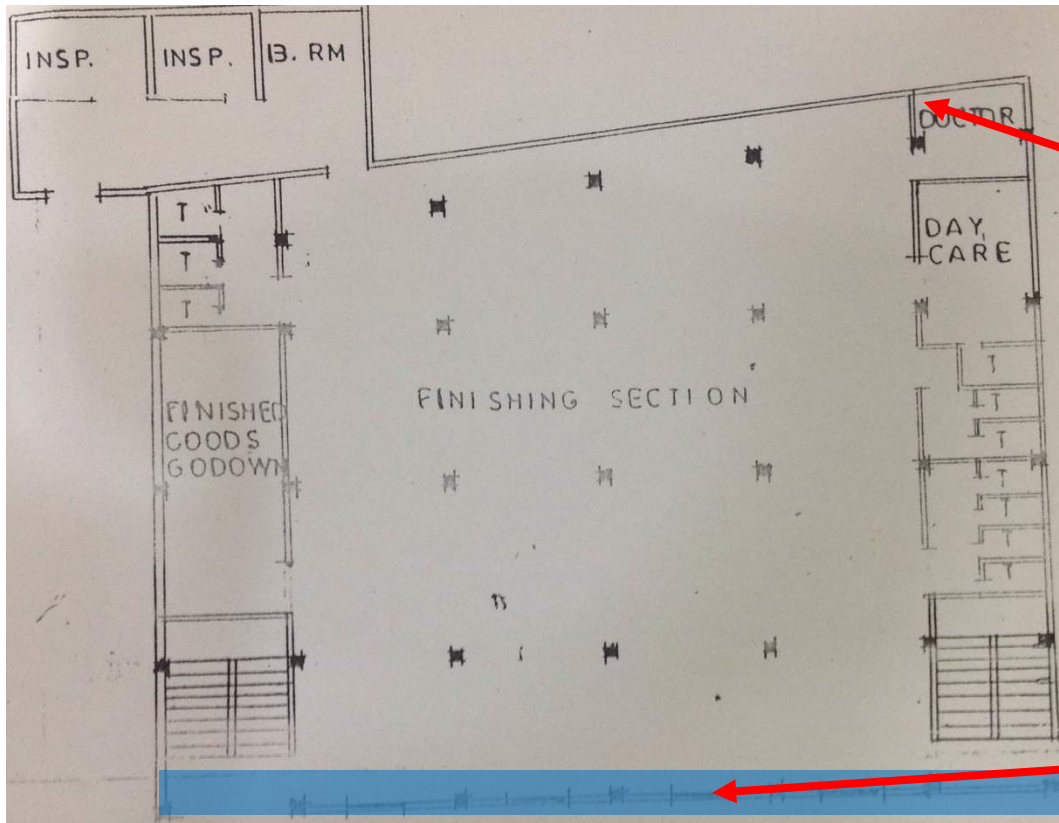
Column not centred  
below beam

| Item No. | Observation | Recommended Action Plan | Recommended Timeline |
|---|---|---|---|
| 15 | Misalignment between beams and columns | As part of Detail Engineering Assessment, ensure the eccentricity of the beam/column connections is considered. | 6-weeks |
| 15 | Misalignment between beams and columns | Capacity of the columns in these locations to be calculated. | 6-weeks |
| 15 | Misalignment between beams and columns | Implement actions arising from Detail Engineering Assessment. | 6-months |

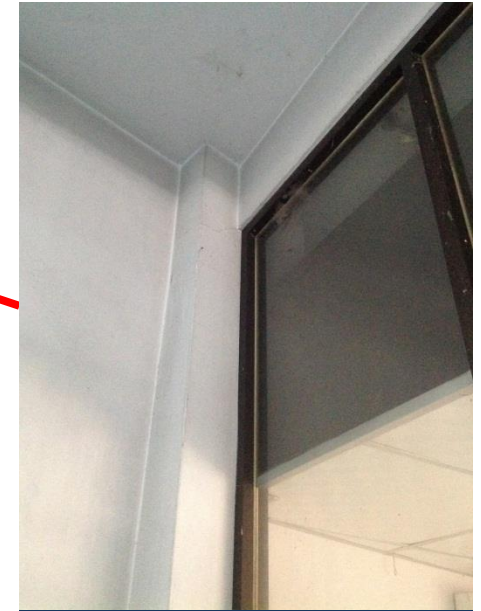
Beam along front face  
of building in line with  
outside face of column

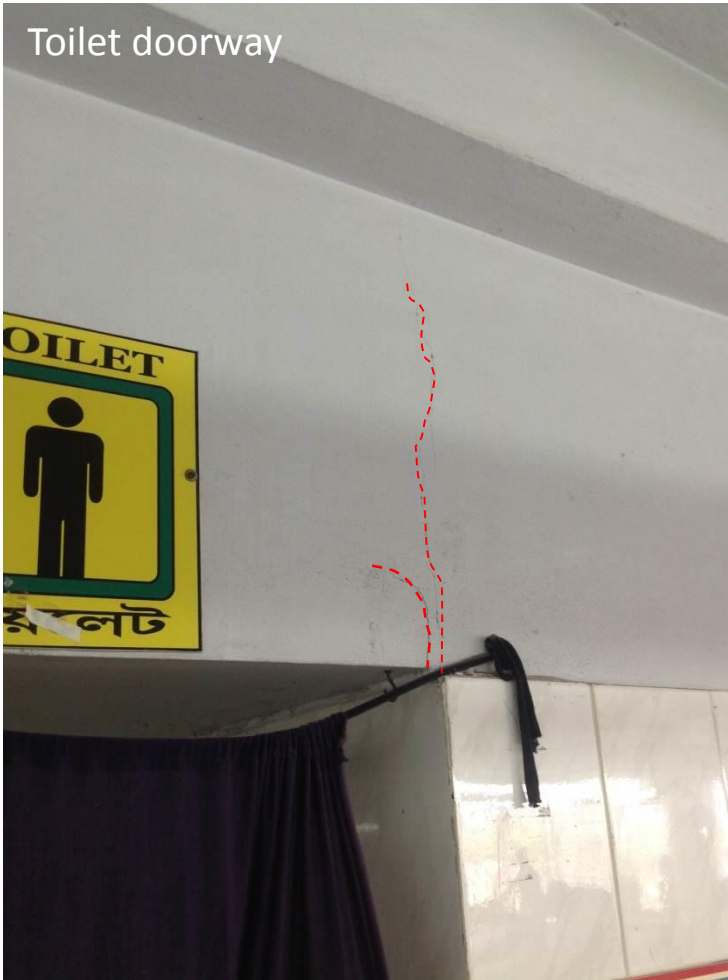
Toilet doorway

- Cracking was observed in the soffit of the slab over each toilet on each floor. This slab was cast directly over each of the toilet areas and is not connected to the floor.
- Significant cracking was also noticed over the doorway leading into the toilets.

| Item No. | Observation | Recommended Action Plan | Recommended Timeline |
|---|---|---|---|
| 15 | Cracking in toilet areas at all levels | As part of Detail Engineering Assessment (see Item 1), check design of overhead slab in all toilet blocks. | 6-weeks |
| 15 | Cracking in toilet areas at all levels | Implement actions arising from Detail Engineering Assessment. | 6-months |

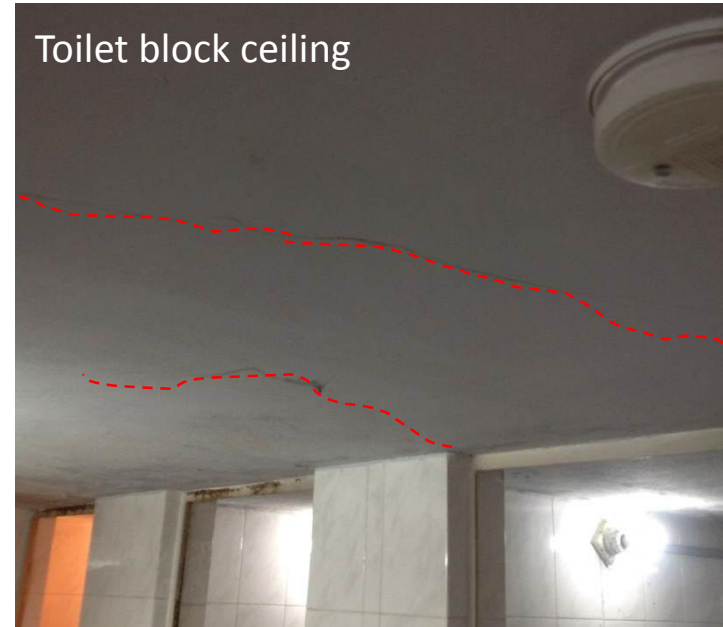
Toilet block ceiling

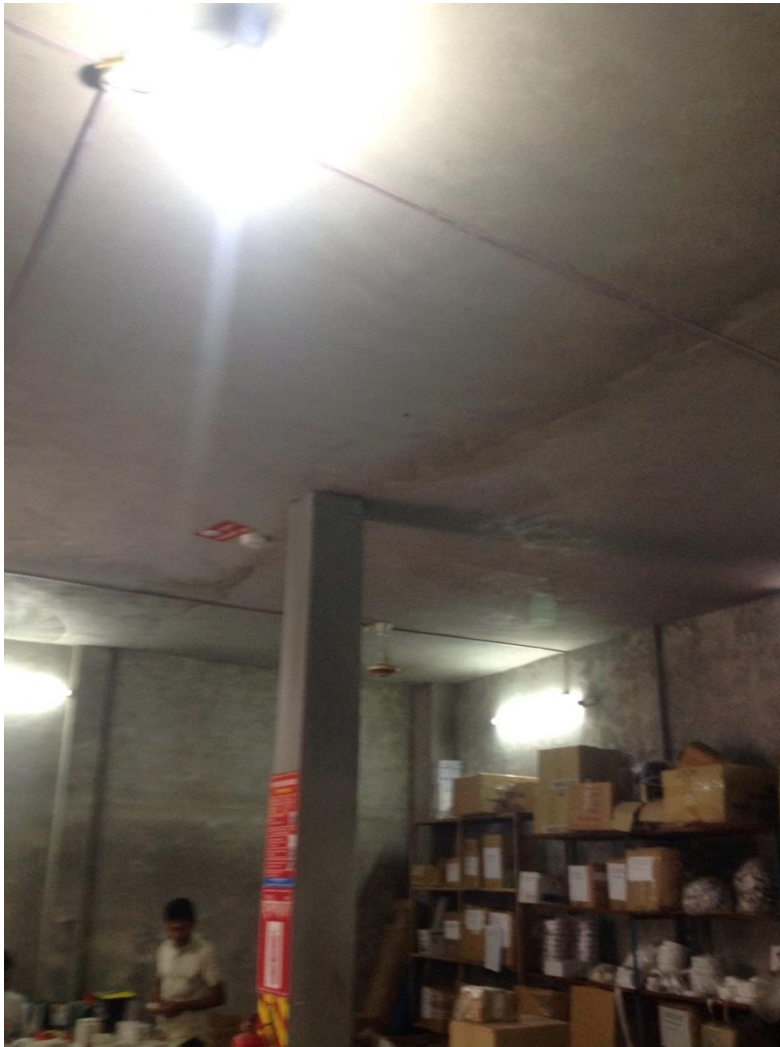
- The roof slab over the undocumented area on ground level was constructed as a flat slab.
- After discussion with building owner it appears that this slab was non-engineered.
- Both the slab thickness and rebar quantities are unknown.

| Item No. | Observation | Recommended Action Plan | Recommended Timeline |
|---|---|---|---|
| 15 | Non-engineered flat slab over ground floor extension | As part of Detail Engineering Assessment (see Item 1), carry out check on design of flat slab. | 6-weeks |
| 15 | Non-engineered flat slab over ground floor extension | If found to be inadequate, Building Engineer to propose strengthening works | 6-weeks |
| 15 | Non-engineered flat slab over ground floor extension | Implement actions arising from Detail Engineering Assessment. | 6-months |
