# **FIRE SAFETY INSPECTION REPORT**

**EXPERIENCE CLOTHING CO.LTD**

**PLOT # 72,82, DEPZ. GANAKBARI, SAVAR, DHAKA**

March 31, 2014

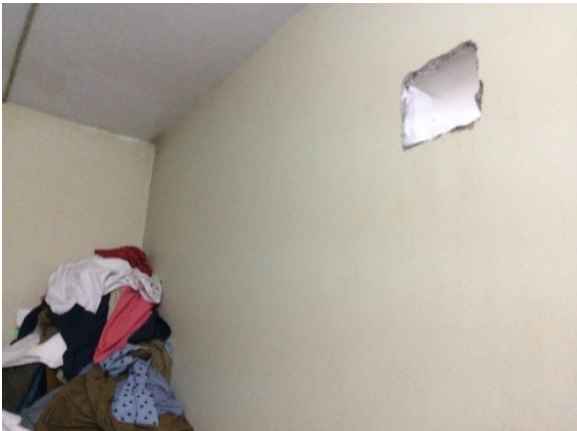
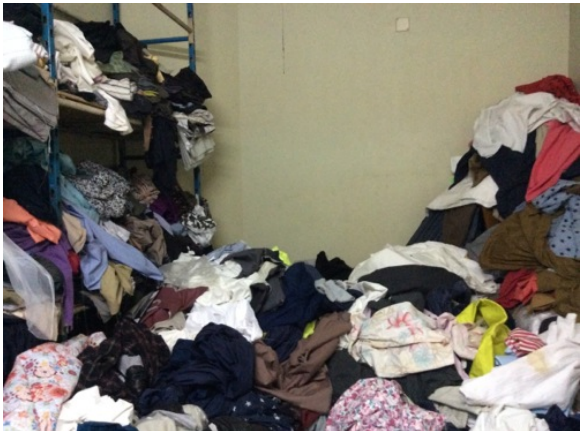
| No. | Category | Finding | Recommendation | Remediation Timeframe |
|---|---|---|---|---|
| F-1 | Fire Rated Construction | <p>Areas used for combustible storage are not separated by fire-rated construction.</p> <p>Third floor East wing storage room, seal all penetrations that open into production floors.</p> | Provide dedicated storage rooms separated by minimum 1-hr fire-rated construction. | Within 1 month |

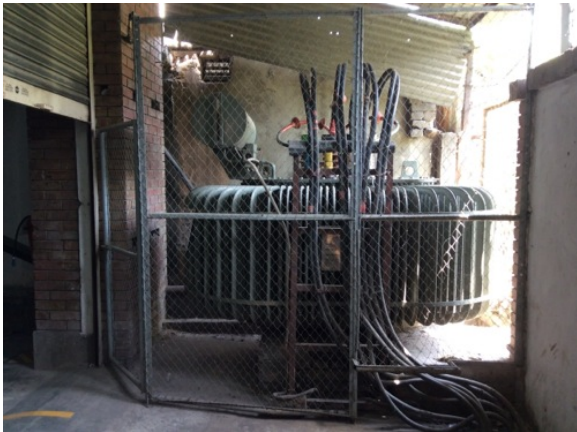
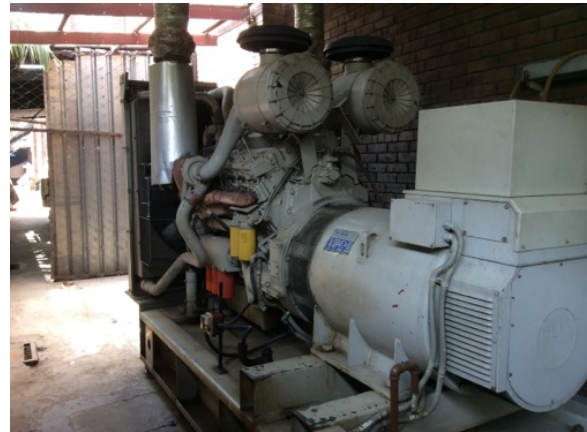
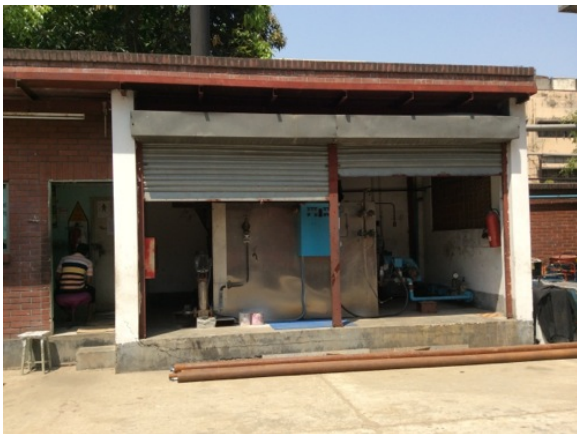
| No. | Category | Finding | Recommendation | Remediation Timeframe |
|---|---|---|---|---|
| F-2 | Fire Rated Construction | <p>The boiler, generator, and transformer room is not separated by fire-rated construction openings, non-rated doors, and penetrations.</p> <p>Ground floor West wing, and ground floor East wing.</p> | Separate the boiler, generator, and transformer room by a minimum 2-hr fire-rated construction. Seal and/or protected all openings to maintain the required fire separations | Within 3 months |

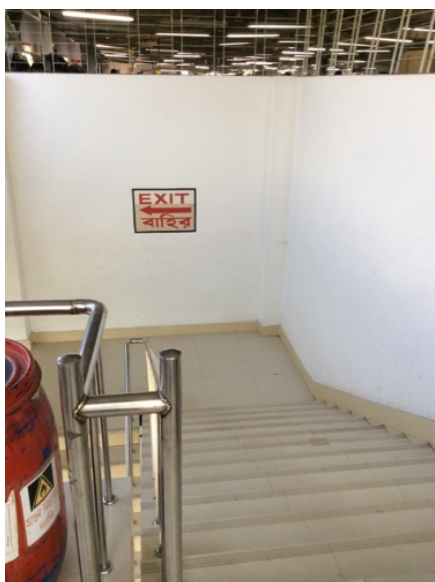
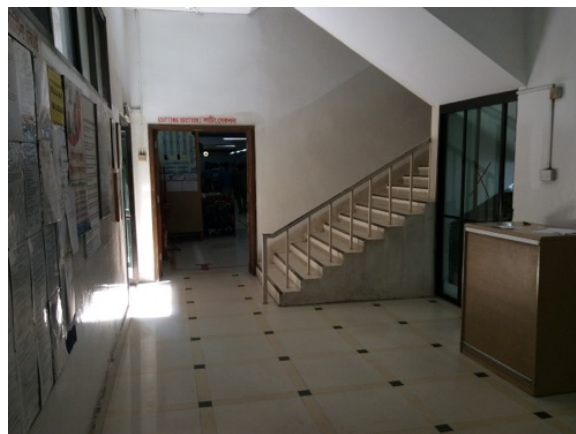
| F-3 | Fire Rated Construction | The exit stairs are not separated from work areas on each floor by fire-rated construction. All four stairwells were open to production floors on each level. Fourth floor west wing west stairwell enclosures do not extend to the ceiling. | Provide minimum 1.5-hr fire rated doors and seal all unprotected openings to separate the exit stairs from work areas and other building spaces on all floor levels. Ensure that the fire doors are self-closing and positive latching and that they are provided with fire exit (panic) hardware where serving production floors. | Within 3 months |

If fire doors are required to be held open for functional reasons, provide automatic-closing devices tied to the fire alarm system.

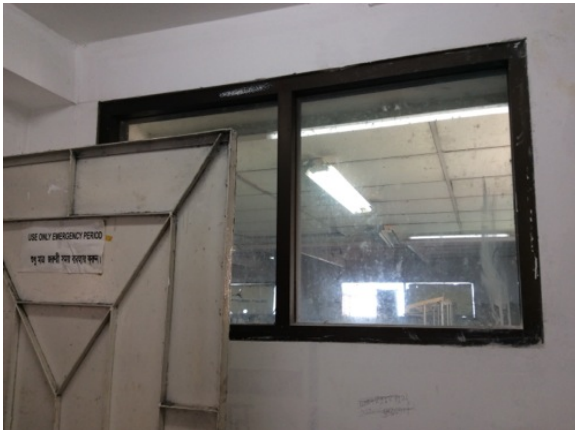
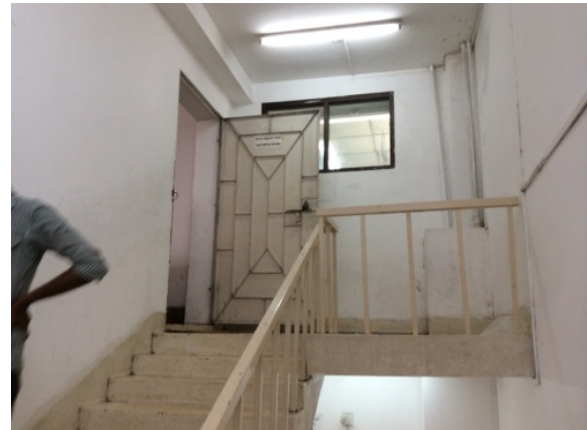
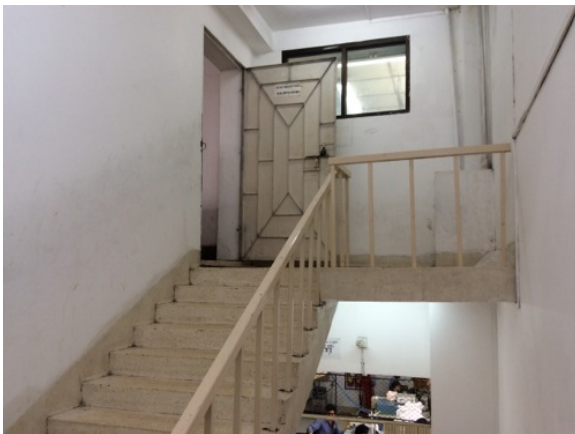
| F-4 | Fire Rated Construction | Unsealed penetrations and openings are located in exit stair enclosures. West wing East stairwell has a window within the stairwell enclosure leading into production floors. | Seal all penetrations and openings in exit stair enclosure walls to maintain the fire separation. | Within 3 months |

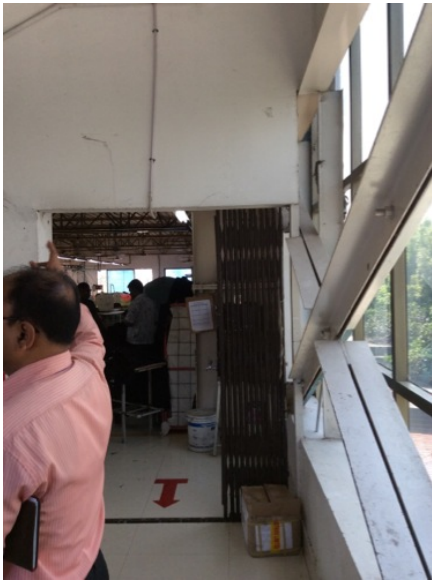
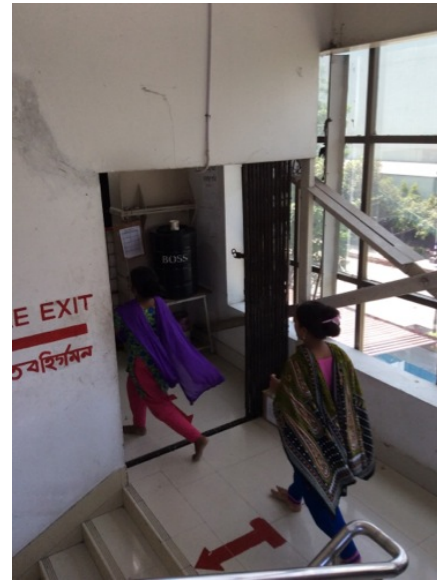
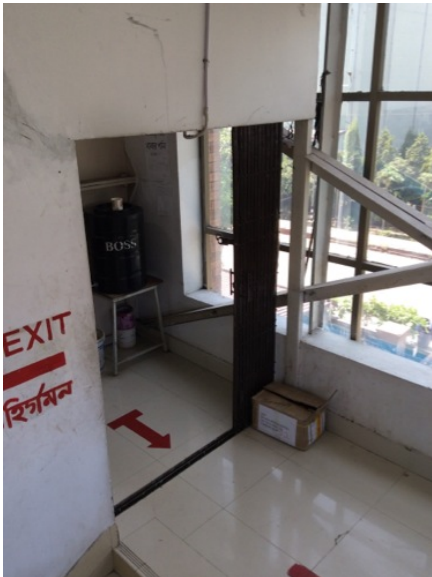
| F-5 | Fire Rated Construction | Unsealed penetrations and openings are located in the East wing East exit stairwell enclosure on all floors preceding it. | Seal all penetrations and openings in exit stair enclosure walls to maintain the fire separation. | Within 3 months |

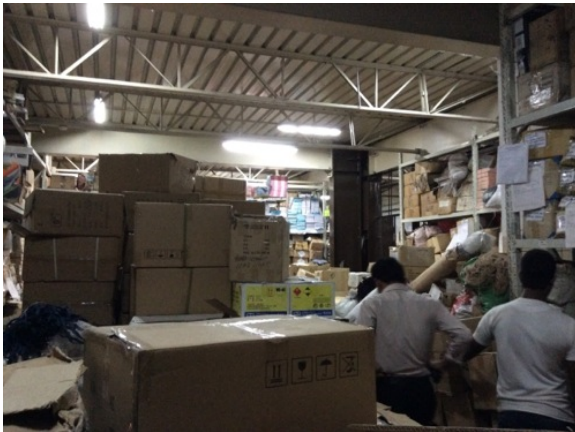
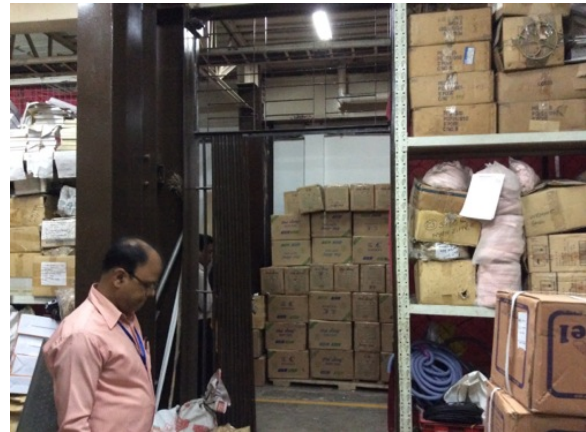
| F-6 | Fire Rated Construction | Areas used for combustible storage are not separated by fire-rated construction.<br>Ground floor west wing storage room adjacent to the east stairwell. | Provide dedicated storage rooms separated by minimum 1-hr fire-rated construction. | Within 3 months |

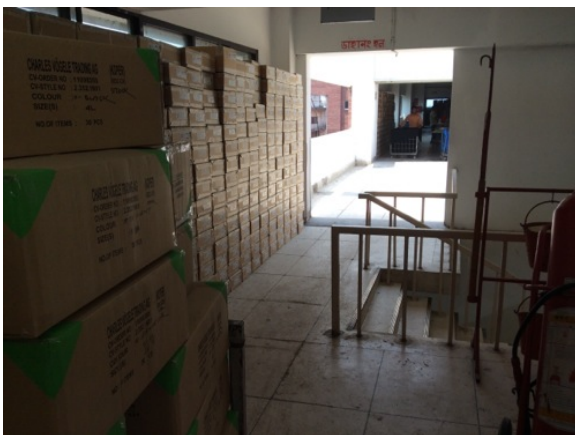
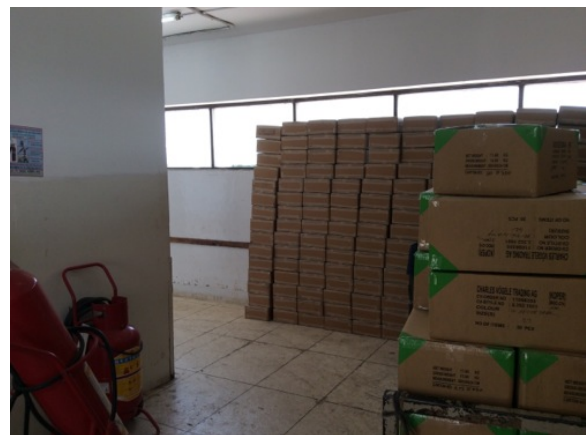
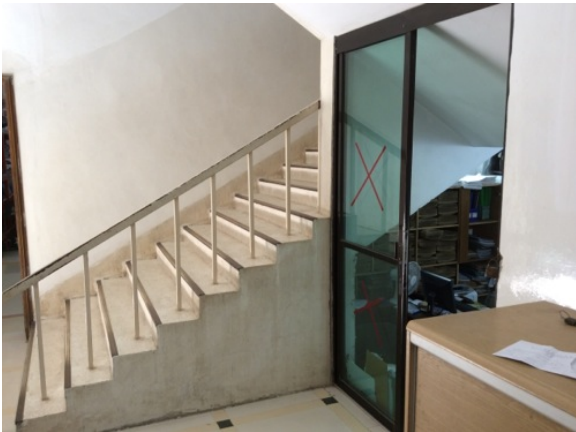
| F-7 | Egress | Storage was located in the exit stair. West wing roof stairwell storage shall be removed. An office was located under the stairwell at ground floor, east wing. Stairwells shall be separated and enclosed. | Remove all storage from exit stairs and egress paths. | Immediate |

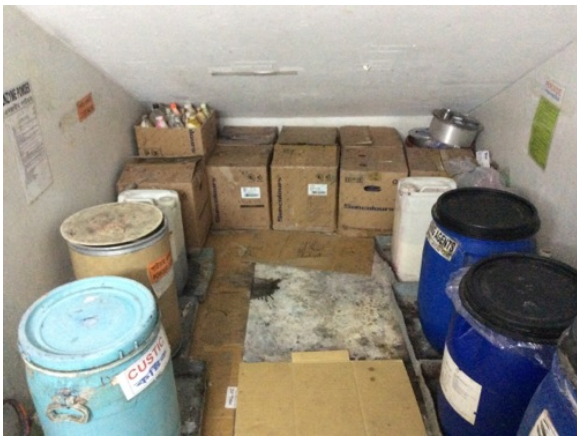
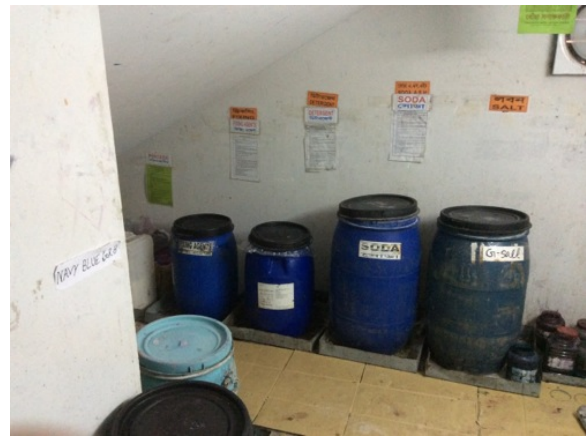
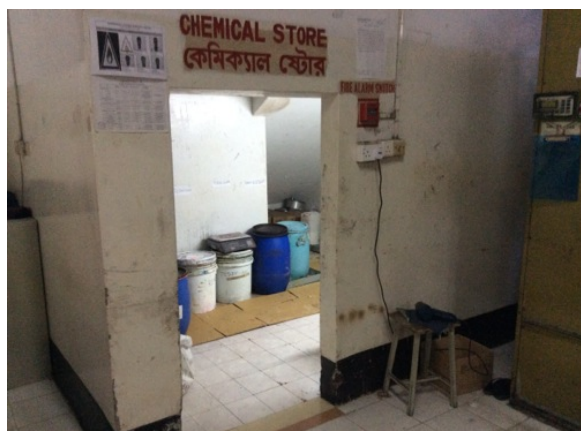
| F-8 | Egress | Chemical storage room was found underneath the stairwell at ground floor, west wing. | Remove all storage from exit stairs and egress paths. | Immediate |

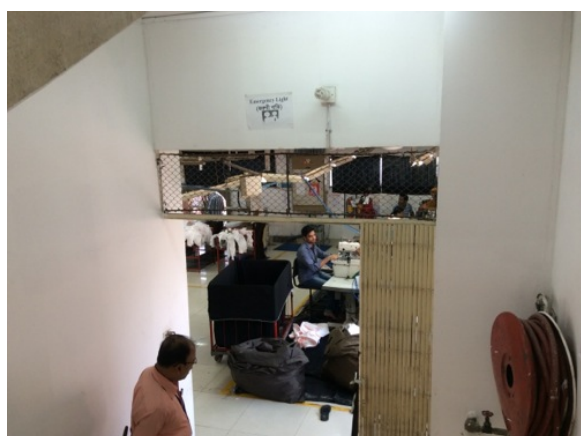
| F-9 | Egress | Collapsible gates / sliding doors are provided at building exits, exit stairs, along egress routes, and exit discharge. | Replace all gates / sliding doors along the means of egress with side-hinged, swinging egress doors.<br><br>If locks are required for security reasons, utilize special door locking features complying with NFPA 101. | Within 1 month |

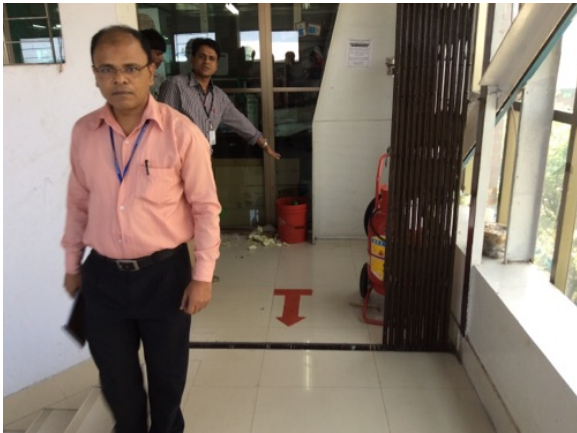
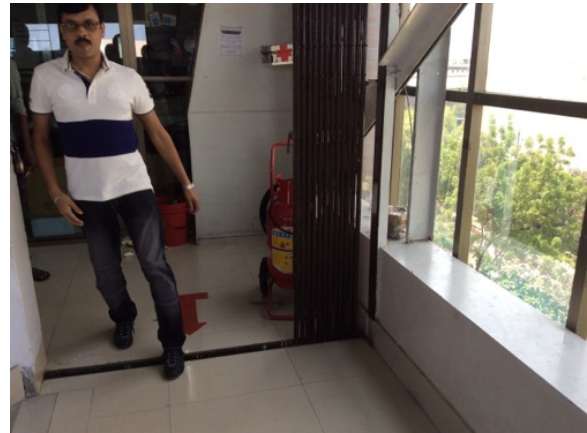
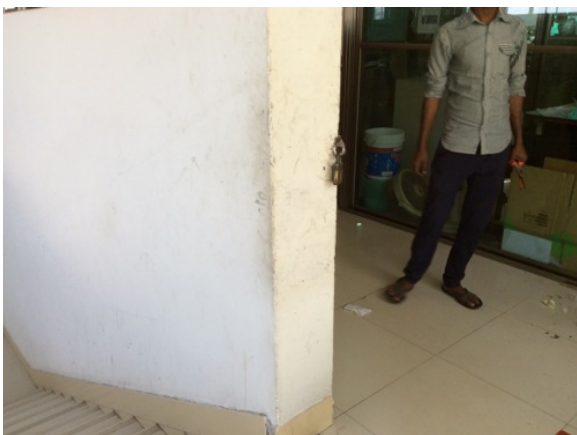
| F-10 | Egress | Egress doors / gates with locking features are provided at building exits, exit stairs, along egress routes, and exit discharge. Fourth floor west wing sliding gate type doors shall be replaced by fire rated doors and panic hardware | Remove locking features from all egress doors / gates.<br><br>If locks are required for security reasons, utilize special door locking features complying with NFPA 101. | Within 3 months |

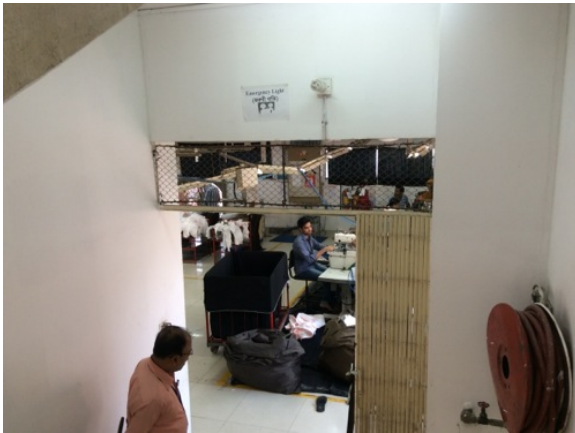
| F-11 | Egress | Exit stair doors were of Collapsible gates / sliding doors and were not capable of having a swing. | Replace all collapsible gates / sliding doors with side hinged type doors. Modify the egress door to swing in the direction of egress travel. | Within 3 months |

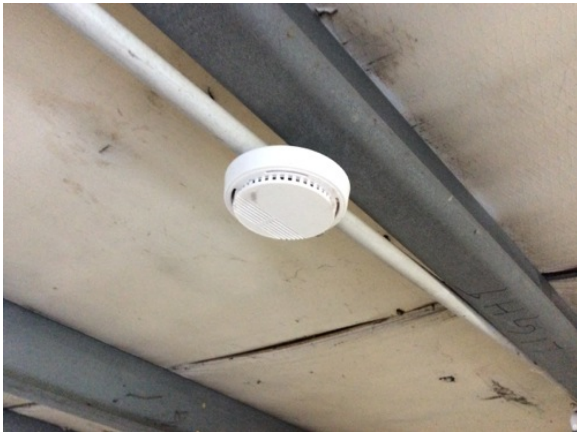
| F-13 | Fire Protection | The building is equipped with single-station smoke alarms. Smoke alarm activation sounds only a local alarm and does not provide automatic fire alarm notification of occupants. | Replace the single-station smoke alarms Provide automatic smoke detection throughout the building in accordance with NFPA 72. | Within 6 months |

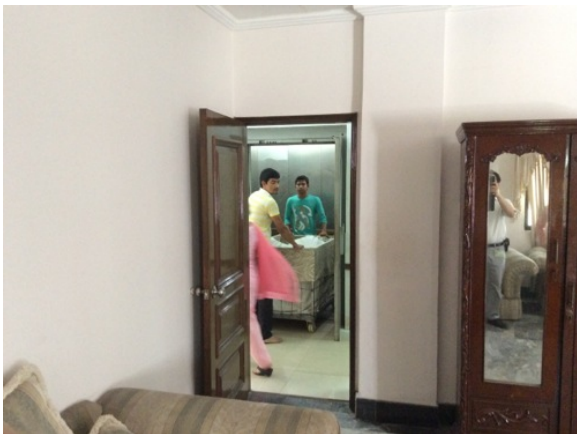
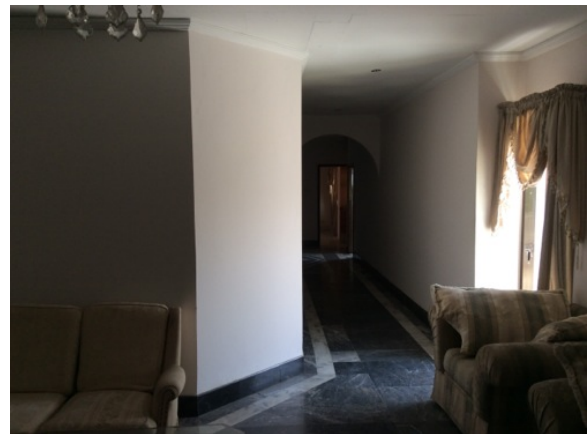
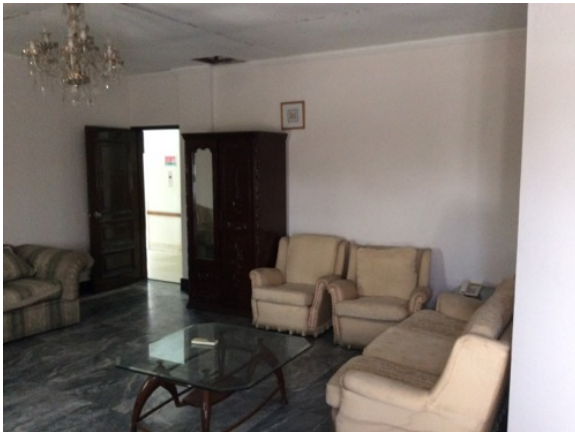
| F-14 | Egress Lighting | Exit sign not provided at exit. Third floor east wing office rooms. Add exit signs in rooms with more than one door | Provide exit signs above all exits to the exterior and all doors to the exit stairs. | Immediate |
