# **FIRE SAFETY INSPECTION REPORT**

**MONDOL FABRICS LTD.  
NAYAPARA, KASHIMPUR**

**ACCORD**  
on Fire and Building Safety in Bangladesh

April 5, 2014

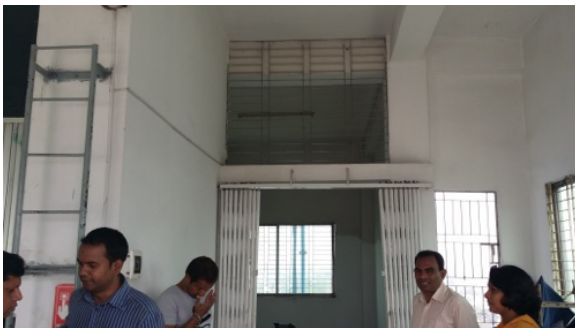
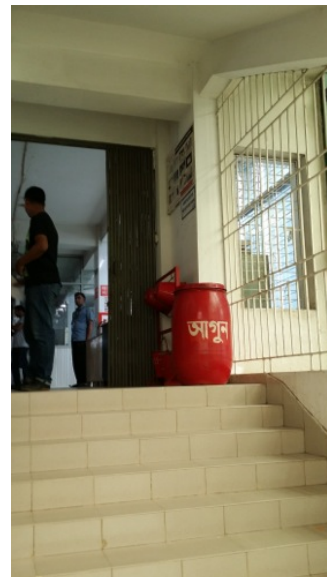
| No. | Category | Finding | Recommendation | Remediation Timeframe |
|---|---|---|---|---|
| F-1 | Fire Rated Construction | Unsealed penetrations and openings are located in exit stair enclosures specifically on the roof floor, south stairwell. In addition to the roof floor, the south stairwells preceding floors have windows that open into production floors. | Seal all penetrations and openings in exit stair enclosure walls to maintain the fire separation. | Within 3 months |

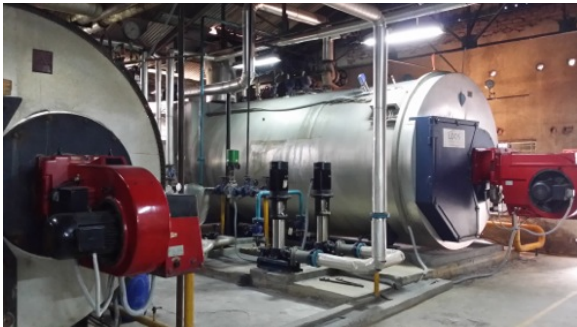
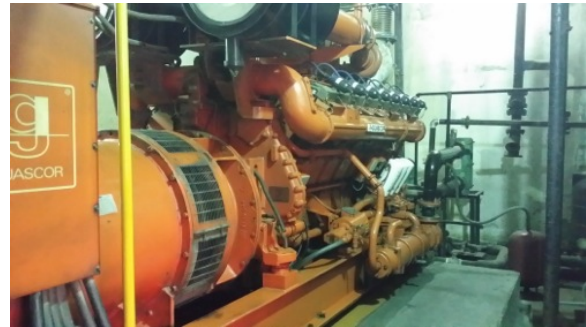
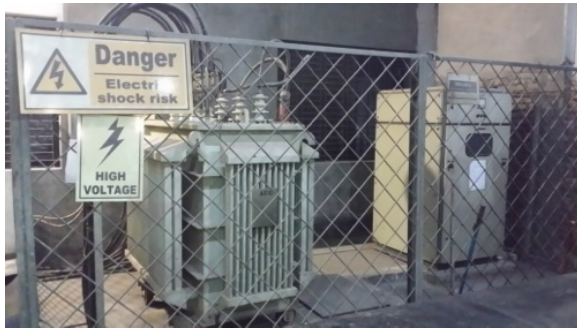
| F-2 | Fire Rated Construction | The boiler, generator, and transformer room is not separated by fire-rated construction openings, non-rated doors, and penetrations. However the boiler room, generator room, and transformer rooms are located in an auxiliary building approximately 15 meters away from the main building. | Separate the boiler, generator, and transformer room by a minimum 2-hr fire-rated construction. Seal and/or protected all openings to maintain the required fire separations | Within 3 months |

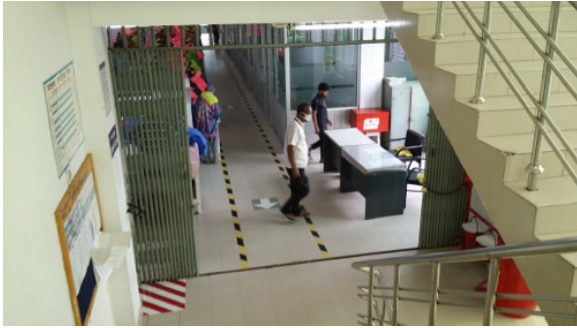
| F-3 | Fire Rated Construction | The exit stairs are not separated from work areas on each floor by fire-rated construction. This was reflected on all floors. | <p>Provide minimum 1.5-hr fire rated doors and seal all unprotected openings to separate the exit stairs from work areas and other building spaces on all floor levels. Ensure that the fire doors are self-closing and positive latching and that they are provided with fire exit (panic) hardware where serving production floors.</p> <p>If fire doors are required to be held open for functional reasons, provide automatic-closing devices tied to the fire alarm system.</p> | Within 3 months |

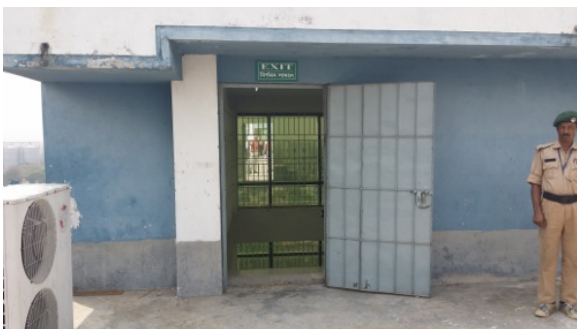
| F-4 | Egress | Exit stair door does not swing in the direction of egress travel. Roof floor stairwell enclosures, doorways within the path of egress should swing in the direction of egress. | Modify the egress door to swing in the direction of egress travel. | Immediate |

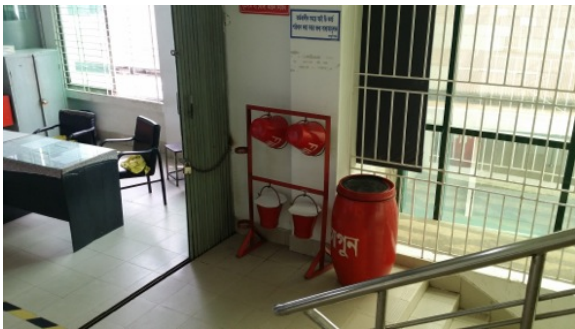
| F-5 | Egress | Egress doors / gates with locking features are provided at building exits, exit stairs, along egress routes, and exit discharge. This was apparent on all floor. | Remove locking features from all egress doors / gates.<br><br>If locks are required for security reasons, utilize special door locking features complying with NFPA 101. | Immediate |

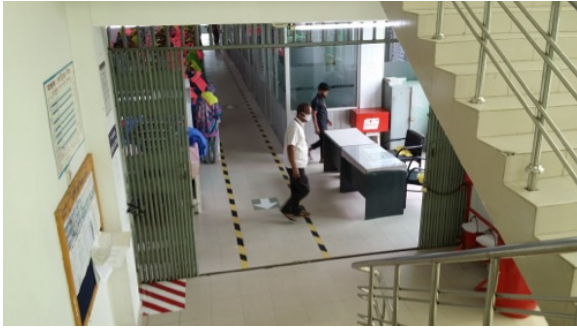
| F-6 | Egress | Collapsible gates / sliding doors are provided at building exits, exit stairs, along egress routes, and exit discharge. Located on all floors in each exit doorway leading into exit stairwells. | Replace all gates / sliding doors along the means of egress with side-hinged, swinging egress doors.<br><br>If locks are required for security reasons, utilize special door locking features complying with NFPA 101. | Within 1 month |

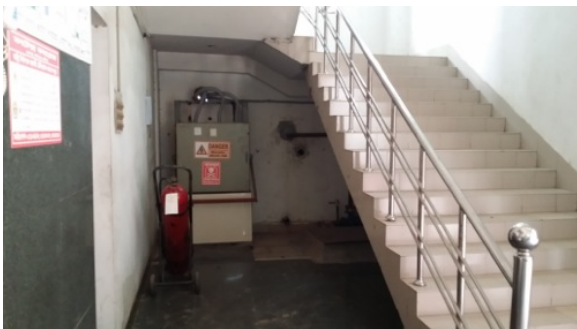
| F-7 | Egress | Storage located within stairwell enclosures were found in all exit stairwells, primarily on the ground, and roof floors. | Remove all storage from exit stairs and egress paths. | Within 1 month |

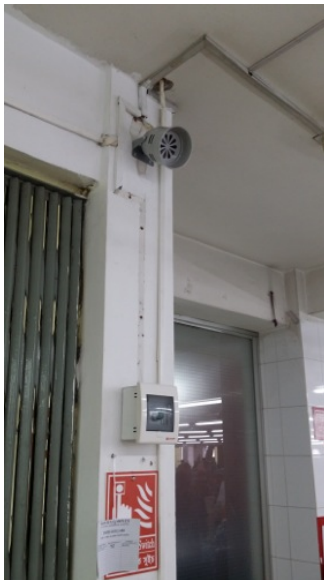
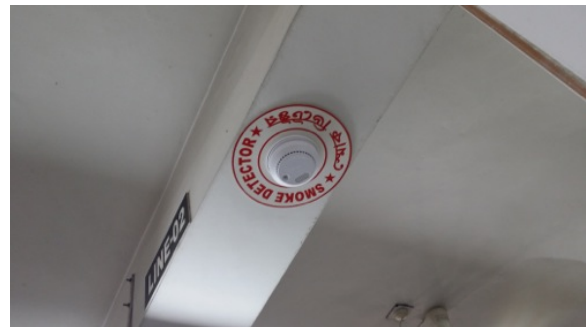
| F-8 | Fire Protection | The fire alarm system is antiquated, not a listed system, and does not provide alarm and notification features consistent with acceptable standards. | Replace the fire alarm system with a new, listed addressable fire alarm system in accordance with NFPA 72. | Design within 4 months, install within 9 months |

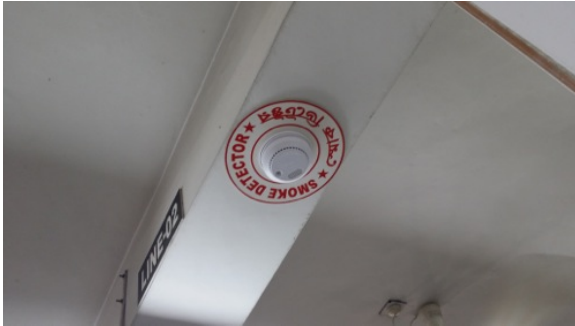
| F-10 | Fire Protection | The building is equipped with single-station smoke alarms. Smoke alarm activation sounds only a local alarm and does not provide automatic fire alarm notification of occupants. | Replace the single-station smoke alarms. Provide automatic smoke detection throughout the building in accordance with NFPA 72. | Within 6 months |

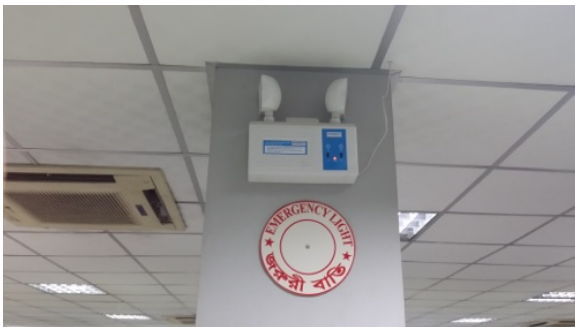
| F-11 | Egress Lighting | Manual on-off switch is provided for emergency lighting units. All floors were seen to be using emergency lighting appliances with on/off switches. | Remove manual on/off switches from emergency lighting units to prevent them from being switched off. | Immediate |
