# Raiyan Knit Composite Ltd. Noor Group Ltd.

Hortokitola, Chandra, Kaliakoir, Gazipur  
(24.050241N 90.234168E)

26 APRIL 2014

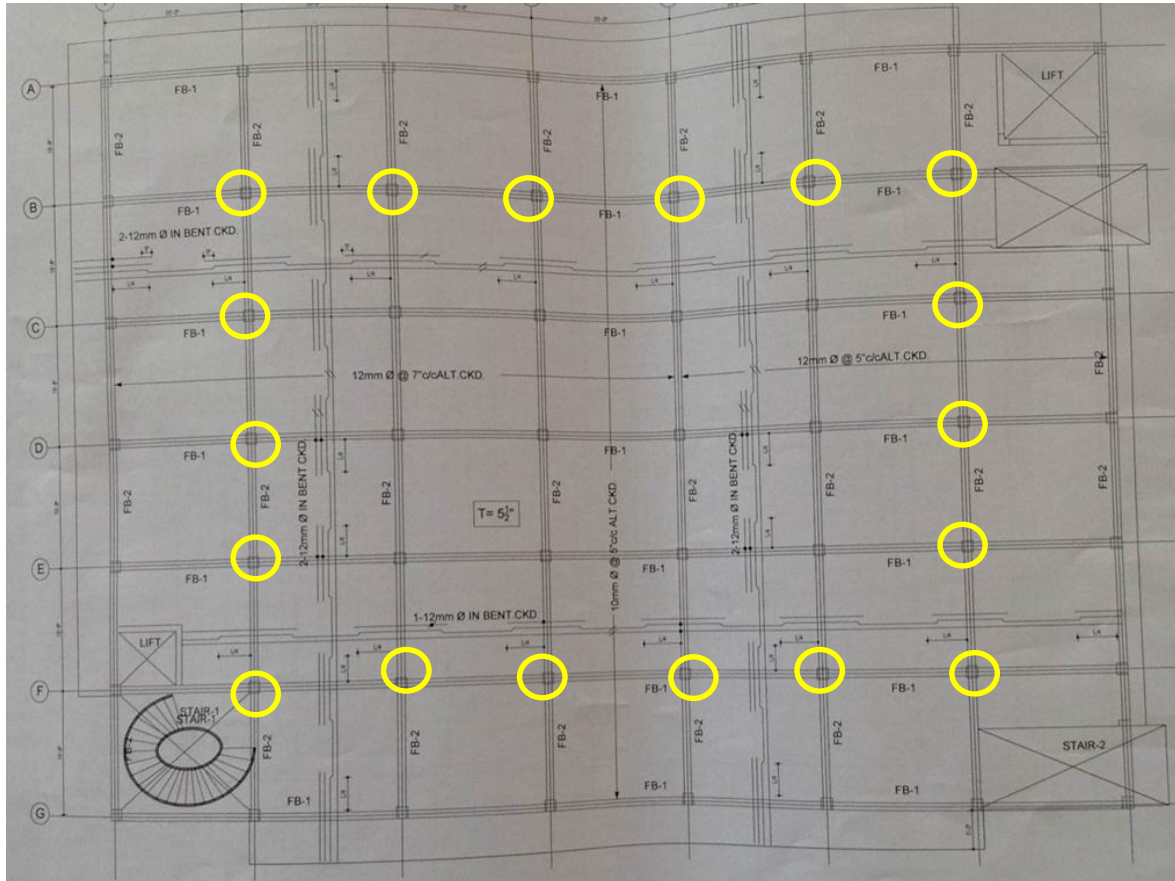
BUILDING 1: Heavy loaded column.

Highlighted columns appear to be stressed to high levels.

| Item No. | Observation | Recommended Action Plan | Recommended Timeline |
|---|---|---|---|
| 1 | BUILDING 1+2: Review of column stresses | Establish if grade 60ksi rebar steel was used in the columns in building one. | 6-weeks |
| 2 | BUILDING 1+2: Review of column stresses | Verify insitu concrete stresses either by 100mm diameter cores or existing cylinder strength data for 100mm diameter cores from 4 internal columns including those shown in observations | 6-weeks |
| 3 | BUILDING 1+2: Review of column stresses | No further construction to proceed until rebar grades have been established. | 6-months |

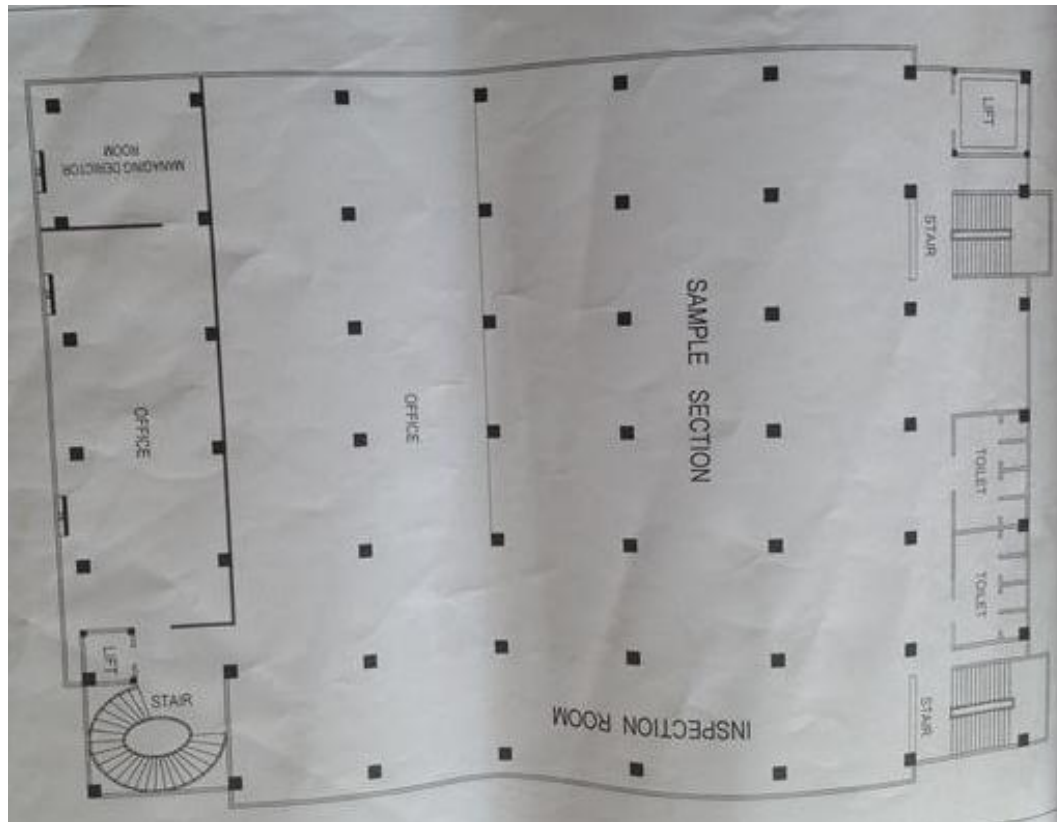
BUILDING 1: Flat slab thickness.

The thickness for the flat slab is given as 165mm (6.5inch) on the structural drawing. On site we measured about 180mm but this considers a thin slab for the 6.1 x 5.1m grid. Concern with punching shear and bending. Partitions is to be considered in the design. Load limits resulting from the calculations are to be recorded and loading plans produced.

| Item No. | Observation | Recommended Action Plan | Recommended Timeline |
|---|---|---|---|
| 4 | BUILDING 1: Flat slab thickness | Carry out verification of adequacy of flat slab | 6-weeks |
| 5 | BUILDING 1: Flat slab thickness | Load restrictions resulting from the calculations to be obeyed. | 6-weeks |
| 6 | BUILDING 1: Flat slab thickness | Strengthening of slab should this be required | 6-months |

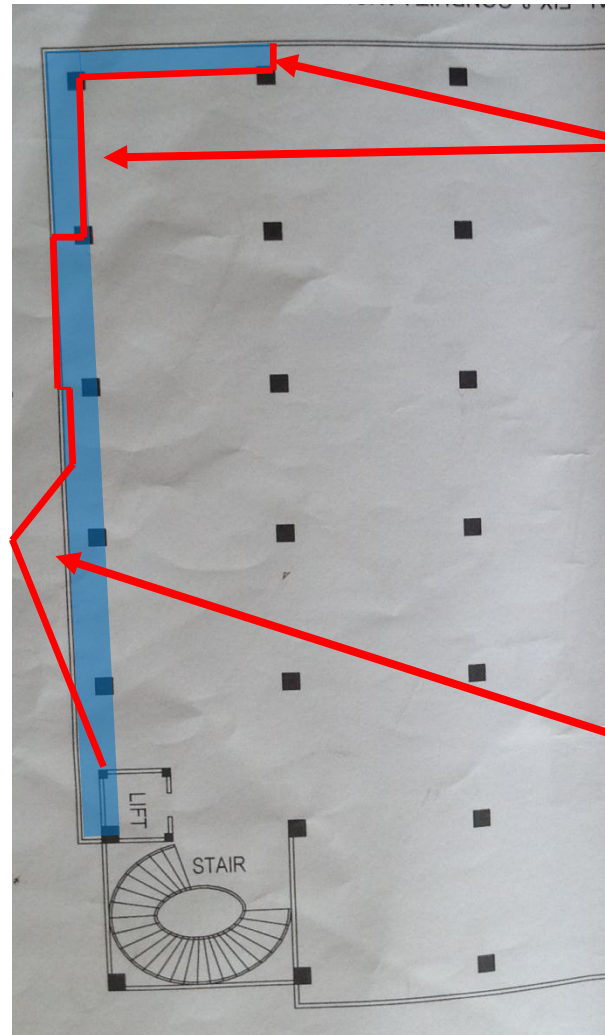
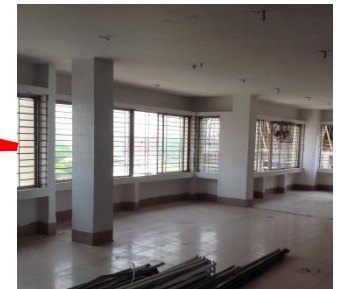
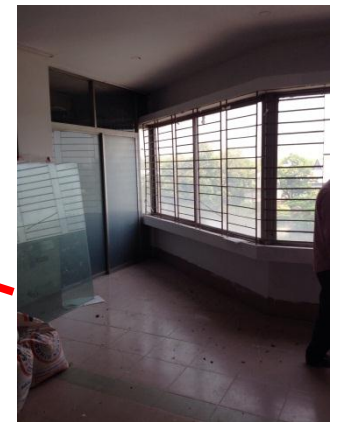
BUILDING 1: Structural drawings for cantilever façade on building 1 do not match current arrangement of the structure.

Building façade outline differs to what is shown in drawings for several floors. Since only one typical reinforcement drawing was provided for all flat slabs and one typical drawing for both beam-slabs the slab reinforcement needs to be justified by calculation. The different cantilever lengths do have an influence on the required reinforcement

Building façade on 3<sup>rd</sup> floor

Façade cantilever extends to maximum 2.575m

| Item No. | Observation | Recommended Action Plan | Recommended Timeline |
|---|---|---|---|
| 7 | BUILDING 1: Structural drawings for cantilever façade on building 1 do not match current arrangement of the structure | Building engineer to check, collect information and produce accurate and complete as-built documentation soonest. | 6-months |

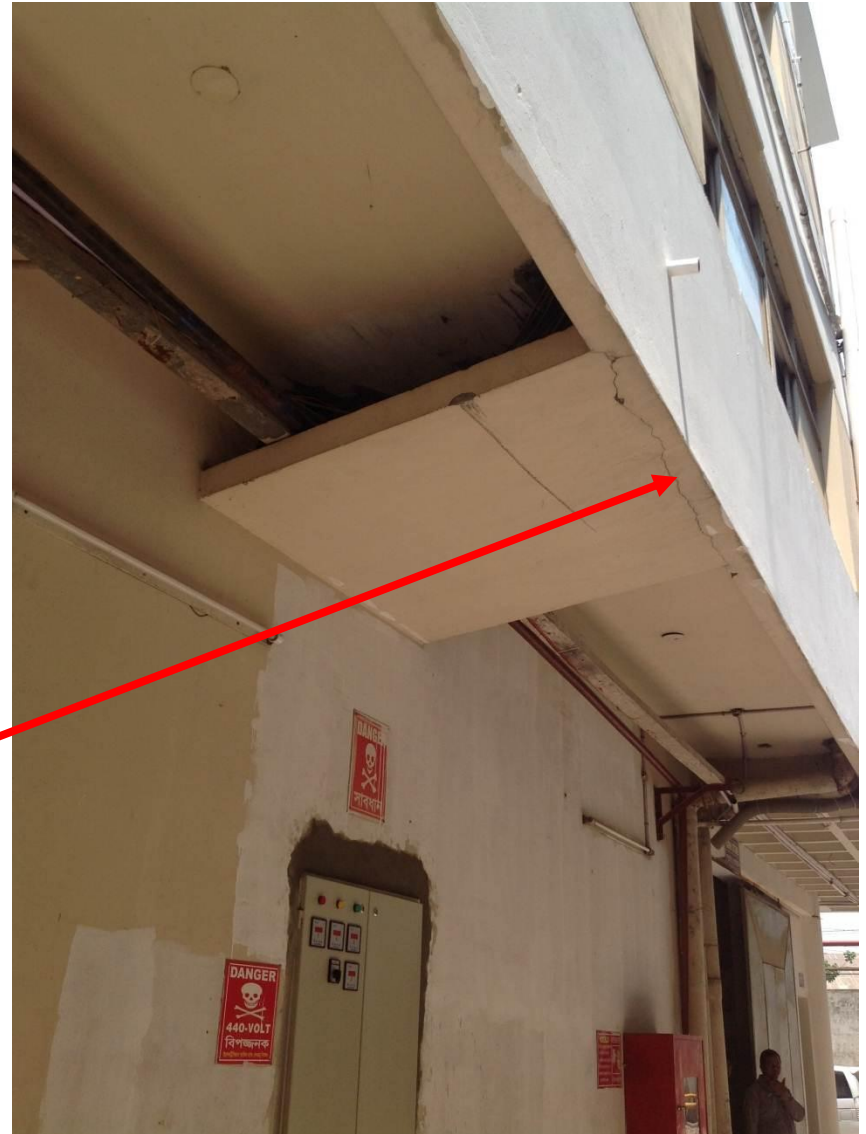
Cracking in slab to facade connection holding and covering cables for power supply on ground floor level

| Item No. | Observation | Recommended Action Plan | Recommended Timeline |
|---|---|---|---|
| 8 | BUILDING 1: RC cover plate under external façade to cover up electrical cables | Replace slab with new lightweight metal cable tray. Ensure proper fixing to façade and external building wall. | Immediate - Now |

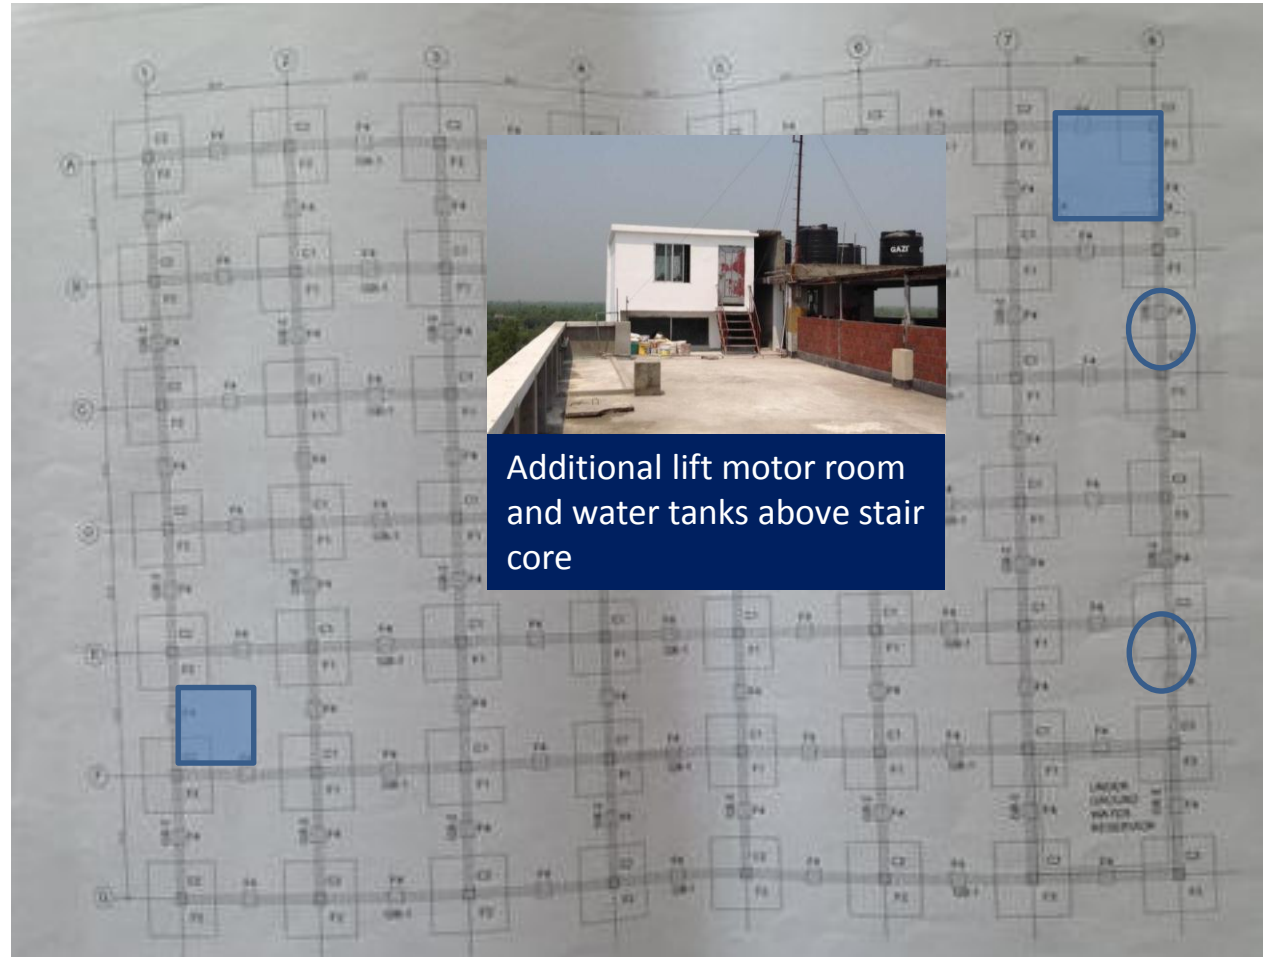
BUILDING 1: No documentation for two RC columns supporting stair core and the foundations for the lift cores

The foundation drawing does not include any information on the foundation for the lift cores. Reportedly done as a raft foundation.

The stair cores at the back of the building have an additional RC columns (confirmed by taking off plaster), which is not shown on the drawings

| Item No. | Observation | Recommended Action Plan | Recommended Timeline |
|---|---|---|---|
| 9 | BUILDING 1: Foundation drawings do not show footings below columns located around lift shafts and stair core. Undocumented columns in wall of stairwell | Building engineer to check, collect information and produce accurate and complete as-built documentation soonest.<br>Note: the loads should also include the water tanks and the additional lift motor building recently built | 6-months |

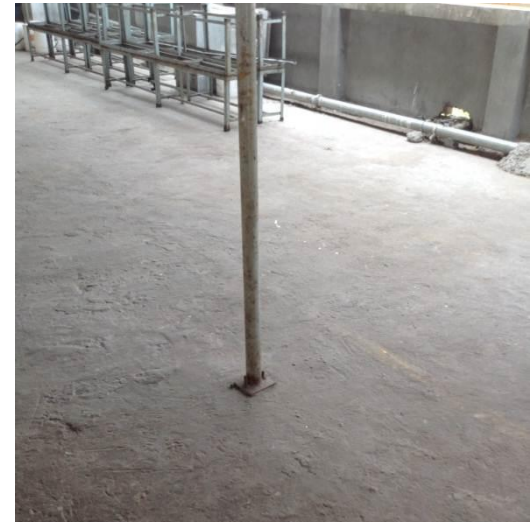
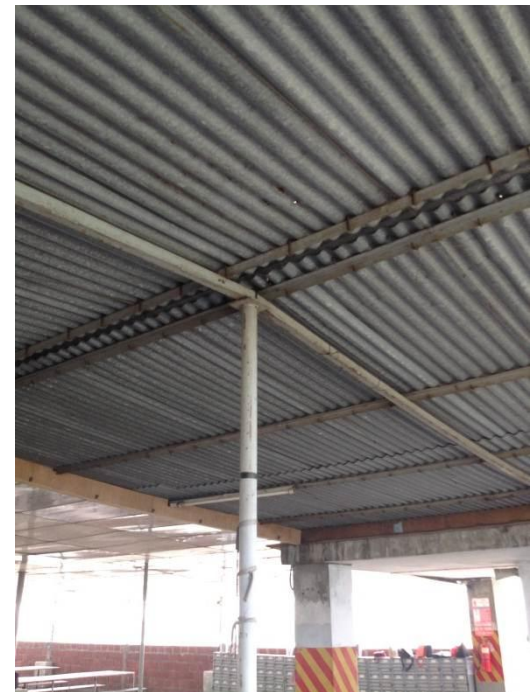
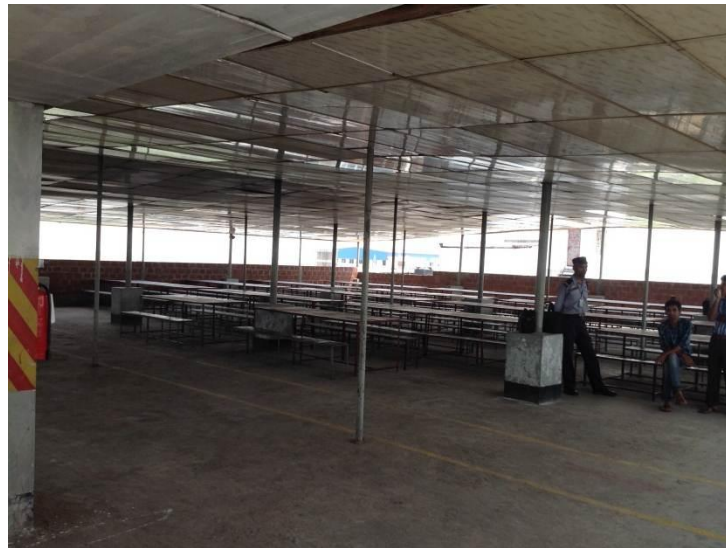
BUILDING 1: Tin roof to cover dining area

Non engineered dining shed roof structure. Single angle steel section used as rafter beam. Weak fixing provided from column to both rafter and roof slab. Angle section used as purlins. No bracing provided for lateral stability.

| Item No. | Observation | Recommended Action Plan | Recommended Timeline |
|---|---|---|---|
| 10 | BUILDING 1: Tin roof to cover dining area<br>non-engineered steel roof structure is unlikely to be able to withstand strong winds | Steel roof structure to be reviewed, designed and documented. | 6-weeks |
| 11 | BUILDING 1: Tin roof to cover dining area<br>non-engineered steel roof structure is unlikely to be able to withstand strong winds | Steel structure to be upgraded to support code vertical and wind loads. | 6-months |

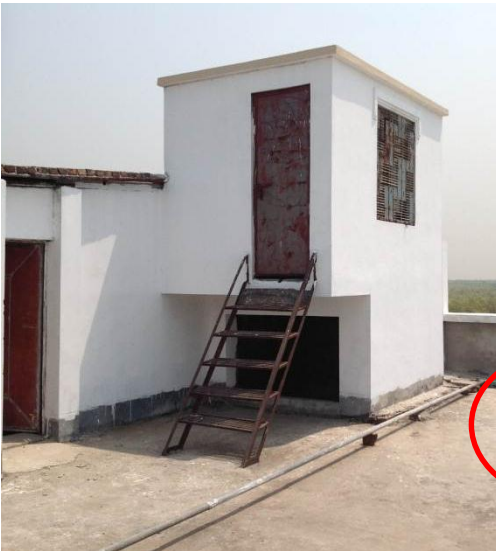
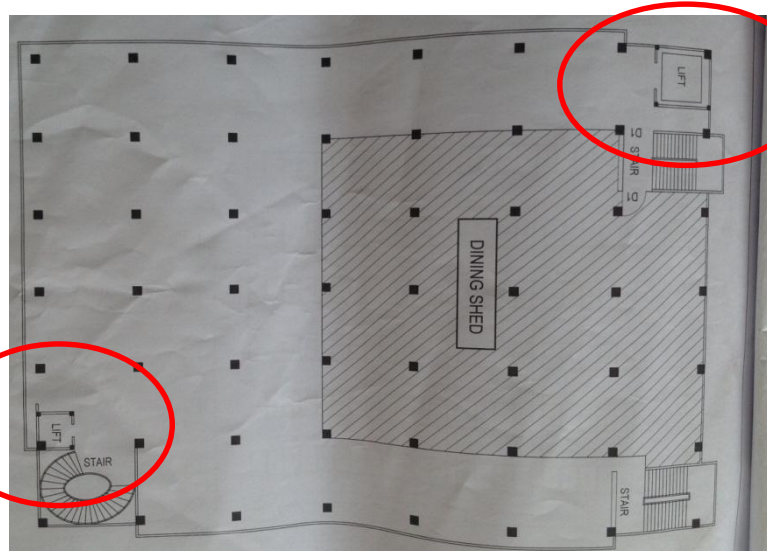
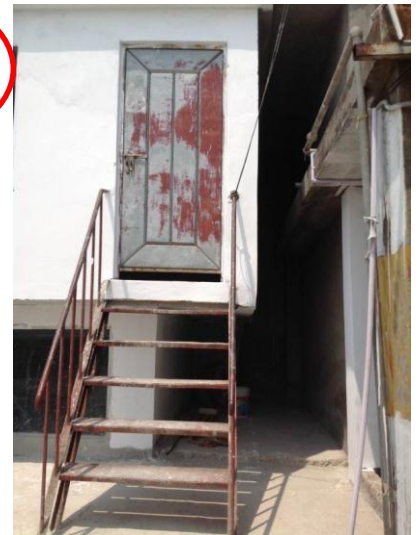
Lift shaft motor room not in original drawings.

Both comprise cantilever slabs / structures.

| Item No. | Observation | Recommended Action Plan | Recommended Timeline |
|---|---|---|---|
| 12 | BUILDING 1: Additional structures at roof level (above the lifts) | Additional structures should be designed and upgraded to support code vertical and wind loads by the building Engineer. Loads to be followed through to foundation (note: cantilever effects to be taken into account when calculating foundation loads) | 6-months |

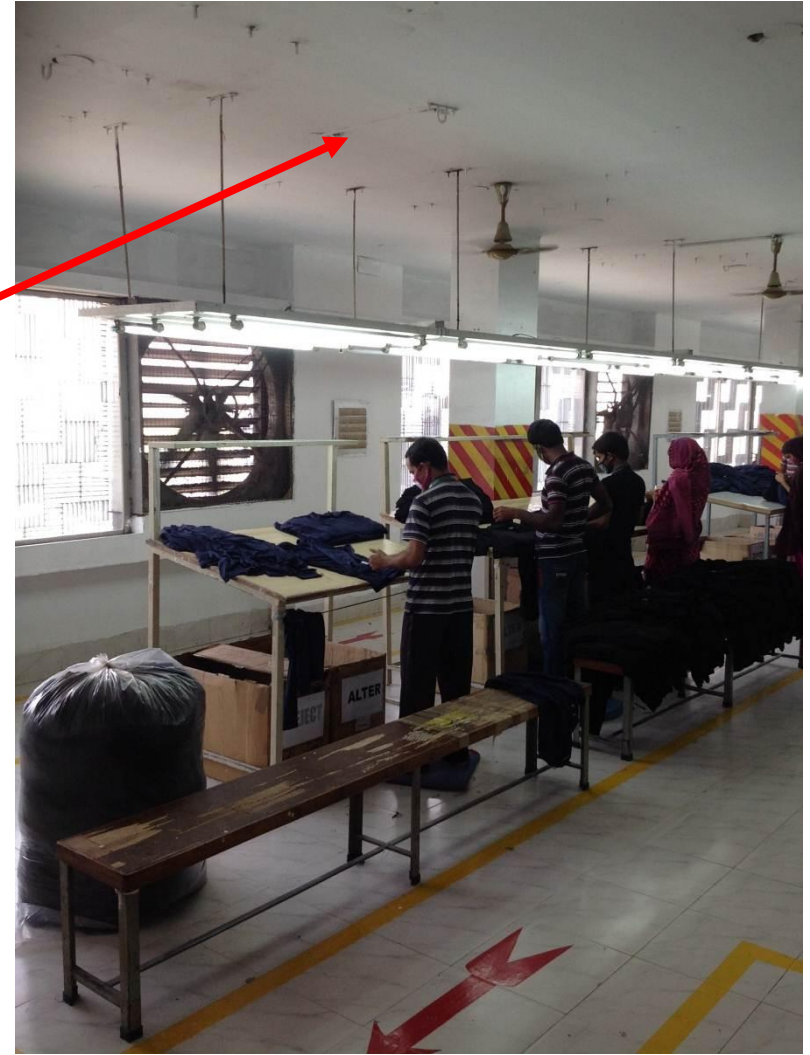
BUILDING 1: Cracking in some floor areas

Cracking observed in soffit of flat slabs possibly due to conduit in slab base , to be investigated

| Item No. | Observation | Recommended Action Plan | Recommended Timeline |
|---|---|---|---|
| 13 | BUILDING 1: Cracking in soffit of flat slabs | Monitor the development of all cracks | 6-weeks |
| 14 | BUILDING 1: Cracking in soffit of flat slabs | Remove the cast- in pipe and replace with external piping. Repair the concrete along the removed pipe together with any required remedial works for the flat slab established in the design checks | 6-months |

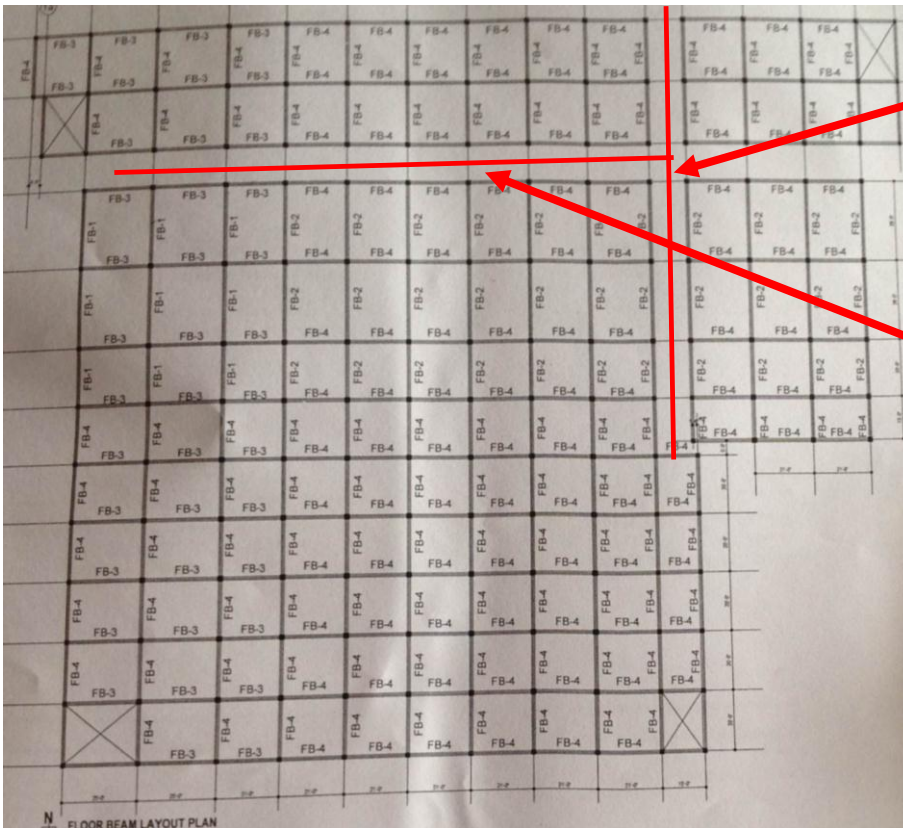
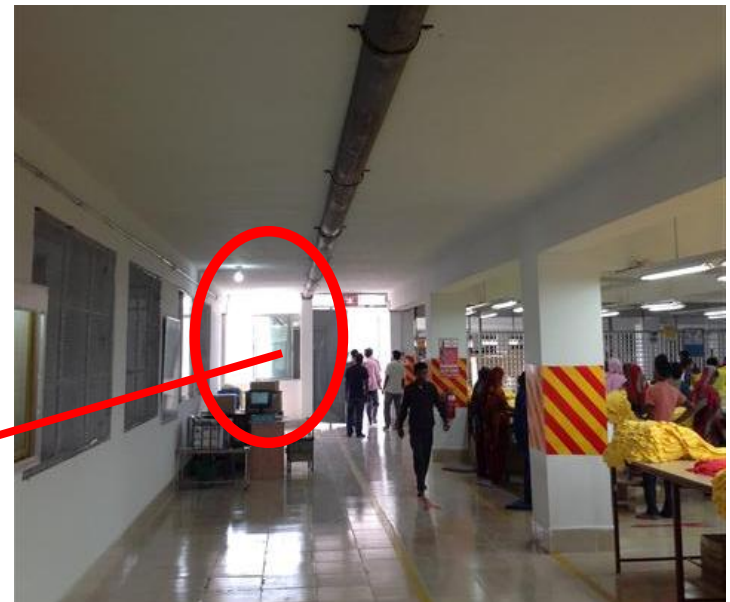
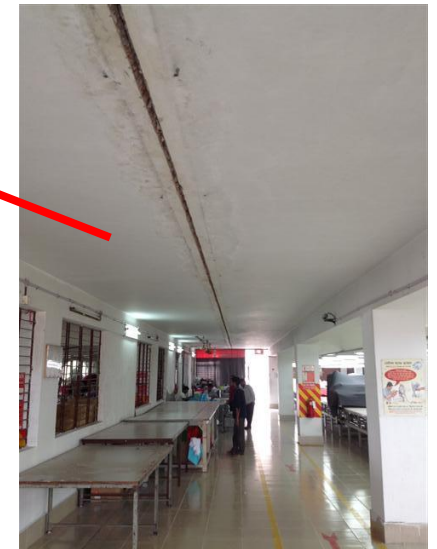
Column and facade at end of corridor (gridline 6) is not supported below and hence provides additional dead load to one side of the cantilever

| Item No. | Observation | Recommended Action Plan | Recommended Timeline |
|---|---|---|---|
| 15 | BUILDING 2: Cantilever slab at movement joint locations. | Assess the design floor load (imposed live load) on the 2m long cantilever and clearly mark the areas accordingly. | 6-weeks |

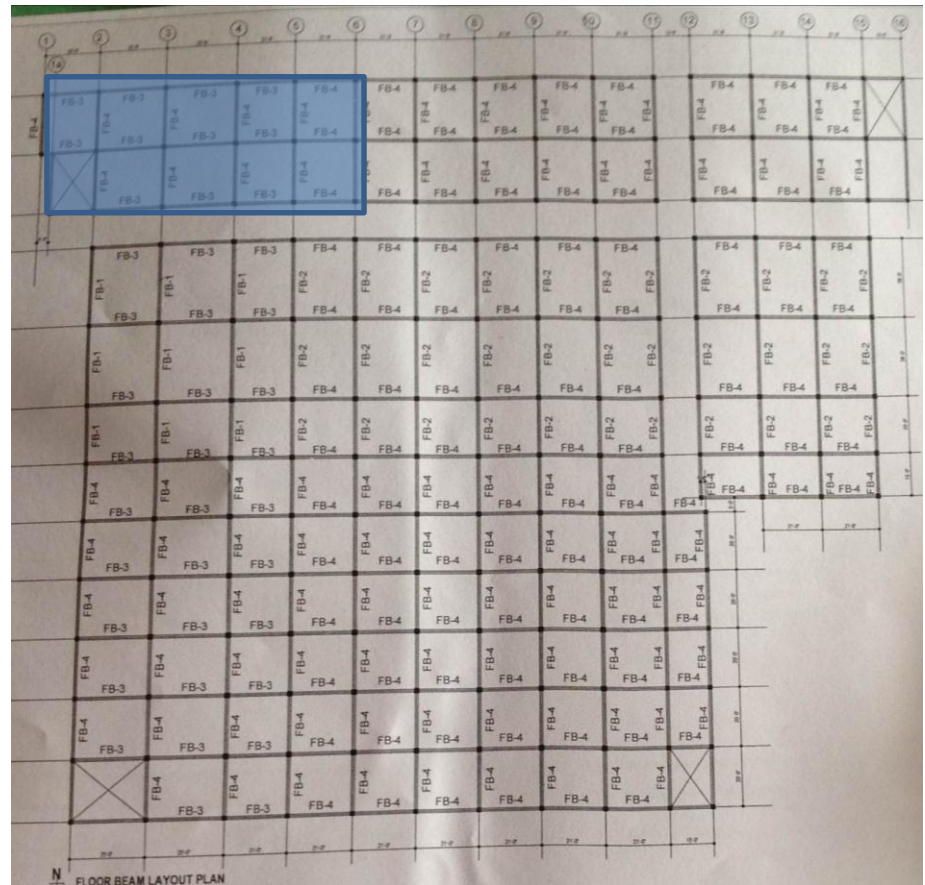
## BUILDING 2: Stability of building part J-M/1-6

Stability for the highlighted building part (gridline J-M / 1-6) is only provided in short direction by a moment frame with 2 spans (3 columns). Moment frame should therefore be checked for adequacy.

| Item No. | Observation | Recommended Action Plan | Recommended Timeline |
|---|---|---|---|
| 16 | BUILDING 2: Stability of building part J-M/1-6 | Structural checks for adequacy of stability frame. | <b>Immediate - Now</b> |
| 17 | BUILDING 2: Stability of building part J-M/1-6 | Design of strengthening elements if required (we currently do not see any reason why the buildings have to be separated by movement joints in 3 parts. Strengthening could just mean to connect the slabs) | <b>6-weeks</b> |
| 18 | BUILDING 2: Stability of building part J-M/1-6 | Implementation of strengthening elements if required. | <b>6-months</b> |

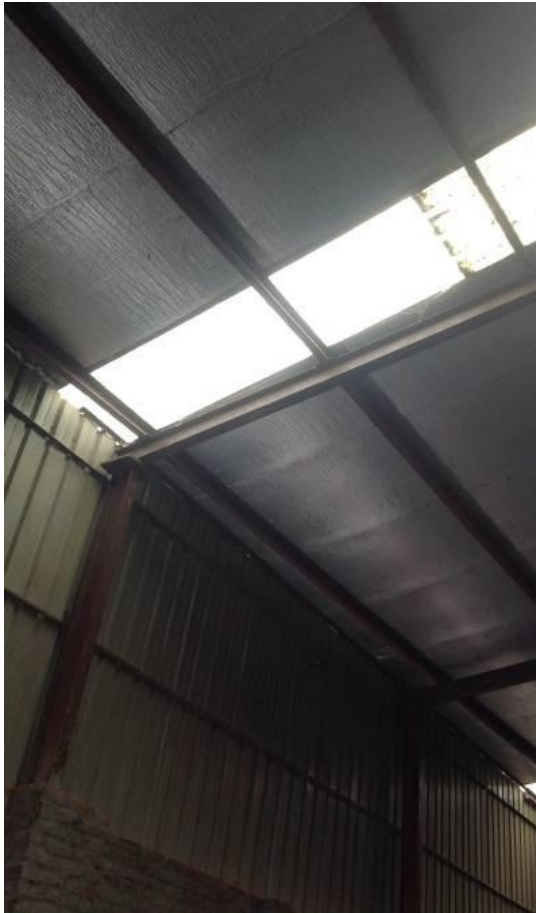
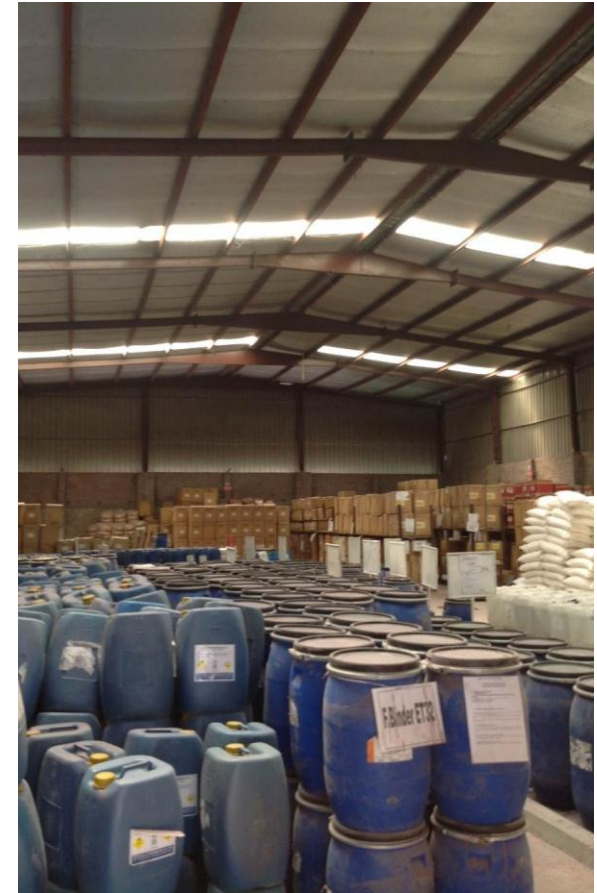
## STEEL SHED: Stability of steel shed

Building appears to be non engineered

Weak lateral stability across the frames as Edge/Haunch connections do not appear to be designed to take moments.

Weak longitudinal stability, no bracing is provided either horizontally on wall planes.

| Item No. | Observation | Recommended Action Plan | Recommended Timeline |
|---|---|---|---|
| 19 | STEEL SHED: Stability of steel shed | DO NOT USE IN STRONG WIND CONDITIONS. | <b>Immediate - Now</b> |
| 20 | STEEL SHED: Stability of steel shed | Building engineer to design temporary measures to stabilise the building (e.g. diagonals) | <b>Immediate - Now</b> |
| 21 | STEEL SHED: Stability of steel shed | Implement the temporary measures to stabilise the building | <b>6-weeks</b> |
| 22 | STEEL SHED: Stability of steel shed | Replace temporary measures with a permanent design or remove the shed. | <b>6-months</b> |

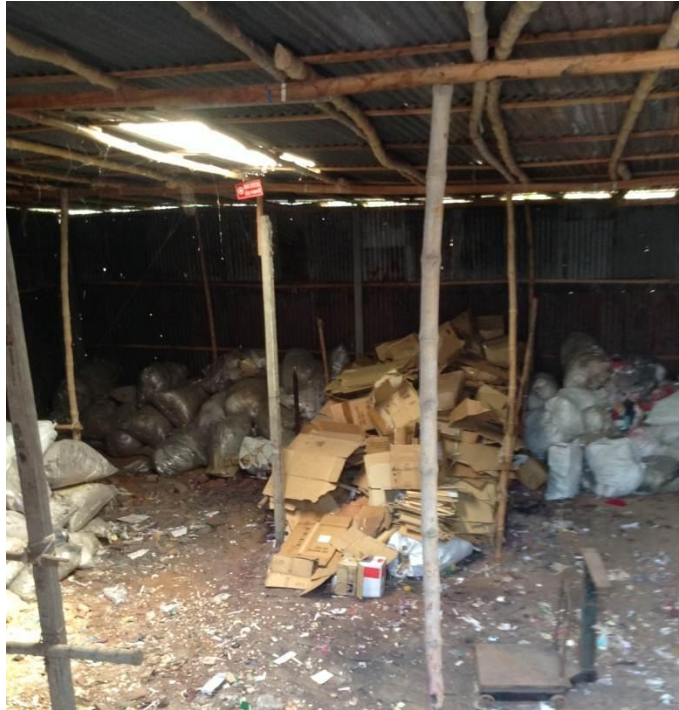
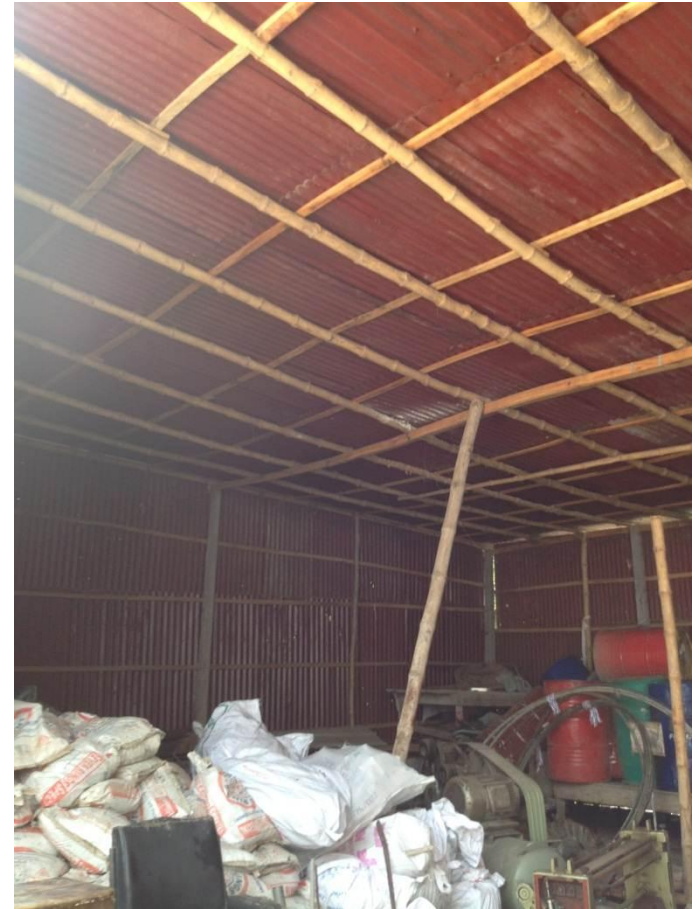
BAMBOO SHEDs: Stability and vertical props

Two bamboo supported sheds observed on site. One used for waste storage, the second for storage of construction material. These are non engineered and appear unstable. To be reviewed.

| Item No. | Observation | Recommended Action Plan | Recommended Timeline |
|---|---|---|---|
| 23 | BAMBOO SHEDS: Stability and vertical props | DO NOT USE IN STRONG WIND CONDITIONS. | Immediate - Now |
| 24 | BAMBOO SHEDS: Stability and vertical props | Building engineer to instruct additional timber props to be installed. Some of them diagonally to provide lateral restraint | Immediate - Now |
| 25 | BAMBOO SHEDS: Stability and vertical props | Make the building safer with additional props and diagonals | 6-weeks |
| 26 | BAMBOO SHEDS: Stability and vertical props | Replace temporary shed with a permanent design or remove the shed. | 6-months |

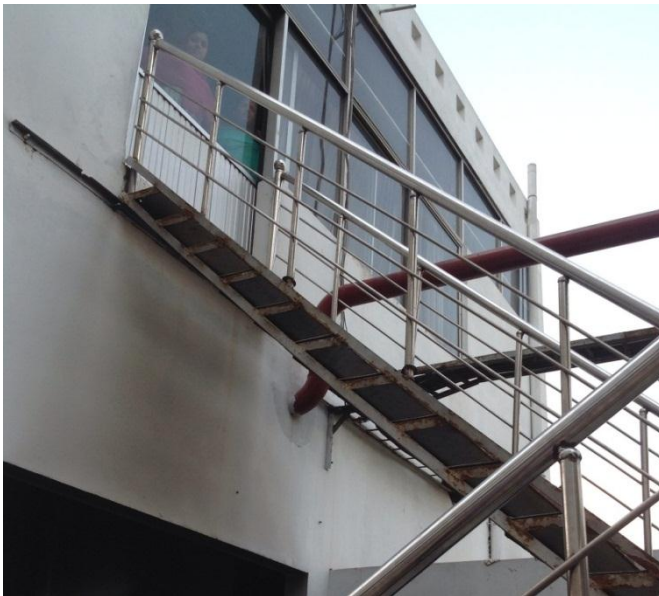
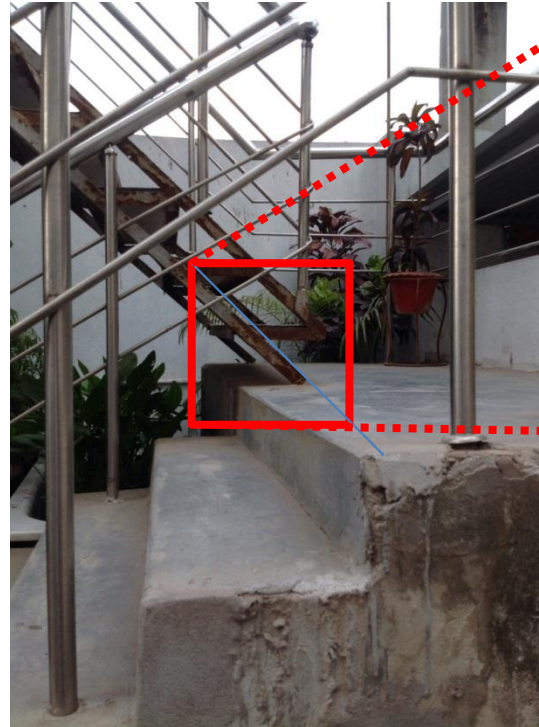
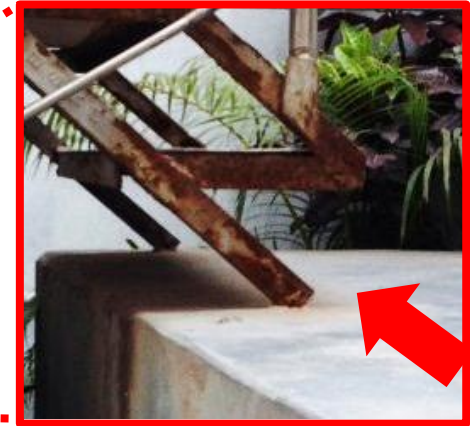
Staircase to first floor does not appear to have been engineered.  
Poor bearing provide at both ends of flight.  
Risk of buckling at base of flight under evacuation loading.

| Item No. | Observation | Recommended Action Plan | Recommended Timeline |
|---|---|---|---|
| 27 | ADMIN BUILDING: Stair support | Building engineer to design proper support for the upper level / review and justify the fixing for the lower level | Immediate - Now |
| 28 | ADMIN BUILDING: Stair support | Implement a proper support bracket for the stair on the upper level | Immediate - Now |
