# **FIRE SAFETY INSPECTION REPORT**

**INDESORE SWEATER FACTORY  
DEGER CHALA, NATIONAL UNIVERSITY, GAZIPUR  
SADAR, GAZIPUR-1704.**

**ACCORD**  
on Fire and Building Safety in Bangladesh

August 14, 2014

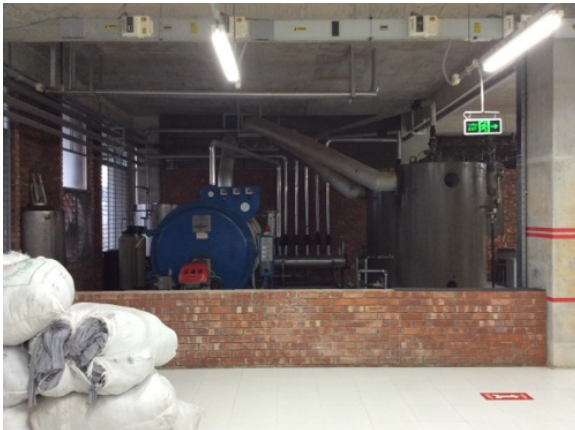
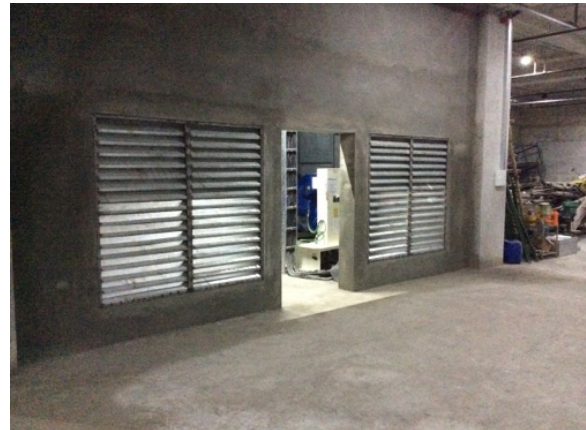
| No. | Category | Finding | Recommendation | Remediation Timeframe |
|---|---|---|---|---|
| F-1 | Fire Rated Construction | The boiler area and generator room were not separated by fire-rated construction. The boiler area on the ground floor was open to the surrounding washing section. The generator room in the basement was not provided with a fire-rated door and had unprotected openings (vents). | Separate the boilers and generators by a minimum 2-hr fire-rated construction. Seal and/or protected all openings to maintain the required fire separations | Within 3 months |

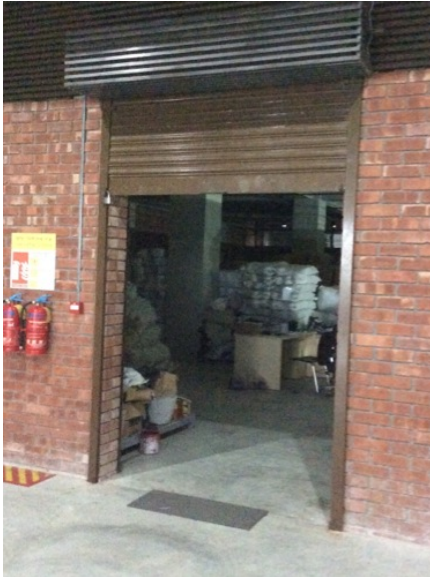
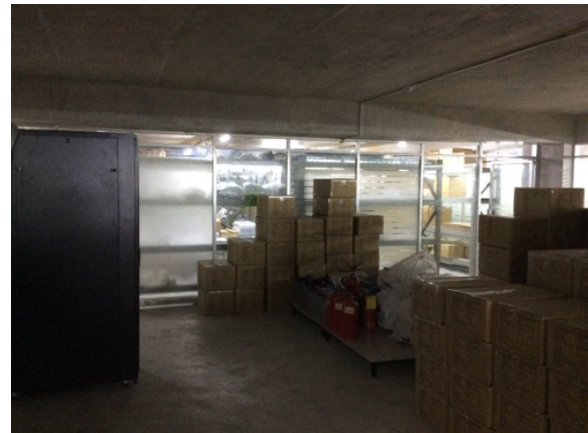
| F-2 | Fire Rated Construction | Rooms used for combustible storage are not separated by fire-rated construction. Specifically, rooms on the ground (bonded warehouse) and second (accessory store) floors. | Provide dedicated storage rooms separated by minimum 1-hr fire-rated construction. | Within 3 months |

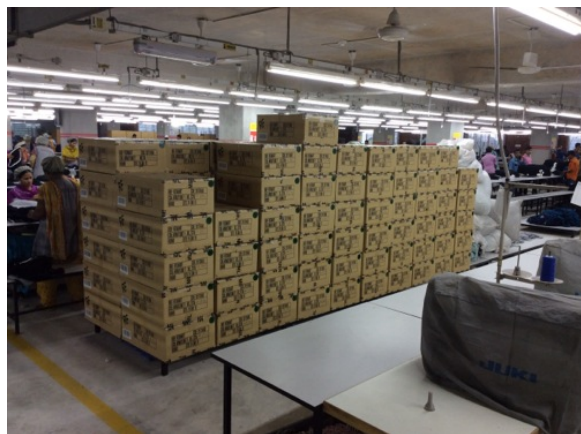
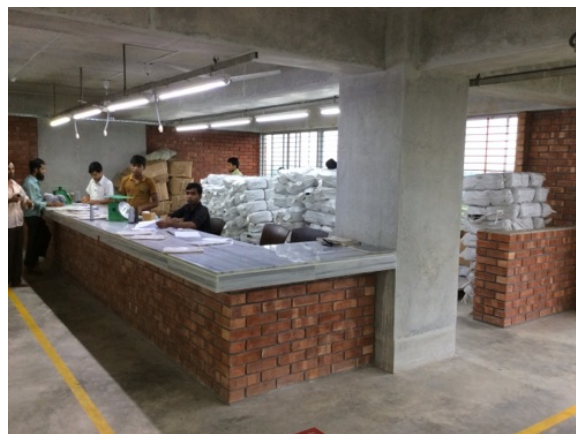
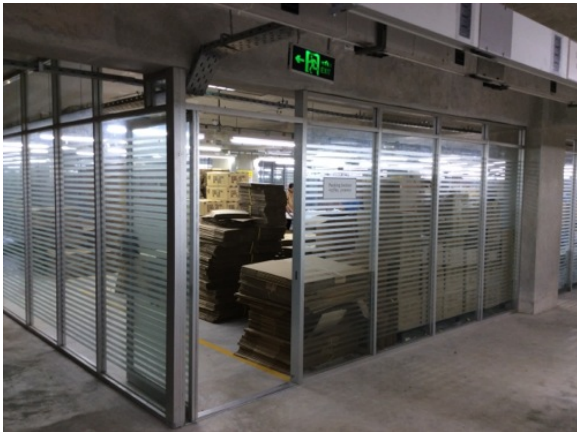
| F-3 | Fire Rated Construction | Areas used for combustible storage, open to the factory floor, are not separated by fire-rated construction. Specifically, storage was open to the factory floor on the basement, ground, first, second and third floors. Also, there were distribution counters, located in two (2) separate areas, on the second, third and fourth floors. A packing section was located on the first floor. | <p>Provide dedicated storage rooms separated by minimum 1-hr fire-rated construction.</p> <p>Where separate storage rooms are not feasible, provide defined storage areas and limit the storage arrangement as follows:</p> <ul style="list-style-type: none"><li>- Maximum height of 2.4m and maximum area of 23m<sup>2</sup></li><li>- If sprinkler protected: maximum height of 3.66m and maximum area of 93m<sup>2</sup></li></ul> <p>Separate areas of unenclosed combustible storage by a minimum clear distance of 3m.</p> | Within 3 months |

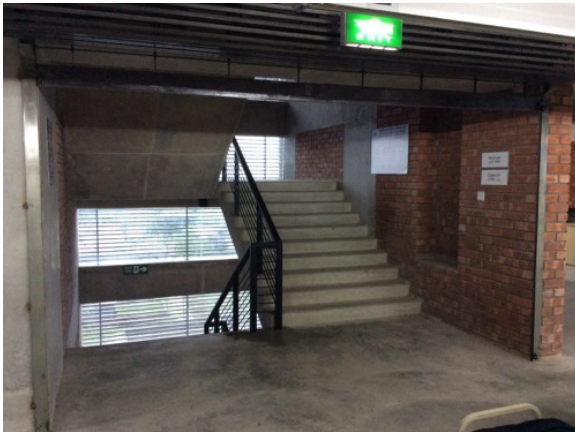
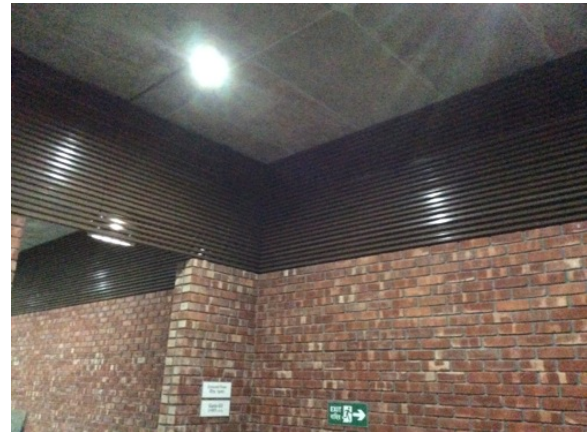
| F-4 | Fire Rated Construction | The exit stairs are not separated from work areas and other spaces on each floor by fire-rated construction. | <p>Provide minimum 1.5-hr fire rated doors and seal all unprotected openings to separate the exit stairs from work areas and other building spaces on all floor levels. Ensure that the fire doors are self-closing and positive latching and that they are provided with fire exit (panic) hardware where serving production floors.</p> <p>If fire doors are required to be held open for functional reasons, provide automatic-closing devices tied to the fire alarm system.</p> | Within 3 months |

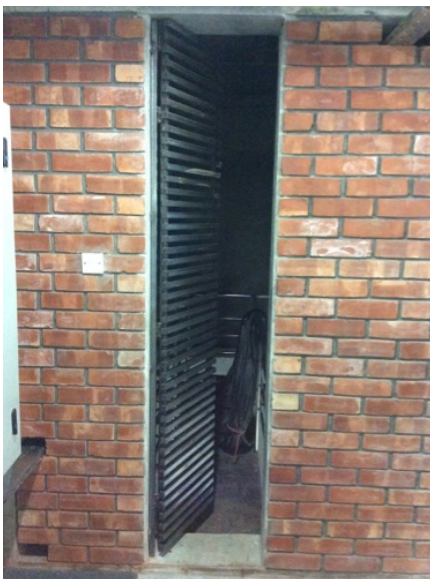
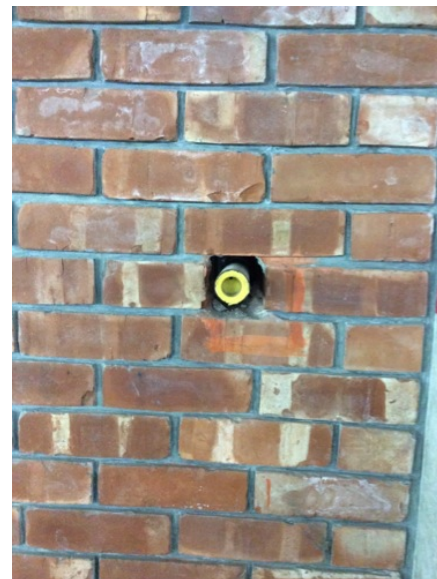
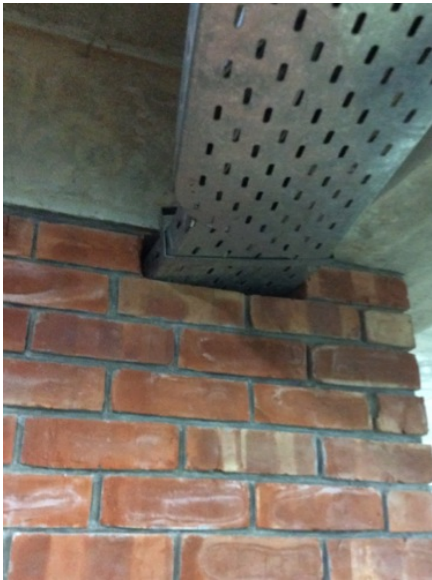
| F-5 | Fire Rated Construction | The electrical, maintenance and engineering (EME) shaft, present between all floors, is not separated by fire-rated construction. The shaft had unprotected openings and penetrations on all floors. | Separate the EME shaft by a minimum 2-hr fire-rated construction. Seal and/or protected all openings to maintain the required fire separations | Within 3 months |

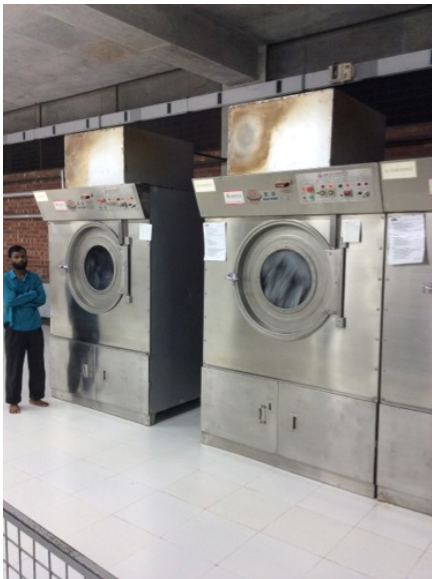
| F-6 | Fire Rated Construction | The two (2) gas dryers in the ground floor washing section were not separated by fire-rated construction and open to the factory floor. | Separate the gas dryers by a minimum 2-hr fire-rated construction. Seal and/or protected all openings to maintain the required fire separations. | Within 3 months |

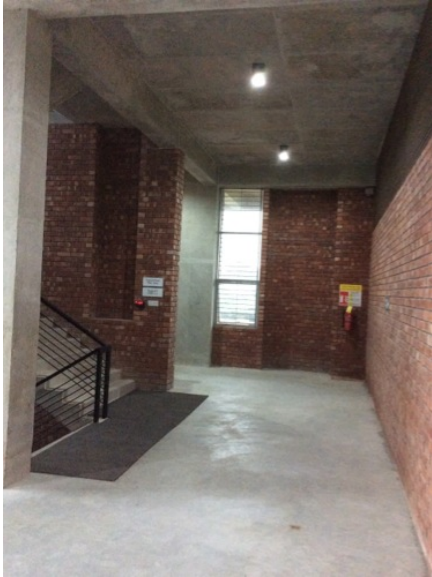
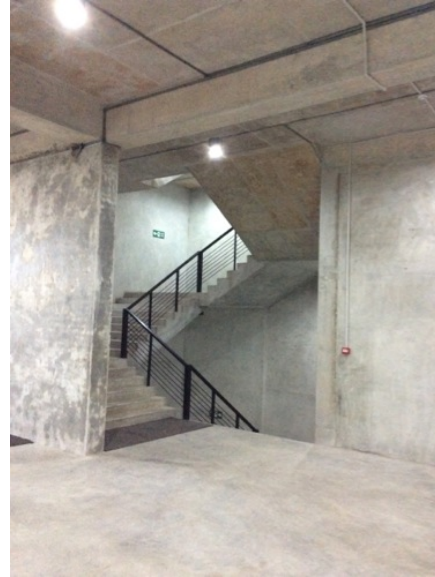
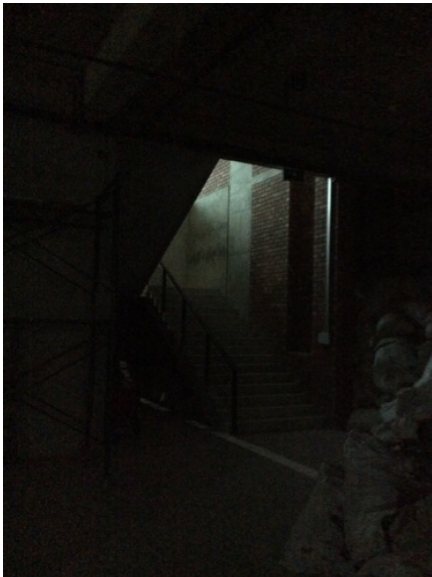
| F-7 | Fire Rated Construction | The northeast and southwest exit stairs were not enclosed in fire-rated construction in the basement or on the ground floor. | Enclose the northeast and southwest exit stairs in 2-hr fire-rated construction on all floors. | Within 3 months |

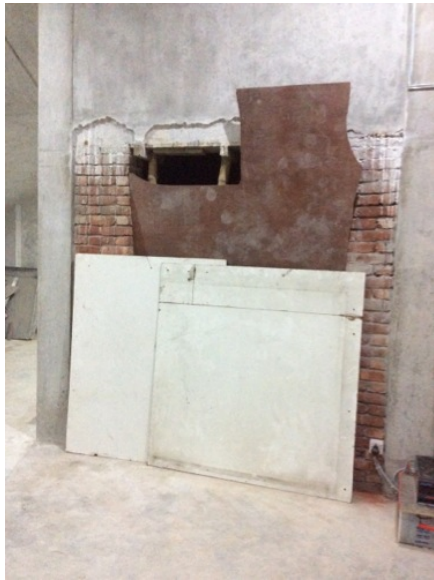
| F-8 | Fire Rated Construction | The southwest cargo lift shaft was sealed on all floors but the basement. | Seal the cargo lift shaft on all floors. | Within 3 months |

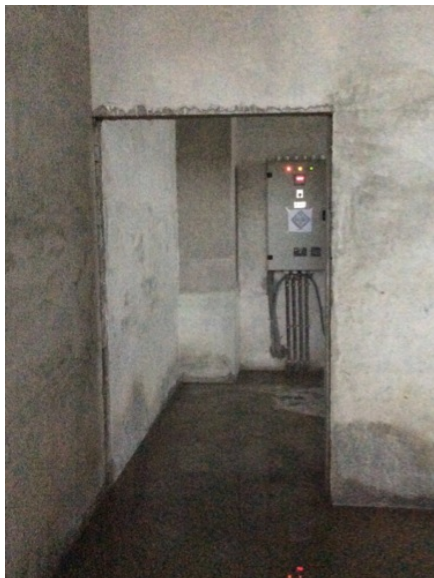
| F-9 | Fire Rated Construction | The reported pump room, accessed from the ground floor from within the southeast exit stair, is not separated by fire-rated construction and open to the exit stair. | Separate pump room by a minimum 2-hr fire-rated construction. Seal and/or protected all openings to maintain the required fire separations | Within 3 months |

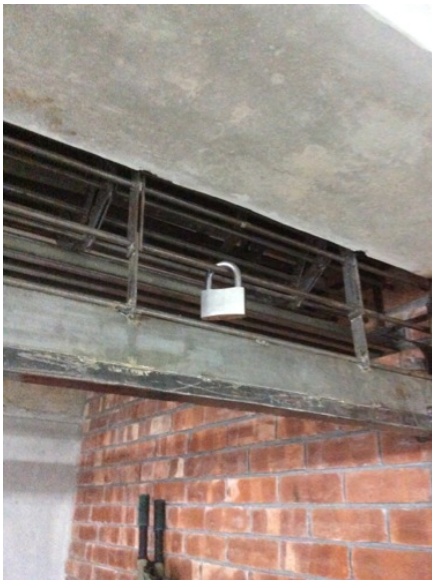
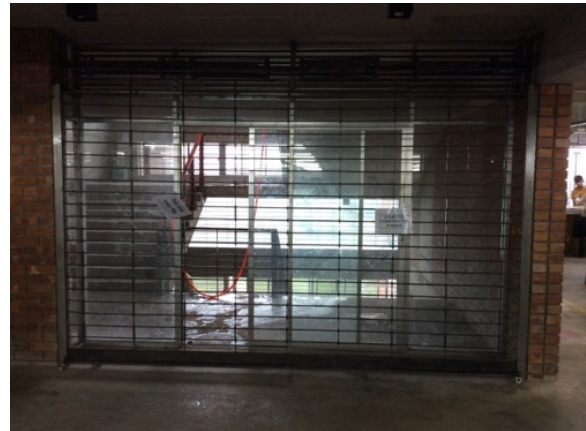
| F-10 | Egress | Egress doors and gates with locking features are provided at building exits, exit stairs, along egress routes and at exit discharge. All gates and doors, except the gates to the southeast exit stair, were open and unlocked during the inspection. | Remove locking features from all egress doors and gates.<br><br>If locks are required for security reasons, utilize special door locking features complying with NFPA 101. | Immediate |

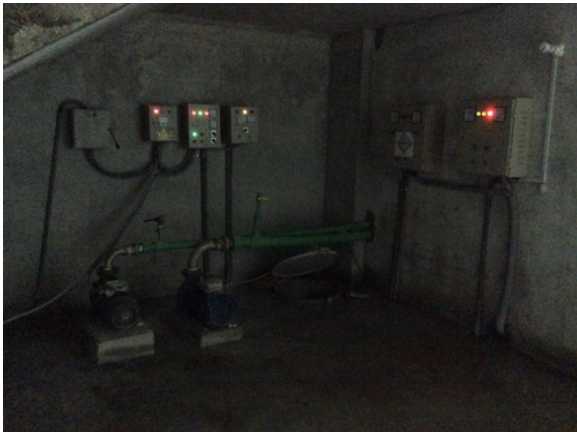
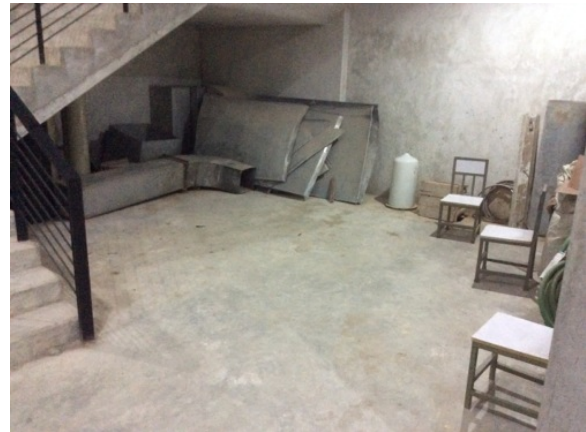
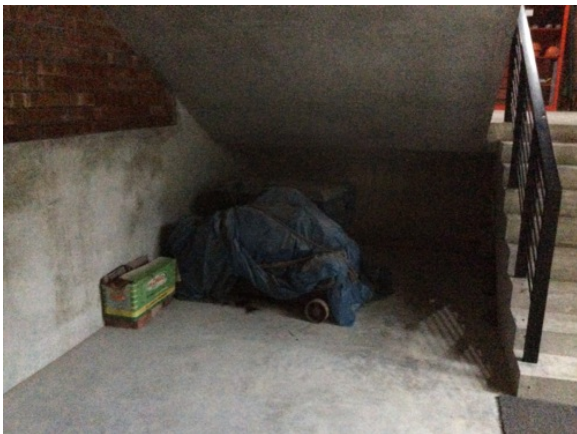
| F-11 | Egress | Storage was located in the northwest and southeast exit stairs on the ground floor. | Remove all storage from exit stairs and egress paths. | Immediate |

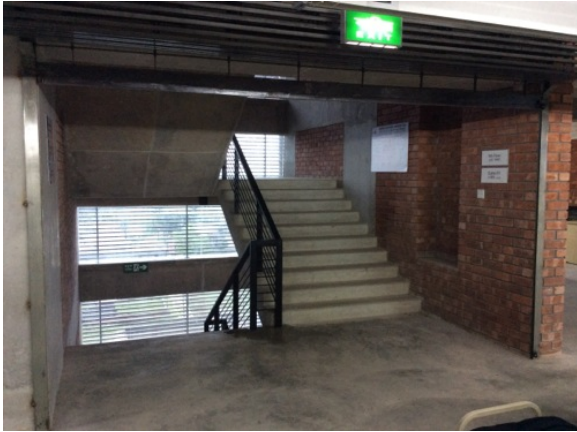
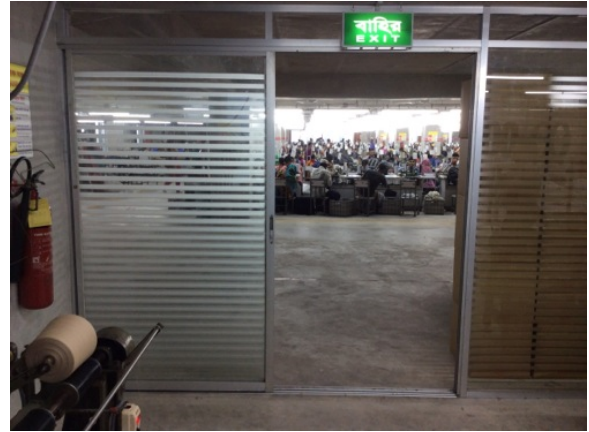
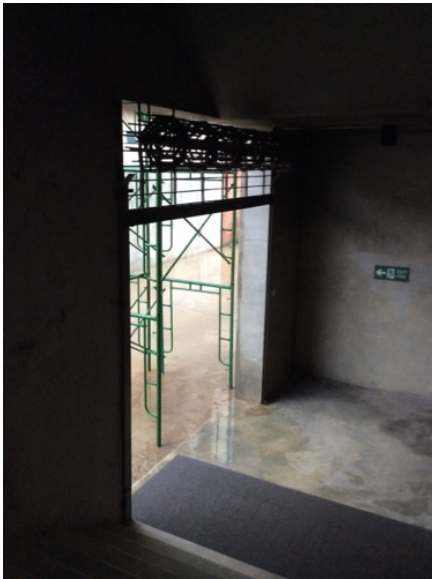
| F-12 | Egress | Collapsible gates and sliding doors are provided at building exits, exit stairs, along egress routes and at exit discharge. | Replace all gates and sliding doors along the means of egress with side-hinged, swinging egress doors.<br><br>If locks are required for security reasons, utilize special door locking features complying with NFPA 101. | Within 1 month |

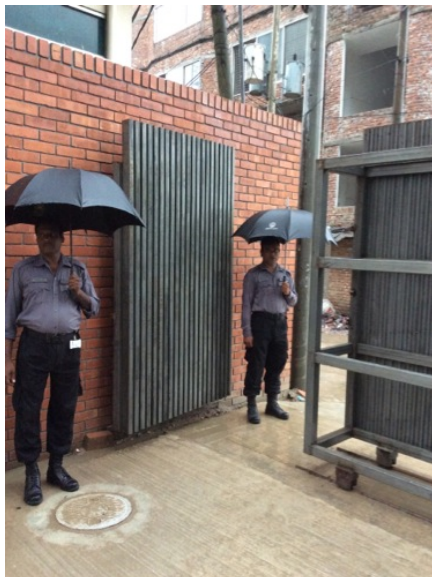
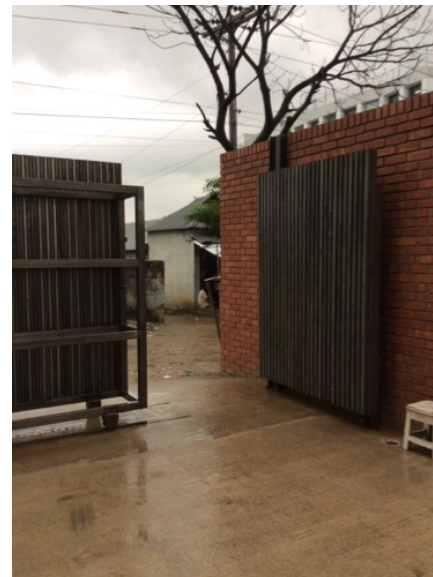
| F-14 | Egress | The swing doors passing through the two main sliding doors from the factory premise to the main road, located at the northeast and northwest corners of the property, did not swing in the direction of egress travel. | Modify the egress doors to swing in the direction of egress travel. | Within 3 months |

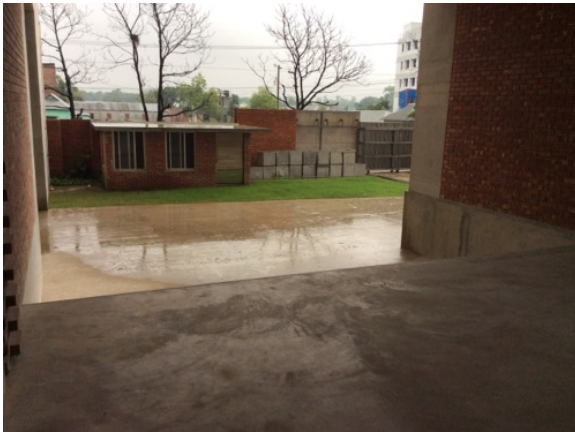
| F-15 | Egress | No handrails were present on the stairs to the main, front entrance of the building. | Provide intermediate handrails for the stair. | Within 3 months |

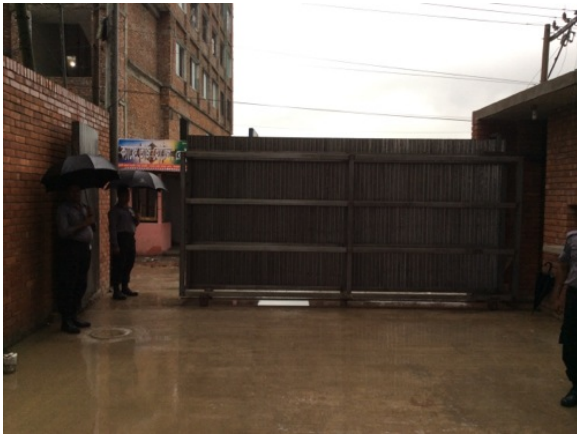
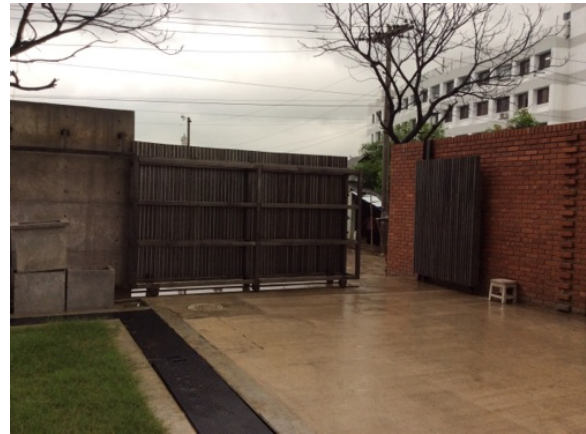
| F-17 | Egress | The two main sliding doors from the factory premise to the main road, located at the northeast and northwest corners of the property, were not remotely located. | Provide an additional remote exit for egress from the factory premise. | Within 6 months |
