Geebee (Bangladesh) Ltd.

Plot # 74~77, sector # 02, KEPZ, North Patenga, Chittagong-4204.

10th June 2014

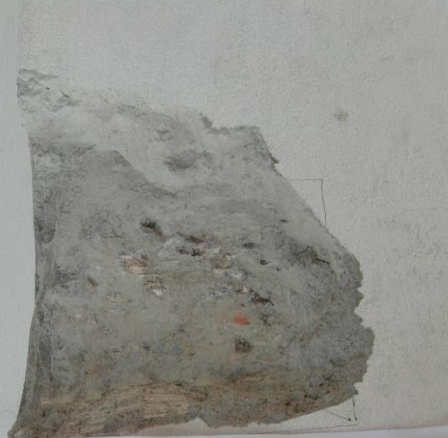
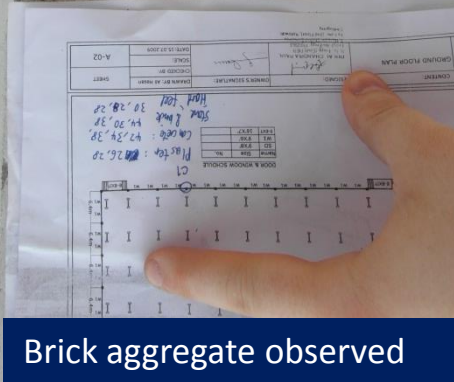
Brick aggregate observed

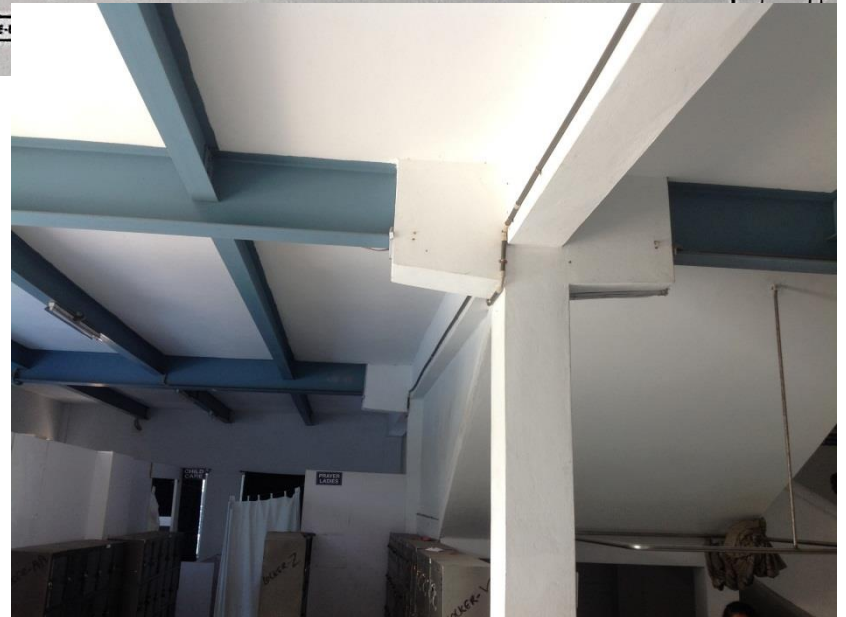
Poor steel detailing

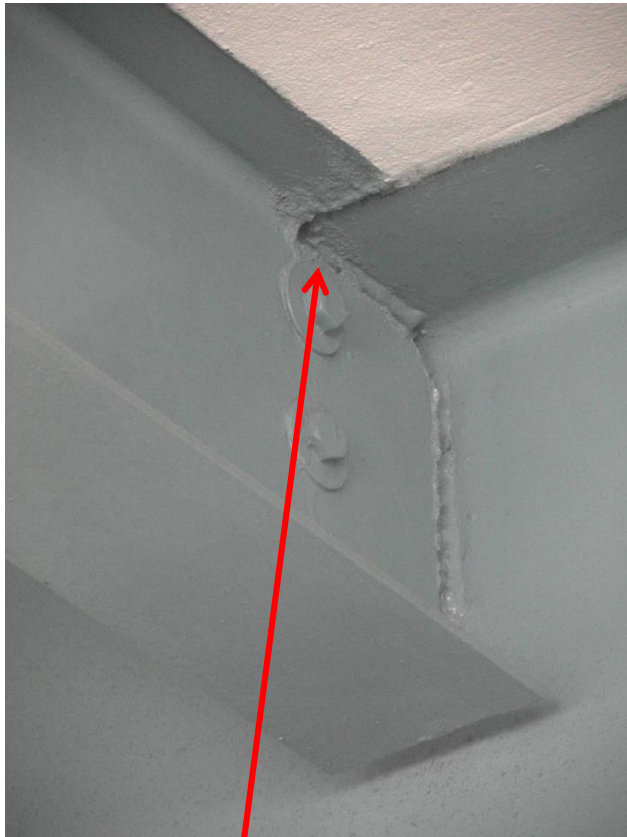
Edge distance to bolts appears too low

Packers placed under flange instead of under entire section – reduces vertical capacity of connection

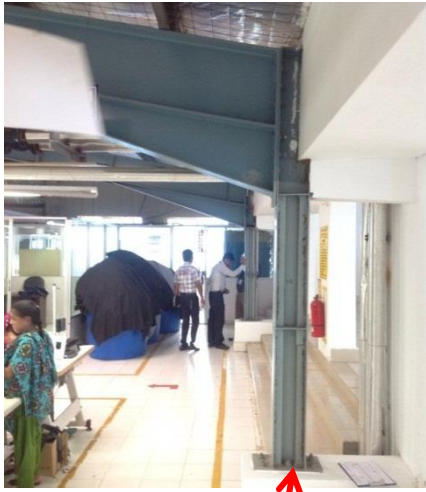
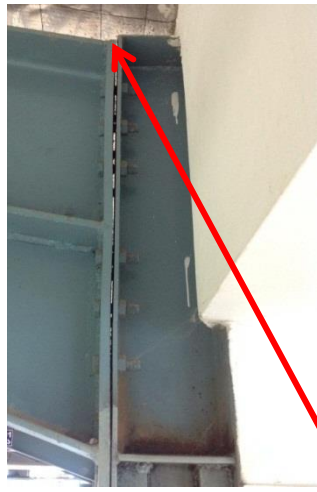
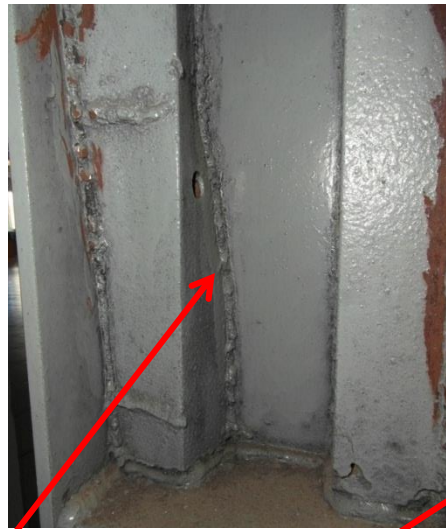
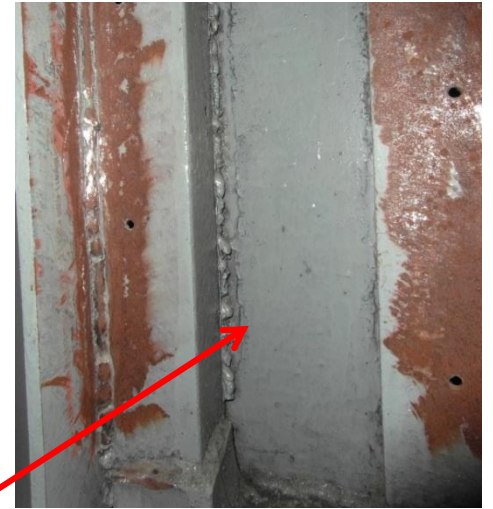
Column does not appear large enough to resist bending moments from haunch and rafter for vertical loads.

Poor haunch detailing (no stiffeners, no tension plate, welding very poor quality)

Item No.	Observation	Recommended Action Plan	Recommended Timeline
8	Poor portal frame haunch detailing	Building Engineer to review portal frame design as built, including haunches, column sizes and weld quality	6-weeks
9	Poor portal frame haunch detailing	Provide remedial details as appropriate	6-weeks
10	Poor portal frame haunch detailing	Carry out remedial work as required	6-months
11	Poor steel detailing	Building Engineer to review steel detailing and weld quality	6-weeks
12	Poor steel detailing	Provide remedial details as appropriate.	6-weeks
13	Poor steel detailing	Carry out remedial work as required	6-months
14	Apparently non-engineered external structures	Building Engineer to review design of ancillary steel structures with regard to their capacity to support code vertical and wind loads	6-months
15	Apparently non-engineered external structures	Carry out remedial works as necessary, or replace structures	6-months

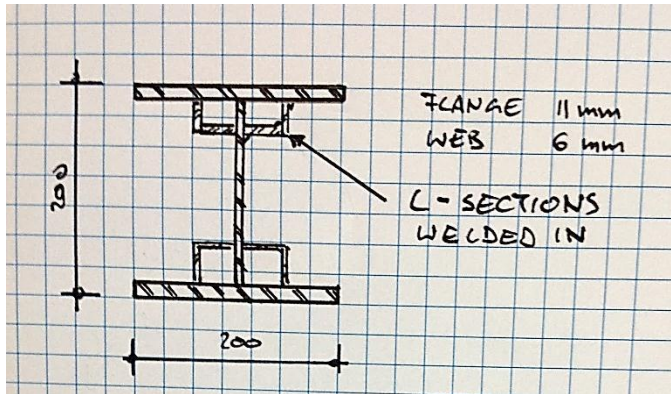
Cracks to paint and bowing of plates suggest flanges may have locally buckled slightly. L-sections were apparently welded on later to strengthen the column

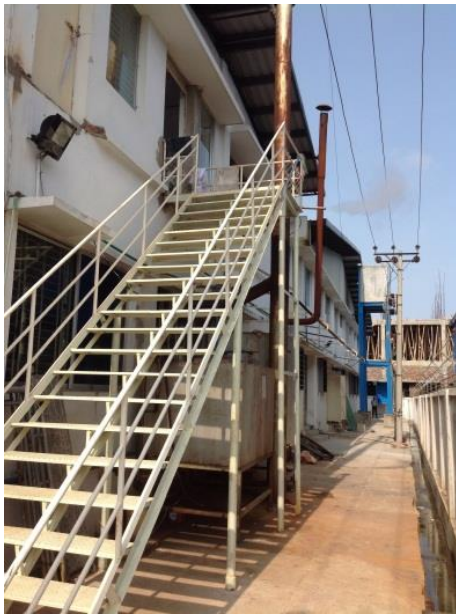
Fire escape stairs outside the building (5 no.): poor structural details and weld quality

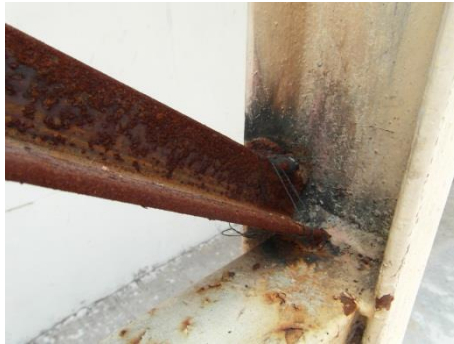
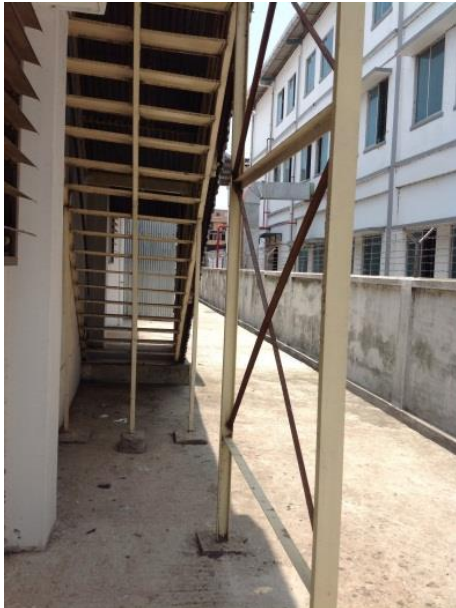
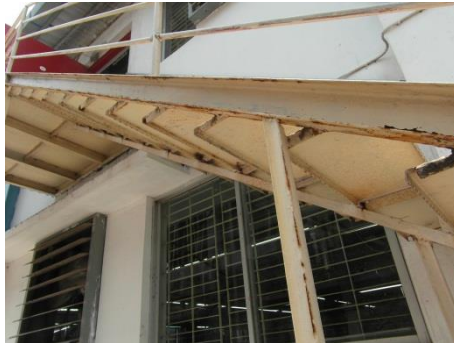
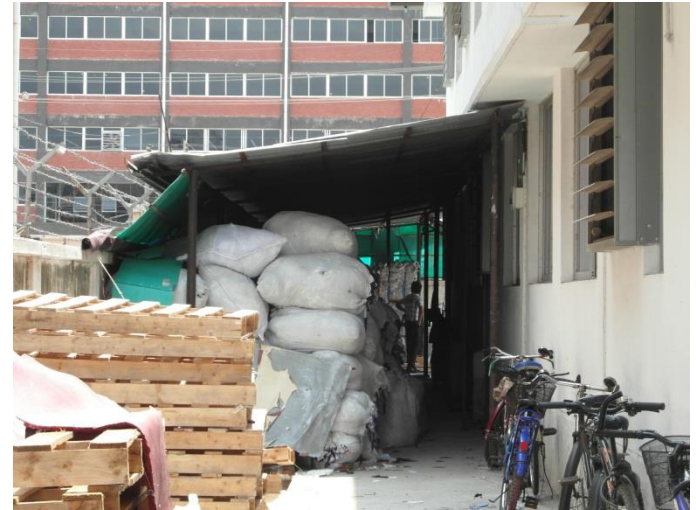
Apparently non-engineered steel structure outside the building

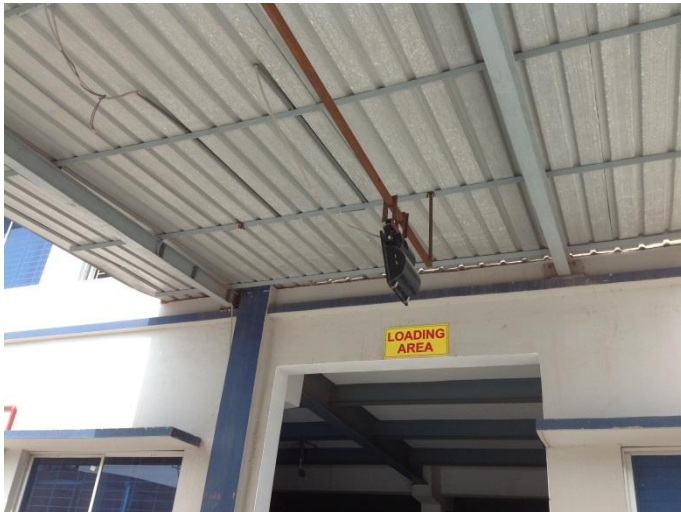
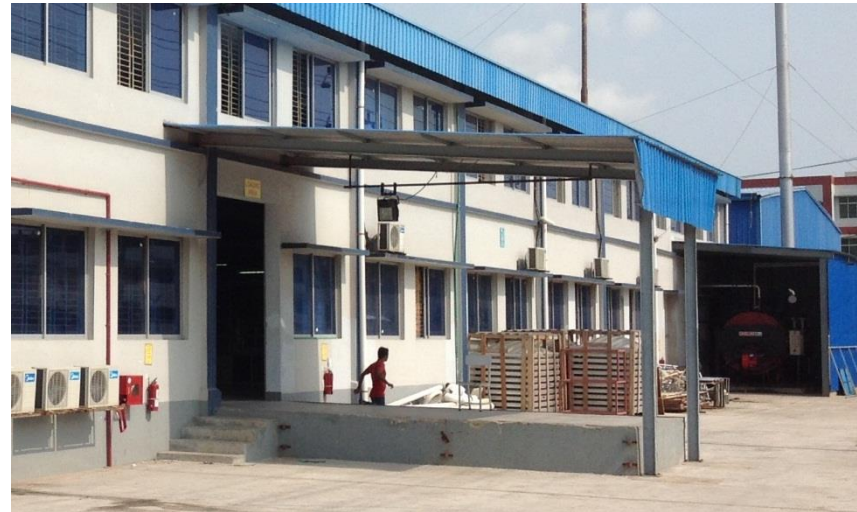
Lightweight roof structure over main entrance

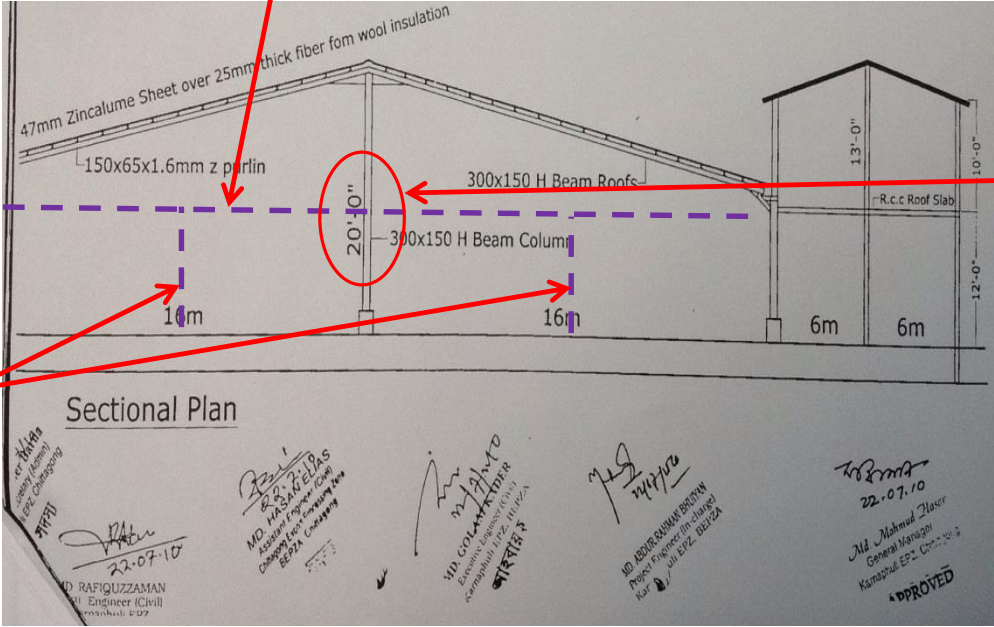
1st floor not shown

Incorrect dimension

Ground floor columns not shown

16	Absence of structural information and inconsistencies between drawings and as-built construction	Building Engineer to carry out as-built survey of building and produce accurate and complete as-built drawings	6-months
17	Absence of structural information and inconsistencies between drawings and as-built construction	Building Engineer to provide structural documentation for external steel structures.	6-months

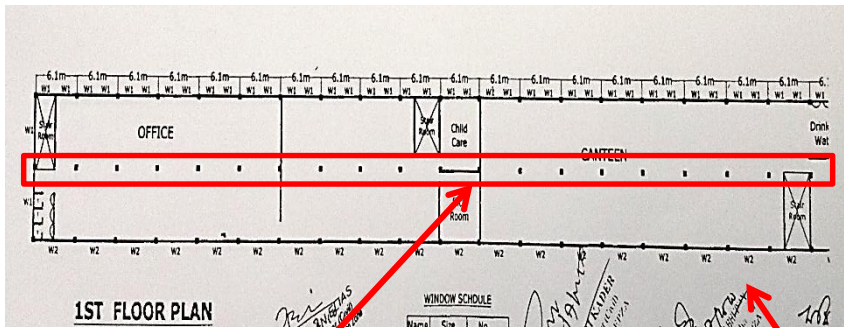
Incorrect details on Permit drawings

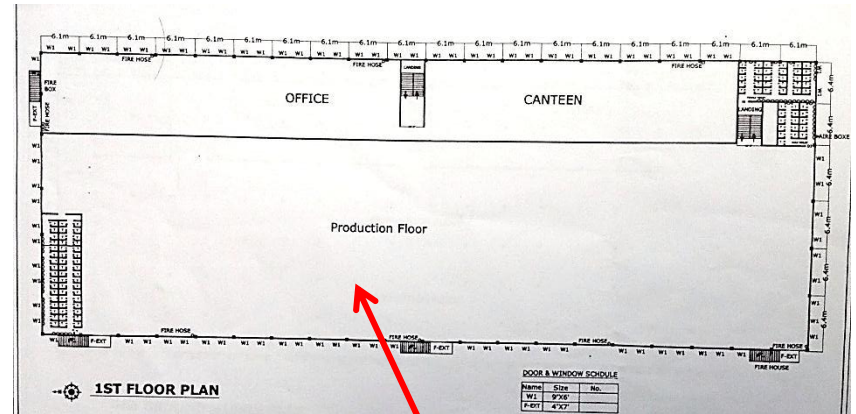
Columns on 1st floor not existent

Two different floor plans provided. Some column sizes shown are different from as-built
