# Raidha Collections Ltd.

Zamirdia, Valuka, Mymensingh, Bangladesh

25 June 2014

# Observations

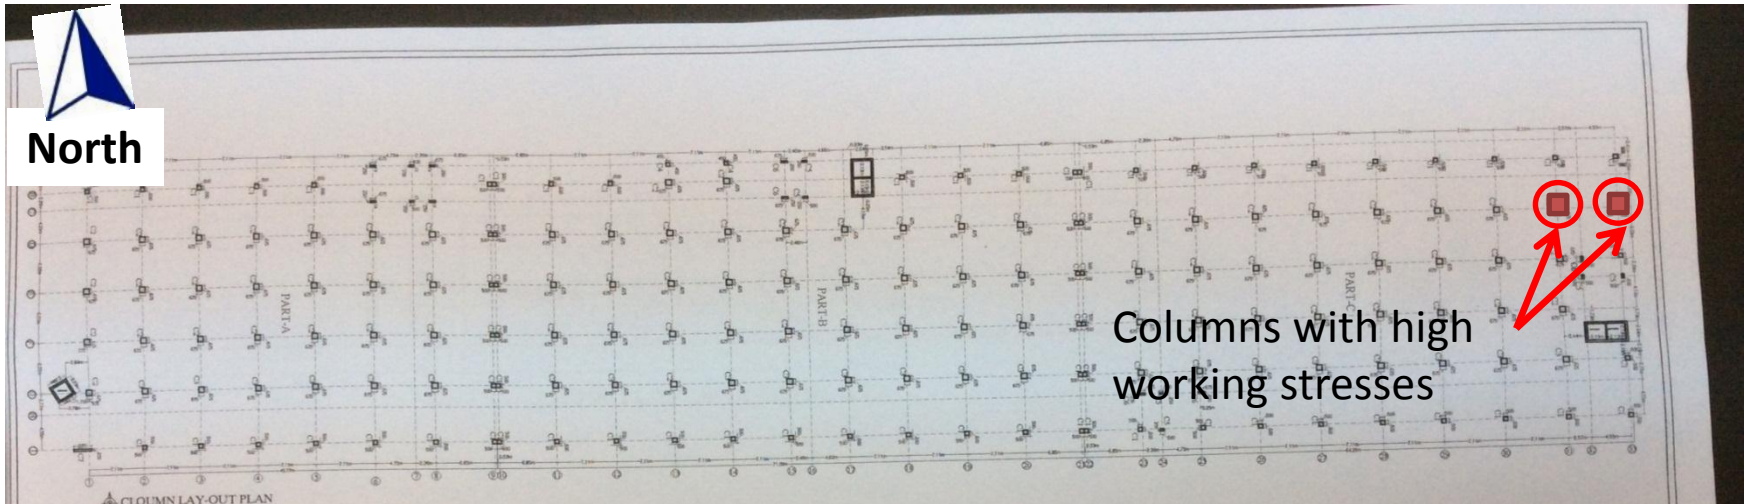
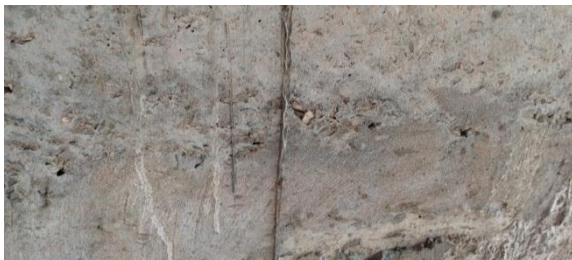
Main Factory Building – Column Layout

Testing of columns confirmed Stone aggregate.

Cursory calculations indicate that working stresses exceed normal acceptable levels in the columns supporting the toilet block.

Building Engineer to perform detailed calculations based on “as built” dimensions and loadings. Material data from concrete tests to prove column strength.

| Item No. | Observation | Recommended Action Plan | Recommended Timeline |
|---|---|---|---|
| 1 | Cursory calculations indicate columns to be stressed in excess of normal design limits. | Building Engineer to review design, loads and column stresses in Building 1 | 6-weeks |
| 2 | Cursory calculations indicate columns to be stressed in excess of normal design limits. | Verify insitu concrete stresses either by 4 no. 100mm dia. Cores or existing cylinder strength data for the columns | 6-weeks |

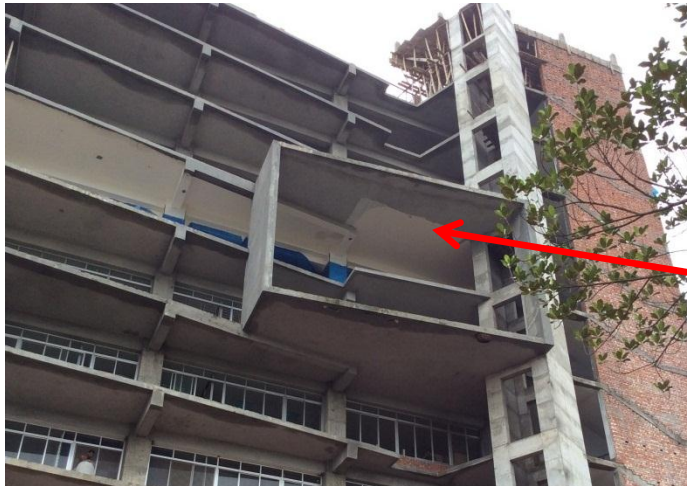
West Elevation Architectural Feature

A large architectural concrete box feature has been added to the front (west) elevation of the factory. The feature does not appear on the Architectural or Structural drawings that were presented. The support structure is a cantilever beam slab and has been modified introducing an additional edge beam which is not indicated in the documentation

| Item No. | Observation | Recommended Action Plan | Recommended Timeline |
|---|---|---|---|
| 5 | Design check required due to discrepancies between 'as-built' drawings and building structure | Complete as-built survey and commence calculations for verification of Concrete Architectural Feature box to the West Elevation and the omission of the beam below the toilet block. | 6-weeks |
| 6 | Design check required due to discrepancies between 'as-built' drawings and building structure | Calculations to consider the impact on all slabs, beams and columns affected. | 6-weeks |

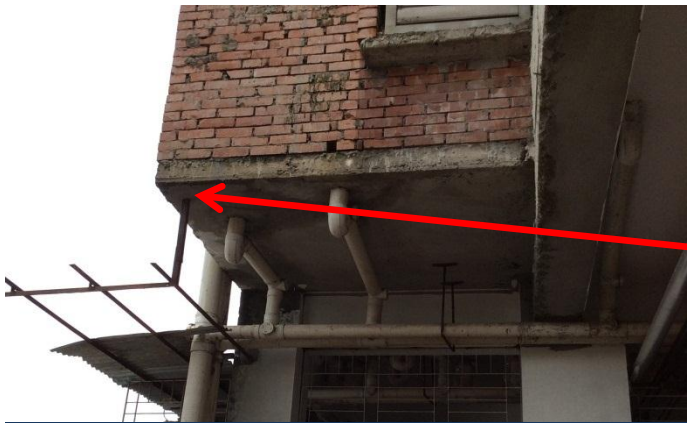
North Elevation Slab Cantilever

Cantilever slab provided on the North Elevation to support the toilets. No increase in structure or beams provided to support the additional load of the brickwork partitions and additional concrete ceilings. Beam indicated on drawings not provided.

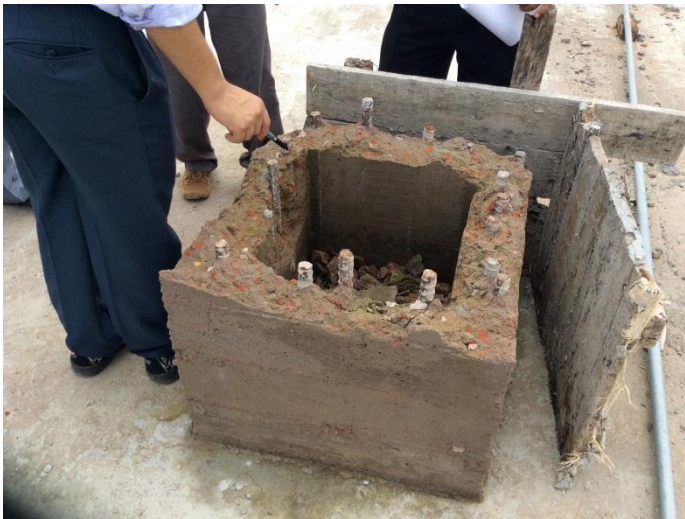
Column Reinforcement at Roof Level

The column reinforcement at roof level has been cut down to 600mm to provide planter boxes. Should vertical expansion be proposed the building engineer should confirm that a sufficient lap length can be achieved or provide a detail capable of adequately transferring the vertical load.

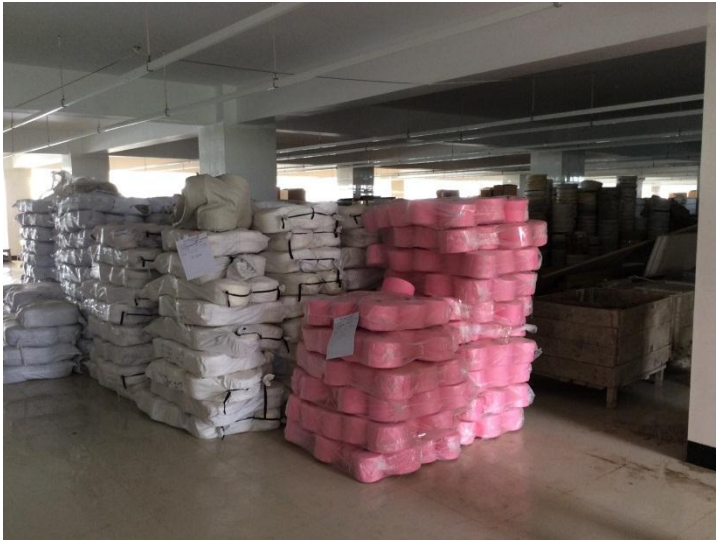
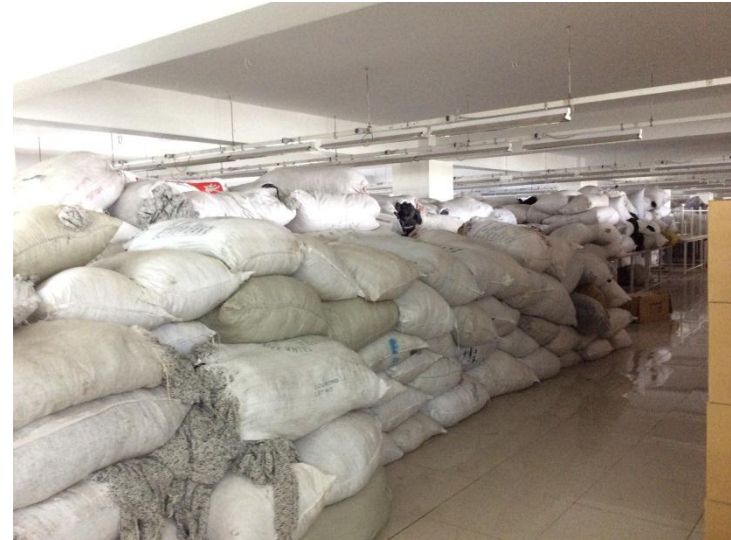
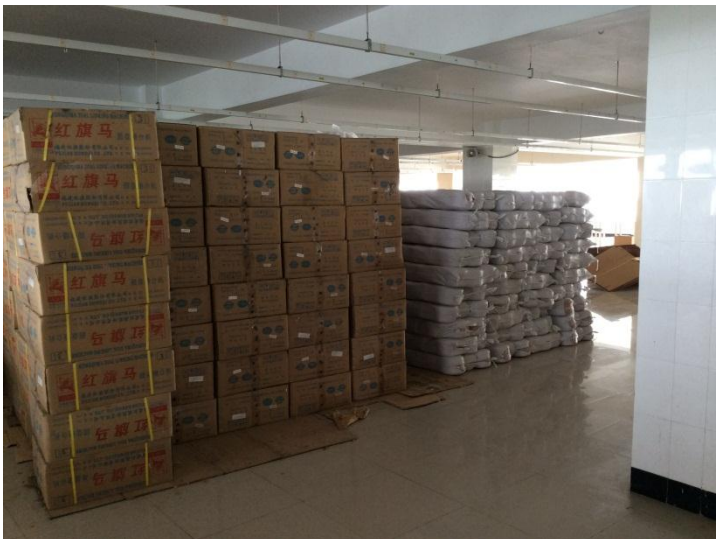
Areas of High Loadings were observed in all floors. A load management plan is required for the factory. The building engineer should prepare a set of loading plans and aid in the implementation of the management plan for all floor plates within the factory giving consideration to floor capacity and column capacity.

| Item No. | Observation | Recommended Action Plan | Recommended Timeline |
|---|---|---|---|
| 8 | Localised areas of high loading on suspended slabs | Produce and actively manage a loading plan for all floor plates within the Main Building giving consideration to floor capacity and column capacity. | 6-weeks |
| 9 | Localised areas of high loading on suspended slabs | Continue to implement load management plan | 6-months |

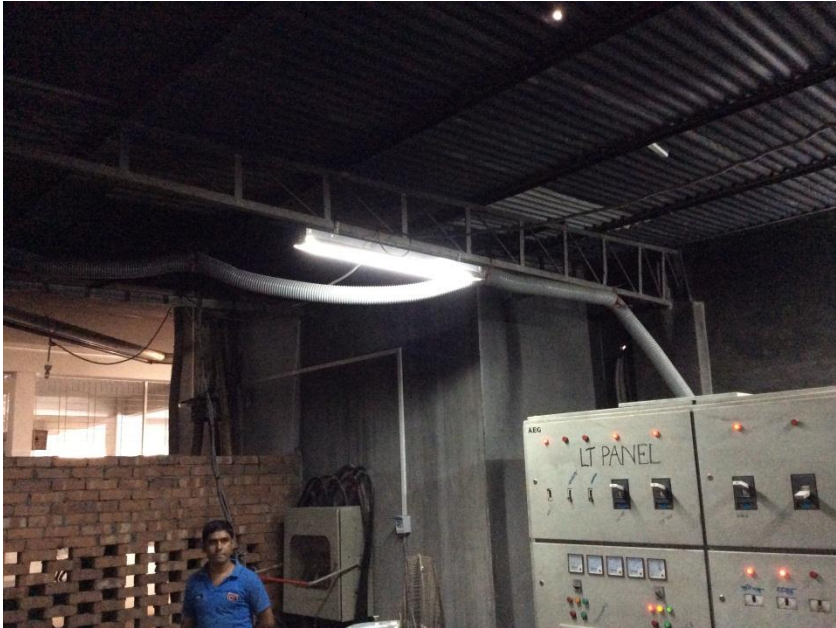
Transformer and Switch Room LW Roof Structure

Apparently non-engineered roof structure, no bracing provided, connection of truss to RC columns does not appear to be designed

| Item No. | Observation | Recommended Action Plan | Recommended Timeline |
|---|---|---|---|
| 10 | Lightweight structures | Building engineer to check the capacity of non-engineered lightweight structures under horizontal and vertical loading and make any necessary alterations required. | 6-weeks |

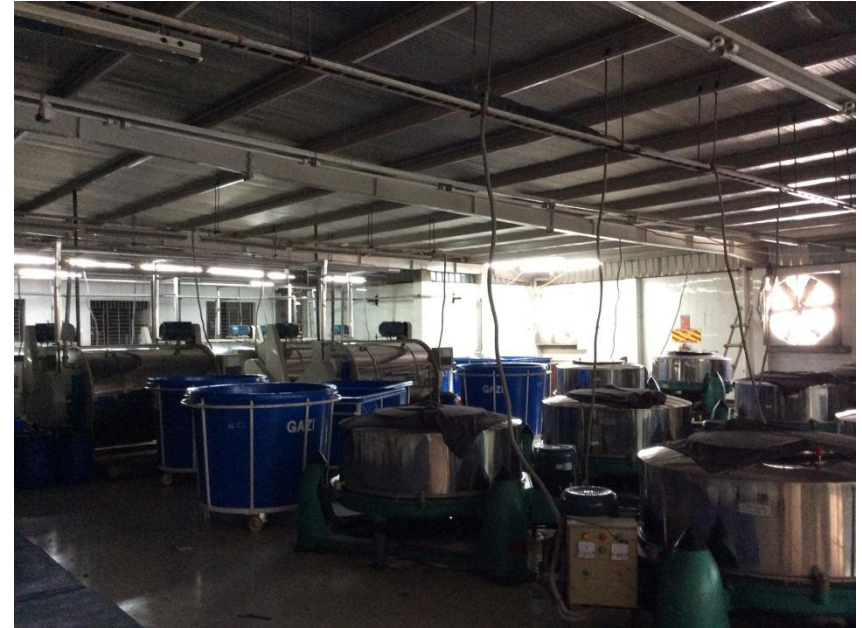
Laundry Room LW Steel Roof Frame

Steel rafter beams span onto steel columns on one side and RC columns at the other, connection of truss to RC columns does not appear to be designed. No bracing provided, lateral stability system not apparent.

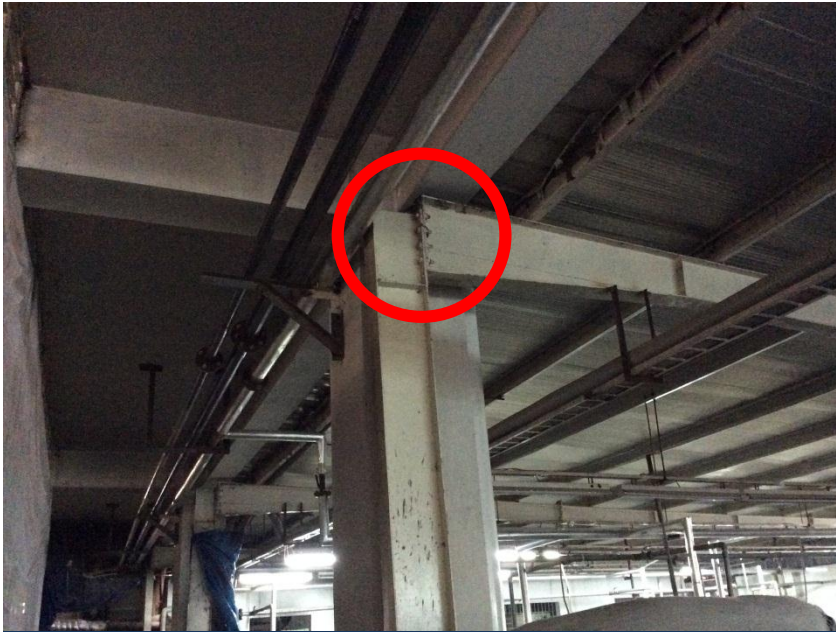
Laundry Room LW Steel Roof Frame

Column member was cut short in a number of locations. Top bolts omitted in what appears to be a moment connection.

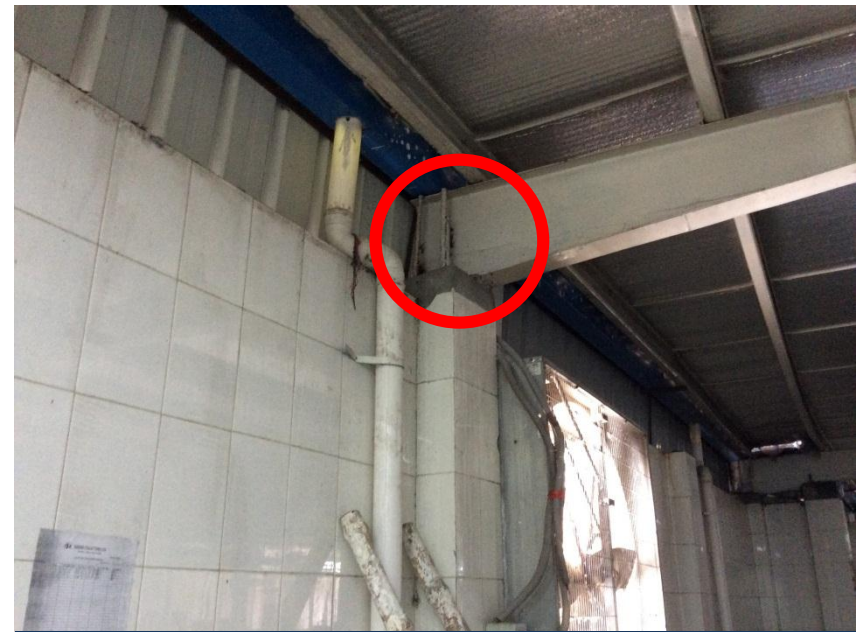
Laundry Room LW Steel Roof Frame

Steel rafter appears to have been designed as a moment transferring member but is currently resting on top of an RC column. Connection does not appear to have been designed and lateral restraint system not evident

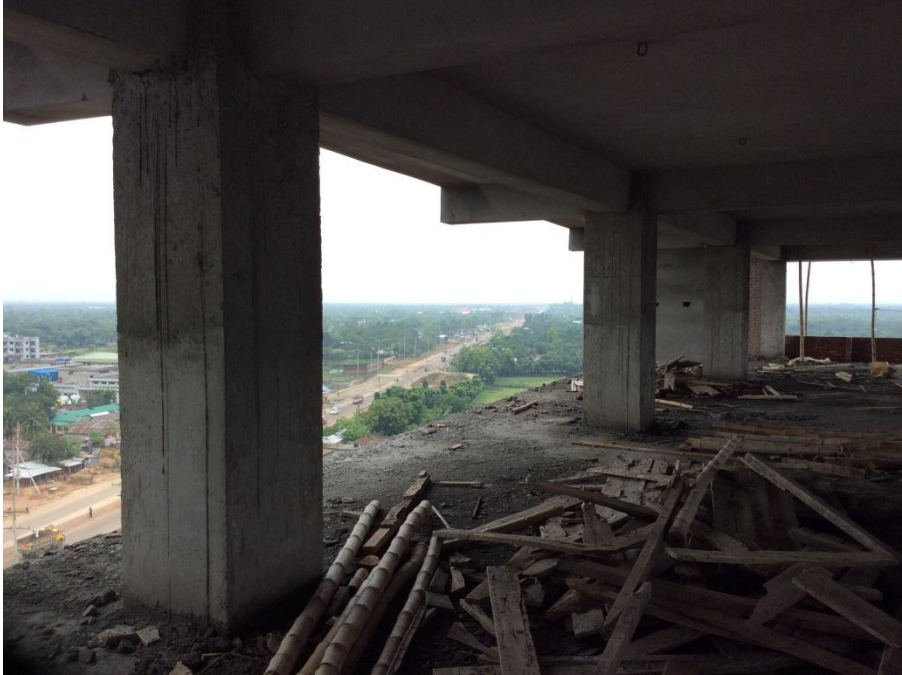
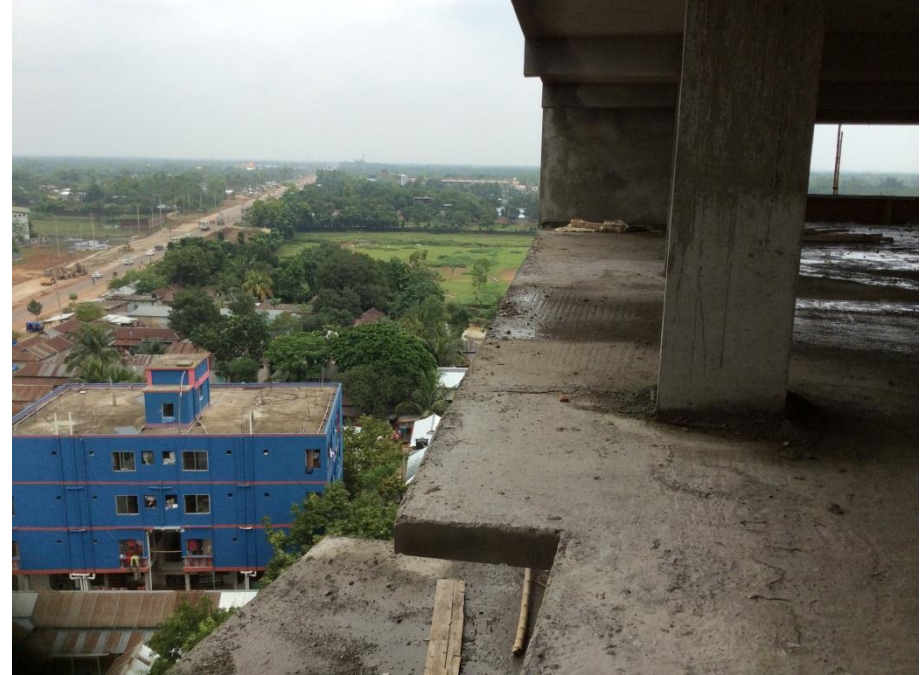
No handrail or edge protection provided on the floors currently under construction.

| Item No. | Observation | Recommended Action Plan | Recommended Timeline |
|---|---|---|---|
| 11 | Edge protection to slab edges | Handrails to be provided to all open slab areas or access to be prohibited. | 6-weeks |

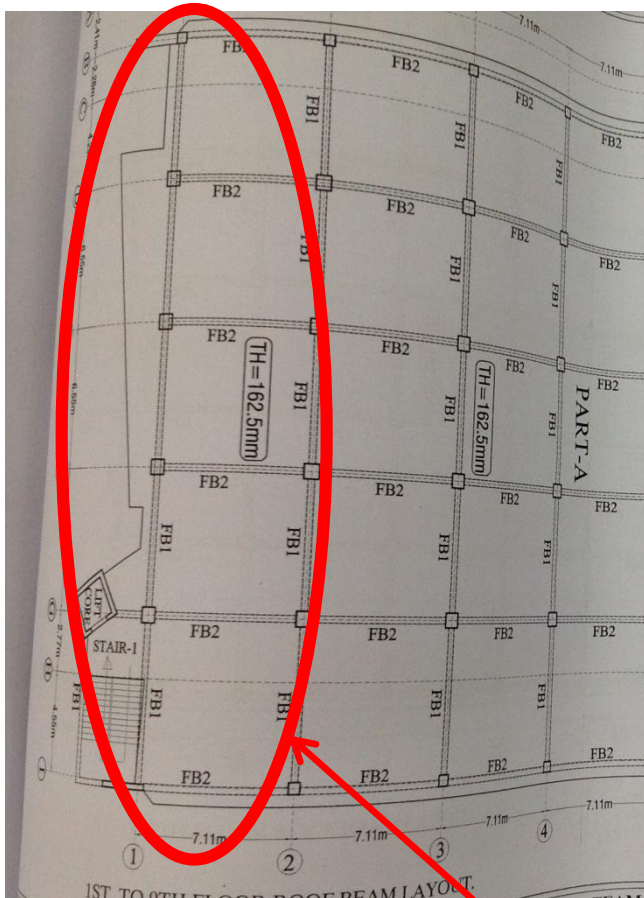
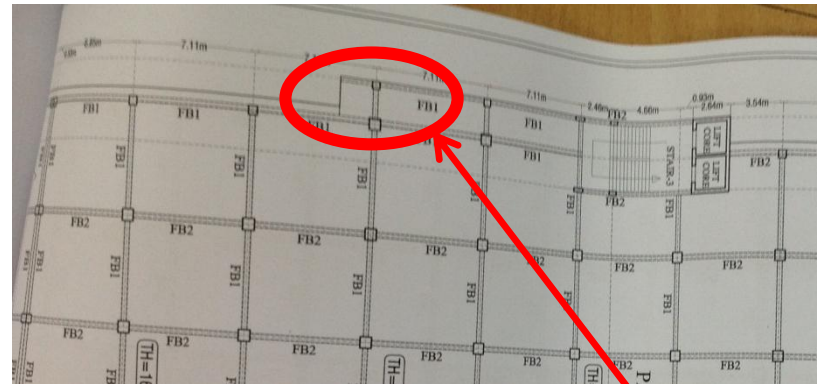
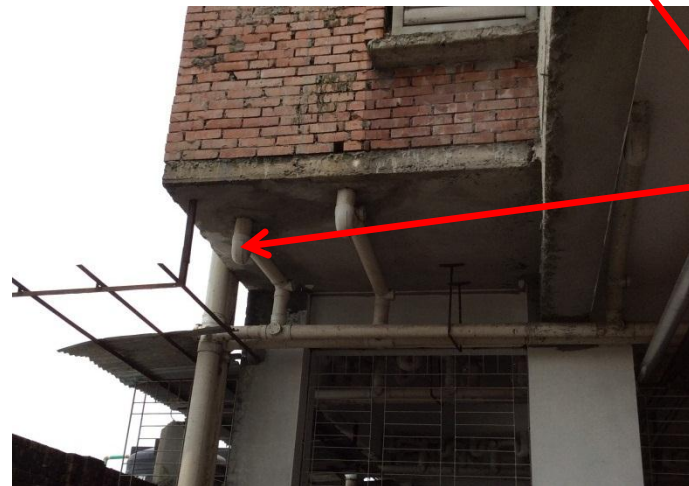
Cantilever beam indicated on the drawings not provided

Cantilever Beams provided not indicated on the drawings

| Item No. | Observation | Recommended Action Plan | Recommended Timeline |
|---|---|---|---|
| 12 | Inconsistencies noted between as built drawings and as built construction | Building engineer to prepare a set of “as built” drawings for all structures linked to the factory’s activities. | 6-months |
| 13 | Inconsistencies noted between as built drawings and as built construction | Permit documentation and drawings also to be updated. | 6-months |
