Ocean Apparels Nangtong Tongfeng Co. Ltd

DS-2, 1st Floor, Road 02, Export Processing Zone, Chittagong

21 June 2014

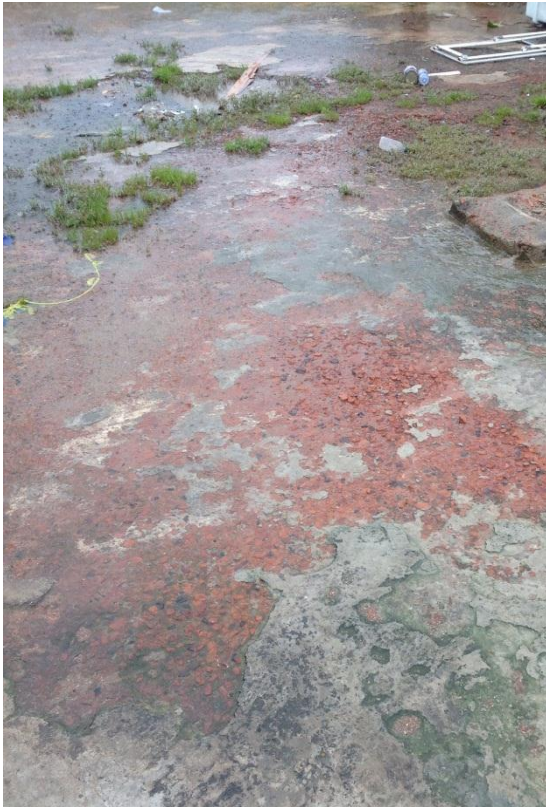
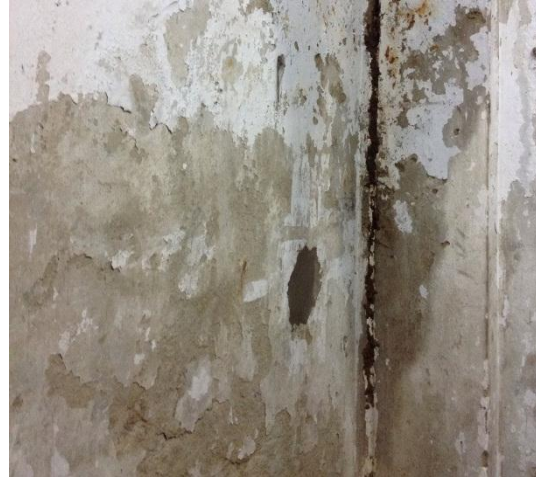
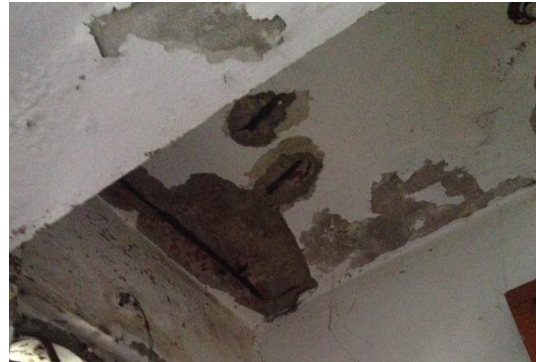
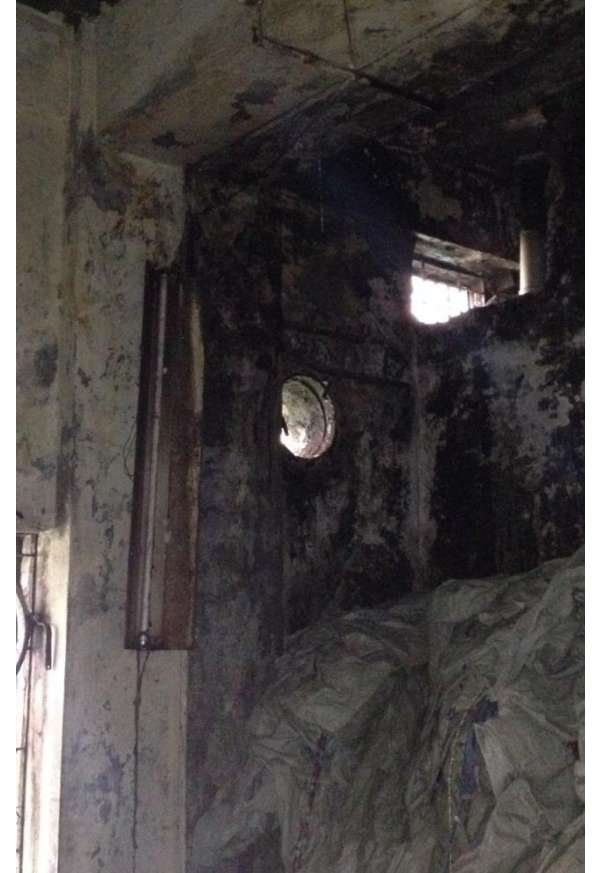
Standing water and ponding on roof with no adequate drainage system or waterproofing in place.

Extensive water ingress at roof level causing deterioration of structure.
Water ingress causing spalling to beams, slabs and columns throughout structure, particularly on 1st Floor.

Item No.	Observation	Recommended Action Plan	Recommended Timeline
1	Water ingress through structure throughout	Install a functional waterproofing membrane and drainage system to the roof slabs throughout	6-months
2	Water ingress through structure throughout	Remove areas of spalling concrete to slabs, beams and columns and reinstate concrete sections appropriately, once the building envelope is water-tight	6-months
3	Uncontrolled storage on first floor and roof	Building Engineer to create and implement load management plan for whole building (Also see Item 4)	6-months
4	Movement joint has been stitched across at roof level	Demolish concrete upstand that straddles movement joint at roof and install an appropriate joint detail that complies with the developed waterproofing strategy (see Item 1)	6-months
5	Movement joint has been stitched across at roof level	Clear the joint of stiff fill at all locations, to fully allow differential movement, and install an appropriate joint cover plate on all floor slabs	6-months

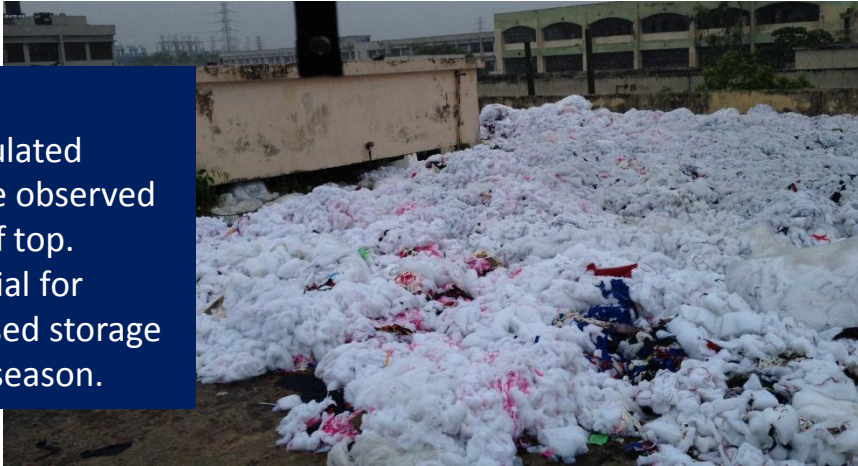
Roof

Unregulated storage observed on roof top. Potential for increased storage in dry season.

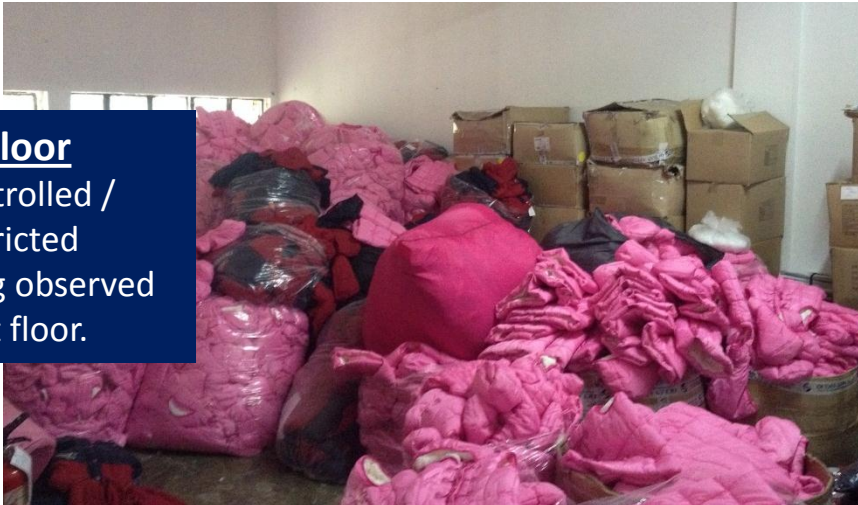
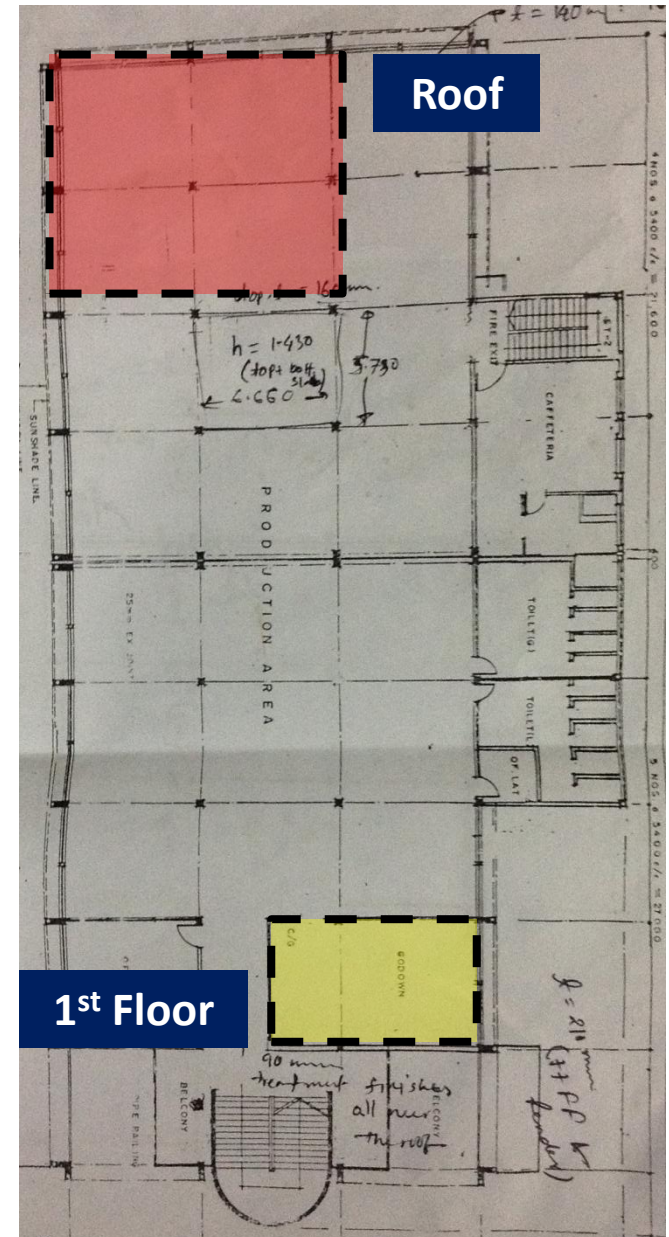
First Floor

Uncontrolled / unrestricted loading observed on first floor.

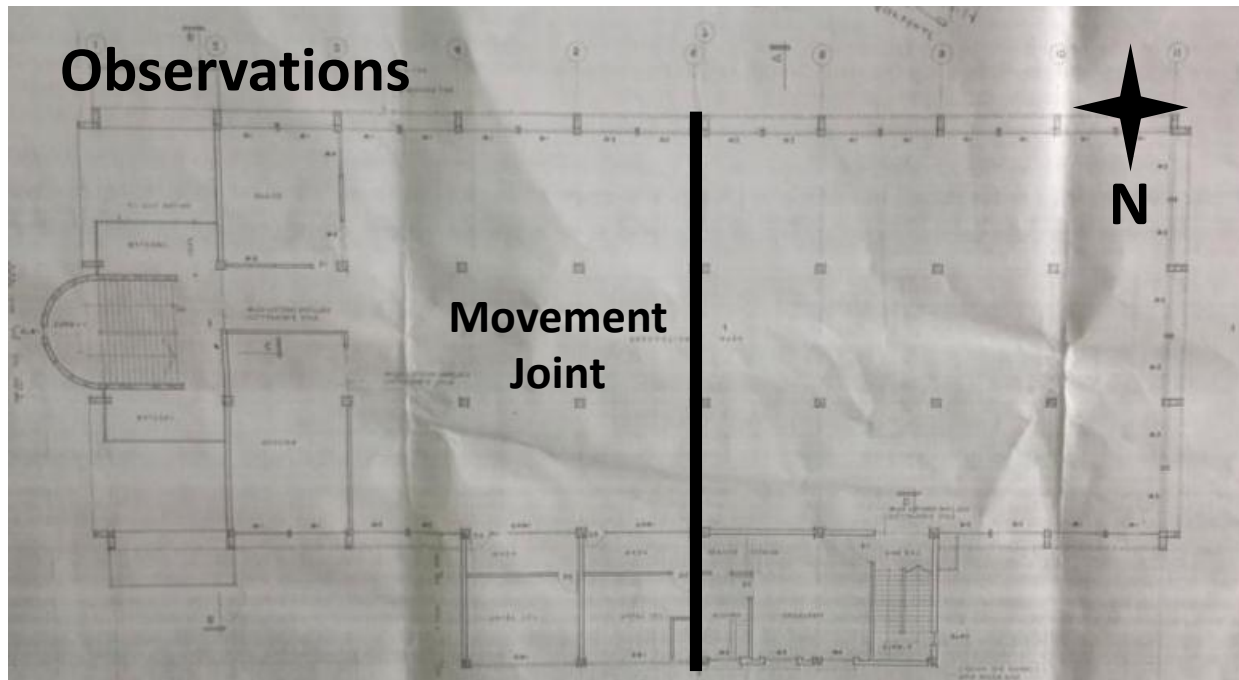
**Movement joint has been
stitched across at roof level**

Movement joint exist at centre of structure, spanning in the North to South direction.

Expansion joint has been covered with concrete at roof level, inhibiting any expansion.

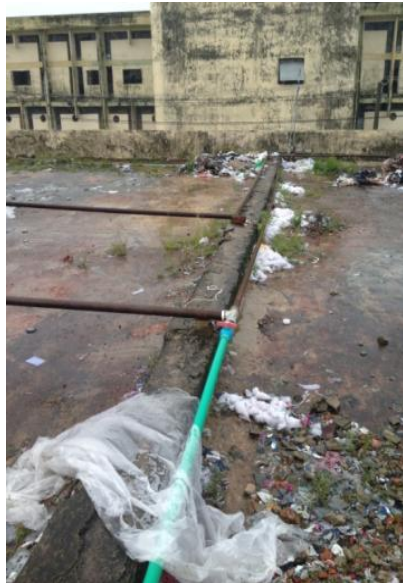
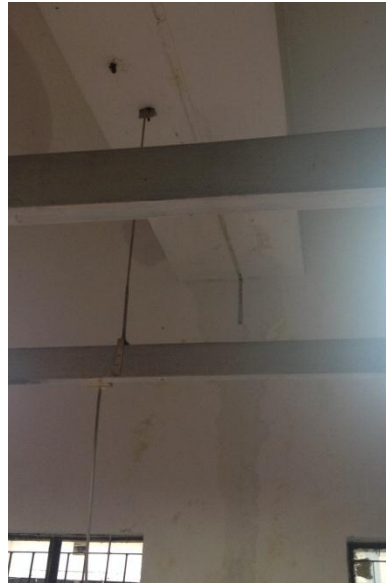
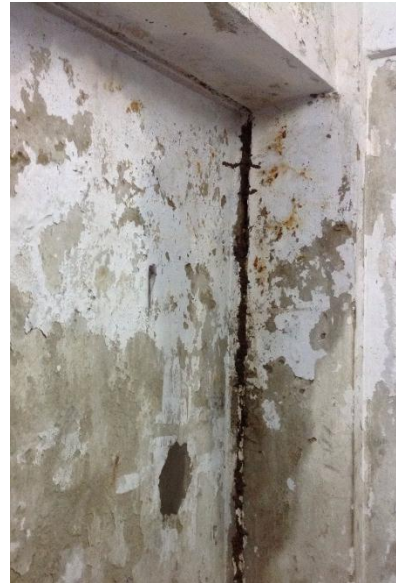
Joint has been plastered over at lower levels with water ingress due to lack of appropriate water proofing at roof level.

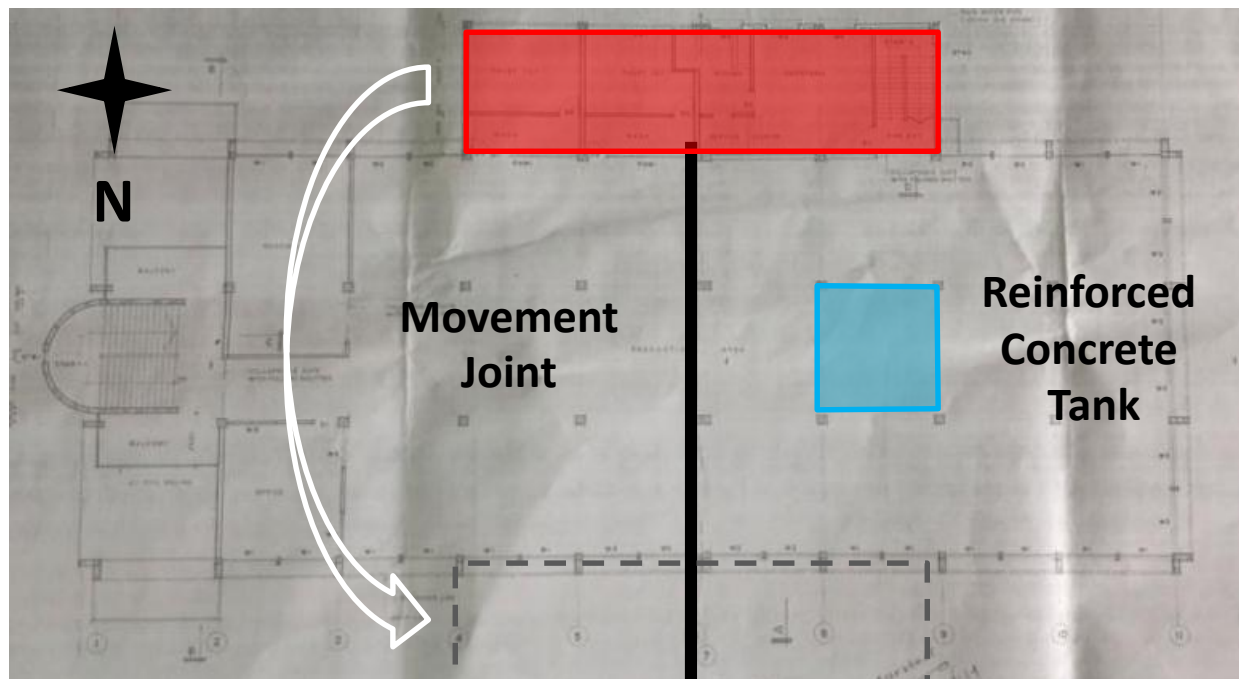
Drawing Inconsistencies

The structural drawings do not match the current arrangement and orientation of the building, and there are inaccuracies in the drawings.

Drawing provided consist of a plan for adjacent building which is a mirror floor plan of surveyed structure.

Additional RC Water Tank observed on roof of structure with no documentation to show structural design of element.

6	Inconsistencies between presented documentation and observed structure	Building Engineer to assess column capacity in location of the RC water tank located on the roof	6-months
7	Inconsistencies between presented documentation and observed structure	Loading plans to be created for all floors (including roof), taking into account the additional load from water storage that was not present on the as-built drawings	6-months
