# Active Composite Mills Ltd.

Dewan Idris Road, Zirabo, Ashulia, Savar.

21<sup>st</sup> June 2014

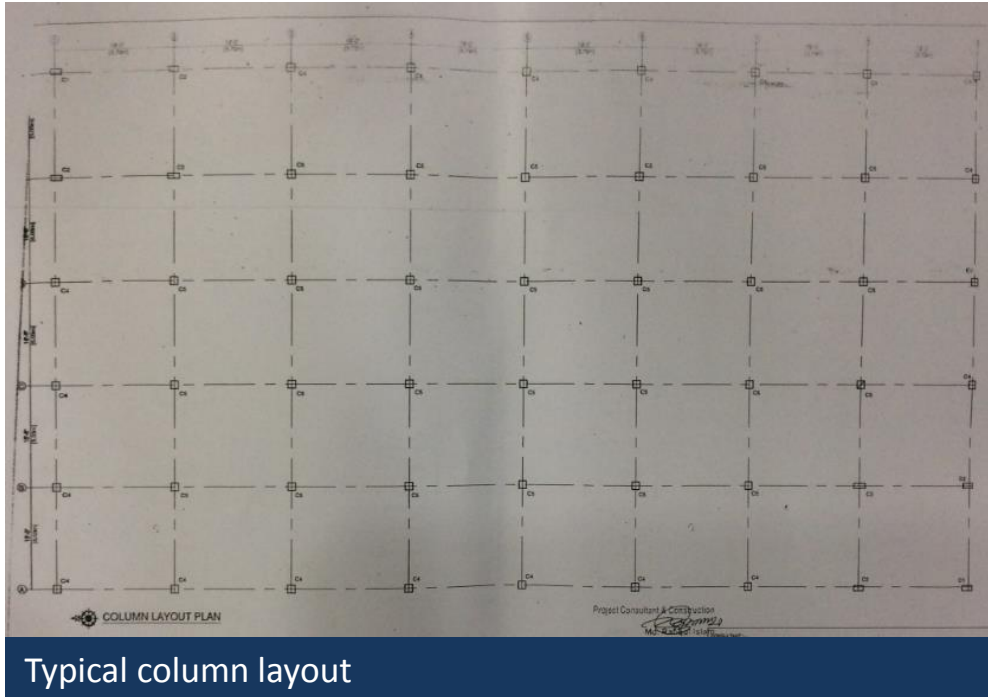
**Columns in factory building appear to be stressed in excess of normal design limits**

## Cursory calculations indicate that columns are highly stressed

Building Engineer is to perform detailed calculations (including preparation of a Detail Engineering Assessment) and concrete tests to prove column size and if required:

- Reduce loads by vacating floors
- Reinforce columns

| Item No. | Observation | Recommended Action Plan | Recommended Timeline |
|---|---|---|---|
| 1 | Cursory calculations for the Main Factory Building indicate columns are highly stressed | Factory Engineer to review design, loads and column stresses. | <b>Immediate - Now</b> |
| 2 | Cursory calculations for the Main Factory Building indicate columns are highly stressed | Verify insitu concrete stresses either by 100mm dia. cores or existing cylinder strength data for or 100mm dia. cores from 4 columns. | <b>Immediate - Now</b> |
| 3 | Cursory calculations for the Main Factory Building indicate columns are highly stressed | Verify existing reinforcement in columns. | <b>Immediate - Now</b> |
| 4 | Cursory calculations for the Main Factory Building indicate columns are highly stressed | A Detail Engineering Assessment of Main Factory to be commenced, see attached Scope. | <b>Immediate - Now</b> |

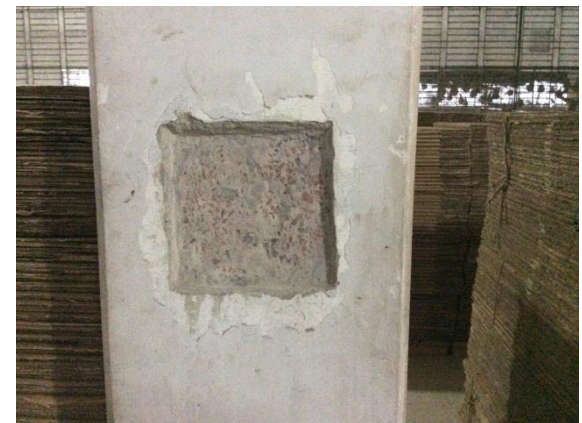
Tested ground floor column –  
Brick aggregate confirmed

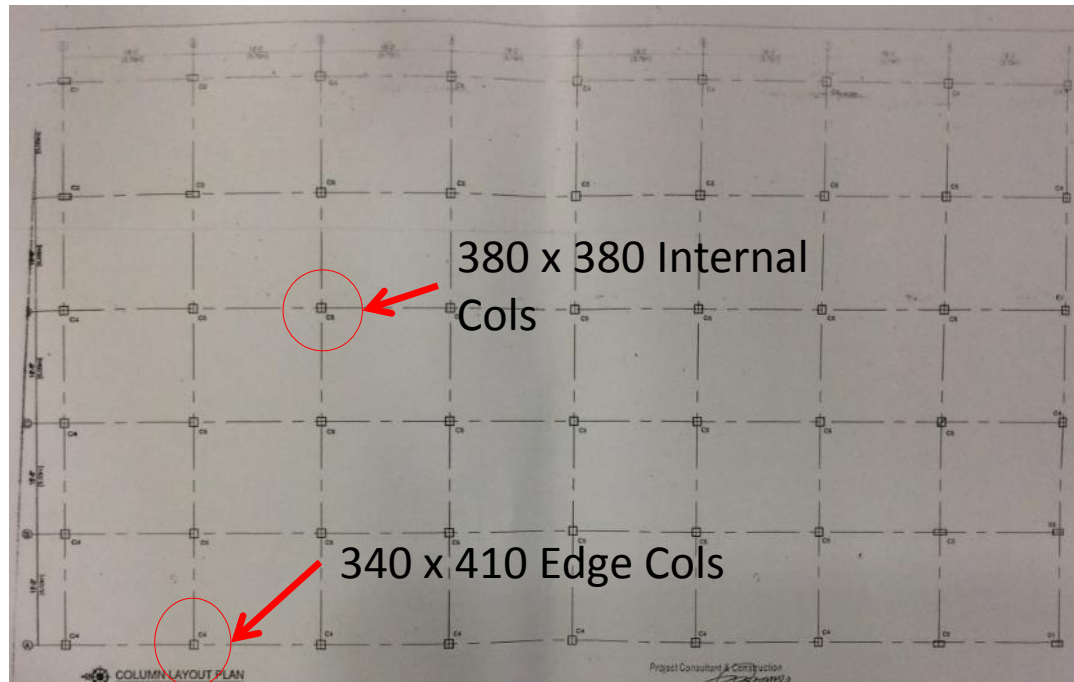
Typical column layout

# High punching shear stresses in suspended slabs in factory building

## Cursory calculations indicate high punching shear stresses in the suspended slabs

Building Engineer to perform detailed calculations and concrete tests to prove punching capacity of floor slabs and, if required:

- Reduce load on slabs
- Reinforce shear capacity of slabs

| Item No. | Observation | Recommended Action Plan | Recommended Timeline |
|---|---|---|---|
| 8 | Cursory calculations indicate high punching shear stress in suspended slabs of Main Factory Building | As part of Detail Engineering Assessment (see Item 1), Factory Engineer to review design, loads and punching stresses in slabs | <b>Immediate - Now</b> |
| 9 | Cursory calculations indicate high punching shear stress in suspended slabs of Main Factory Building | Verify insitu concrete stresses either by 100mm dia. cores or existing cylinder strength data for or 100mm dia. cores from 4 different areas on each slab, remote from columns. | <b>Immediate - Now</b> |

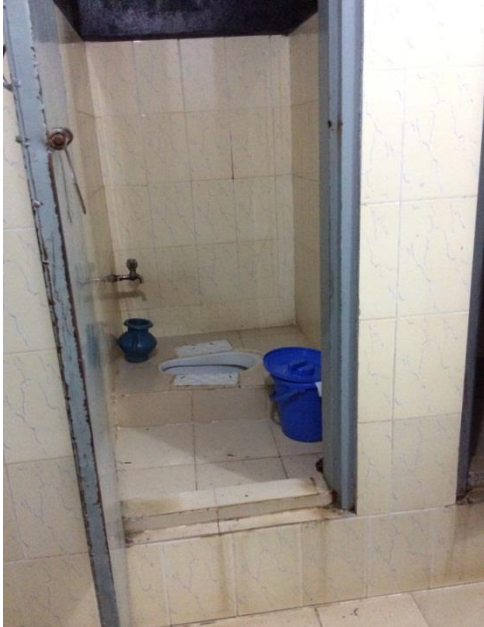
Toilet build-up on suspended slabs

Localised areas of high loadings were observed in all floors. A load management plan was in place, but no calculations were carried out to justify the applied loads.

Produce and actively manage a loading plan for all floor plates within the factory, giving consideration to floor capacity and column capacity.

| Item No. | Observation | Recommended Action Plan | Recommended Timeline |
|---|---|---|---|
| 12 | Localised areas of high loading on suspended slabs | Apply loading plan to all areas of the factory. | 6-weeks |

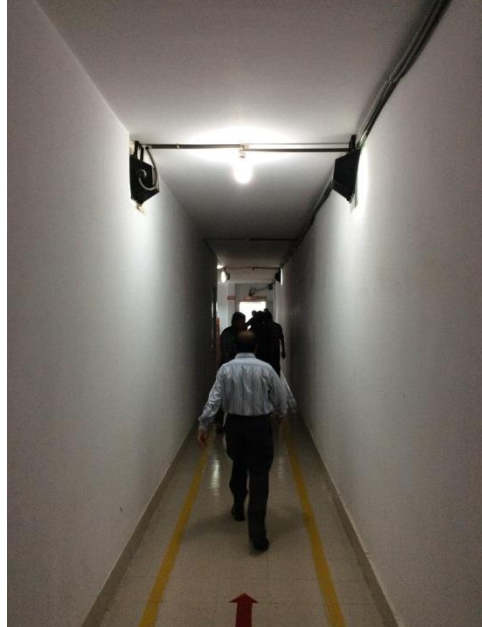
5<sup>th</sup> Floor Brick partition walls on suspended slab

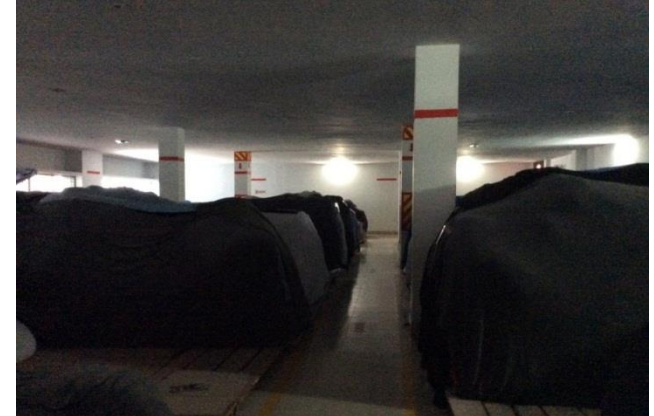
5<sup>th</sup> Floor Material storage – Load height limits indicated on columns are not based on calculations

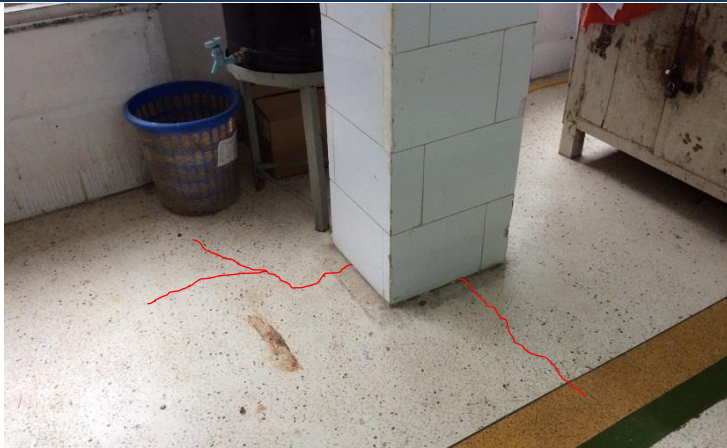
Cracking observed around column heads and along column strips

| Item No. | Observation | Recommended Action Plan | Recommended Timeline |
|---|---|---|---|
| 15 | Cracking and evidence of repairs to structural elements | The cause of the cracking should be identified and remediated as required, including corrosion protection to the reinforcement. | 6-weeks |
| 16 | Cracking and evidence of repairs to structural elements | Building engineer to record all cracking throughout building and monitor on an on-going basis. | 6-months |

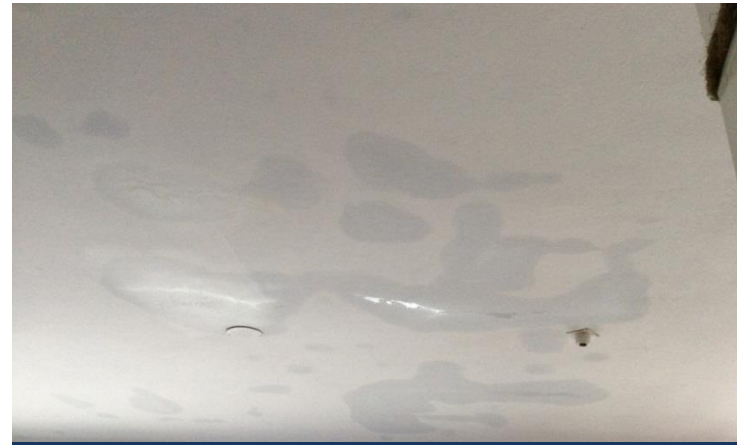
Cracking and water ingress in the soffit of the 6<sup>th</sup> floor slab

| Item No. | Observation | Recommended Action Plan | Recommended Timeline |
|---|---|---|---|
| 14 | Cracking and evidence of repairs to structural elements | As part of Detail Engineering Assessment (see Item 1), Building Engineer to investigate the cracking on the soffit of the 6th floor where water was observed to be penetrating the slab. | 6-weeks |

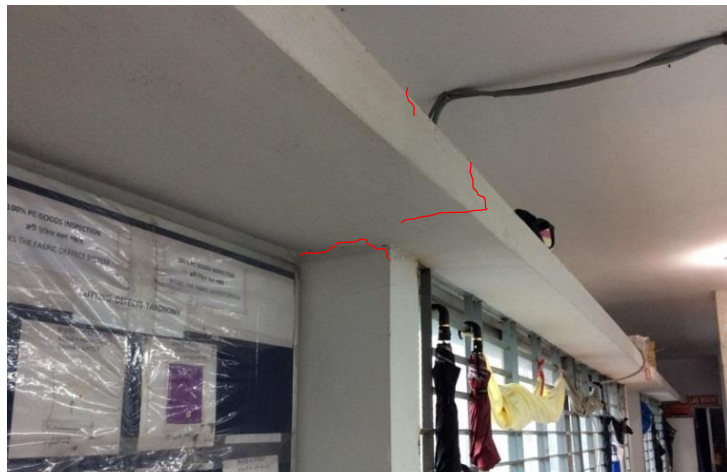
Cracks in façade on 4<sup>th</sup> floor

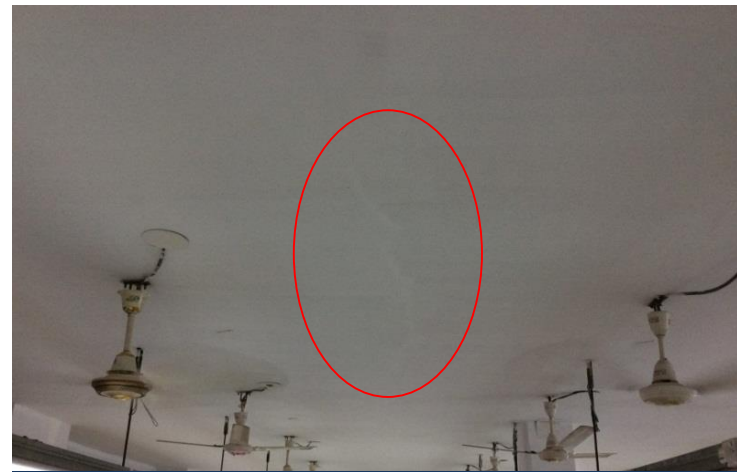
Repairs to soffit of 3<sup>rd</sup> floor slab

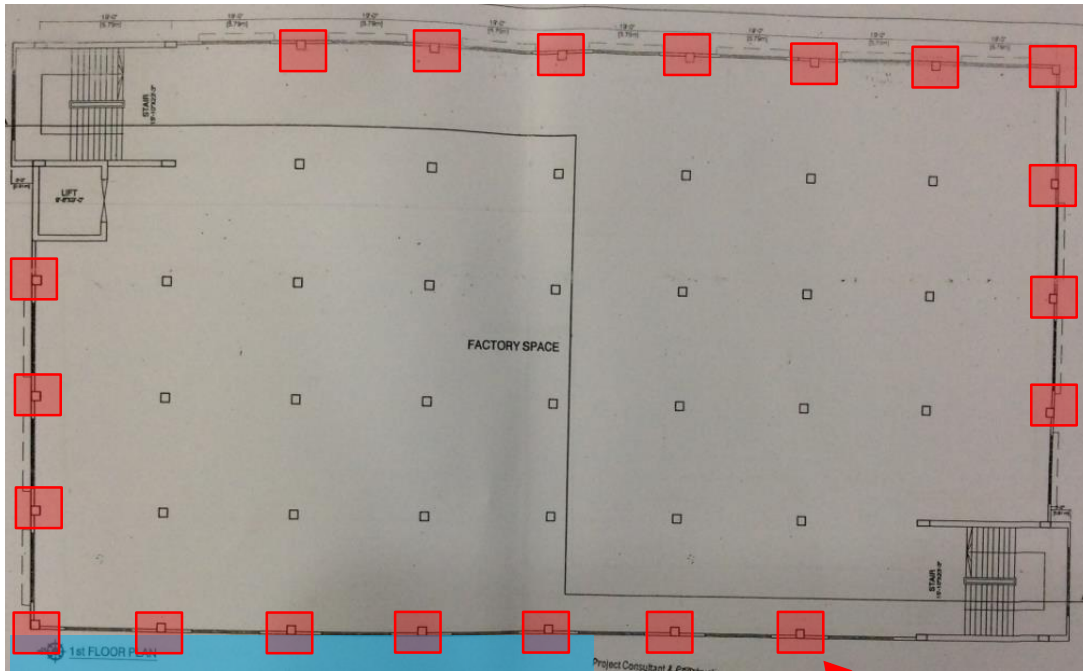
Cantilever on 1<sup>st</sup> floor not shown on drawing

Constructed perimeter columns smaller than indicated on the structural drawings. Building engineer to survey and update drawings as required.

- The 6<sup>th</sup> floor has not been constructed in the manner indicated on the drawings.
- Internal building layouts where indicated do not match the as-constructed building layout

| Item No. | Observation | Recommended Action Plan | Recommended Timeline |
|---|---|---|---|
| 18 | Structural drawings not consistent with the as-constructed arrangement of the factory | As part of Detail Engineering Assessment (see Item 1), Building Engineer to carry out survey of as-constructed building. | 6-weeks |
| 19 | Structural drawings not consistent with the as-constructed arrangement of the factory | As part of Detail Engineering Assessment (see Item 1), develop full engineering as-built drawings showing structure, loading, elements, dimensions, levels, foundations and framing on Plan, Section and Elevational drawings. | 6-months |
