The New Delta ApparelsLtd

Plot# 6,8,10, Road# 1/A, Turag Housing, Mohammadpur, Dhaka - 1207

31st May 2014

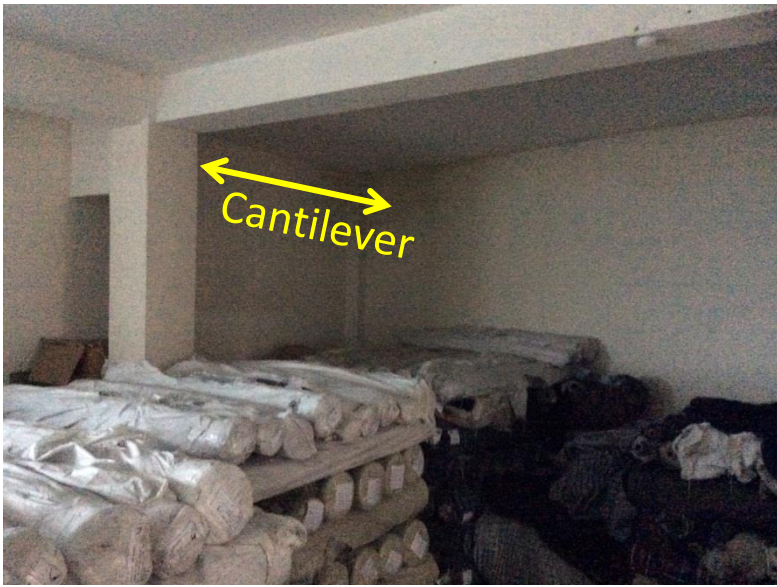
**High stress levels in Perimeter Columns
where slabs have been extended beyond
the design/permit drawings.**

Large storage loading on Cantilever slab.

Item No.	Observation	Recommended Action Plan	Recommended Timeline
1	High stress levels in Perimeter Columns where cantilevers have been extended beyond the design/permit drawings.	Building Engineer to review design, loads and column stresses in all edge columns attracting loads from cantilevers.	Immediate - Now
2	High stress levels in Perimeter Columns where cantilevers have been extended beyond the design/permit drawings.	Live load in cantilever/undocumented perimeter slab areas to be limited to 1.5kPa pending outcome of DEA.	Immediate - Now
3	High stress levels in Perimeter Columns where cantilevers have been extended beyond the design/permit drawings.	Verify in-situ concrete stresses either by 100mm dia. cores or existing cylinder strength data for [the identified columns] or [100mm dia. cores from 4 columns].	Immediate - Now
4	High stress levels in Perimeter Columns where cantilevers have been extended beyond the design/permit drawings.	A Detail Engineering Assessment of the Factory Building to be commenced, see attached Scope	Immediate - Now

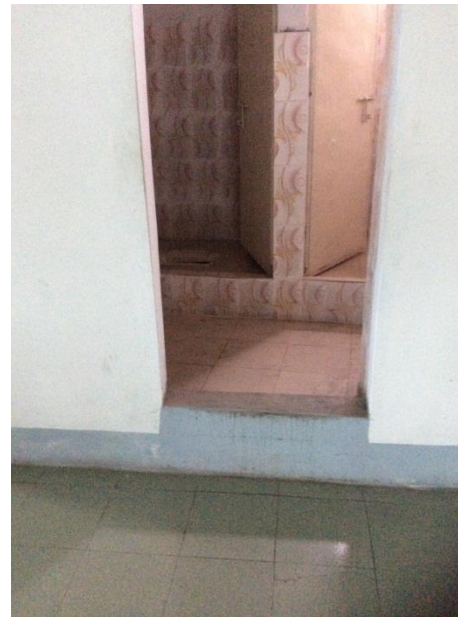
Large build-up in toilet area's on Cantilever slab.

**Heavily Loaded cantilevered slabs.
(toilet build up, storage, heavy machinery)**

11	Heavily Loaded cantilevered slabs. (toilet build up, storage, heavy machinery)	Continue to implement the load management plan	6-months

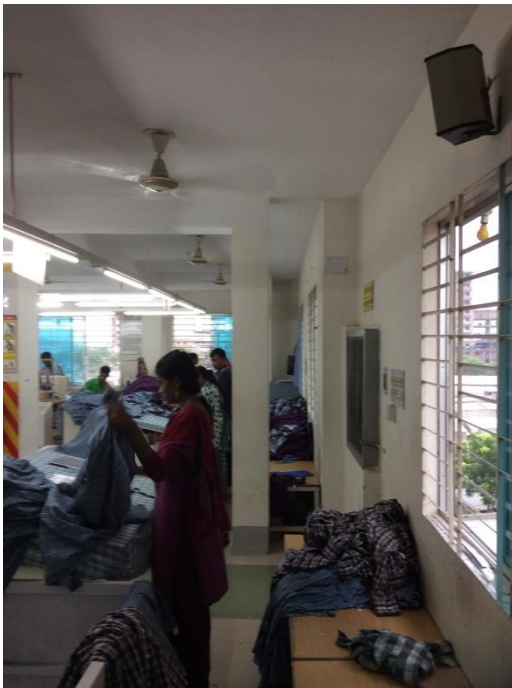
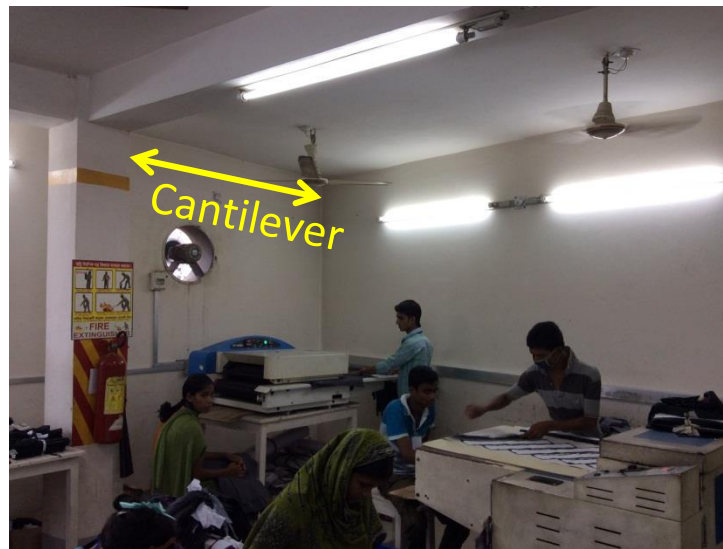
Cantilever slab.

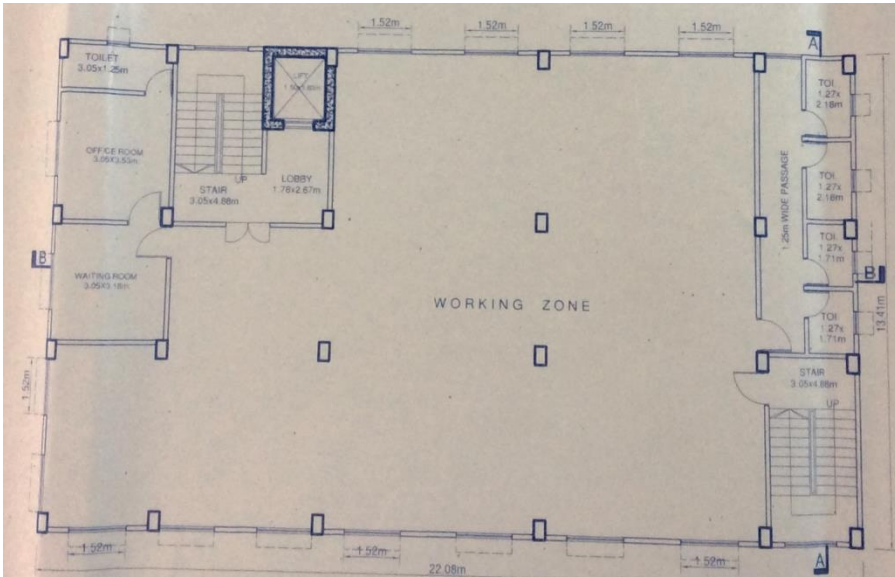
These columns do not exist from first floor to roof level.

Permit Drawing, no Cantilever Shown

Denotes undocumented Cantilevers (may be supported on masonry wall)

Item No.	Observation	Recommended Action Plan	Recommended Timeline
12	Discrepancies between permit drawing, design drawings and as built structure	Building Engineer to commence update of the drawings to reflect the as-built structure and loading levels at all floor levels, including as built floor finishes thickness.	Immediate - Now
13	Discrepancies between permit drawing, design drawings and as built structure	Complete update of as-built drawing	6-weeks
14	Possible Vehicle impact of Columns	As part of DEA, Building Engineer to review and ensure that columns are protected from possible vehicle impact.	6-weeks
15	Cracking in Floor Slabs	Building Engineer to investigate cracking and determine cause	6-weeks
16	Cracking in Floor Slabs	Building Engineer to carry out full design check of all floor slabs to confirm that the slabs are capable of carry the building design loads.	6-weeks
17	Non-engineered lightweight steel structures	Lightweight steel roofs are to be reconstructed/upgraded to ensure adequacy for code vertical and wind loads by the Building Engineer.	6-weeks

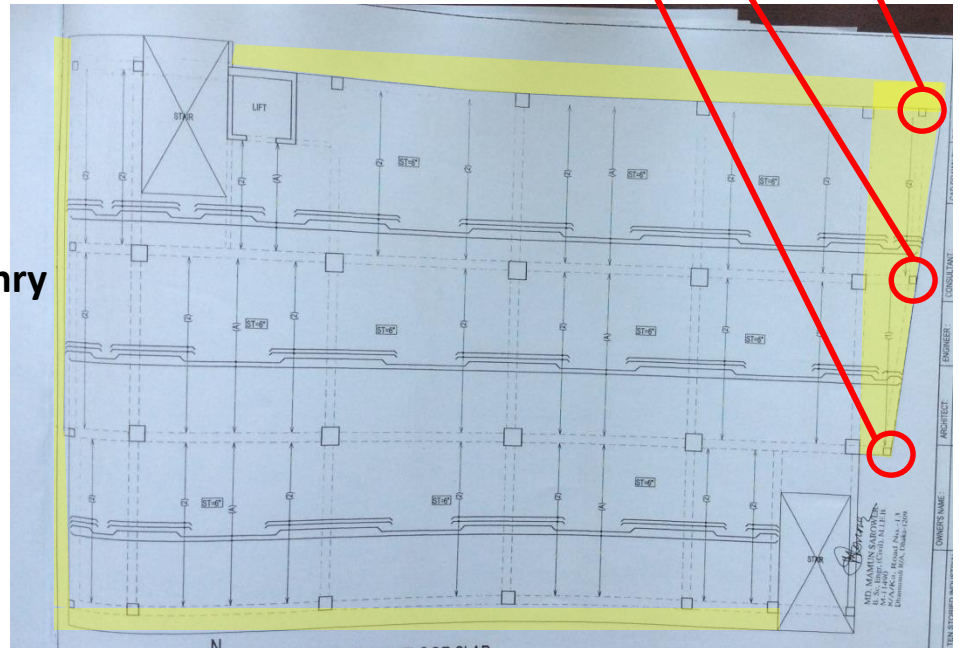
Structural Drawing, no Cantilevers Shown

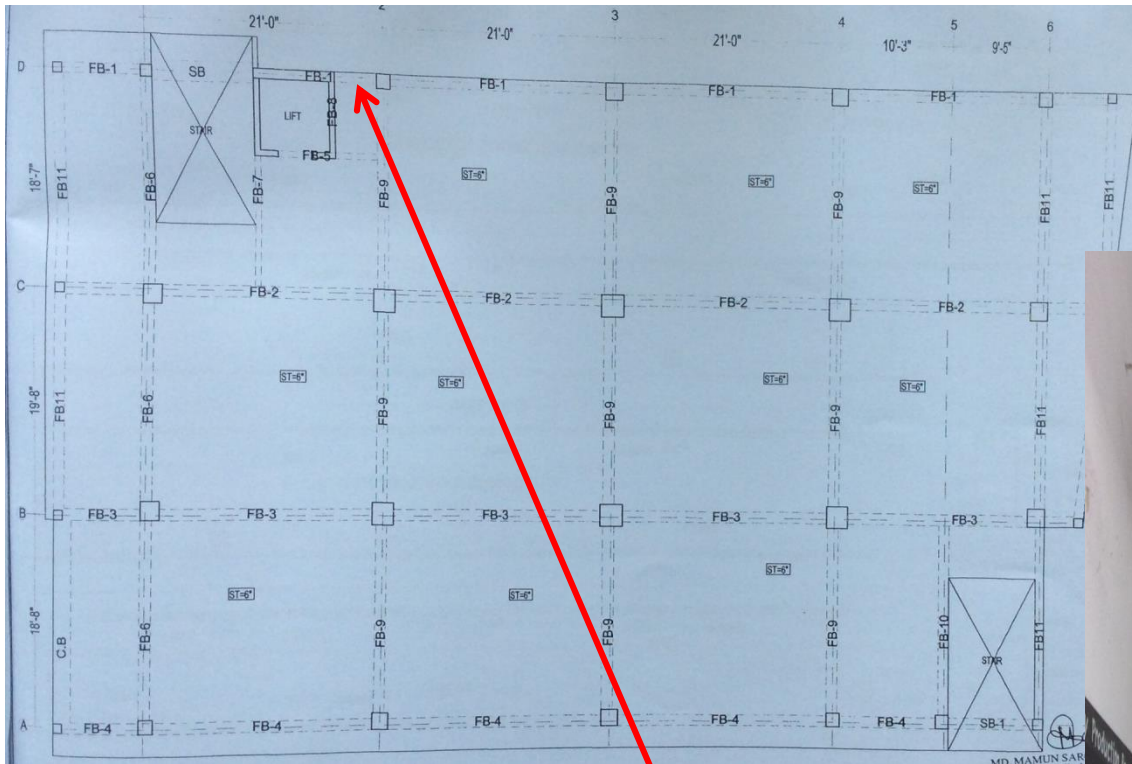
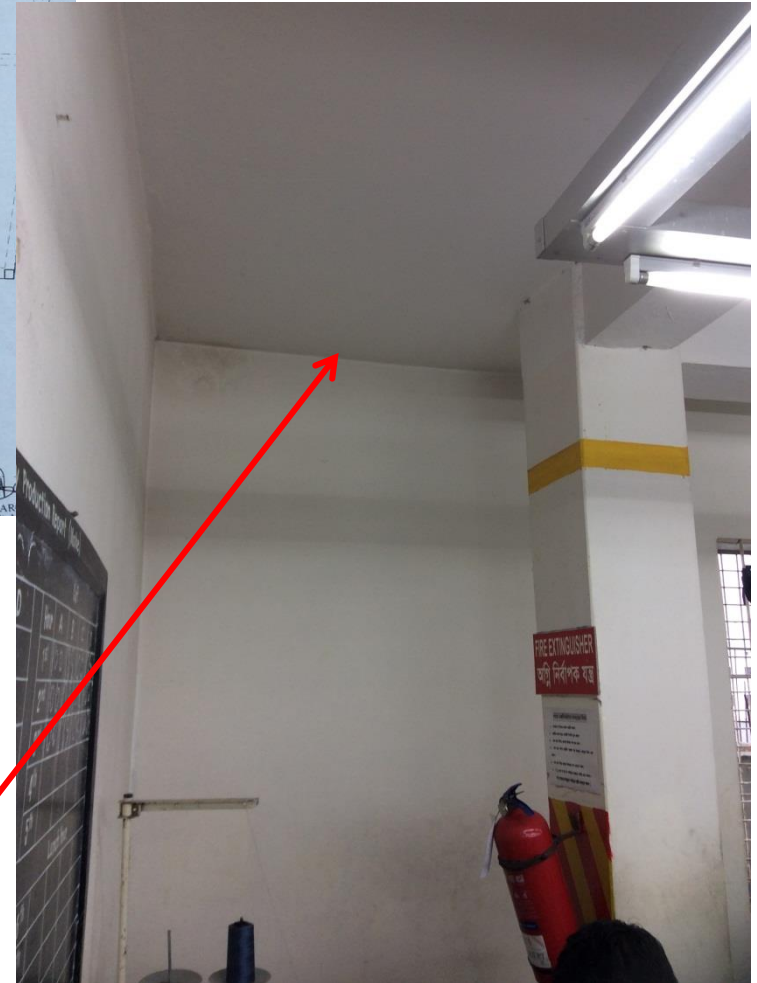
**Beam shown on plans
Missing in as constructed
Building at 2nd floor.**

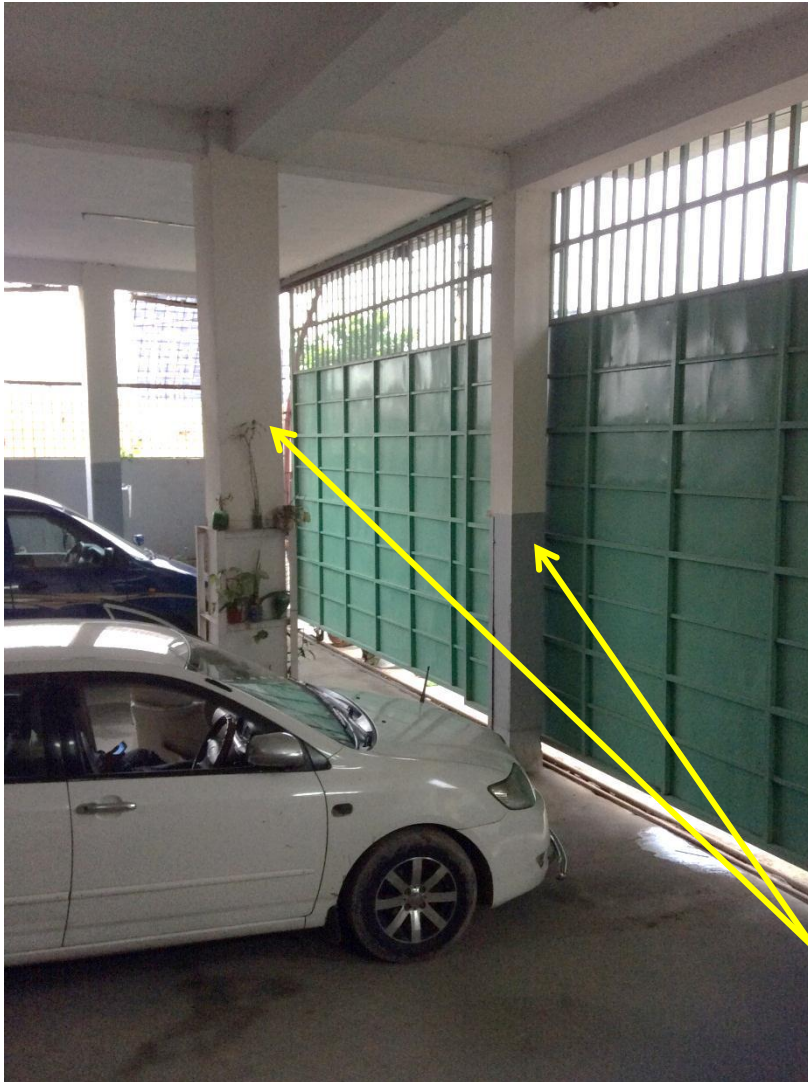
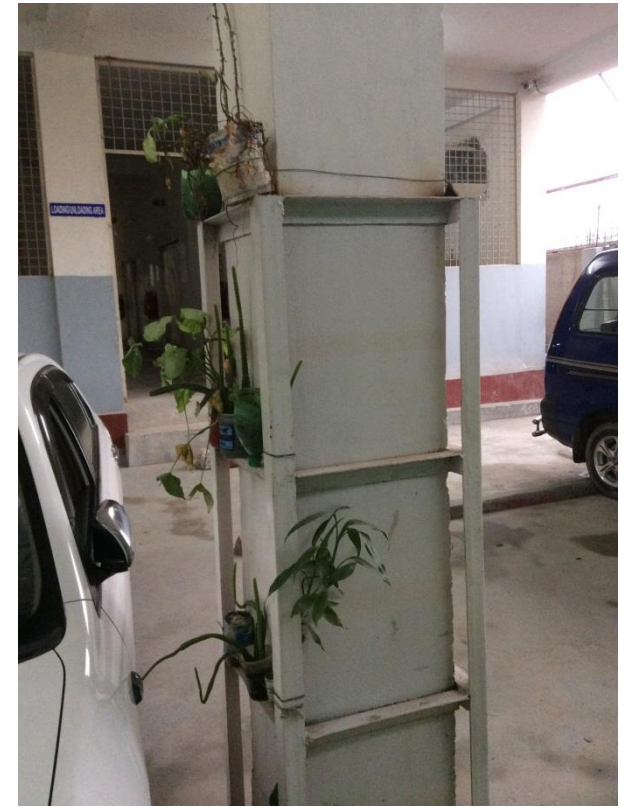
Possible Vehicle Impact of Columns

Current column protection

These columns are prone to vehicle impact.

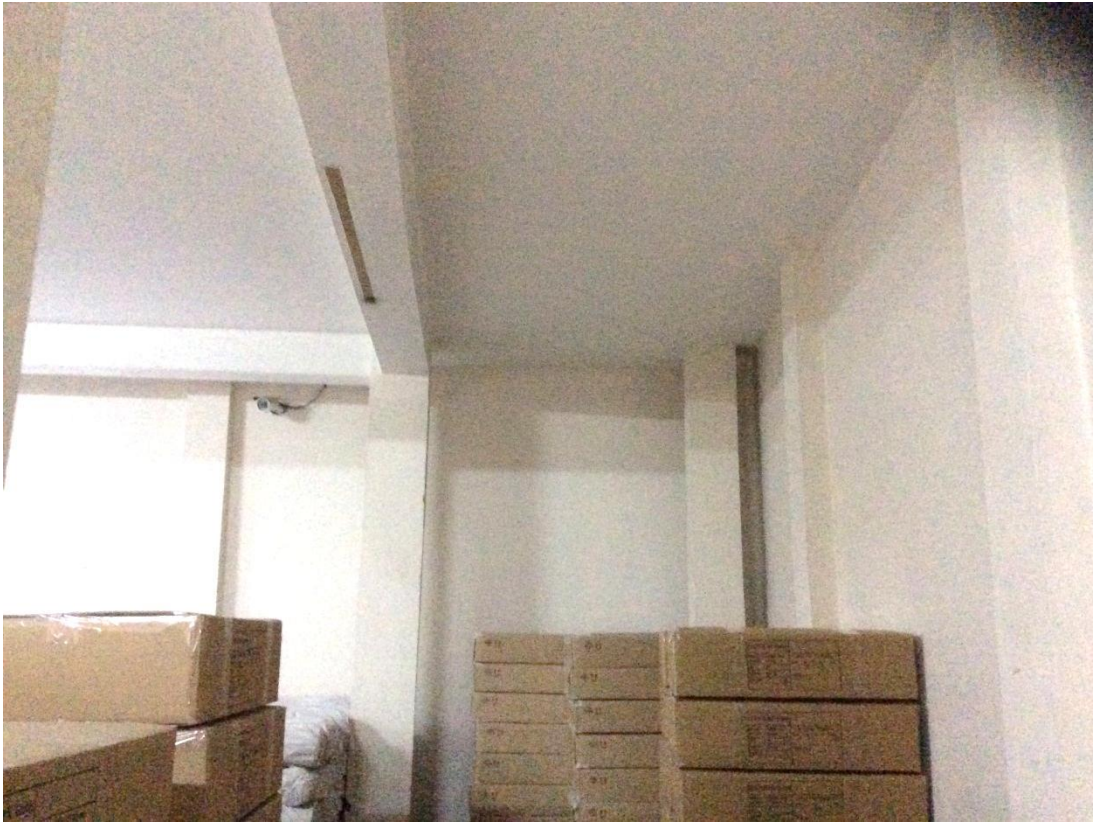
Cracking in floor slabs

Cracks in soffits of slabs were recently decorated.

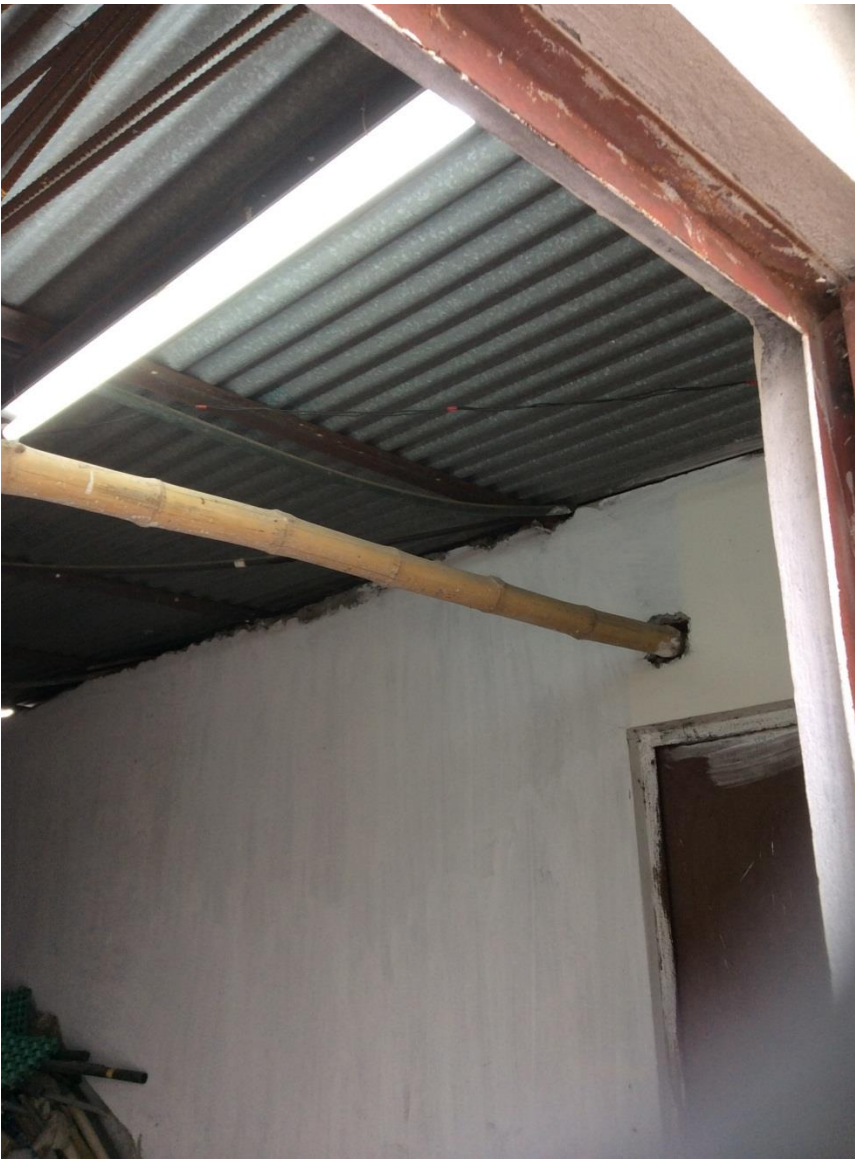
Non-Engineered Steel Roofs to Stair Cores.

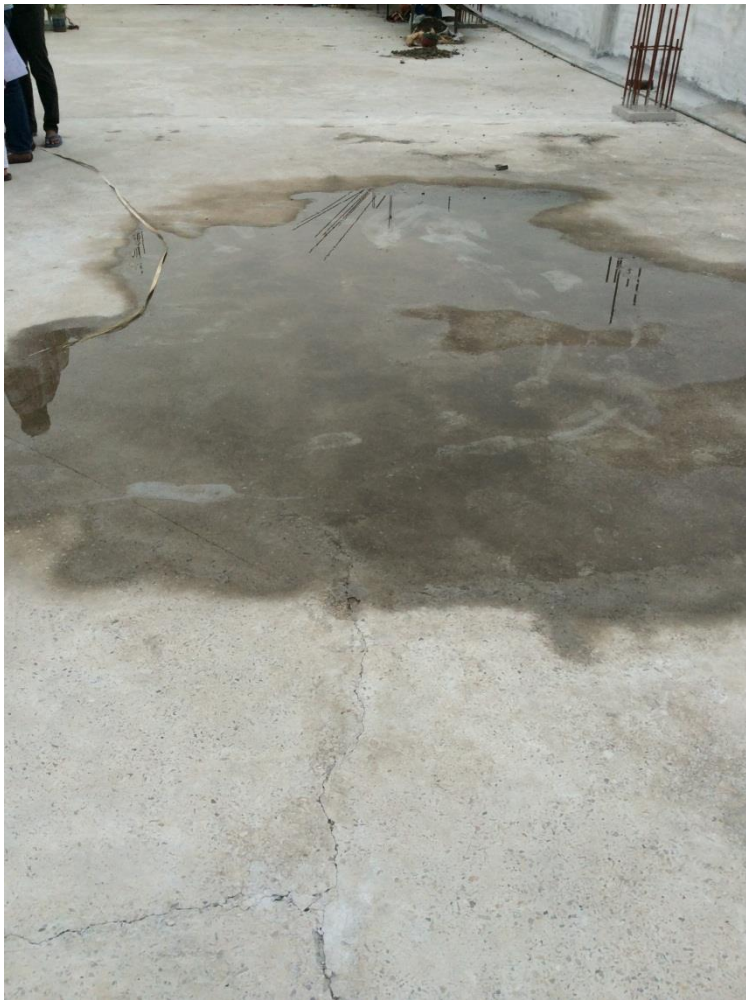
Cracking in roof finish may allow water ingress to structural elements.

18	Water ingress	Building engineer to survey factory and identify areas of water ingress. Divert all water away from structure to protect the RC structures from direct contact with water.	6-months

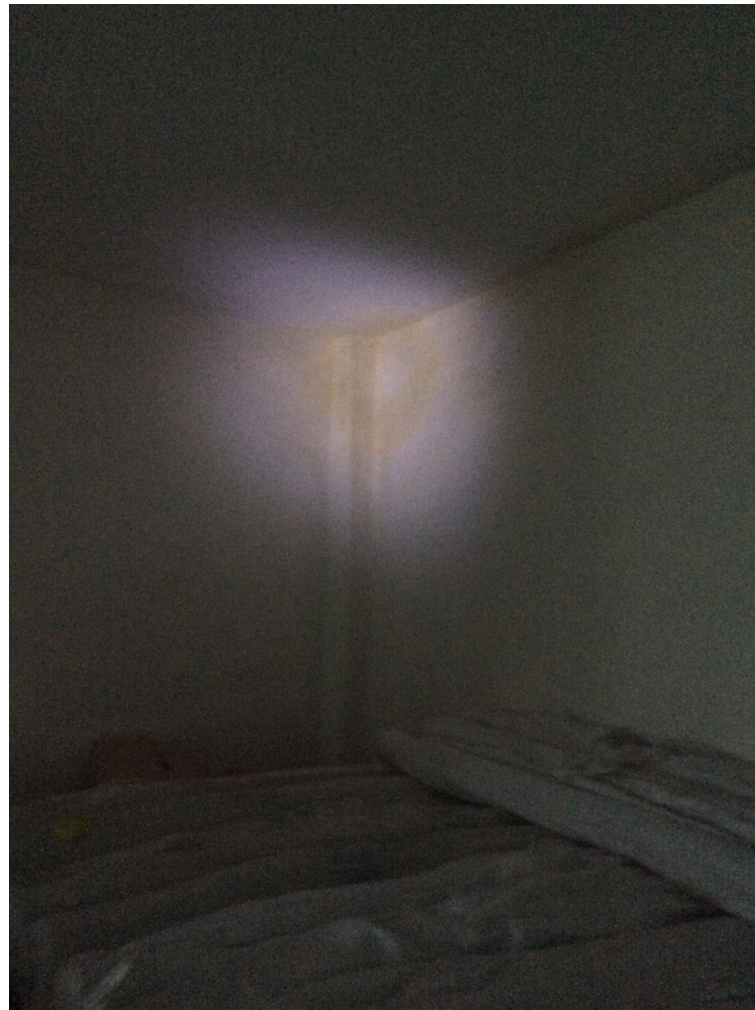
Leaking Toilet may allow water ingress to structural elements.
