# Anupam Hosiery Industry (PVT.) Ltd

Vulta, Rupgonj, Narayangonj, Dhaka  
(+23.77499N, 90.56040E)

10 June 2014

# Observations

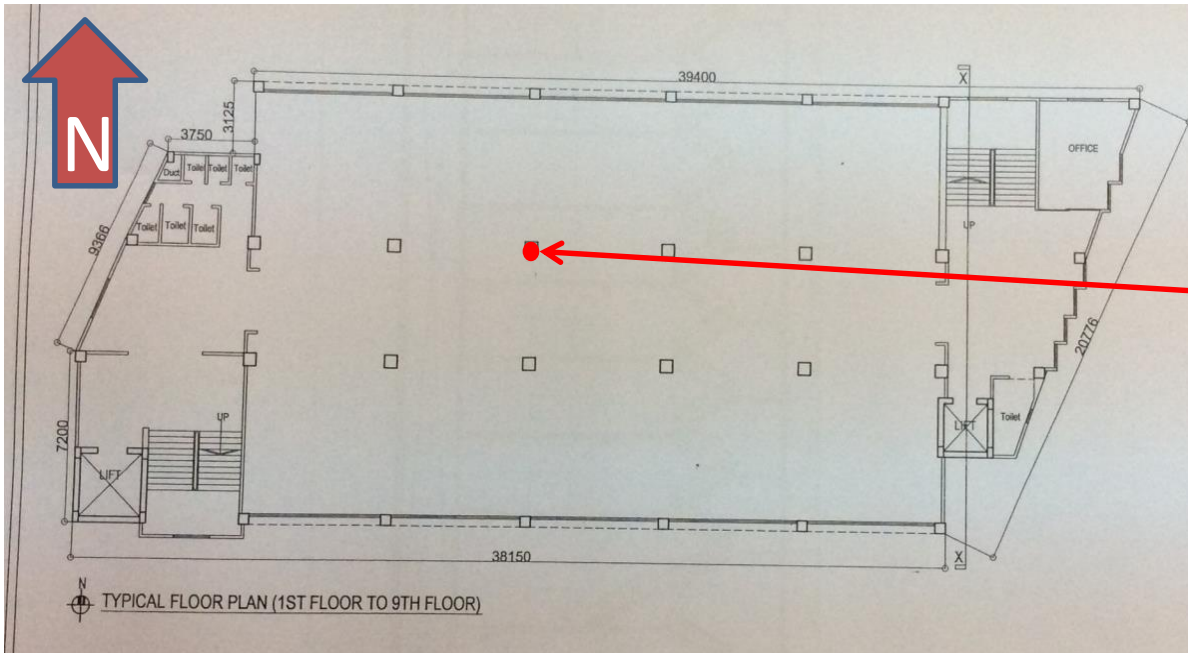
Main Factory Building

## Item 1 – Columns appear to be stressed to a high level

**Outline calculations indicate that columns are stressed to a high level and require immediate review.**

**Building Engineer to perform detailed calculations including a Detail Engineering Assessment (see attached scope) and concrete tests to prove adequacy of column sizes, and (if required):**

- Reduce loads by vacating floors
- Reinforce columns

**Existing reinforcement in columns to be verified on site by Building Engineer**

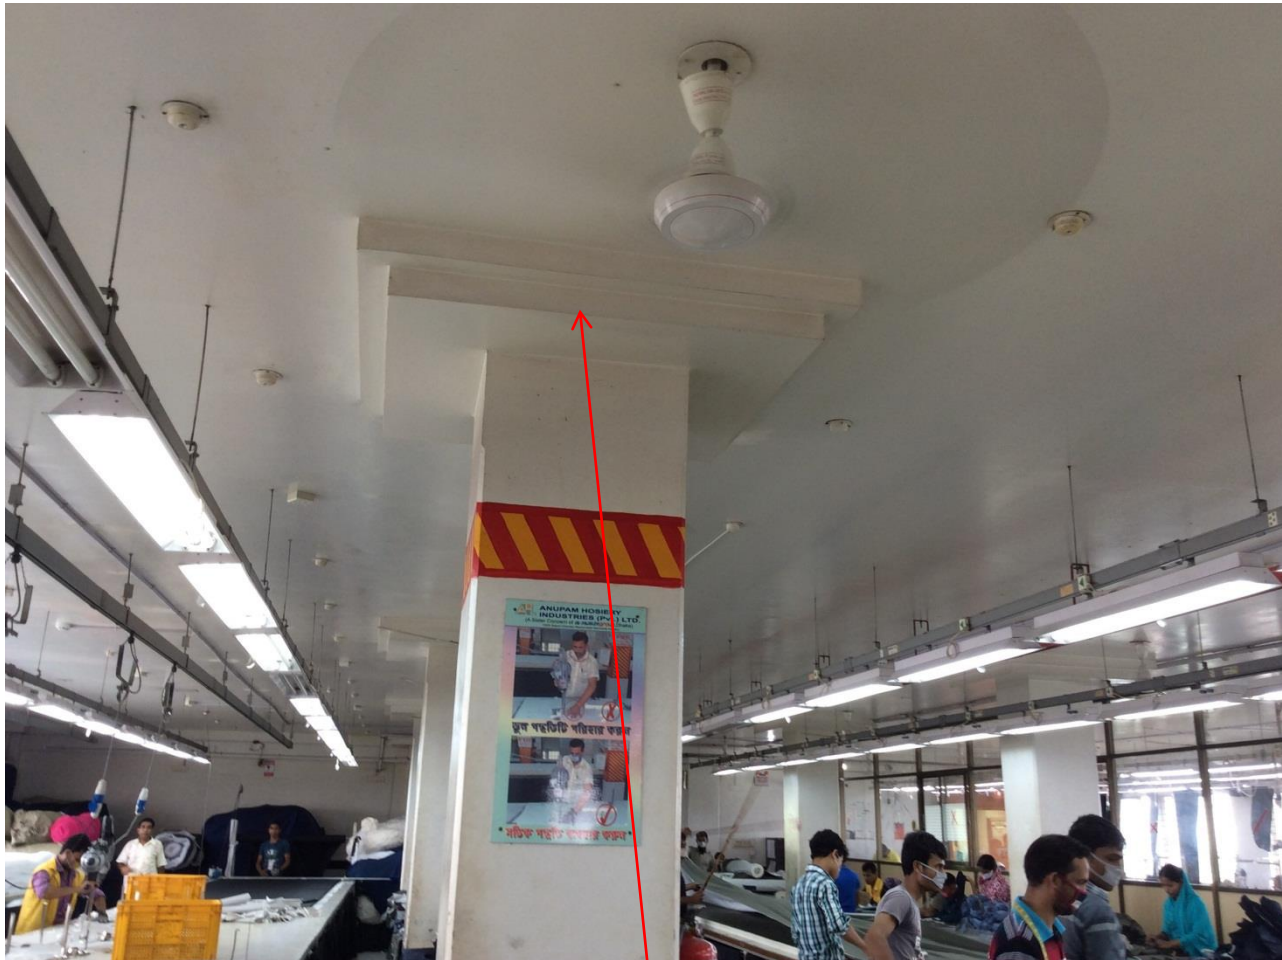
## Item 2 – Design check required for lateral stability of the building

Structural system mainly flat slab with column heads. Frame action due to absence of beams would be considered limited

Item No.	Observation	Recommended Action Plan	Recommended Timeline
8	Design check required for the lateral stability of the Main Factory Building	The Building is tall and relatively narrow with flat slabs for all floors except the ground floor.	<b>6-weeks</b>
9	Design check required for the lateral stability of the Main Factory Building	The Building Engineer is to assess the capacity of the Building to resist lateral loadings as part of the Detail Engineering Assessment. (Refer to Item 1 actions)	<b>6-weeks</b>
10	Design check required for the lateral stability of the Main Factory Building	The Building Engineer is to implement any measures deemed necessary following the completion of the above assessment.	<b>6-months</b>
11	Design check required for the loading from the toilet plinths	The Building Engineer is to check the structural capacity of the floor slab in the area of the toilet plinths to transfer the loading back to the columns.	<b>6-weeks</b>

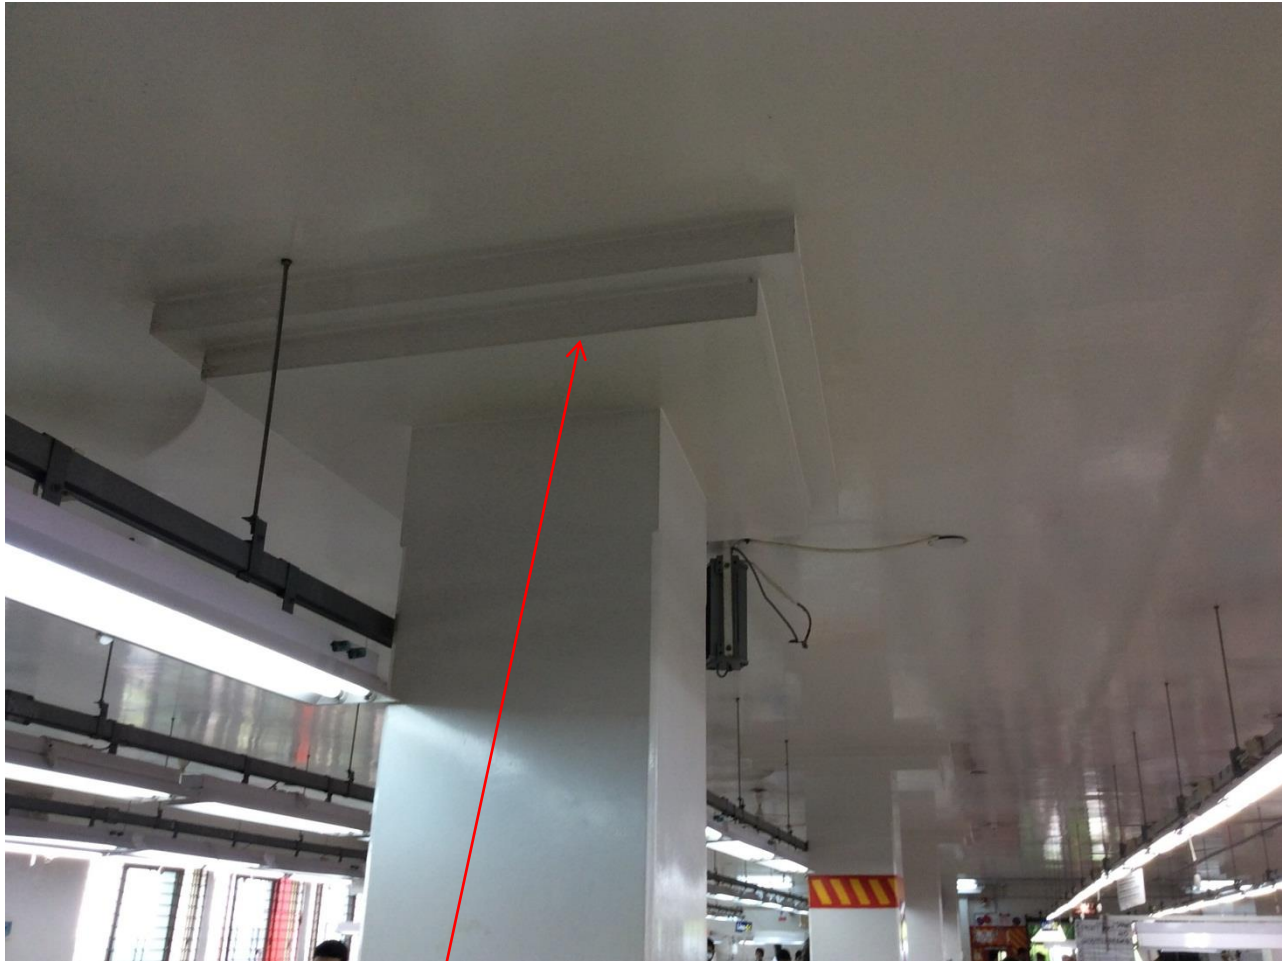
## Item 3 – Design check required for punching shear capacity of flat slab floors

Structural system mainly flat slab floors with column heads. Punching shear capacity to be verified.

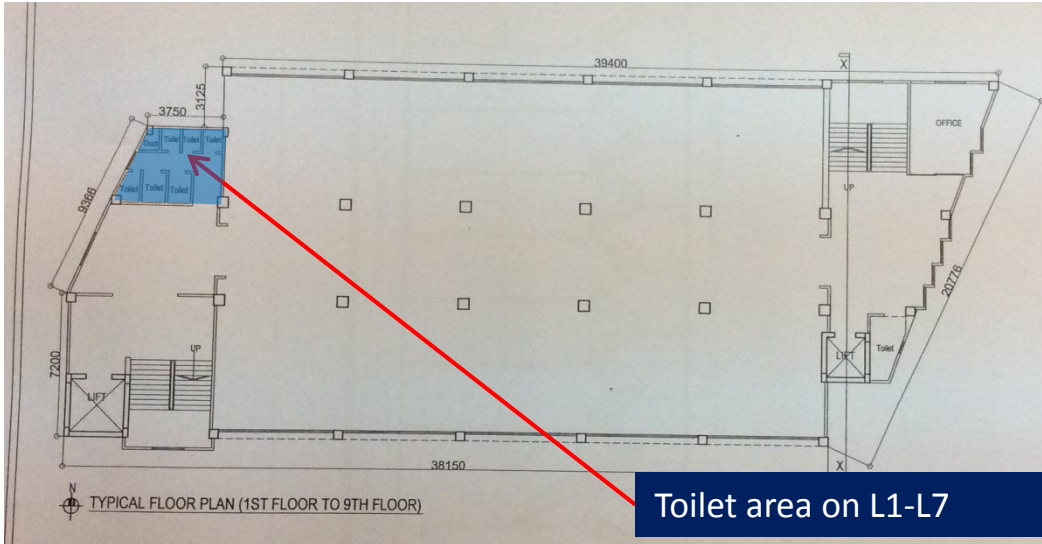
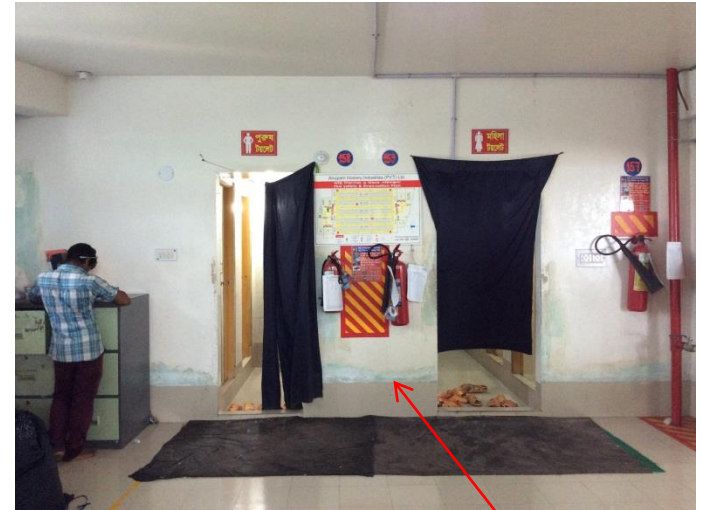
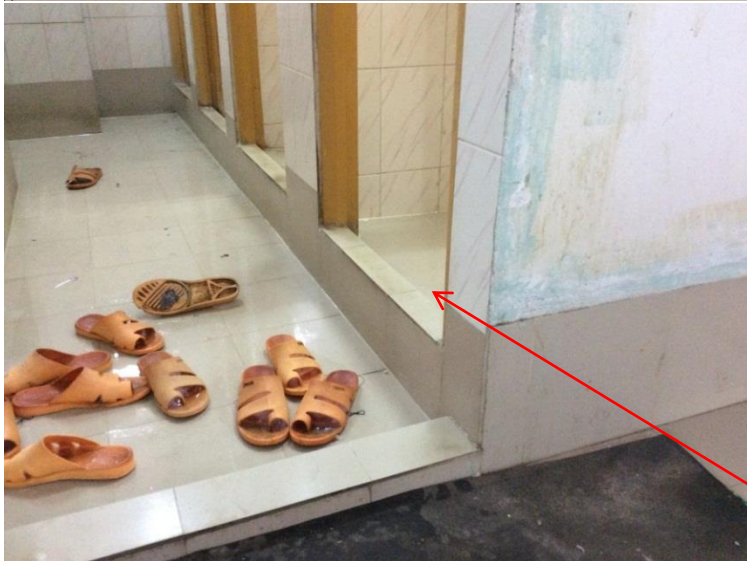
## Floor Build-up in Toilet Areas

# Item 4 – Design check required for the loading from the toilet plinths

12	Design check required for the loading from the toilet plinths	Produce and actively manage a loading plan for all floor plates within the factory giving consideration to floor capacity and column capacity.	<b>6-weeks</b>

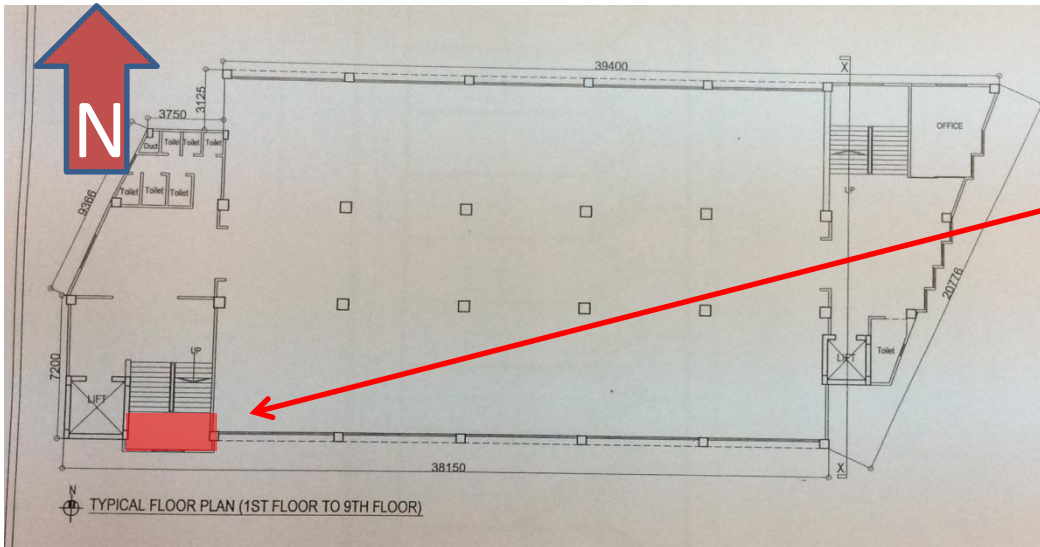
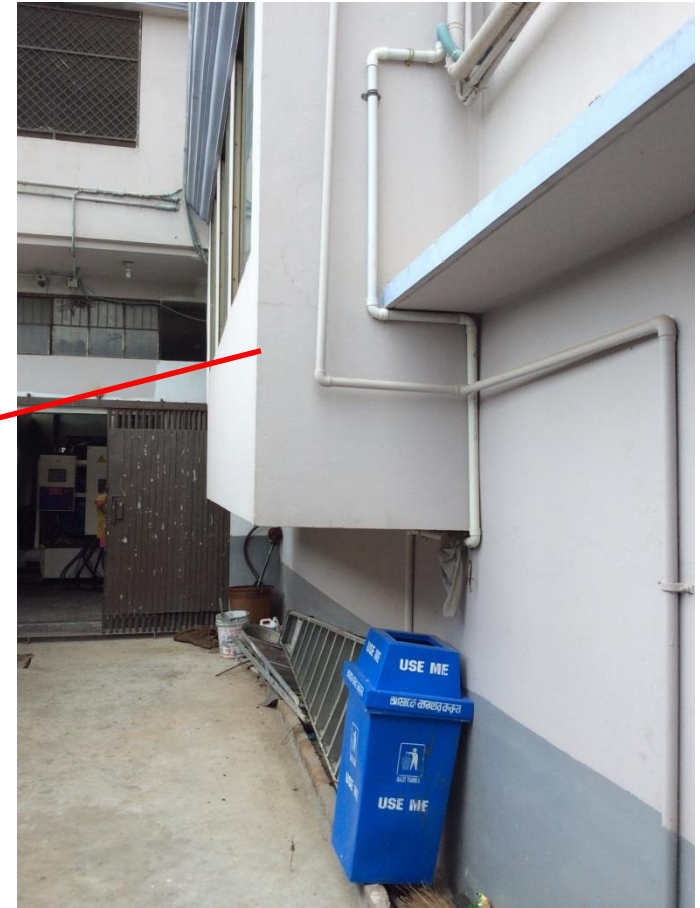
## Cantilever Floor Slab

# Item 5 – Design check required for the cantilever slab on the south west corner of the Building

Item No.	Observation	Recommended Action Plan	Recommended Timeline
13	Design check required for the cantilever slab on the south west corner of the Building	The Building Engineer is to check the structural capacity of the floor slab in the area indicated and confirm with calculations its capacity to support both floor loadings and façade loadings.	6-weeks
14	Design check required for the light steel roofs as noted	No bracing noted in most of the light weight steel roofs and structures viewed on site.	6-months
15	Design check required for the light steel roofs as noted	The Building Engineer is to assess the adequacy of the structures to resist wind loading (pressure, suction & uplift). Bracing and other remedial measures deemed necessary to be implemented.	6-months
16	Inconsistencies between the Utility Building drawings presented and the as-built structure	Building Engineer to check, collect information and produce accurate and fully complete as-built documentation which is to include the correct sizing of all structural members as well as the reinforcement in each.	6-months

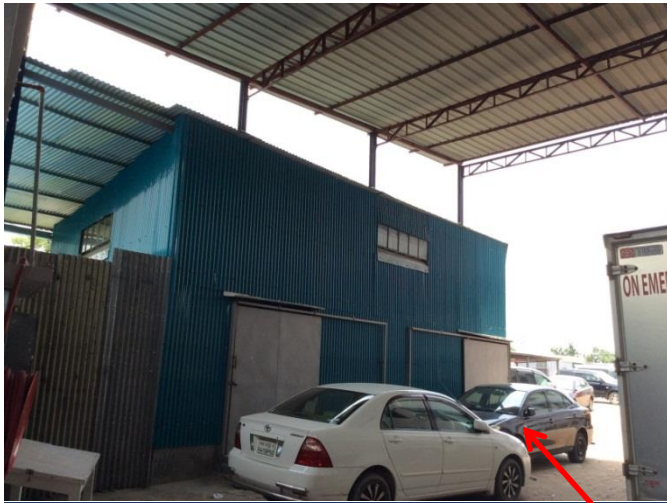
Steel Roof spanning between the Main Building and Childcare Building

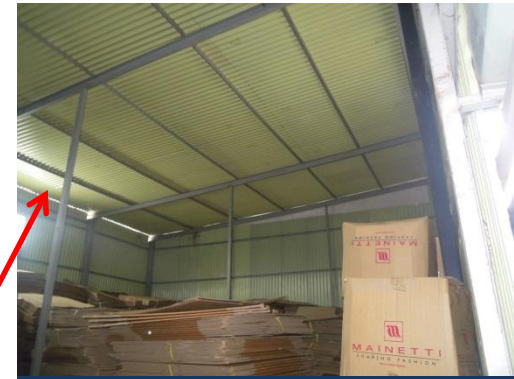
Light steel roof to Storage Building

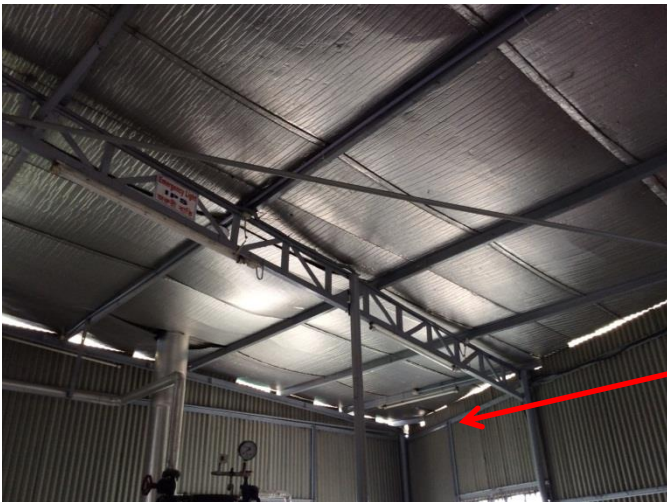
Steel roof of Utility Building

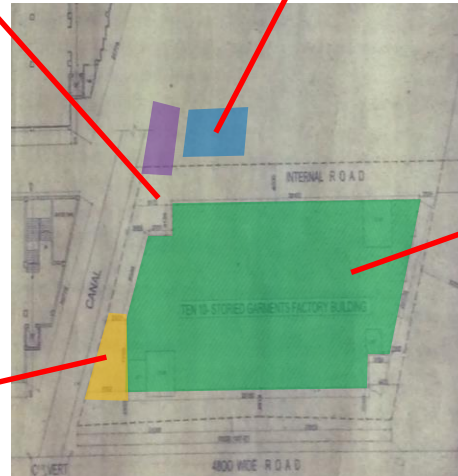
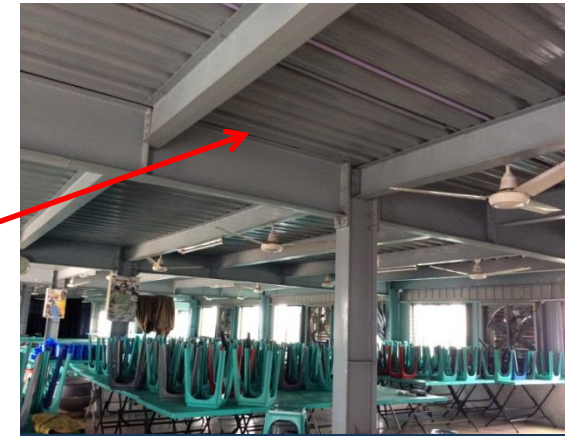
Steel roof of Main Building

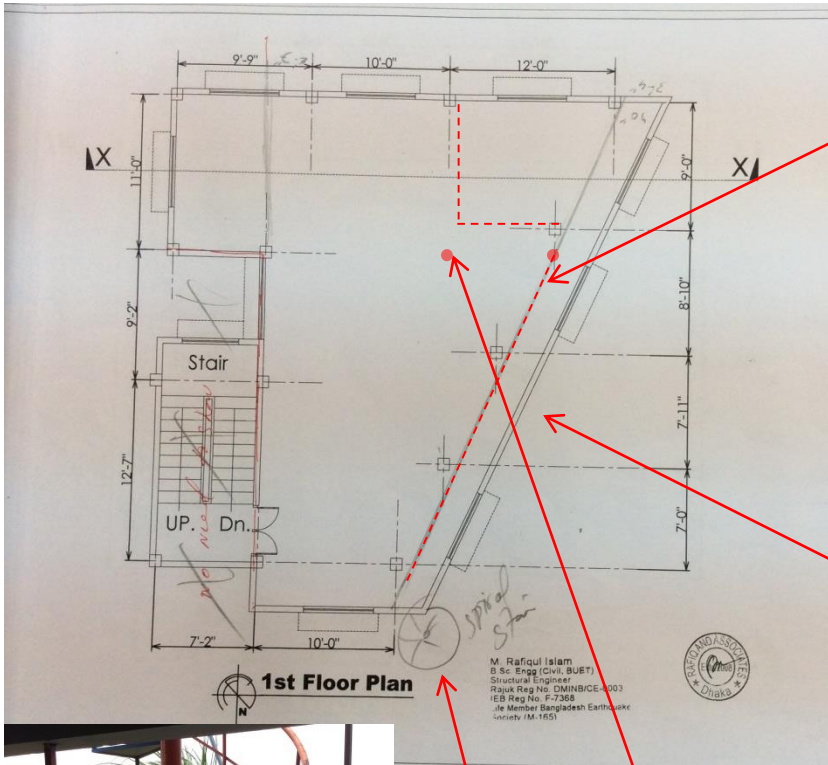
Walls not indicated on drawings

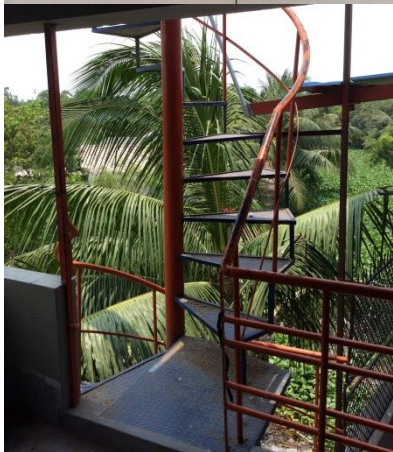
Spiral staircase instead of indicated stairs
