# **FIRE SAFETY INSPECTION REPORT**

## **YOUNG 4 EVER**

**PLOT NO. B-89-90, BSCIC I/A, FATULLAH**

August 16, 2014

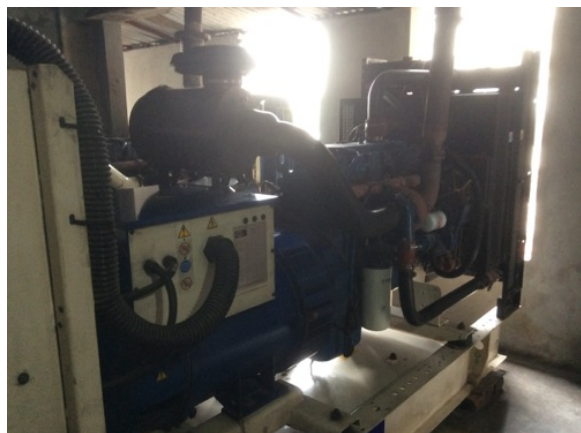
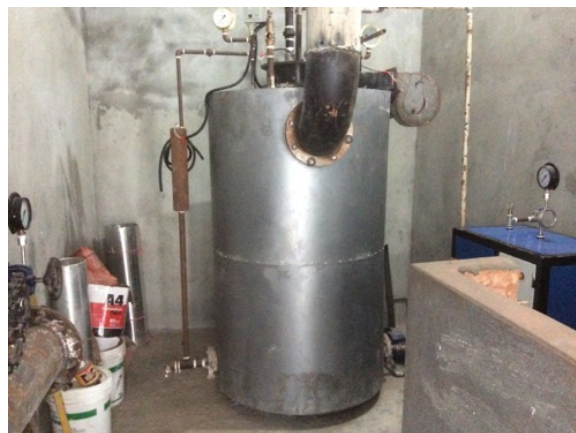
No.	Category	Finding	Recommendation	Remediation Timeframe
F-1	Fire Rated Construction	The boiler and generator room located on the ground floor, is not separated by fire-rated construction, openings, non-rated doors, and penetrations.	Separate the boiler and generator room by a minimum 2-hr fire-rated construction. Seal and/or protected all openings to maintain the required fire separations	Within 3 months

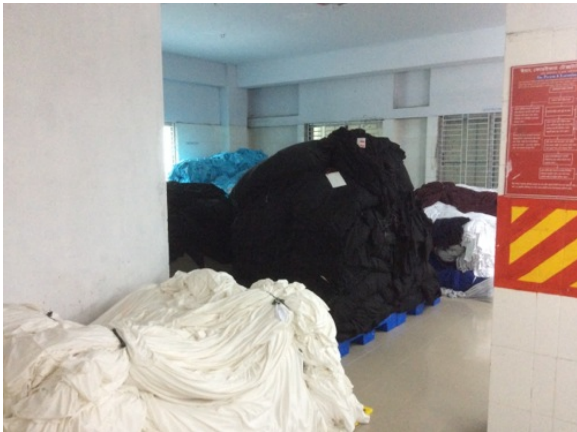
F-2	Fire Rated Construction	Areas used for combustible storage on the first, second, third and fourth floors are not separated by fire-rated construction.	<p>Provide dedicated storage rooms separated by minimum 1-hr fire-rated construction.</p> <p>Where separate storage rooms are not feasible, provide defined storage areas and limit the storage arrangement as follows:</p> <ul style="list-style-type: none"> <li>- Maximum height of 2.4m and maximum area of 23m<sup>2</sup></li> <li>- If sprinkler protected: maximum height of 3.66m and maximum area of 93m<sup>2</sup></li> </ul> <p>Separate areas of unenclosed combustible storage by a minimum clear distance of 3m.</p>	Within 3 months
-----	-------------------------	--	--	-----------------

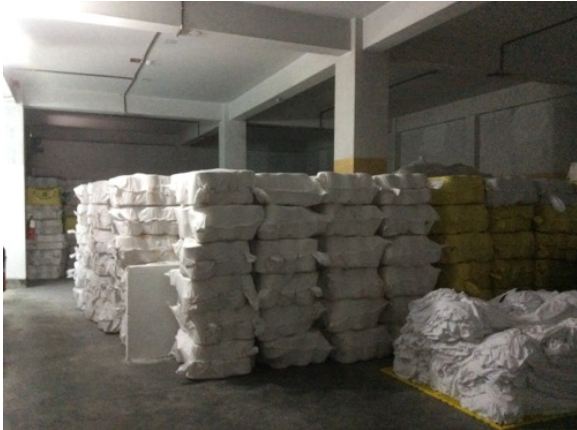
F-3	Fire Rated Construction	Storage rooms used for combustible storage on the ground floor are not separated by fire-rated construction.	Provide dedicated storage rooms separated by minimum 1-hr fire-rated construction.	Within 3 months
-----	-------------------------	--	--	-----------------

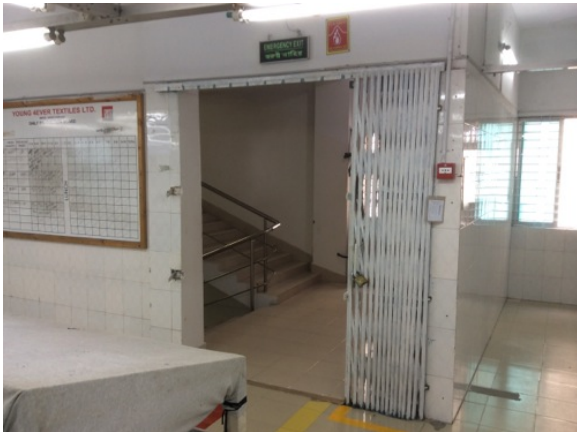
F-4	Fire Rated Construction	The exit stairs are not separated from work areas, and other spaces on each floor by fire-rated construction. This was reflected throughout the building on all floors.	Provide minimum 1.5-hr fire rated doors and seal all unprotected openings to separate the exit stairs from work areas and other building spaces on all floor levels. Ensure that the fire doors are self-closing and positive latching and that they are provided with fire exit (panic) hardware where serving production floors.	Within 3 months
			If fire doors are required to be held open for functional reasons, provide automatic-closing devices tied to the fire alarm system.

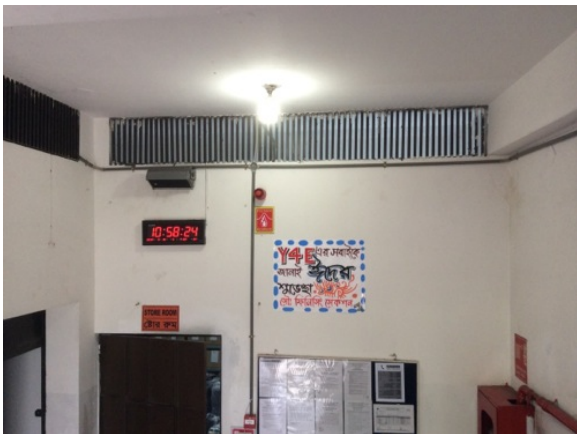
F-5	Fire Rated Construction	Unsealed penetrations and openings on the ground floor are located in both exit stair enclosures.	Seal all penetrations and openings in exit stair enclosure walls to maintain the fire separation.	Within 3 months
-----	-------------------------	---	---	-----------------

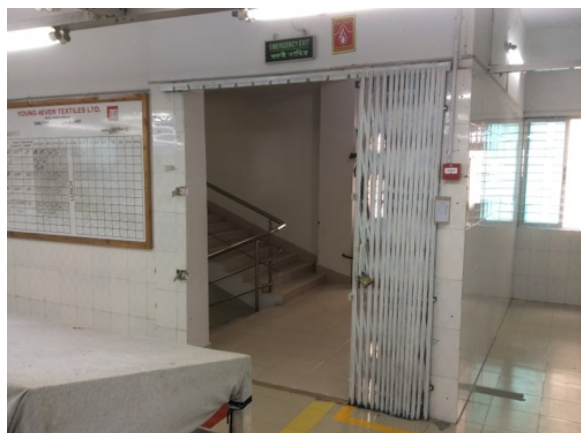
F-6	Egress	Egress doors / gates with locking features are provided at building exits, exit stairs, along egress routes, and exit discharge. This was reflected throughout the building on all floors.	Remove locking features from all egress doors / gates.  If locks are required for security reasons, utilize special door locking features complying with NFPA 101.	Immediate
-----	--------	--	--	-----------

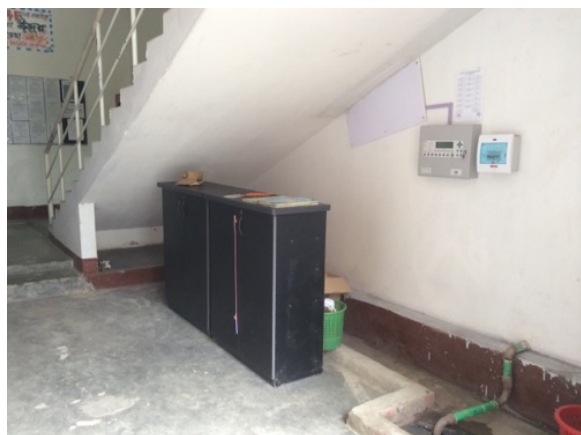
F-7	Egress	Storage was located in both exit stairs, on the ground floor.	Remove all storage from exit stairs and egress paths.	Immediate
-----	--------	---	---	-----------

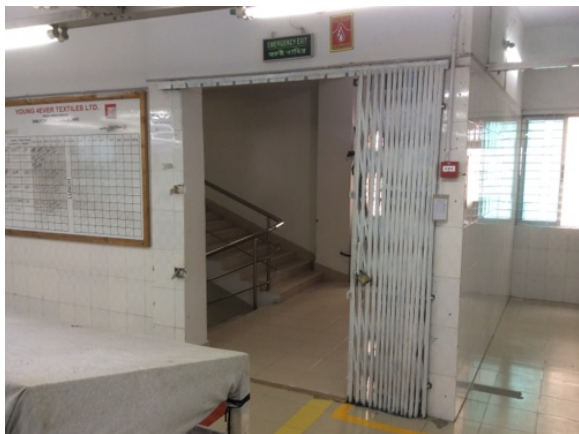
F-8	Egress	Collapsible gates / sliding doors are provided at building exits, exit stairs, along egress routes, and exit discharge. This was reflected throughout the building on all floors.	Replace all gates / sliding doors along the means of egress with side-hinged, swinging egress doors.  If locks are required for security reasons, utilize special door locking features complying with NFPA 101.	Within 1 month
-----	--------	---	--	----------------

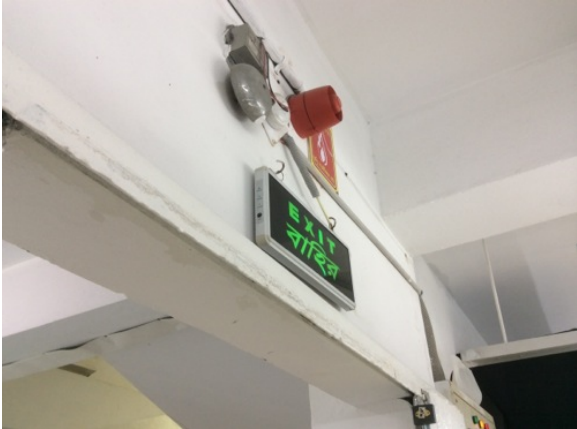
F-12	Egress Lighting	Manual on-off switch is provided for emergency lighting units. This was reflected throughout the building in various locations.	Remove manual on/off switches from emergency lighting units to prevent them from being switched off.	Within 1 month
