# **FIRE SAFETY INSPECTION REPORT**

## **WINDY APPARELS LTD.**

May 4, 2014

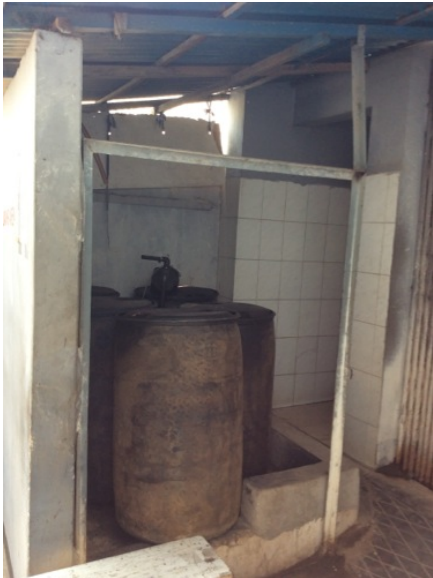
| No. | Category | Finding | Recommendation | Remediation Timeframe |
|---|---|---|---|---|
| F-1 | Fire Rated Construction | Flammable liquid storage area (diesel drums) is located at southeast corner on the ground level, with no separated by fire-rated construction (openings). | Separate the flammable liquid storage room by a minimum 2-hr fire-rated construction. Seal or protected all openings to maintain the required fire separations. | Within 3 months |

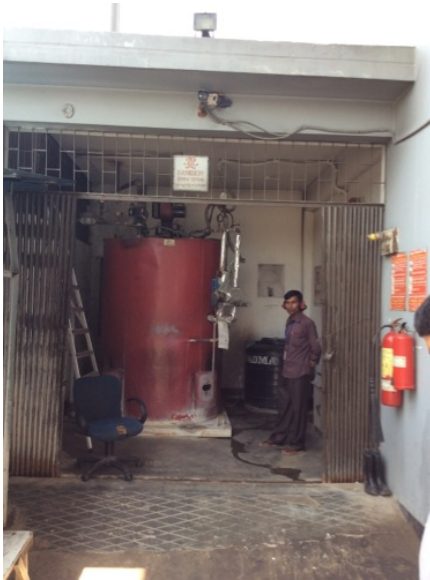
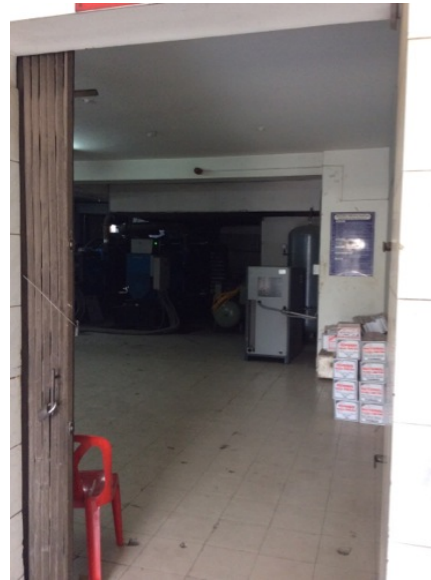
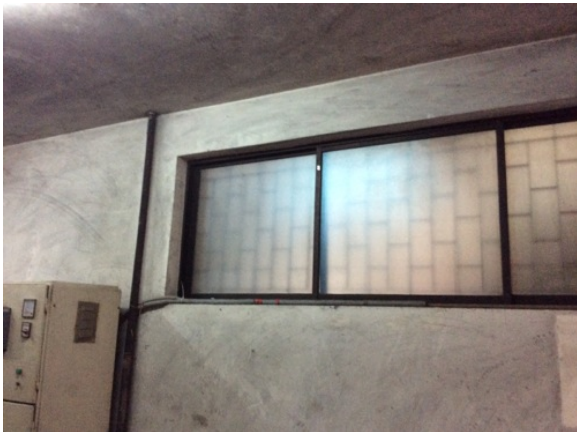
| No. | Category | Finding | Recommendation | Remediation Timeframe |
|---|---|---|---|---|
| F-2 | Fire Rated Construction | The boiler, generator and transformer rooms are not separated by fire-rated construction (openings, non-rated doors, penetrations). | Separate the boiler, generator and transformer rooms by a minimum 2-hr fire-rated construction. Seal and protected all openings to maintain the required fire separations | Within 3 months |

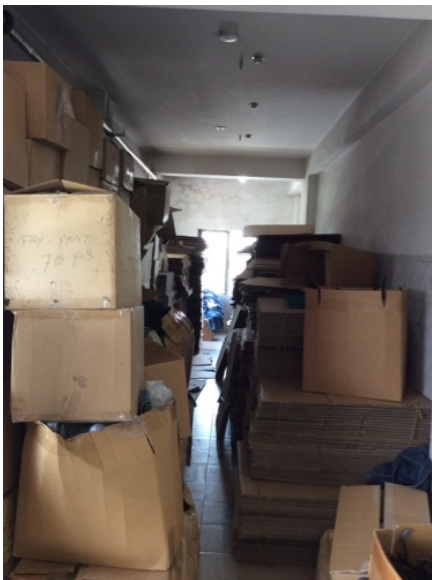
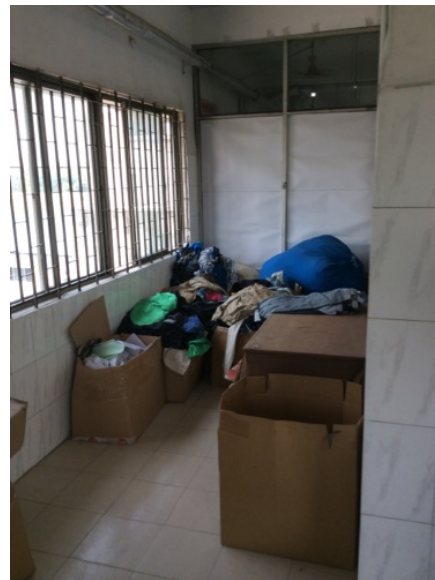
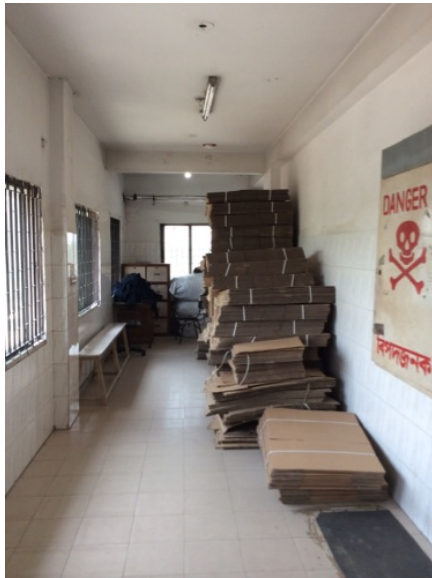
| F-3 | Fire Rated Construction | Areas used for combustible storage on the 2nd and 6th floors are not separated by fire-rated construction. | <p>Provide dedicated storage rooms separated by minimum 1-hr fire-rated construction.</p> <p>Where separate storage rooms are not feasible, provide defined storage areas and limit the storage arrangement as follows:</p> <ul style="list-style-type: none"><li>- Maximum height of 2.4m and maximum area of 23m<sup>2</sup></li><li>- If sprinkler protected: maximum height of 3.66m and maximum area of 93m<sup>2</sup></li></ul> <p>Separate areas of unenclosed combustible storage by a minimum clear distance of 3m.</p> | Within 3 months |

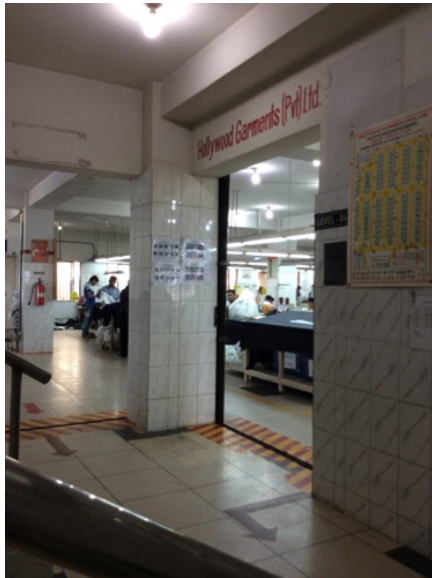
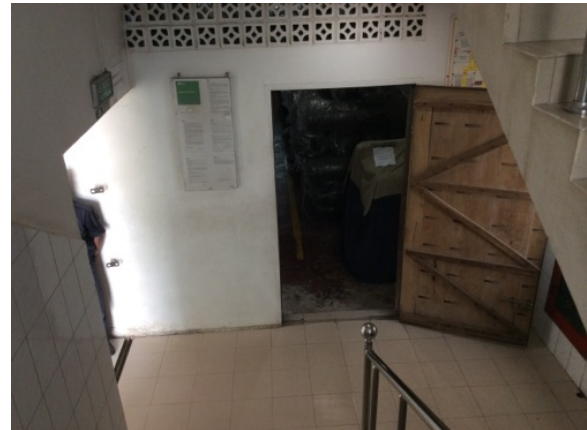
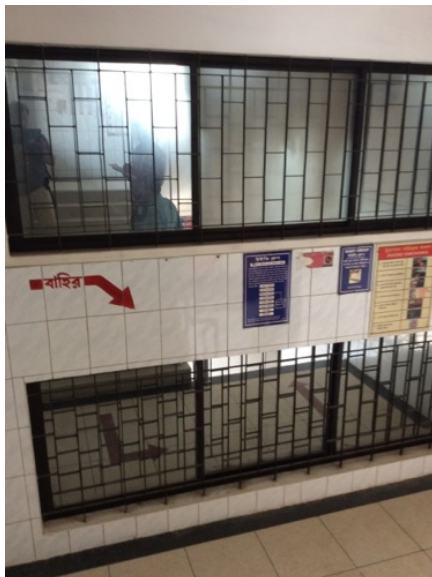
| F-4 | Fire Rated Construction | The north and south exit stairs are not separated from work areas on each floor, and general storage on ground floor by fire-rated construction. | Provide minimum 1.5-hr fire rated doors and seal all unprotected openings to separate the exit stairs from work areas and other building spaces on all floor levels. Ensure that the fire doors are self-closing and positive latching and that they are provided with fire exit (panic) hardware where serving production floors.<br><br>If fire doors are required to be held open for functional reasons, provide automatic-closing devices tied to the fire alarm system. | Within 3 months |

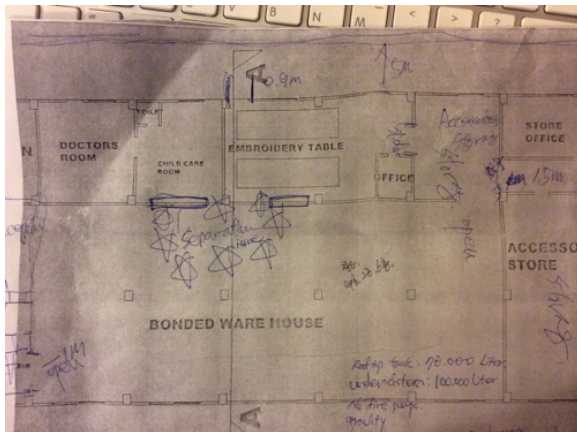
| F-5 | Fire Rated Construction | Unsealed penetrations and openings to day-care and embroidery rooms are located in general storage on the ground floor. | Seal all penetrations and openings in general storage enclosure walls to maintain the fire separation. | Within 3 months |

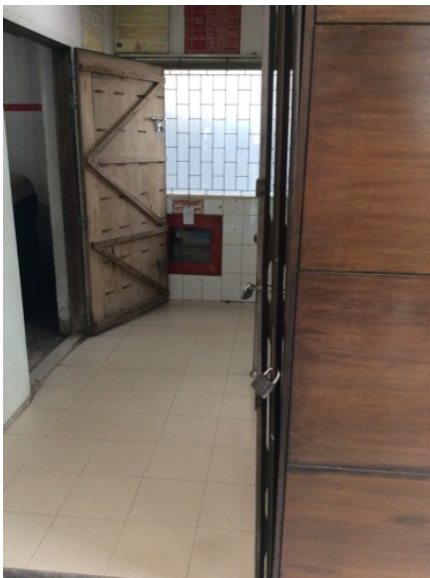
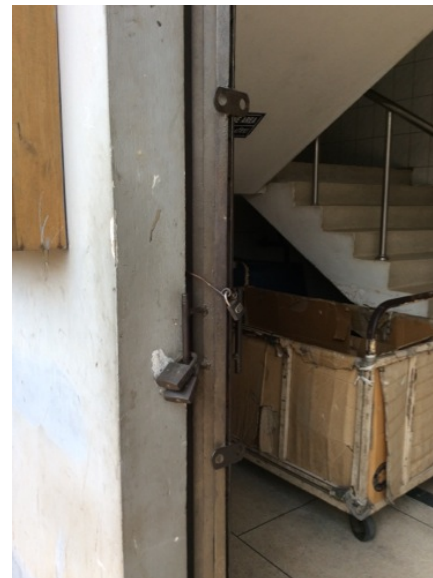
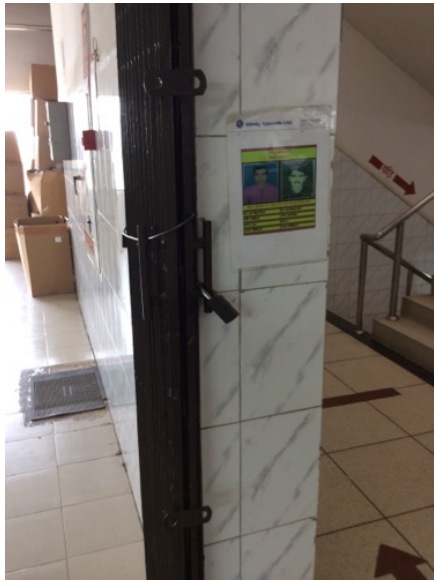
| F-6 | Egress | Egress doors and gates with locking features are provided at building exits, exit stairs, and exit discharge. | Remove locking features from all egress doors and gates.<br><br>If locks are required for security reasons, utilize special door locking features complying with NFPA 101. | Immediate |

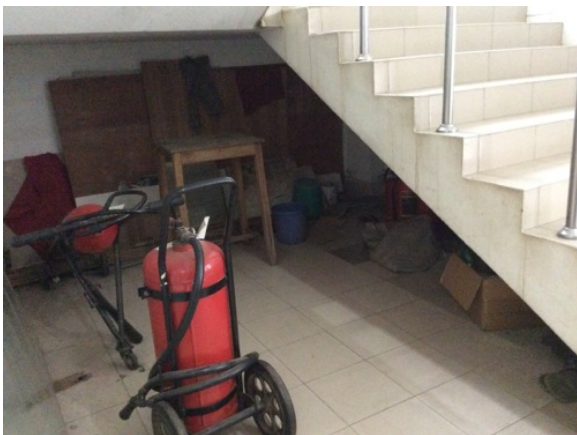
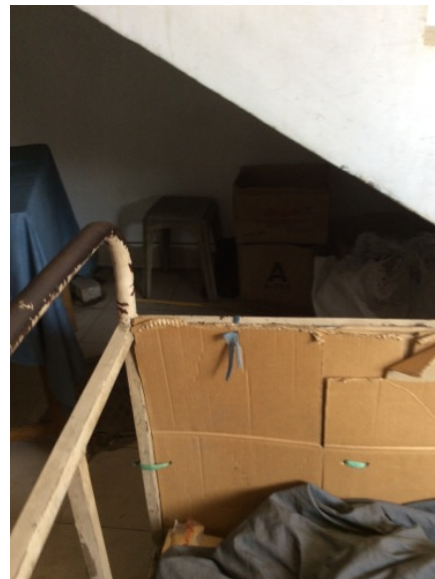
| F-7 | Egress | Storages were located under the north and south exit stairs. | Remove all storage from exit stairs and egress paths. | Immediate |

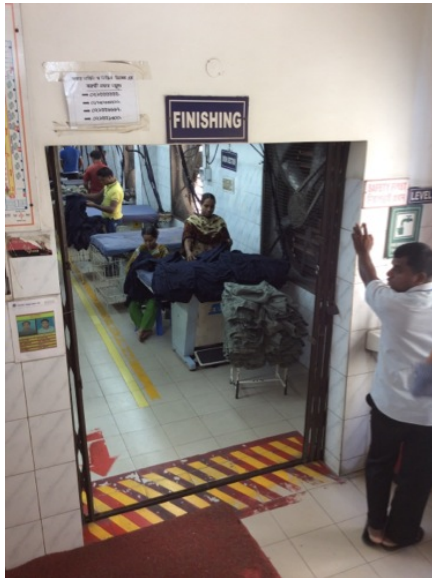
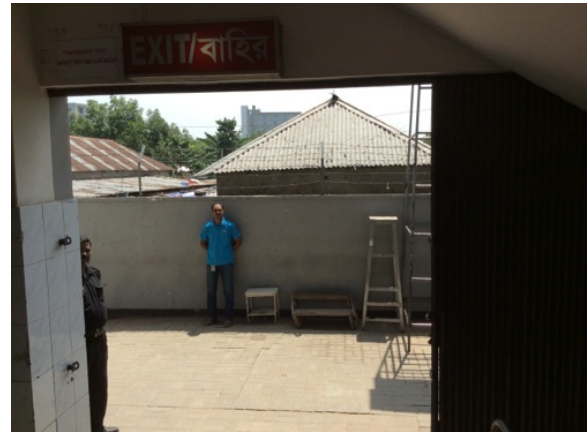
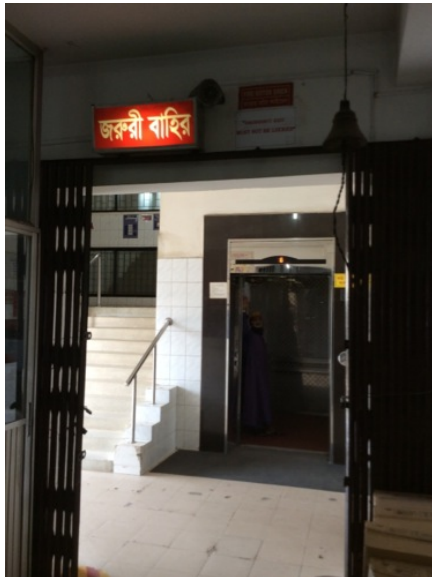
| F-8 | Egress | Collapsible gates are provided at building exits, exit stairs, and exit discharge. | Replace all collapsible gates along the means of egress with side-hinged, swinging egress doors.<br><br>If locks are required for security reasons, utilize special door locking features complying with NFPA 101. | Within 1 month |

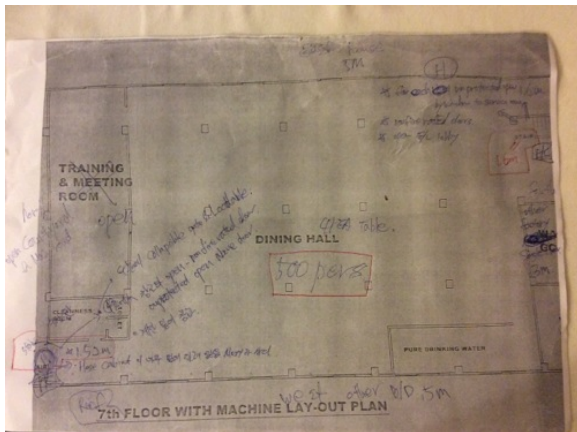
| F-9 | Egress | <p>Exit capacity is not adequate for the occupant load.</p> <p>The occupant load for the roof floor is 500 persons, however these exceed the egress capacity provided which is 390 persons.</p> | <p>Reduce occupant load to not more than available exit capacity or Provide additional exit.</p> | <p>Within 3 months</p> |

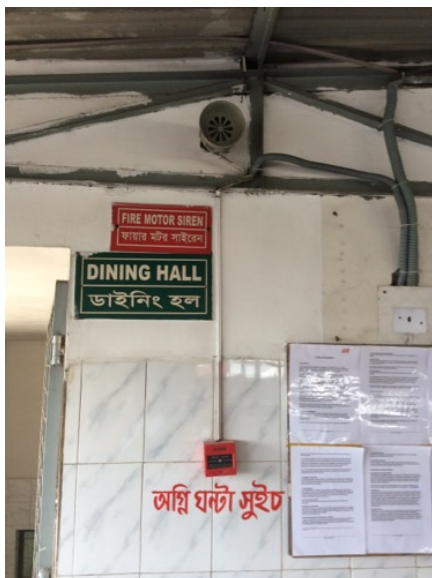
| F-10 | Fire Protection | The fire alarm system is antiquated, not a listed system, and does not provide alarm and notification features consistent with acceptable standards. | Replace the fire alarm system with a new, listed addressable fire alarm system in accordance with NFPA 72. | Design within 4 months, install within 9 months |

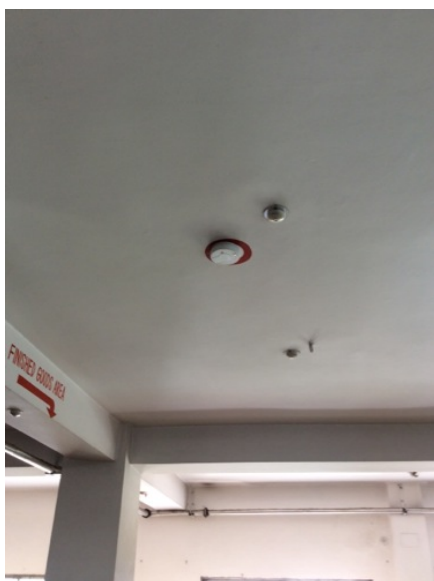
| F-12 | Fire Protection | The building is equipped with single-station smoke alarms. Smoke alarm activation sounds only a local alarm and does not provide automatic fire alarm notification of occupants. | Replace the single-station smoke alarms. Provide automatic smoke detection throughout the building in accordance with NFPA 72. | Within 6 months |
