# **FIRE SAFETY INSPECTION REPORT**

**WINTER DRESS LIMITED**  
**1 NO.KALMA, DAIRY FARM, SAVAR, DHAKA**

**ACCORD**  
on Fire and Building Safety in Bangladesh

August 19, 2014

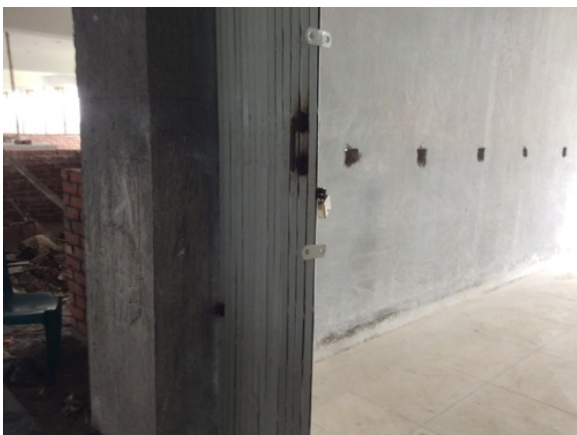
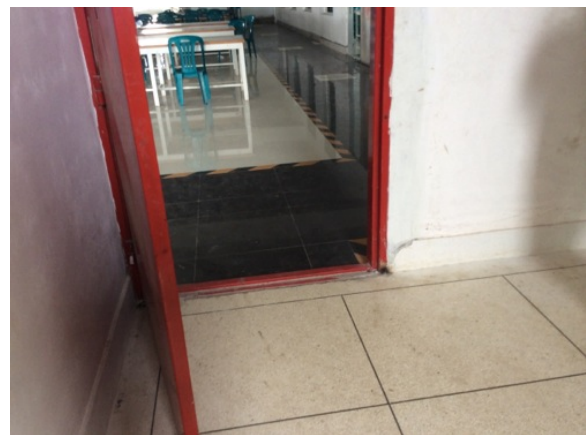
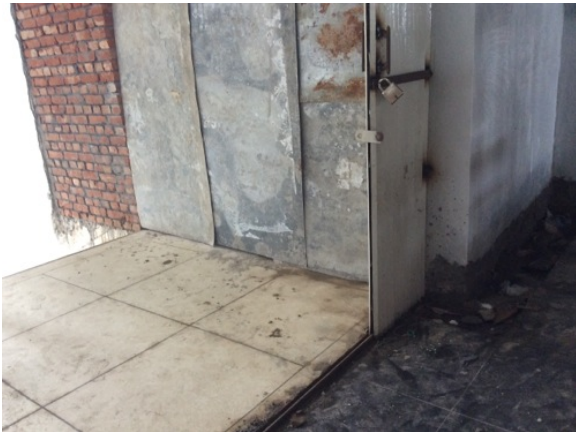
| No. | Category | Finding | Recommendation | Remediation<br>Timeframe |
|---|---|---|---|---|
| F-1 | Fire Rated<br>Construction | The exit stairs are not separated from work areas, other spaces on each floor by fire-rated construction. | <p>Provide minimum 1.5-hr fire rated doors and seal all unprotected openings to separate the exit stairs from work areas and other building spaces on all floor levels. Ensure that the fire doors are self-closing and positive latching and that they are provided with fire exit (panic) hardware where serving production floors.</p> <p>If fire doors are required to be held open for functional reasons, provide automatic-closing devices tied to the fire alarm system.</p> | Within 3 months |

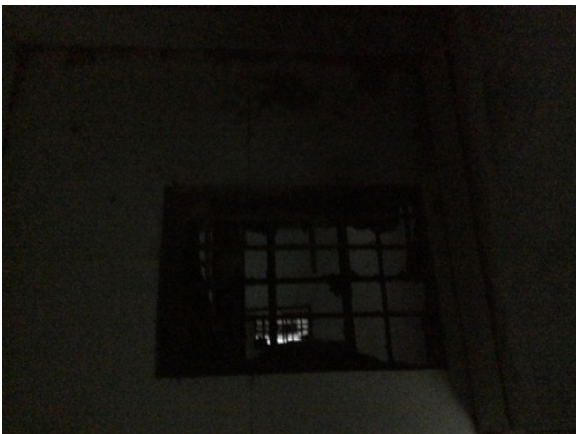
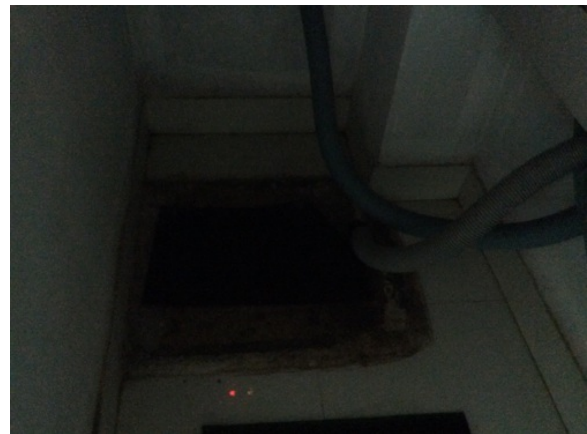
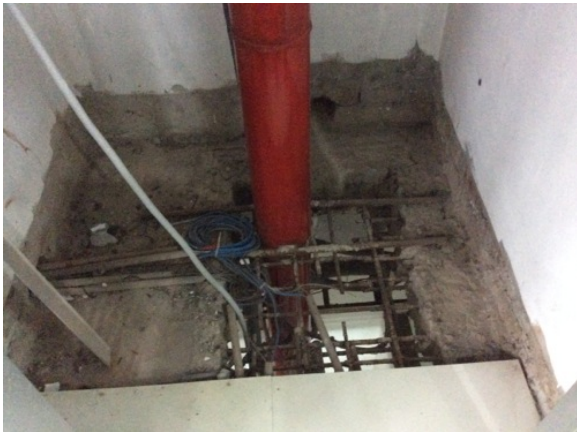
| F-2 | Fire Rated Construction | Unsealed penetrations and openings are located in the fire-rated floor and ceiling assemblies. | Provide a minimum 2-hr fire-rated shaft to separate the utility risers from each floor level. | Within 3 months |

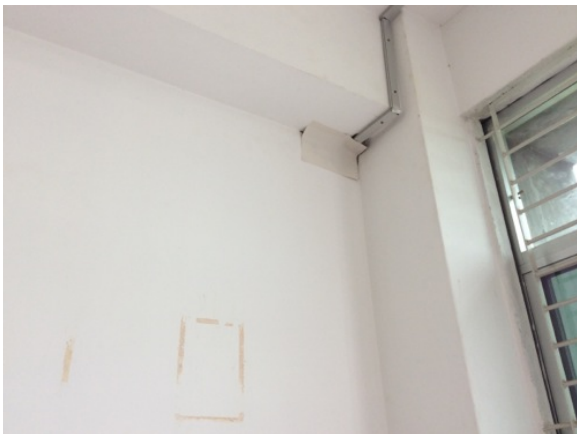
| F-3 | Fire Rated Construction | Unsealed penetrations and openings are located in exit stair enclosures. | Seal all penetrations and openings in exit stair enclosure walls to maintain the fire separation. | Within 3 months |

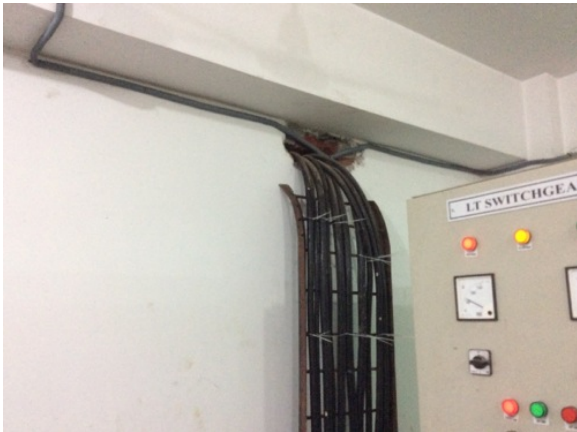
| F-4 | Fire Rated Construction | The transformer room is not separated by fire-rated construction due to penetrations on the ground floor. | Separate the transformer room by a minimum 2-hr fire-rated construction. Seal and protect all openings to maintain the required fire separations | Within 3 months |

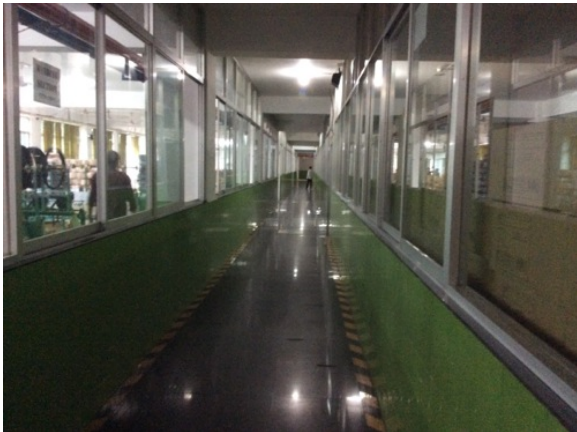
| F-5 | Fire Rated Construction | Storerooms used for combustible storages are not separated by fire-rated construction on the ground and first floors. | Provide dedicated storage rooms separated by minimum 1-hr fire-rated construction. | Within 3 months |

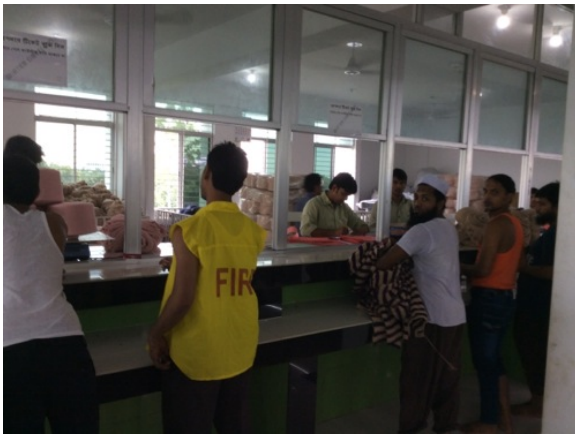
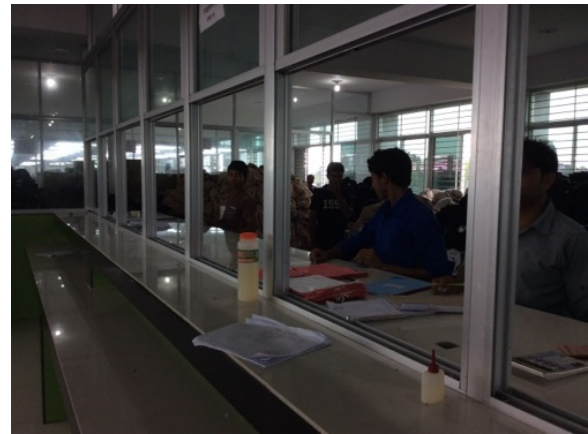
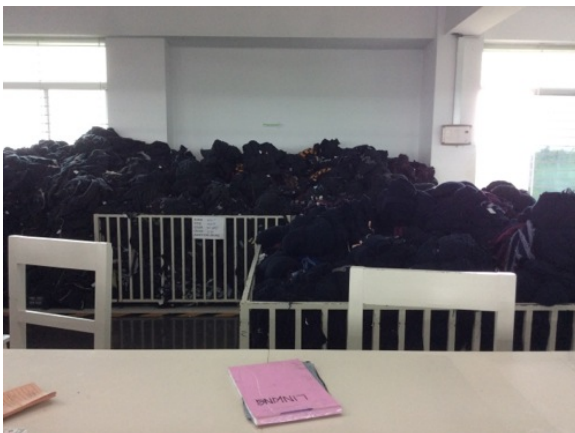
| F-6 | Fire Rated Construction | Areas used for combustible storages are open to the factory floors on the first, second and third floor. | Provide defined storage areas and limit the storage arrangement as follows: <ul style="list-style-type: none"><li>- Maximum height of 2.4m and maximum area of 23m<sup>2</sup></li><li>- Separate areas of unenclosed combustible storage by a minimum clear distance of 3m.</li></ul> | Within 3 months |

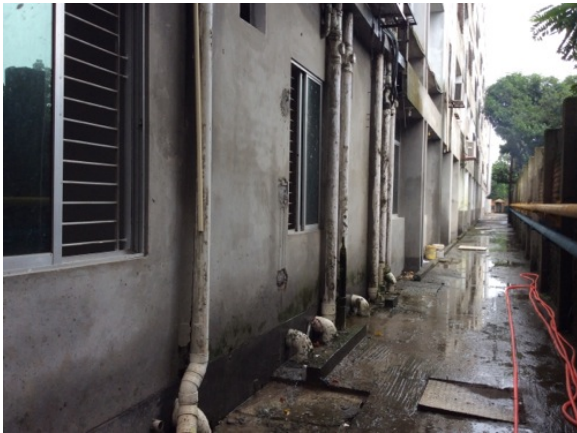
| F-7 | Fire Rated Construction | The exit discharge path serving North East exit is less than 10 ft wide and is not separated from the building interior. | Seal all penetrations and openings to the interior of the building along the discharge path, up to a height of 10 ft., to provide a minimum 1-hr fire separation. | Within 6 months |

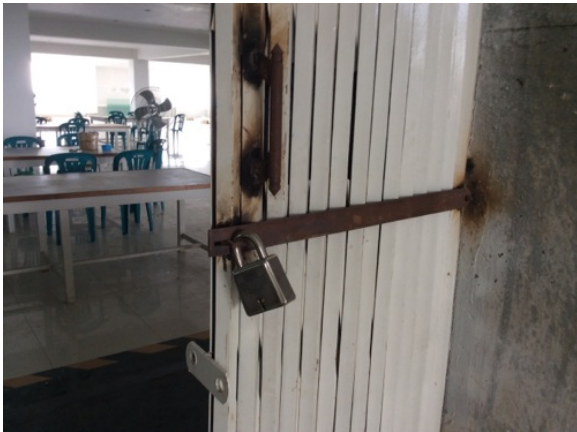
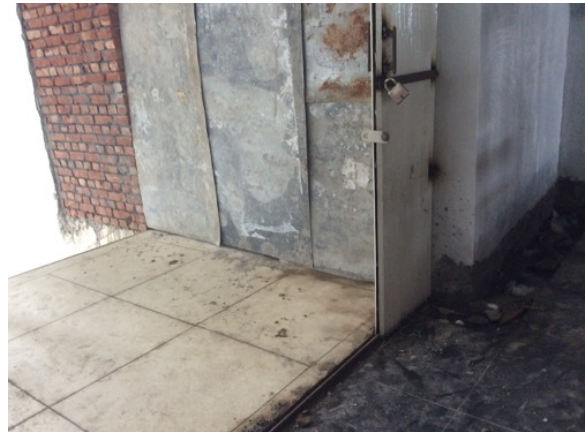
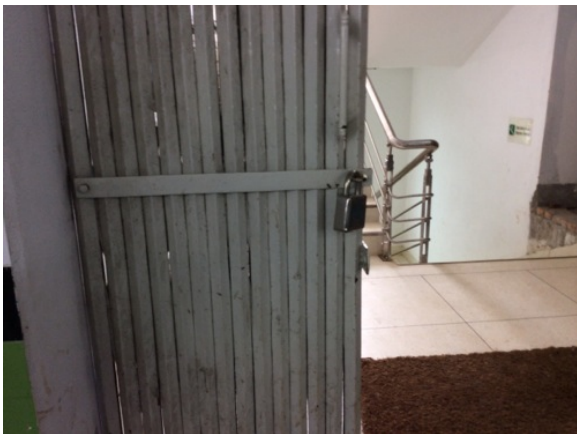
| F-9 | Egress | Egress gates with locking features (padlocks) are provided at building exits and exit stairs. All gates and doors were open and unlocked during the inspection. | Remove locking features from all egress gates.<br><br>If locks are required for security reasons, utilize special door locking features complying with NFPA 101. | Immediate |

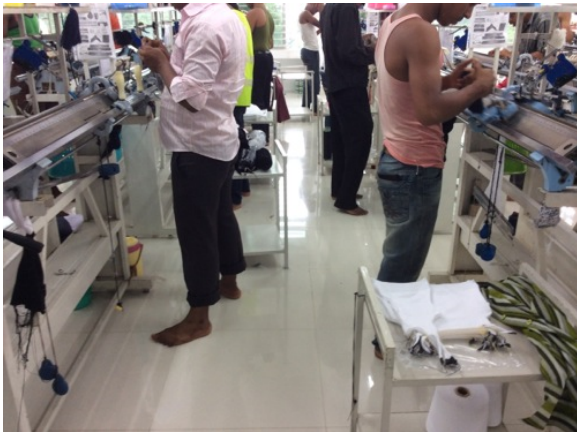
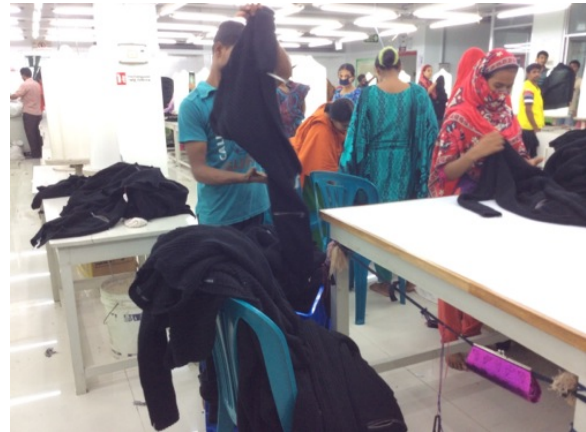
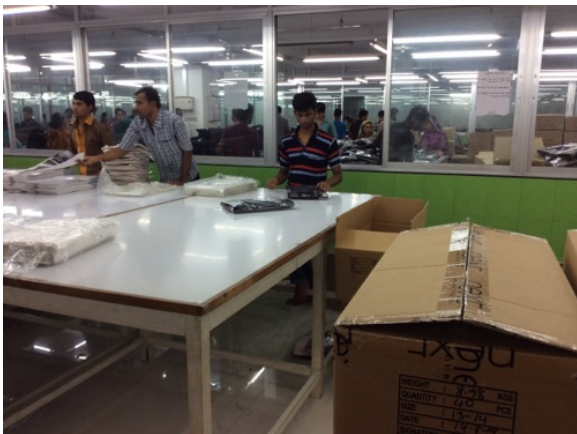
| F-10 | Egress | Storage was located in the egress path on all the floors except the fourth floor. | Keep egress paths and stairs clear of storage. | Immediate |

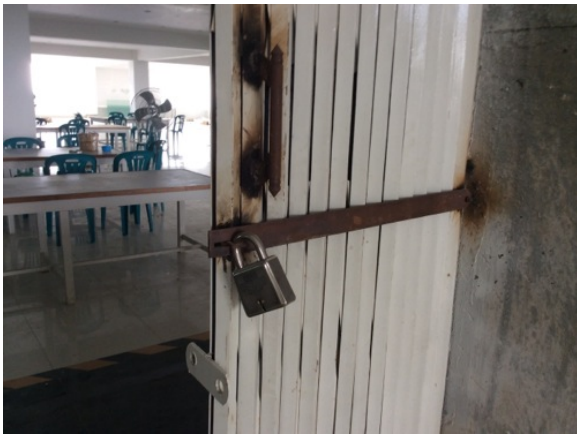
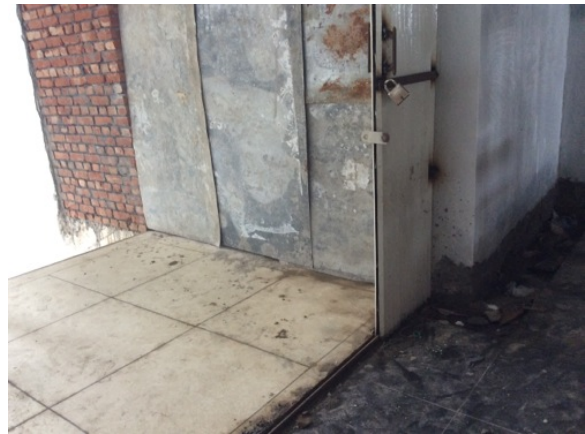
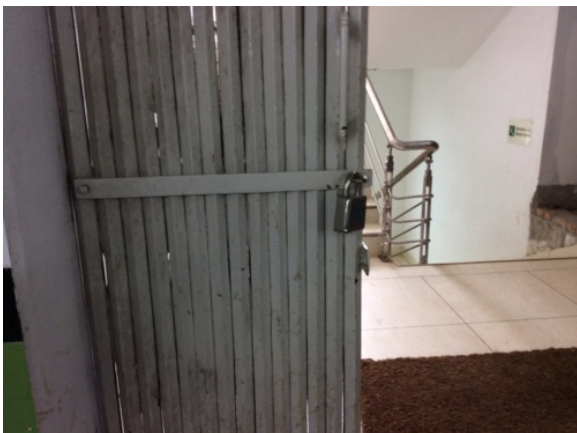
| F-12 | Egress | Collapsible gates are provided at building exits and exit stairs. | Replace all gates along the means of egress with side-hinged, swinging egress doors. | Within 1 month |

If locks are required for security reasons, utilize special door locking features complying with NFPA 101.

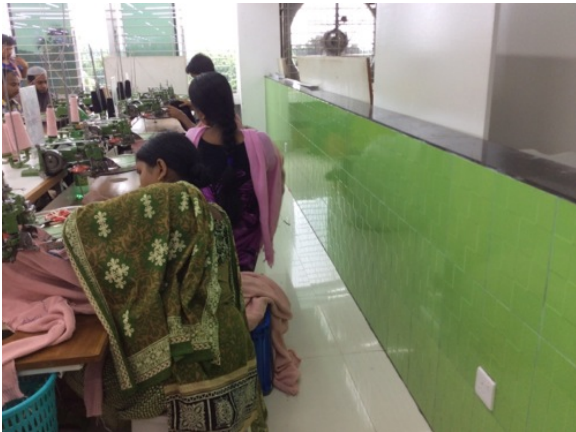
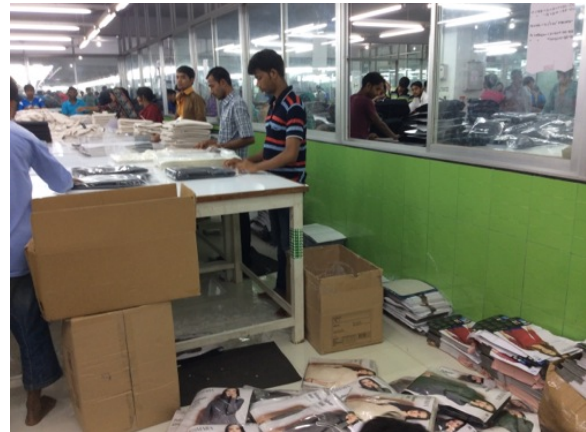
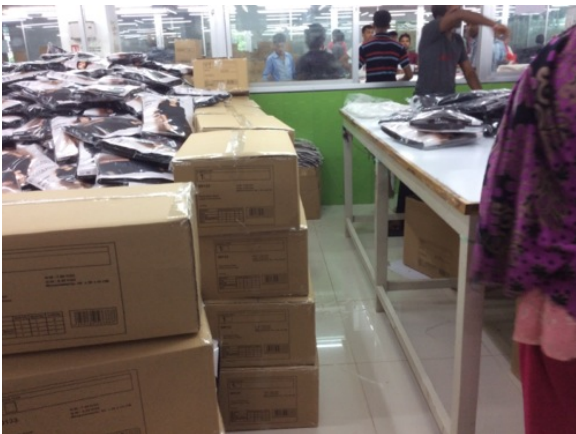
| F-13 | Egress | The width of egress aisles is less than 36-in. on all the floors except the fourth floor. | Provide minimum aisle widths of 36-in. | Within 3 months |

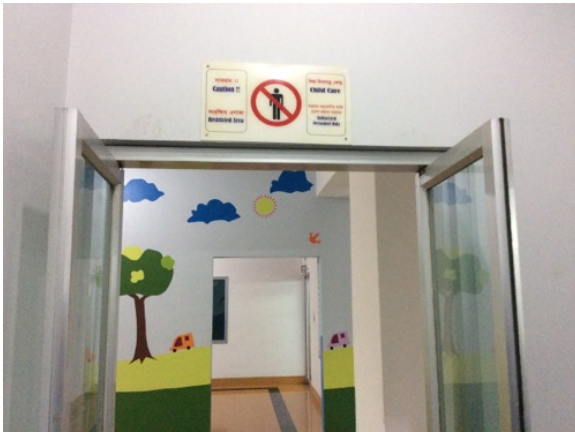
| F-14 | Egress | The day-care room does not have direct access to an exit stair on the first floor. | Relocate day-care room to ground floor with maximum travel distance of 9m (30 ft). | Within 3 months |
