# Integra Apparel (Bangladesh) Co., Ltd.(11376)

16.MARCH.2014

**ACCORD**  
on Fire and Building Safety in Bangladesh

## Site Observations

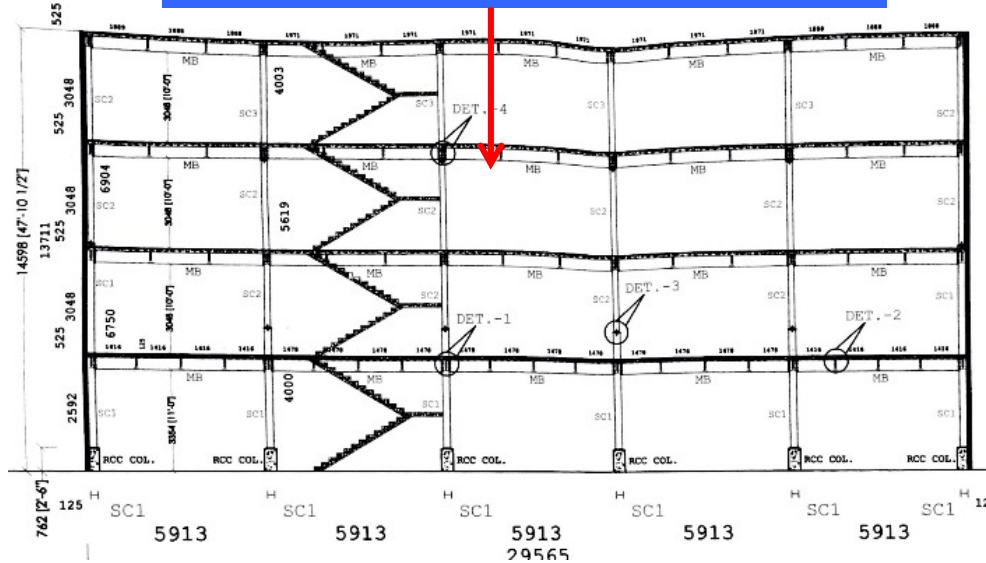
## Proposed 4 Storey Structural Drawing

**Adequacy of column and foundation capacities are required to be investigated and confirmed.**

**Load rundown based on the 4 storey structural drawings** - at a key steel column, it is found that the steel column has a FOS between 1.25 and 1.50 which gives an AMBER rating.

- A Detailed Engineering Assessment of factory to be carried out and in particular column capacity and foundation aspects to be investigated in detail.

- Continue to implement loading plan. Detail engineering assessment to be completed.
- Do not construct any further structural construction without a thorough structural design and full building approval.

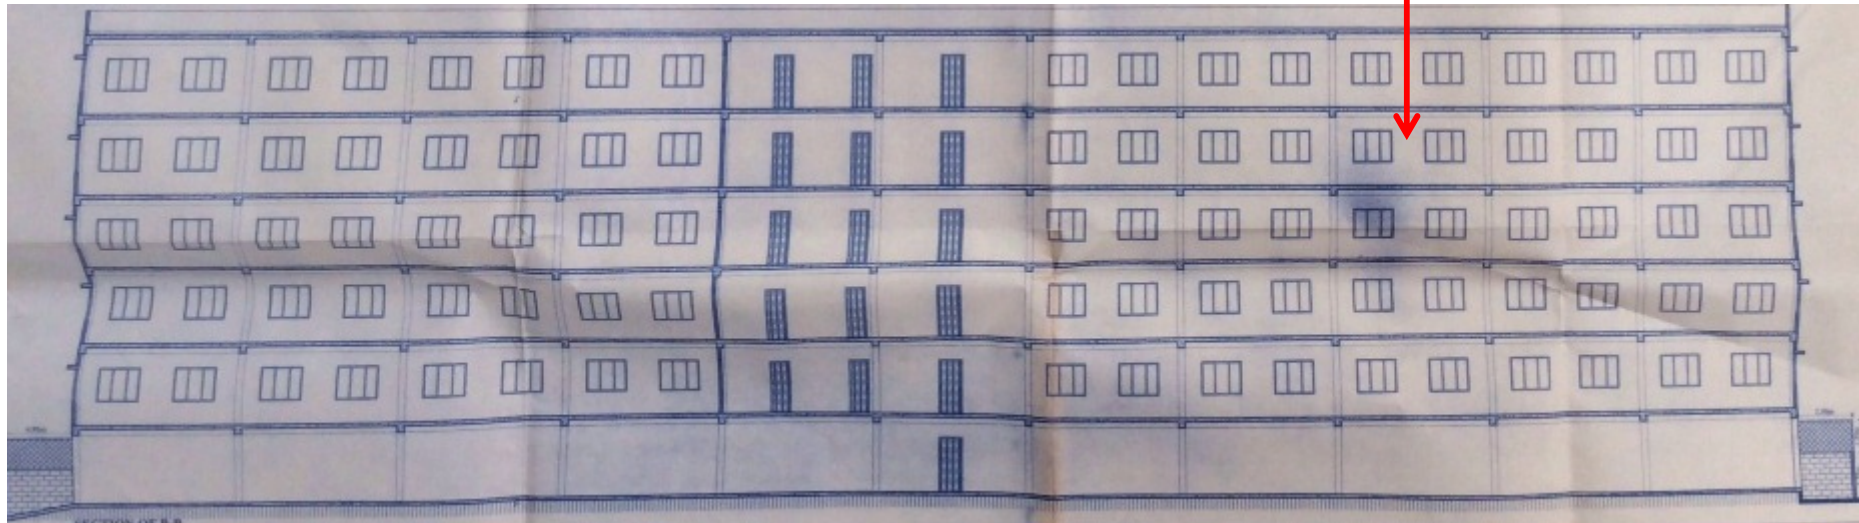
## Proposed 6 Storey Architectural drawing

**Load rundown based on the 6 storey architectural drawings** - at a key steel column, it is found that the steel column has a FOS lower than 1.00 which is RED rating.

**NOTE:** The structural drawings don't match with the architectural drawings. The adequacy of the columns and foundations must be investigated and confirmed.

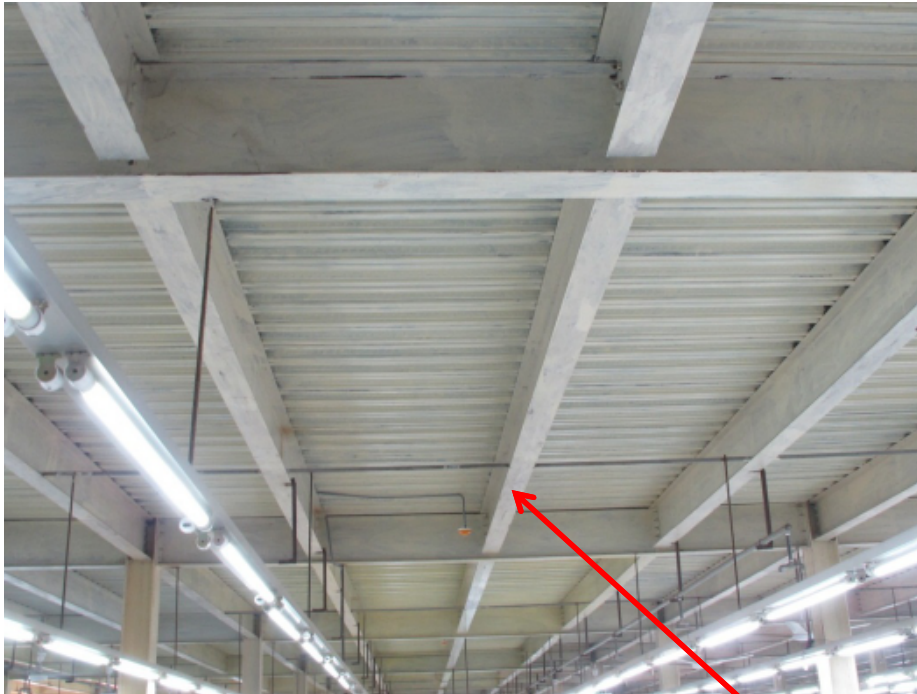
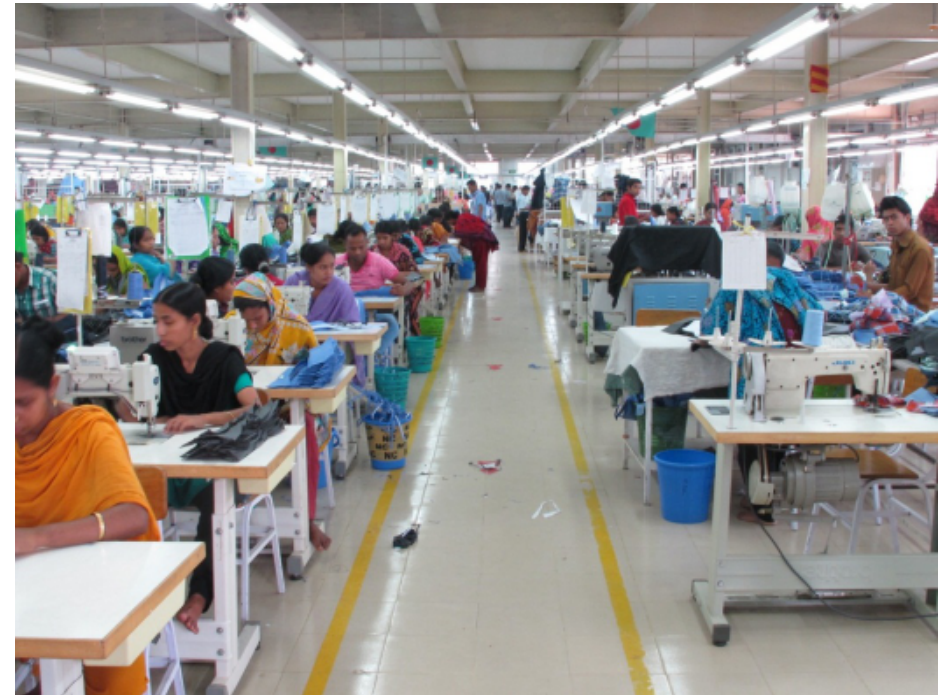
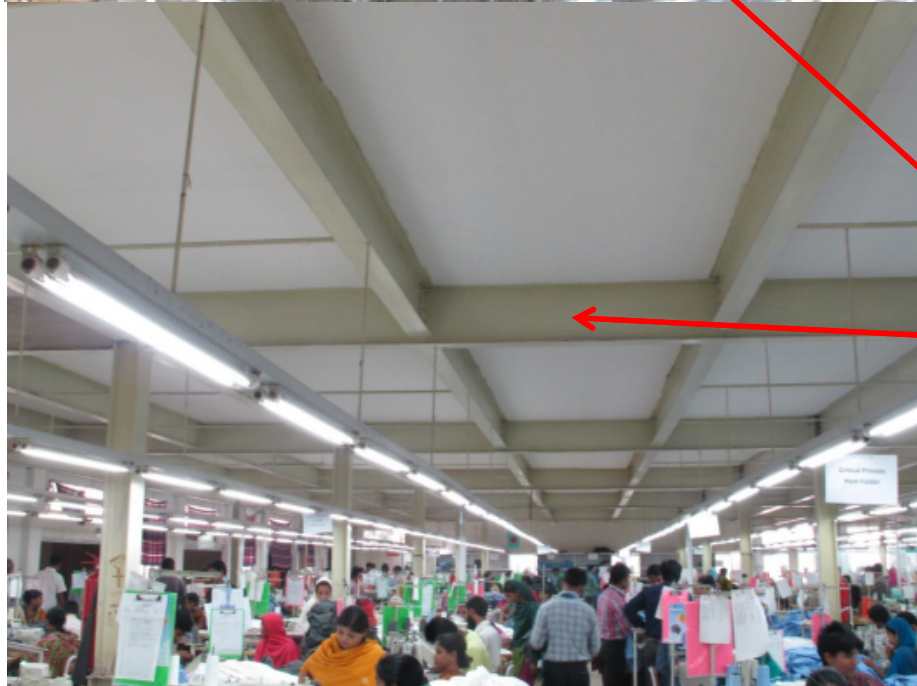
Fire proofing material for steel structure is required.

Fire proofing material for structural steel element is recommended.

- Fire proofing material for structural steel element is recommended as it is normal good building practice.

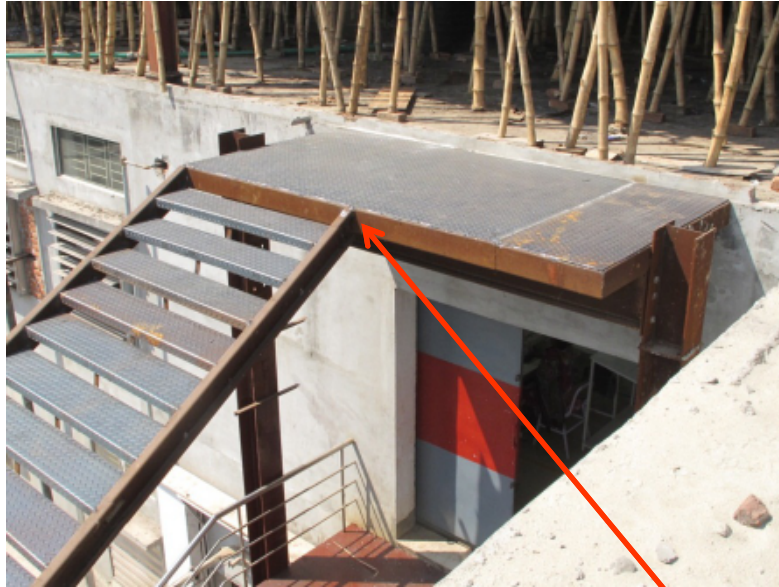
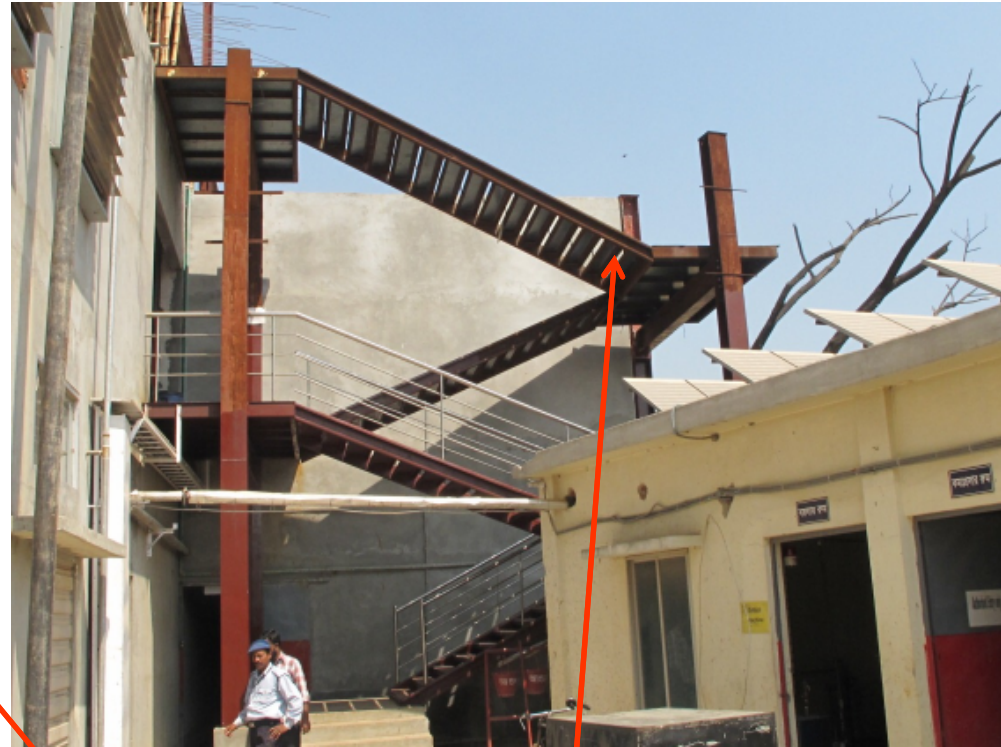
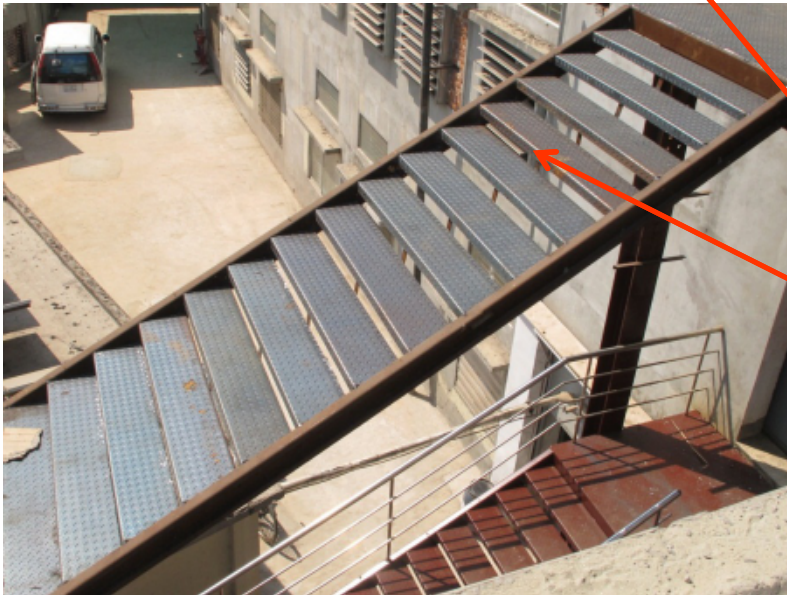
## Capacity check for fire escape steel staircase

Capacity check for fire escape steel staircase is required due to no drawings being provided.

- A Detailed Engineering Assessment to be carried out in particular the steel column capacities and the connection capacities.

- Continue to implement loading plan. Detailed Engineering Assessment is to be completed.

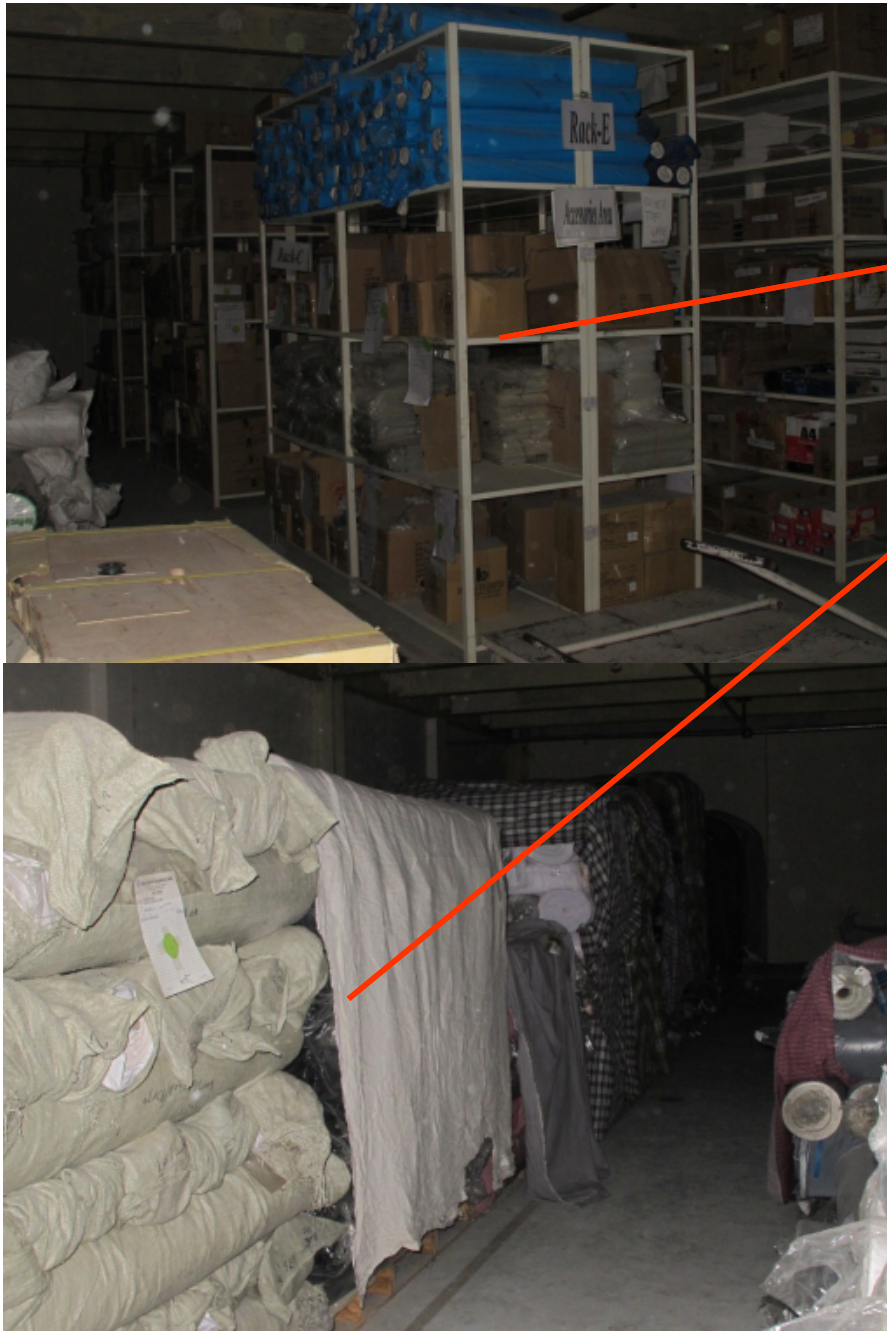
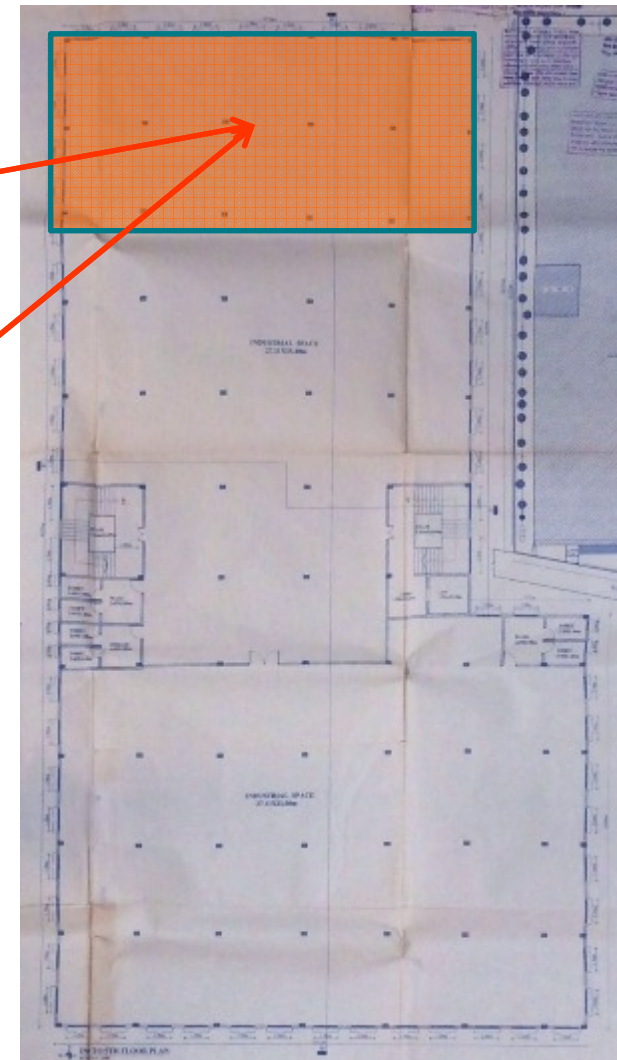
# Uncontrolled Heavy Storage Loading

Uncontrolled heavy storage on ground floor.

- Reduce stacking height of fabric rolls to ensure total load does not exceed 3.0kPa
- Adopt some sort of signage/staff guidance or a loading Plan to ensure that the maximum weight of storage is not exceeded.

- Maintain standards of quality control to ensure that storage procedures are correctly followed so that overloading problems do not arise in the future.

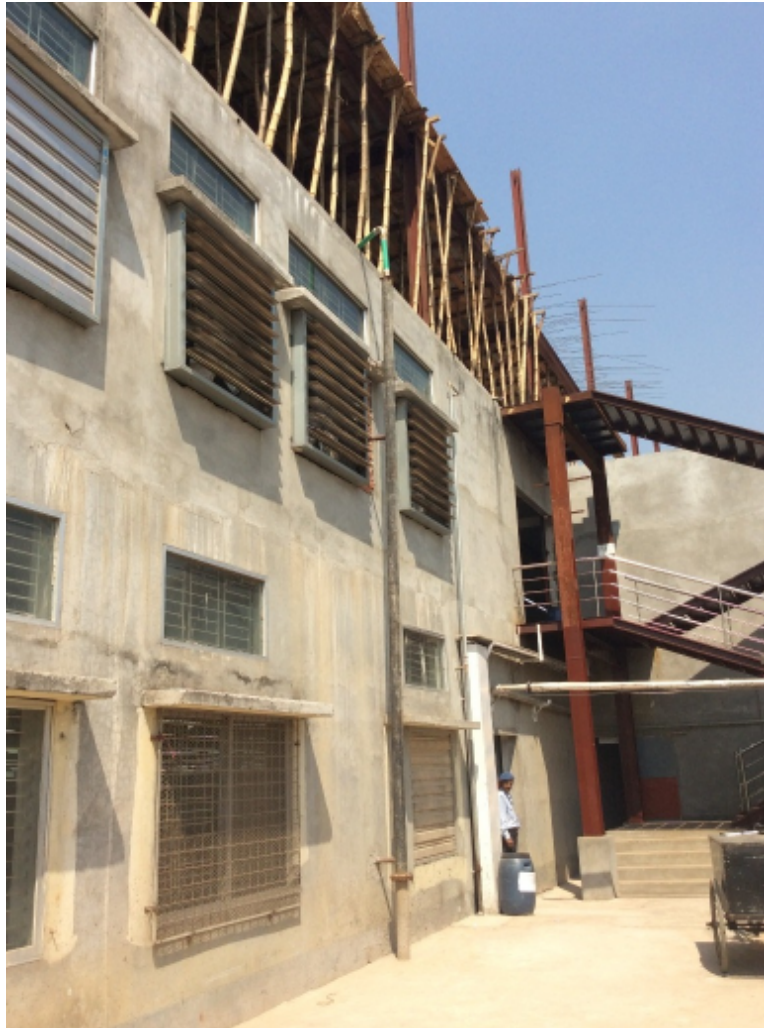
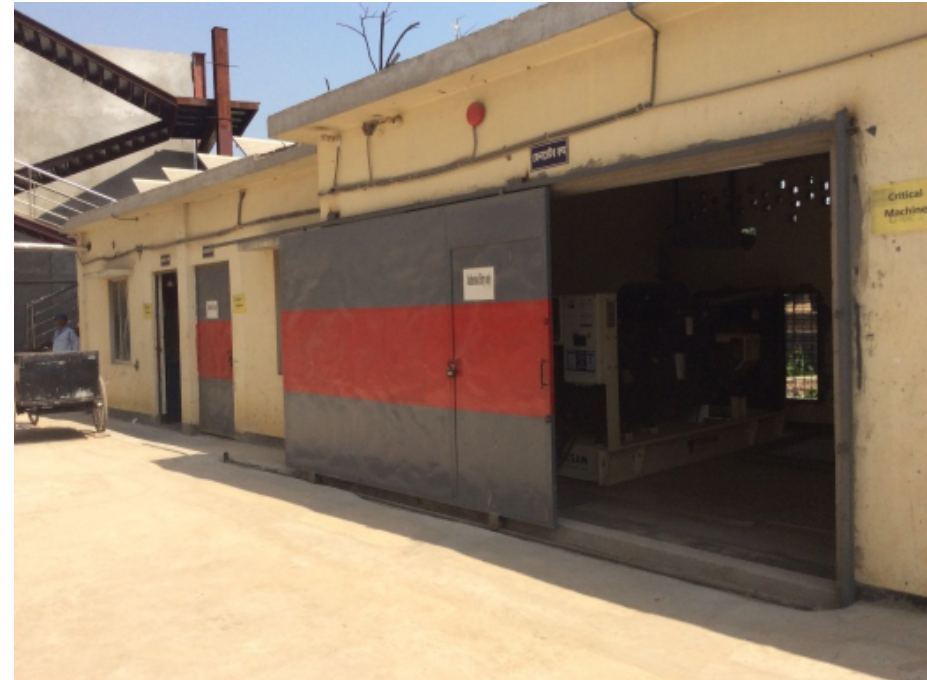
## Overall Stability System

Further detail engineering assessment is required whether such system can resist the lateral load from wind & earthquake

Concerns on the stability system for lateral loading and seismic loading. Façade brickwork with little capacity; lack of moment capacity in connection between columns and beams.

- Detail engineering assessment to be carried out in particular stability and foundation aspects to be investigated in detail.

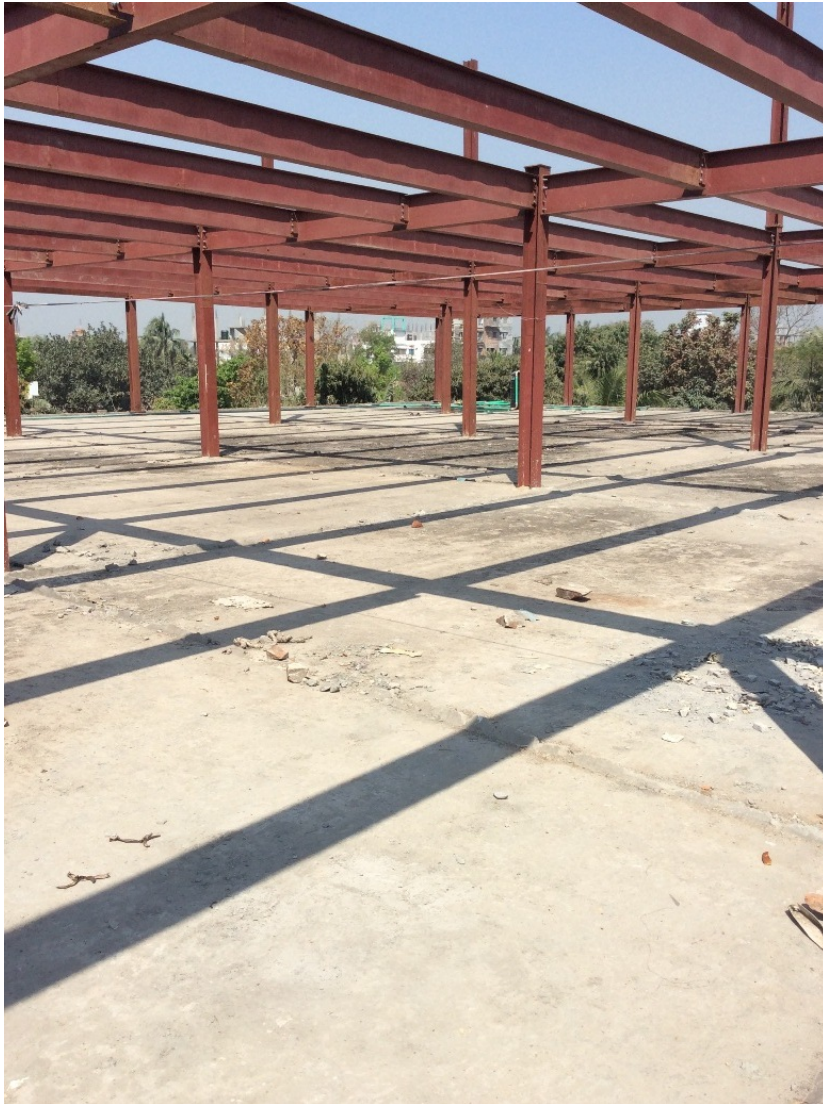
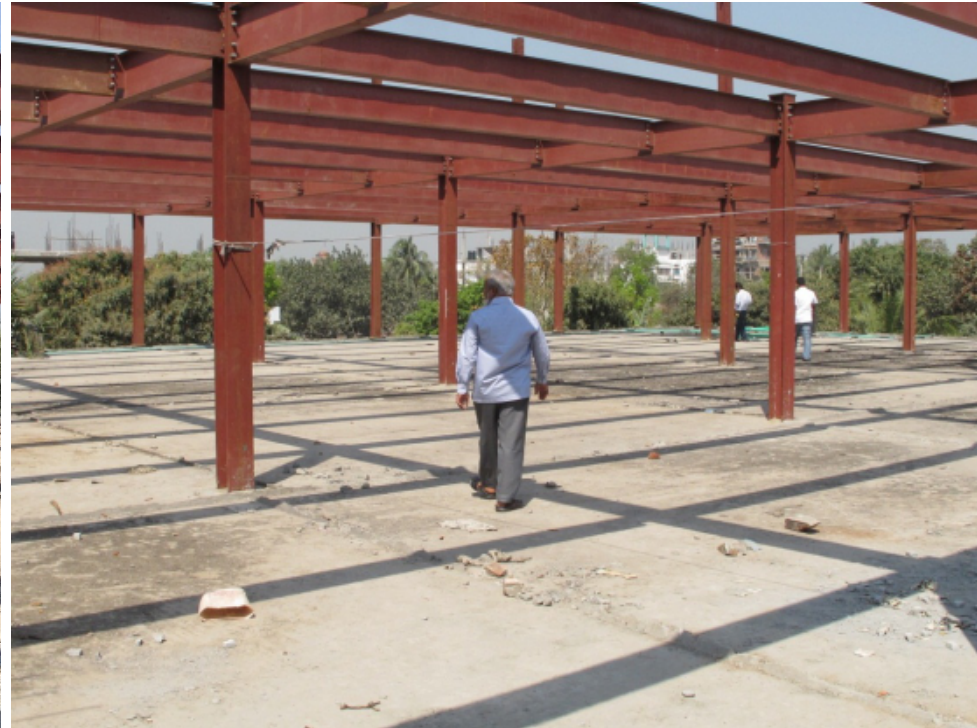
# Water Ingress

There is no evidence of water ingress on the 2<sup>nd</sup> floor, however, it should be considered as an on-going action to apply waterproofing measures during construction, while the 4<sup>th</sup> floor acts as a roof level.

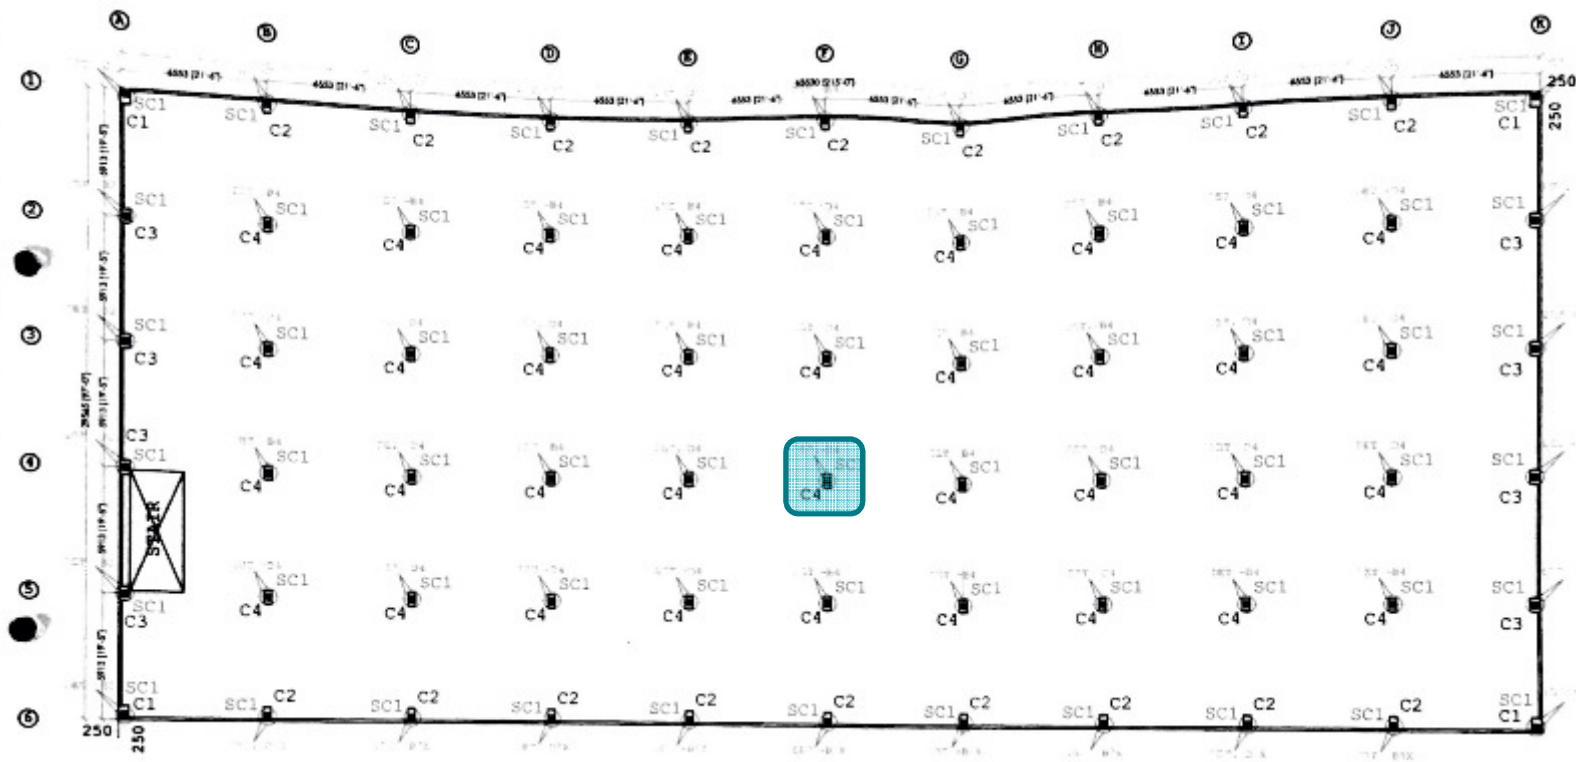
## Key Column Stress Check :

**Load rundown based on the 4 storey structural drawings** - a key steel column, it is found that the steel column is within the range of FOS equal to between 1.25 and 1.50 which is AMBER rating.

**Load rundown based on the 6 storey architectural drawings** - a key steel column, it is found that the steel column is within the range of FOS lower than 1.00 which is RED rating.
